Subject: Transmittal of the Cow Pen Creek Wetland Restoration Monitoring Report
Lockheed Martin Corporation – Middle River Complex
2323 Eastern Boulevard, Middle River, Baltimore County, Maryland

**COW PEN CREEK
WETLAND RESTORATION MONITORING REPORT
2323 EASTERN BOULEVARD
LOCKHEED MARTIN MIDDLE RIVER COMPLEX
MIDDLE RIVER, MARYLAND**

March 2020

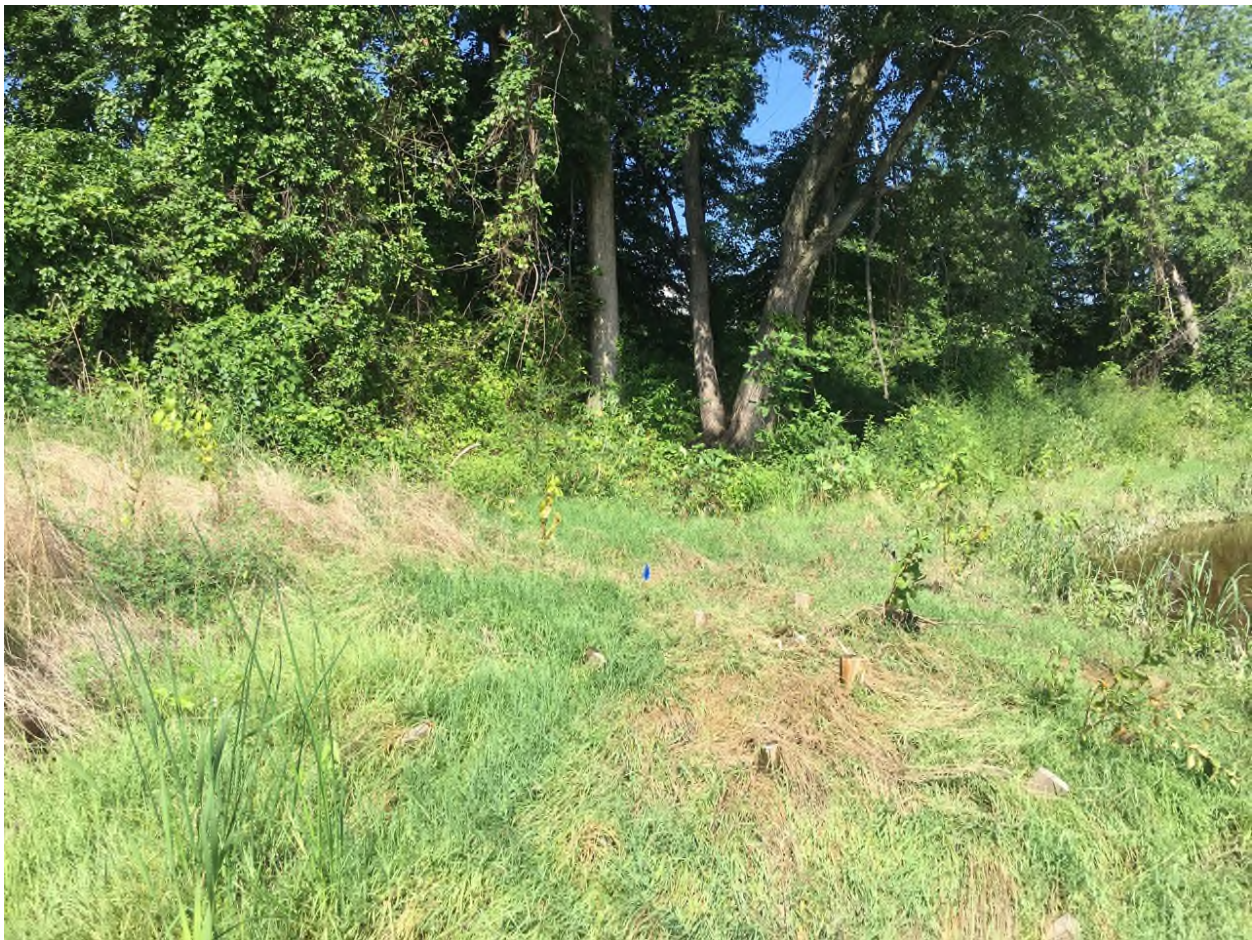
WP1 (Appendix A: DWG L-103): This scrub-shrub wetland monitoring location is between stormwater Outfalls 002 and 003 (Figure 3-2). Ground cover is 100% with no bare spots, and the dominant herbaceous vegetation (with 95% coverage) is creeping bentgrass (*Agrostis stolonifera*), that was seeded according to the approved seed mix for wetland areas. Woody stem count in this plot was 9 and there appears to be 100% survival of planted woody material since no dead shrubs were observed (Table 3-1). Soil in the monitoring location was wet or saturated at the surface. Although not within the boundary of this plot, common reed should be monitored because it is growing adjacent to the site under the power lines. Three or four stems of what appears to be narrowleaf cattail (*Typha angustifolia*) are growing adjacent to the plot and can become an aggressive colonizer forming a mono-culture. No invasive ground cover was observed in the plot.

Figure 3-2 WP1 Photo looking southwest away from Martin Boulevard. Dominant herbaceous vegetation is creeping bentgrass. Planted small trees and shrubs are visible.

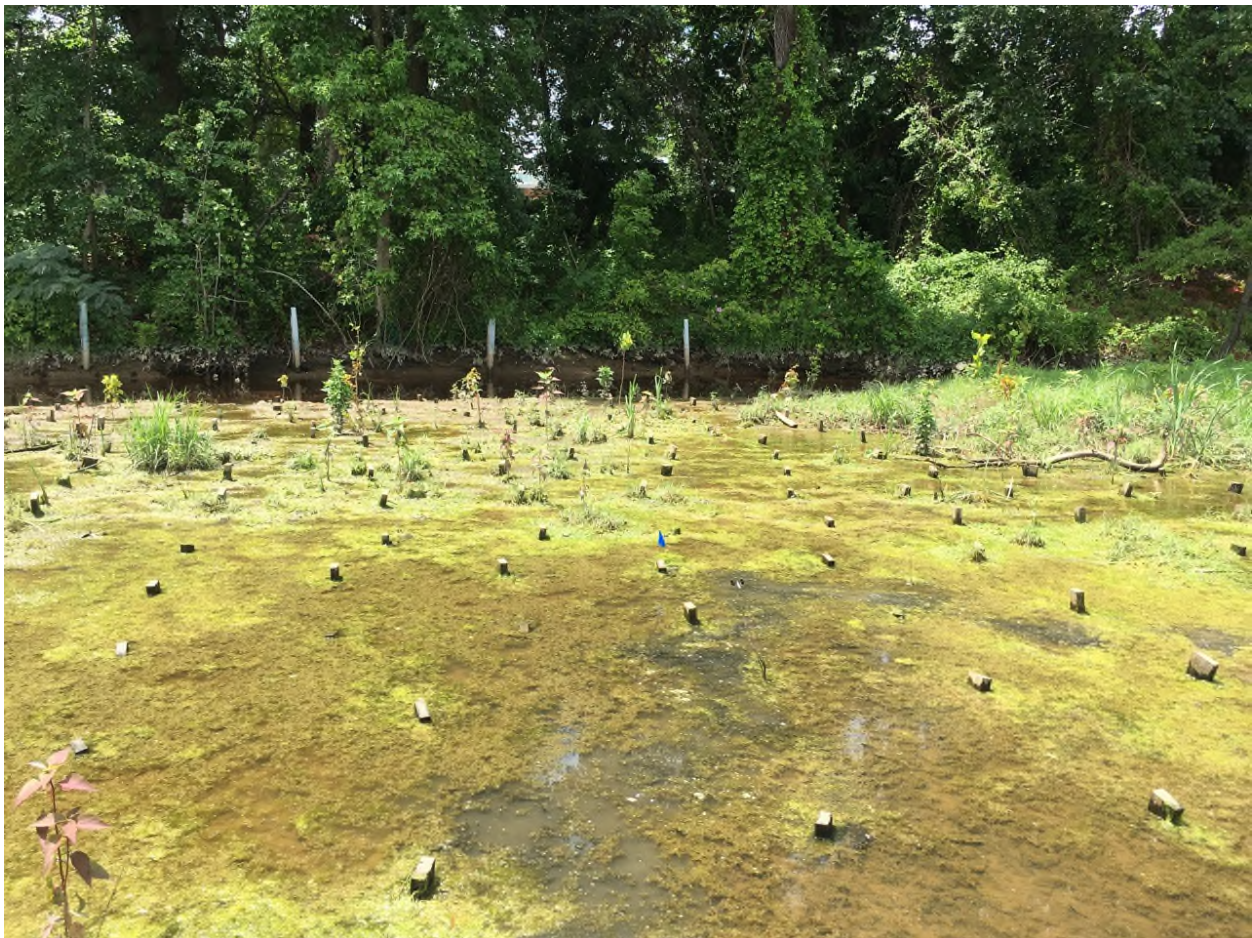
WP3 (Appendix A: DWG L-104): This scrub-shrub sampling plot is downstream or southeast of sampling plot WP2 (Figure 3-4). No woody stems (shrubs or trees) were observed within the sampling plot (0% woody plantings survival, Table 3-1). Signs of woody vegetation have disappeared at this monitoring location. The area inside this plot appeared to be continuously flooded due to the presence of algae and submerged aquatic vegetation (SAV). Shrubs and or trees that are typically grown in nursery potting mixes may not survive in not preconditioned for areas that are continually saturated or have inundated soils, Hibiscus or Button Bush would likely survive with the best chance of survival when grown in (or pre-conditioned) to saturated soils. The areas adjacent to WP3 contained both live and dead woody plants. No invasive ground cover or woody plants were observed within the plot.

Figure 3-4 WP3 Photo looking southwest away from Martin Boulevard. This area appears to be semi-permanent or permanently flooded. Shrubs such as Hibiscus or Button Bush would likely survive here but they probably need to be conditioned before planting to the flooded anaerobic soil.

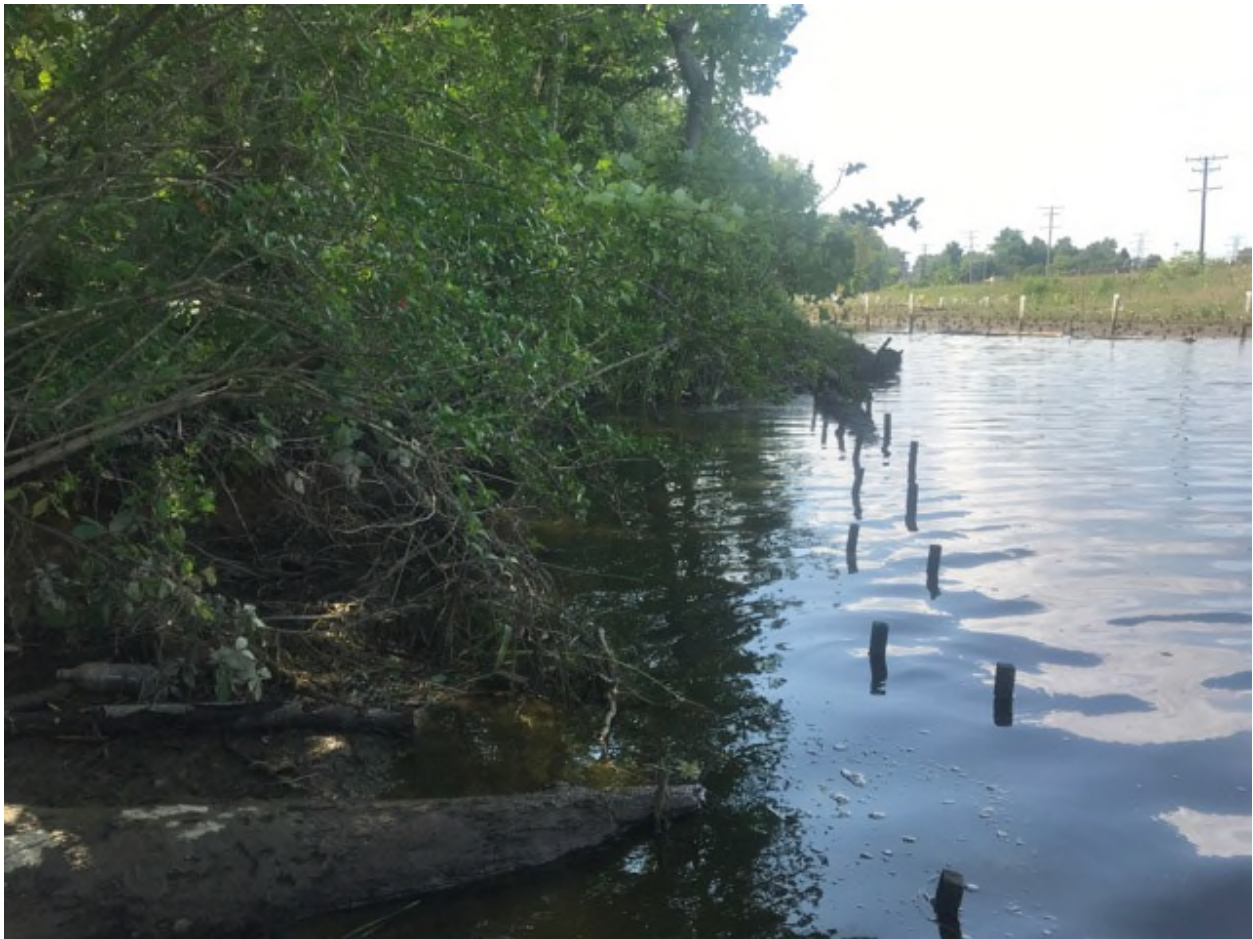
WP5 (Appendix A: DWG L-105): This emergent wetland plot is on the southeast shoreline of Cow Pen Creek, downstream of the farthest downstream forested wetland area (Figure 3-6). The shoreline is relatively steep and rapidly transitions to upland forest. This area was flooded at the time of sampling, and no emergent vegetation was found during sampling within the sampling plot. There was a small stand of emergent vegetation consisting of pickerelweed (*Pontederia cordata*) downstream but outside of the plot area. Overall none of the planted emergent vegetation survived in this emergent wetland plot (Table 3-1).

Figure 3-6 WP5 Photo of near-shore emergent zone. No emergent vegetation was observed.

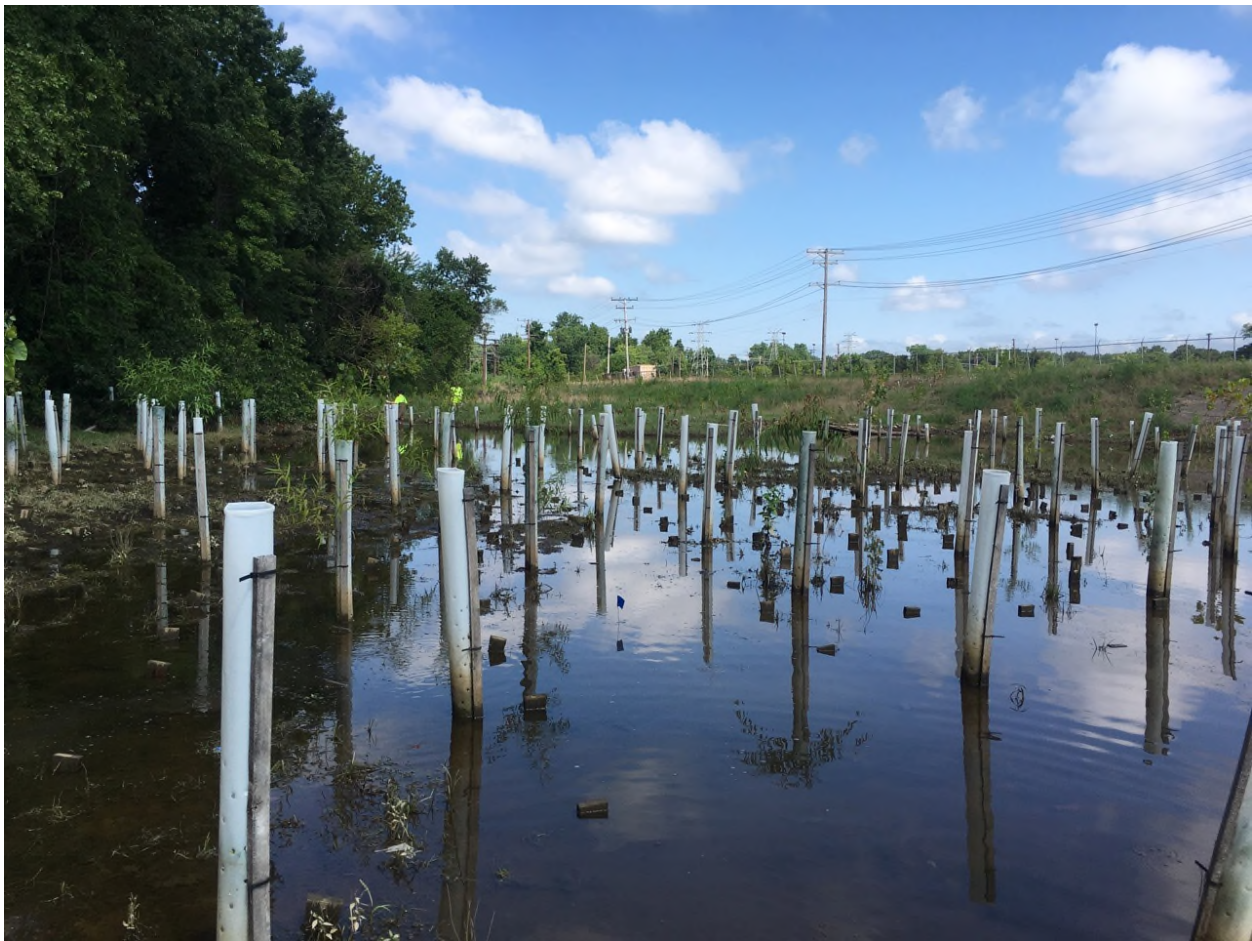
WP6 (Appendix A: DWG L-105): This forested wetland plot is on the southeastern shore where the creek bends with the resulting forested wetland along the shore (Figure 3-7). The sampling plot and adjacent areas appear to have been flooded with at least a few inches of water for long periods of time. The flooded soils are 70% covered with algae and SAV. Approximately 10% of the area is at water level and is vegetated with creeping bentgrass, the dominant herbaceous vegetation. Woody plants are mostly trees with protective tree tubes in place. Only 40% of the woody vegetation in this plot is alive, most likely due to the flooded conditions (Table 3-1). As noted previously, shrubs and or trees planted in continually saturated or inundated soils have the best chance of survival when grown in or pre-conditioned to saturated soils, as compared to those grown in typical nursery potting mixes then planted in anaerobic soils. The forested wetland areas adjacent to this plot contained both live and dead woody plants. No invasive herbaceous plants or woody plants were observed within the plot.

Figure 3-7 WP6 Photo of southern shore looking northeast. This area is shown on the design plan as forested wetland, but the area appears to be continually flooded; that may be the reason for limited survival.

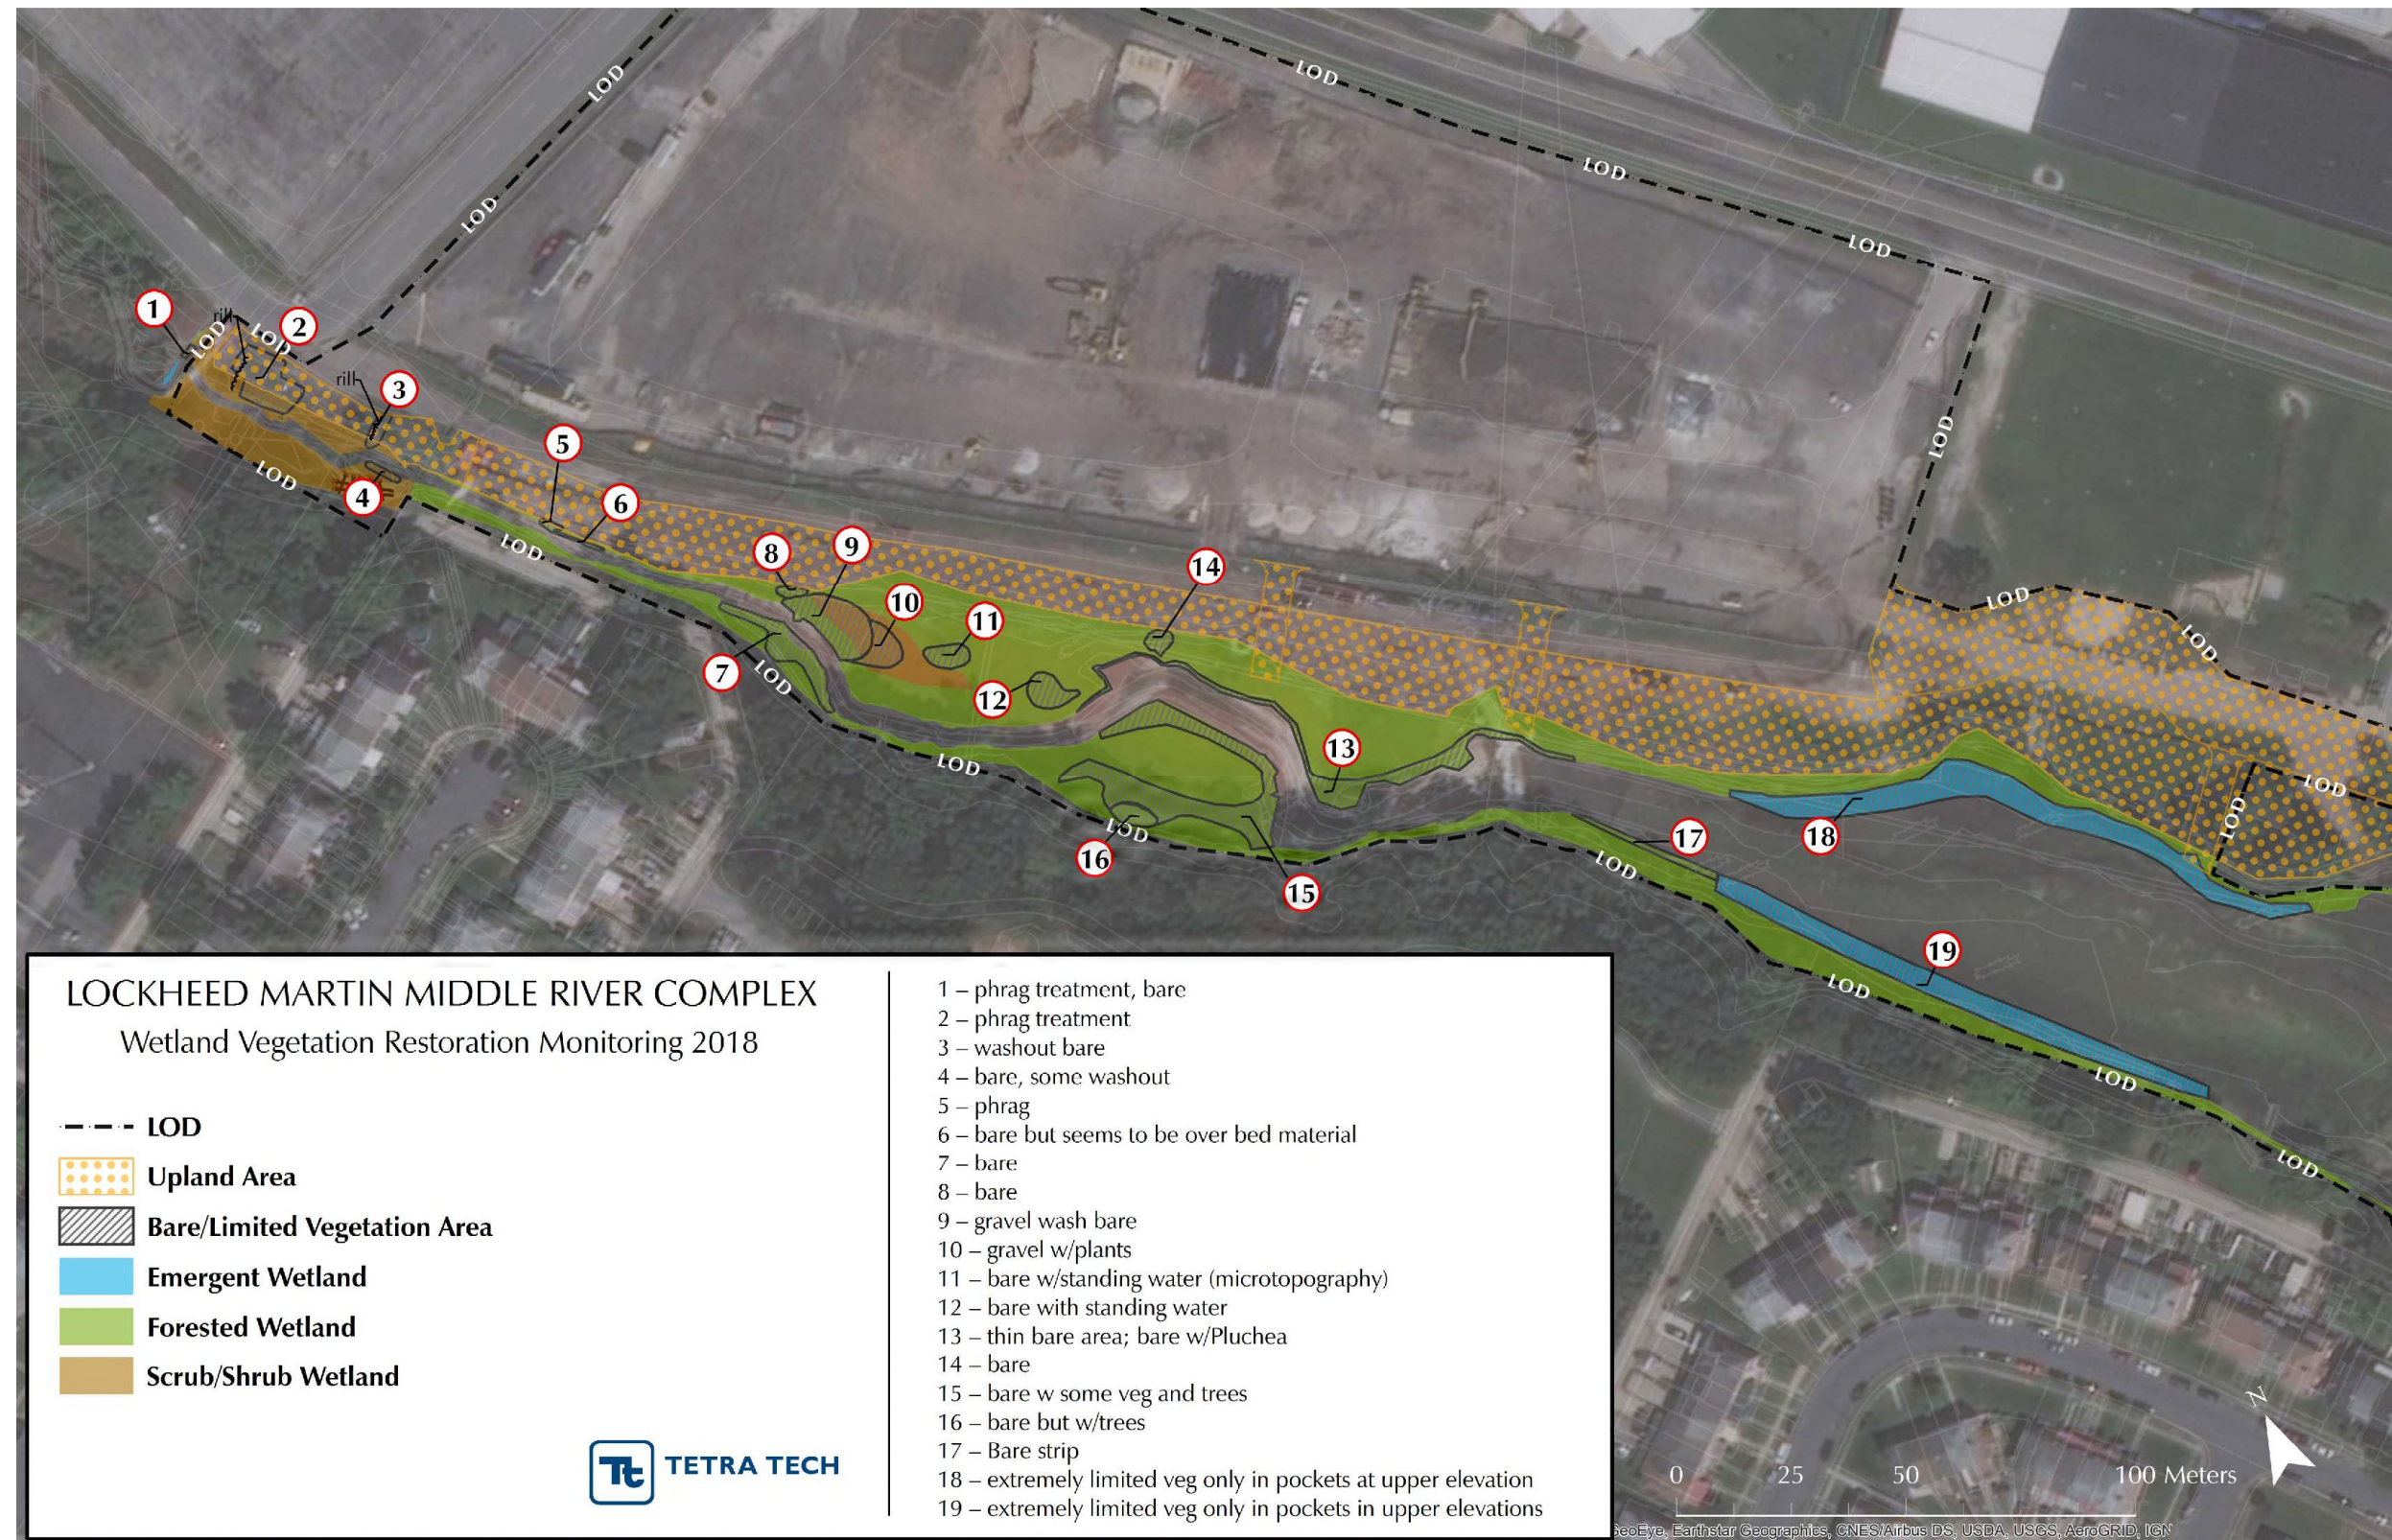
Two areas of scrub-shrub wetland were restored, one in the BGE easement near the upstream portion of the site and one about half way downstream. Areas of scrub-shrub wetlands that are not flooded are dominated by bentgrass and contain planted shrubs and trees. Part of the downstream scrub-shrub wetland closest to the stream channel was flooded with two to three inches of water and appeared to be consistently inundated with water over extended periods of time (Figure 4-1). Most of the flooded area does not contain planted shrubs. The revegetation plan calls for shrubs in this area.

Figure 4-1 Site-wide observation map of bare areas in restored wetlands along Cow Pen Creek.

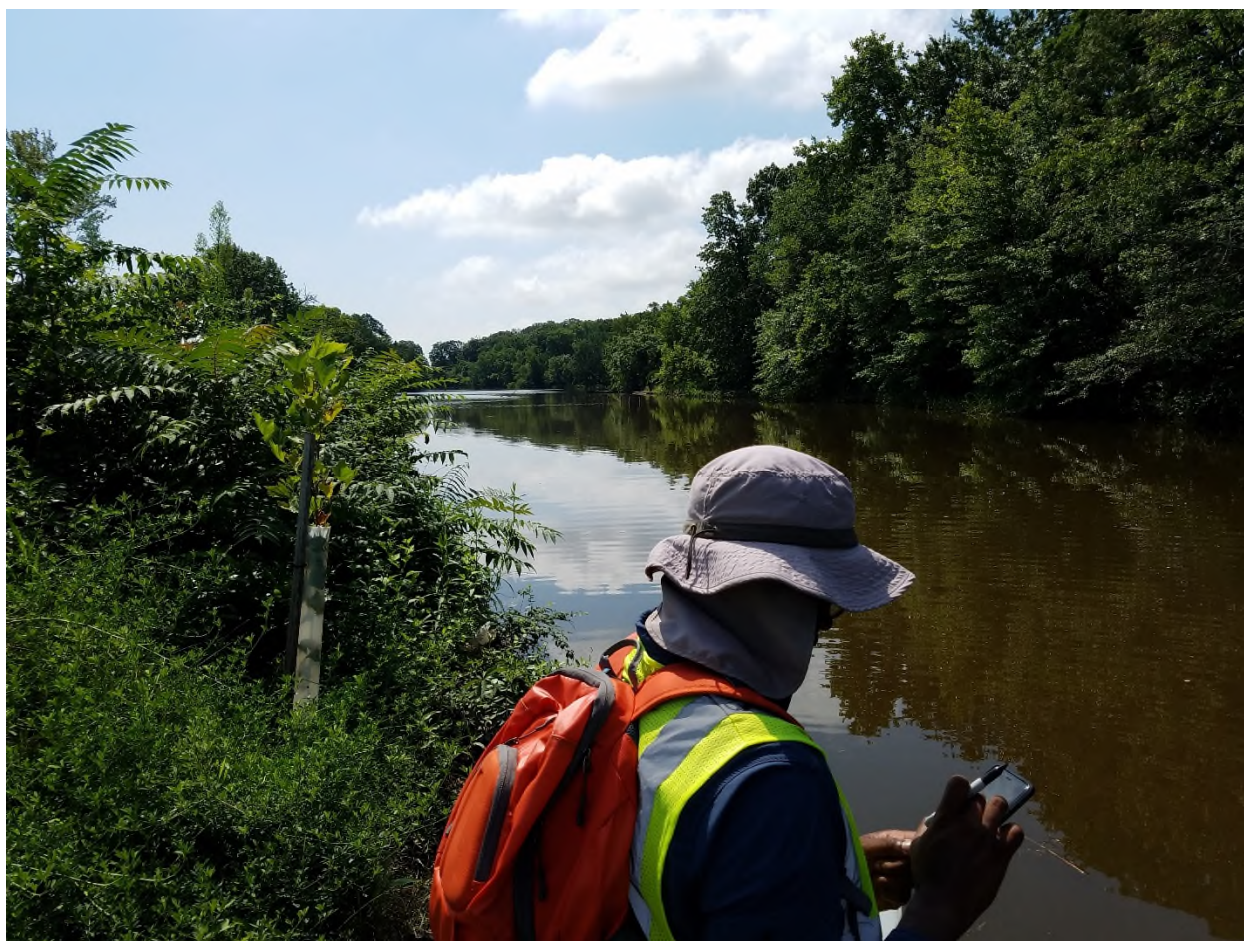
Figure 5 – Area designated as emergent wetlands along creek. No emergent plants at this location.
