# Block E Soil Cleanup Photo Tour

February 2022

# Block E Soil Cleanup Project Accomplishments

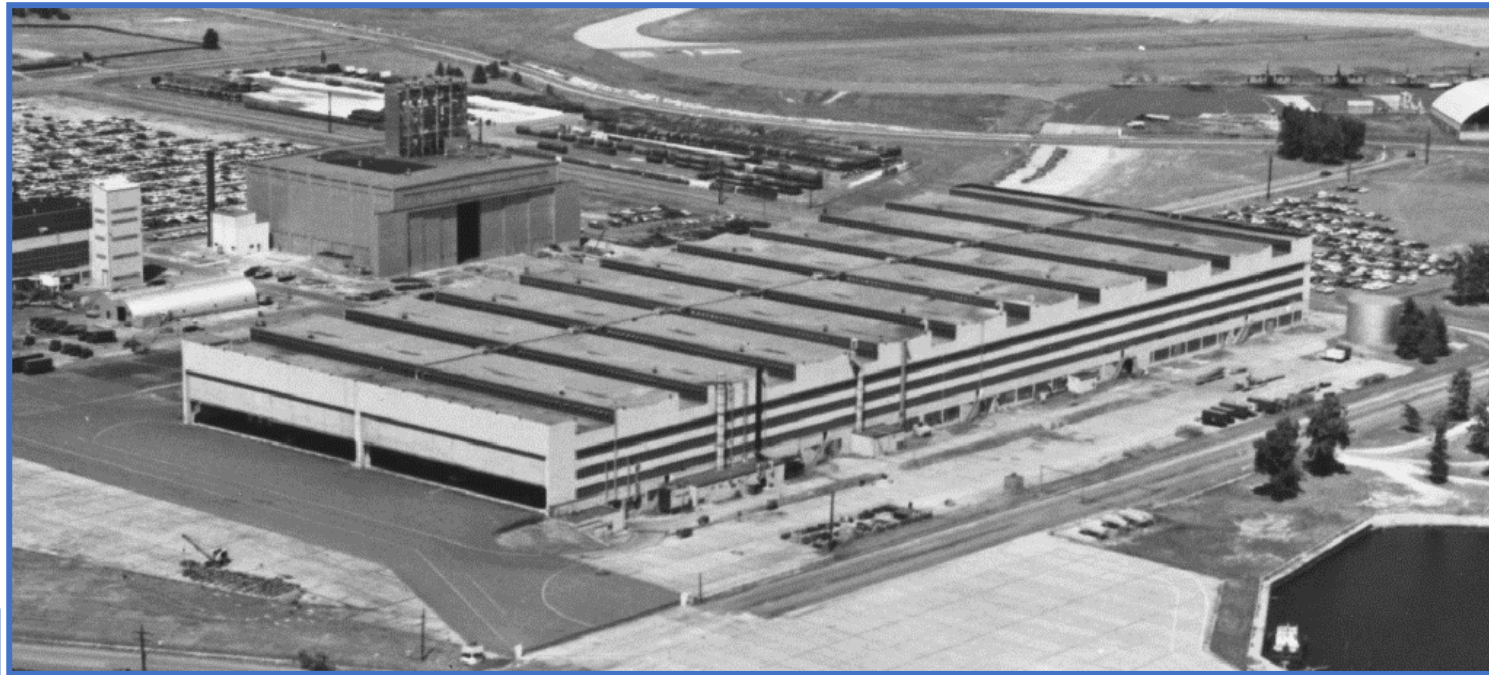
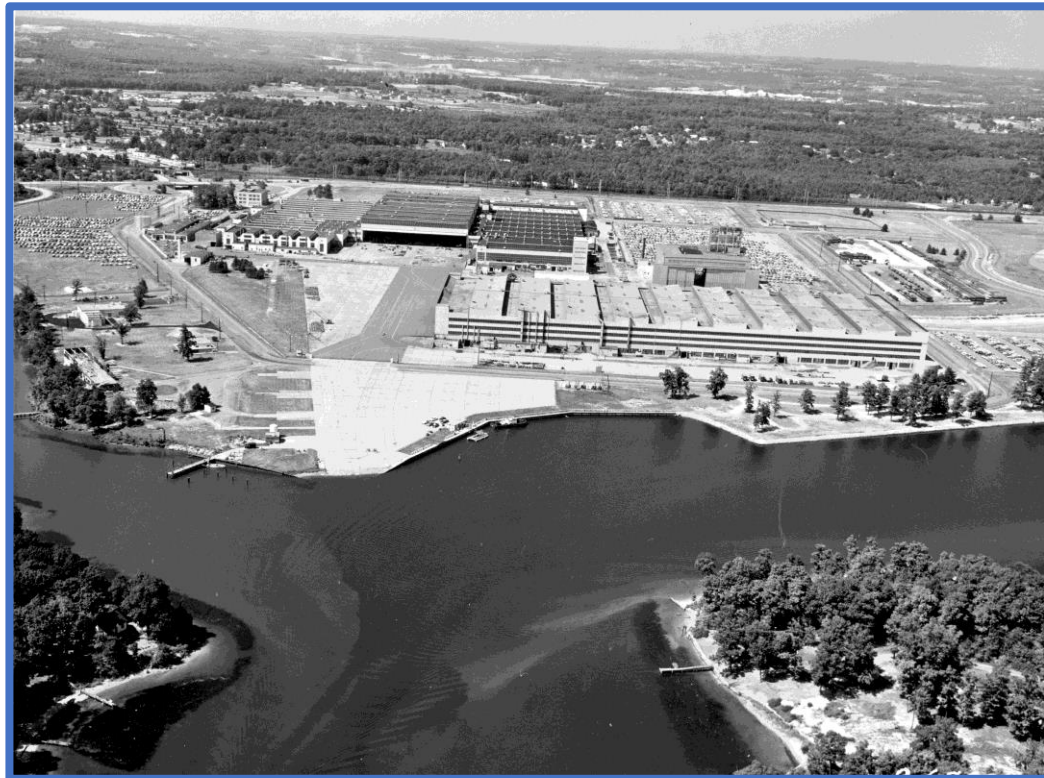
# Historic Views of Former D-Building, Located In Tax Block E

- Block E is located in the southern portion of the Middle River Complex and is about 16 acres in size.
- The former D-Building encompassed much of Block E. The building was constructed in the early 1940's for final assembly of aircraft. After World War II, part of the building was converted for various production and research purposes. The building was demolished in the early 1970s, but part of the building's foundation and basement-level floor slab remained.
- Environmental investigations have been conducted since 2003 and identified polychlorinated biphenyls (PCBs) and polycyclic aromatic hydrocarbons (PAHs) as contaminants of concern.

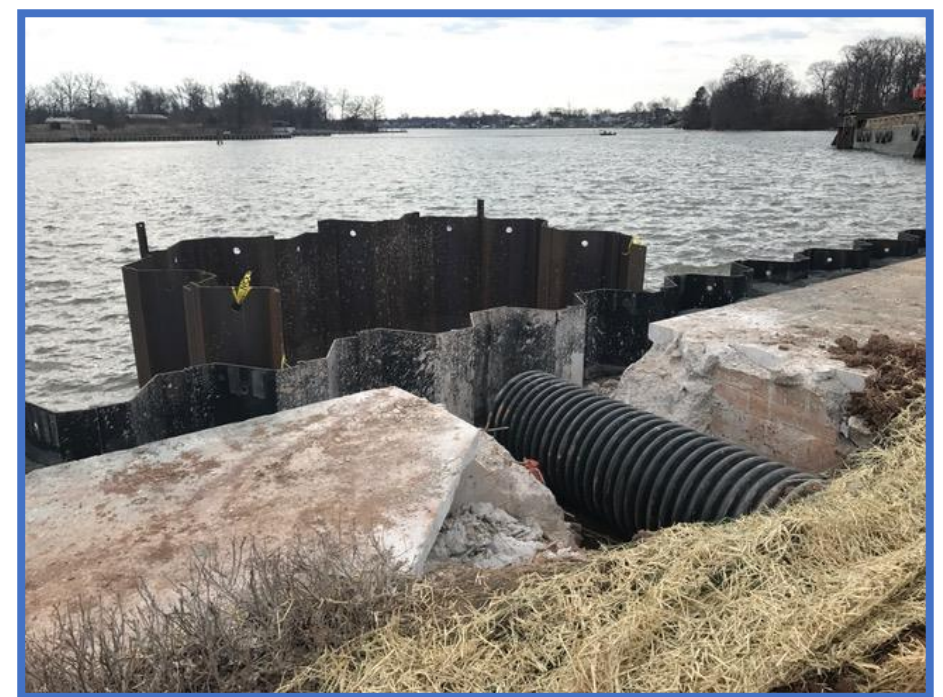
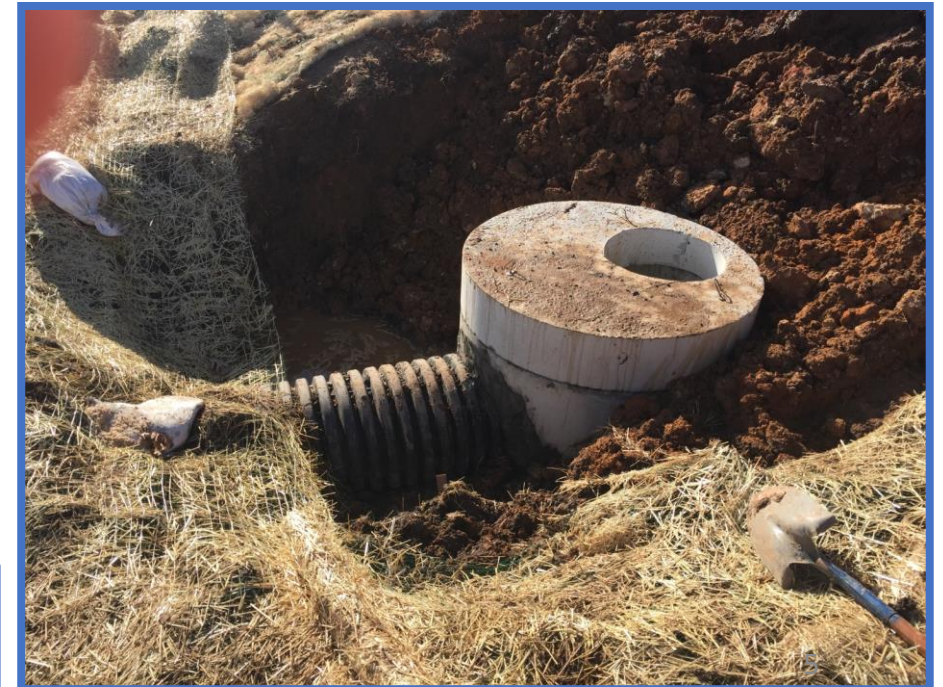
Some PCBs appear to have previously moved off Block E. This movement appears to be limited to sediment transported through the Block E stormwater drain system into Dark Head Cove. Lockheed Martin removed contaminated sediment from the storm drains and inlets in 2011, and in 2014-15 removed PCB-contaminated sediment from the lower portions of the Outfall 005 stormwater drain system. Portions of the Outfall 006 and 008 systems were cleaned in 2016 as part of the full sediment remedy for Cow Pen Creek and Dark Head Cove. To prevent the potential for further movement of contaminated soil and debris, the Outfall 005 system near Block E was plugged in 2015 to prevent contaminants from moving into Dark Head Cove. At the conclusion of the sediment remedy, Lockheed Martin began monitoring and cleaning out PCB-impacted sediments in the Block E storm drains annually, most recently in January 2021.

**During sediment cleanup in 2016, new outfalls and manholes were installed.**

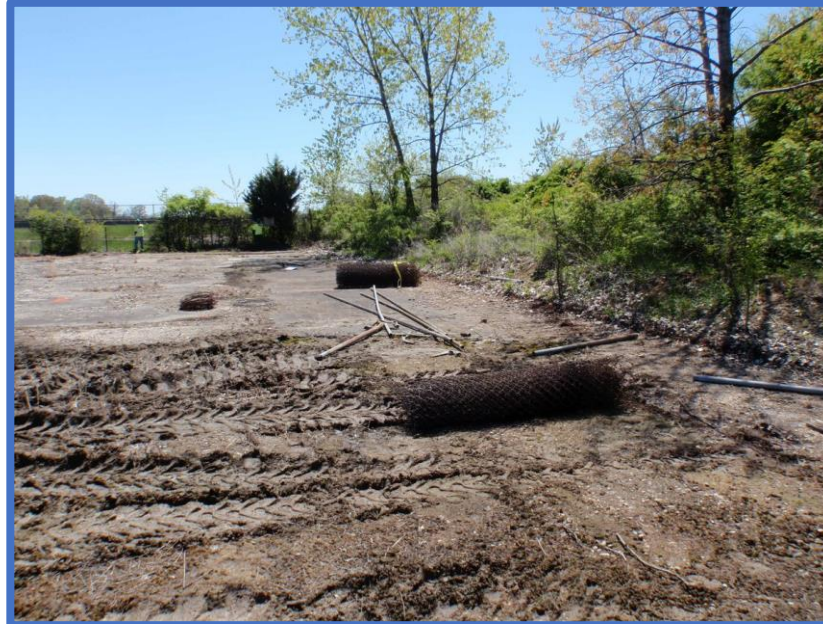
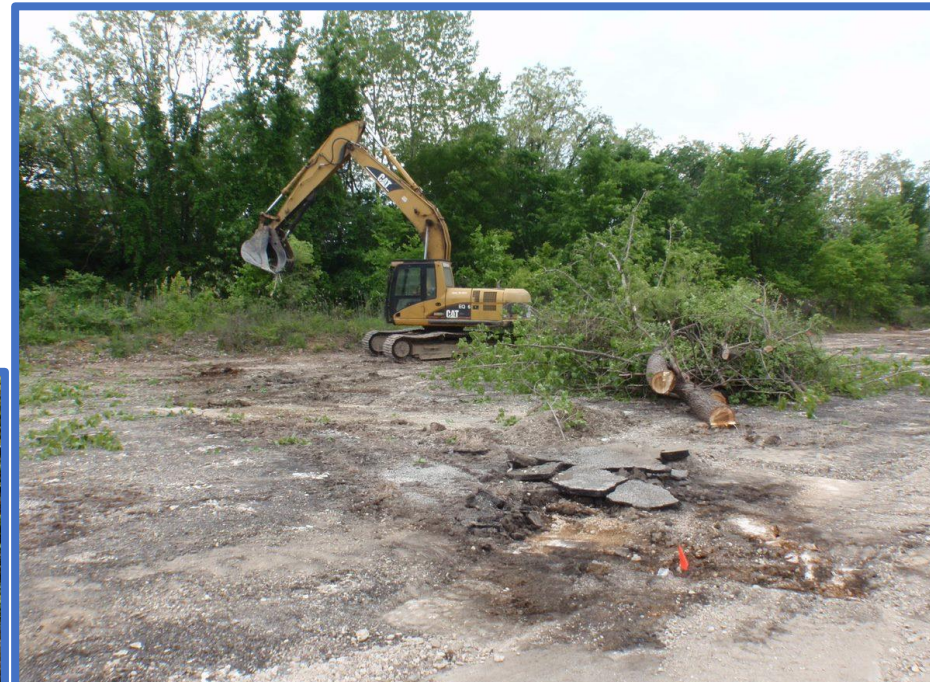
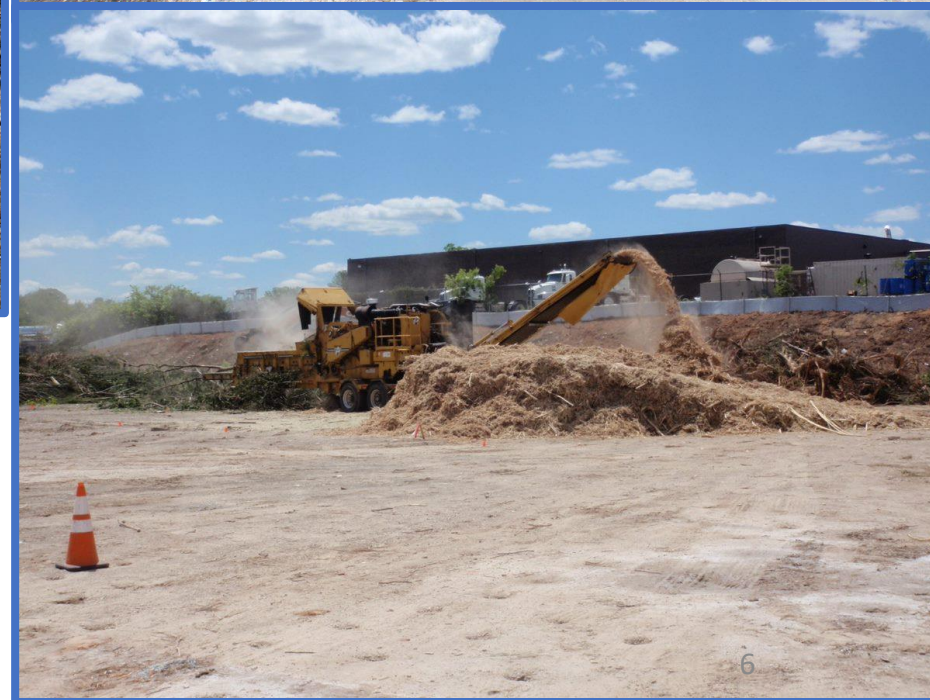
Activities required prior to soil cleanup in Block E included removal of fencing and about one acre of ‘volunteer’ trees, that is, trees that have self-seeded in the area, their seeds having been carried to the spot by natural dispersal— by wind or animals.

Because the trees were within the Chesapeake Bay Critical Area, Baltimore County requires that the effect of the trees’ removal be mitigated.

New trees will be planted elsewhere at the Middle River Complex to compensate for the removal in Block E. Trees were chipped and used as bedding material for breaking concrete footers.

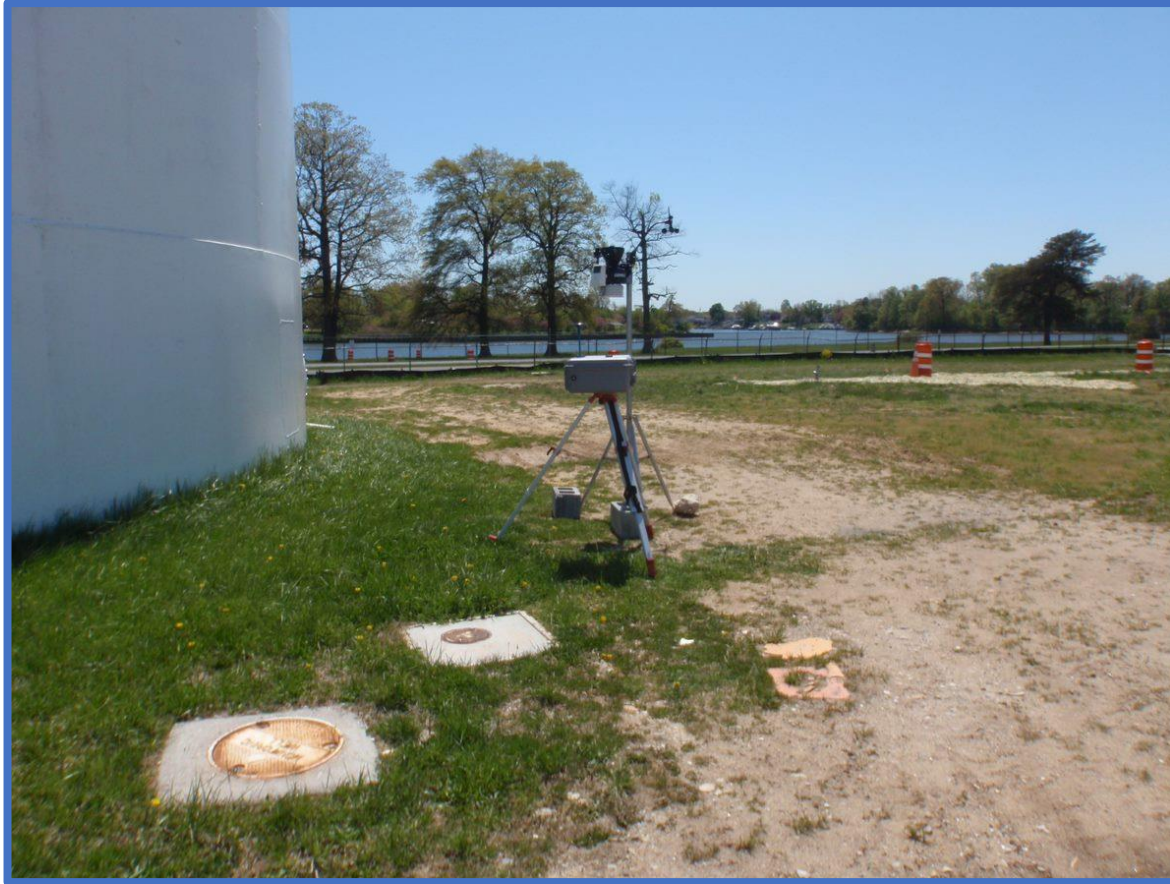
Air monitoring at the perimeter of work ensures dust from the site is managed.

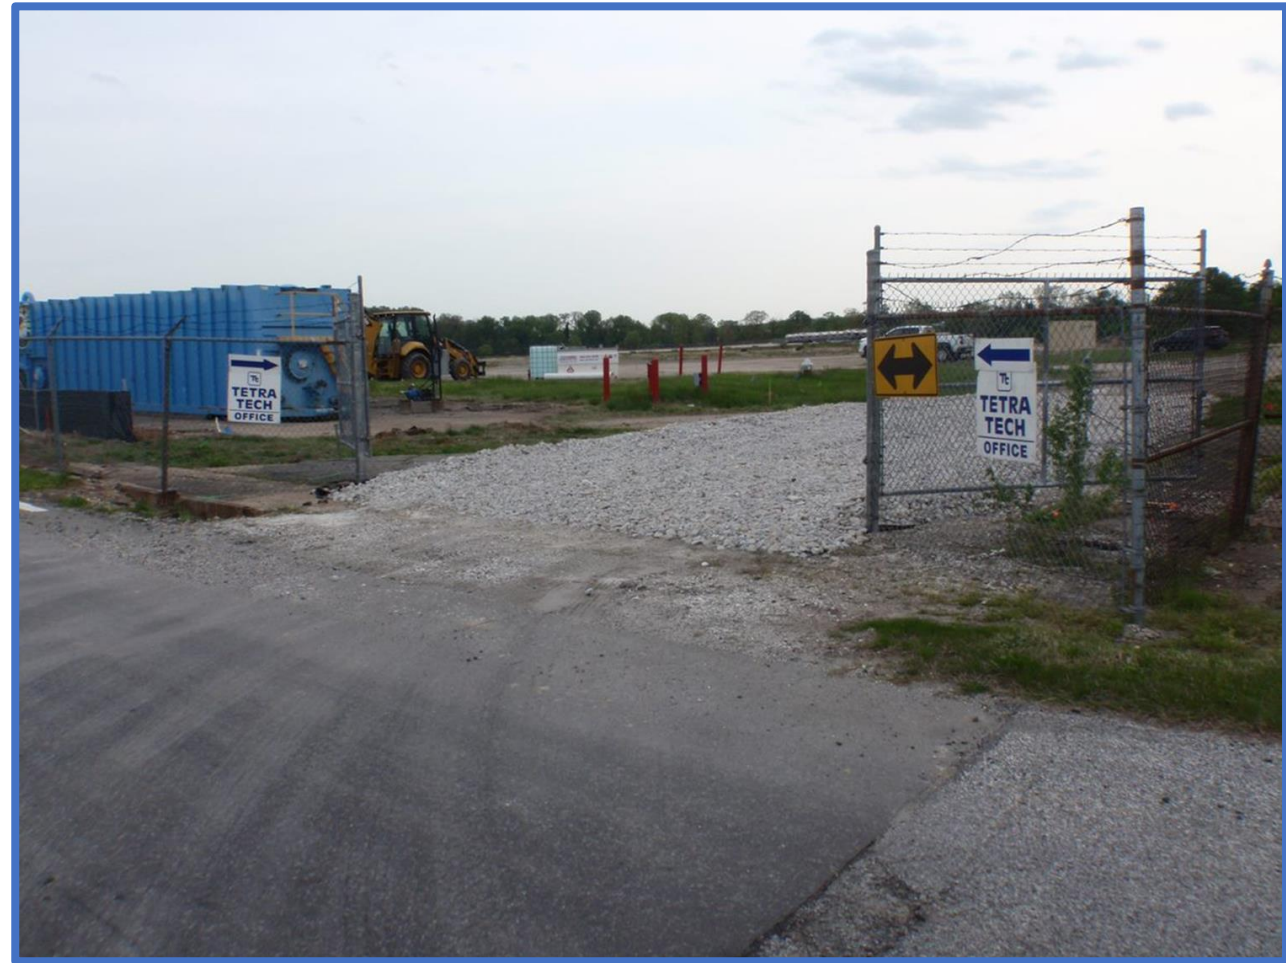
The work site was prepared for equipment arrival during the last week of April 2021.

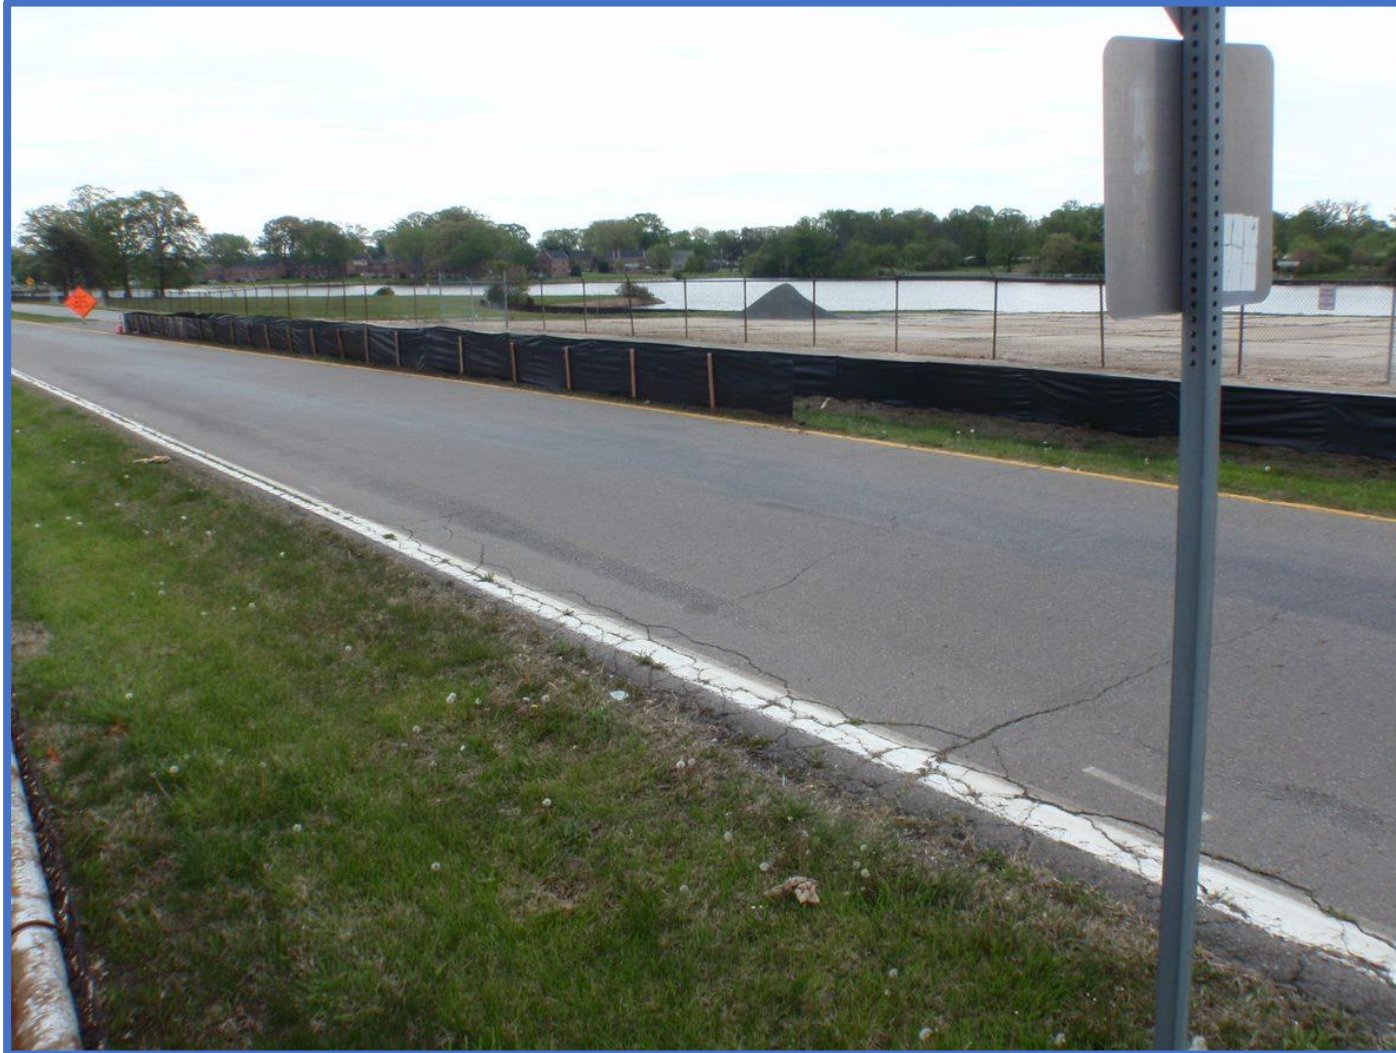
Silt fences protect the surrounding area from storm water runoff.

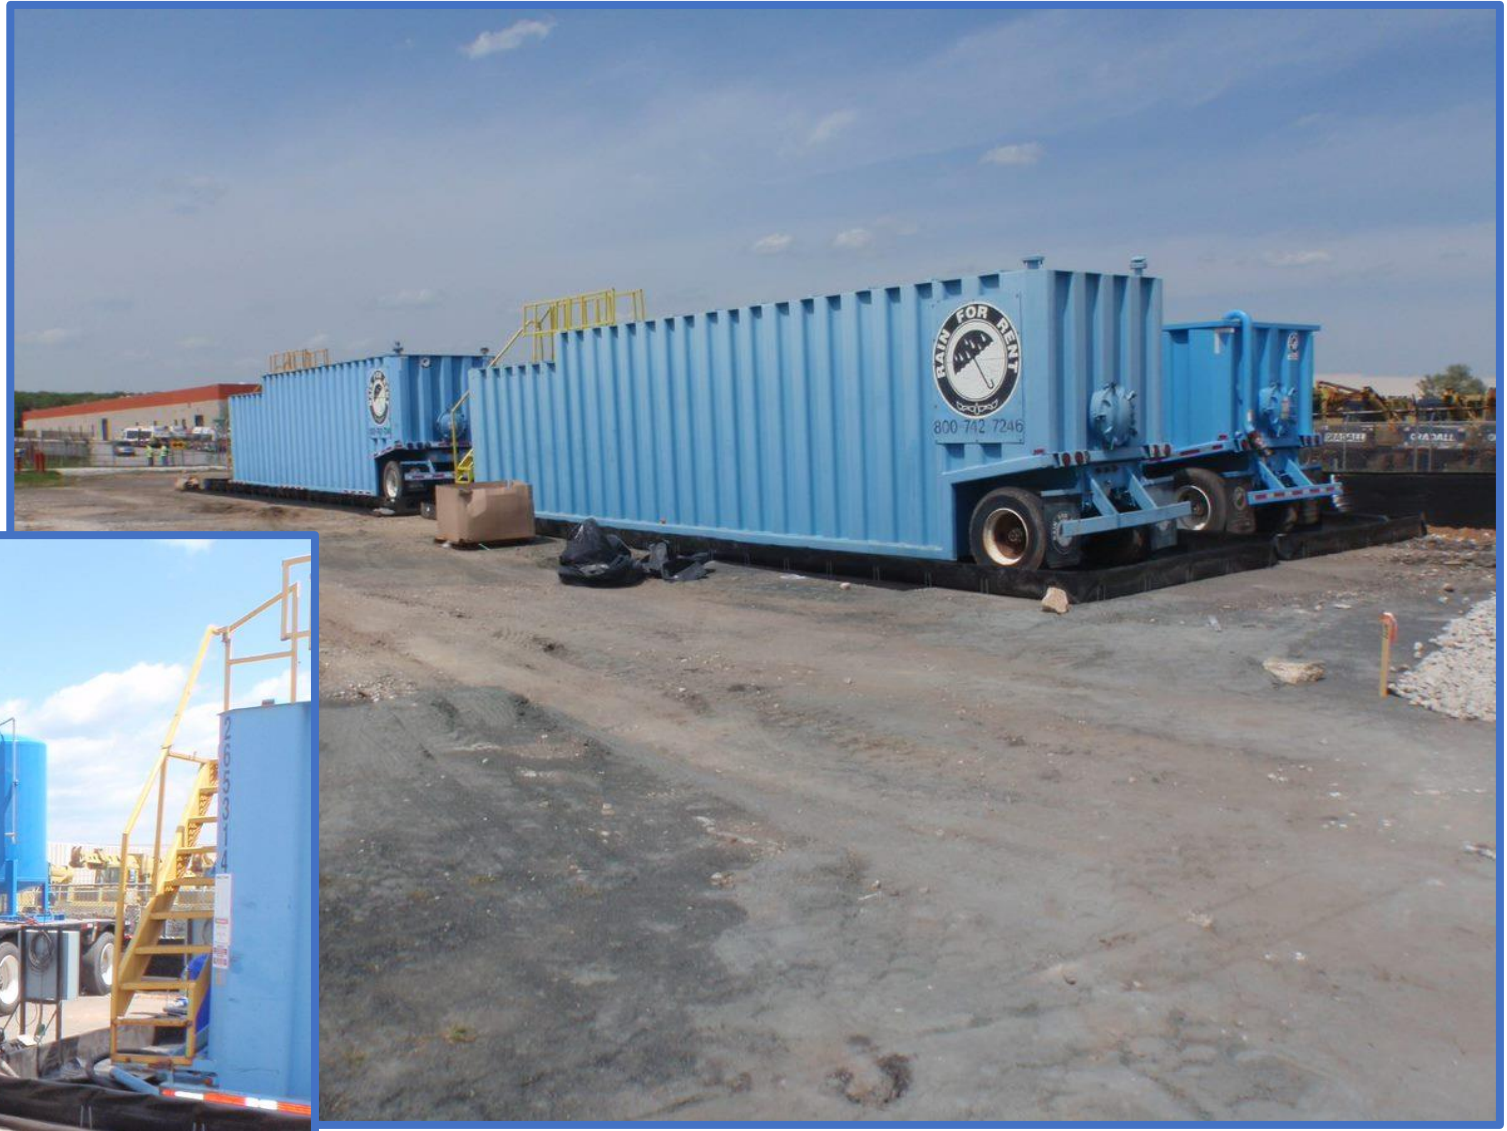
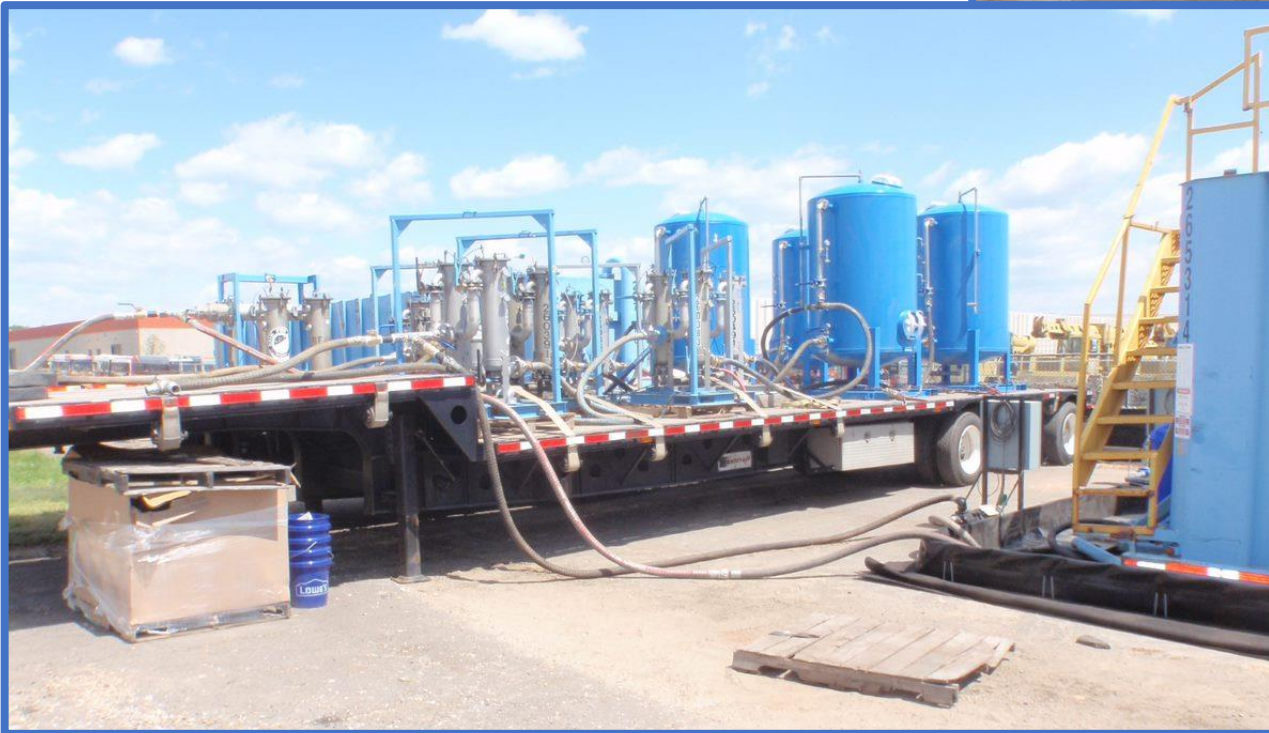
A water treatment system was used to treat any groundwater or storm water collected from excavations. Once treated, water was released to the sanitary sewer system. Treated water was tested regularly for Baltimore County Permit compliance.

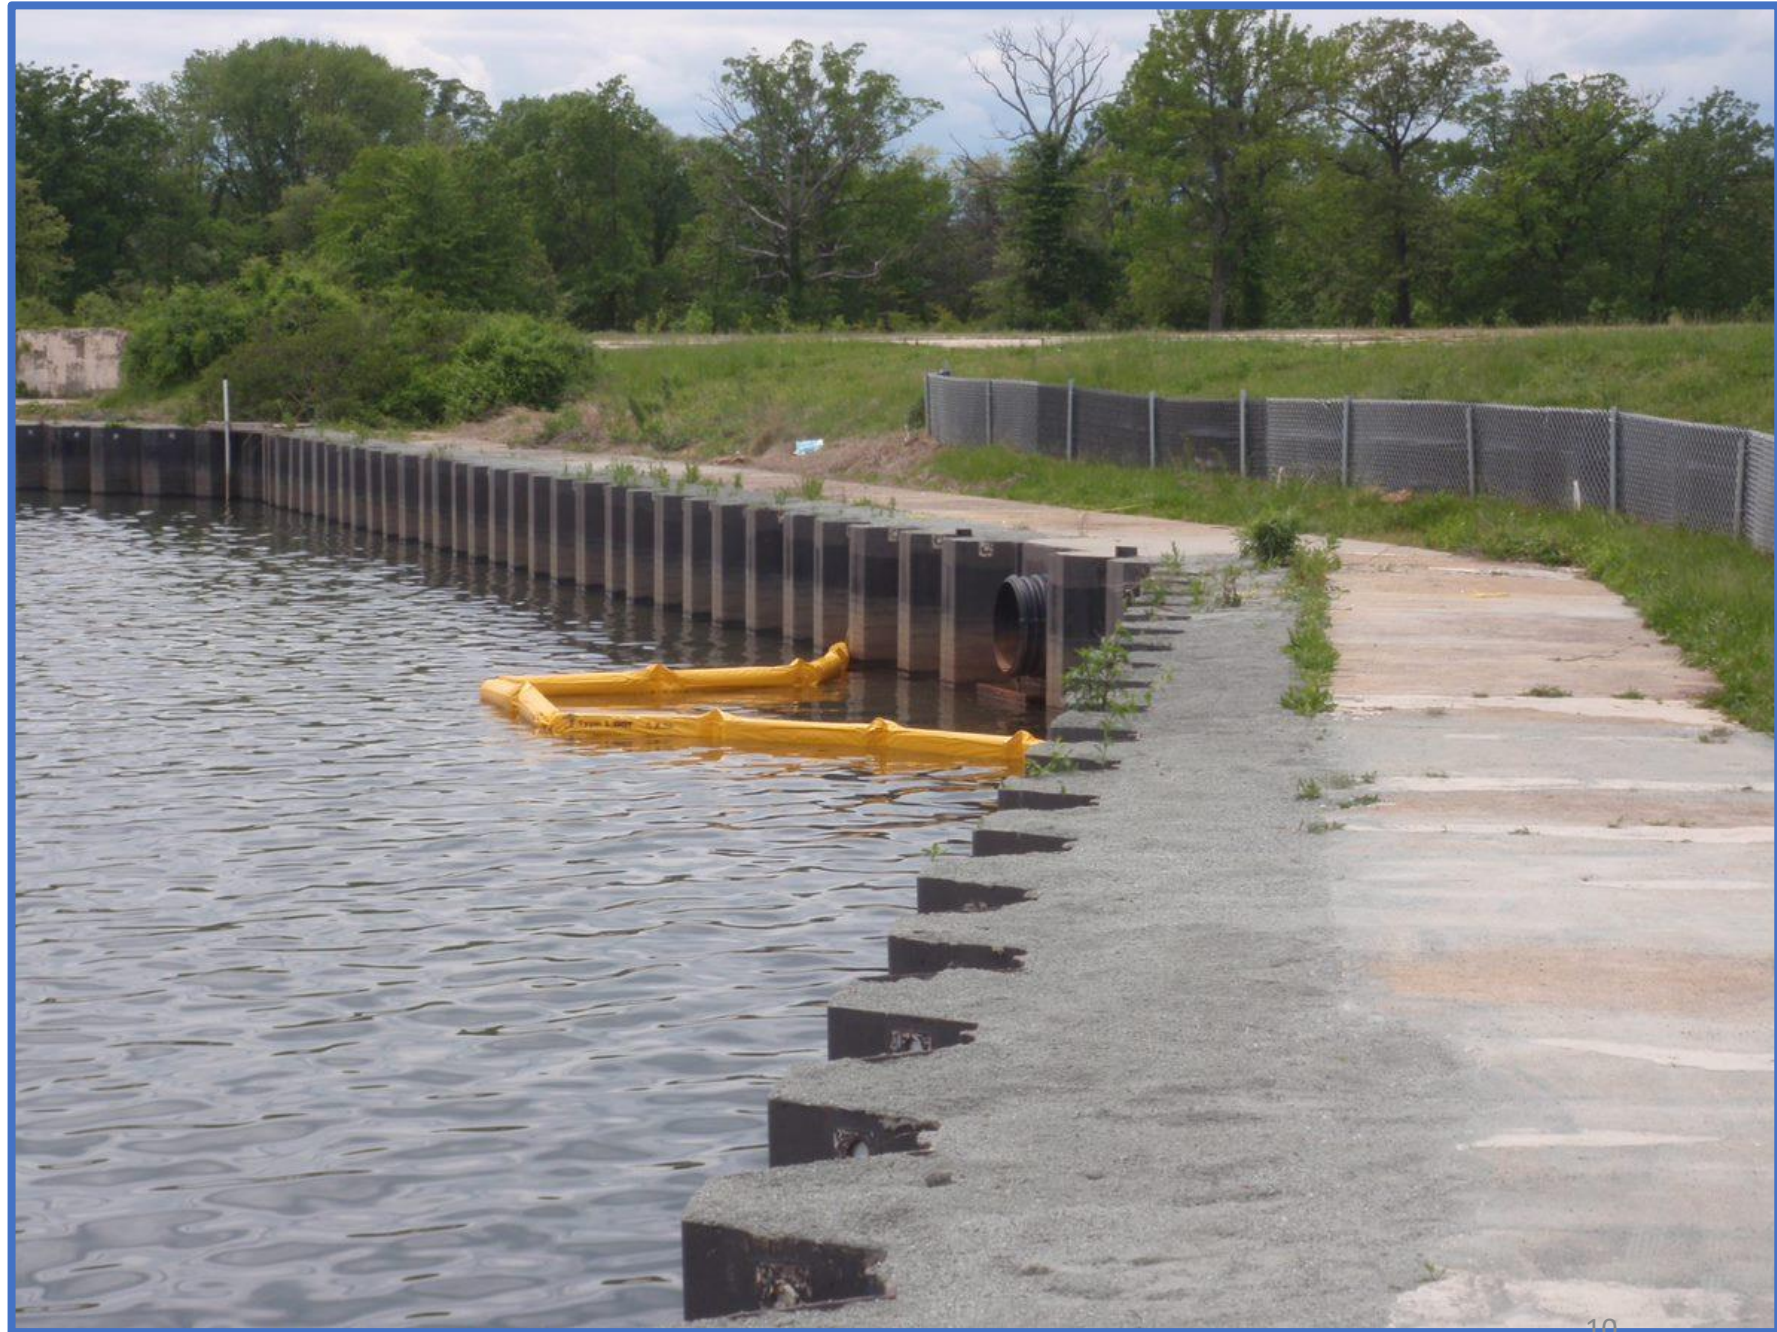
A turbidity curtain was installed at Outfall 005 in Dark Head Cove to manage any sediments in storm drain piping that might be released to the cove.

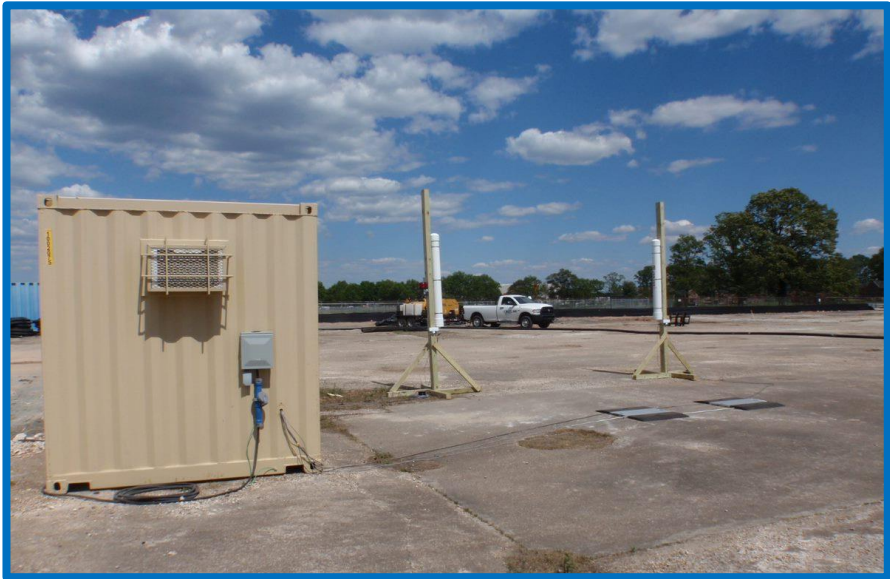
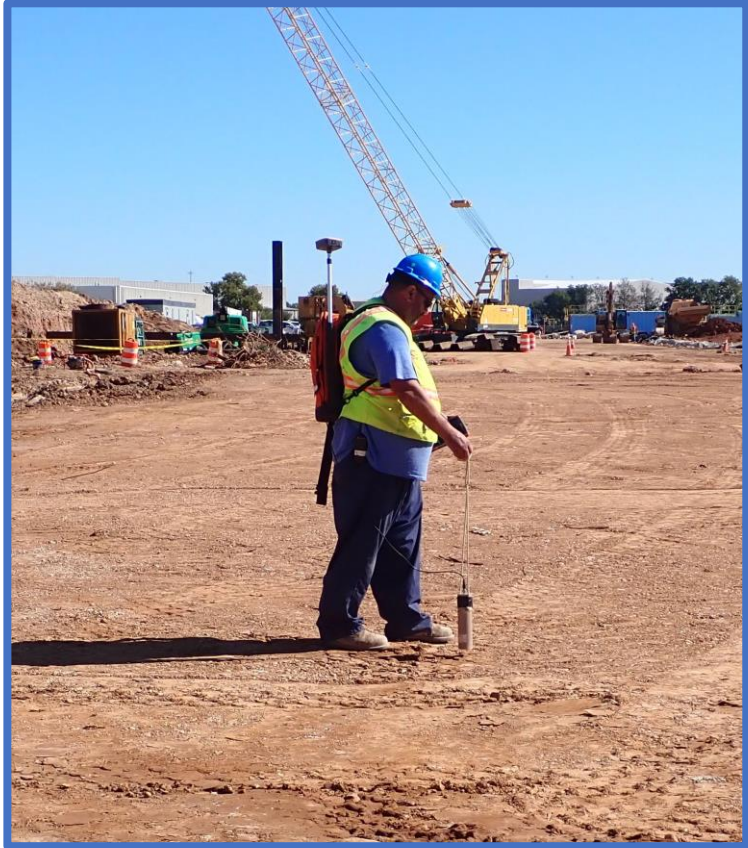
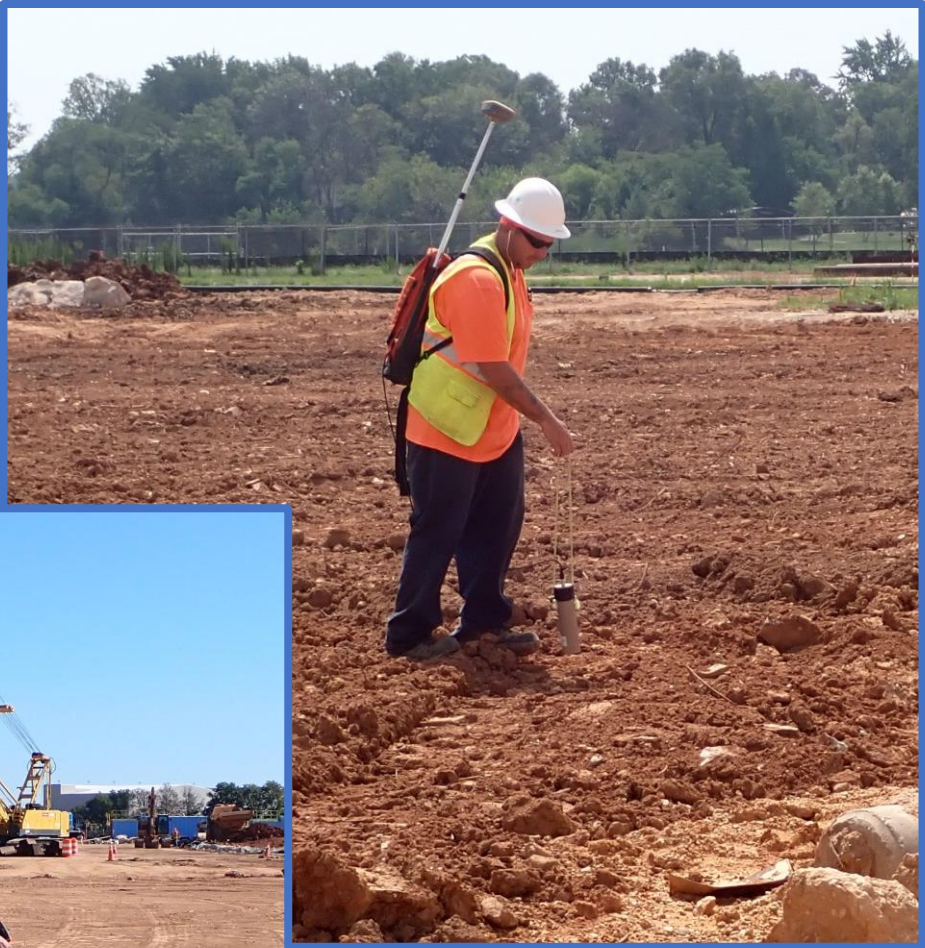
The project team anticipated removing radiologically-contaminated pipe from the southeast quadrant of the foundation. As a result, scanning for radiation occurred throughout the project, including an initial scan prior to beginning demolition work. Radiation monitoring identified several pieces of pipe in the southeast area that had elevated activity levels. These pipes were separated from the rest of the waste and disposed of at an appropriate facility. All trucks containing waste leaving the site are scanned for radiation using portal monitors (shown below).

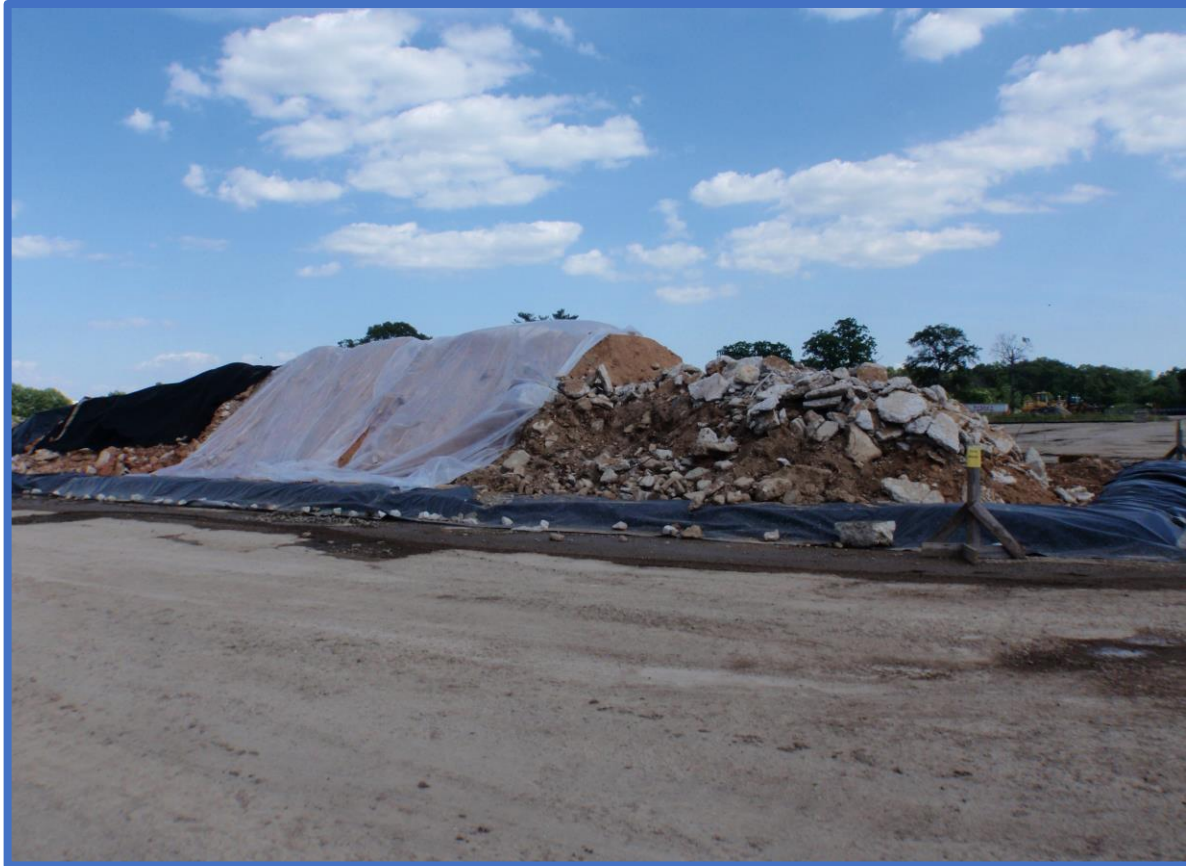
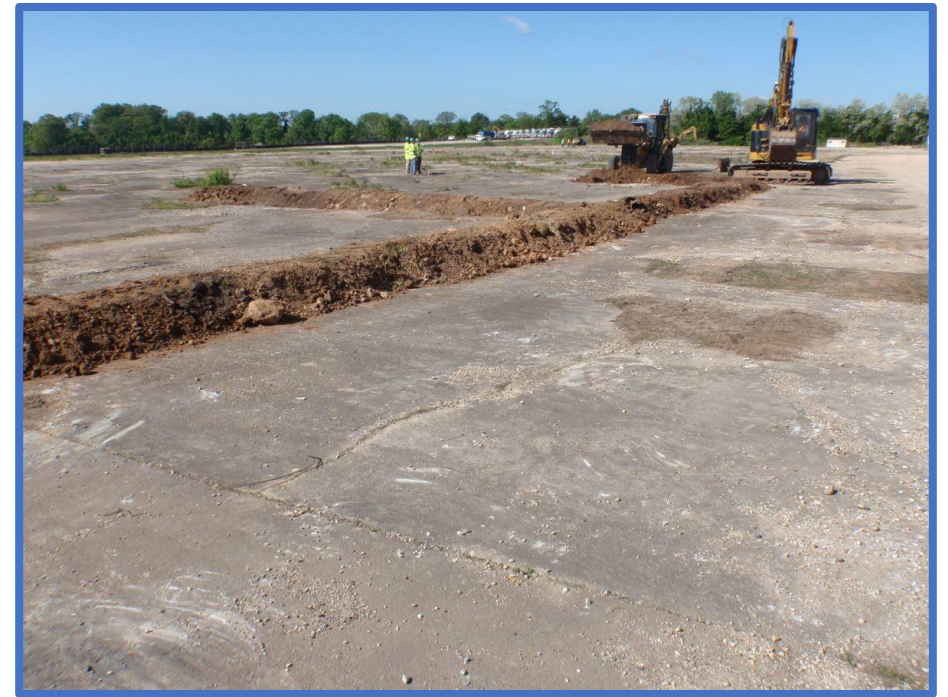
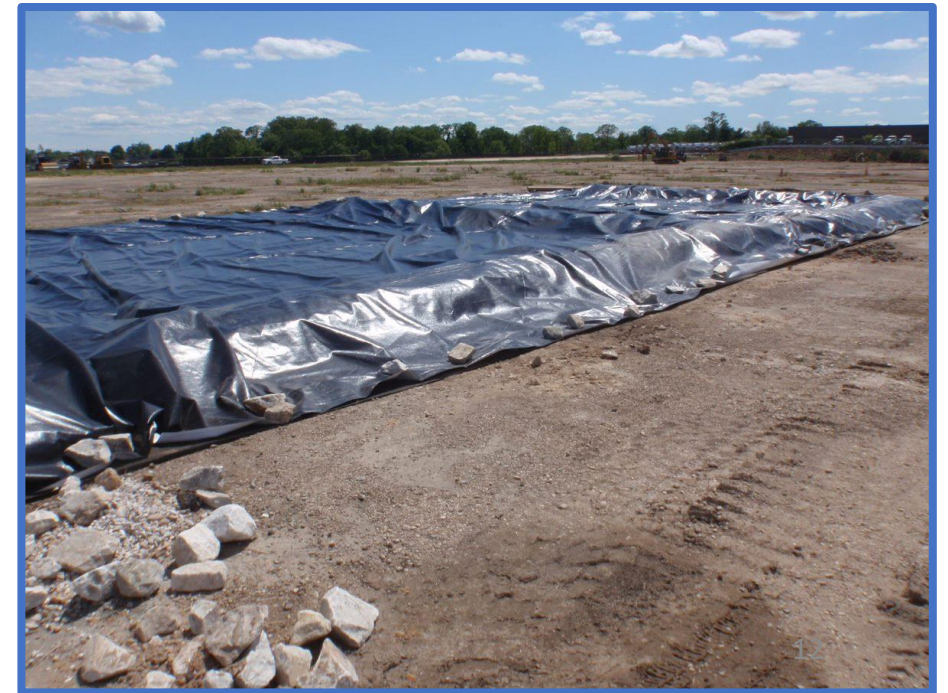
Soil and other debris that were identified as containing high PCB levels were stored on a waste management area pad, created by forming an outside berm and covering that with a heavy plastic liner. Stored soil piles are then covered with plastic to keep the soil from being dispersed.

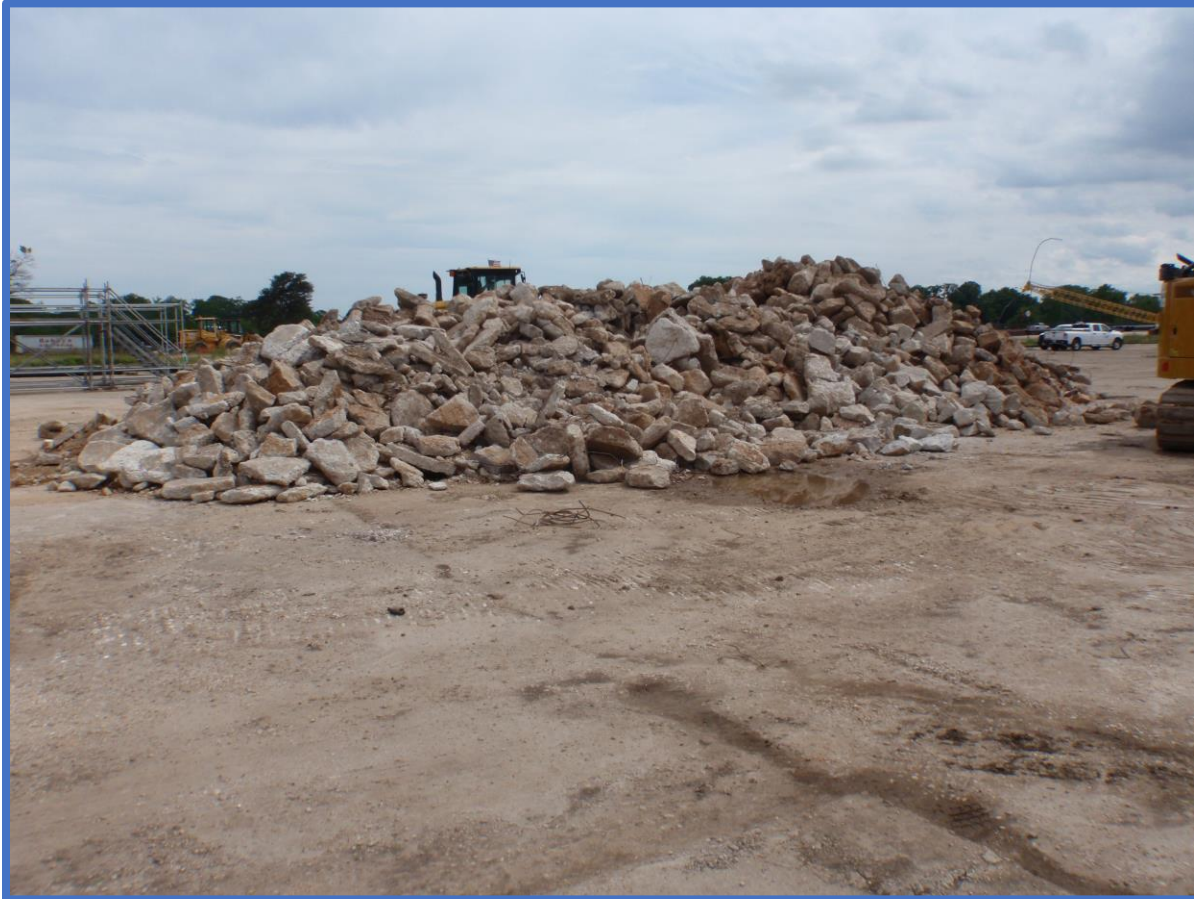
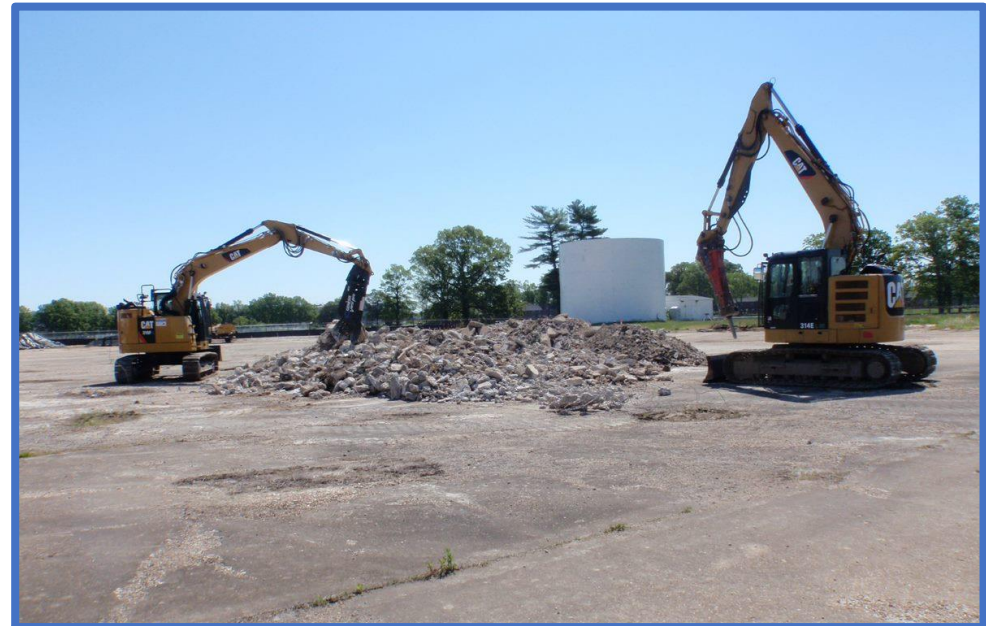
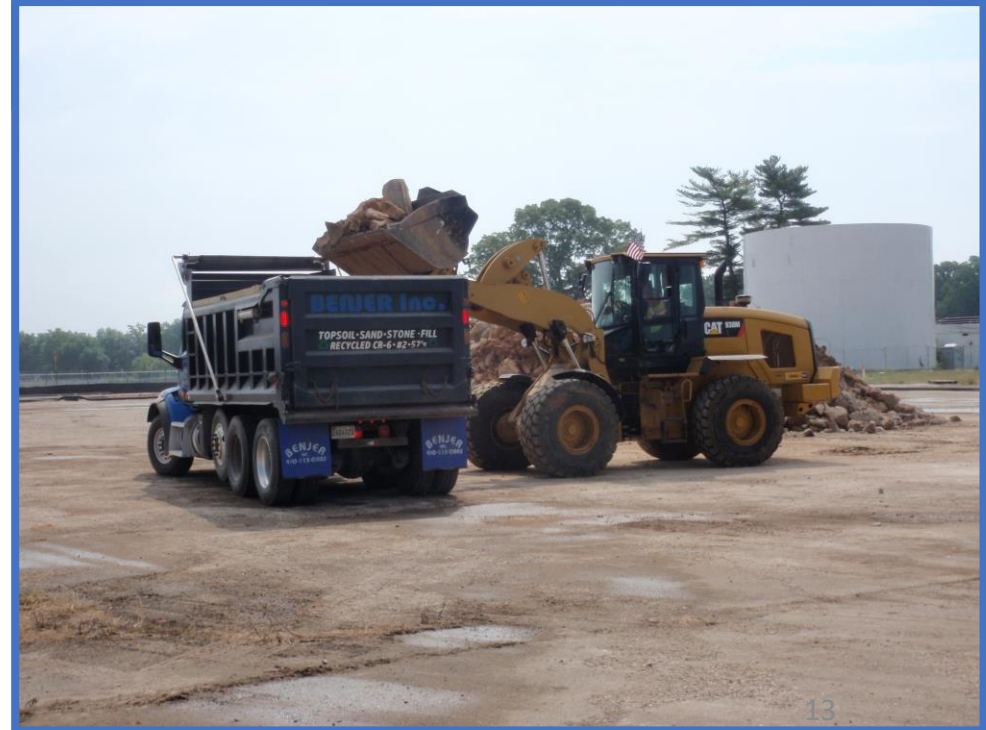
The building's concrete foundation was broken up in sections. Concrete was further broken into manageable sizes. Any contaminated concrete was transported to a licensed landfill. Uncontaminated concrete was transported offsite to a local concrete recycling facility.
