# Block E Soil Cleanup Photo Tour

February 2022

# Block E Soil Cleanup Project Accomplishments

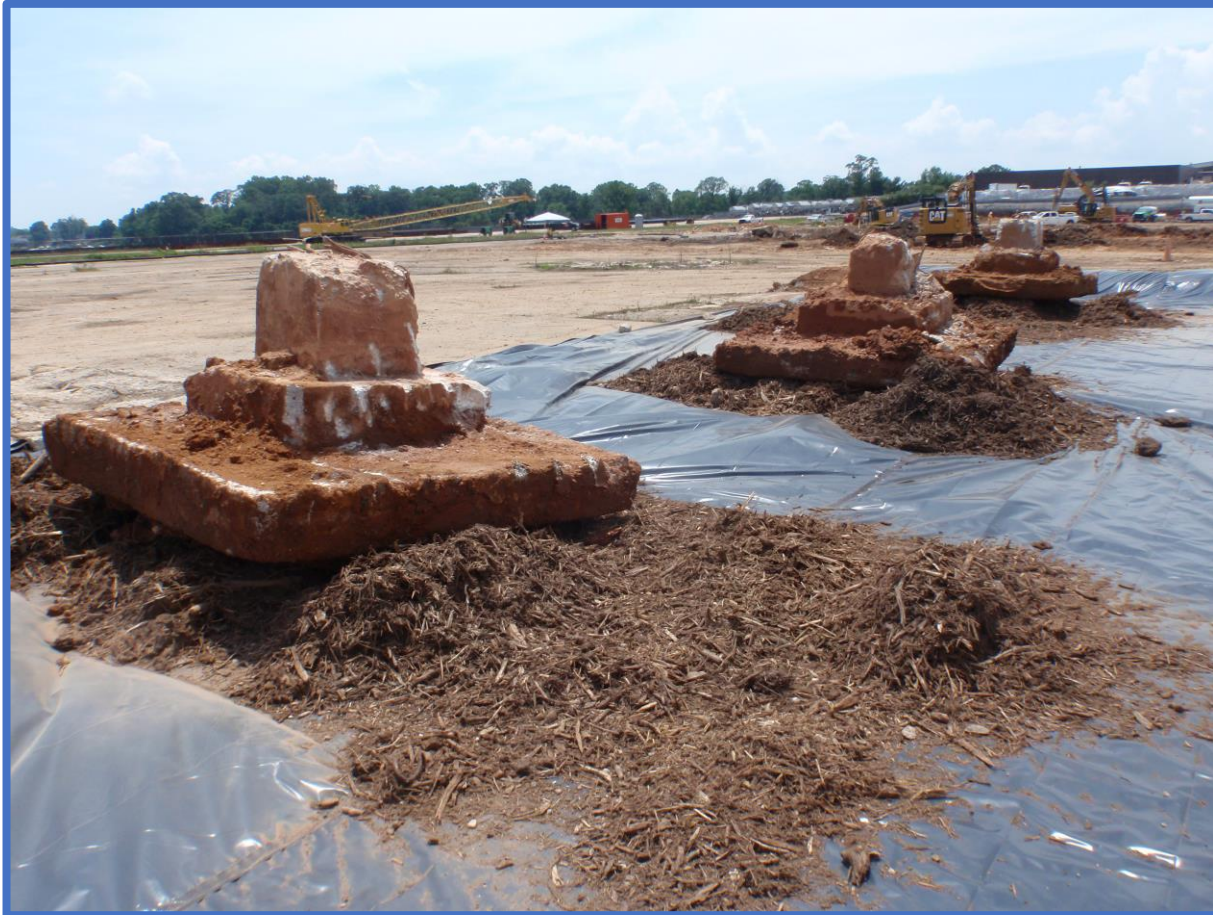
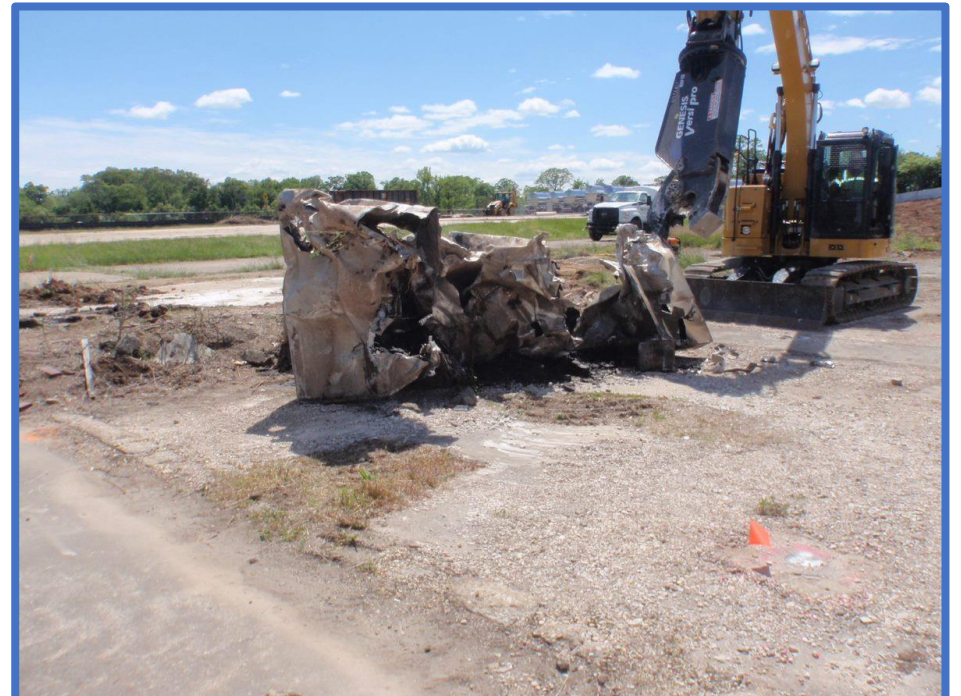
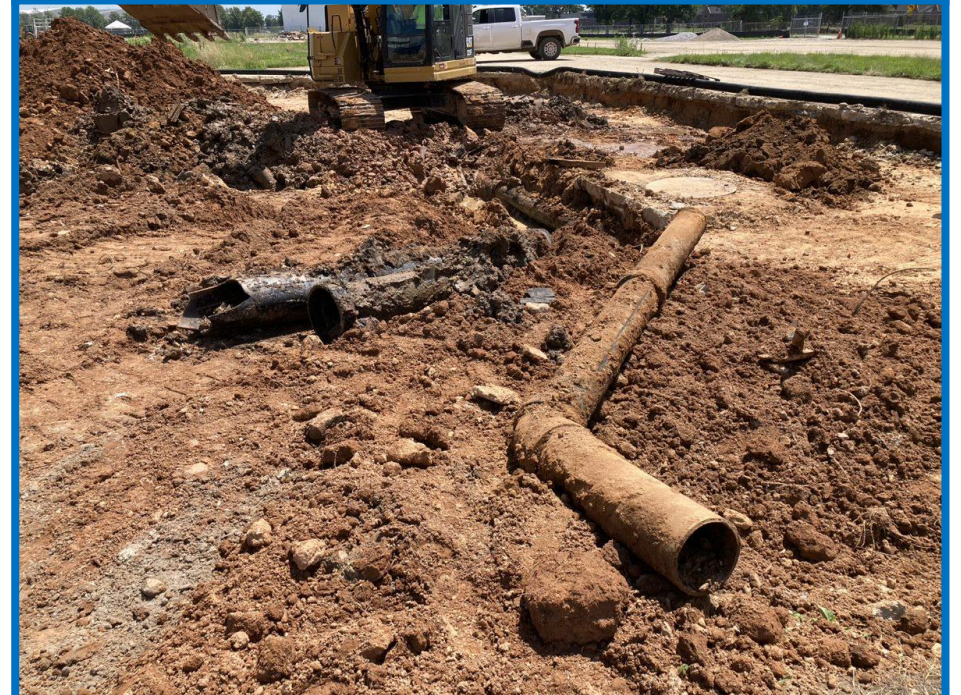
Other items found beneath the concrete foundation included metal and building debris contained within the elevator pits, electrical ducts, metal such as sump linings shown at upper right, and piping (lower right). Some of the foundation footings were contaminated with PCBs, and those that were contaminated required transportation to a licensed disposal facility.

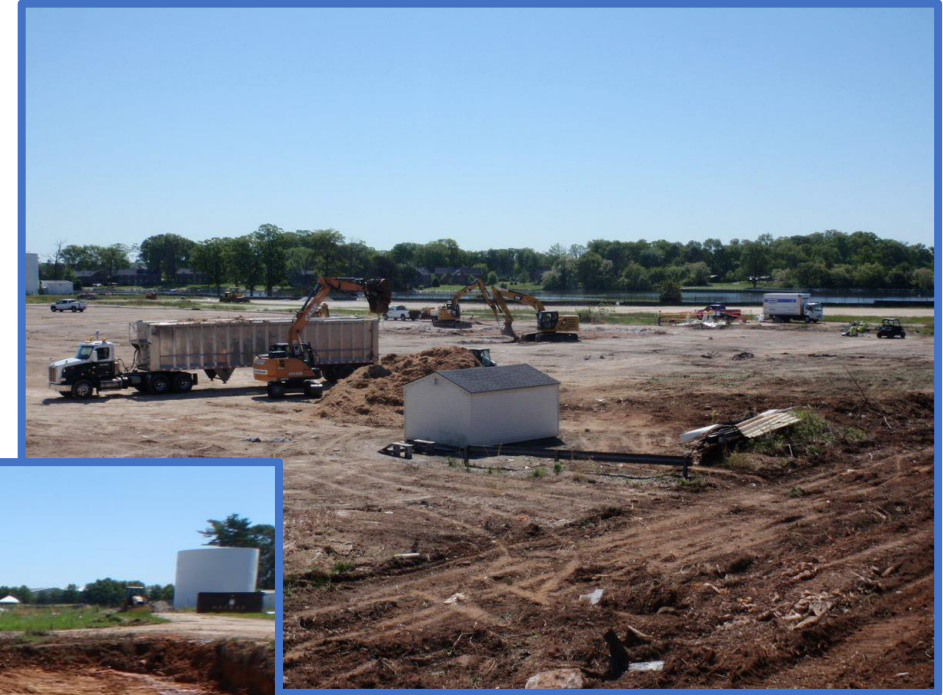
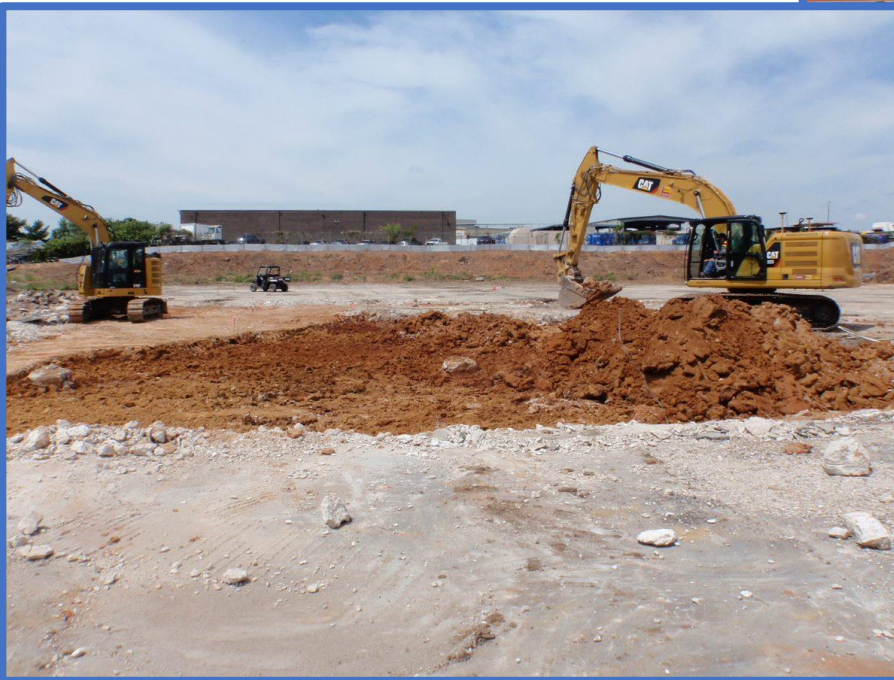
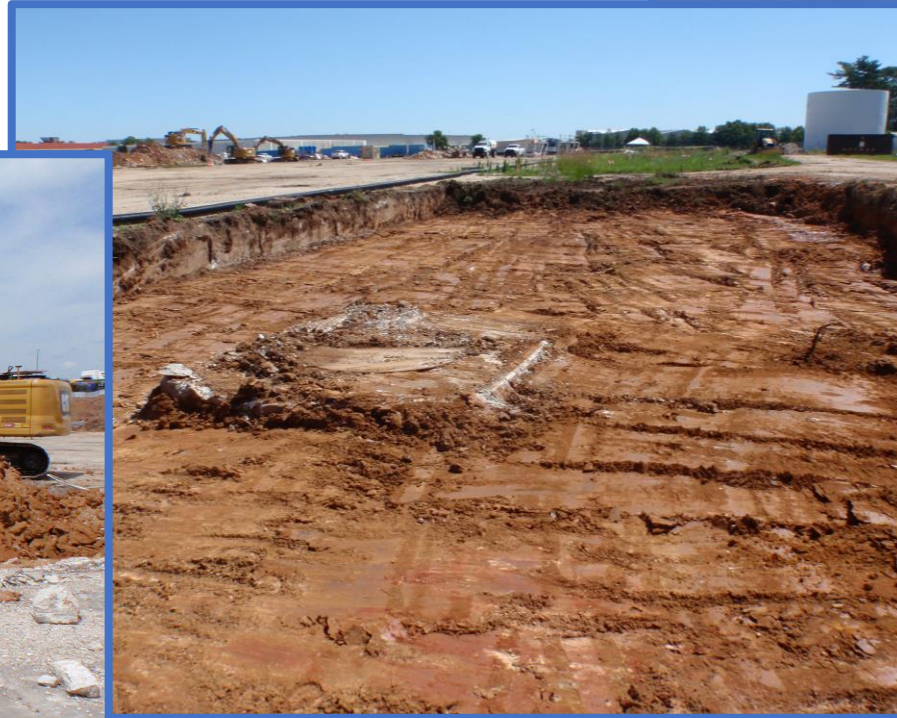
To be able to limit impacts, concrete foundation was removed in sections, and then soil was removed. The depth and location for soil removal was anticipated by previous investigations. Once soil was removed to the anticipated depth, floor and side walls were sampled to confirm contamination removal met planned goals which were established in collaboration with the Maryland Department of Environment (MDE) and the U.S. Environmental Protection Agency (EPA).

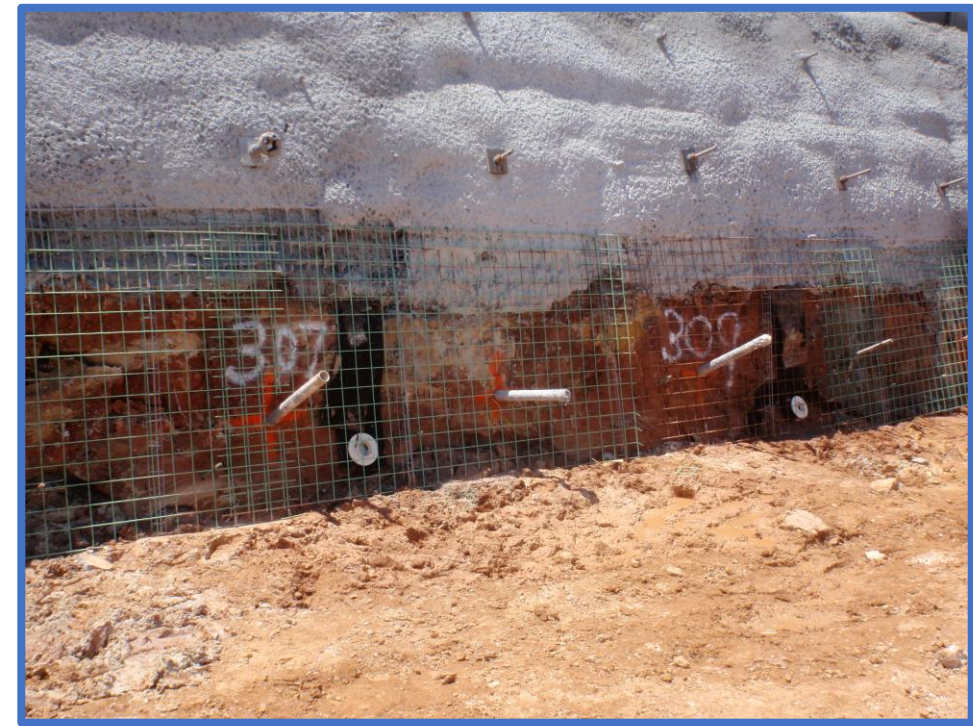
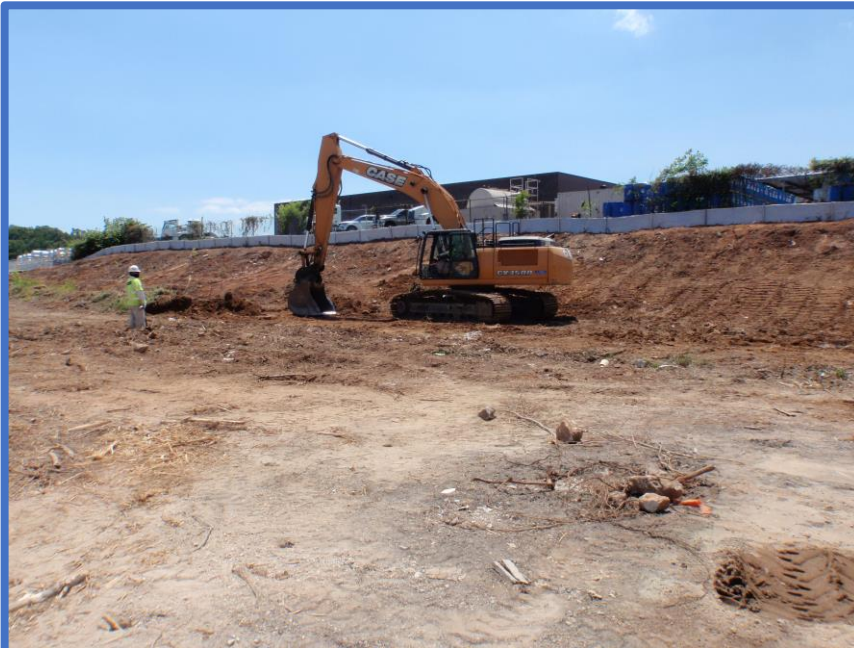
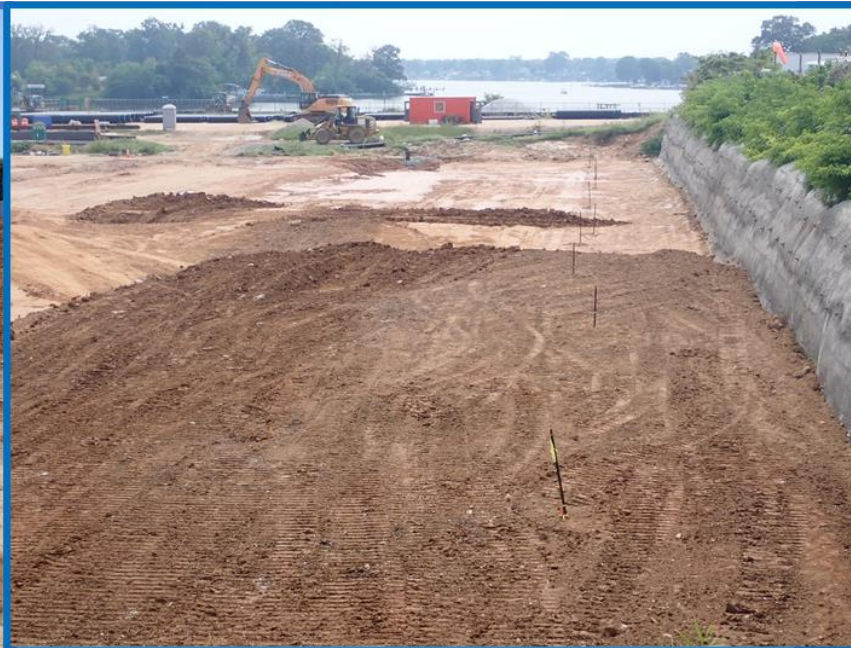
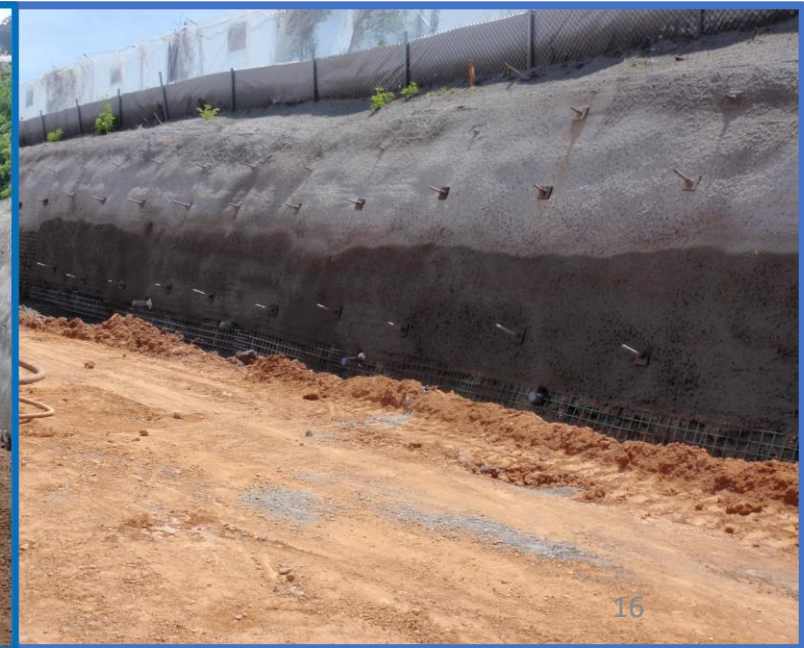
A slope existed on the western portion of the site adjacent to Tilley Chemical Company. A soil nail wall was installed to create a stable side wall for the excavation area. A new, steeper wall was created where soil needed to be removed to access the underlying former building slab and foundation. It will remain in place, and will be covered with fill and topsoil. The final restoration will be a hill as before, but at a slightly steeper slope than was there before. The photo at bottom left shows where fill has been placed in the western area, closest to Tilley Chemical Company.

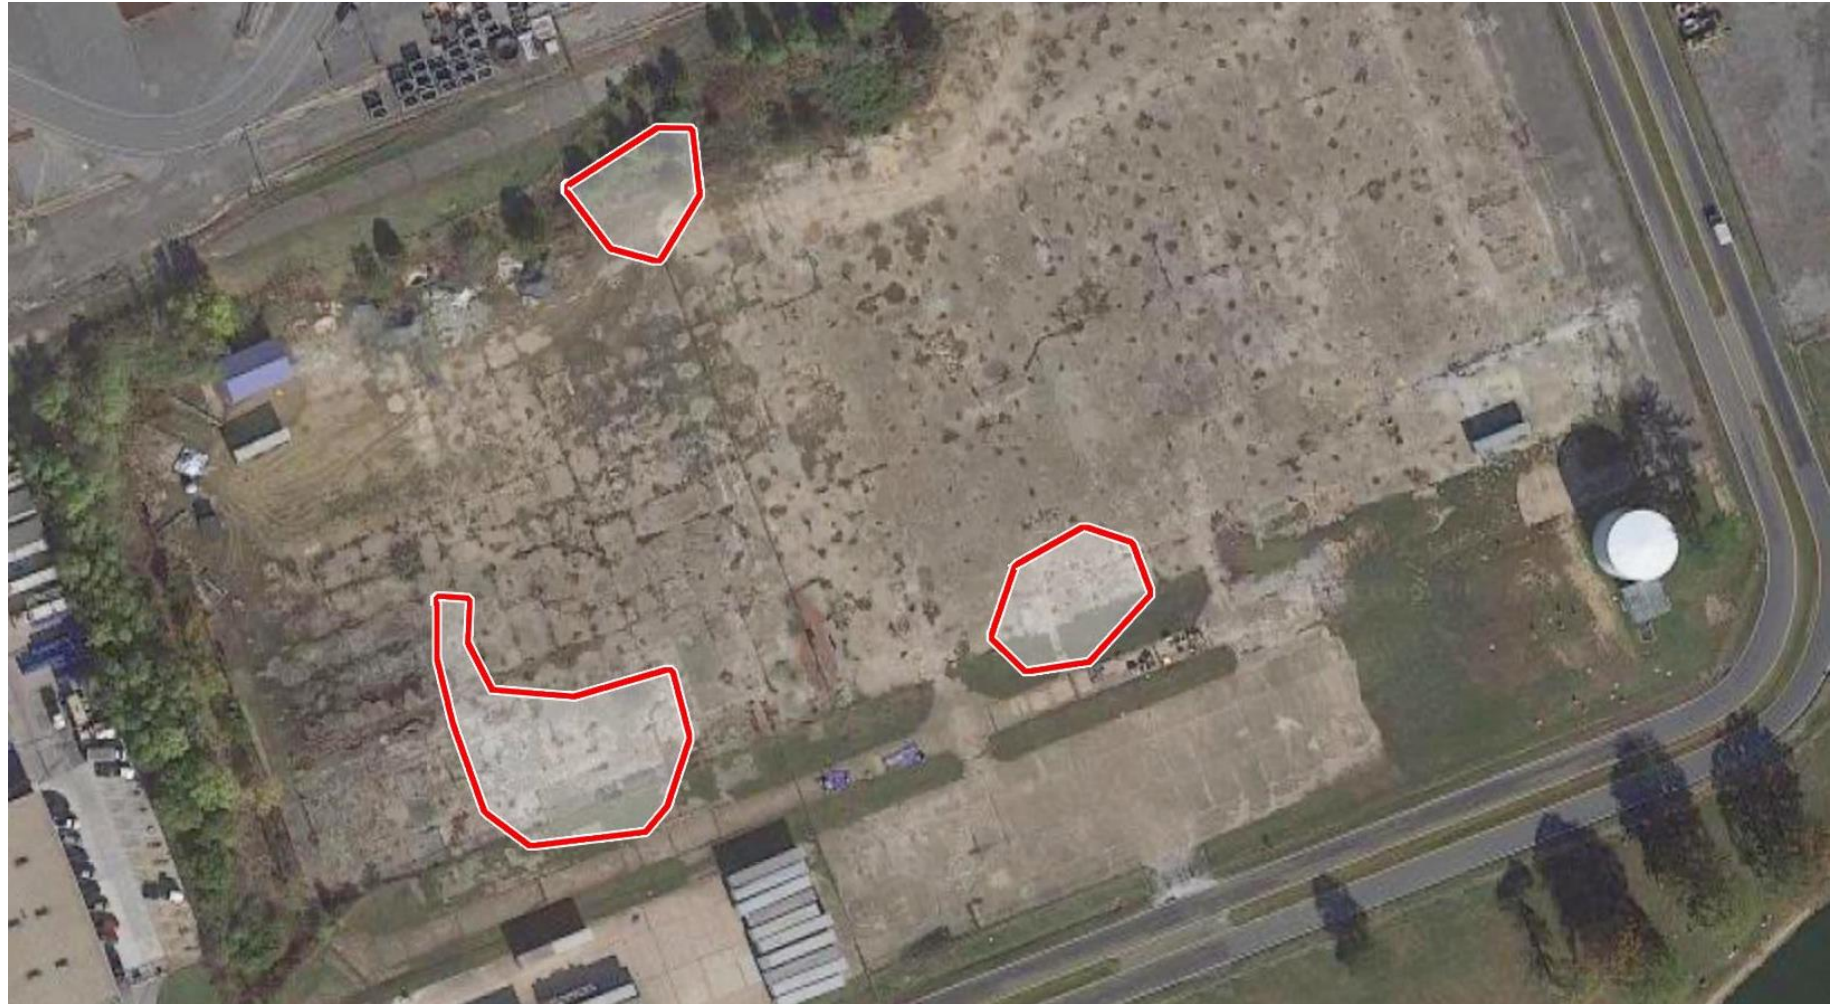
Three areas located beneath former transformer rooms were planned to be excavated to depths of up to twenty feet. These deep excavations required metal sheets to be driven into the ground to shore up the side walls. Given the proximity to the airport, use of pile-driving cranes was approved by the Federal Aviation Administration and the Maryland Aviation Administration. When the holes are refilled with clean soil, the steel sheets will be removed using the crane.

The locations of the deep excavations shown here are approximate.

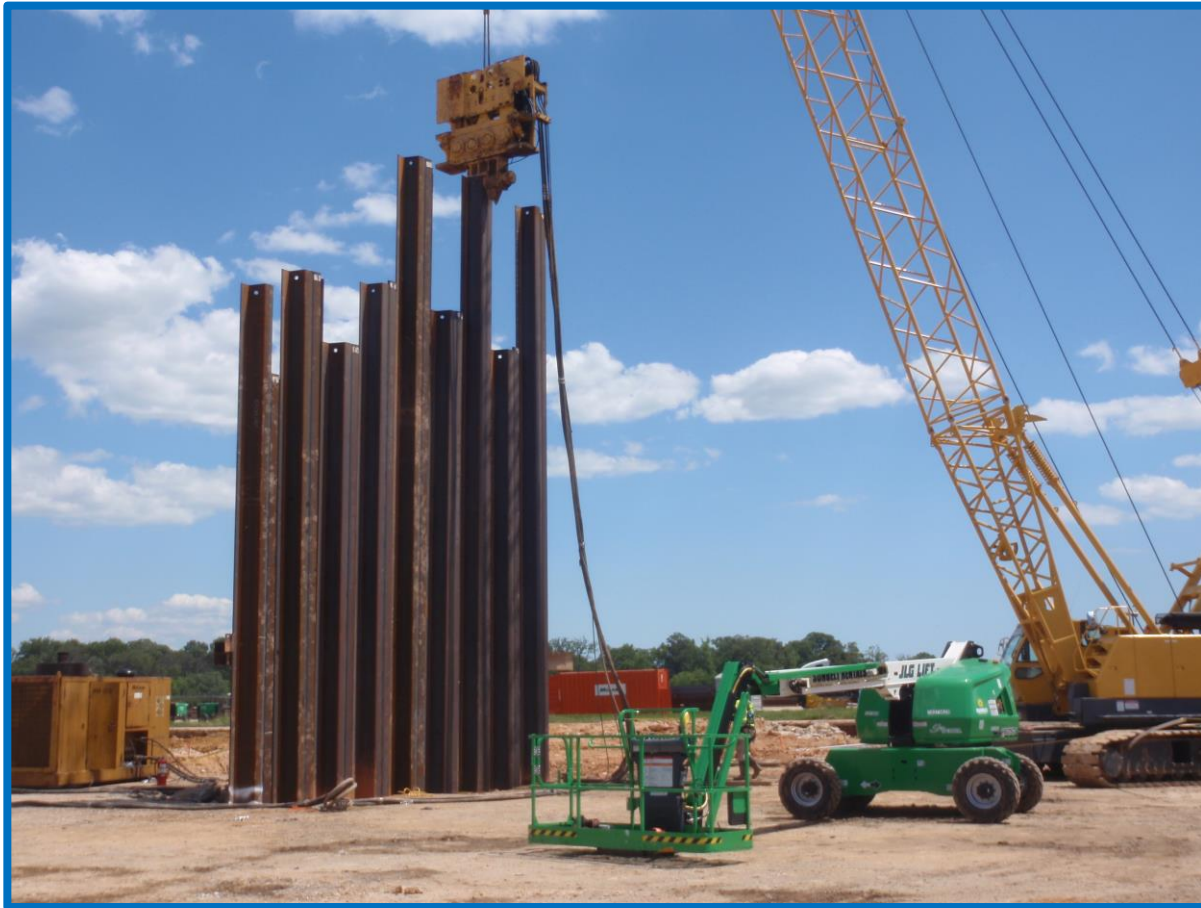
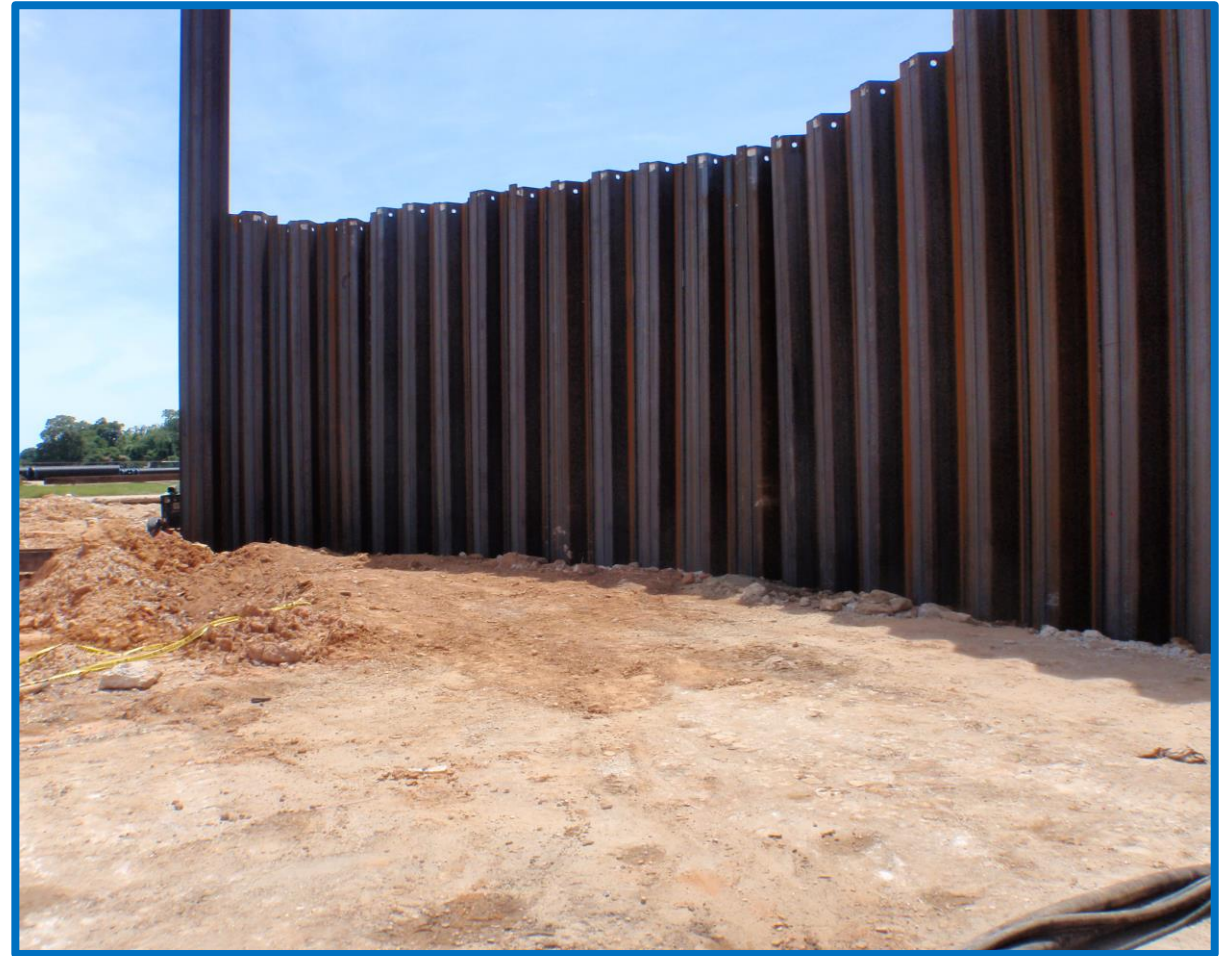
Temporary steel sheets were installed to shore up the sides of work areas where deeper soils were removed. Excavation at the area shown in this photo will be completed to 20 feet deep. This is the deepest excavation area.

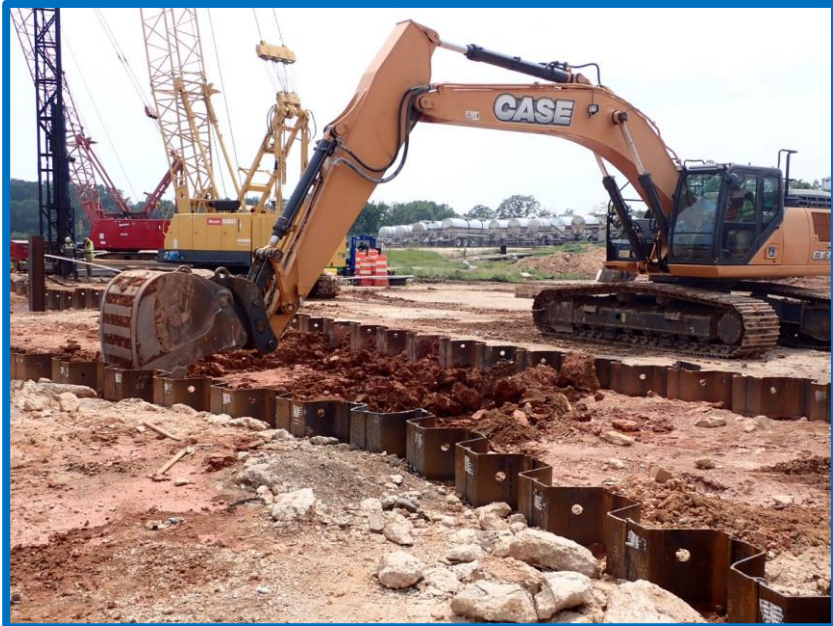
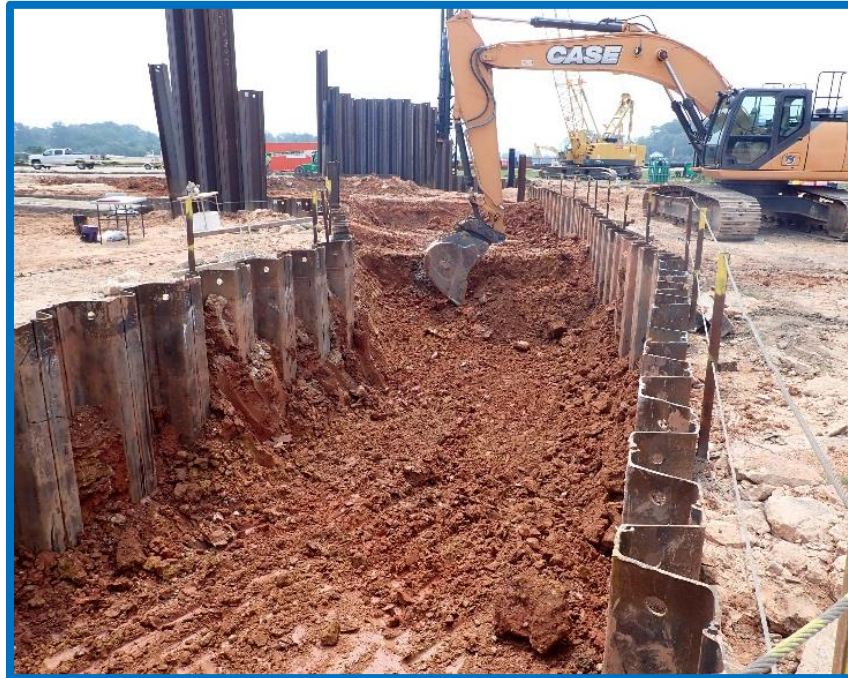
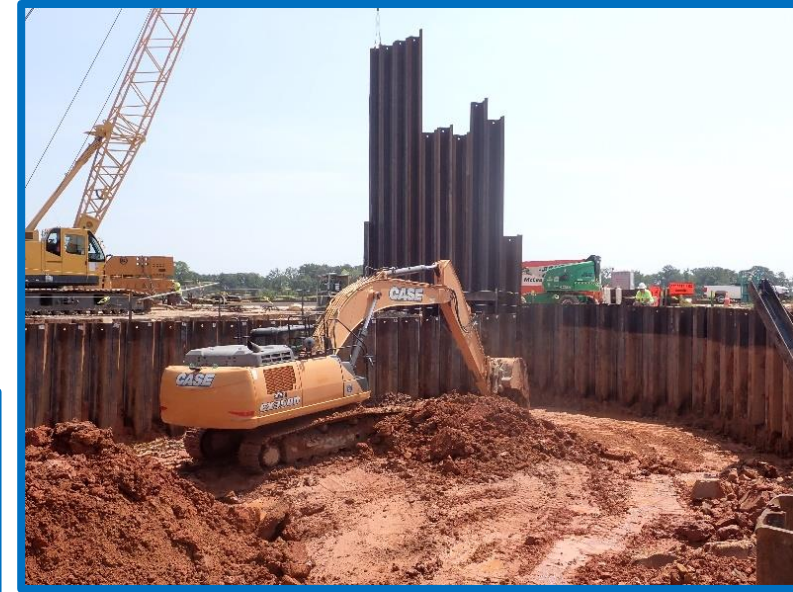
Once shoring was installed, deep excavations were completed in lifts from various points both outside and within the excavation. A ramp was established to allow access by equipment into each excavation.

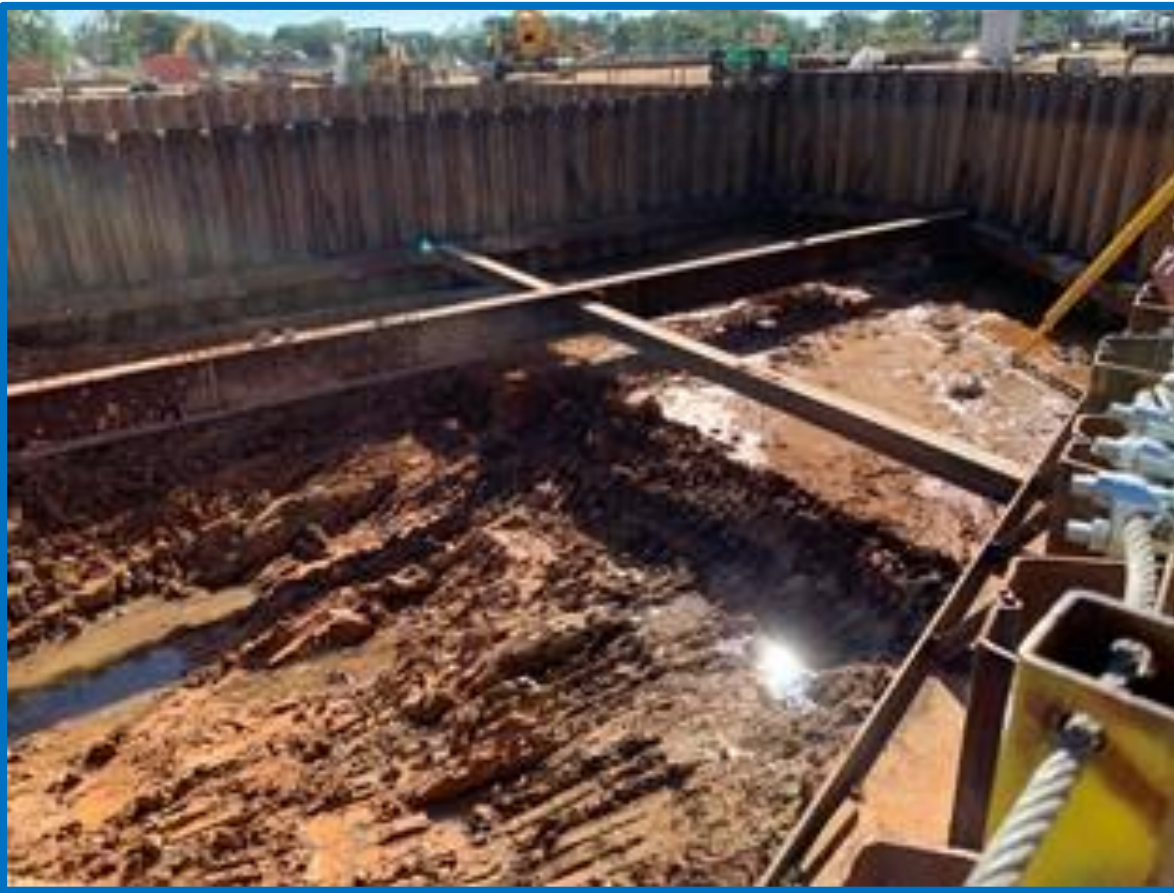
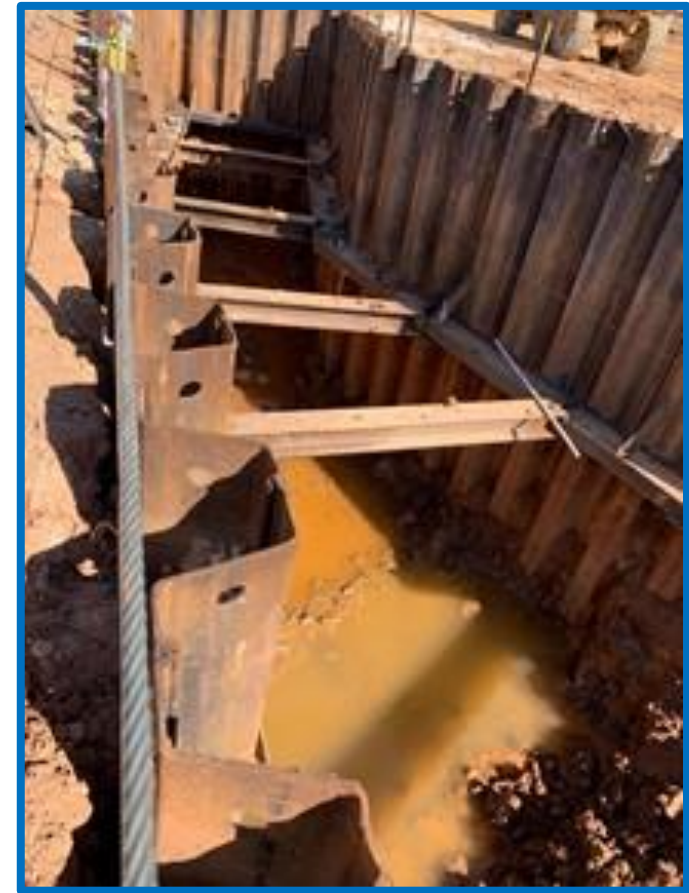
Walers (along the perimeter of the sheeting) and struts (going across the excavation) were installed at approximately 12 feet to support the sheeting at further depths.

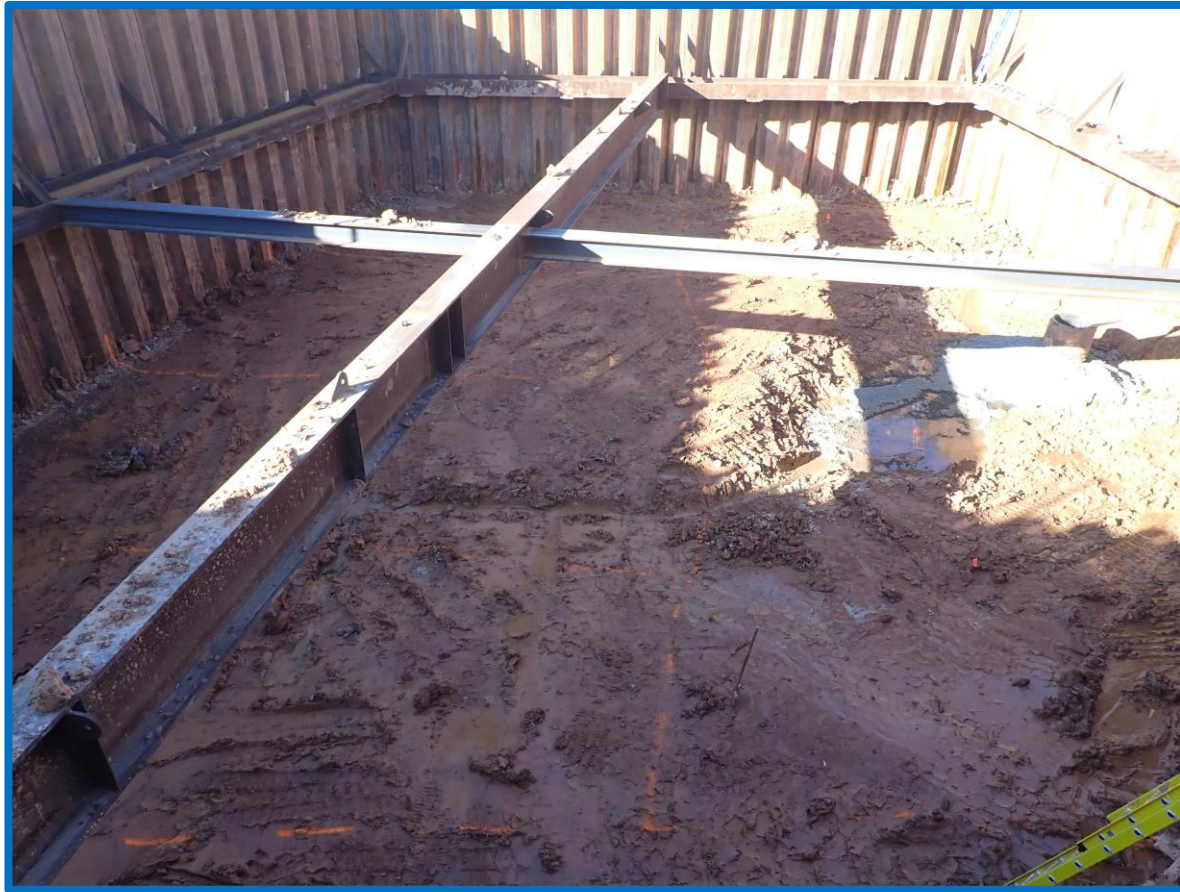
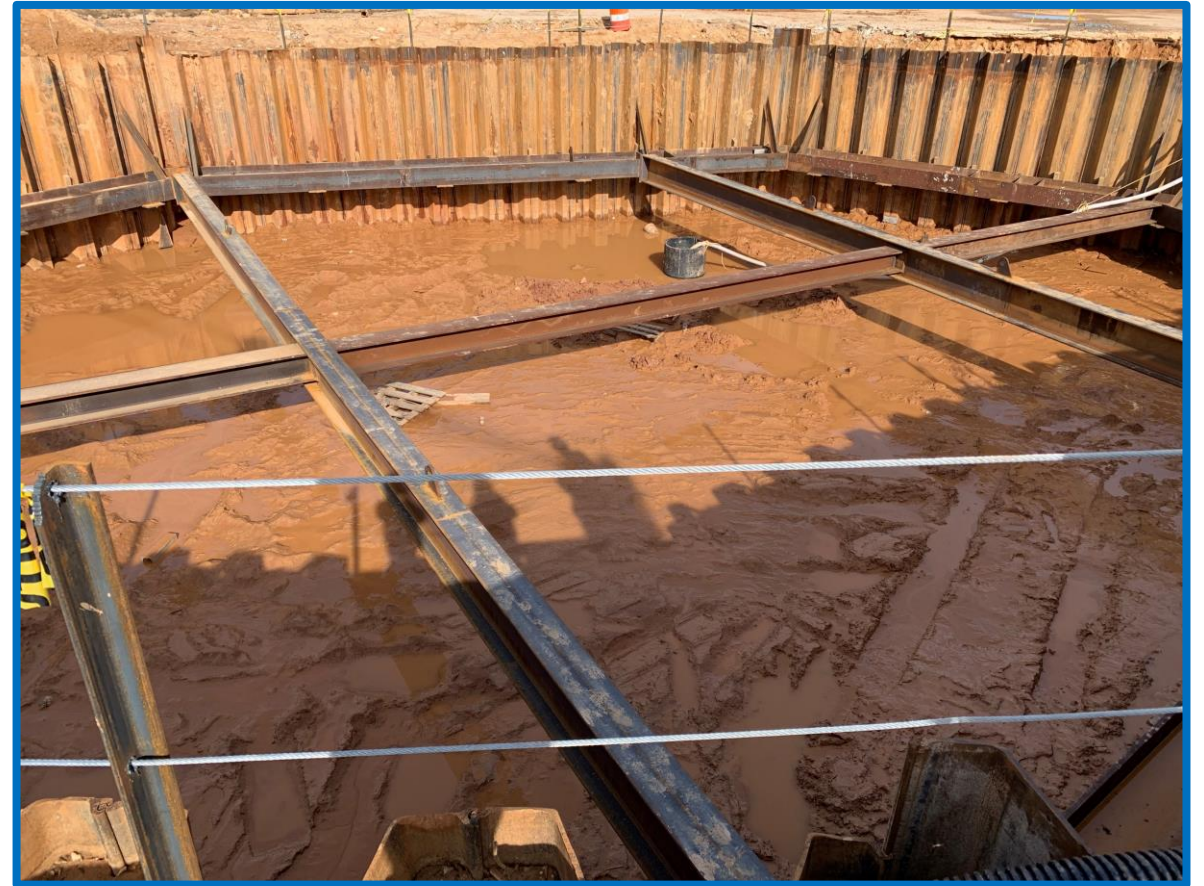
Once the excavation was complete, confirmation samples were collected.

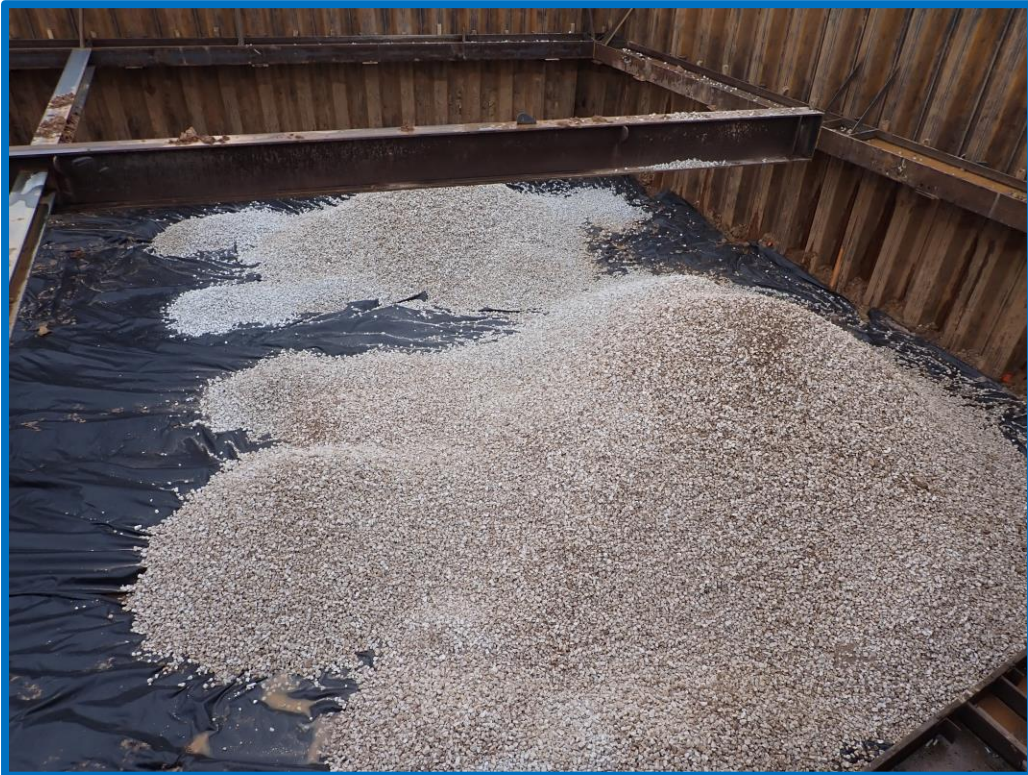
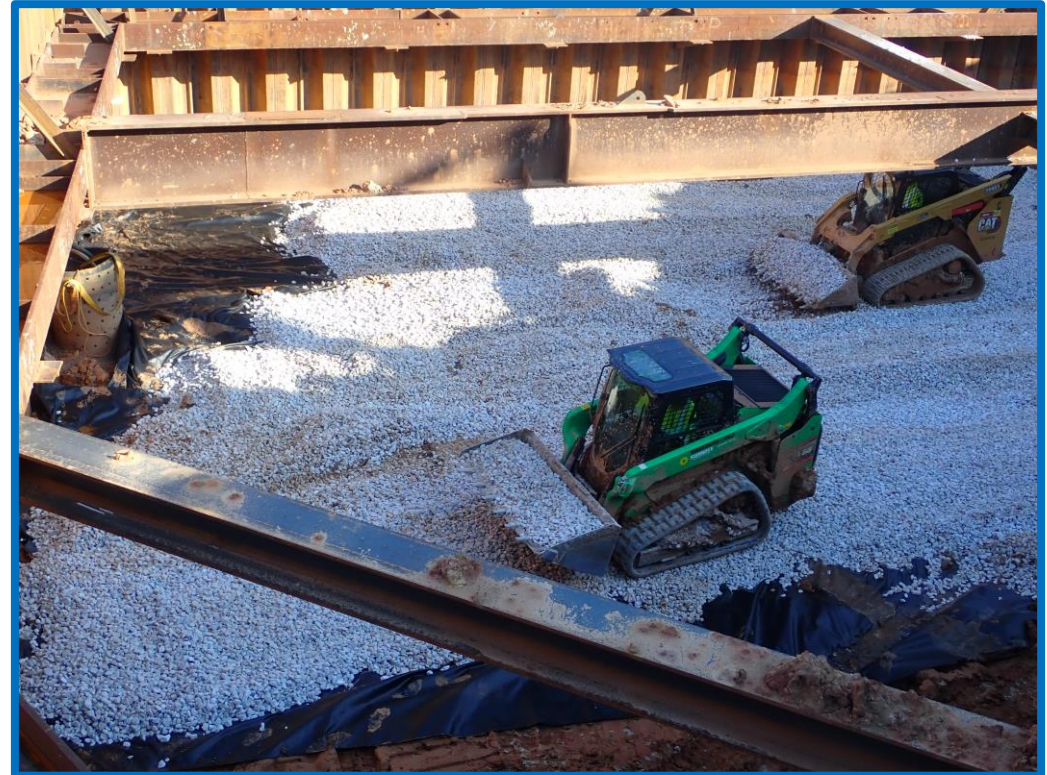
Backfill began after confirmation sampling results confirmed the excavation had removed all of the contaminated soil and met planned goals which were established in collaboration with the Maryland Department of Environment (MDE) and the U.S. Environmental Protection Agency (EPA). Due to wet conditions at the bottom of the deep excavations, backfill consisted of placing a layer of geotextile fabric, followed by crushed stone and/or recycled concrete for approximately 6-10 feet, then another layer of geotextile fabric, and then clean fill. Using the fabric as a barrier before and after the crushed stone prevented the soil from settling into the stone layer.

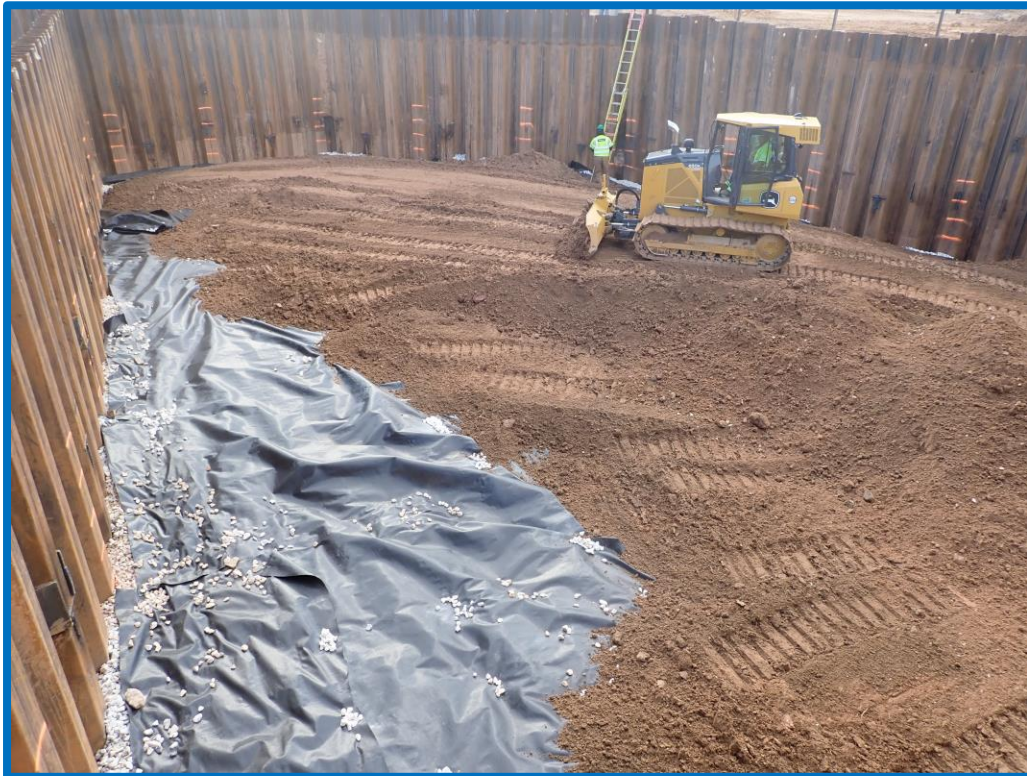
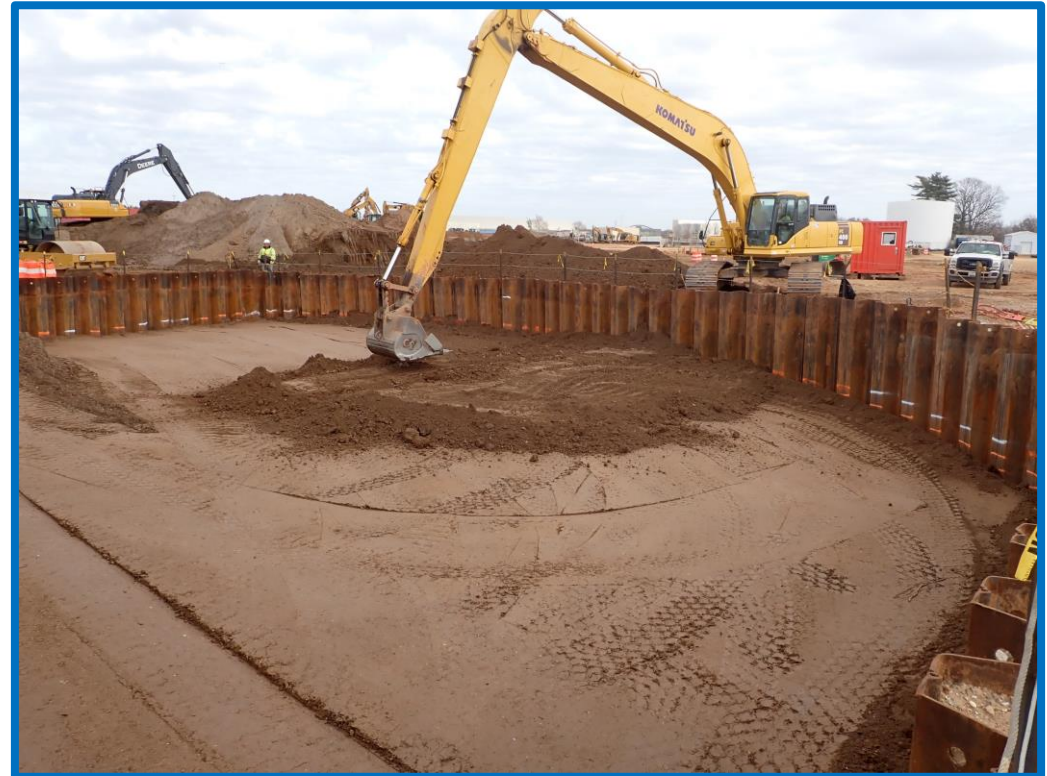
Once the crushed stone was placed, backfill continued using clean soil up to the existing surface.

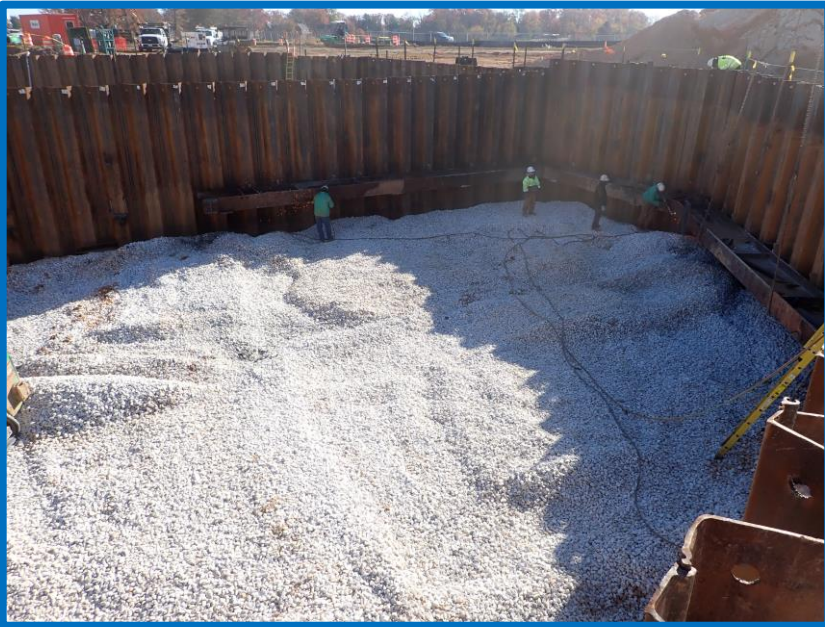
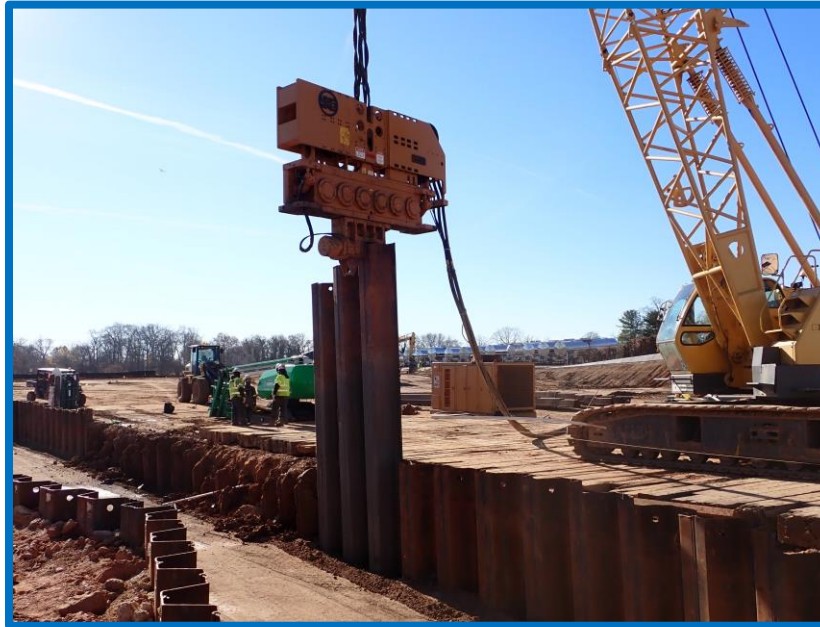
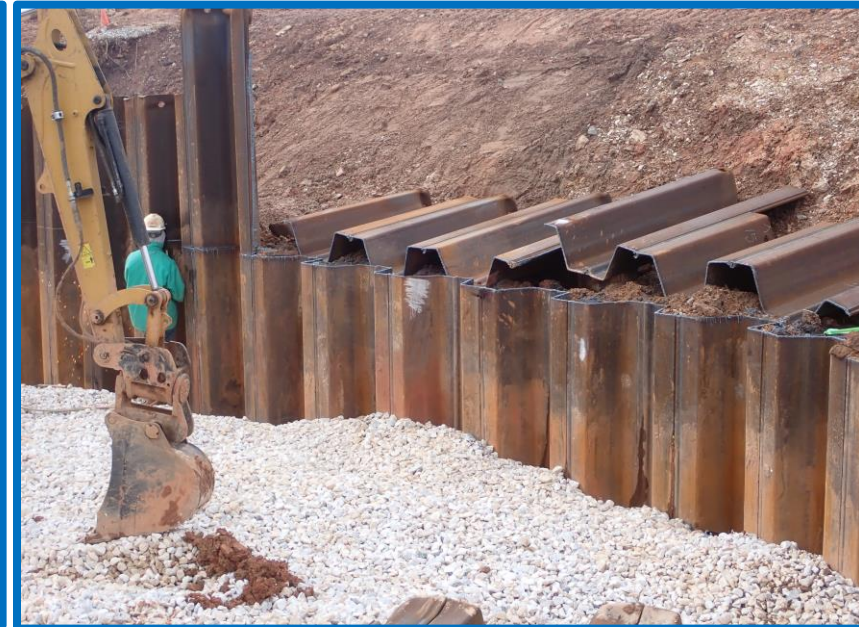
As backfill was completed, the walers and struts were removed from the excavation, decontaminated, and taken off-site. Generally, once backfill neared the surface, the sheeting was pulled, decontaminated, and removed from the site. In one area on the northern side of the site, some sheeting was cut 4 feet below the surface and left in place to avoid damaging an active water utility in that area. The walers, struts, and sheeting will be reused on other projects.
