# Block E Soil Cleanup Photo Tour

February 2022

# Block E Soil Cleanup Project Accomplishments

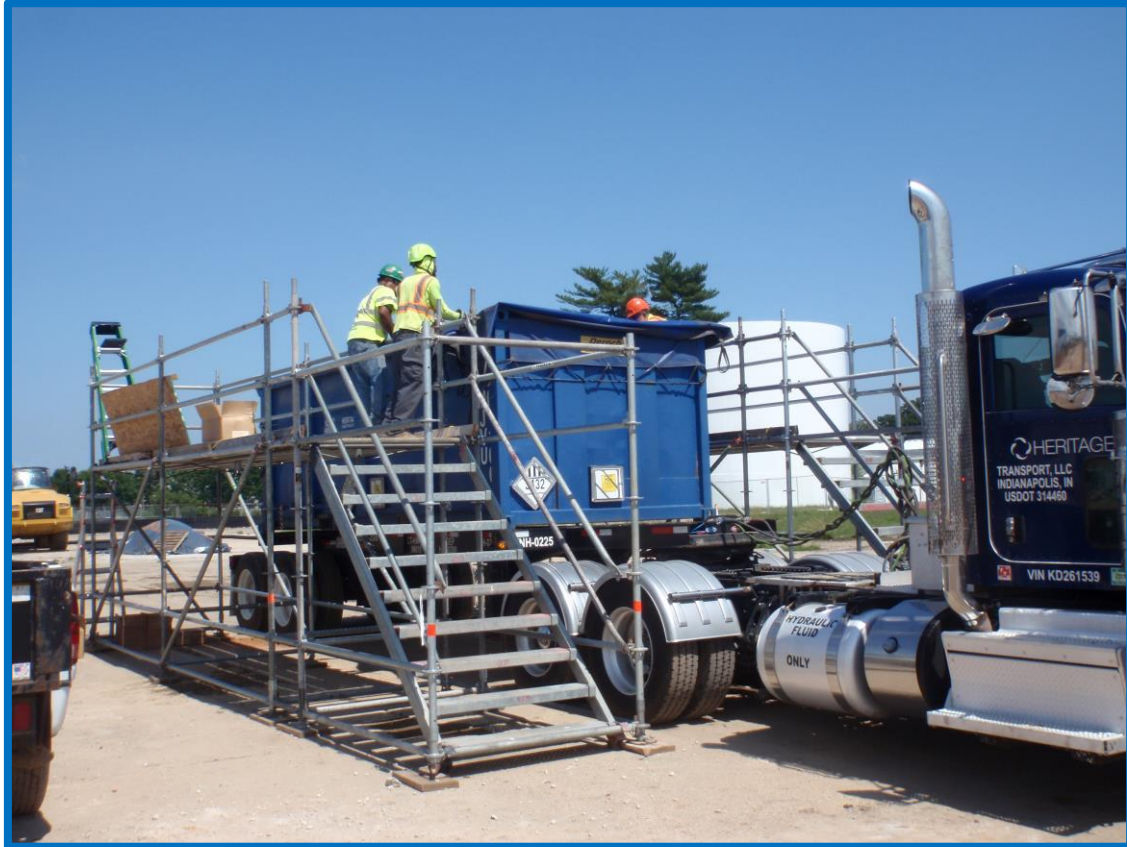
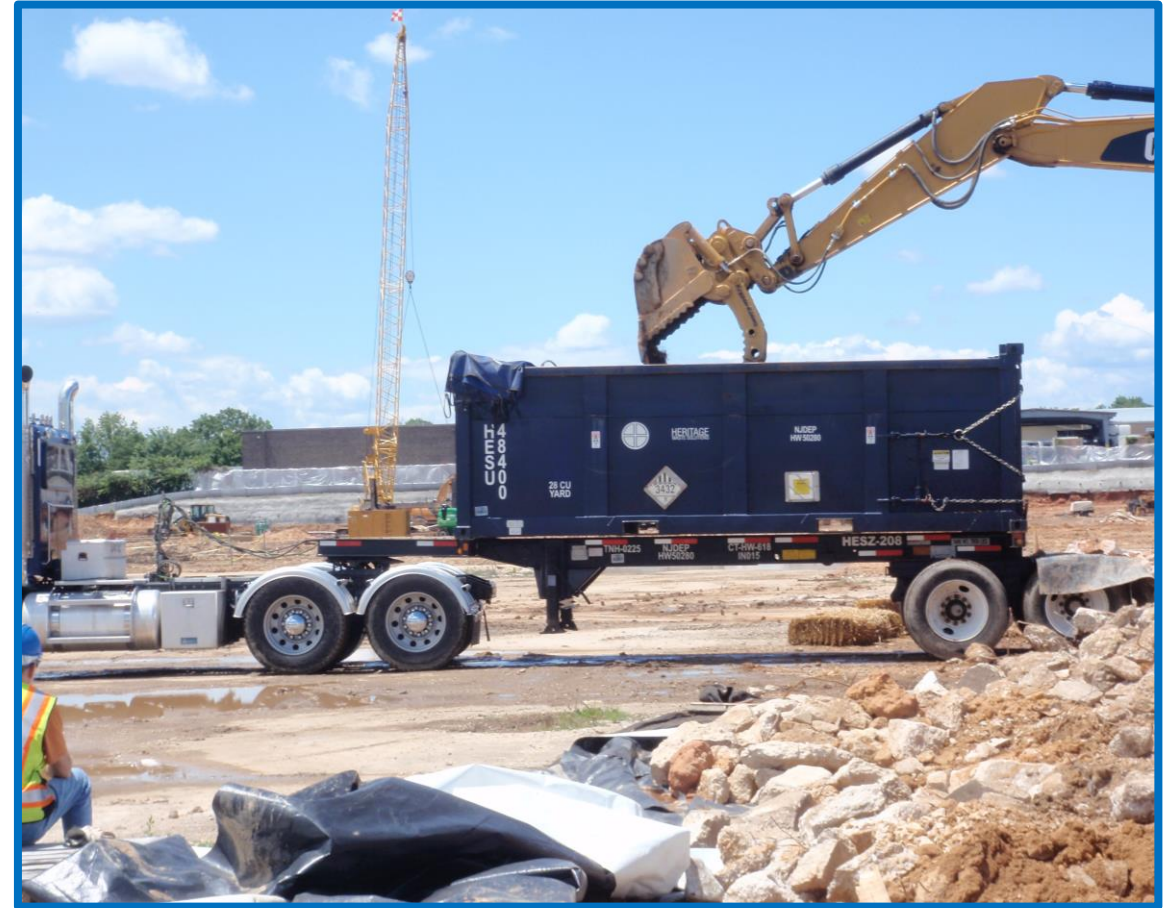
Soils contaminated with polychlorinated biphenyls (PCBs) were stored onsite in a lined and contained area, then loaded into lined trucks, and covered with tarp before leaving the site for disposal at a licensed landfill. Truck containers are shipped by rail for most of their trip to the landfill.

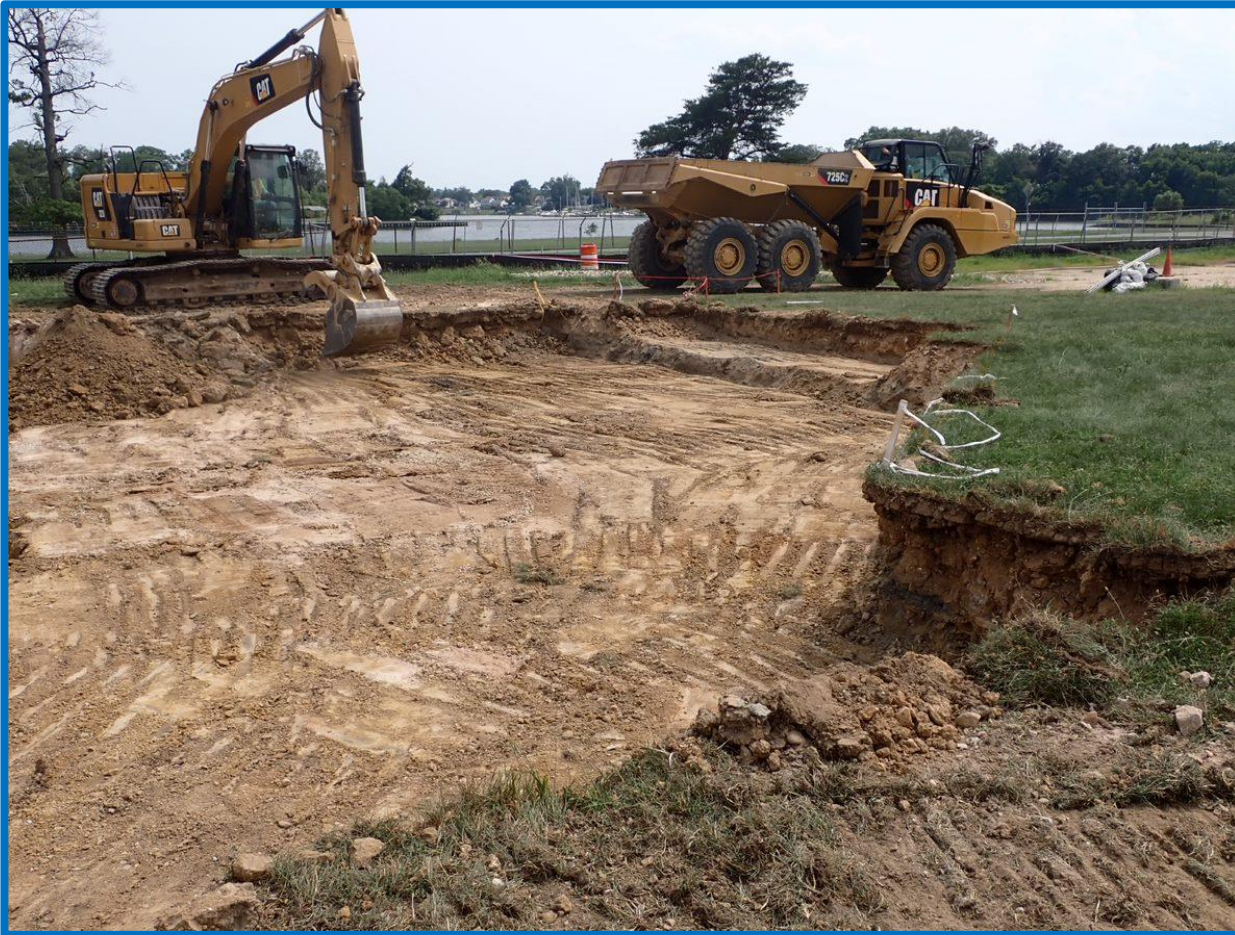
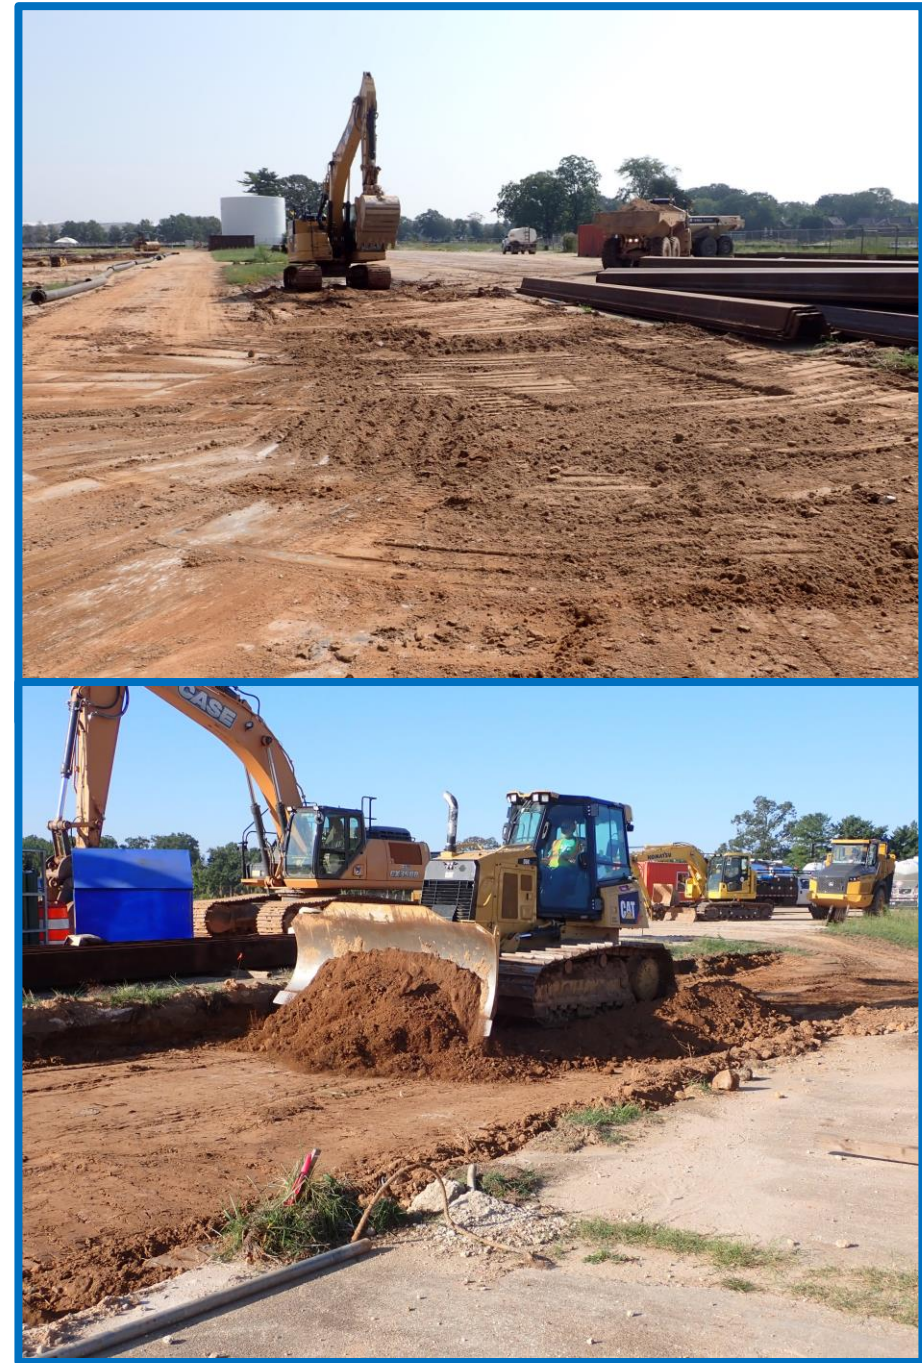
Once an excavated site has had floor and side walls confirmed that the cleanup objectives were accomplished, confirmed clean soil is used to return the hole to its original surface height.

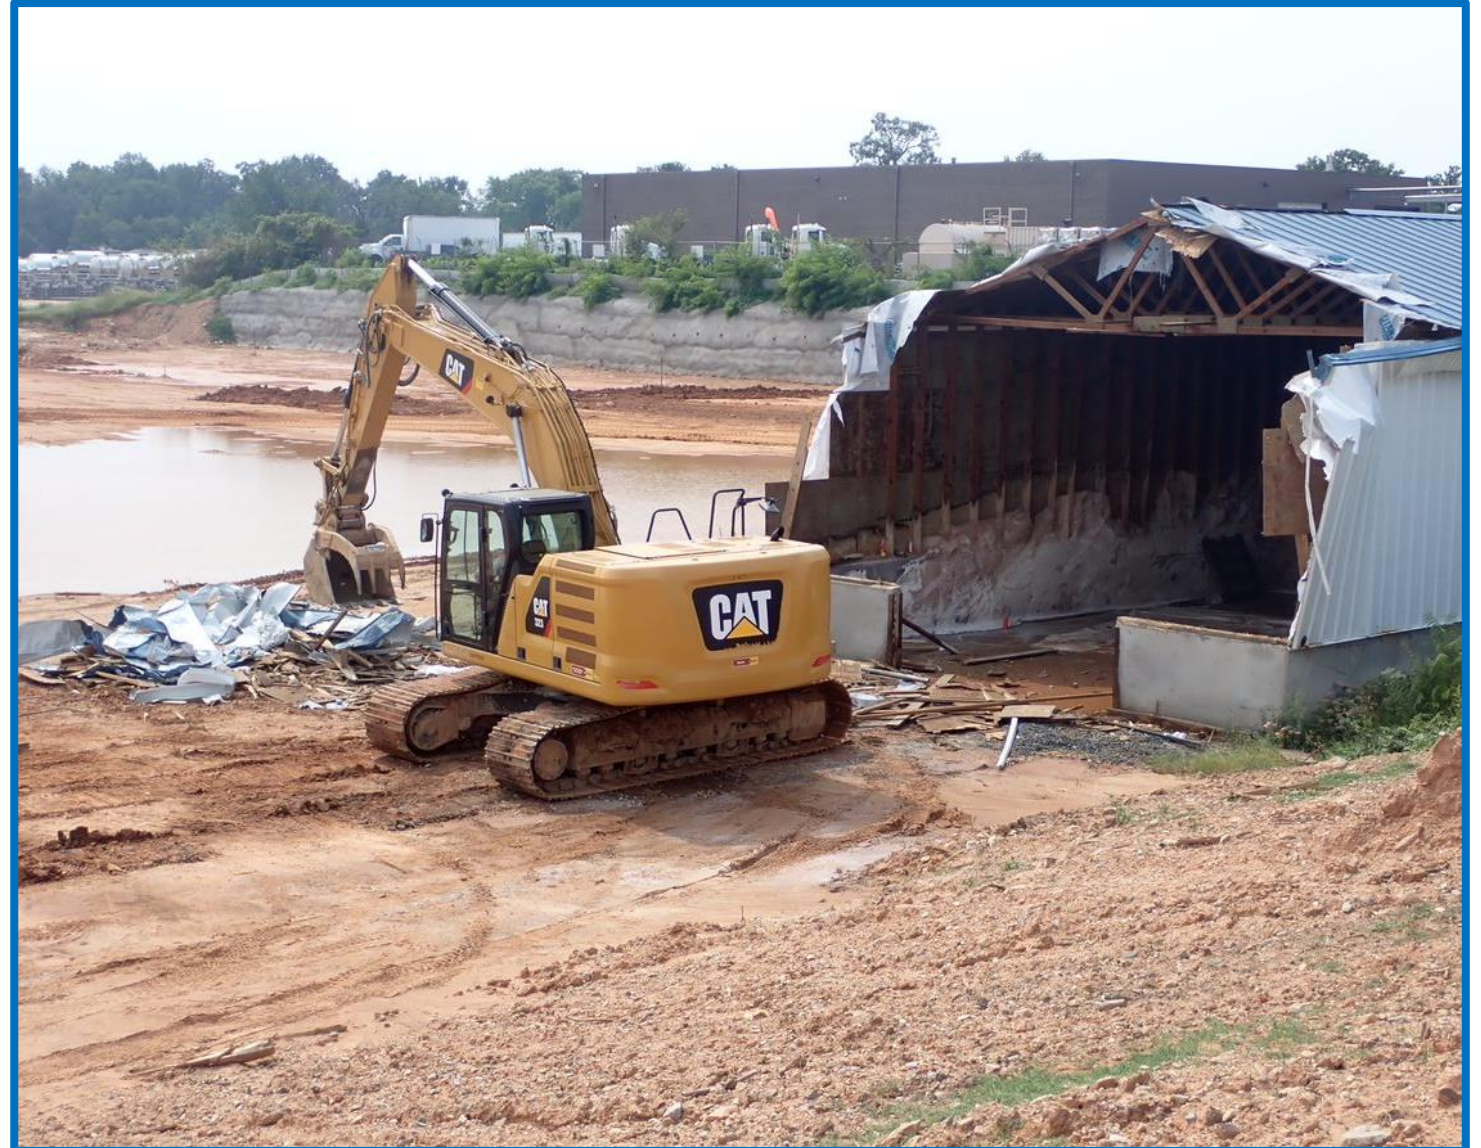
The existing road salt storage shed at Block E was emptied prior to beginning the construction work and has been demolished. Due to the removal of the concrete surface, this location is no longer practical for equipment or materials storage by the facility. A new salt storage area was created inside the Middle River facility.

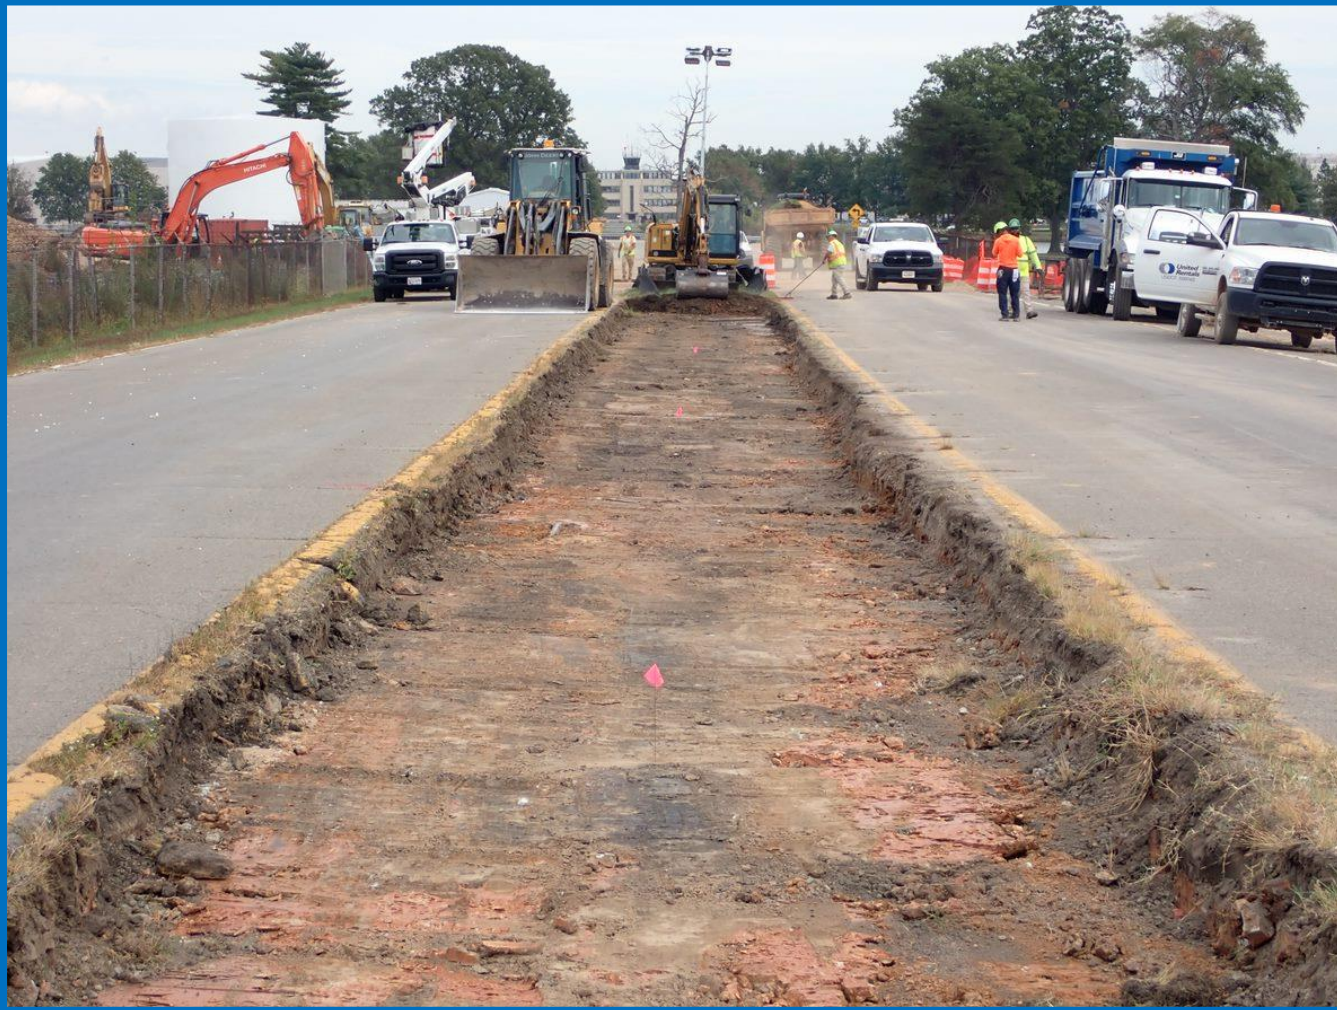
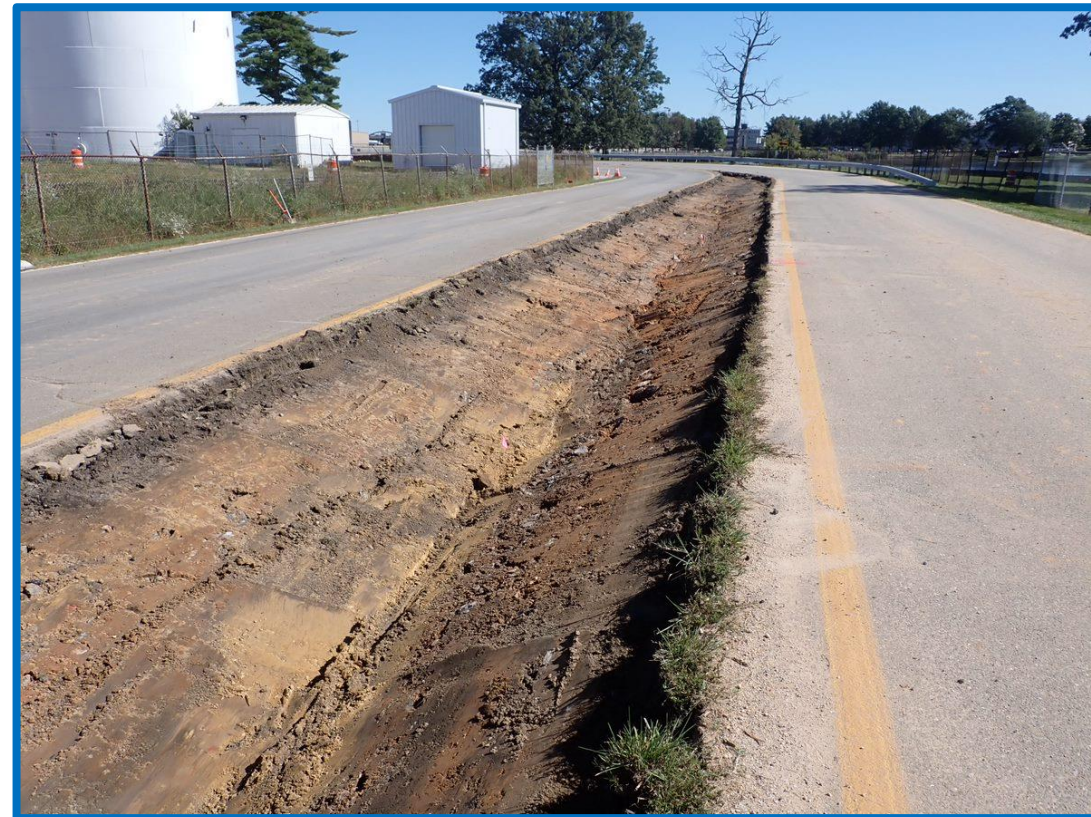
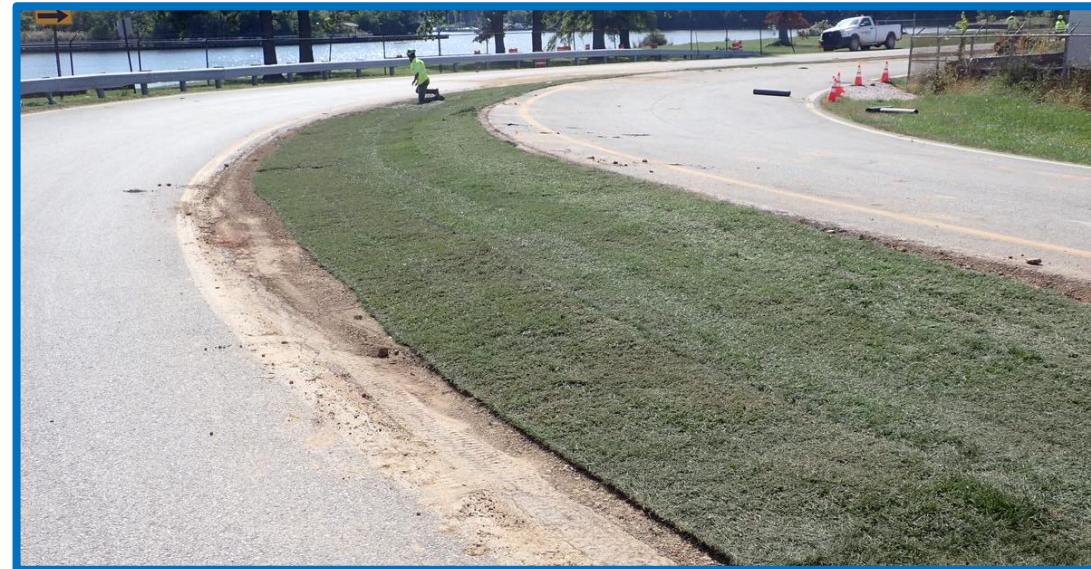
The road was closed while the median was excavated, removing the top soil which was found to contain PCBs. Work occurred in September-October 2021 and the community was notified of the road closure. The lower right shows the restored median.

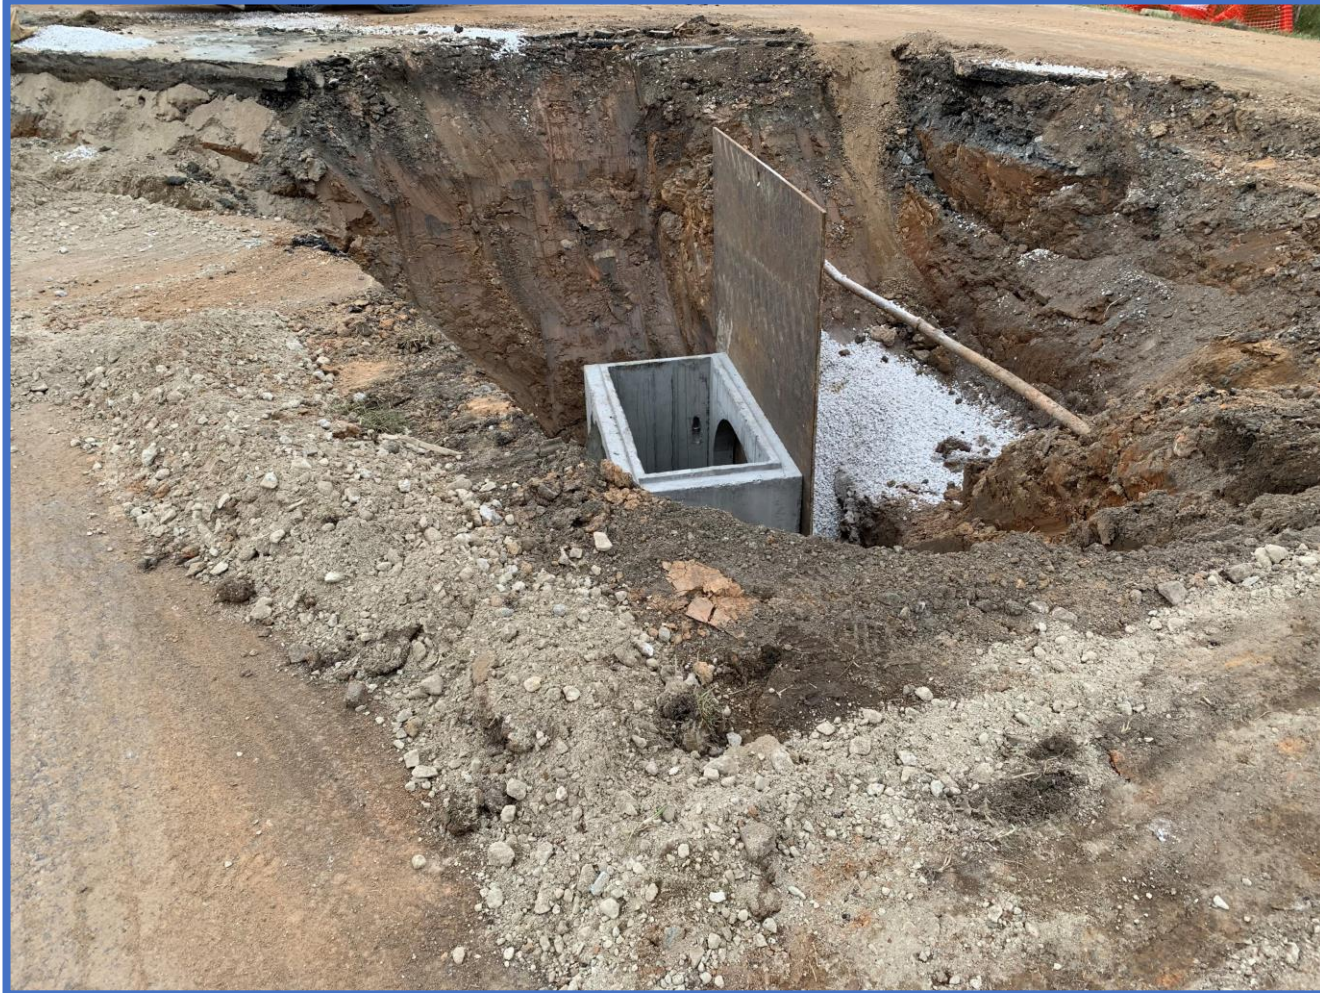
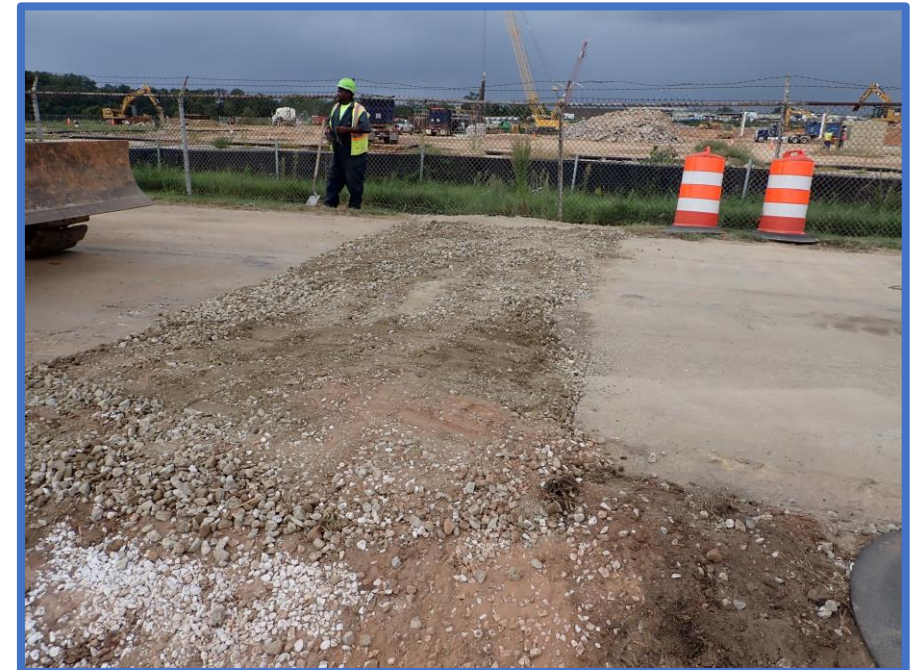
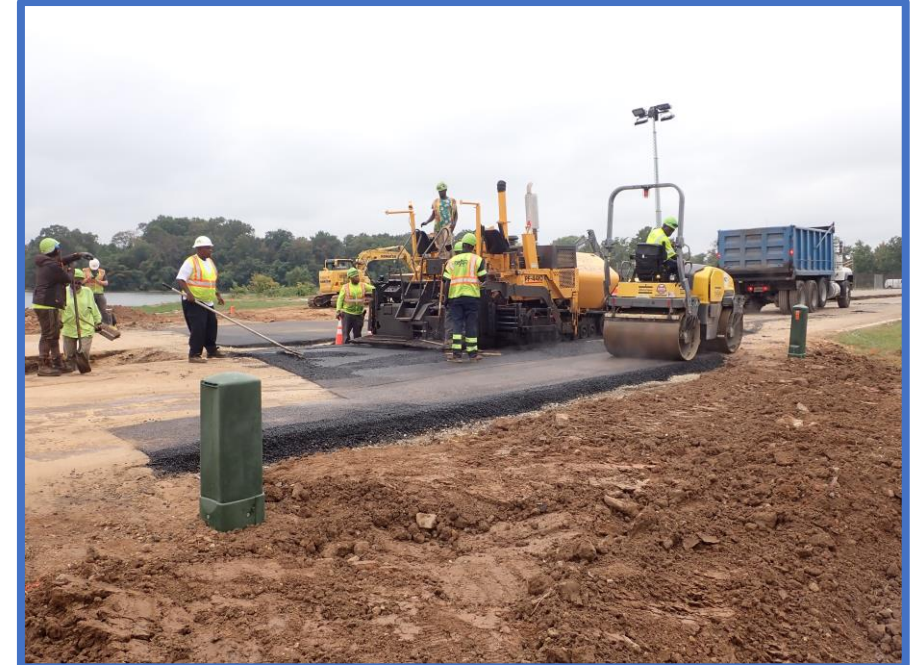
Storm drains underneath Chesapeake Park Plaza that are connected to the storm drain system in Block E were removed and replaced, and the roadway surface restored.

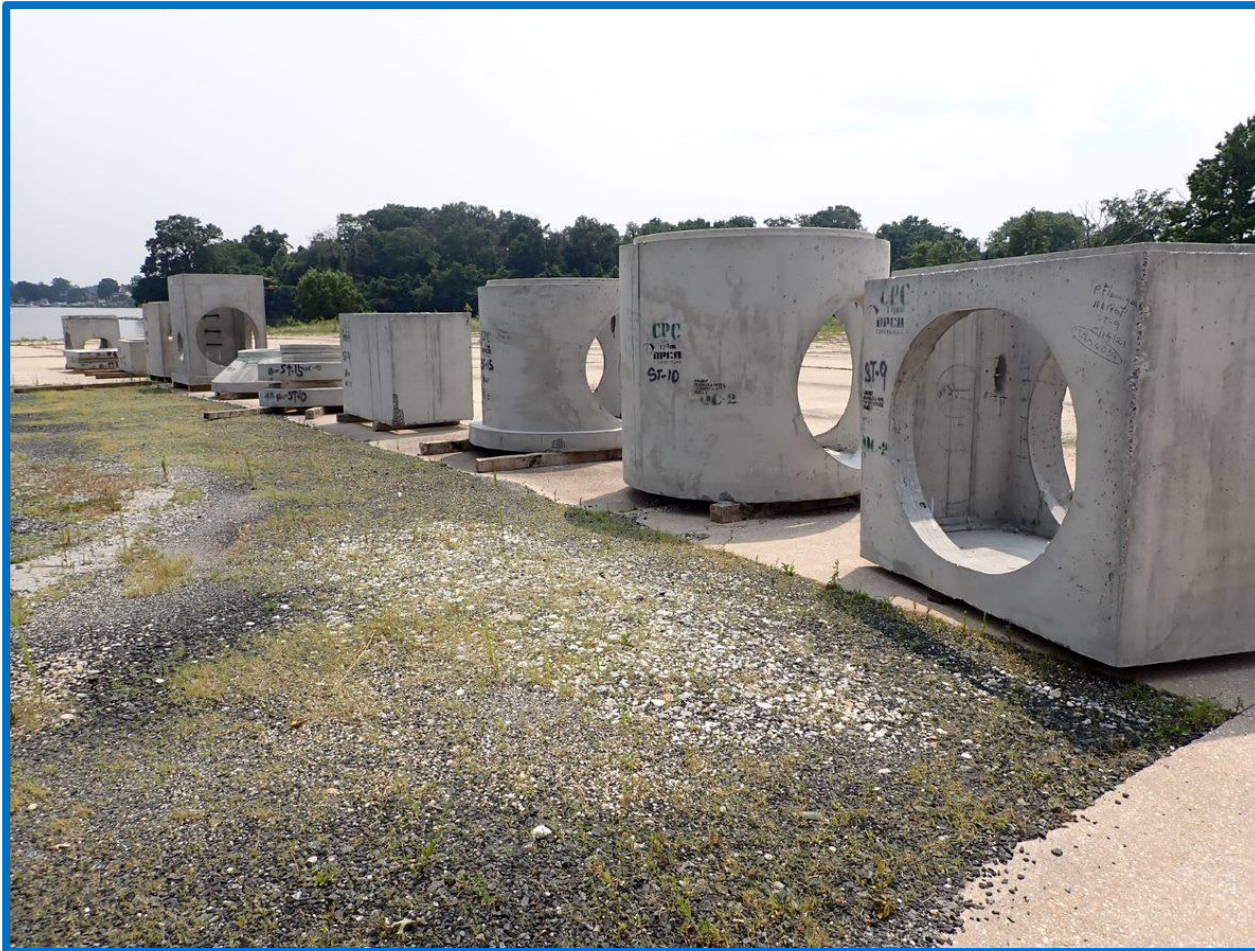
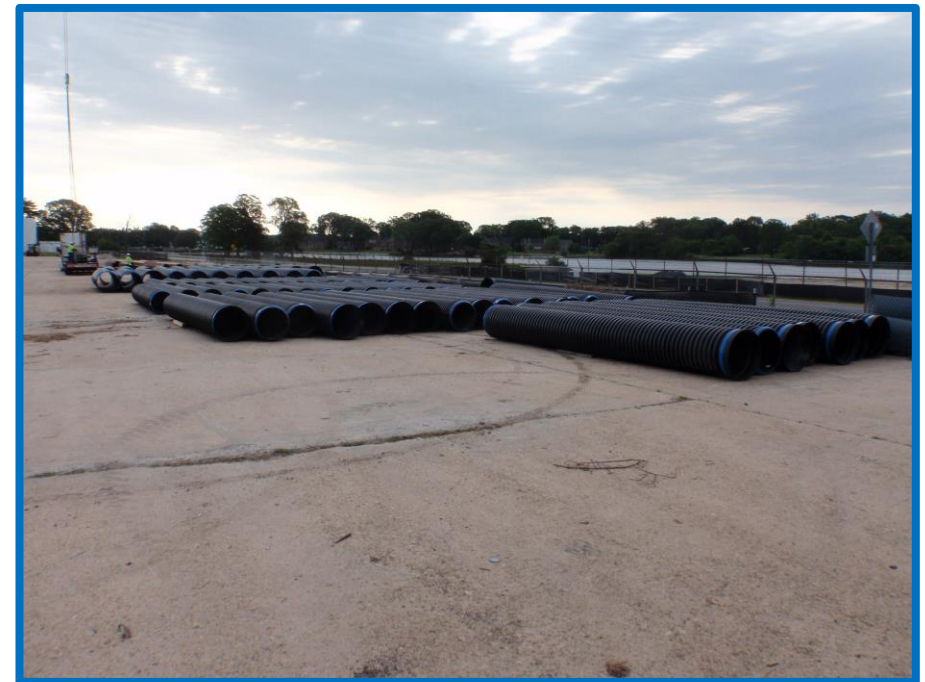
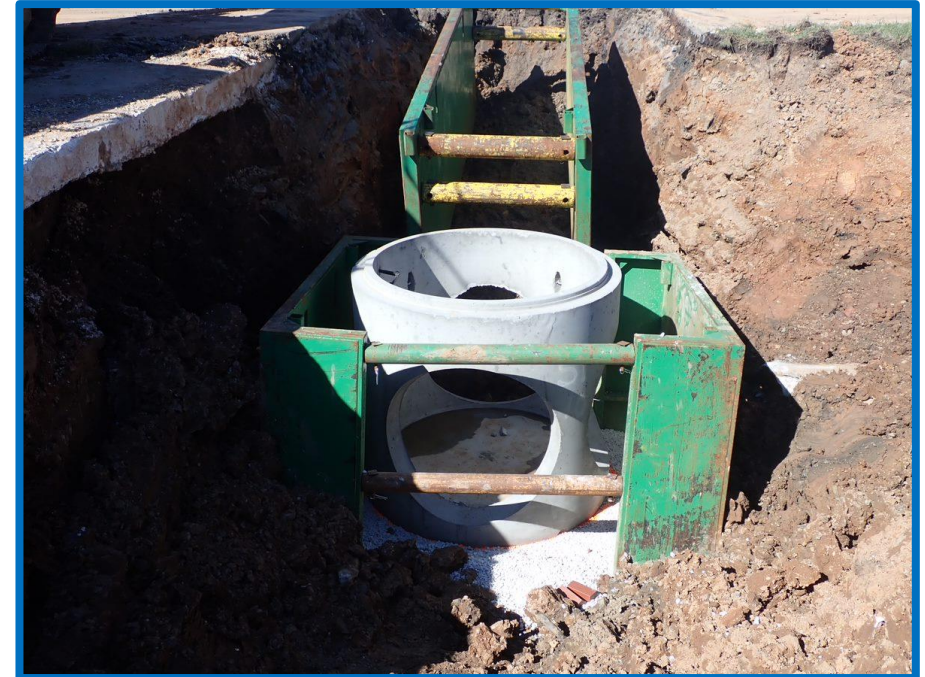
New piping and storm drain structures were brought onsite and are being installed, to replace the removed storm drain system.

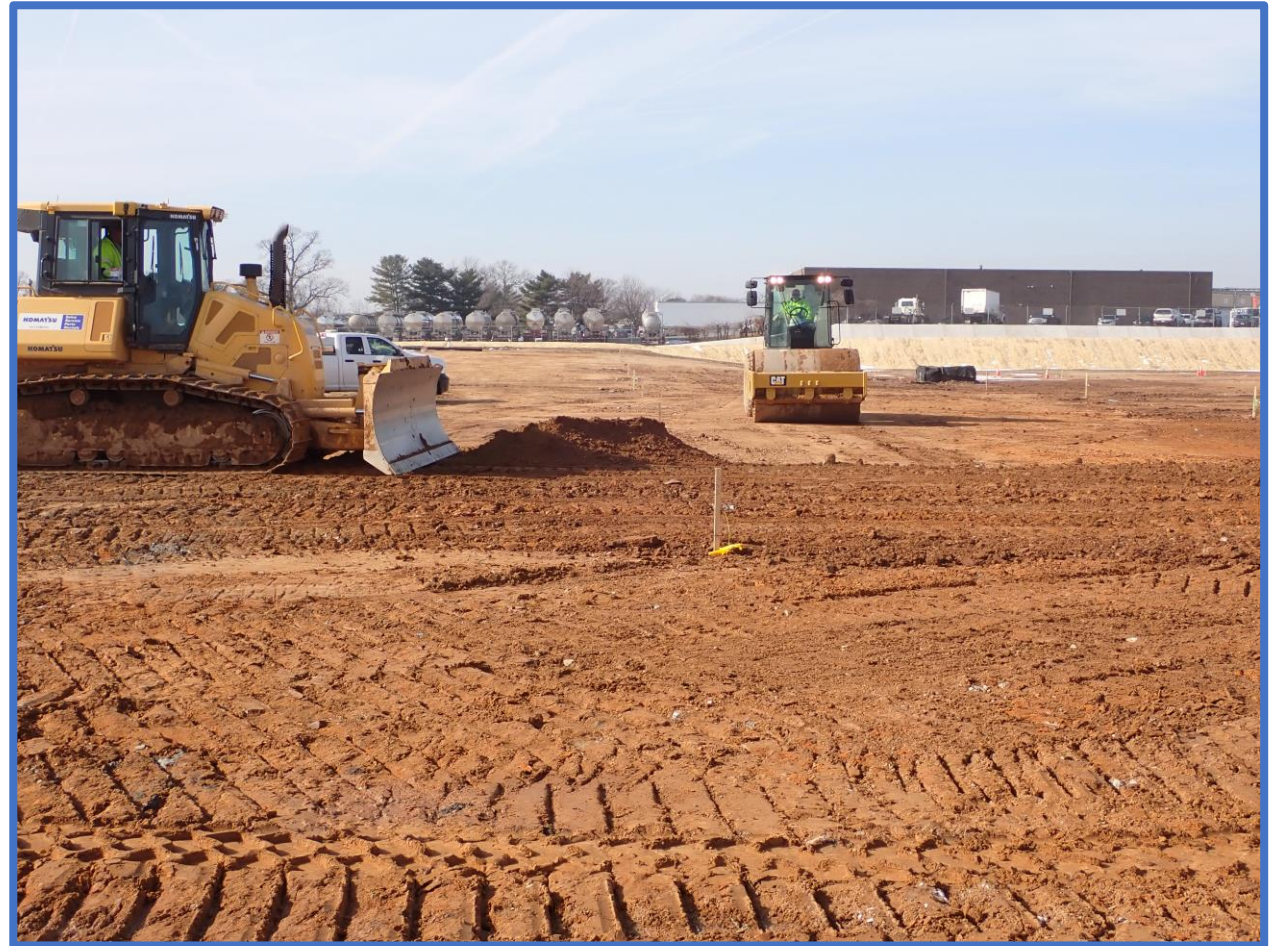
Construction and final site work completed in Winter 2022. Site restoration, which includes planting a pollinator meadow along with nearby tree mitigation planting, will occur in Spring 2022.
