Subject: Transmittal of the Cow Pen Creek and Dark Head Cover SAV Restoration and Monitoring Report
Lockheed Martin Corporation; Middle River Complex
2323 Eastern Boulevard, Middle River, Baltimore County, Maryland

**COW PEN CREEK AND DARK HEAD COVE
SAV RESTORATION AND MONITORING REPORT
LOCKHEED MARTIN MIDDLE RIVER COMPLEX
2323 EASTERN BOULEVARD
MIDDLE RIVER, MARYLAND**

Prepared by:
Tetra Tech, Inc.

November 2018

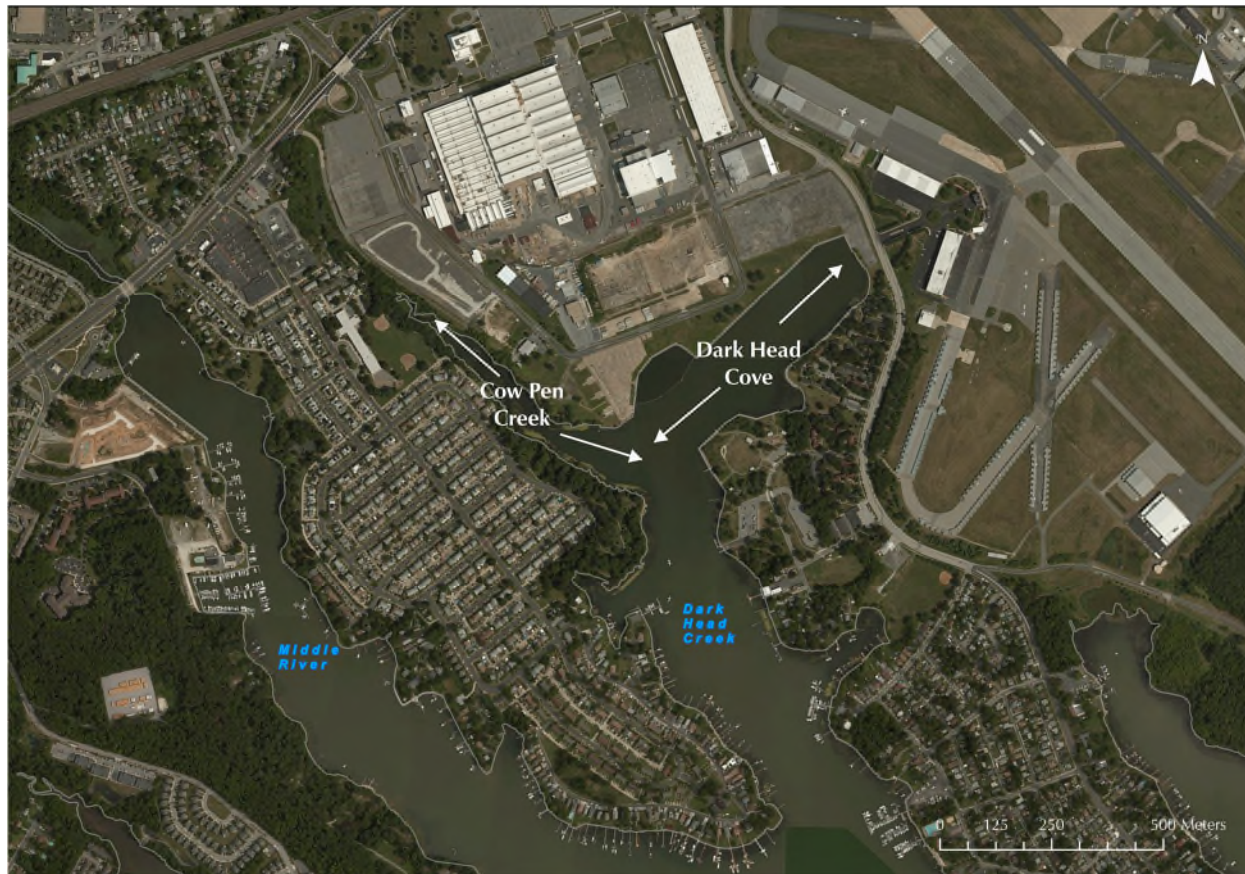
Figure 1 Middle River Complex location, bordered by Cow Pen Creek to the west and Dark Head Cove to the south

The Lockheed Martin Middle River Complex, which is part of the Chesapeake Industrial Park, is located at 2323 Eastern Boulevard in Middle River, Maryland, approximately 11.5 miles northeast of downtown Baltimore. The complex consists of approximately 161 acres and twelve main buildings. The property also includes an active industrial area and yard, perimeter parking lots, an athletic field, a concrete-covered vacant lot, a trailer and parts storage lot, and numerous grass-covered green spaces along the facility's perimeter. Locked chain-link fences surround all exterior lots and the main industrial area. The site is bounded by Eastern Boulevard (Route 150) to the north, Dark Head Cove to the south, Cow Pen Creek to the west, and Martin State Airport to the east (Figure 1).

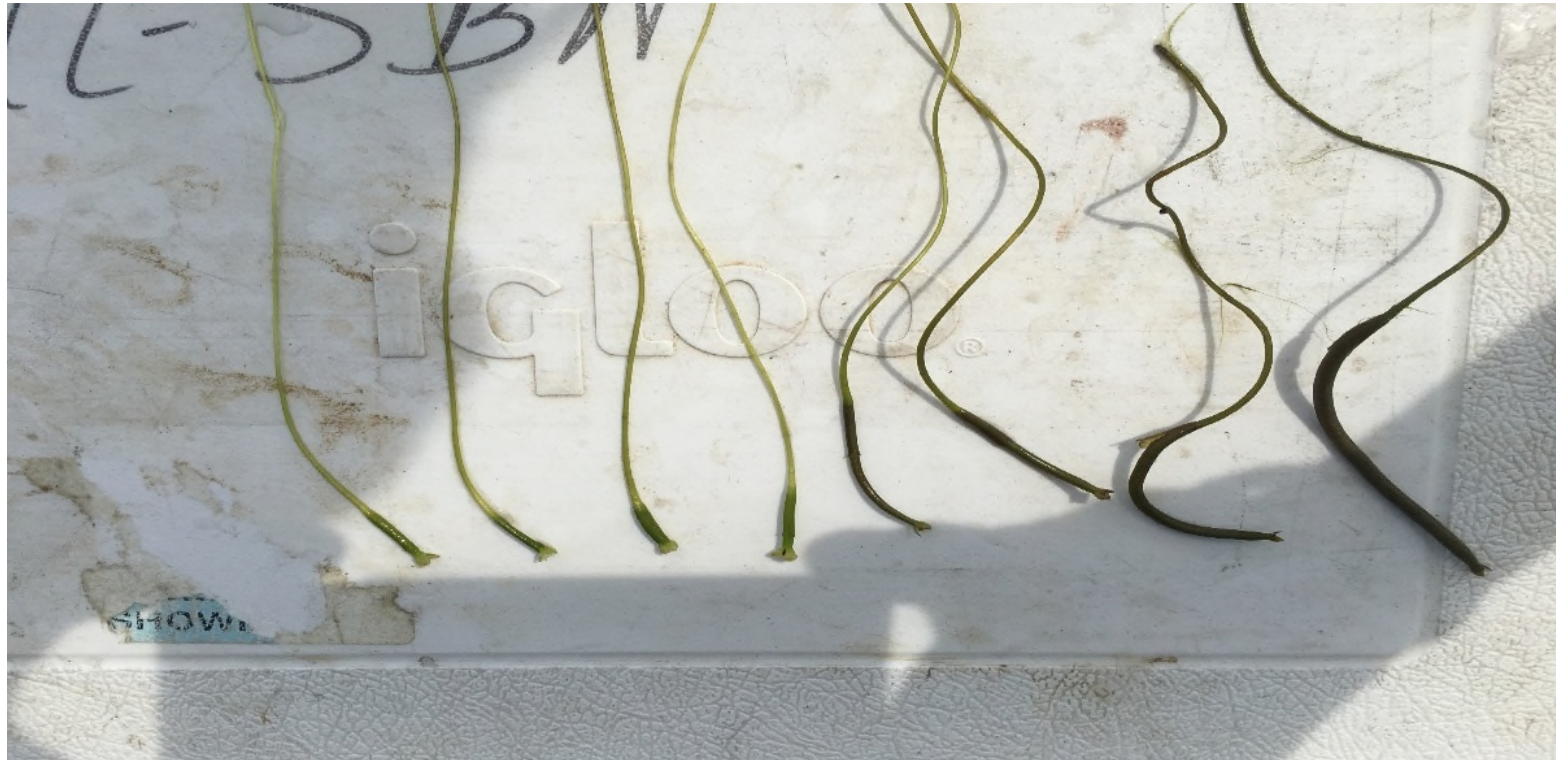
Figure 4 *Vallisneria* seed pods at different stages of development; full developed pod is on far right

Starting in August 2017, several *Vallisneria* beds in Middle River were monitored to assess the maturation of the seedpods. Reproductive shoots showed evidence of maturity (Figure 4) by mid-August, at which point teams conducted multiple days of hand-harvesting to collect seedpods.

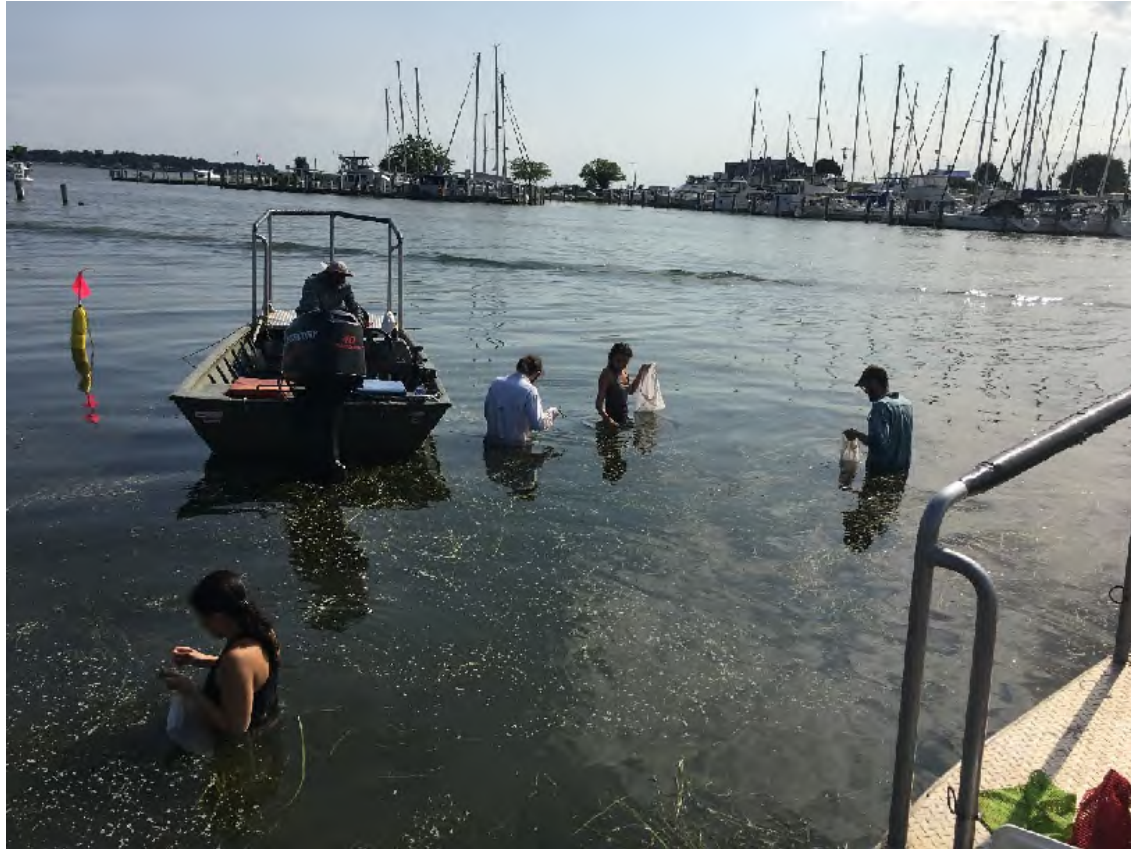
Figure 5 Collecting seed pods in Middle River

Seedpods were transferred to a cooler on the boat filled with river water where they were kept until the conclusion of each collection day (Figure 5).

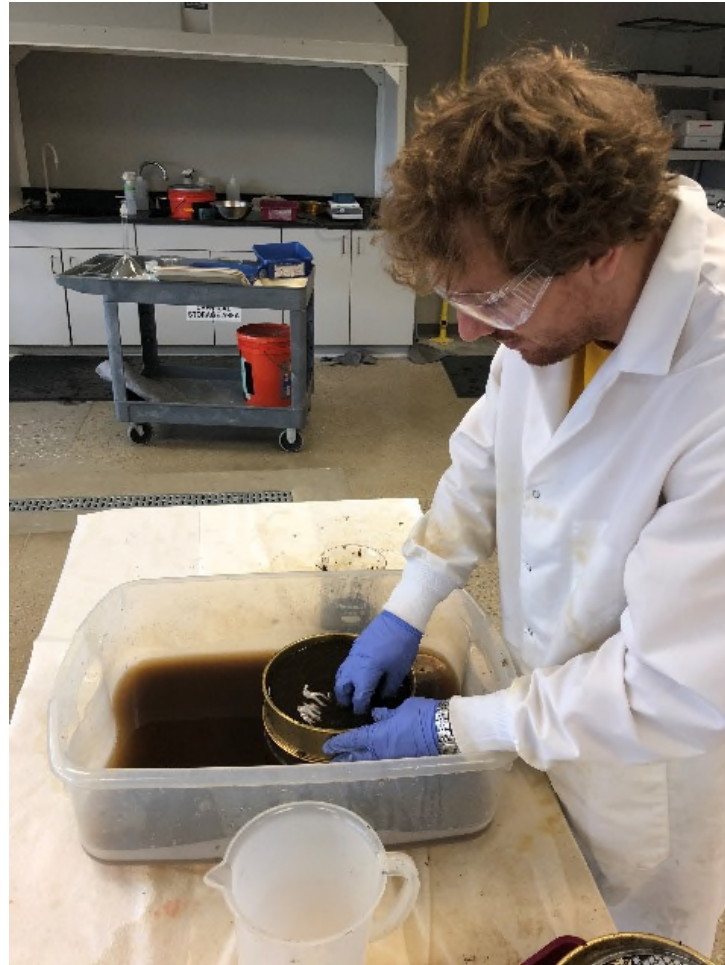
Figure 6 Sieving seeds from remaining detritus

Seed pods were transported to Tetra Tech's Biological Resources Facility (BRF) in Owings Mills, Maryland. The BRF is equipped with a walk-in refrigerator where the seedpods were stored at $\leq 4^{\circ}\text{C}$. Approximately 4,000,000–4,500,000 seeds were collected; this number exceeded the minimum number required to provide 100,000 viable seeds per acre for the 6.5-acre restoration area. Seedpods were stored over winter in 10-gallon aquaria; the pods eventually broke down via natural decomposition with the mature seeds settling to the bottom of the tanks. At this point, seeds were sieved (Figure 6) from any remaining debris and transferred to one-liter storage bottles (Figure 7).

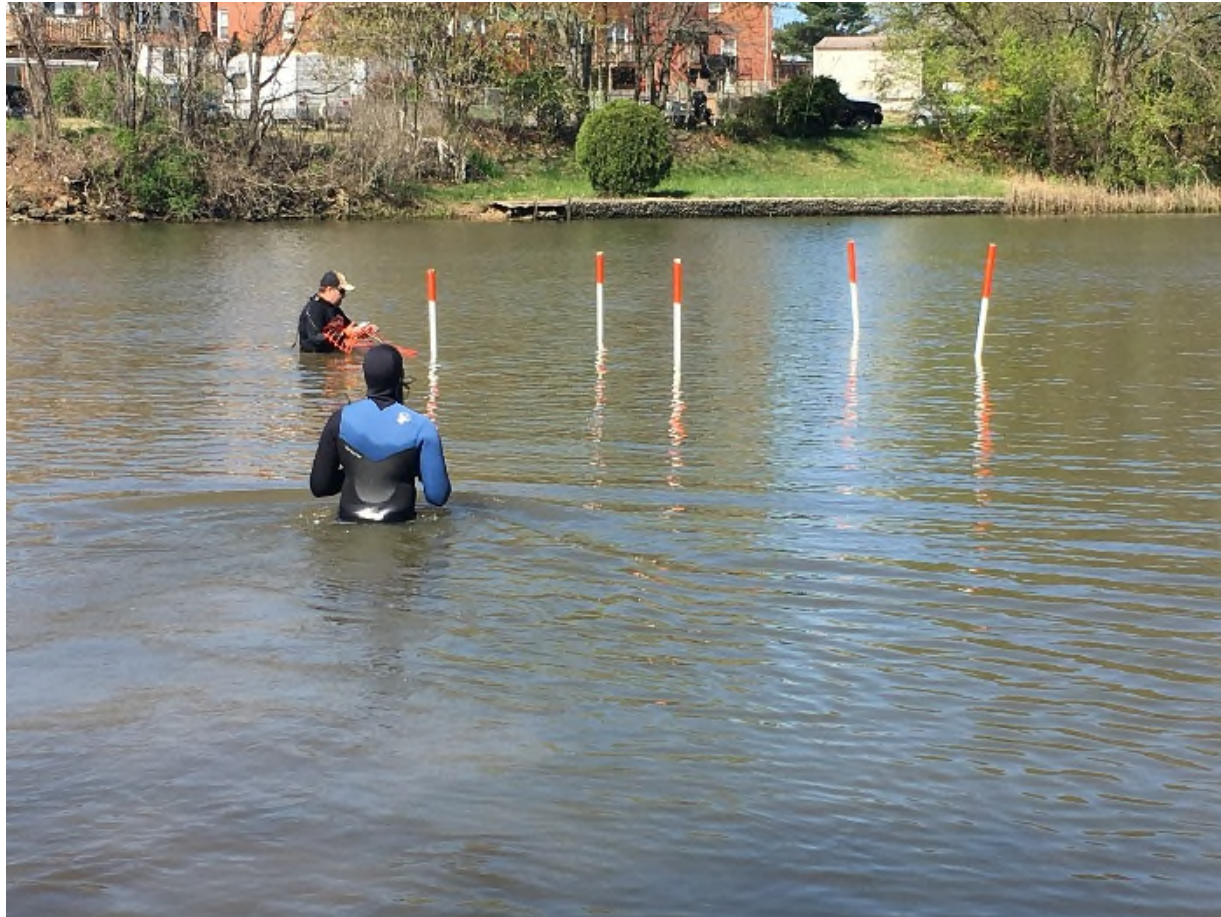
Figure 8 Constructing Exclosure in Cow Pen Creek

Prior to seed dispersal, Tetra Tech erected 12 exclosures as outlined in the work plan. The purpose of the exclosures are to prevent herbivory on the young plants by turtles, waterfowl, or other organisms, thereby allowing the plants to mature and reproduce into a more sustainable bed. The exclosures were erected April 24–26, 2018 (see Figures 8 through 12).

Based on a low germination rate (10%), approximately 400,000 - 450,000 seeds were spread in exclosures (Figure 8) and over the 4.42-acre region (Figure 9 and 10) on April 26, 2018, with an estimated density of approximately 90,500 - 102,000 seeds per acre (Figure 12). In consultation with the Maryland Department of Natural Resources, Tetra Tech made an in-field decision to spread seed over a reduced area (4.42 acres instead of 6.5 acres) due to greater than anticipated depths in some regions of Dark Head Cove. Some dredged regions were deeper than three meters, thereby precluding adequate survival of any seed spread in this environment (Batiuk et al., 2000). Rather than waste seed in these areas, seed dispersal was concentrated in areas that would sustain wild celery habitat.

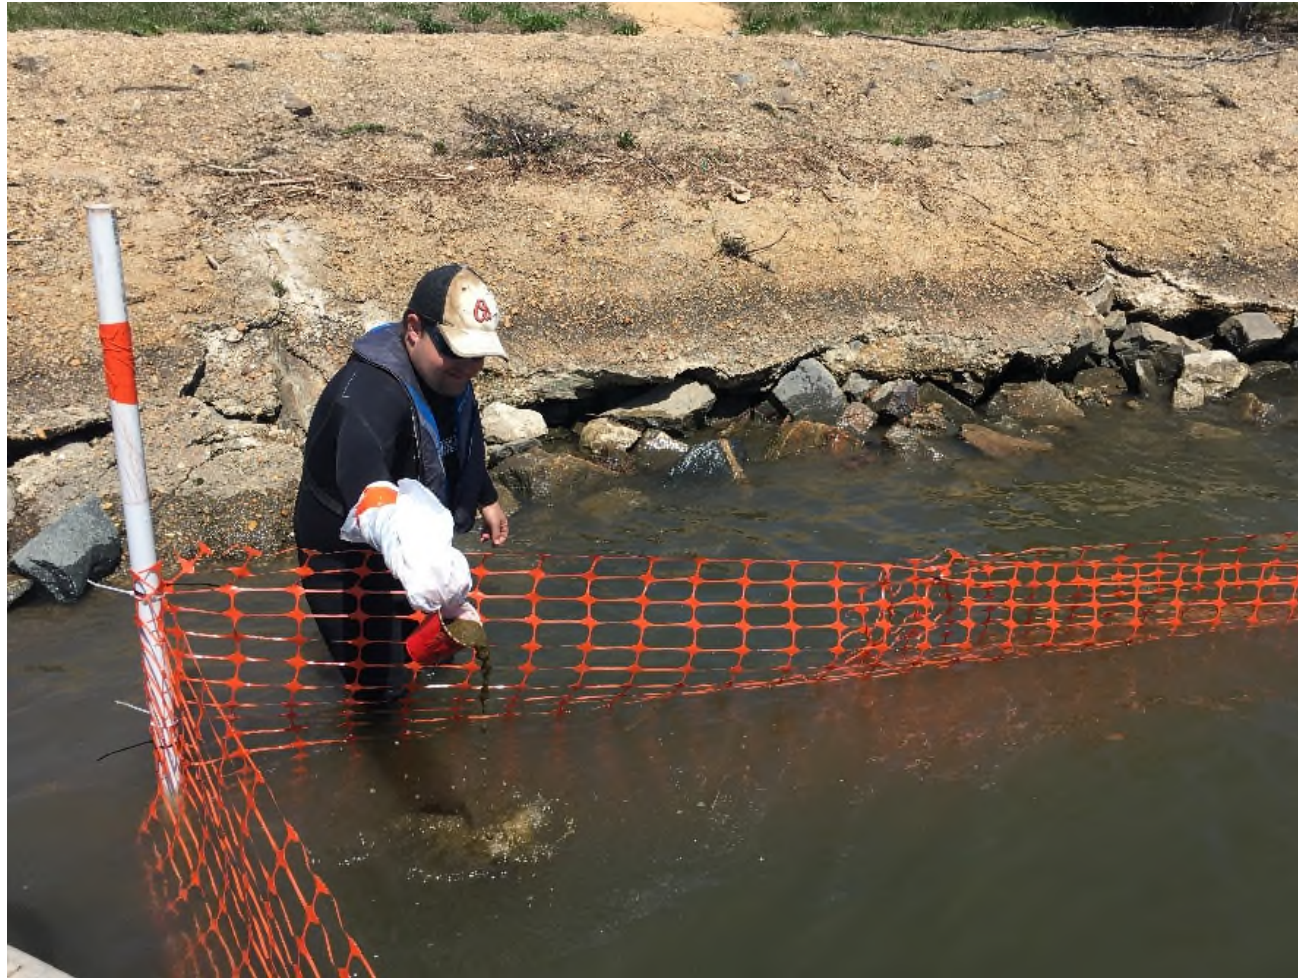
Figure 10 Seed dispersal within Exclosure in Dark Head Cove

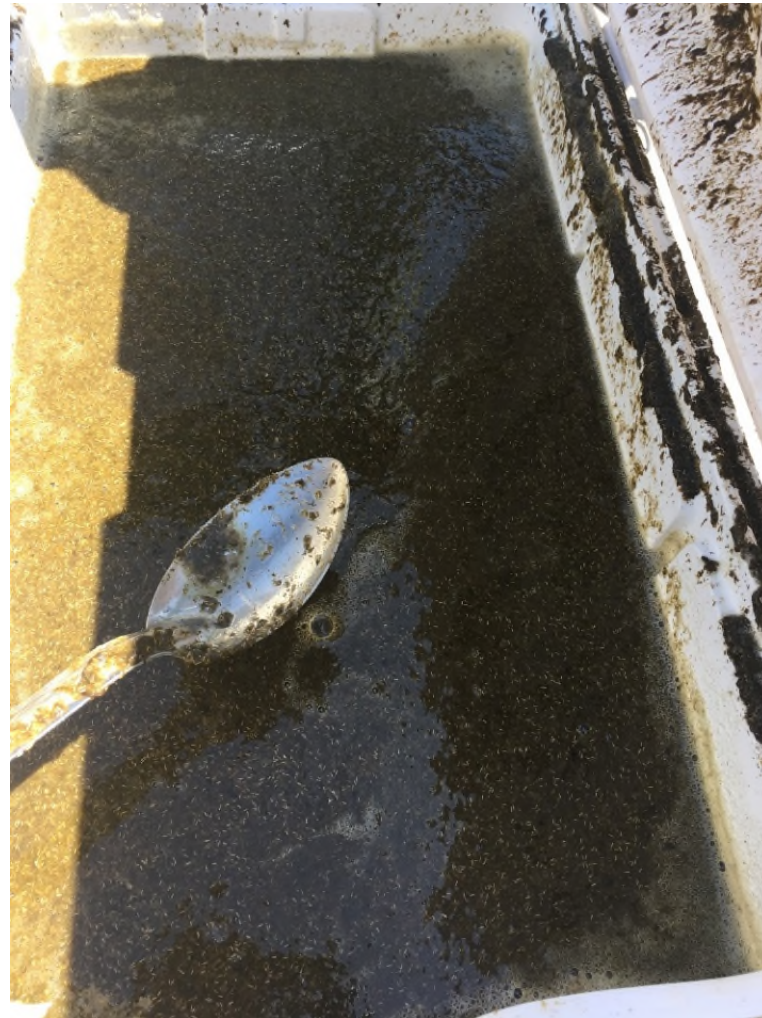
Figure 11 Seeds, held in water, prior to dispersal

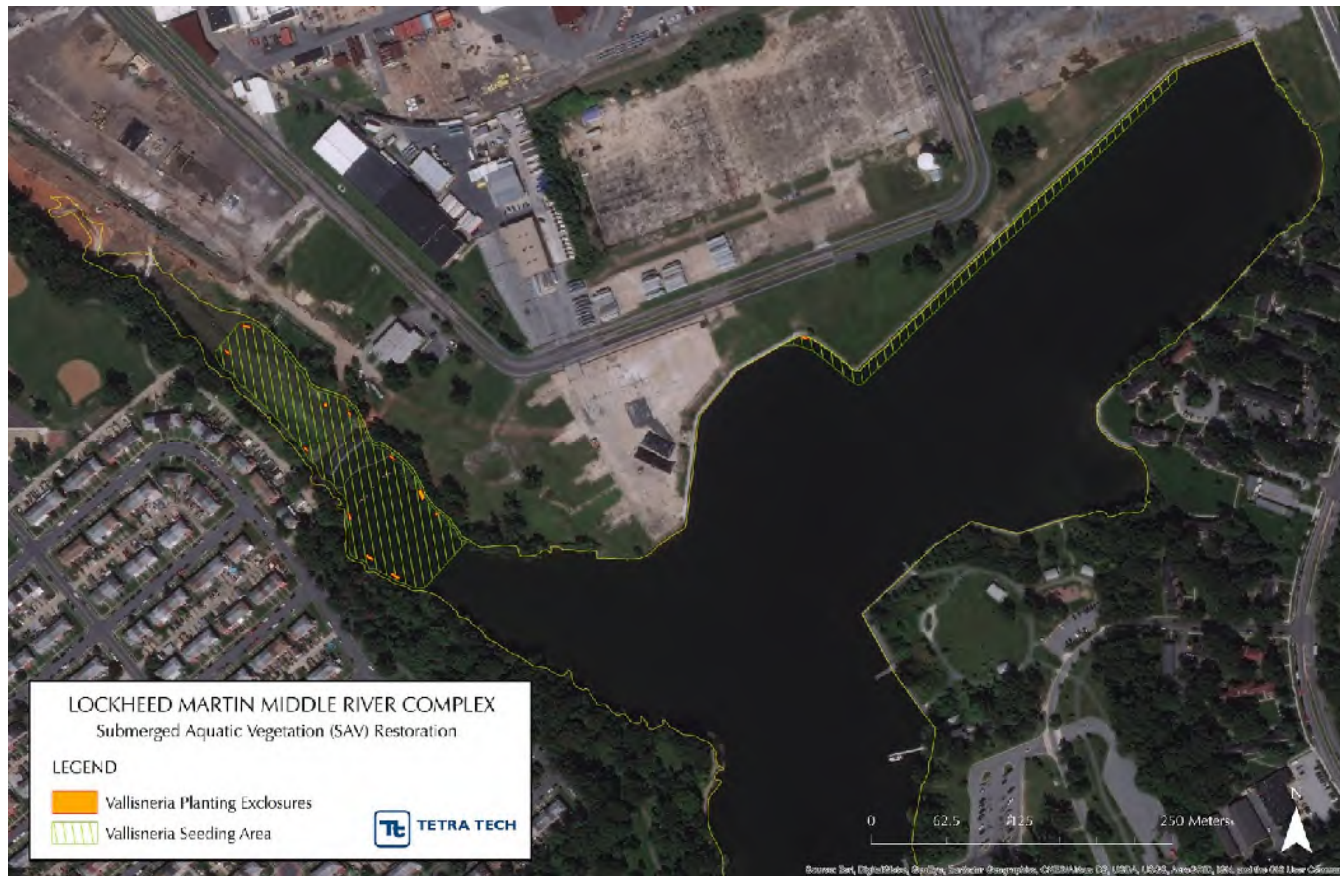
Figure 12 Location of seed distribution in April 2018

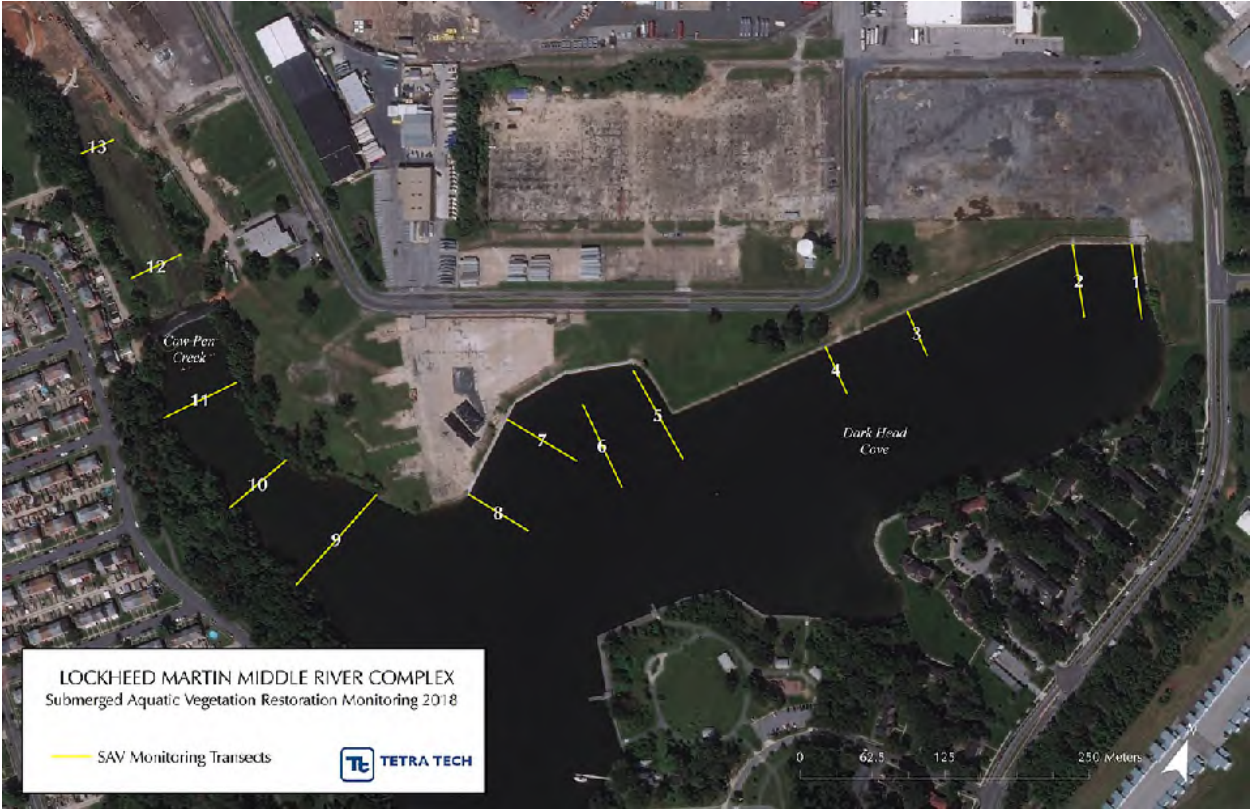
Figure 13 Location of monitoring transects within Cow Pen Creek and Dark Head Cove

The first monitoring event was conducted on August 8, 2018, by Tetra Tech scientific divers, using SCUBA gear to inspect 13 transects and count plants within 0.25 square meter (m²) quadrats along each transect (Figure 13). Water clarity in both Cow Pen Creek and Dark Head Cove was significantly reduced, likely due to rainfall before the dive. Visibility was below 50 centimeters (cm), and approaching 10 cm. Poor water clarity necessitated using touch to locate seedlings within the quadrats.

Eight transects were established in Dark Head Cove, extending up to five meters out from the bank. Three measurements were made on each transect: one at two meters from the bank, one at three meters from the bank, and the last approximately five meters from the bank. The depth or type of substrate (i.e., gravel and cobble) were not conducive to submerged aquatic vegetation (SAV) growth at any of the assessed quadrat locations. Depth ranged from two meters at the bulkhead on Dark Head Cove to approximately four meters at the five-meter survey point. Five transects were surveyed in Cow Pen Creek, extending from bank to bank, and consisting of 10 survey points across each transect equidistant apart, per the work plan. The shallower depths and substrate in Cow Pen Creek were much more conducive to SAV establishment as compared to Dark Head Cove. Plant counts per cubic meter are shown in Table 2.

Results indicate that SAV is not well established within the transects in Dark Head Cove. Note, however, that SAV is becoming established in areas of Dark Head Cove outside of the transect locations. In particular, a large SAV bed is established along the bulkhead in the area between transects 4 and 5.

SAV in Cow Pen Creek was well established. Much higher numbers of SAV were counted in survey points near the banks as compared to survey points in the middle of Cow Pen Creek, likely due in part to the shallower water depths near the banks. Three species of SAV were noted: the planted wild celery (*Vallisneria americana*), milfoil (*Myriophyllum spicatum*), and sago pondweed
