Sediment Cleanup Middle River Complex, 2016-17

Season 1
Project Photo Tour
Updated July 2017

Sediment Cleanup - Season 1

Project Photo Tour

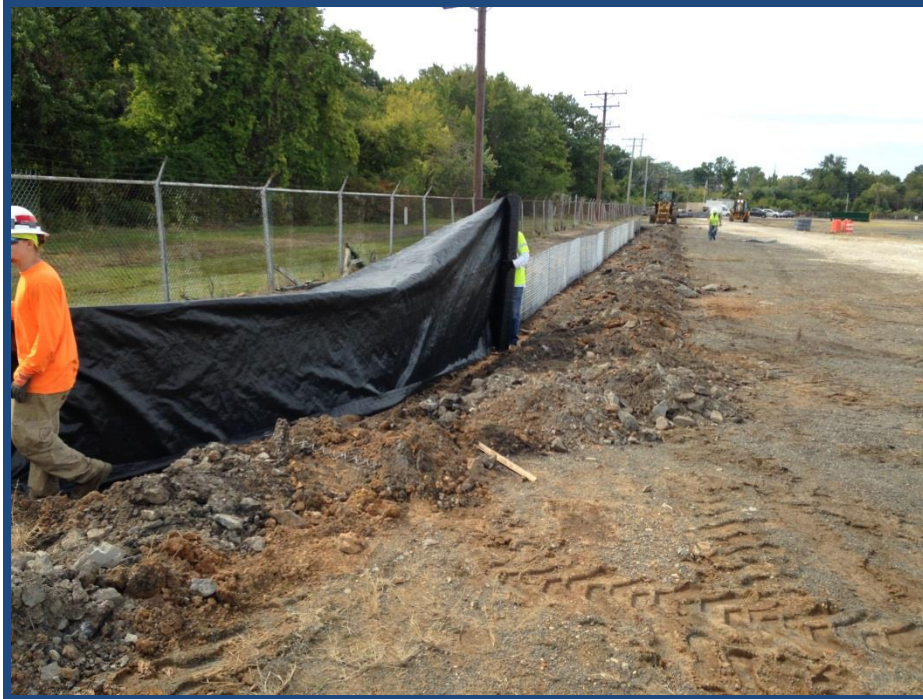
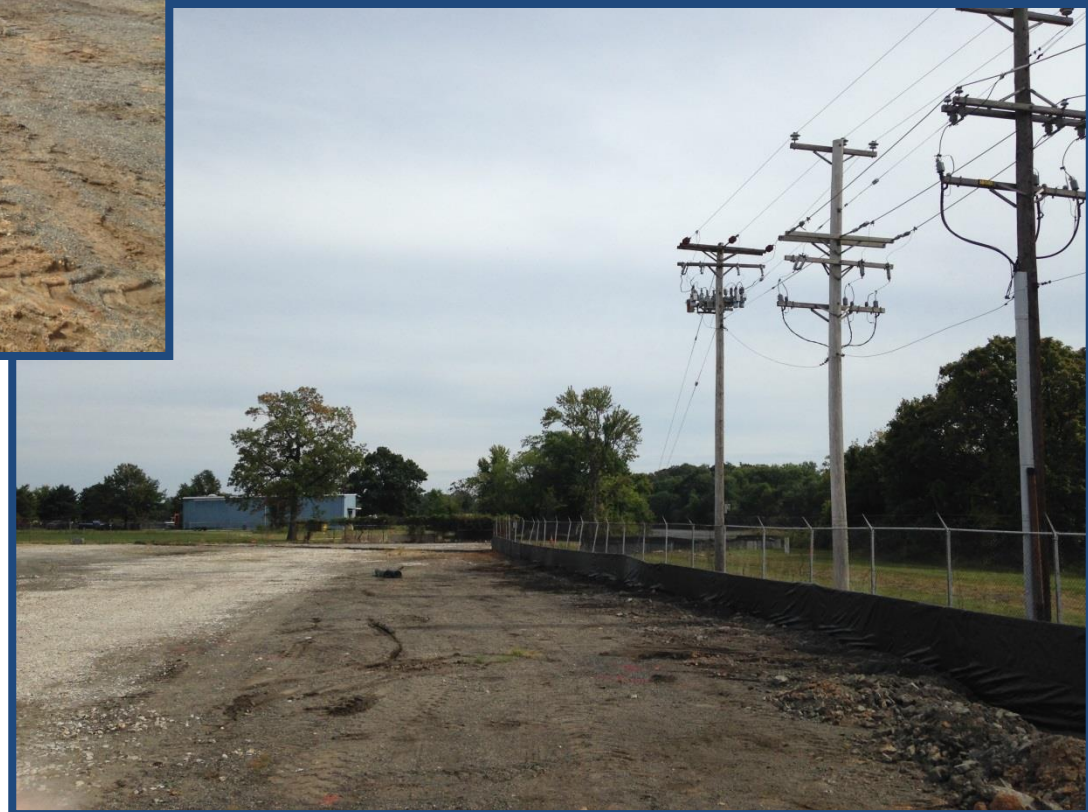
Work began on land, protecting against erosion and sediment release by installing fabric on chain-link fencing, creating “super silt fencing.”

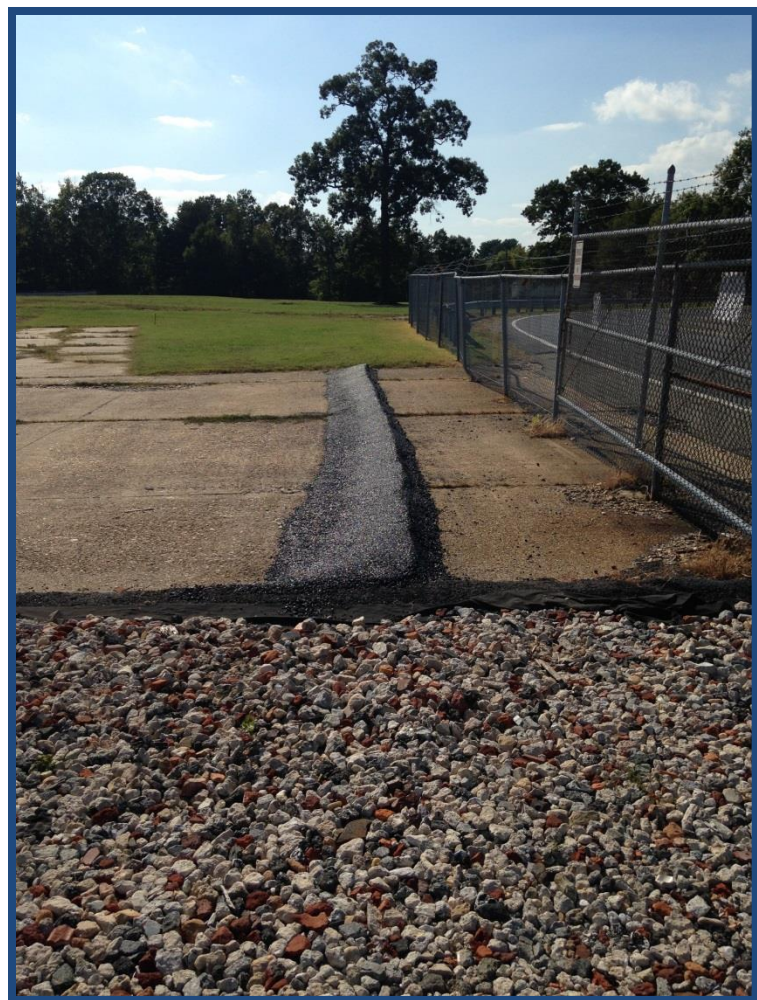
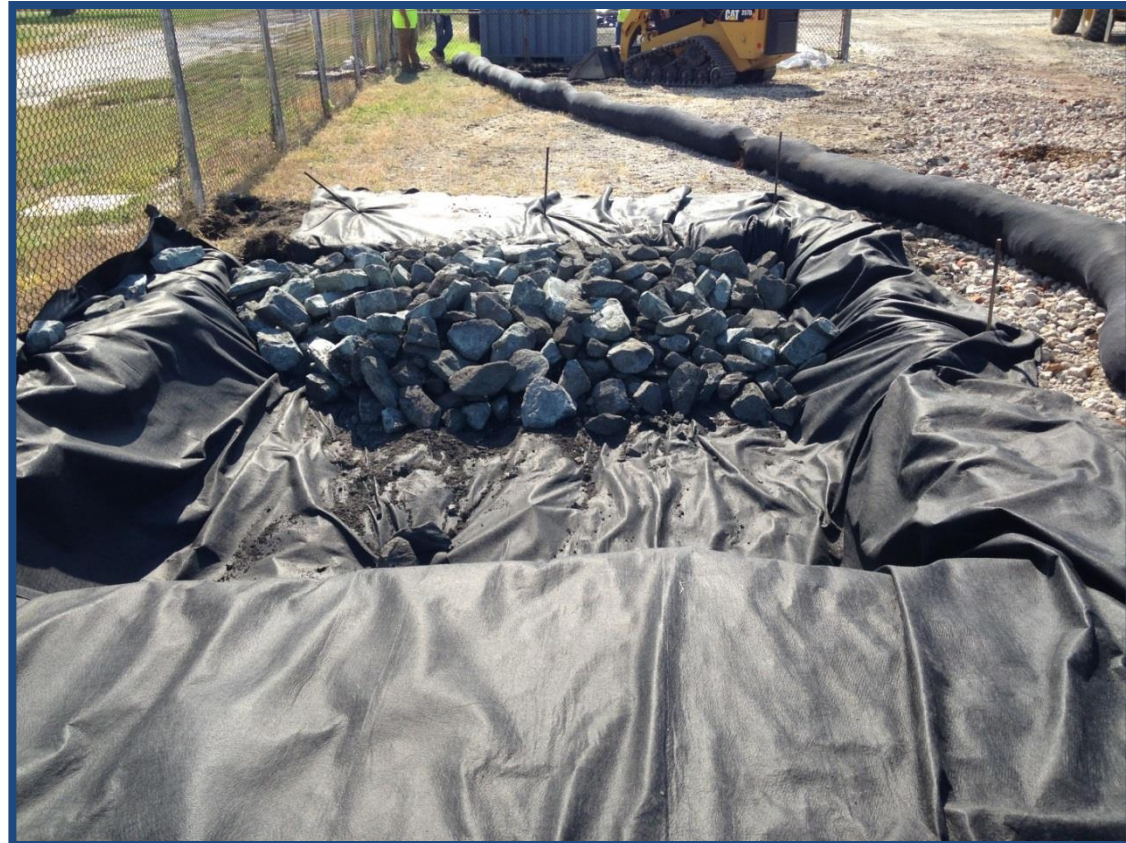
Other methods used to protect work areas included installing temporary asphalt berms, filter logs, and plastic sheeting anchored with rocks to protect rainwater outlets.

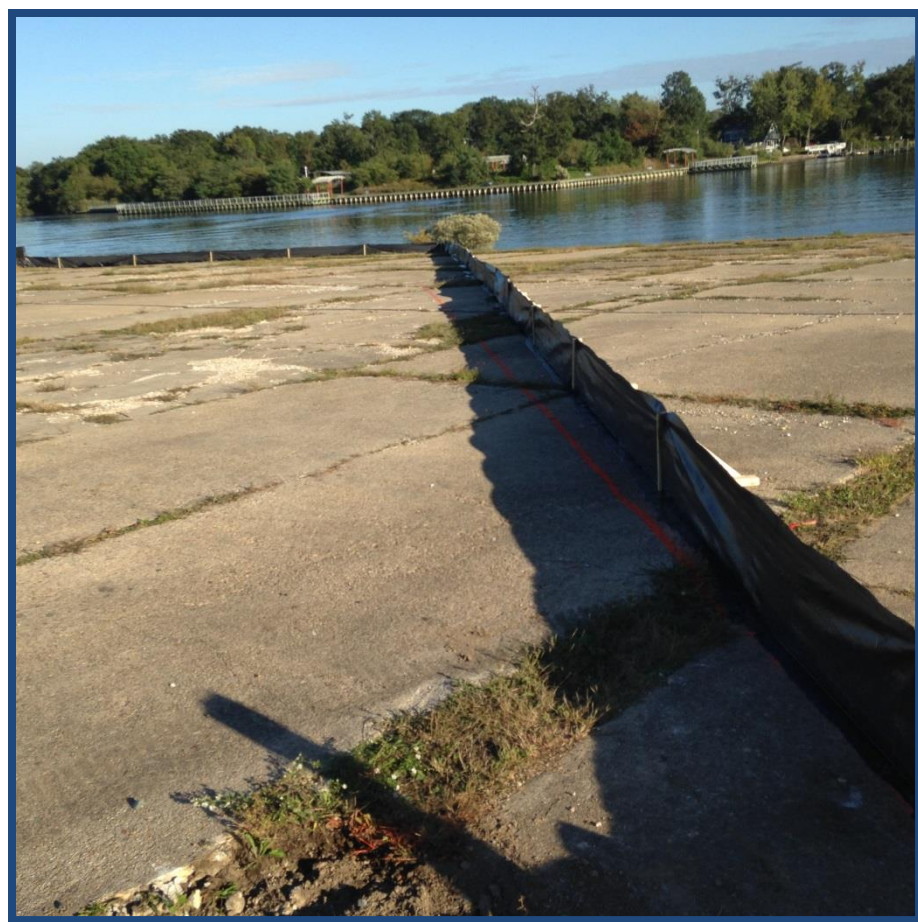
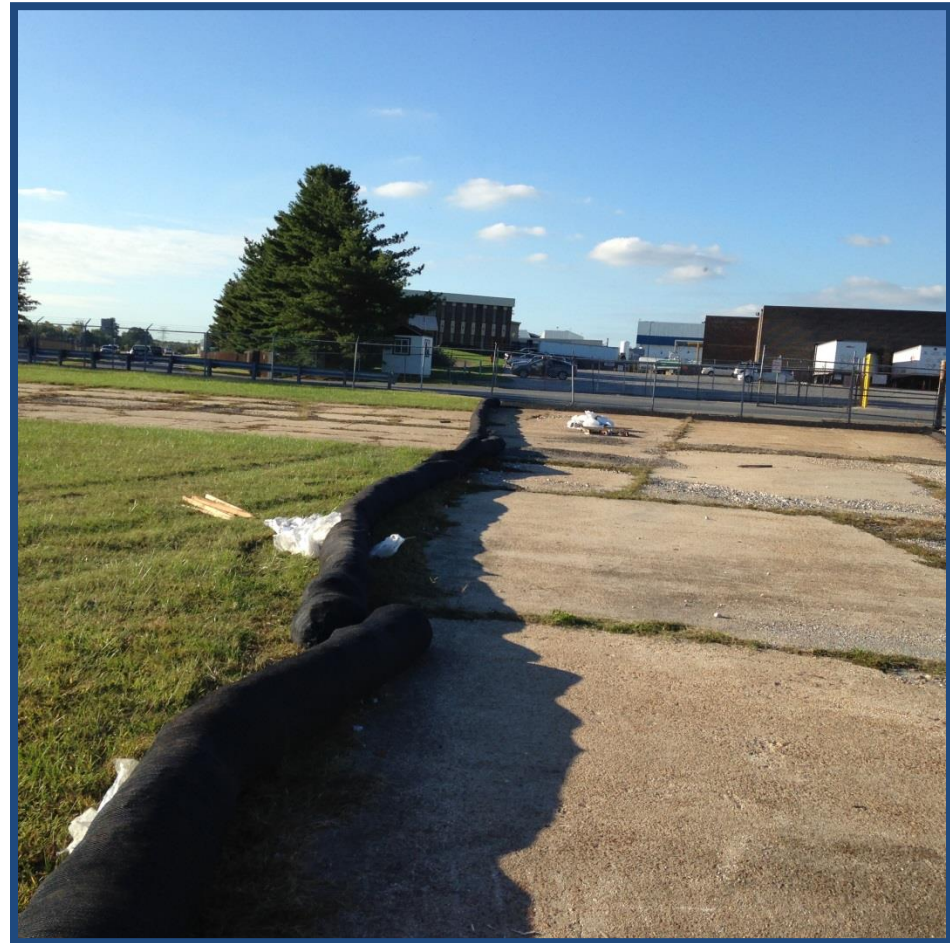
In concrete work areas, silt fencing and filter logs prevented sediments from moving outside the area.

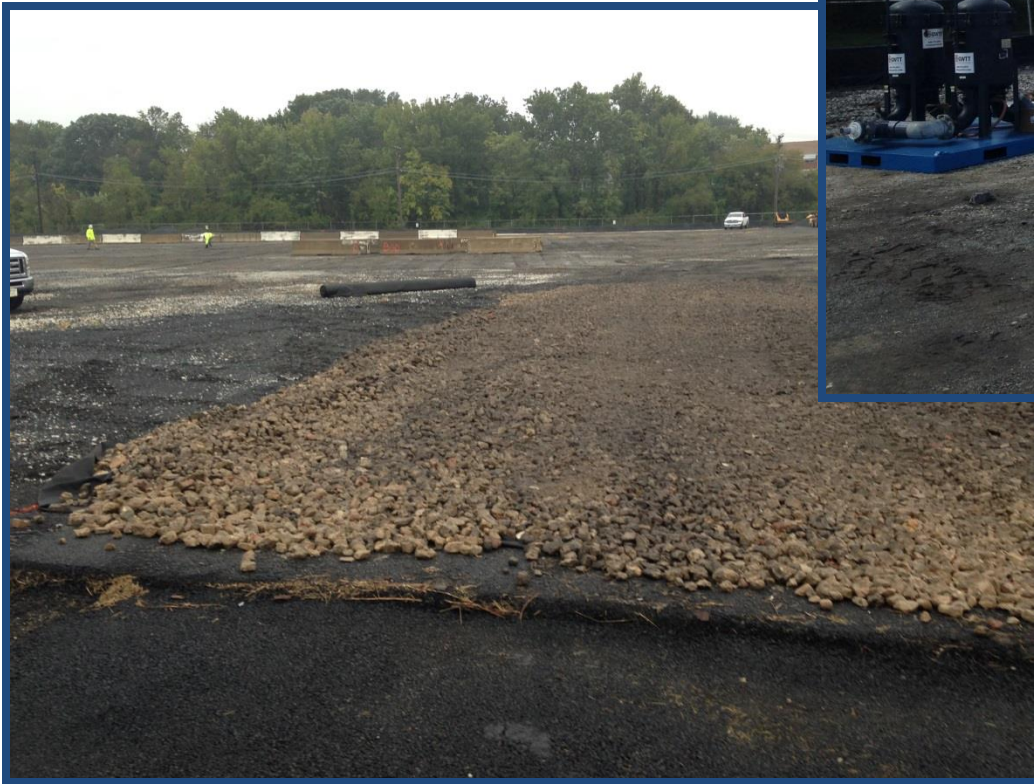
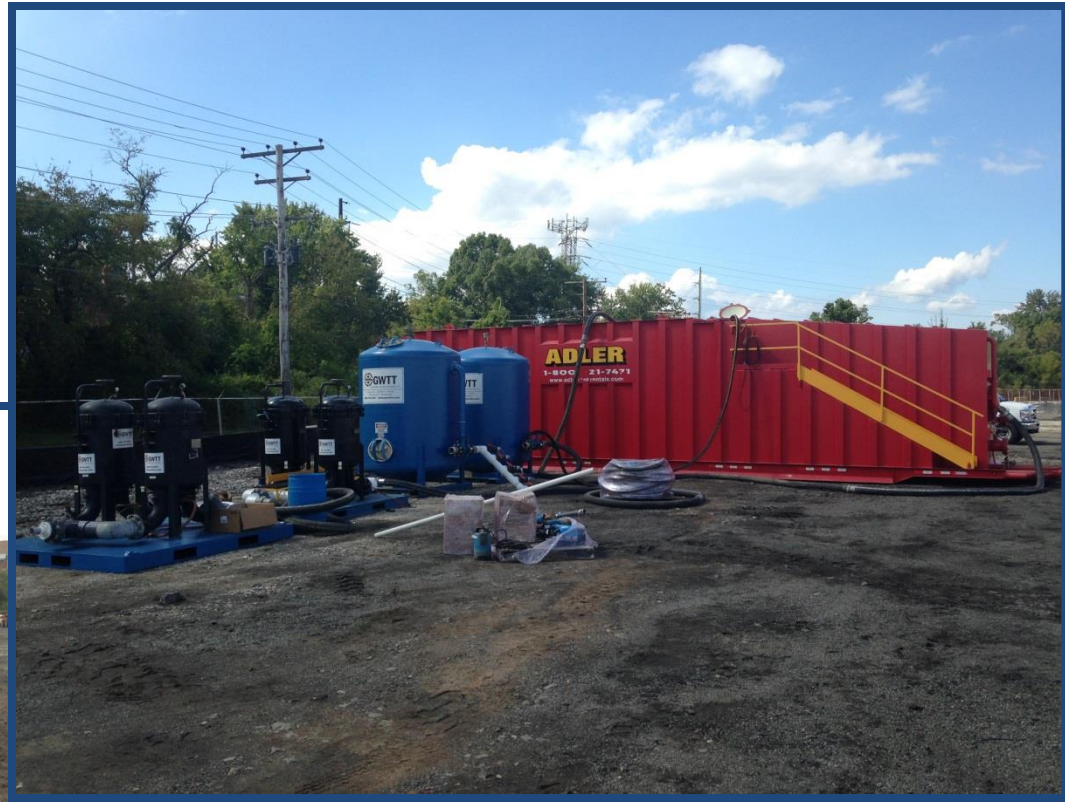
Work preparation included constructing a temporary road and entrance for construction vehicles and installing a mobile treatment system for water drained from sediment.

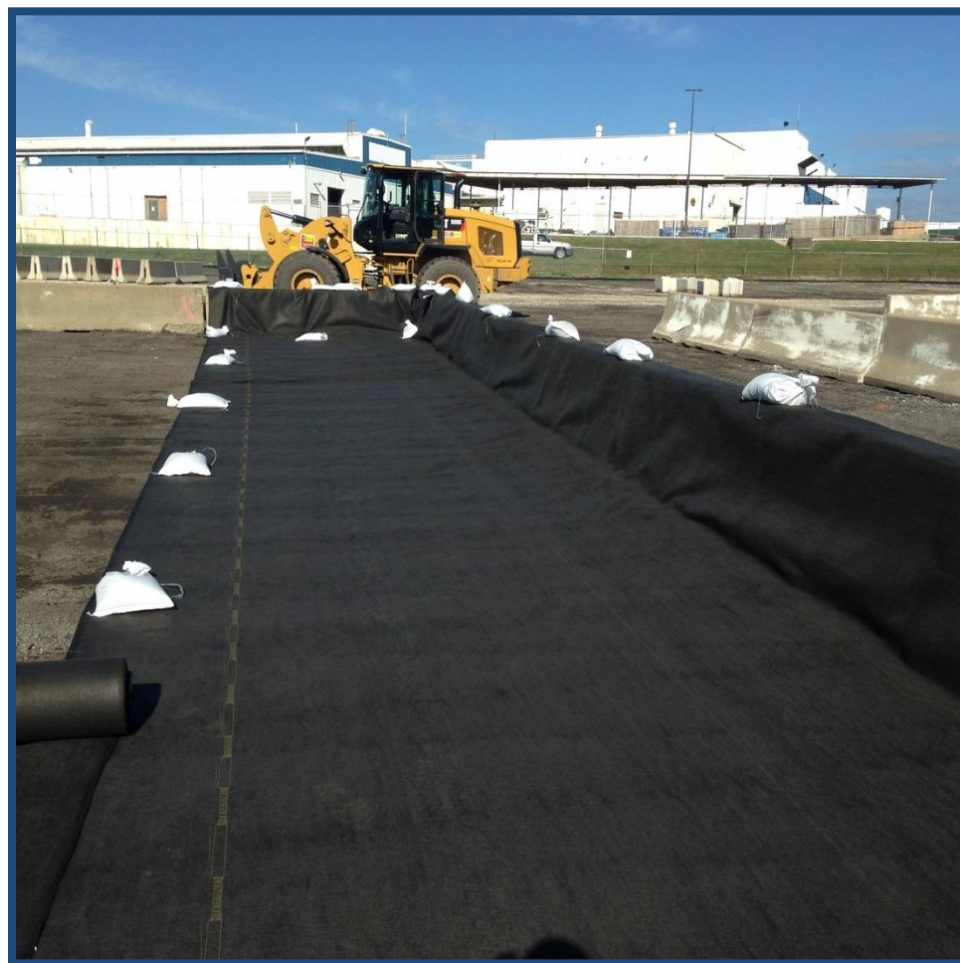
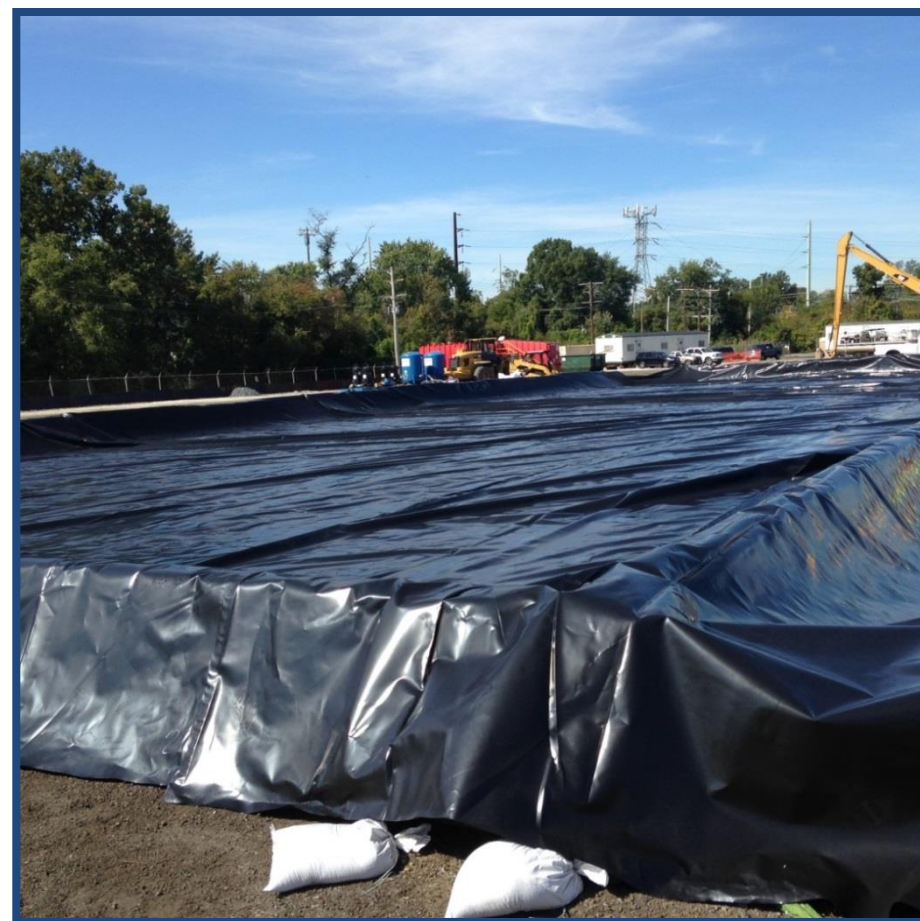
Sediment mixing bins were constructed with concrete barriers and multiple layers of plastic sheeting.

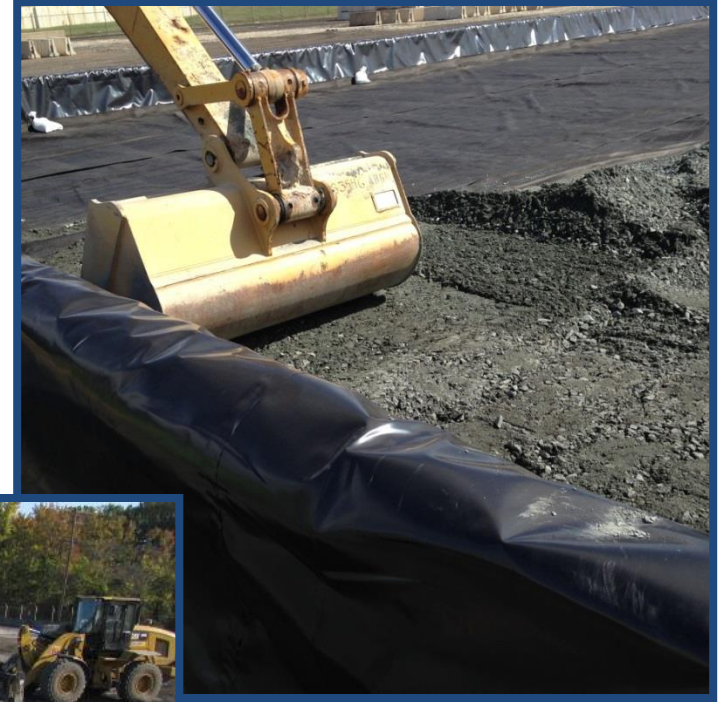
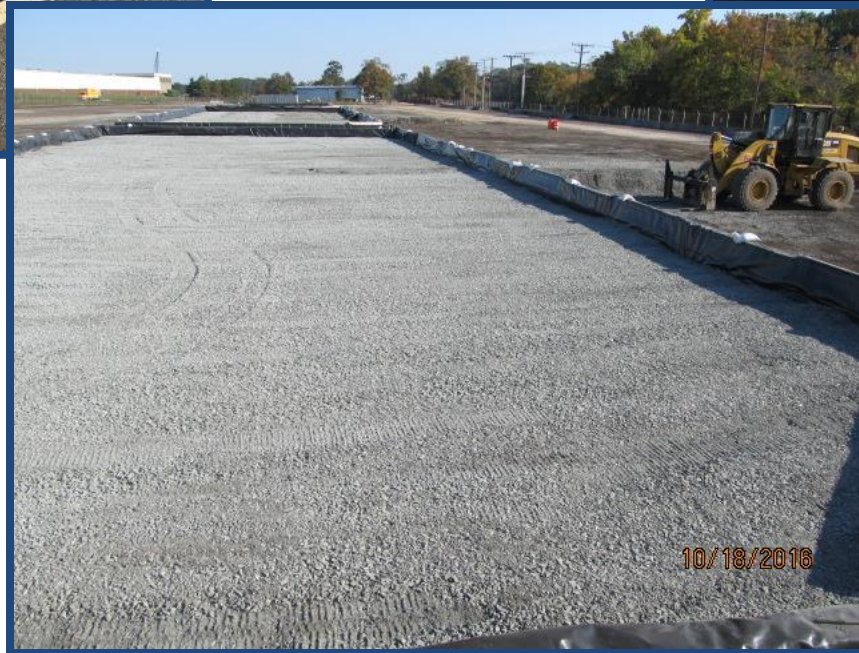
A base-layer of gravel was spread over the plastic sheeting for protection. Drained water filtered through the gravel, then was collected and transported to the temporary onsite water treatment system.

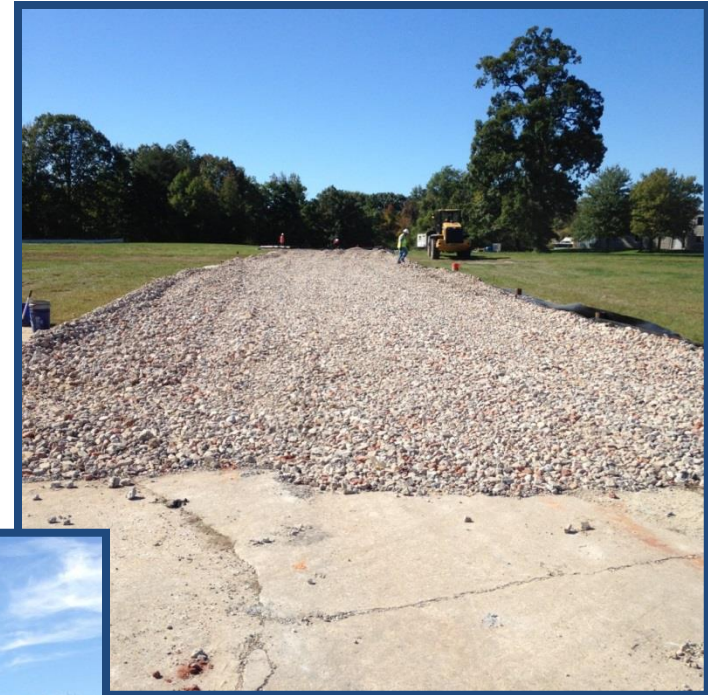
A temporary haul road was built with protective plastic sheeting and covered by gravel.

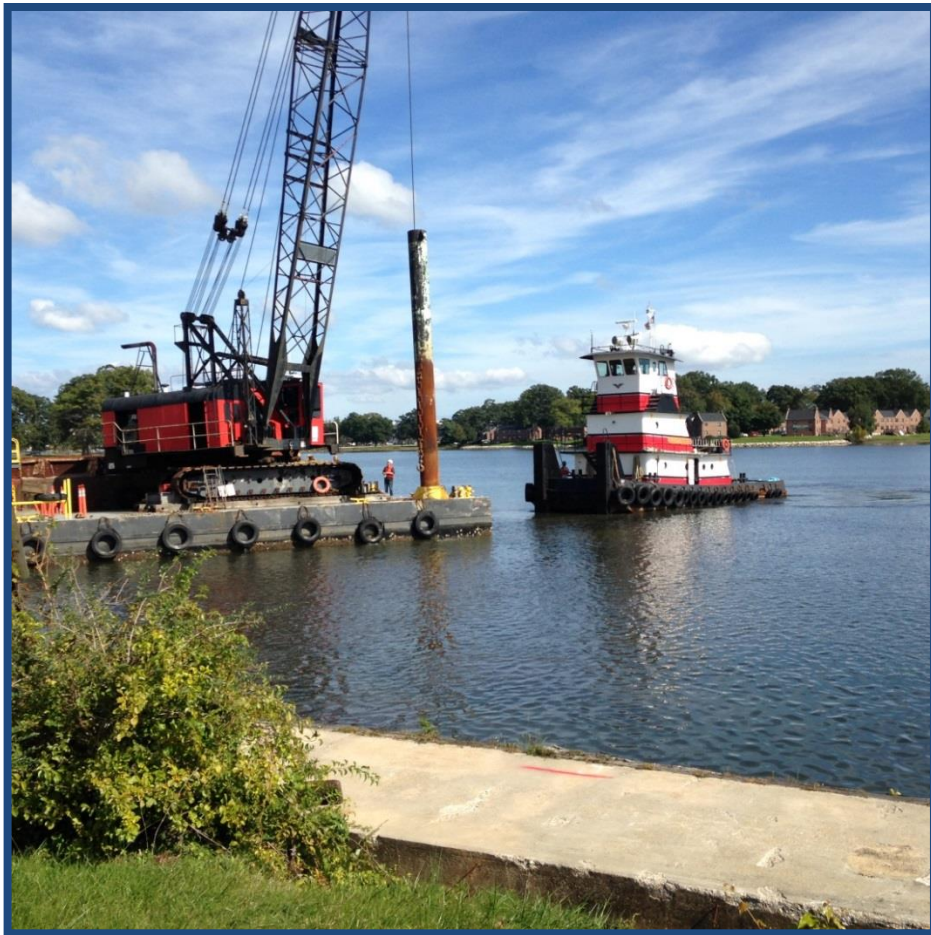
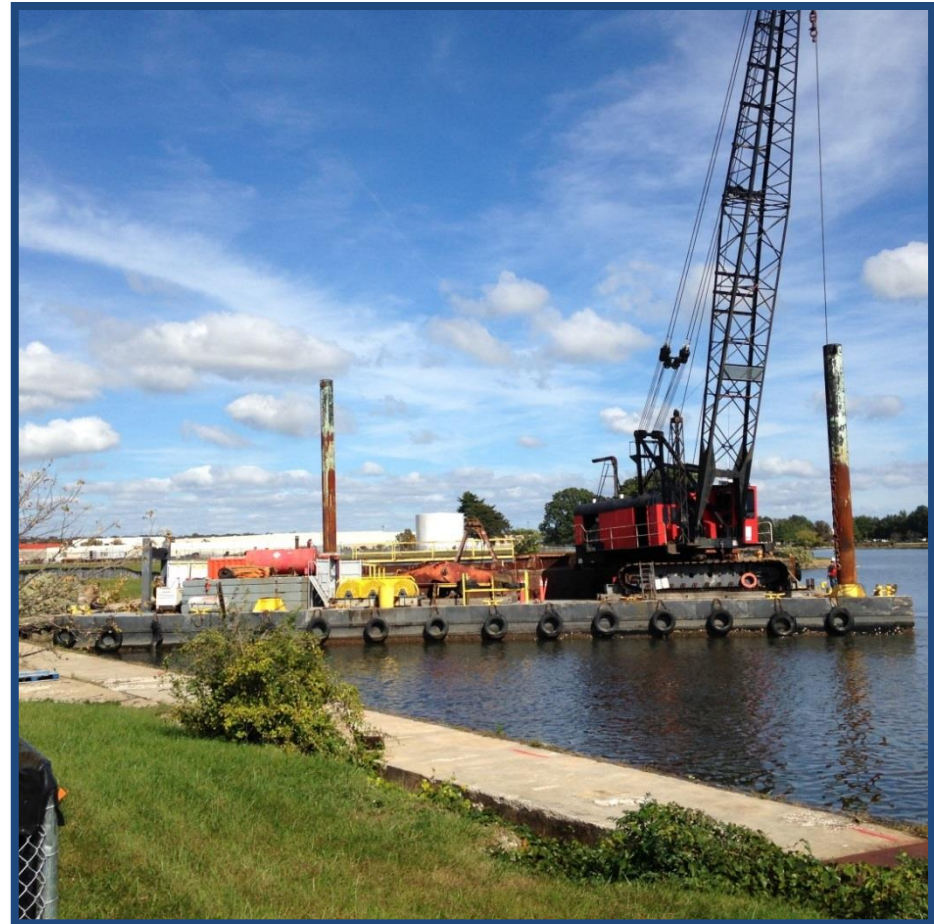
A push-boat delivered the dredge barge.

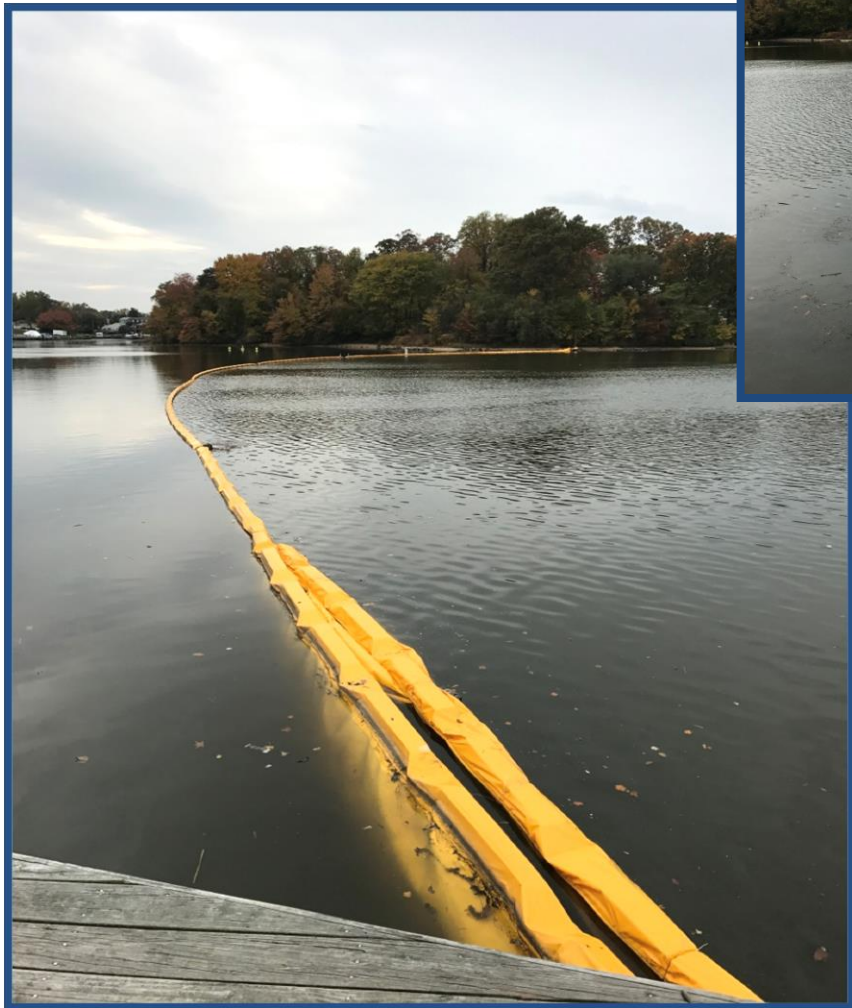
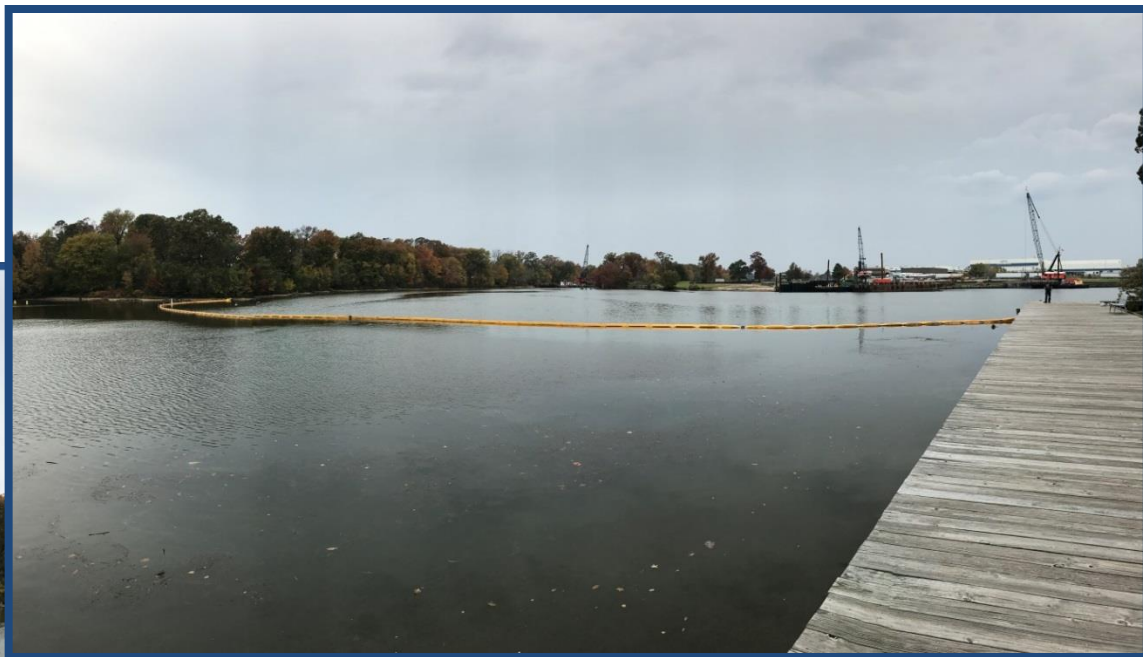
Dredging equipment arrived, then barges and cranes. A silt curtain was installed across the width of Dark Head Cove.

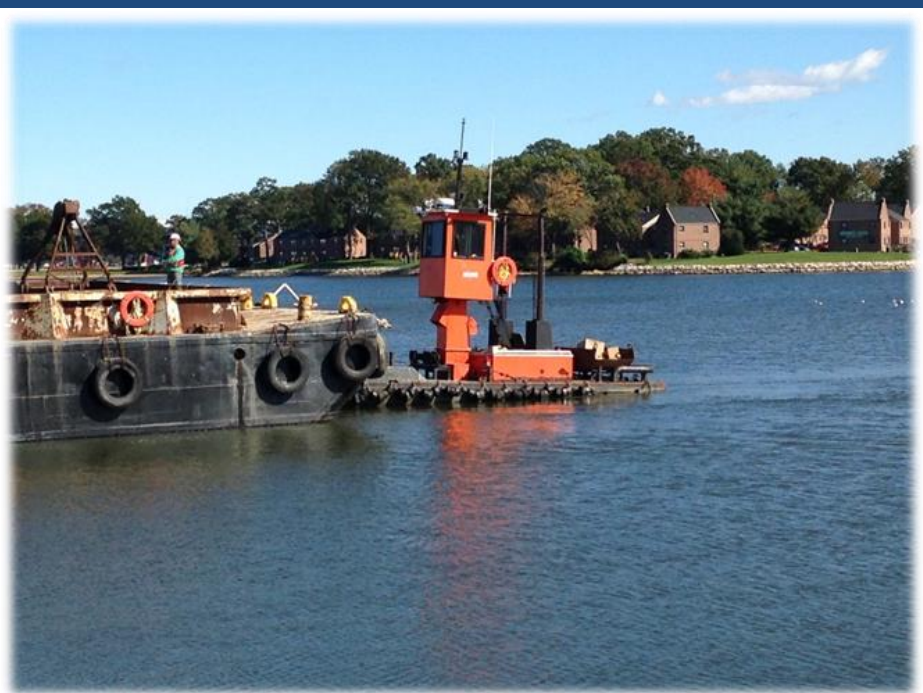
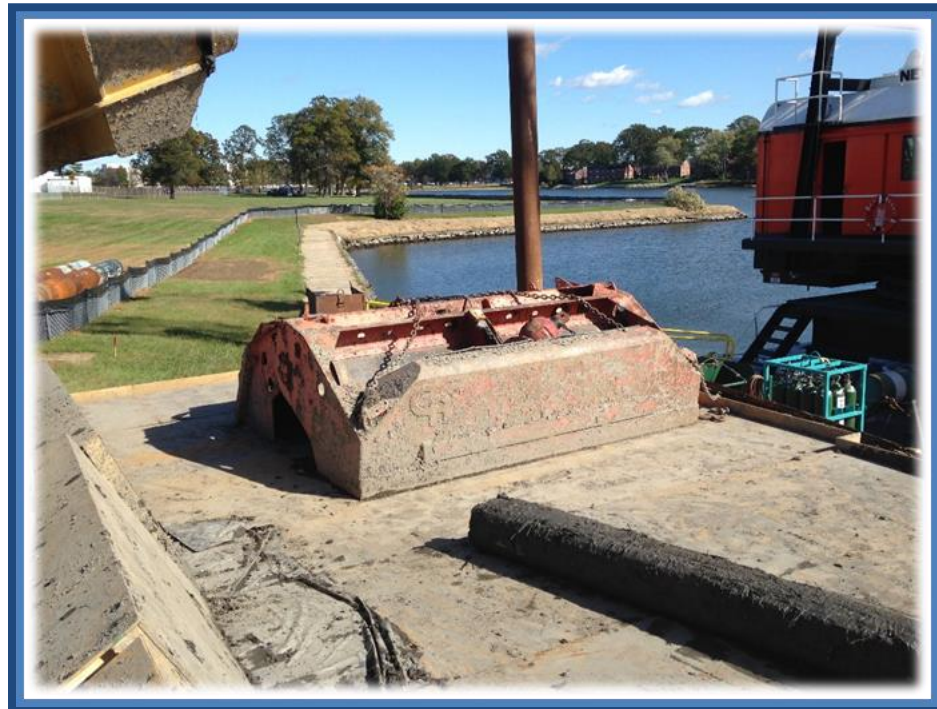
Equipment was moved around the cove using a 500 HP push-boat. Sediments were dredged using an “environmental bucket” which closes before lifting, limiting the amount of sediment released into the waterway.

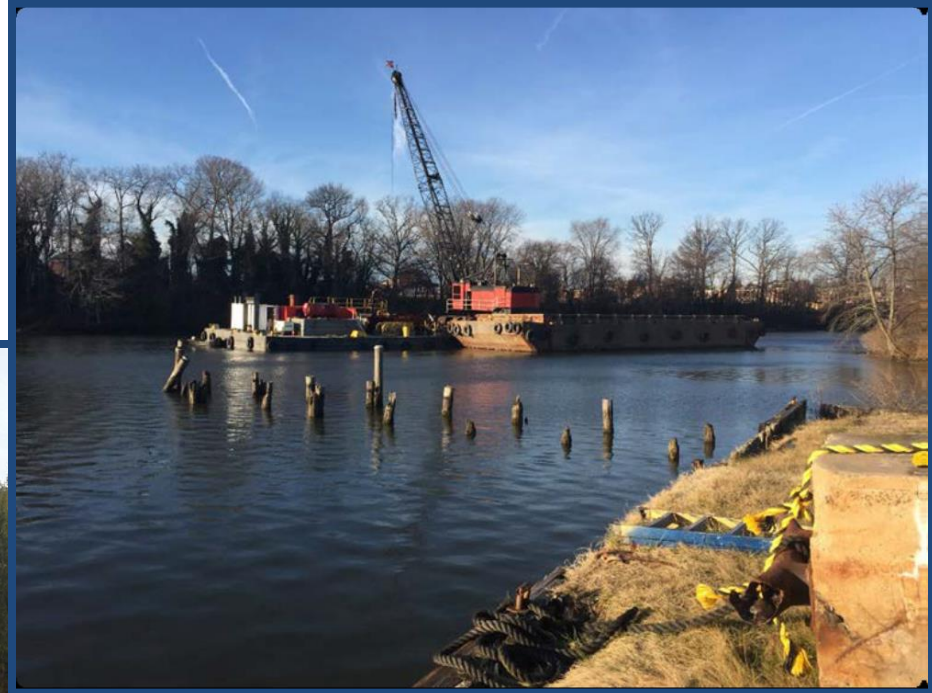
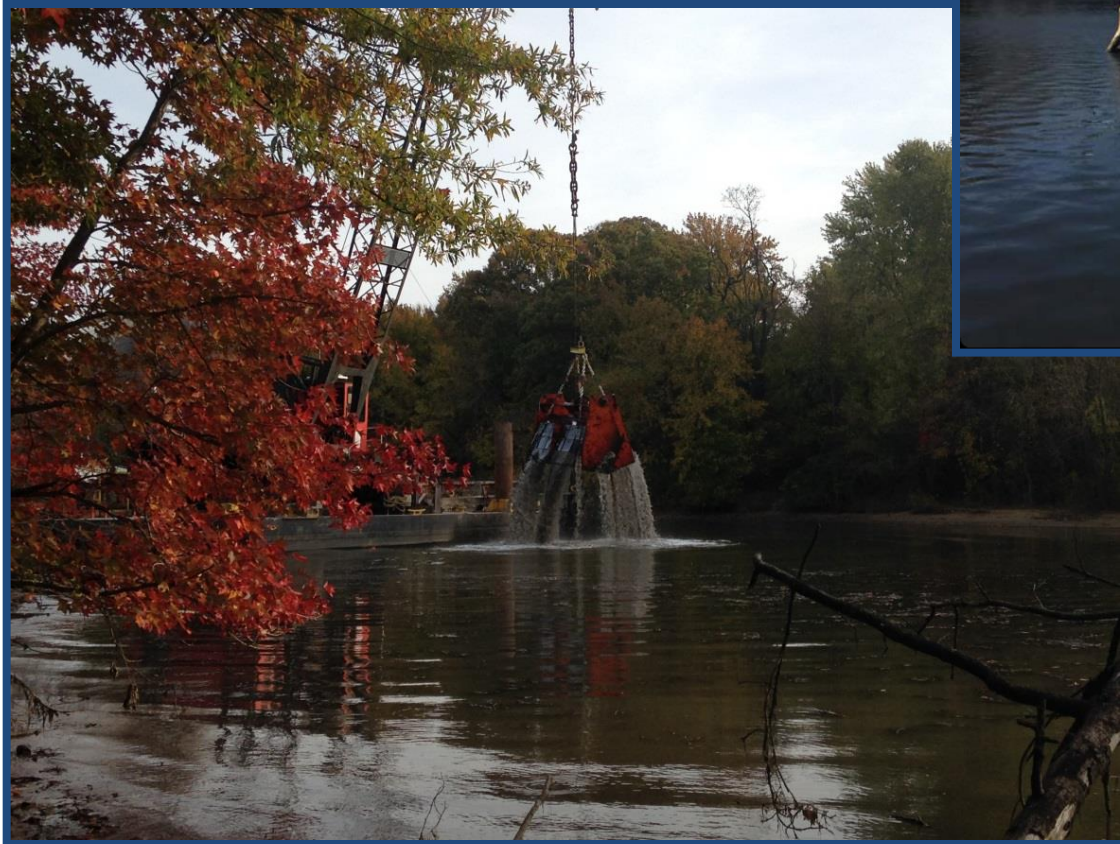
Sediment dredging began at the lower portion of Cow Pen Creek. The material was loaded onto a barge for storage, then transported to the offloading area.

The environmental bucket is shown draining water but retaining sediment.

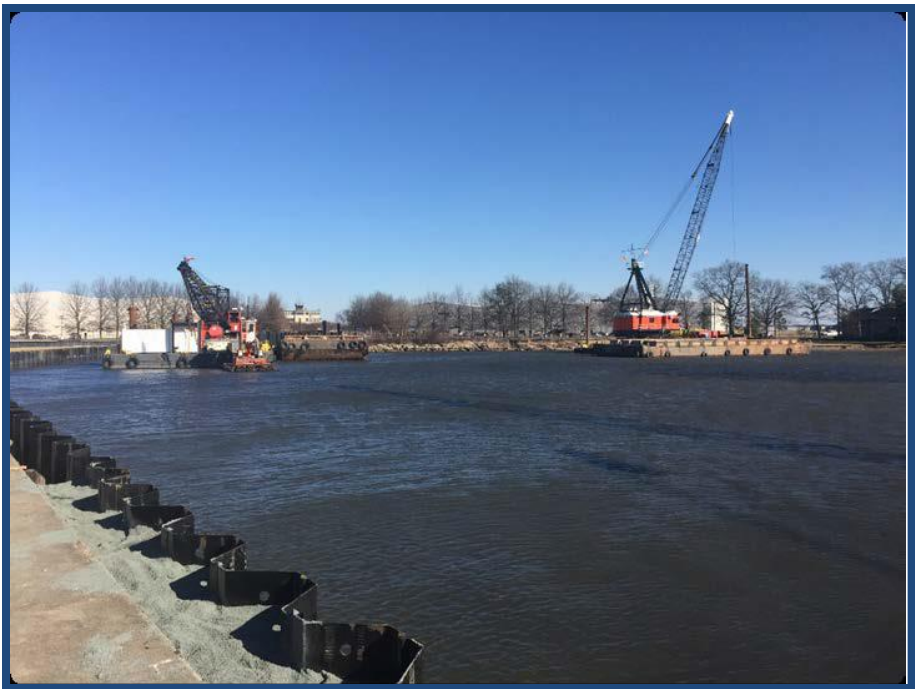
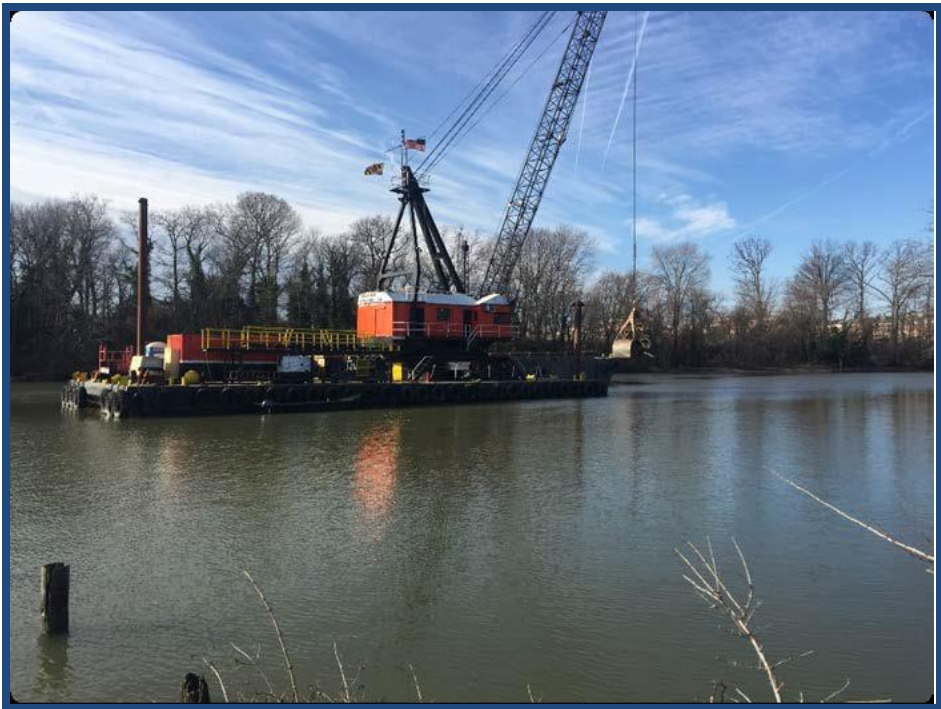
Sediment dredging proceeded to the lowest portion of Cow Pen Creek, then Dark Head Cove.

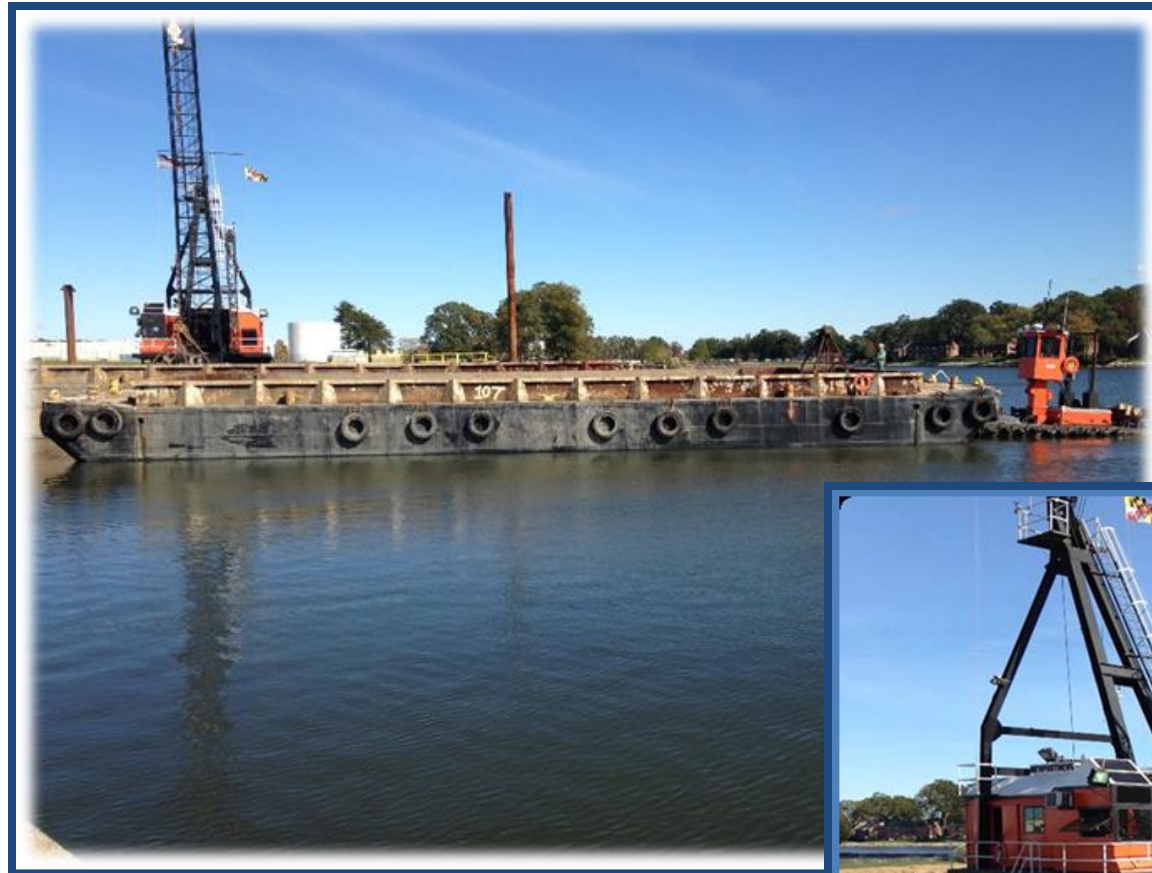
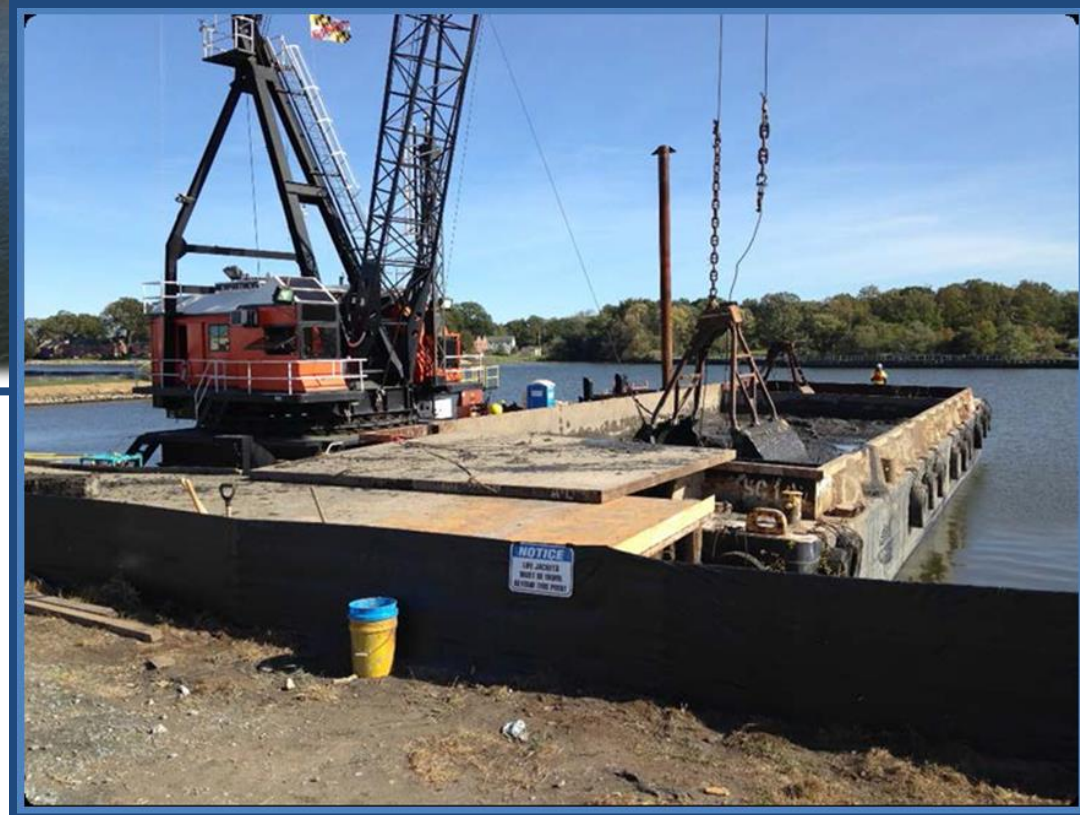
The push-boat moved the barge into position for offloading sediments.

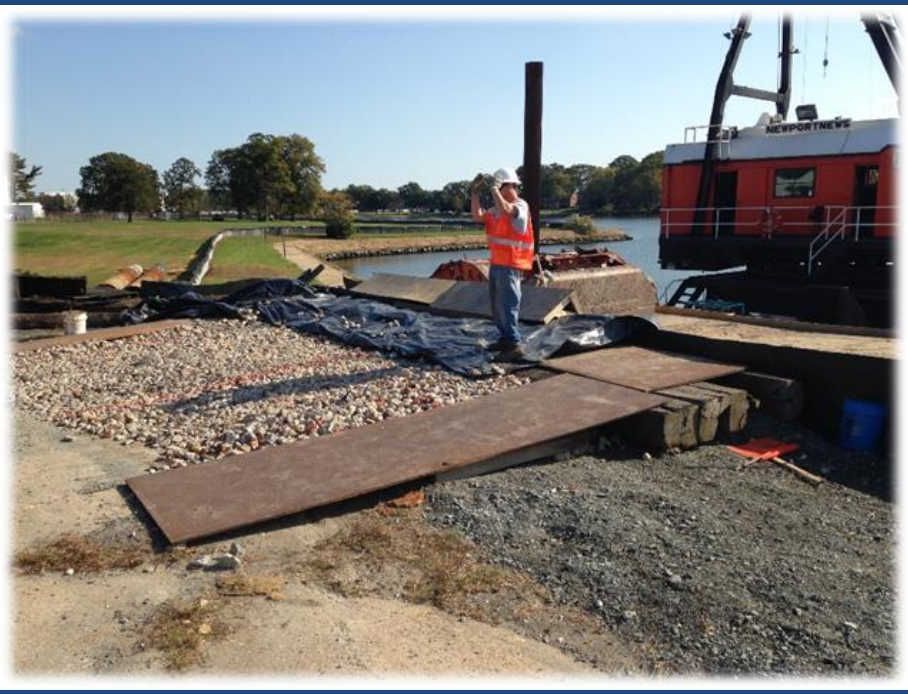
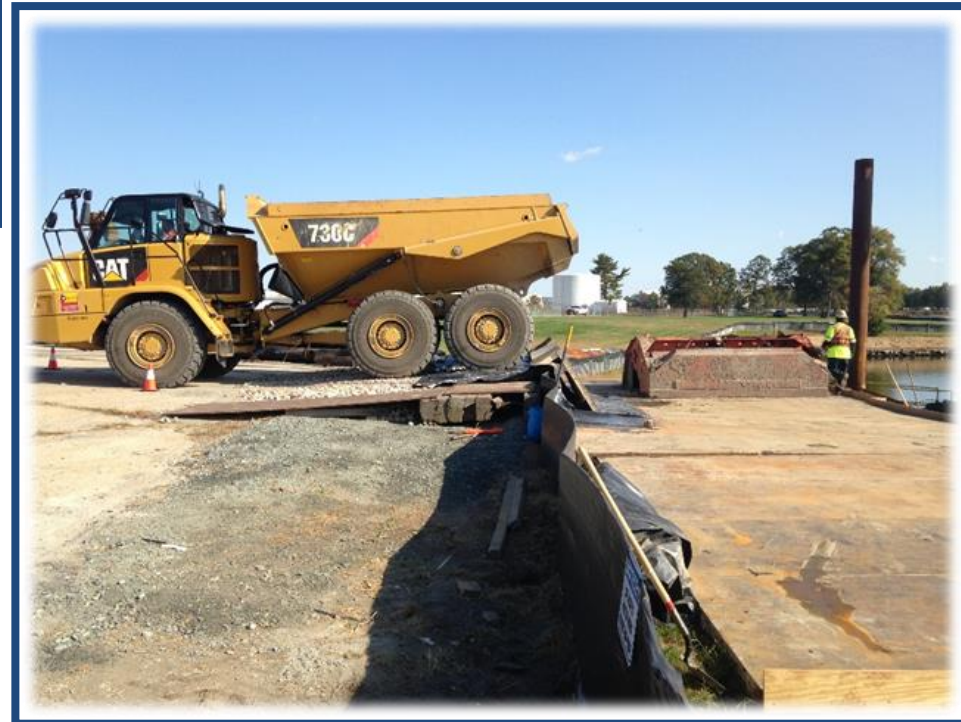
Using an apron to contain spillage, dredged sediments were offloaded from the barge. Haul trucks were positioned for sediment transfer at the spill apron.

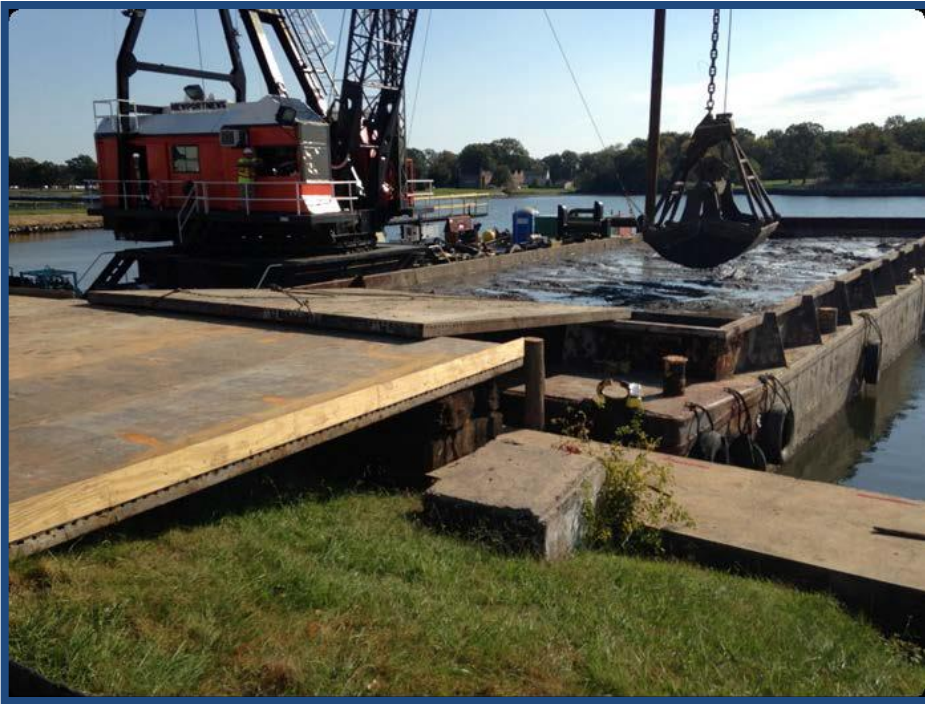
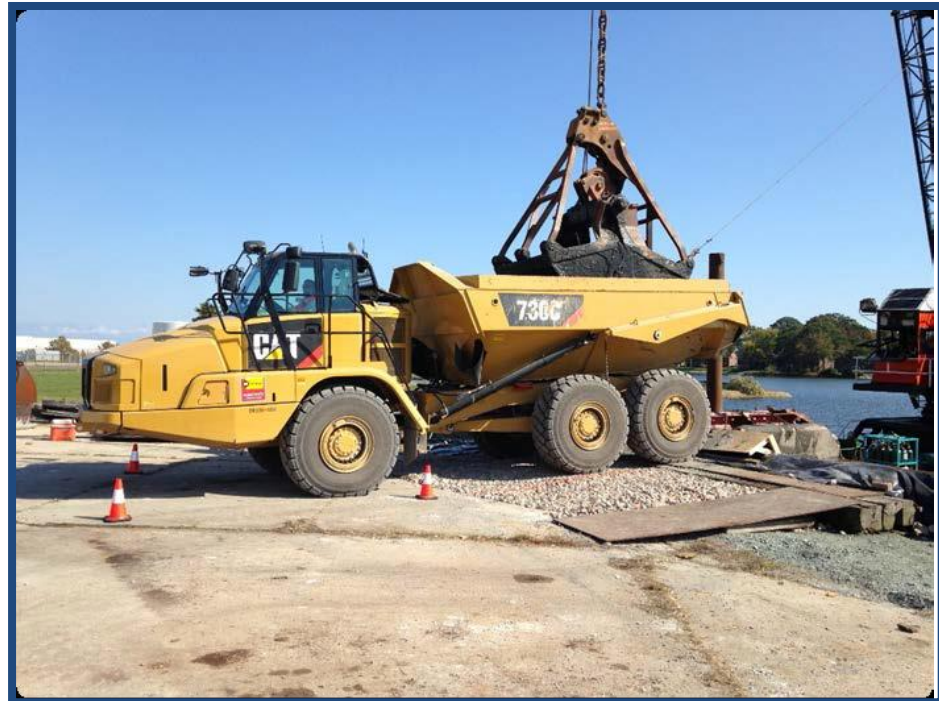
Using a clamshell bucket, dredged sediments were transferred to a haul truck.
