Sediment Cleanup Middle River Complex, 2016-17

Season 1
Project Photo Tour
Updated July 2017

Sediment Cleanup - Season 1

Project Photo Tour

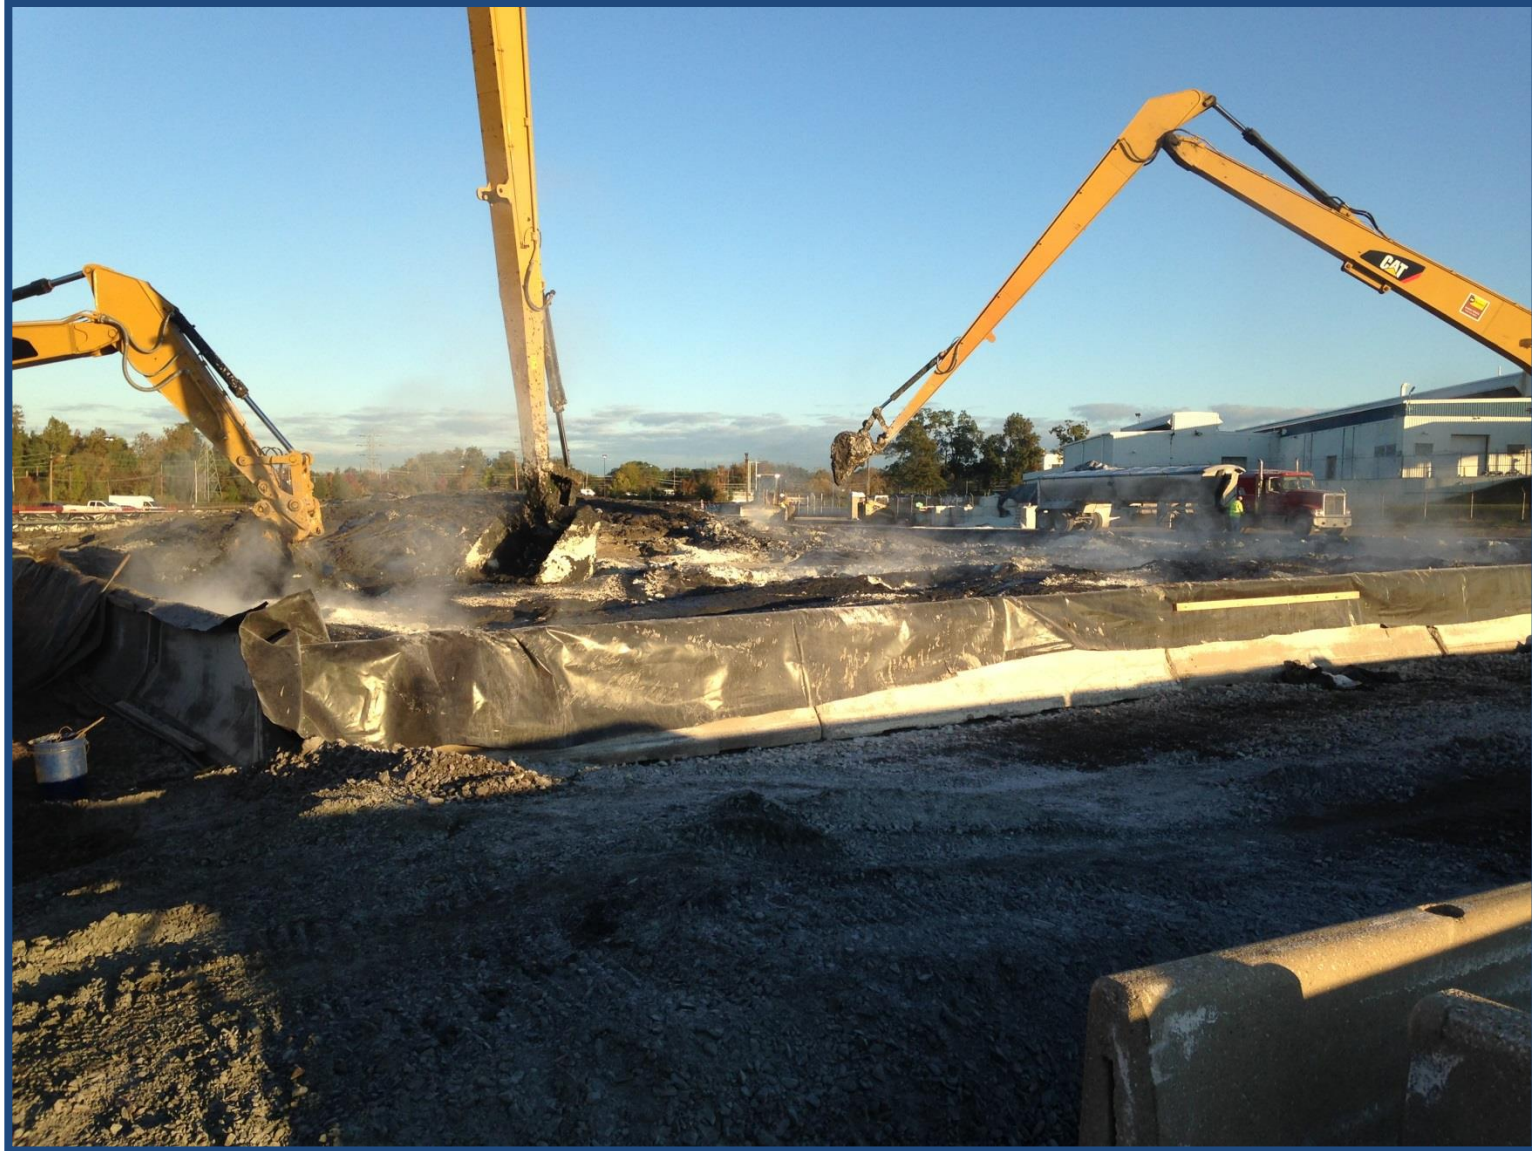
Sediments were then transferred into mixing bins where a specialized material (Calciment™) was added to dry the sediment adequately to meet disposal requirements.

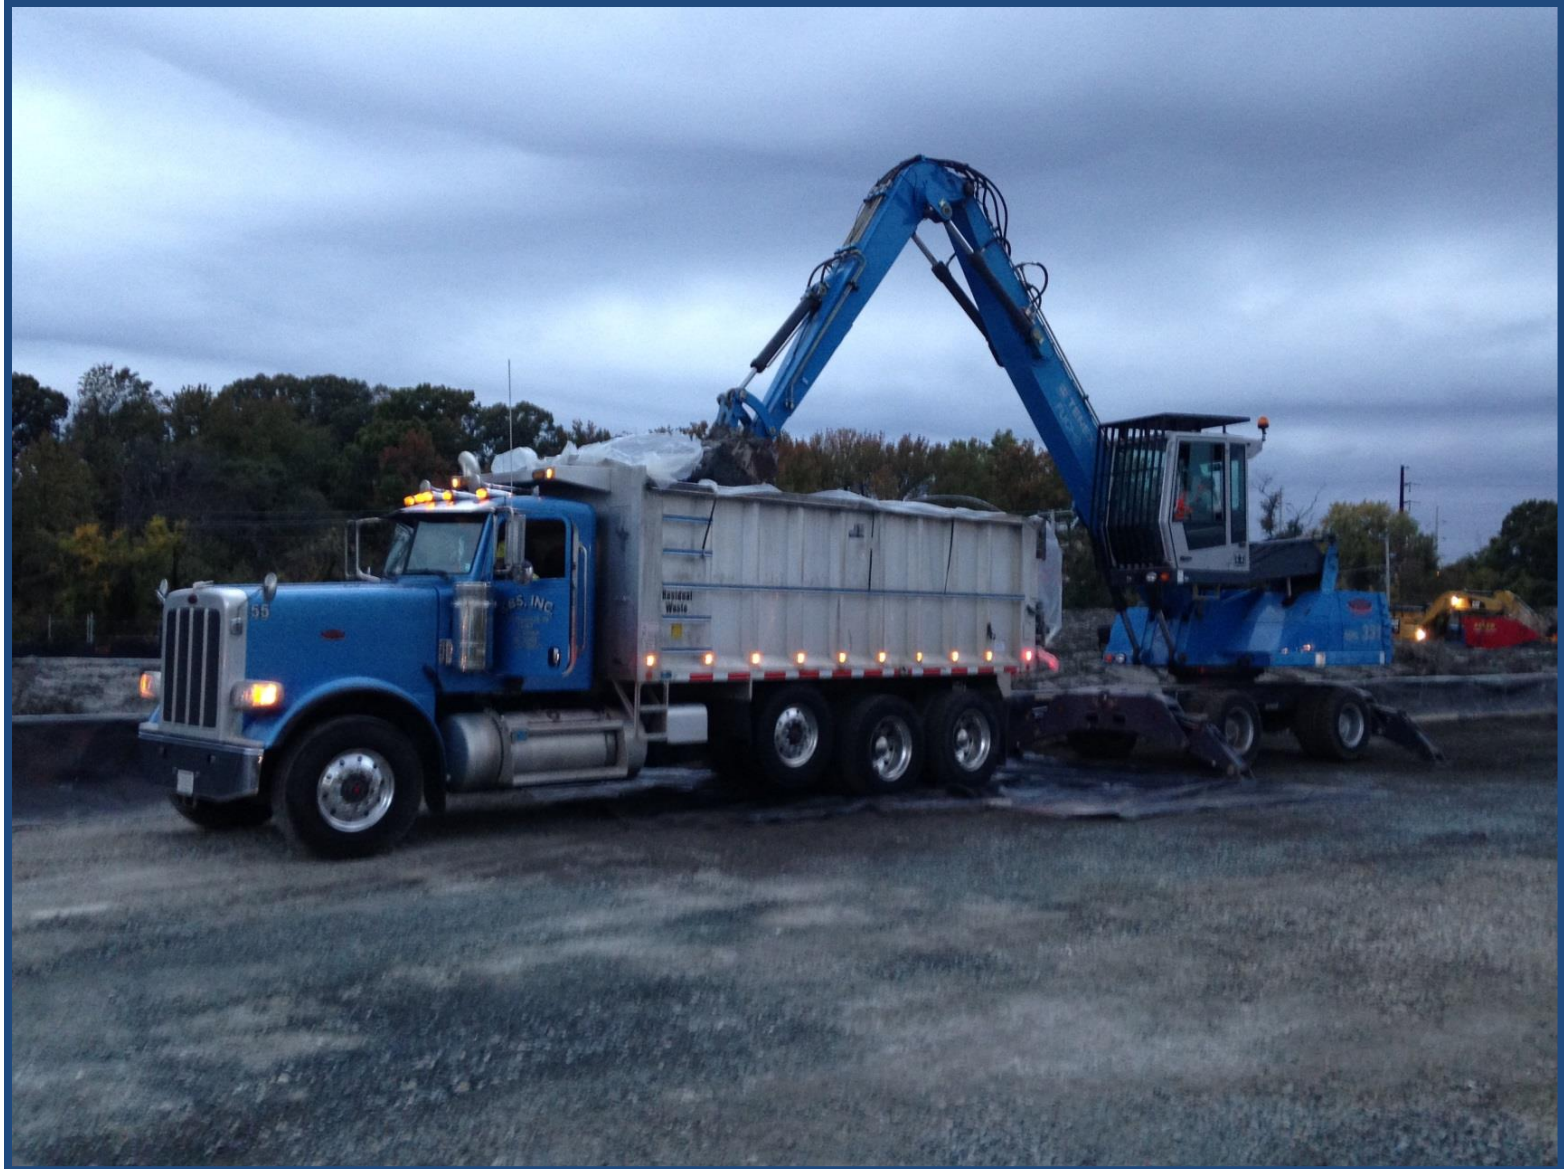
Once the sediments met disposal requirements, they were transferred to lined trucks and hauled off-site to a licensed landfill in York, Pennsylvania.

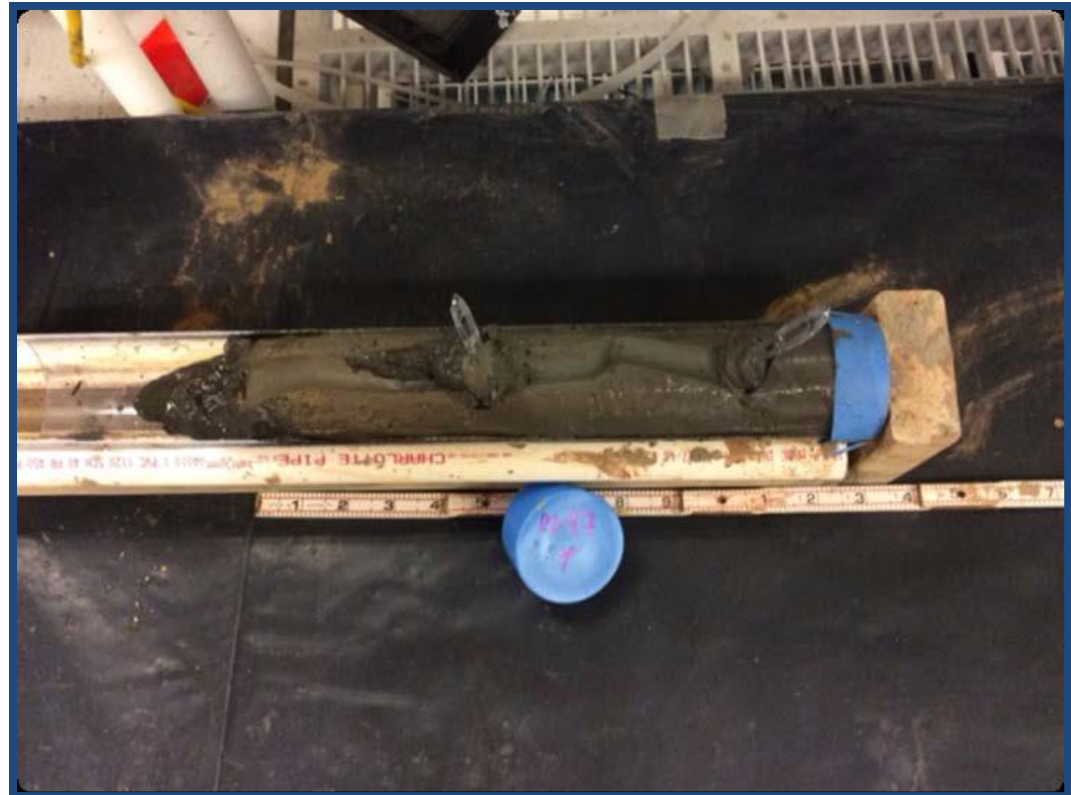
Once planned dredging depths were met, confirmation samples were taken for chemical analysis to determine whether additional dredging was needed. Four dredge areas required additional dredging, extending the project window by three weeks.

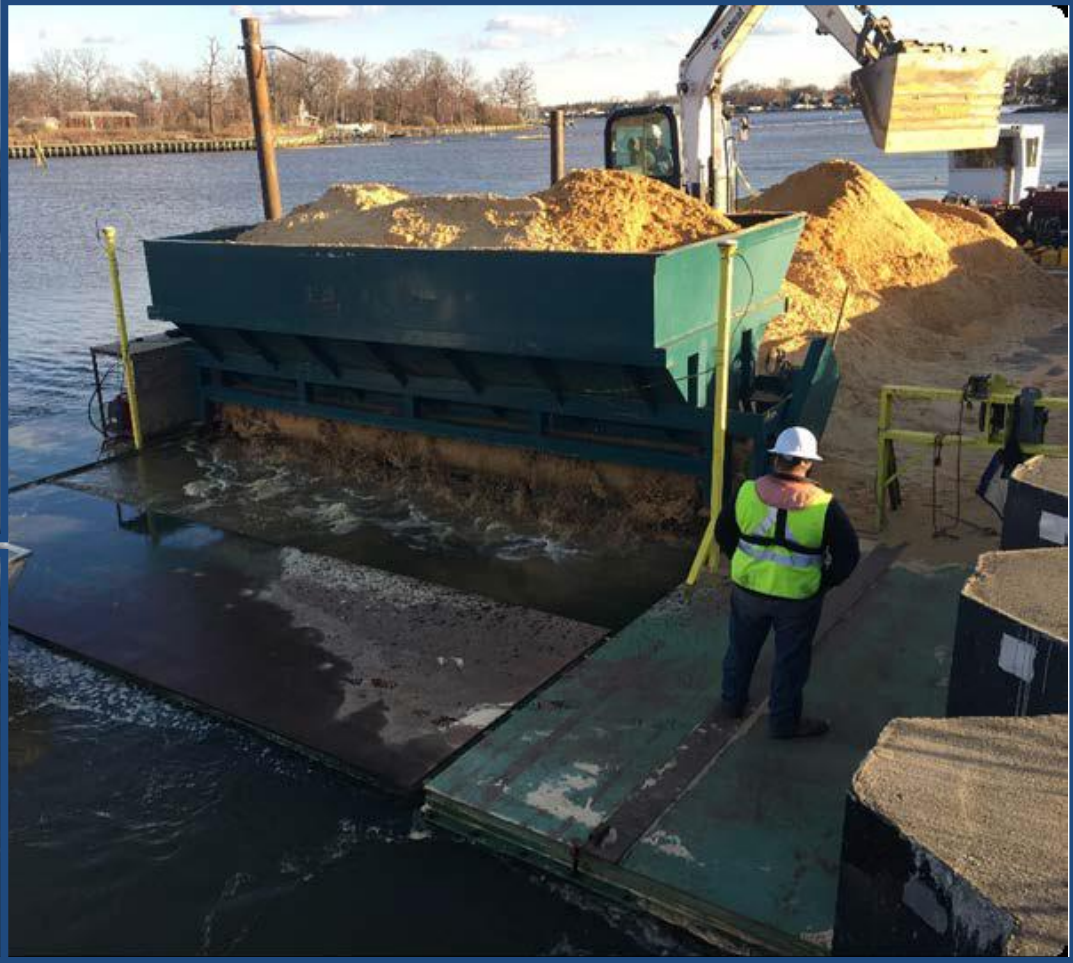
The hoppers were filled with sand using conveyors and barged to dredged areas for placement.

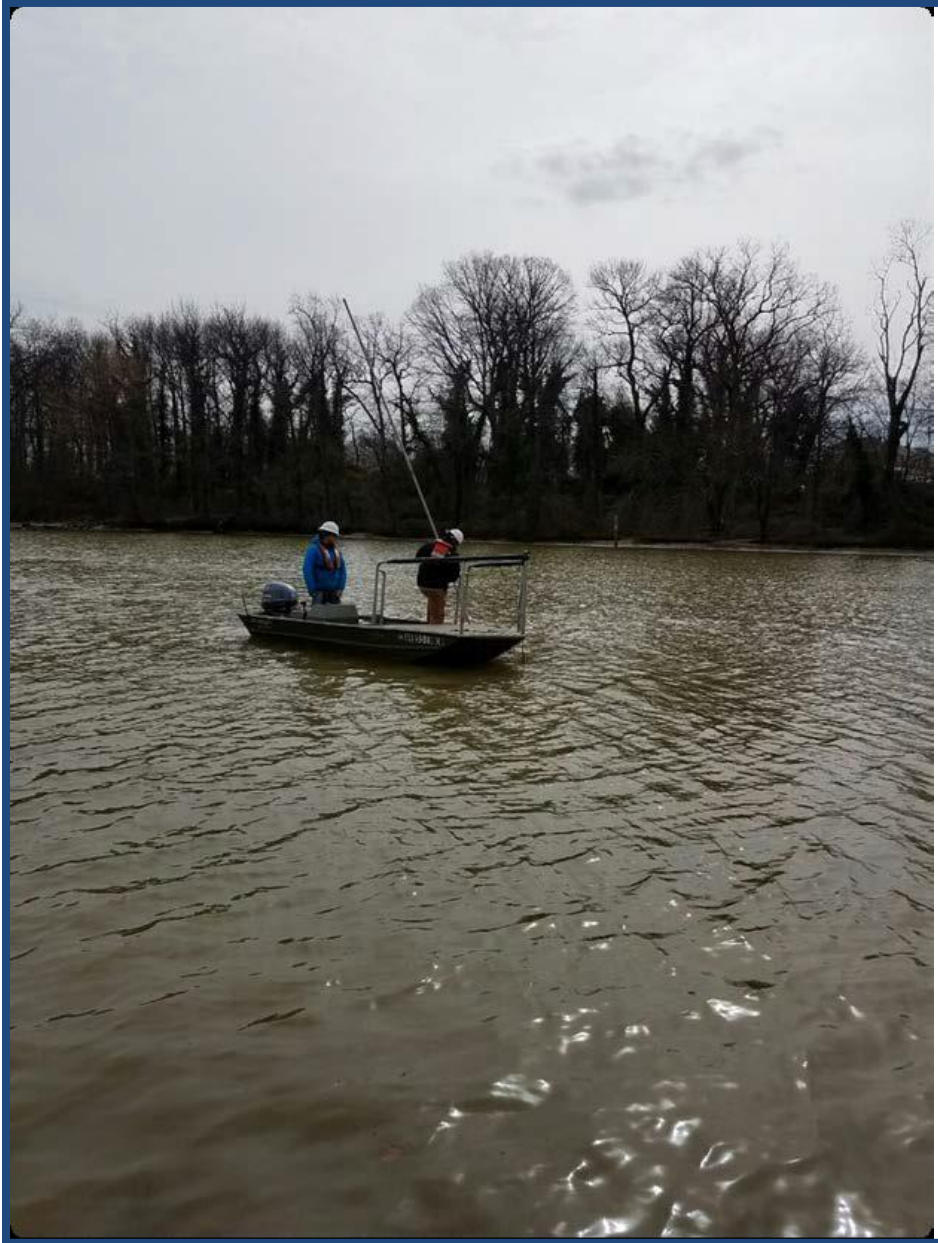
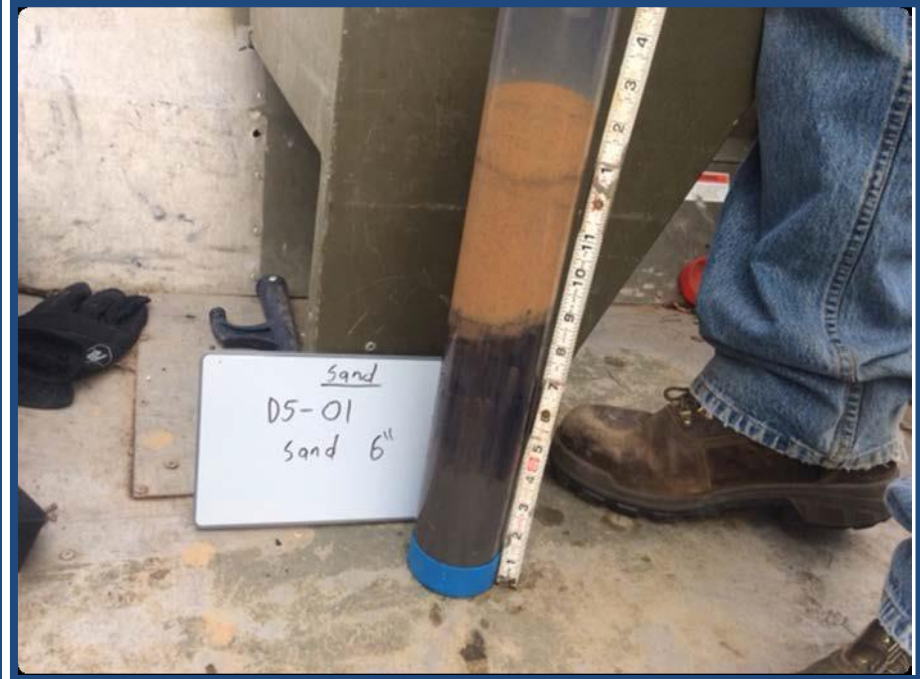
After sand placement, cores were taken to confirm six inches of sand were evenly placed.

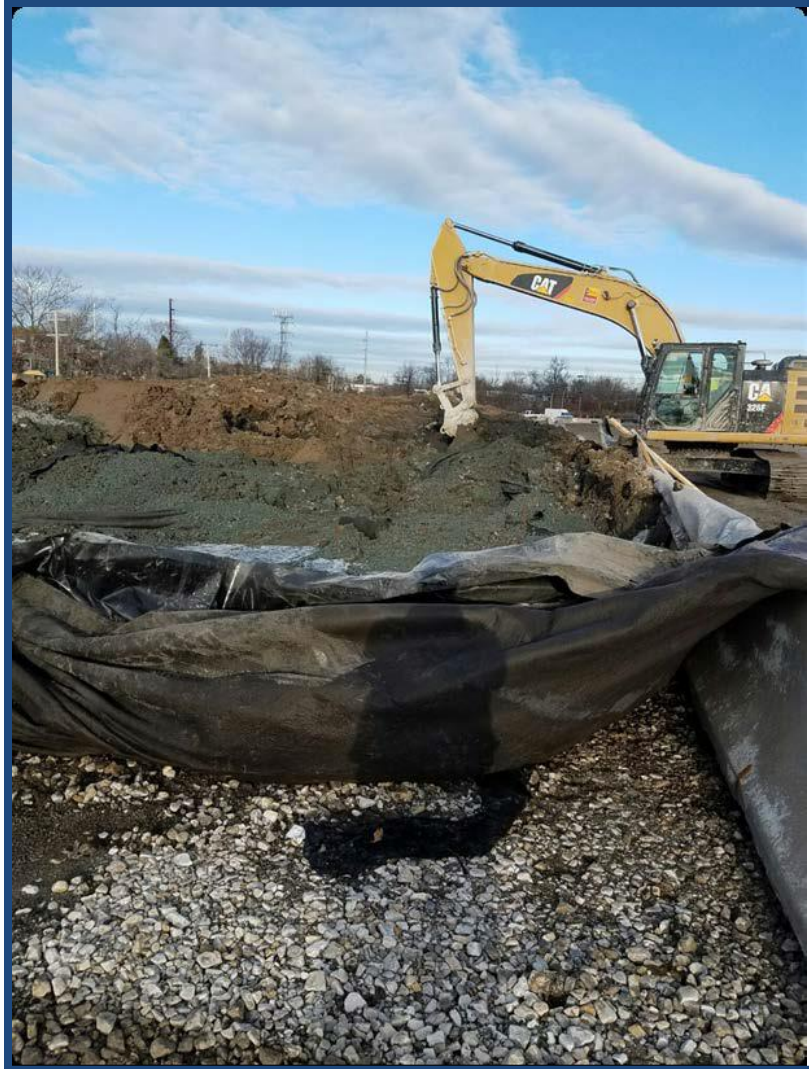
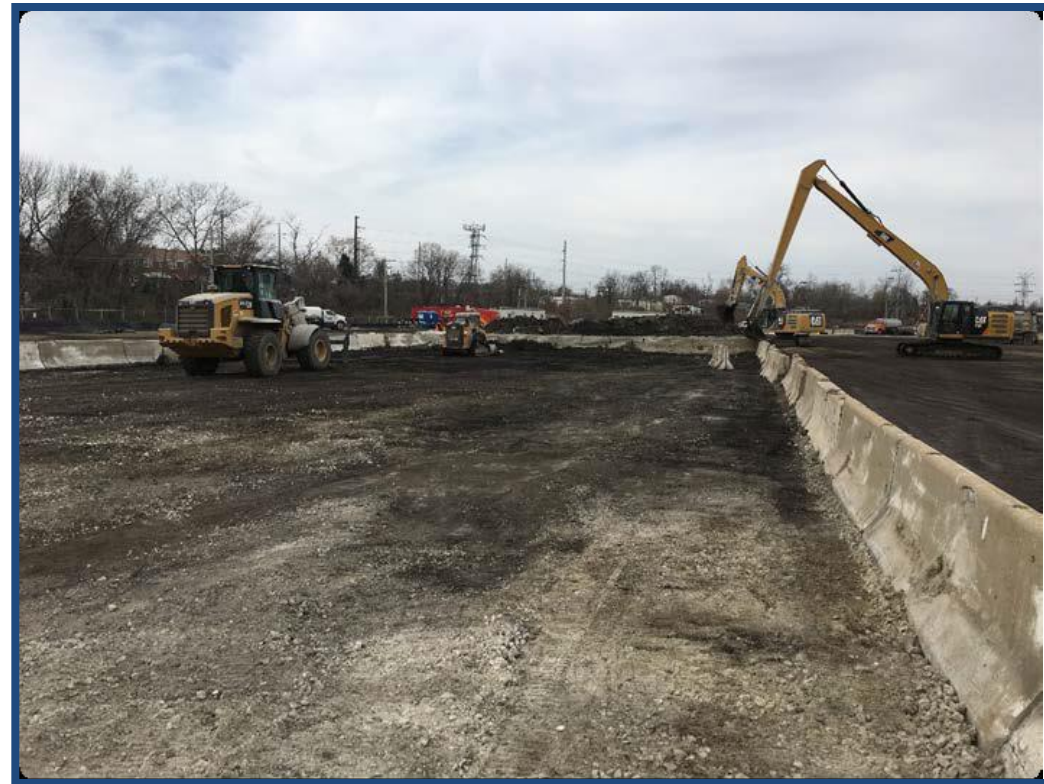
After confirming all dredging goals were met, sediment handling bins were deconstructed, and materials were sent to the landfill.

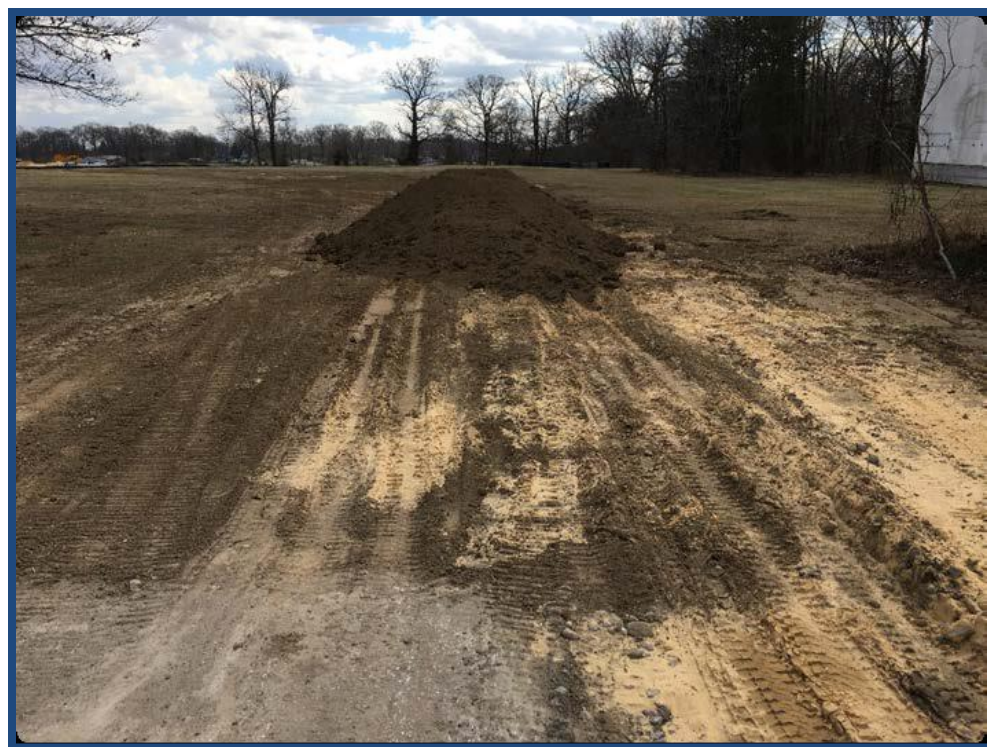
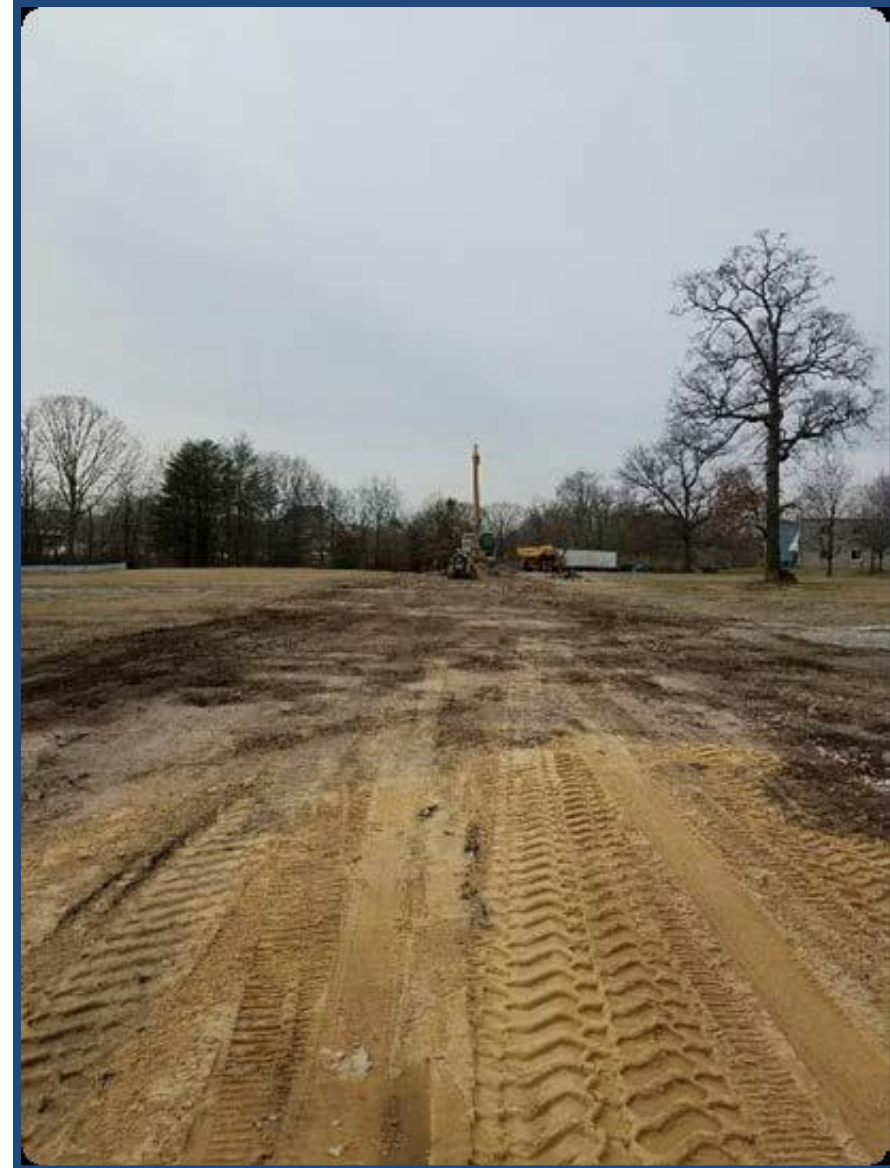
Once sediment and sand handling work was finished, the temporary haul road was removed and restored to its earlier uses, and no longer used as a road.

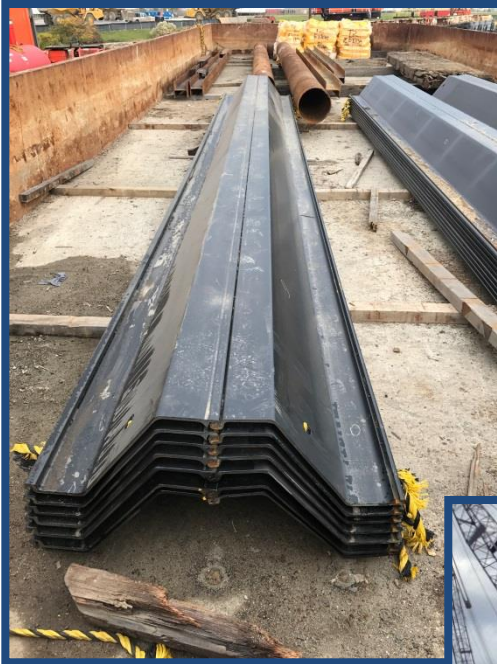
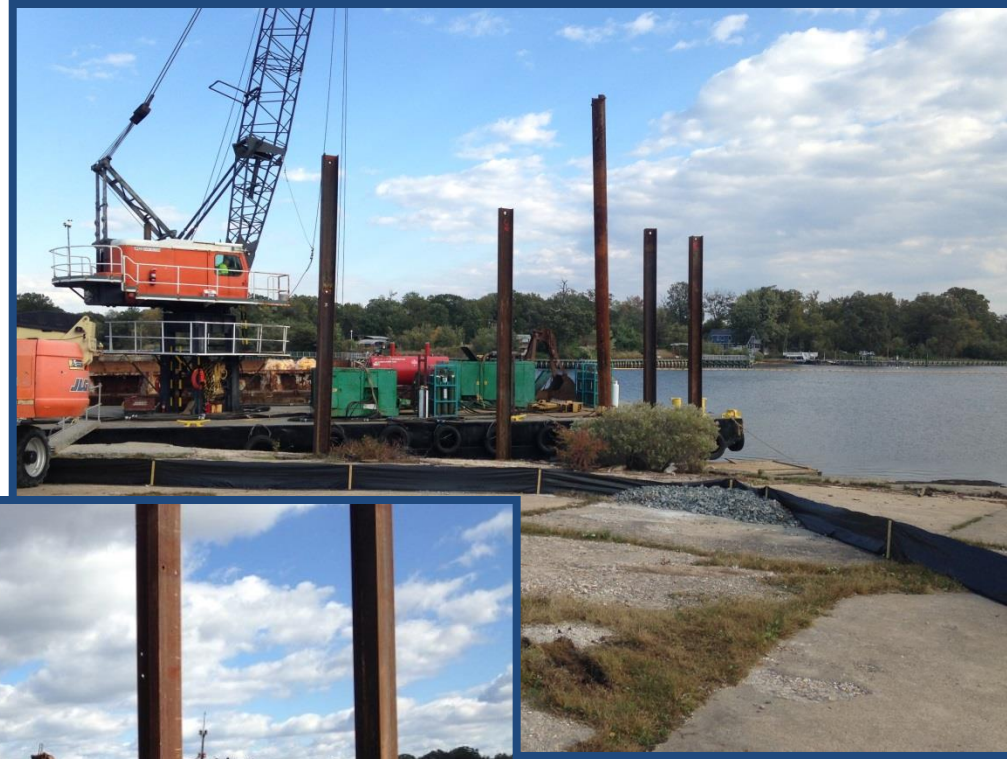
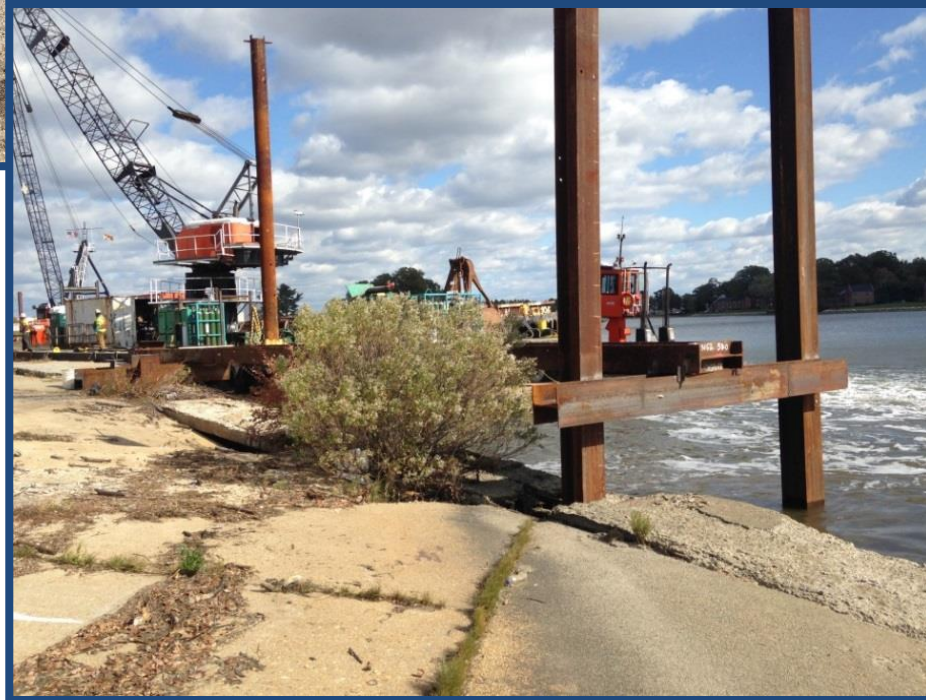
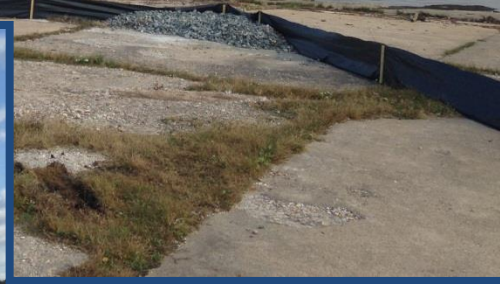
Another separate aspect of Season 1 work was to upgrade the deteriorating bulkhead with new sheet piles, which were barged to the site. Temporary template piles were installed to support construction of the sheet pile wall.

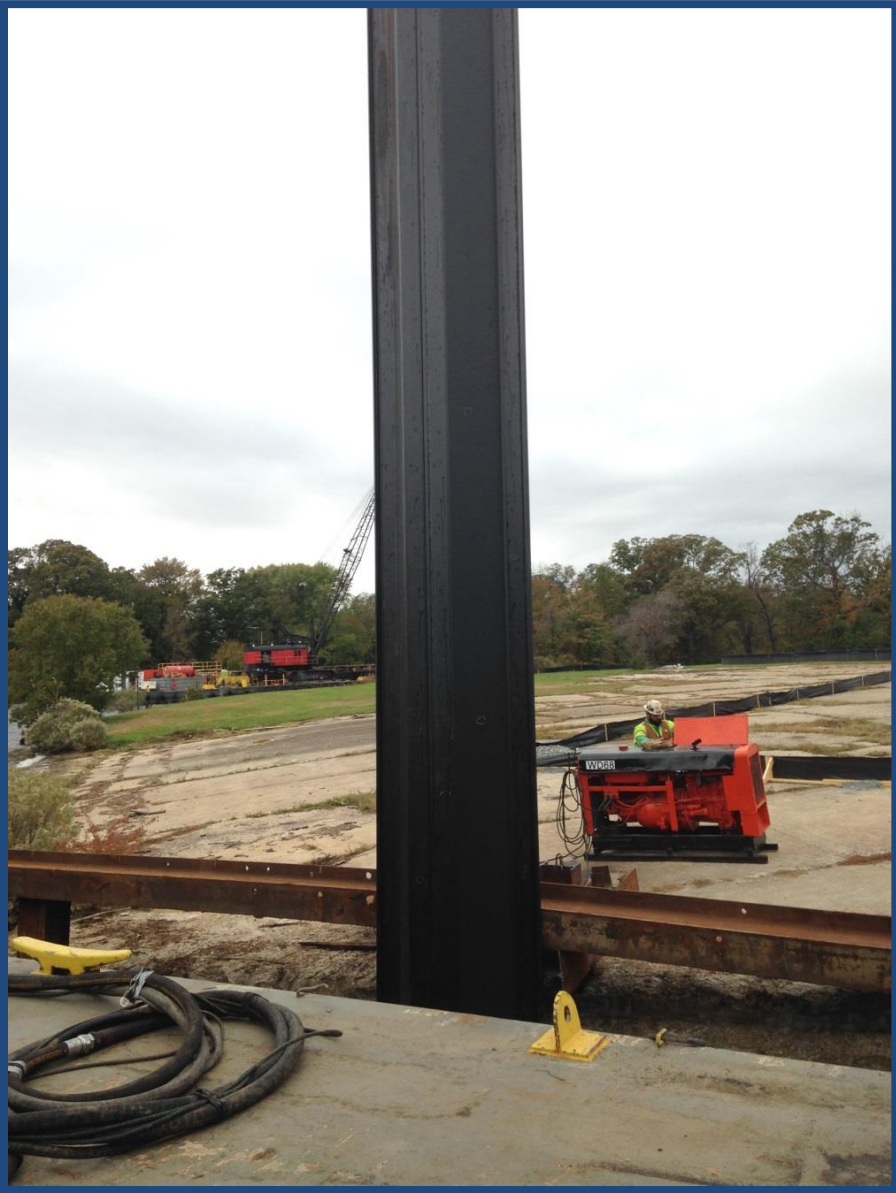
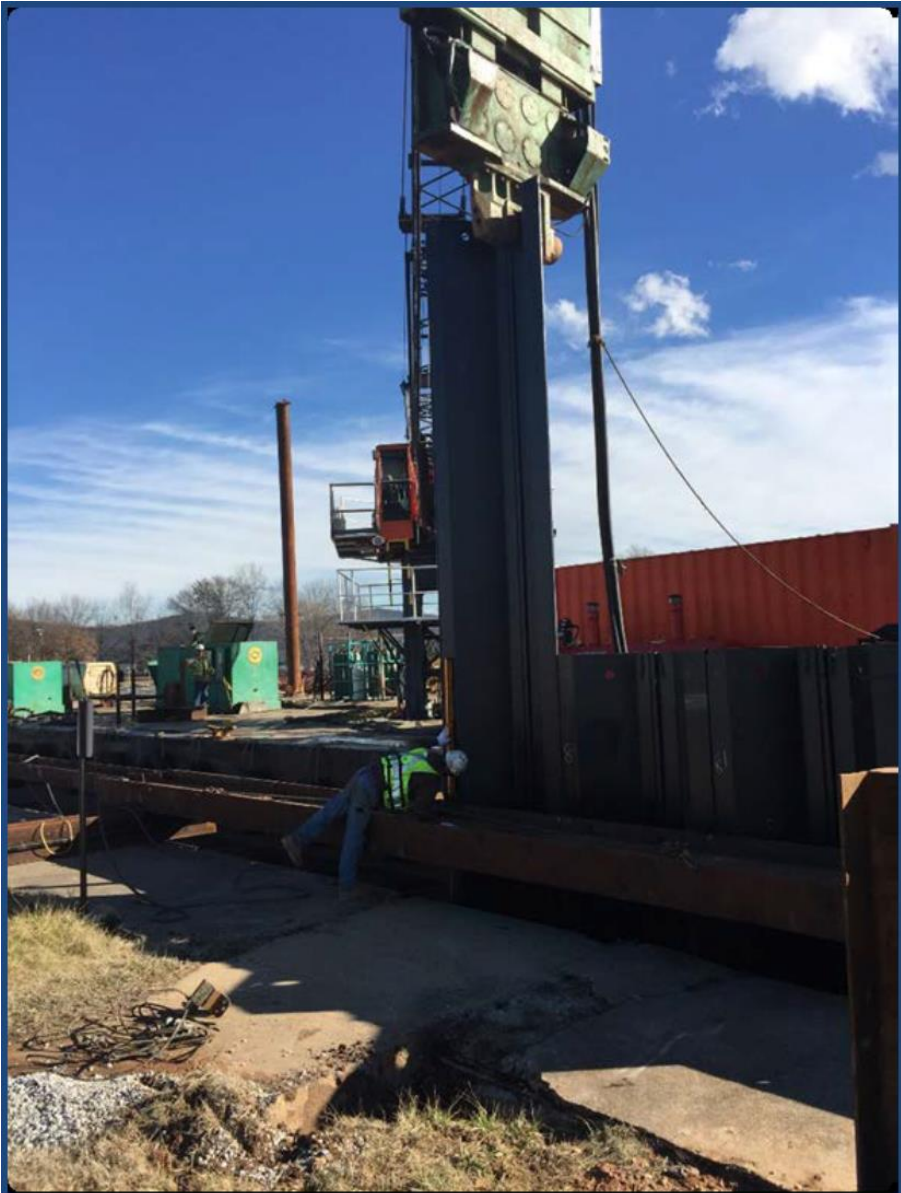
A crane positioned the sheet piles, and a vibrating hammer drove them to the planned depth.

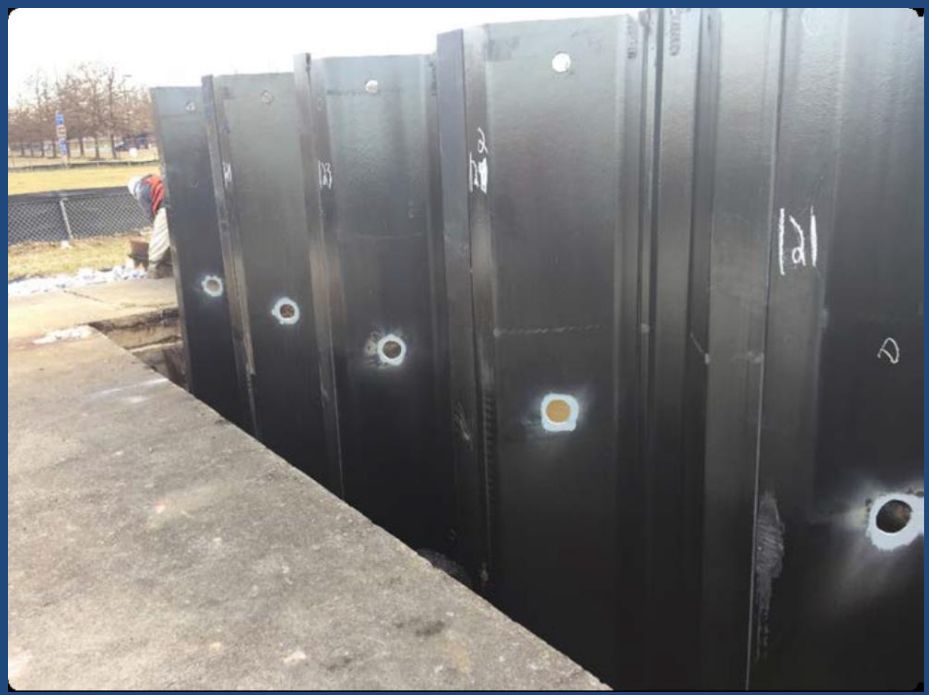
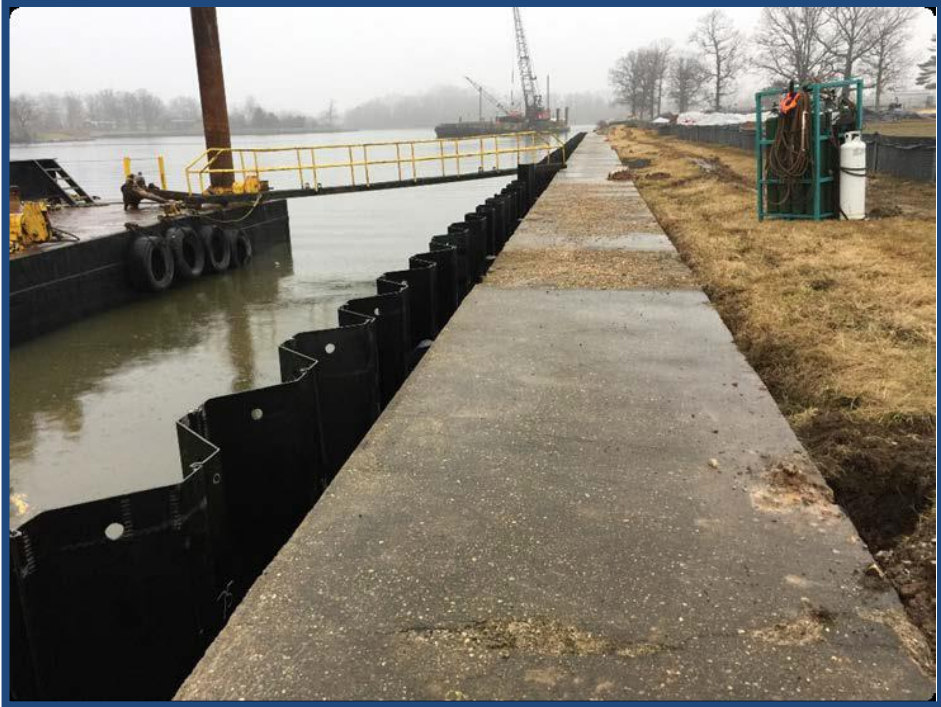
Drainage holes were drilled prior to driving sheet piles to their final grade.

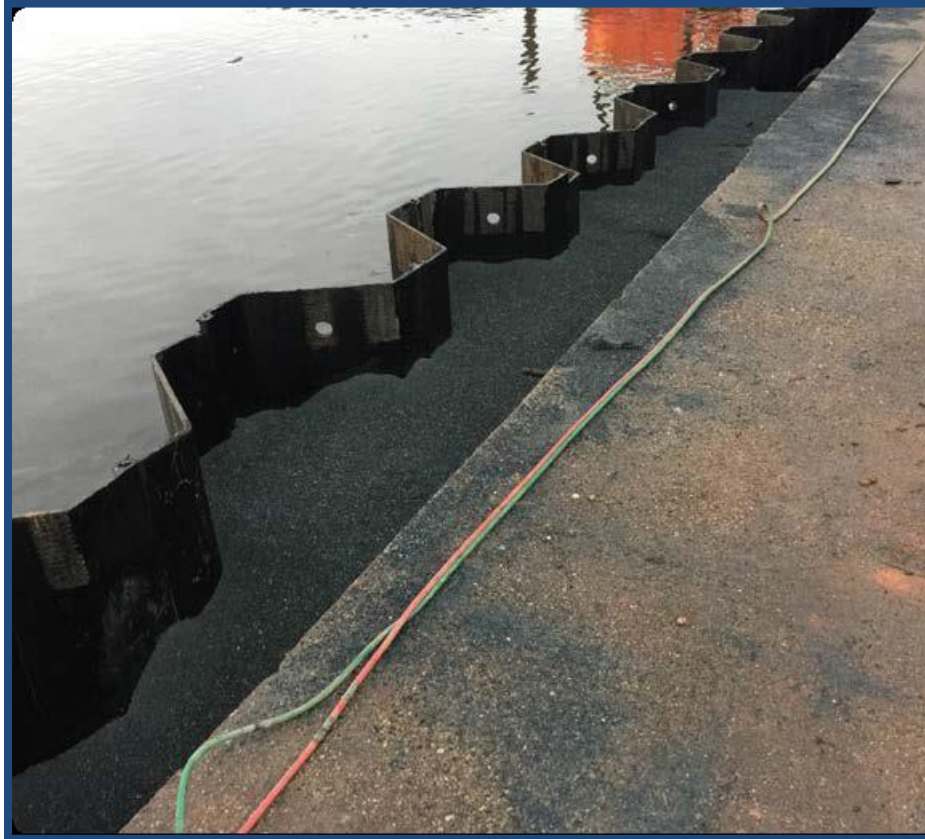
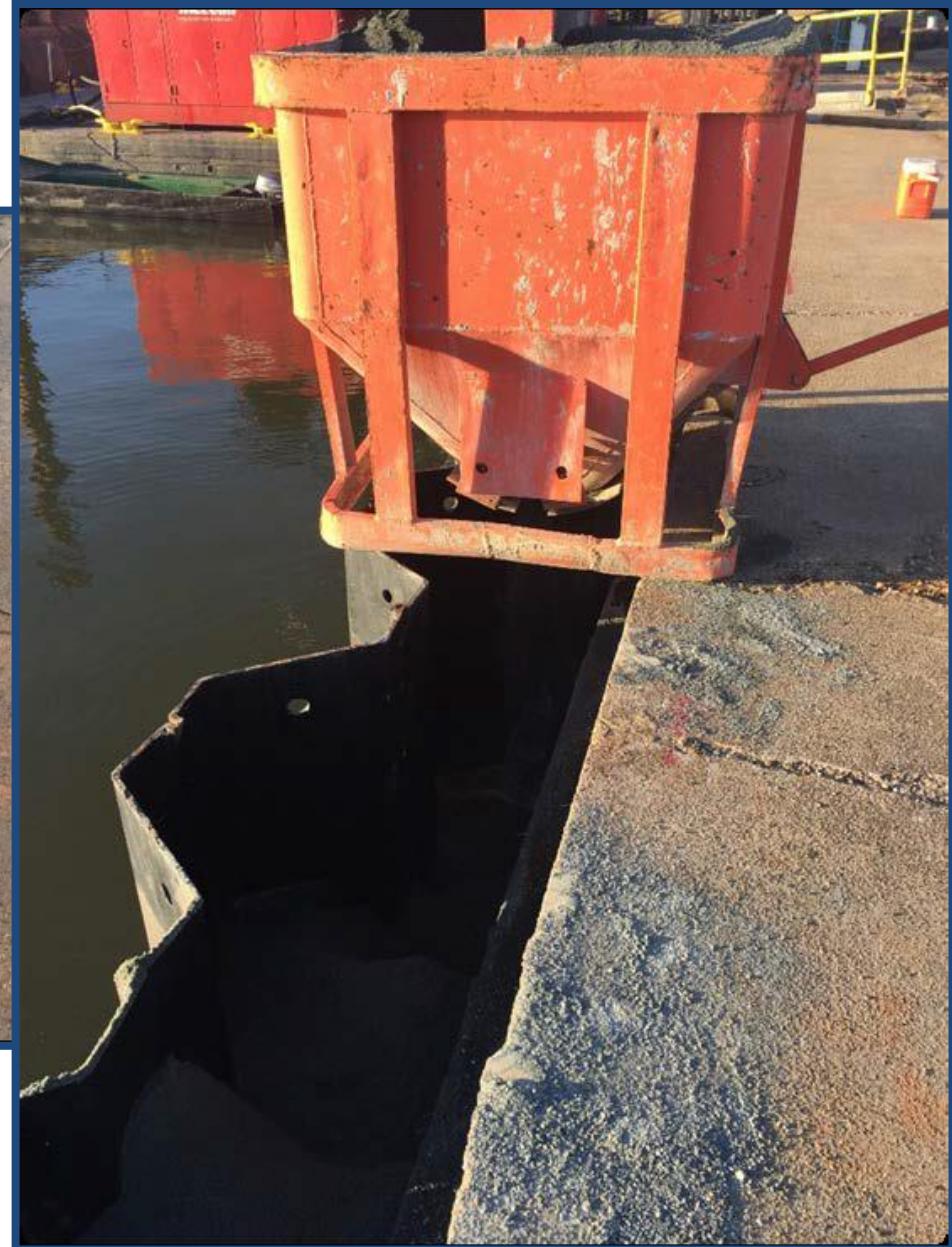
Spaces between the new sheet pile and the old bulk head were filled with gravel.

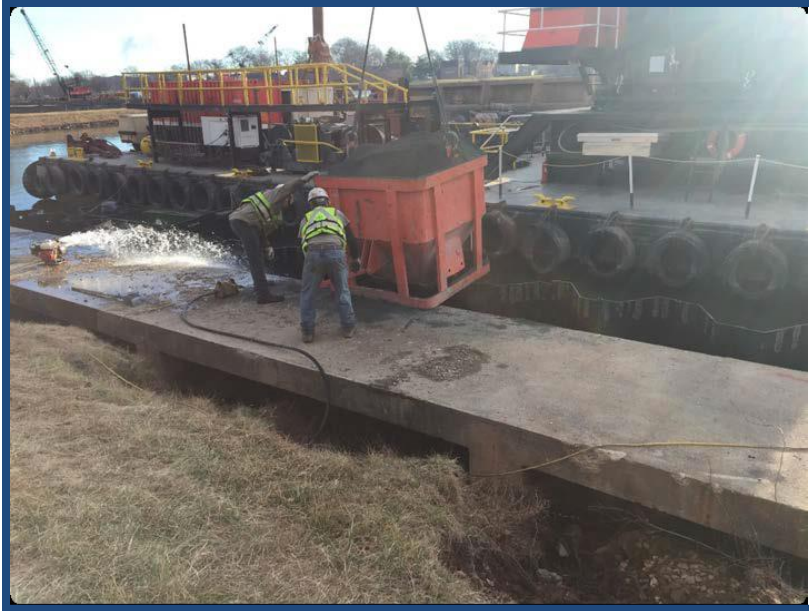
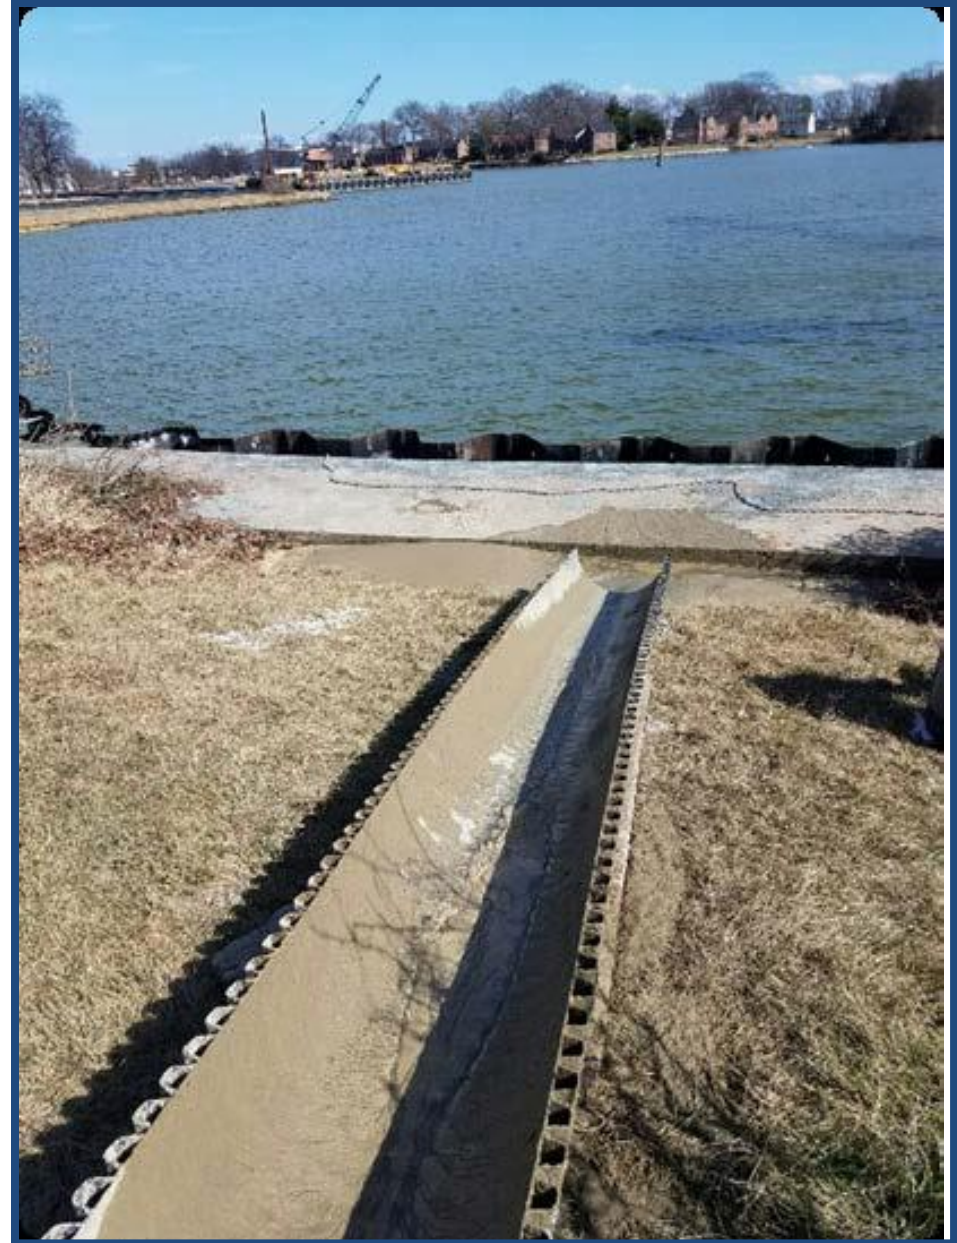
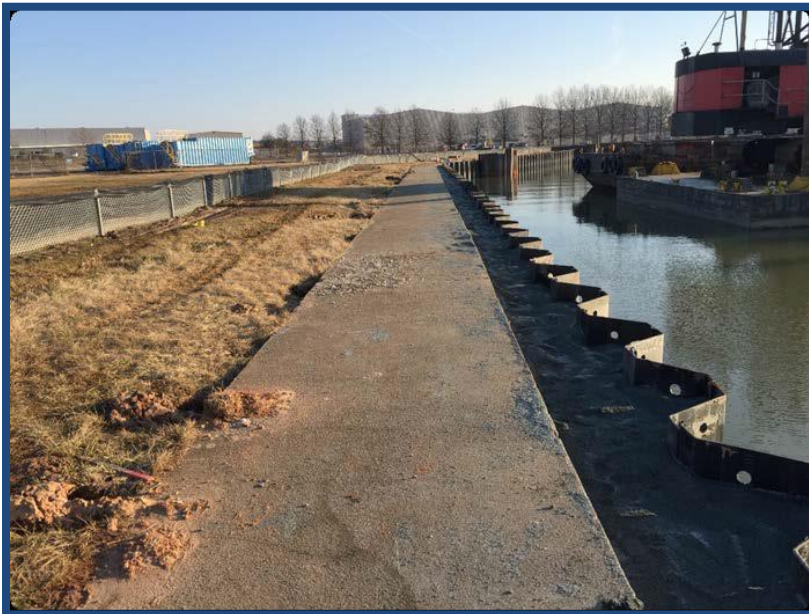
Backfilled areas with granular material were compacted and empty spaces were filled with a flowable material, similar to a watery concrete.

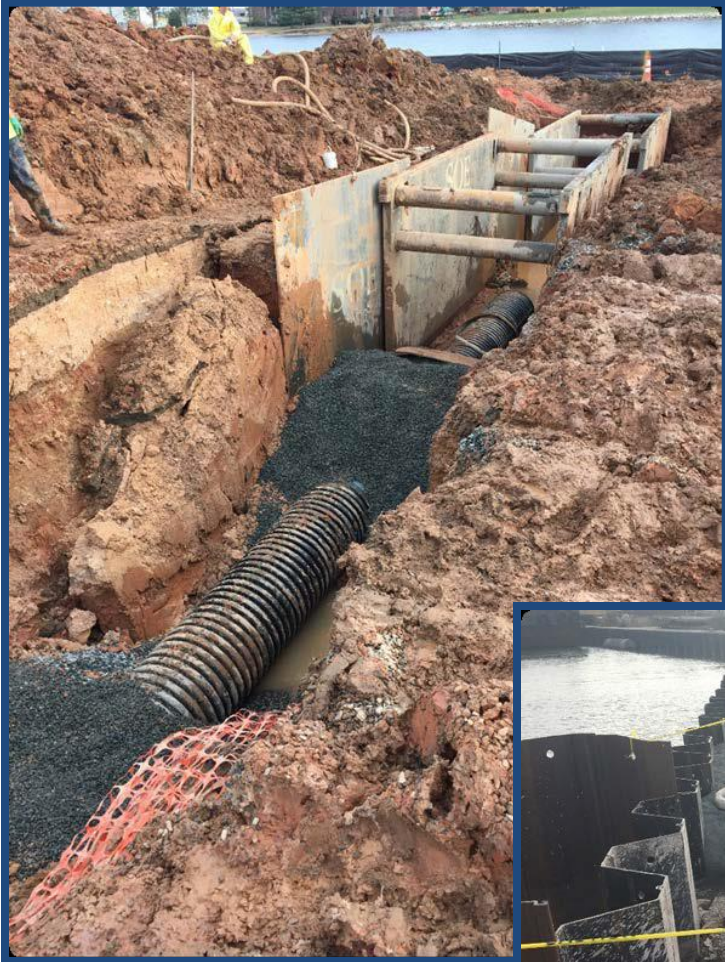
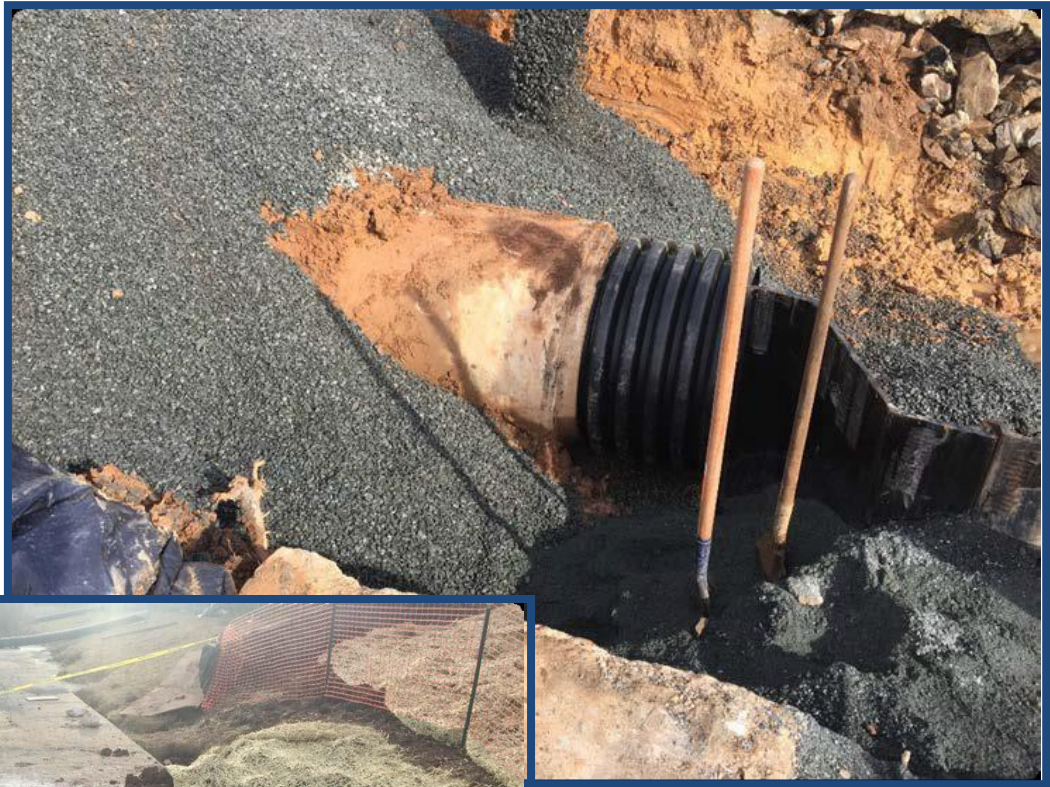
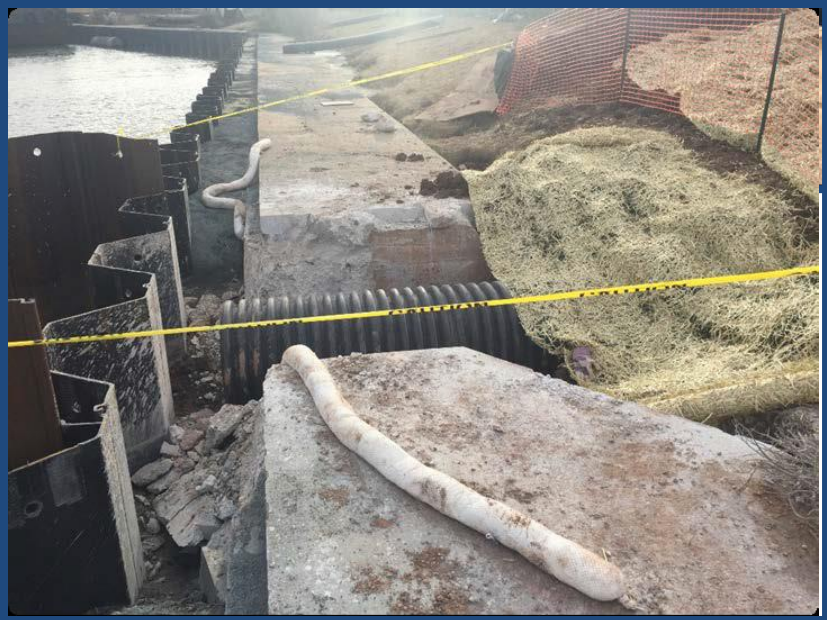
Outfalls passing through the new bulkhead sheet piling were extended and connected using HDPE (High Density Polyethylene) piping.
