Sediment Cleanup Middle River Complex, 2016-17

Season 1
Project Photo Tour
Updated July 2017

Sediment Cleanup - Season 1

Project Photo Tour

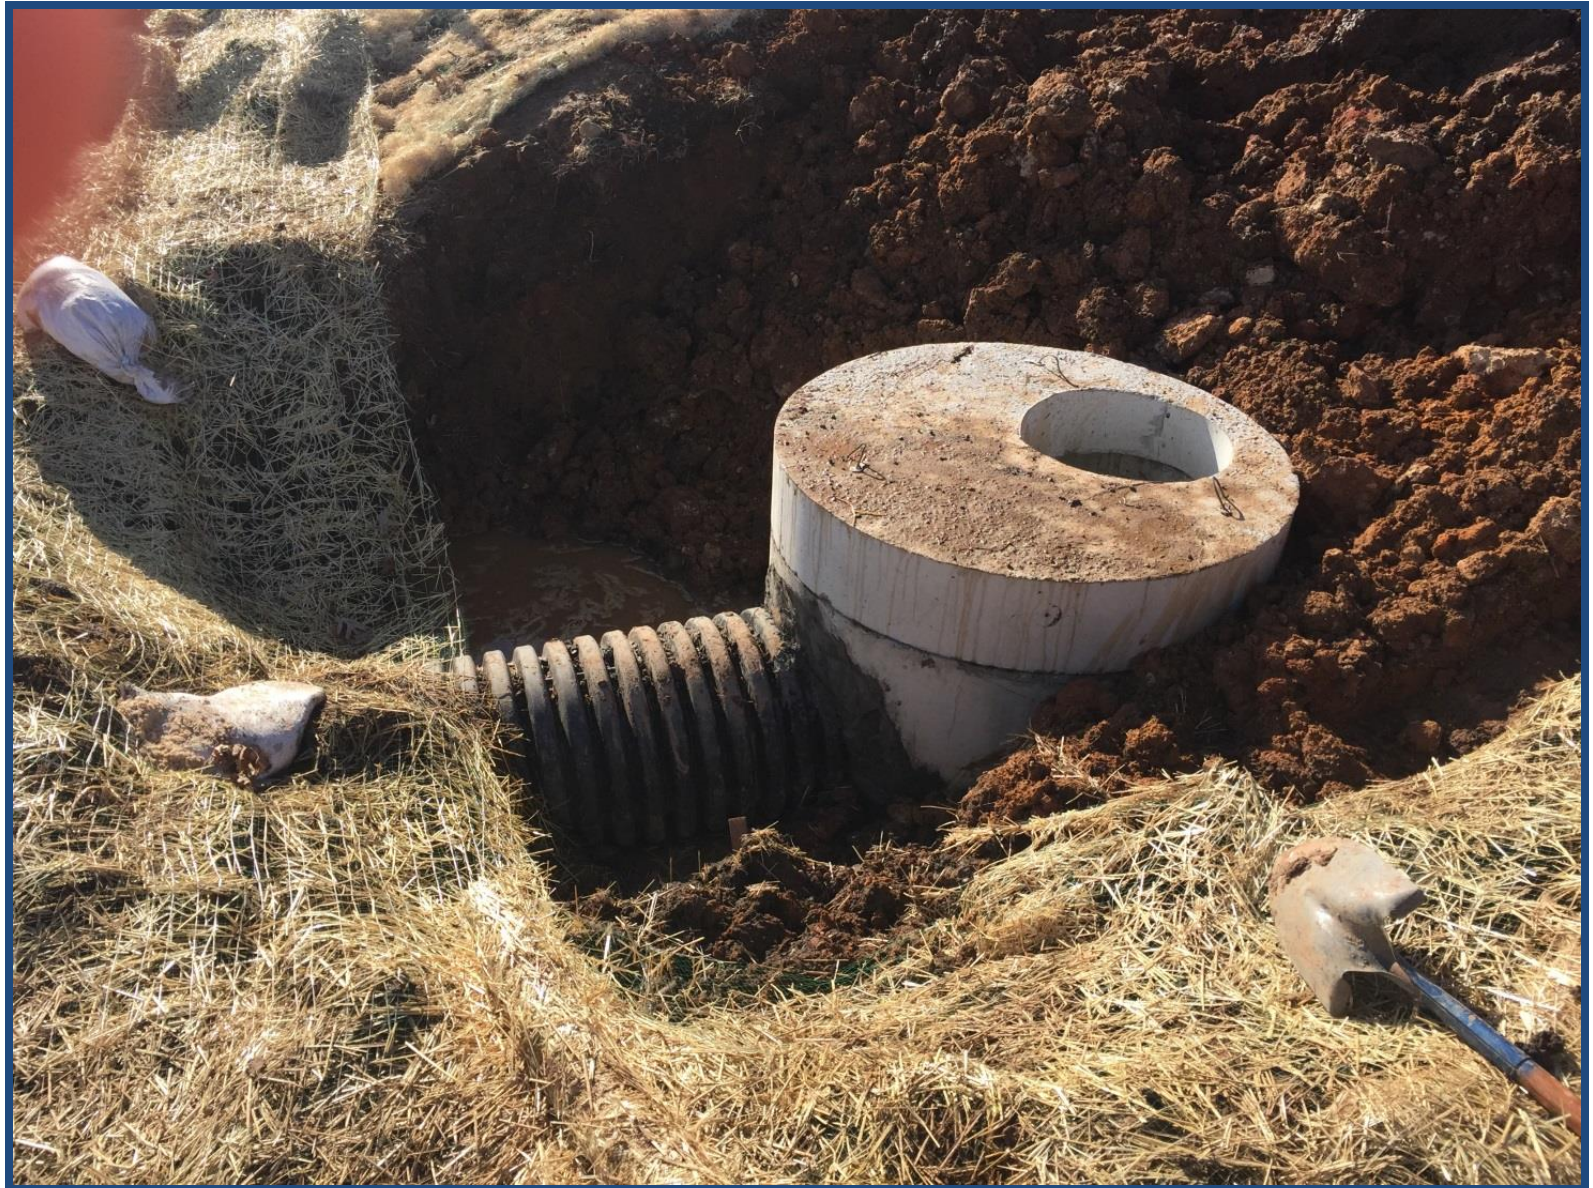
New manholes were installed above five outfalls.

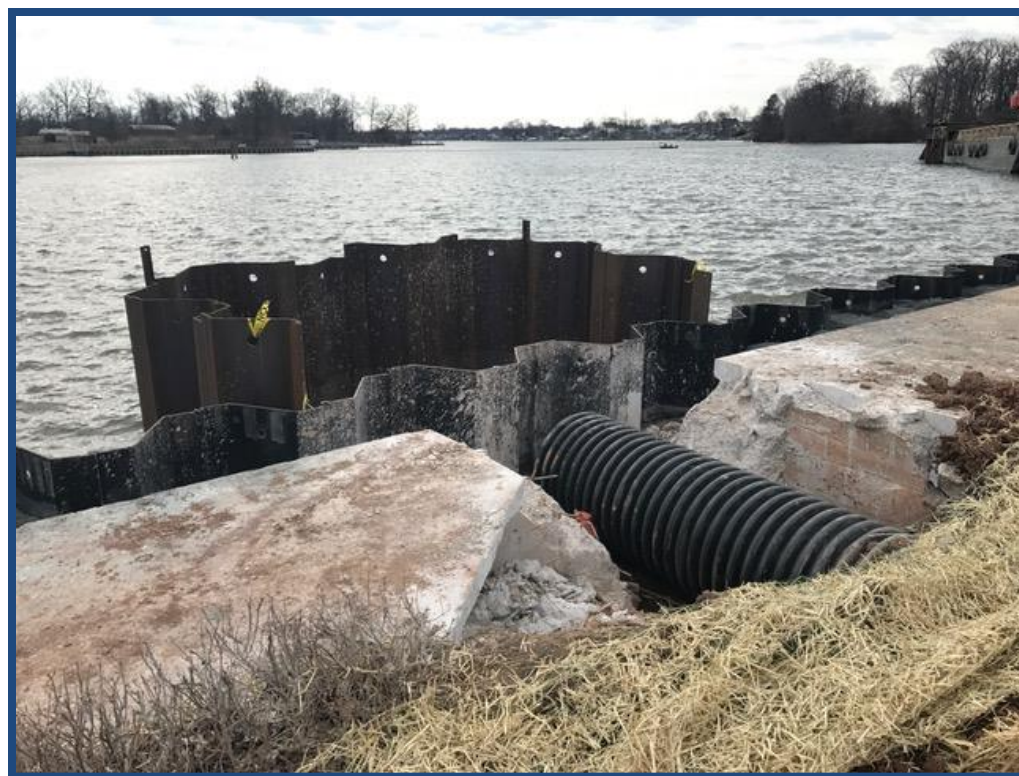
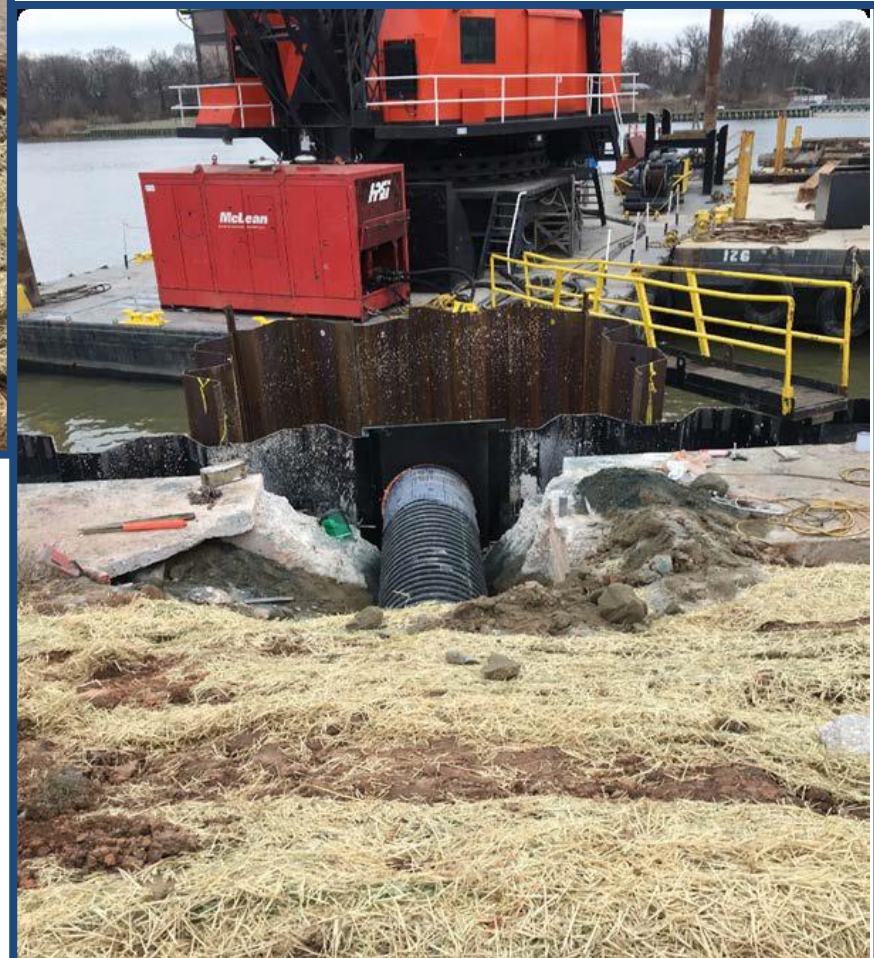
A protective cofferdam was set up outside the area where a new outfall was being installed.

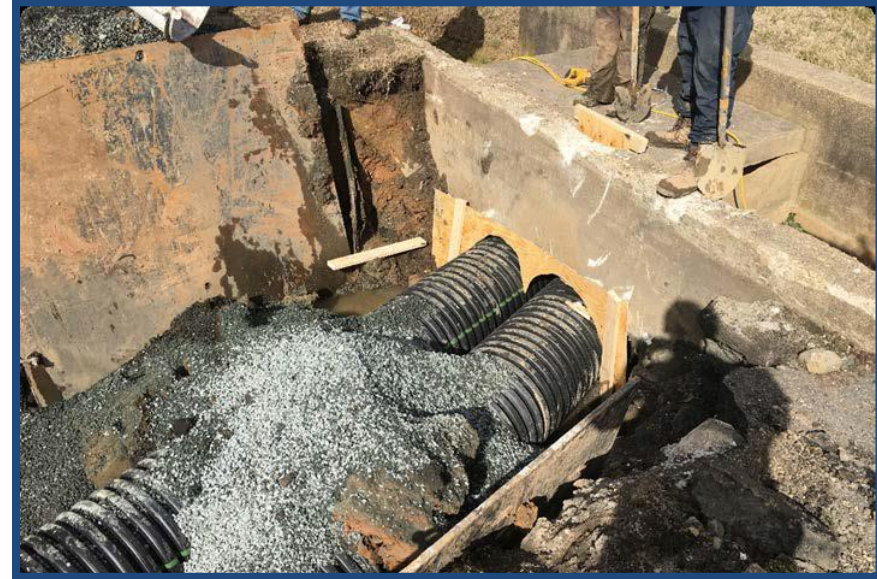
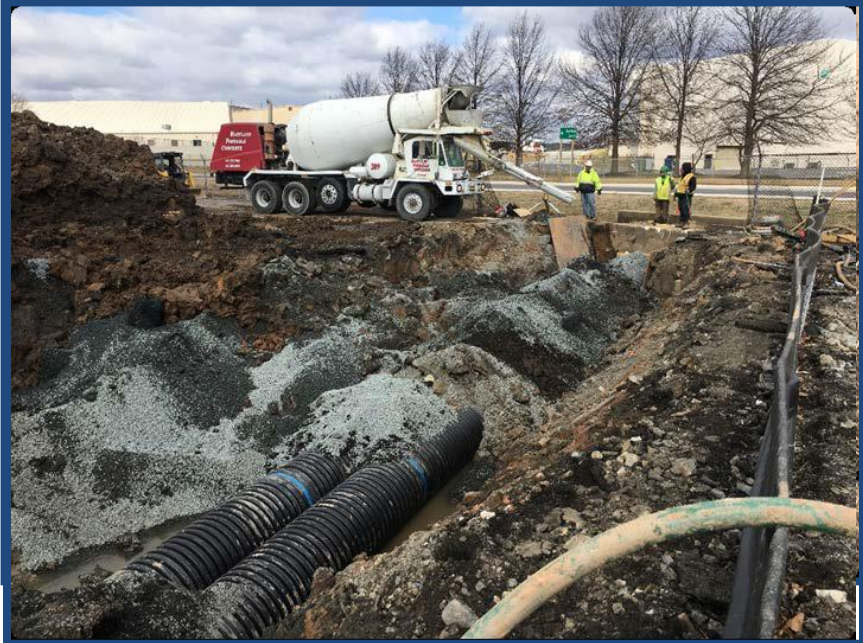
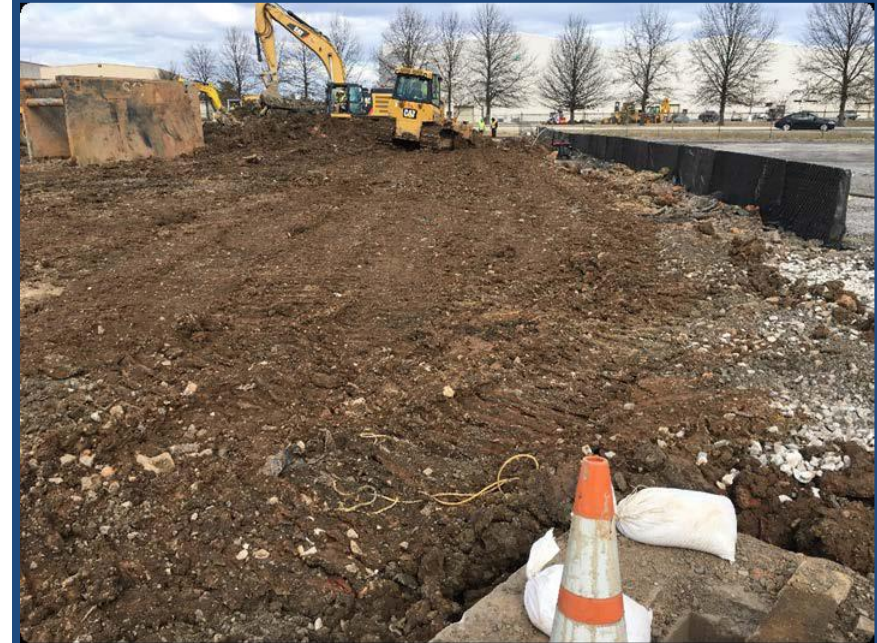
At Outfall 009 a new bed was laid, new pipes installed then covered with concrete followed by dirt, and the top surface was graded.

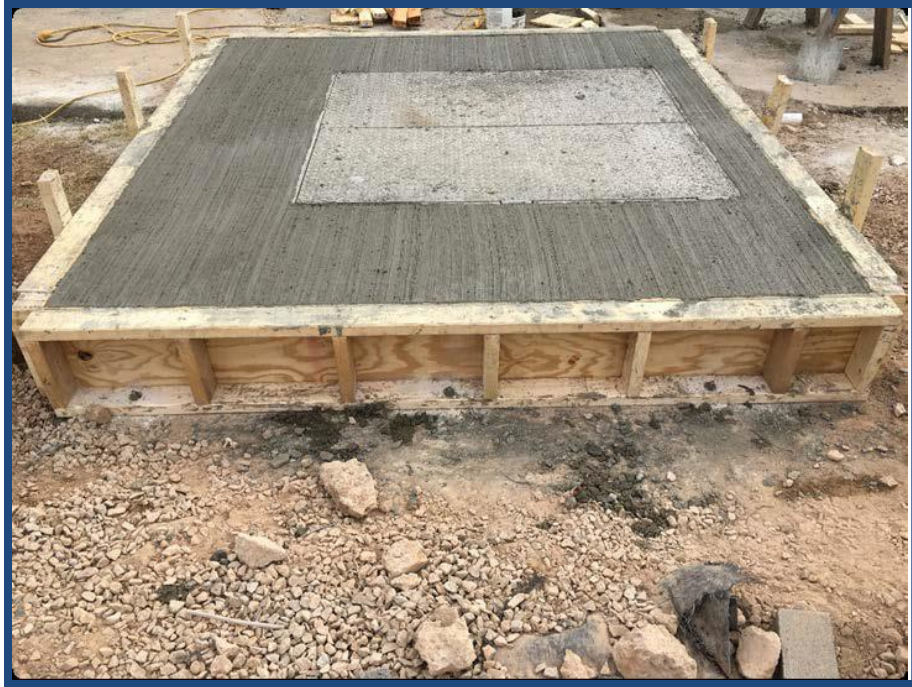
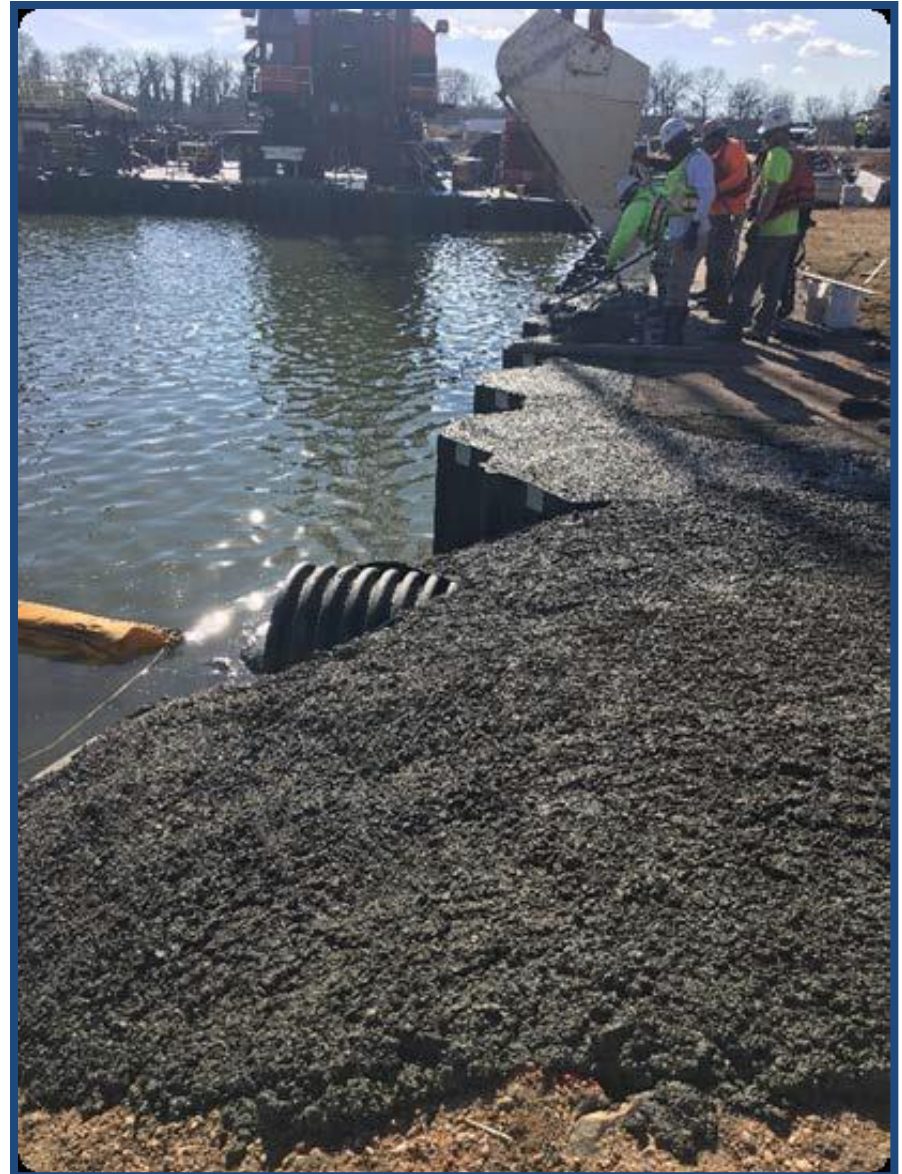
Another outfall (007) needed a culvert hatch box installed.

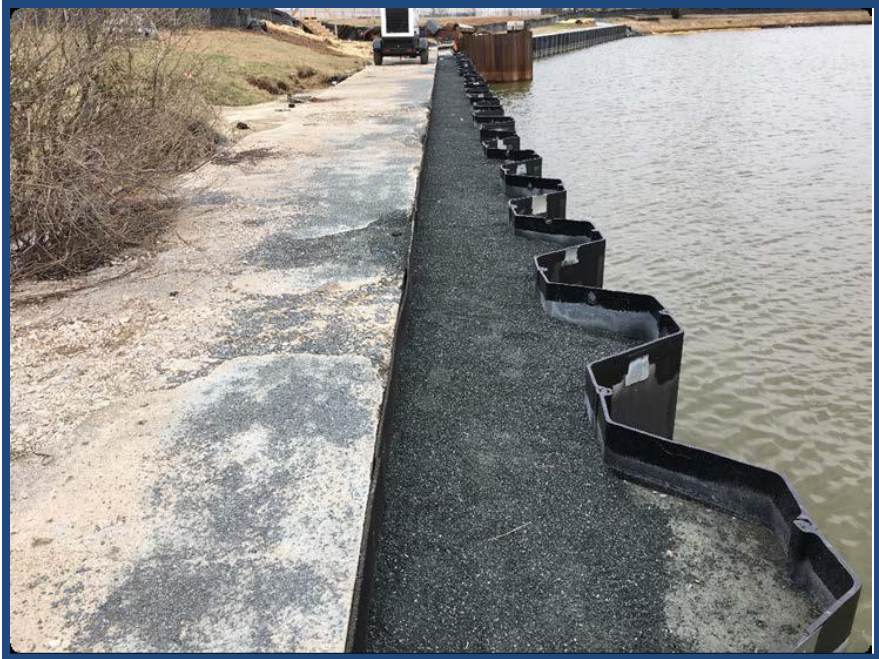
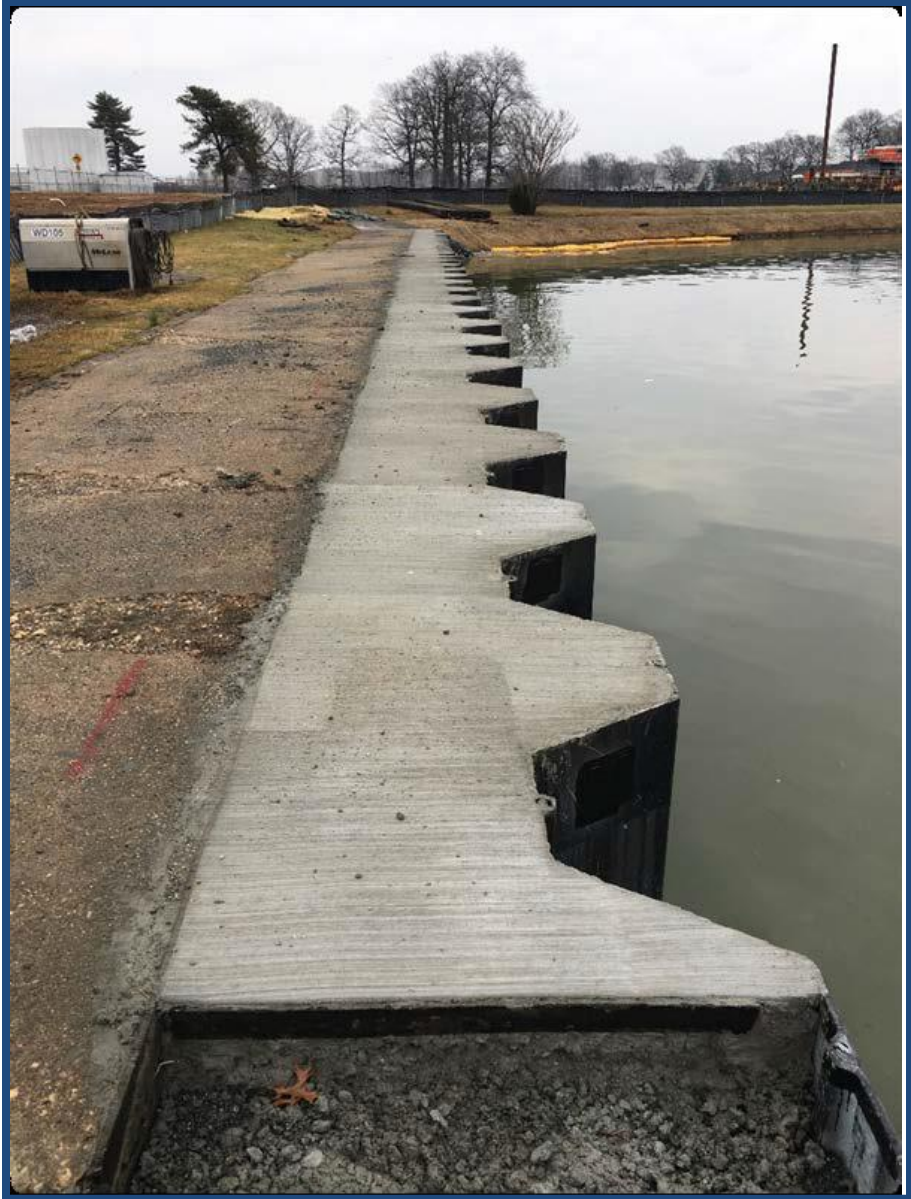
Bulkhead work was almost completed; however, some work remained beyond completion of the Season 1 sediment work.
