Sediment Removal at Outfall 005 in Dark Head Cove - 2014-2015

Project Photo Tour

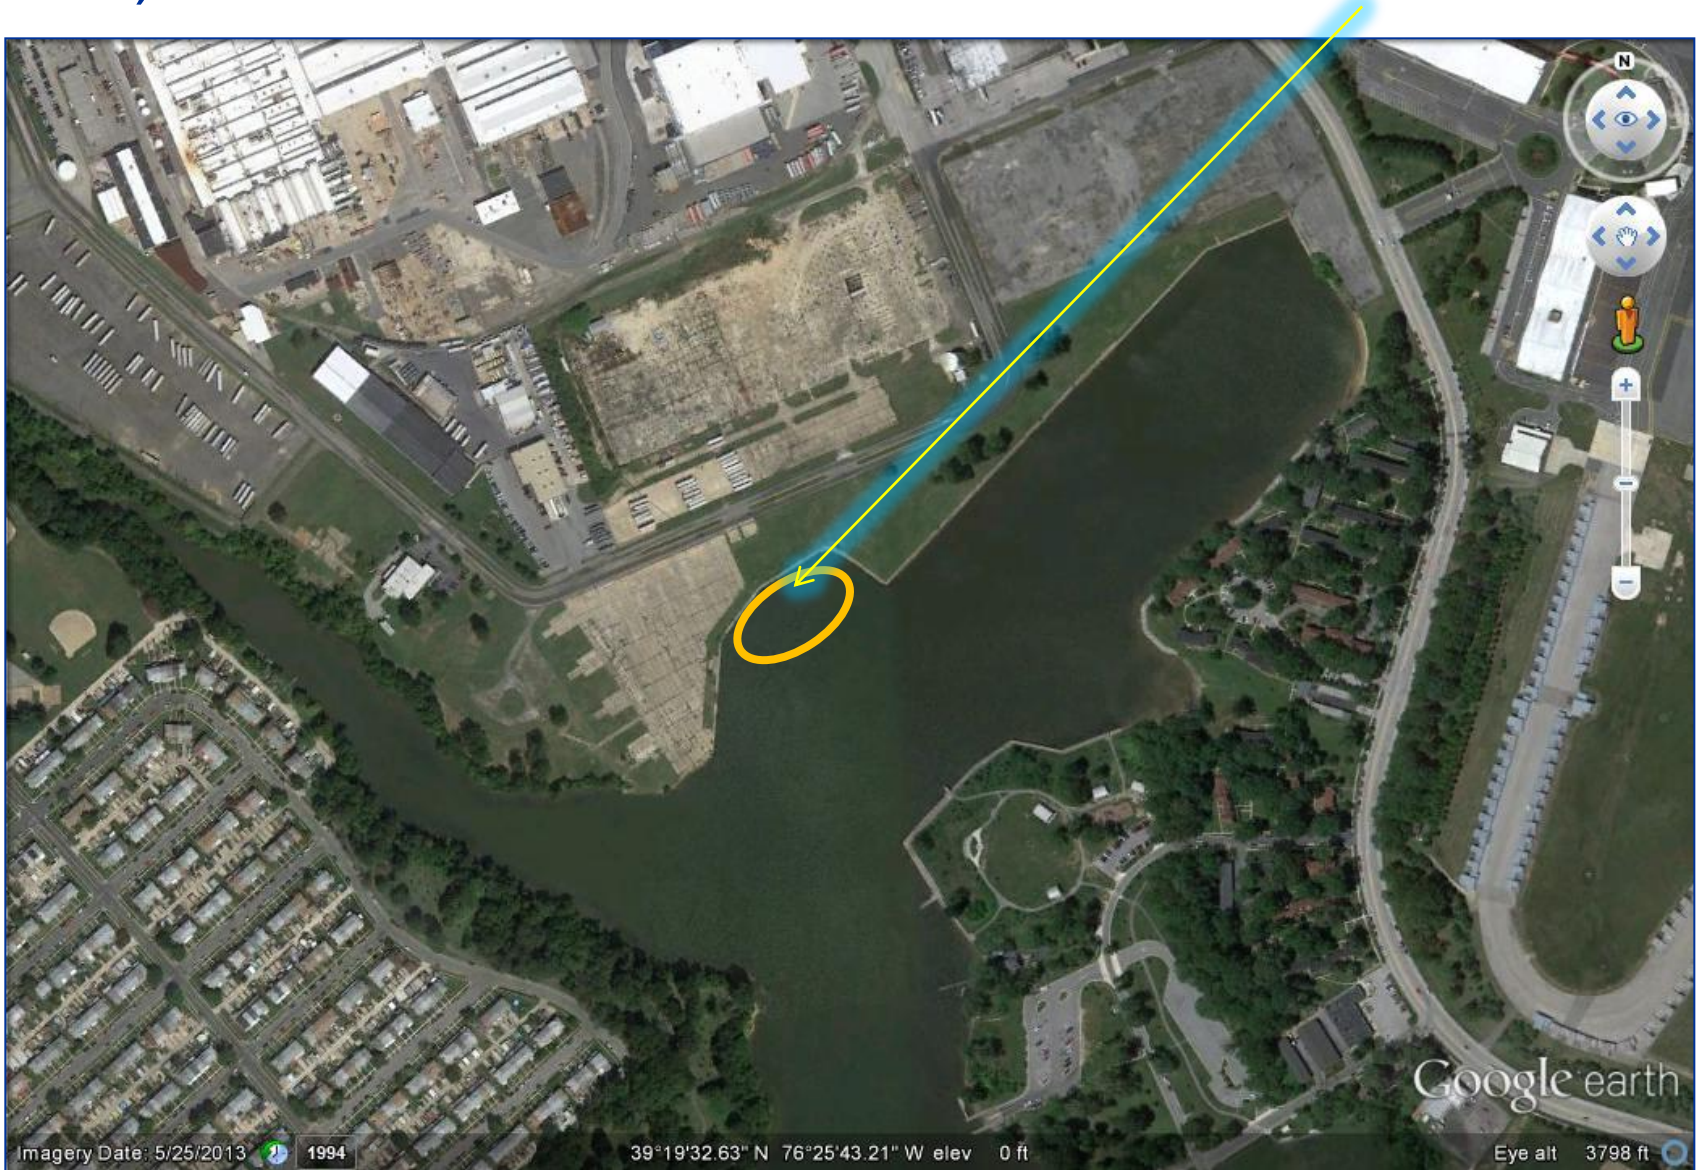
Location where Higher Polychlorinated Biphenyls (PCB) Concentrations were found near Outfall 005.

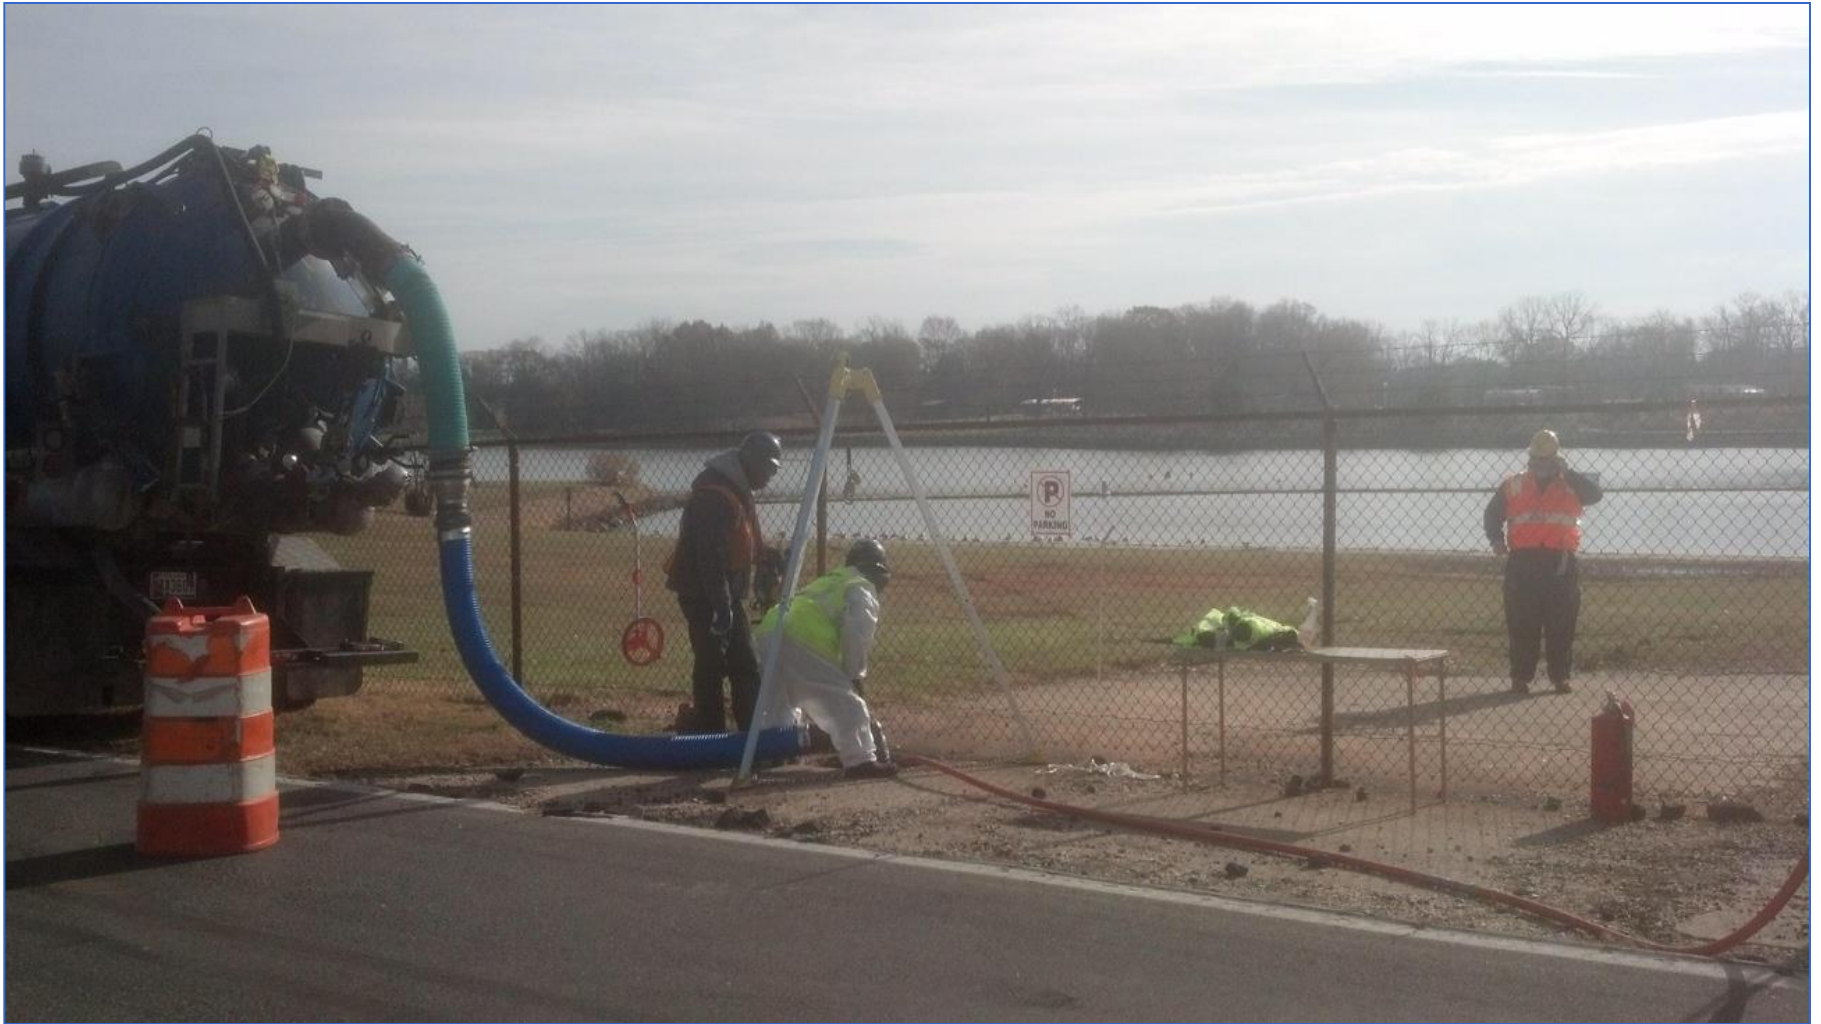
First, storm drain lines leading to the cove were cleaned out: outfalls were plugged, lines were pressure washed and then vacuumed.

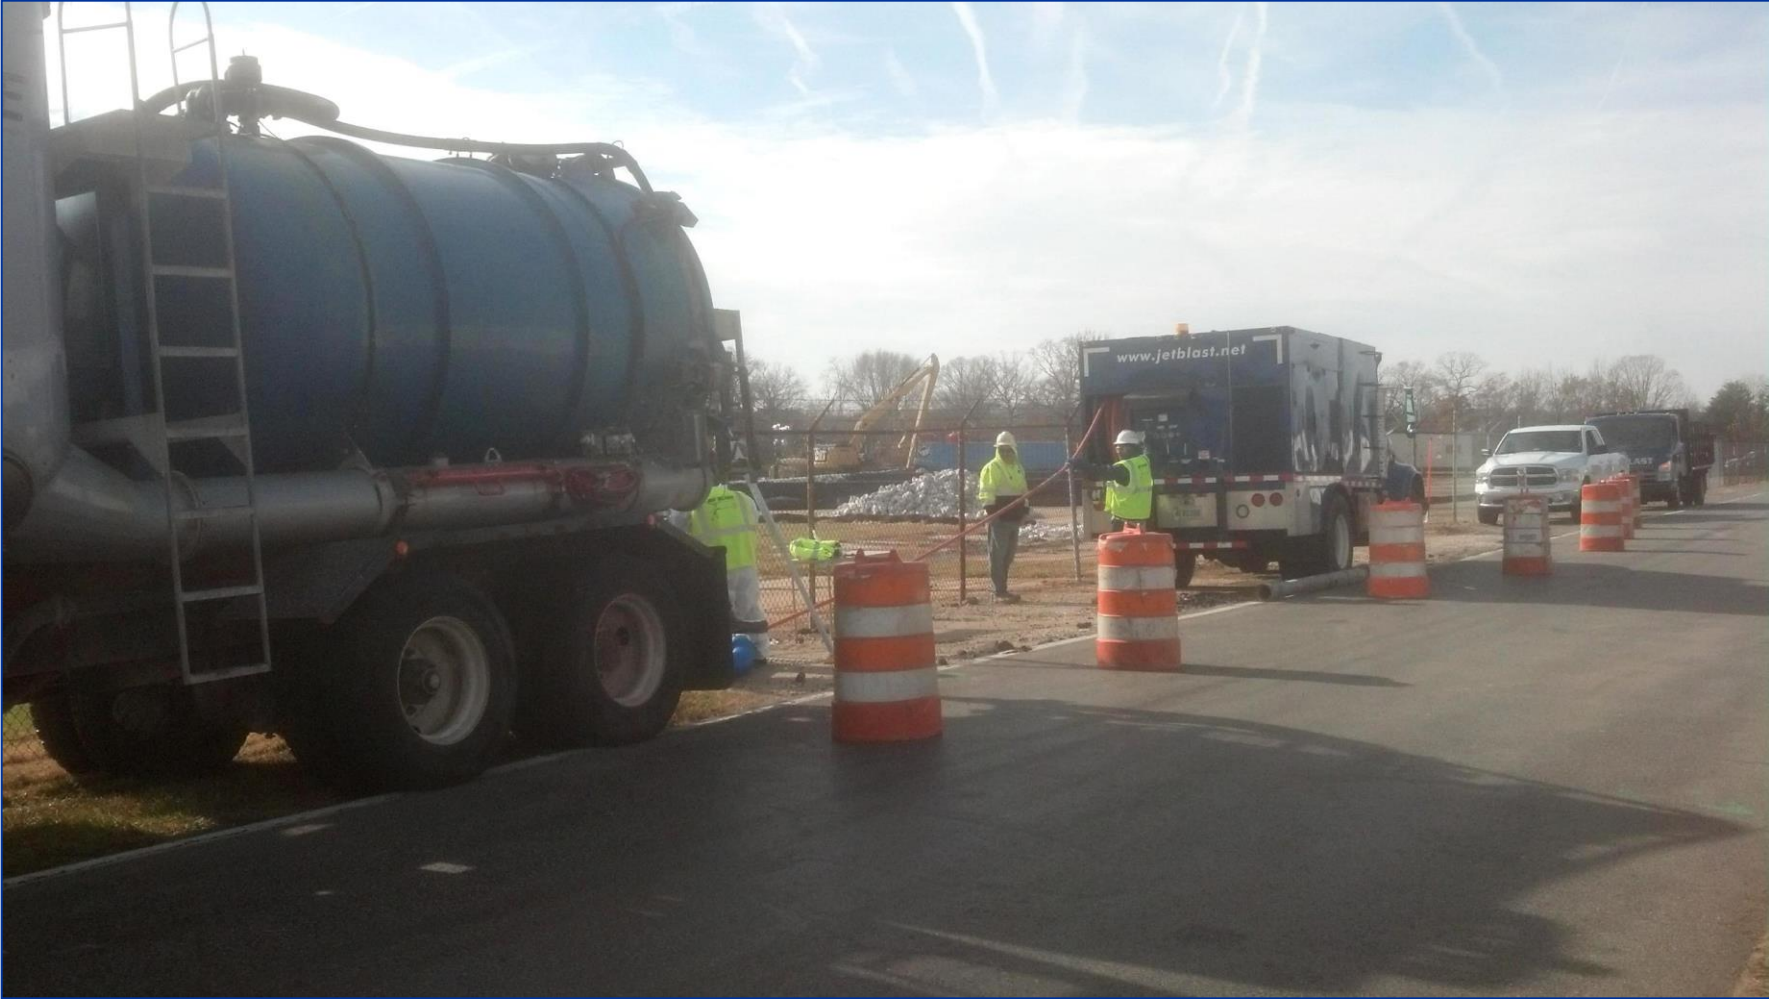
Materials from storm drains were vacuumed into trucks and transported offsite for proper disposal.

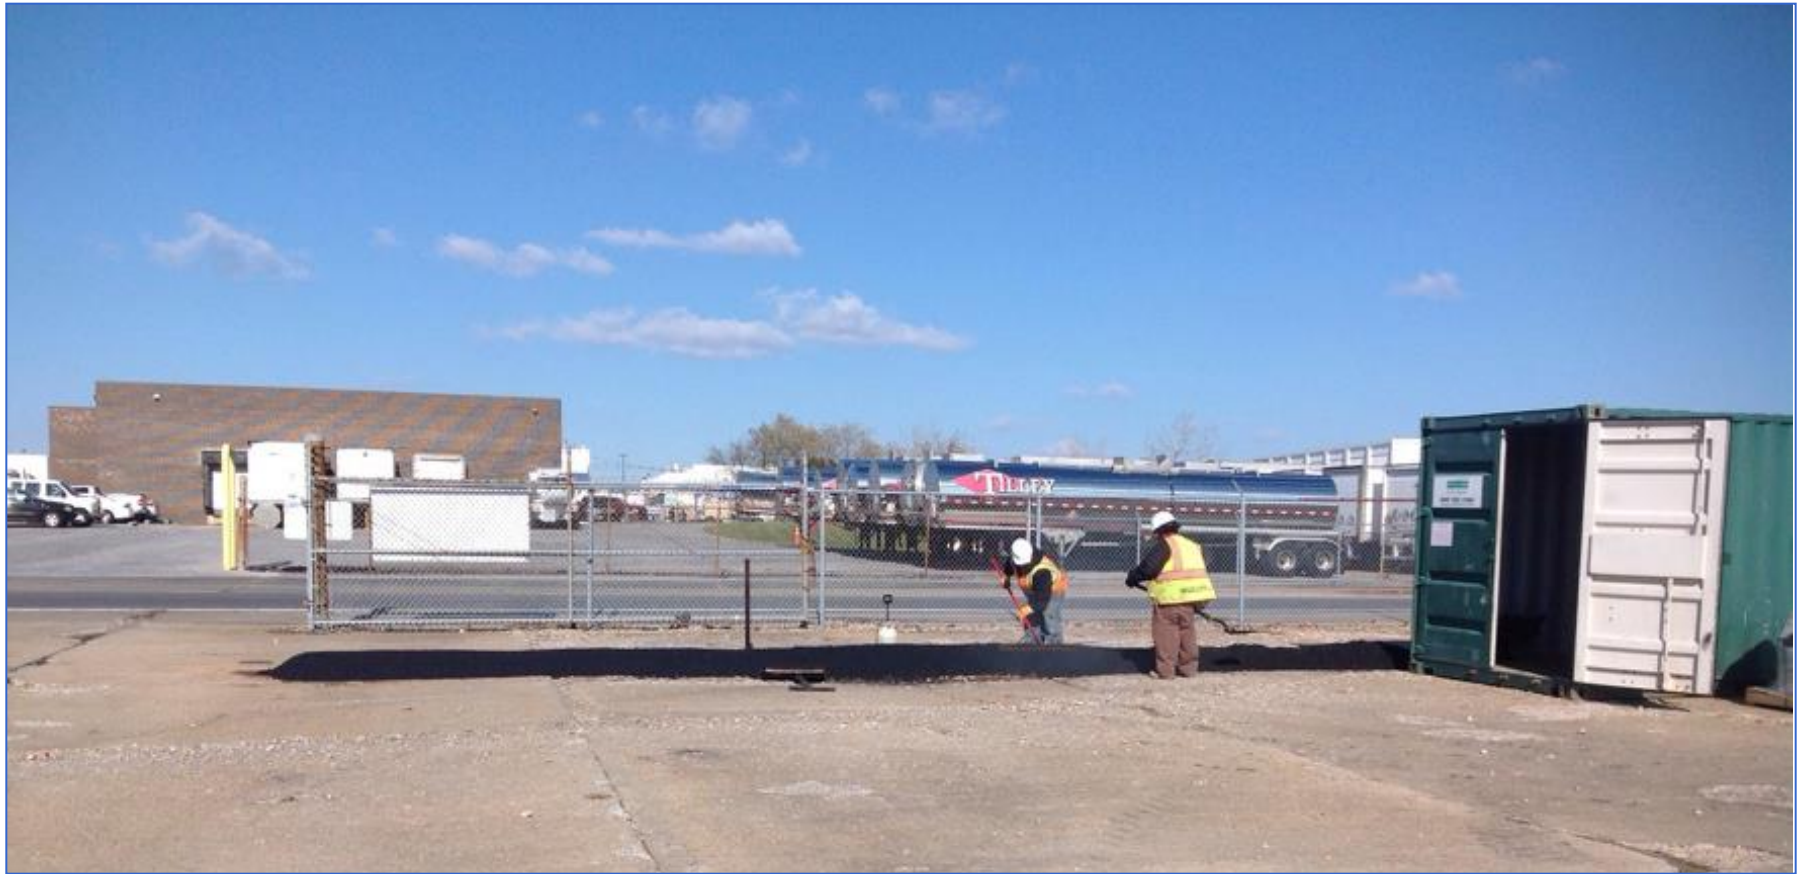
Temporary asphalt curbing was installed to create a barrier preventing sediment from leaving work areas.

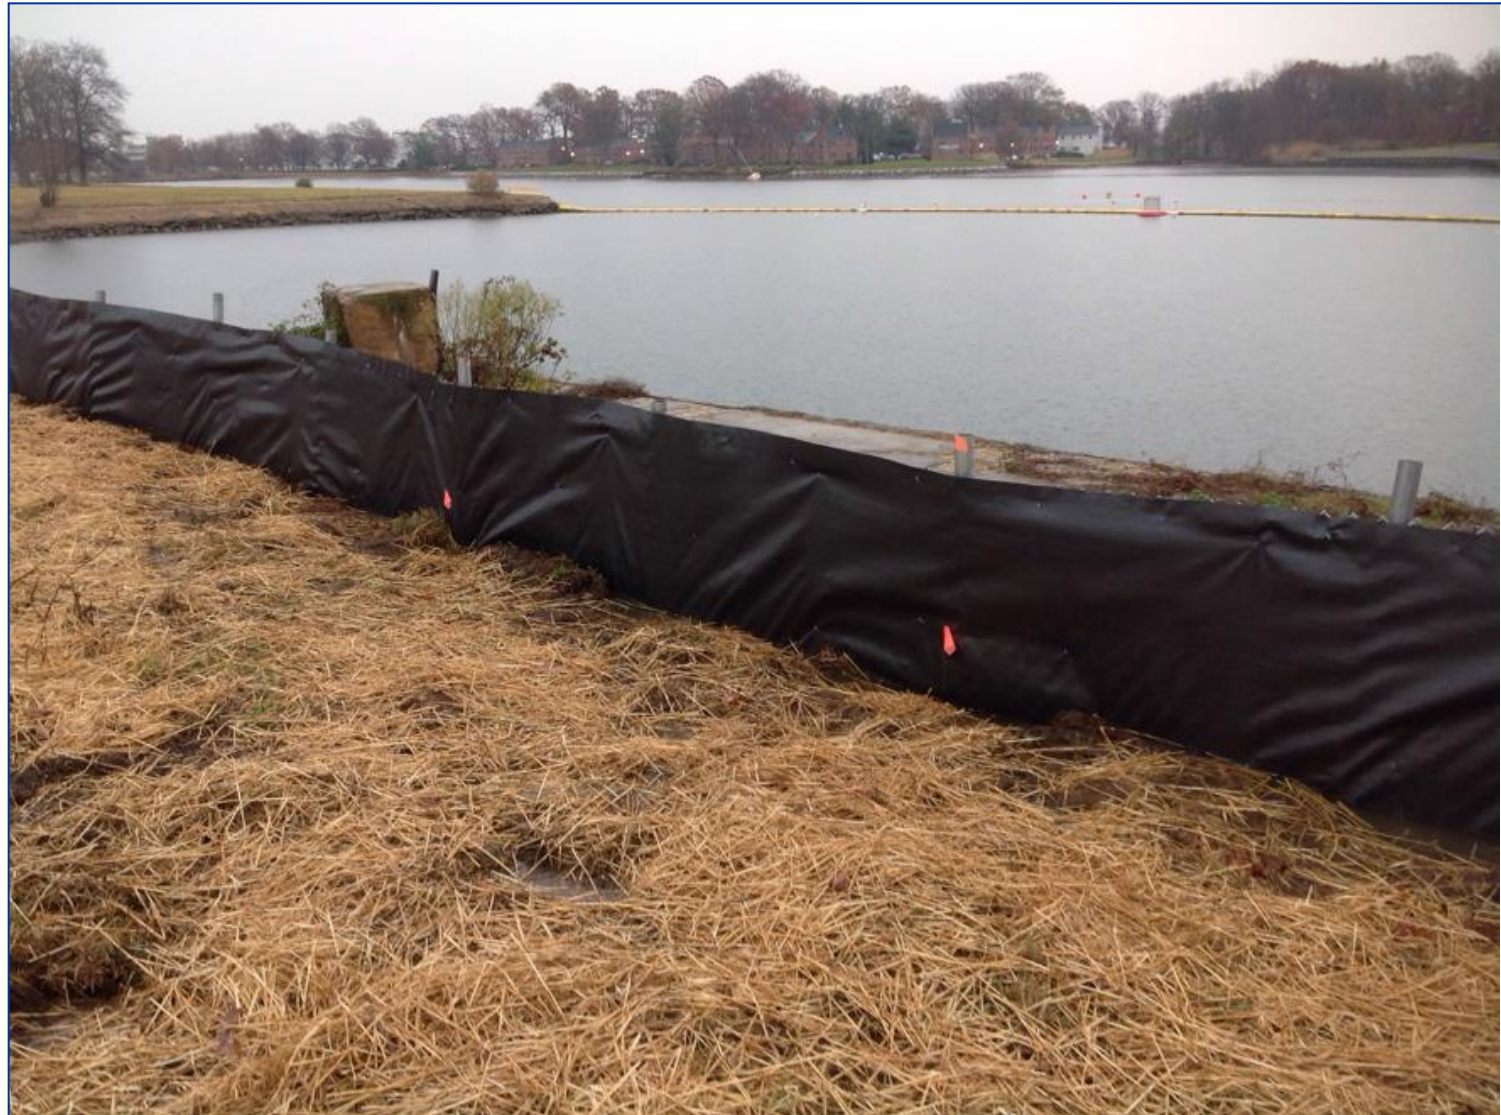
Reinforced super silt fence separated upland work areas and cove, preventing erosion and maintaining sediments upland.

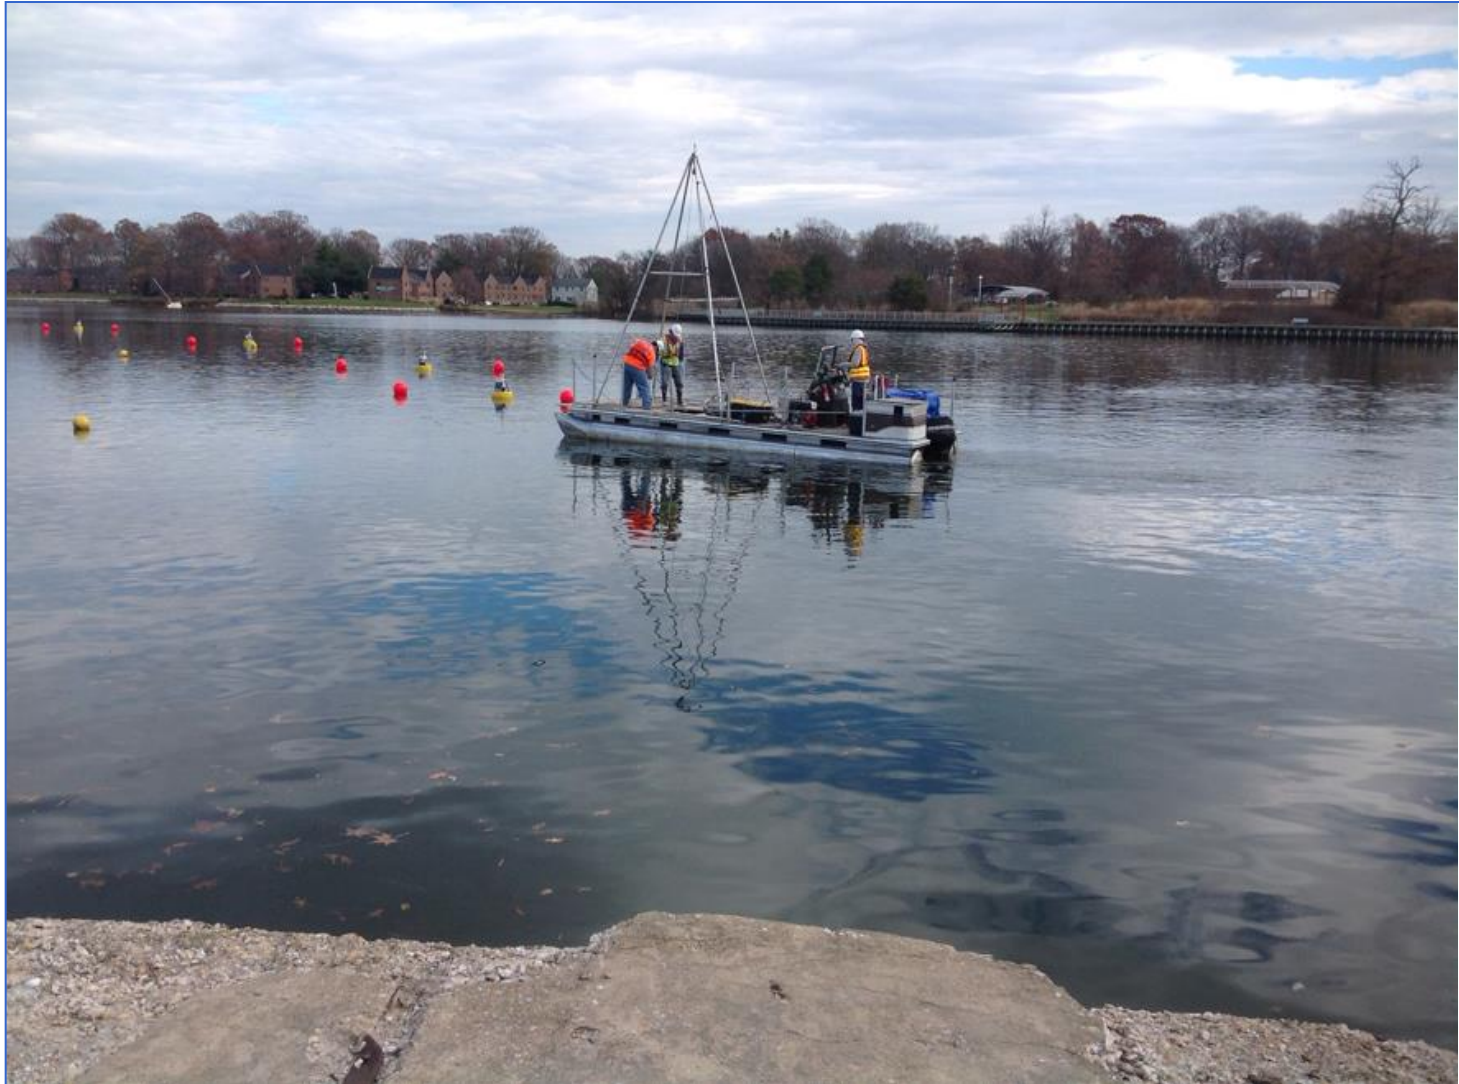
Monitoring was performed before work began to establish what the turbidity level was during "normal" conditions. After work began, the turbidity levels were monitored regularly both inside and outside the work area. This was done to assess what effects the dredge operations might create, and to confirm that water quality requirements were met.

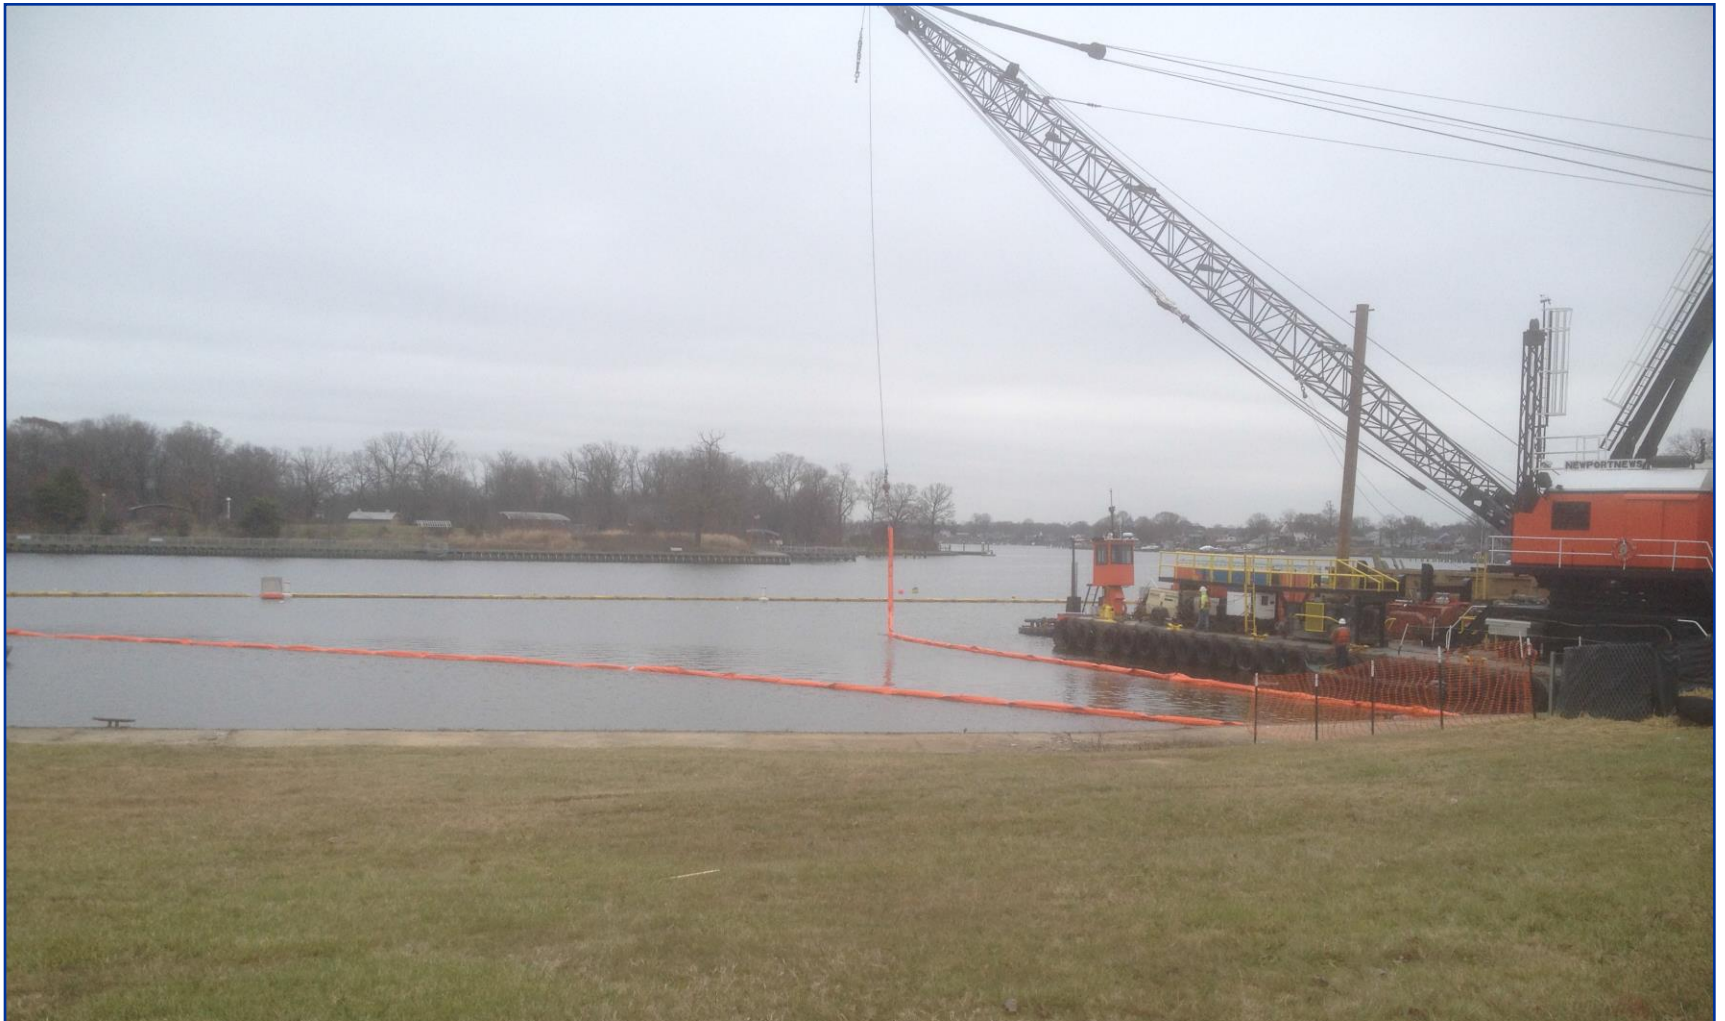
A silt curtain (interior) was placed near the dredge equipment to restrict movement of sediments during the dredging; a second, exterior curtain further restricted silt from leaving the work area; as needed, a third, interior curtain was used.

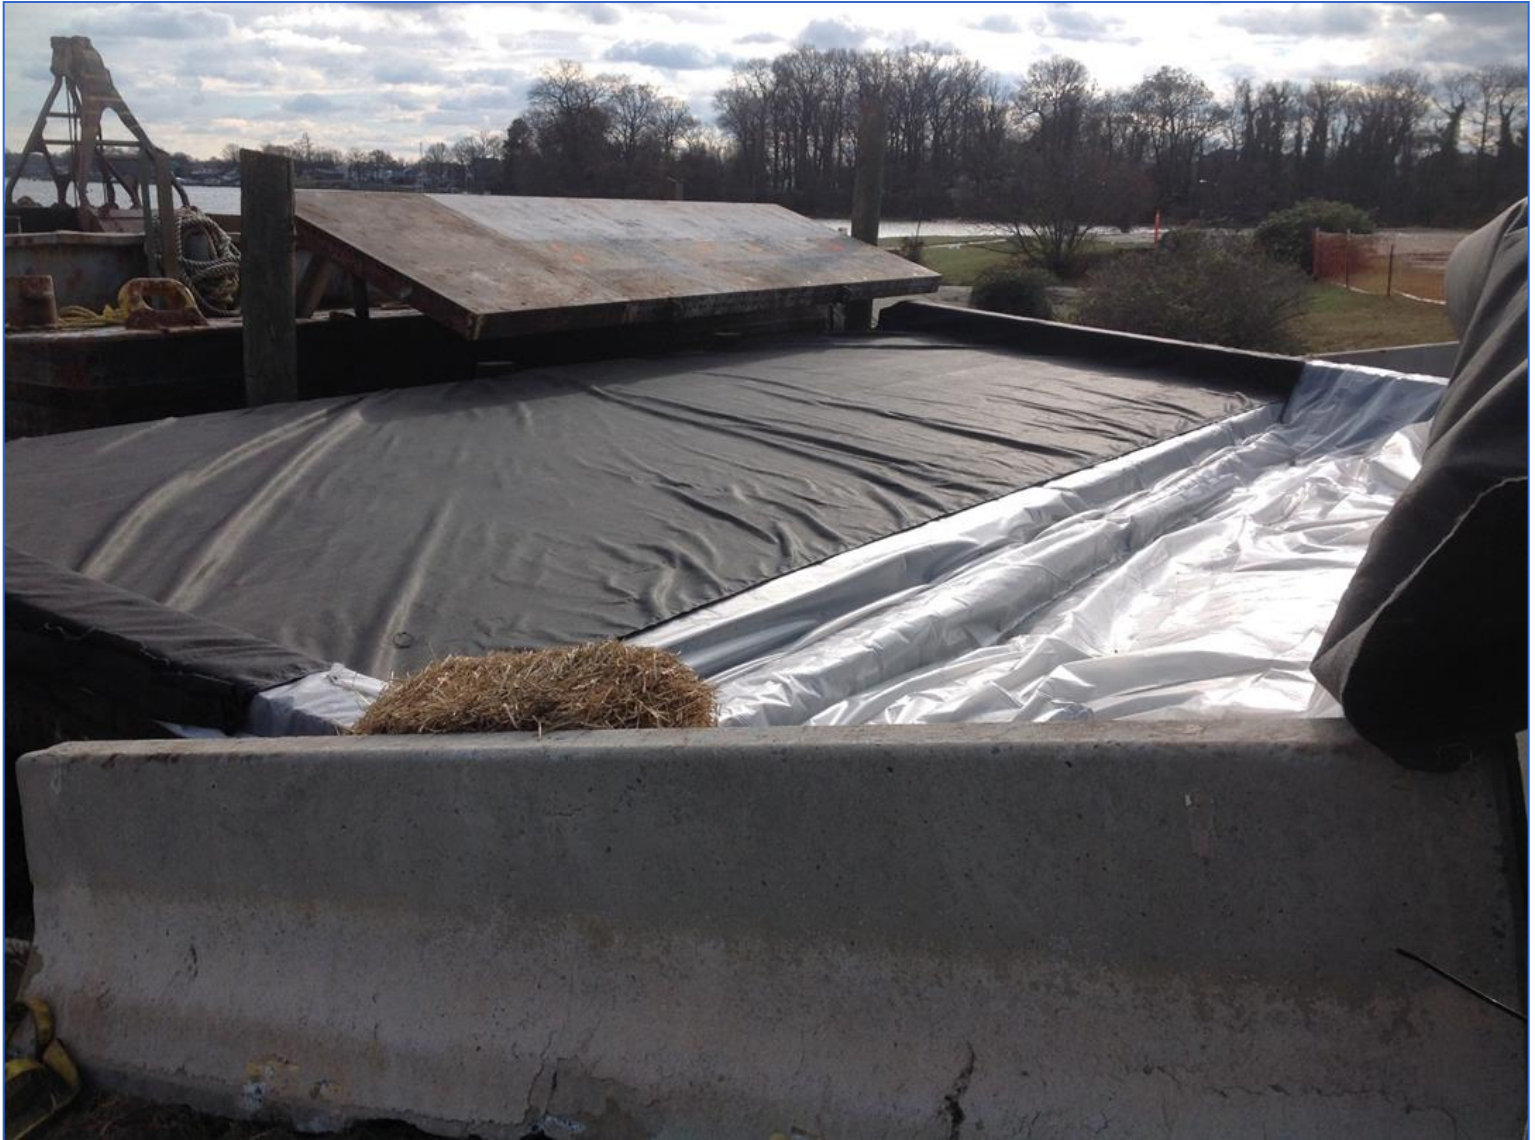
A lined spill apron was installed to capture any spillage of sediments that might occur when sediments were moved from the dredge barge to dump trucks, which then carried the sediments to the dewatering pads. Spillage and eventually the liner were properly disposed in a permitted landfill.

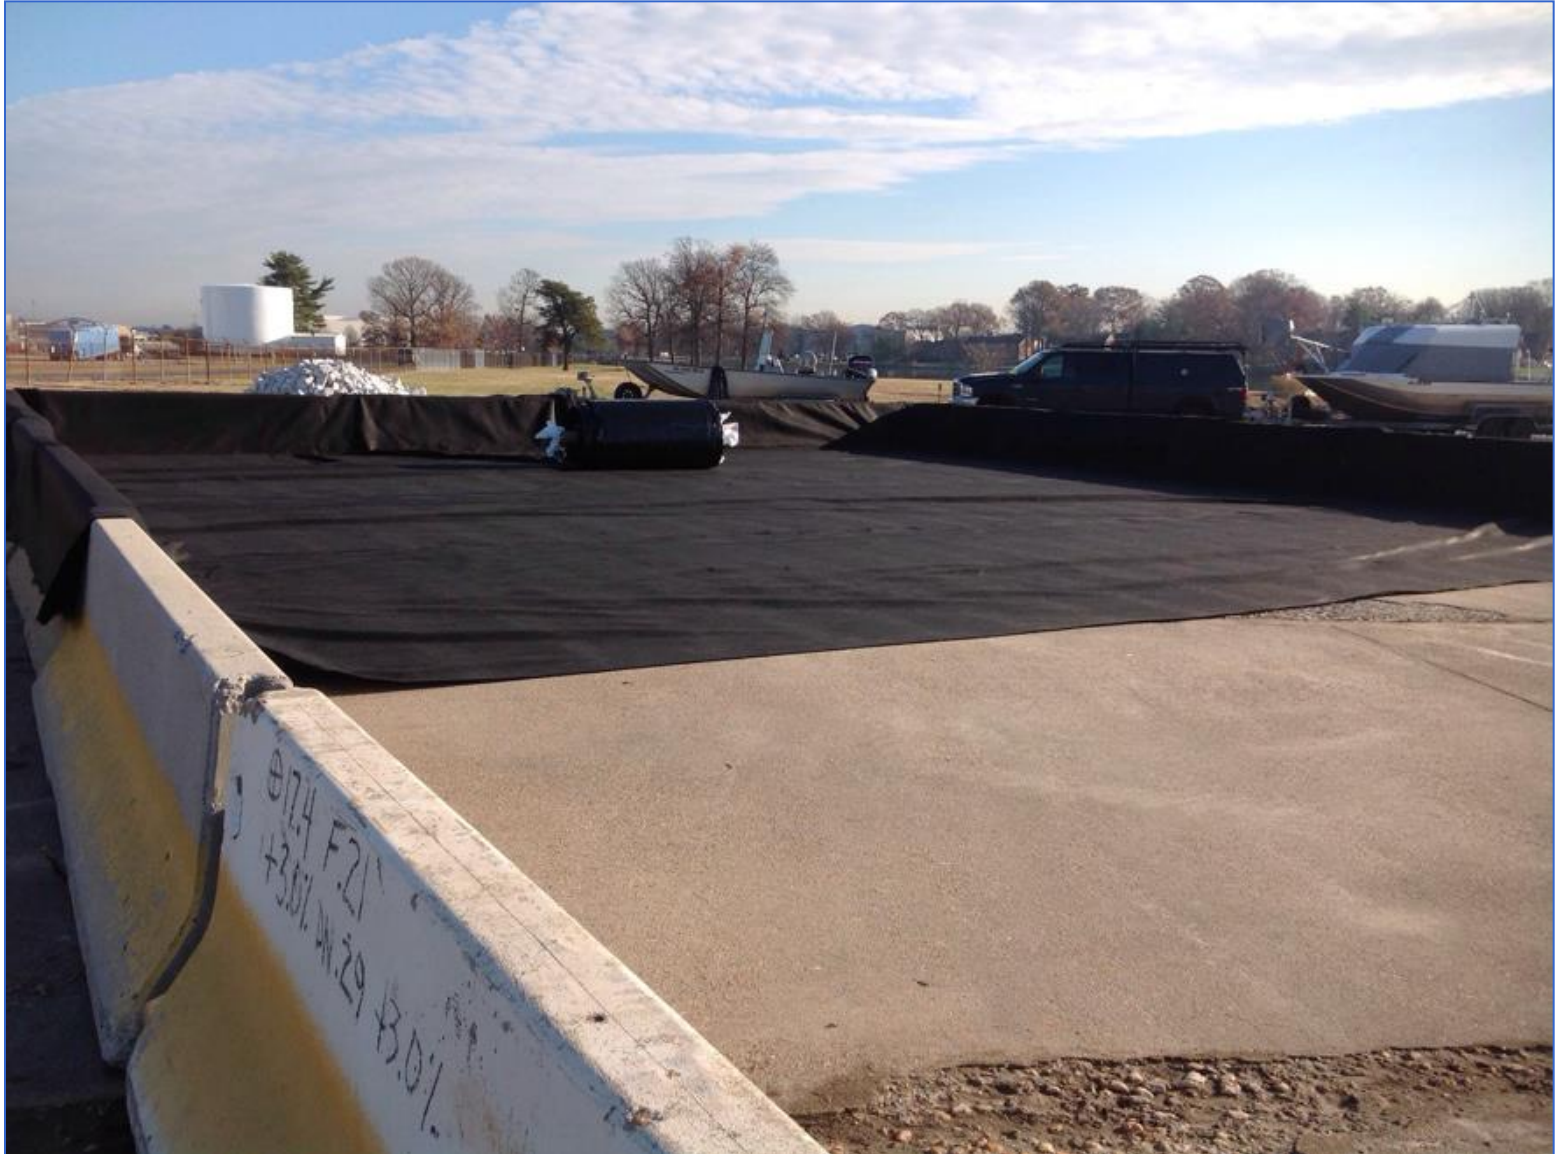
A thick plastic liner was installed as part of the sediment dewatering pad.

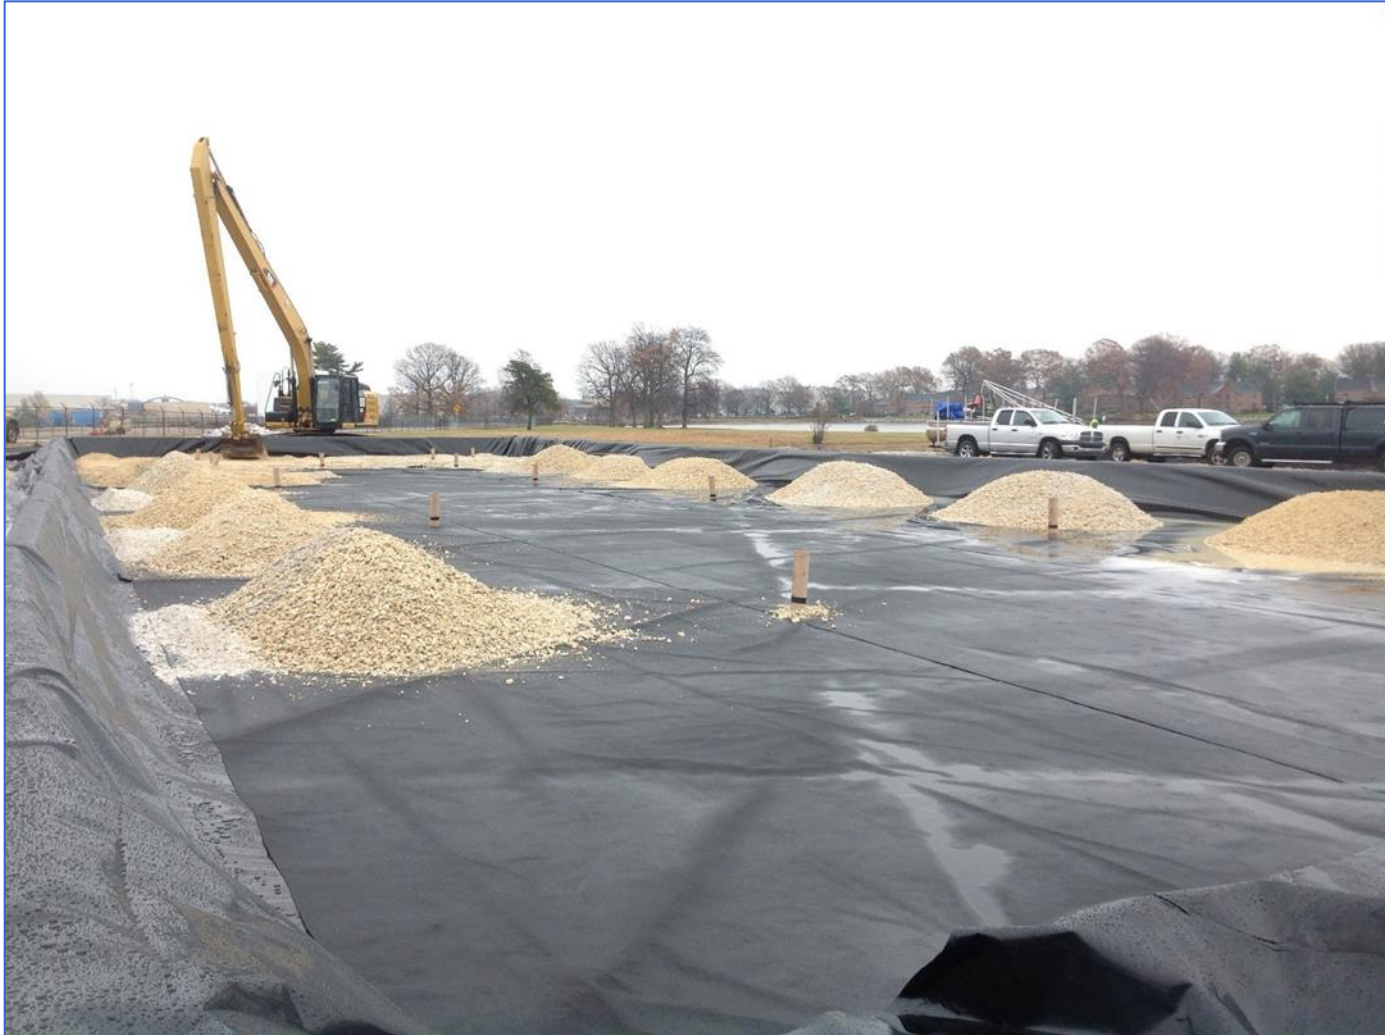
Rock was added on top of the sediment dewatering pad. Water separated out of the sediment and percolated through the rock, then was collected and pumped out for treatment. A smaller amount of water was collected than had been expected.

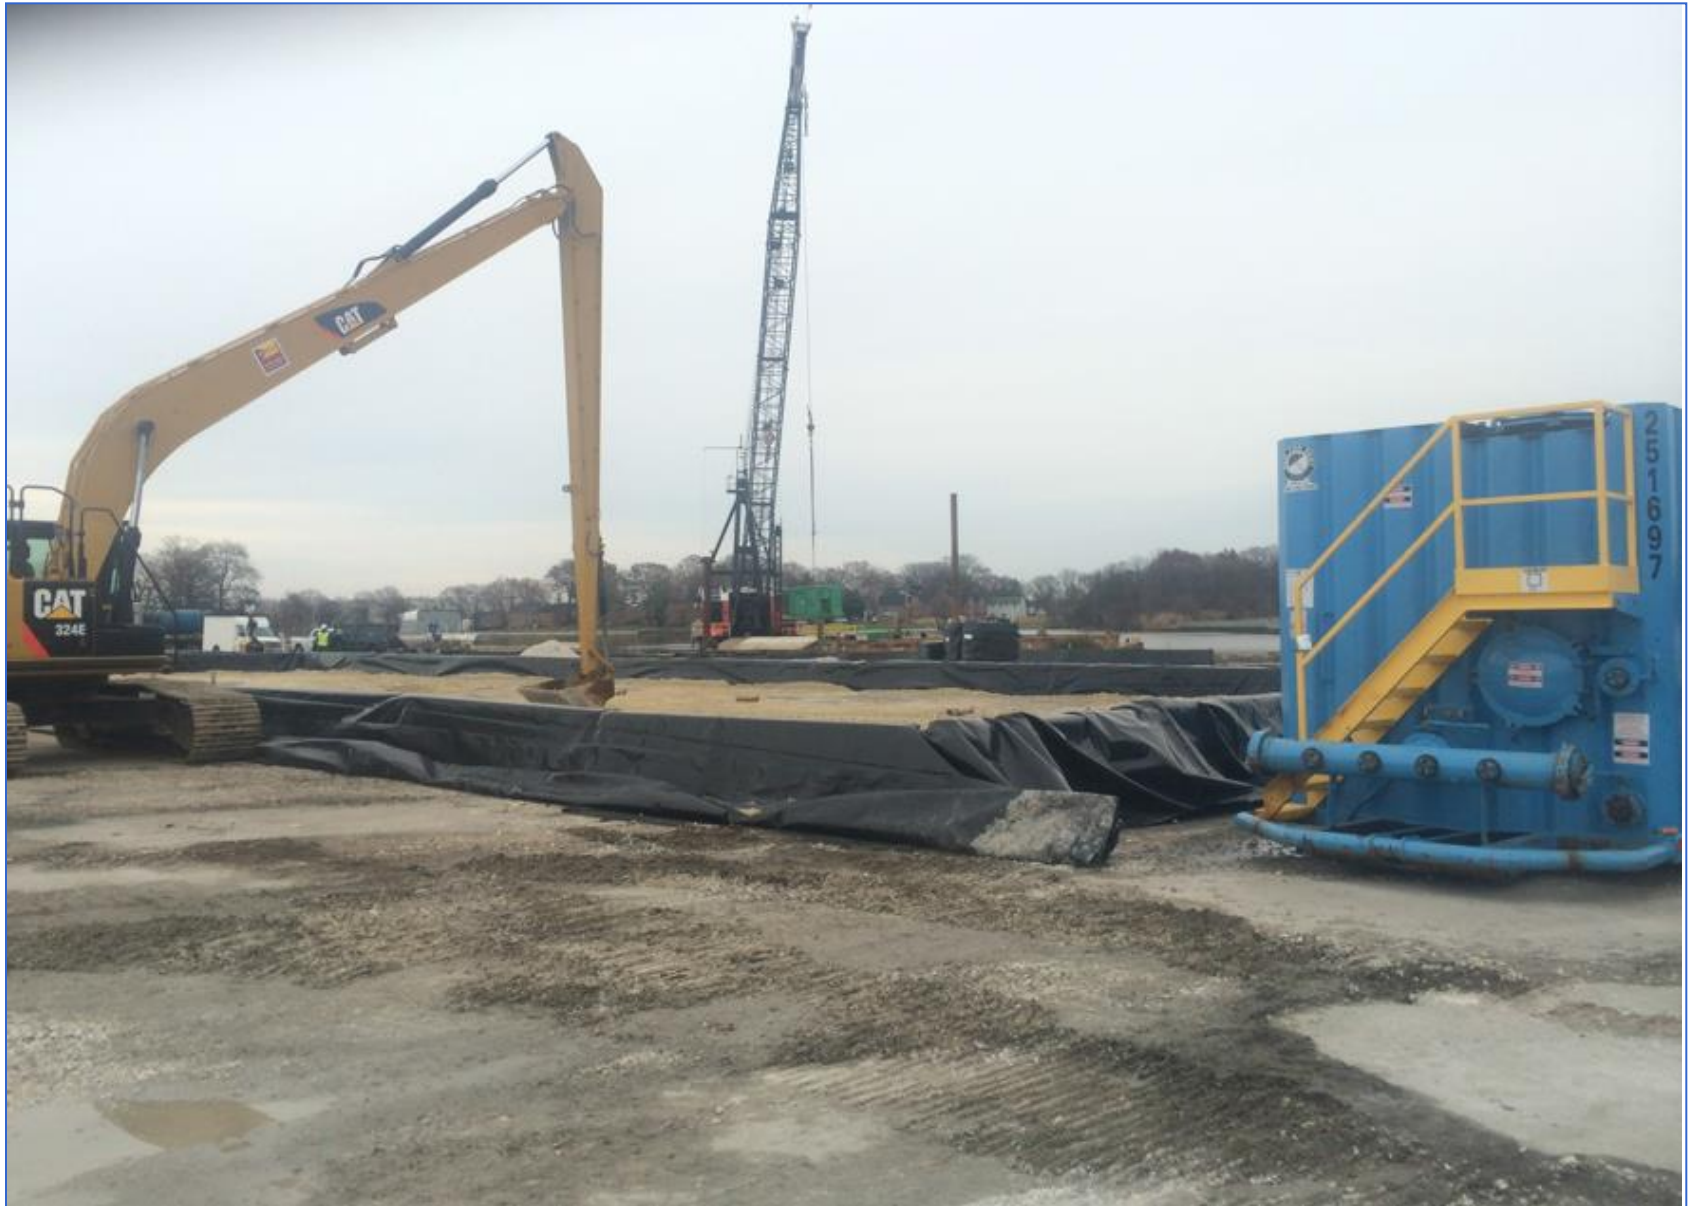
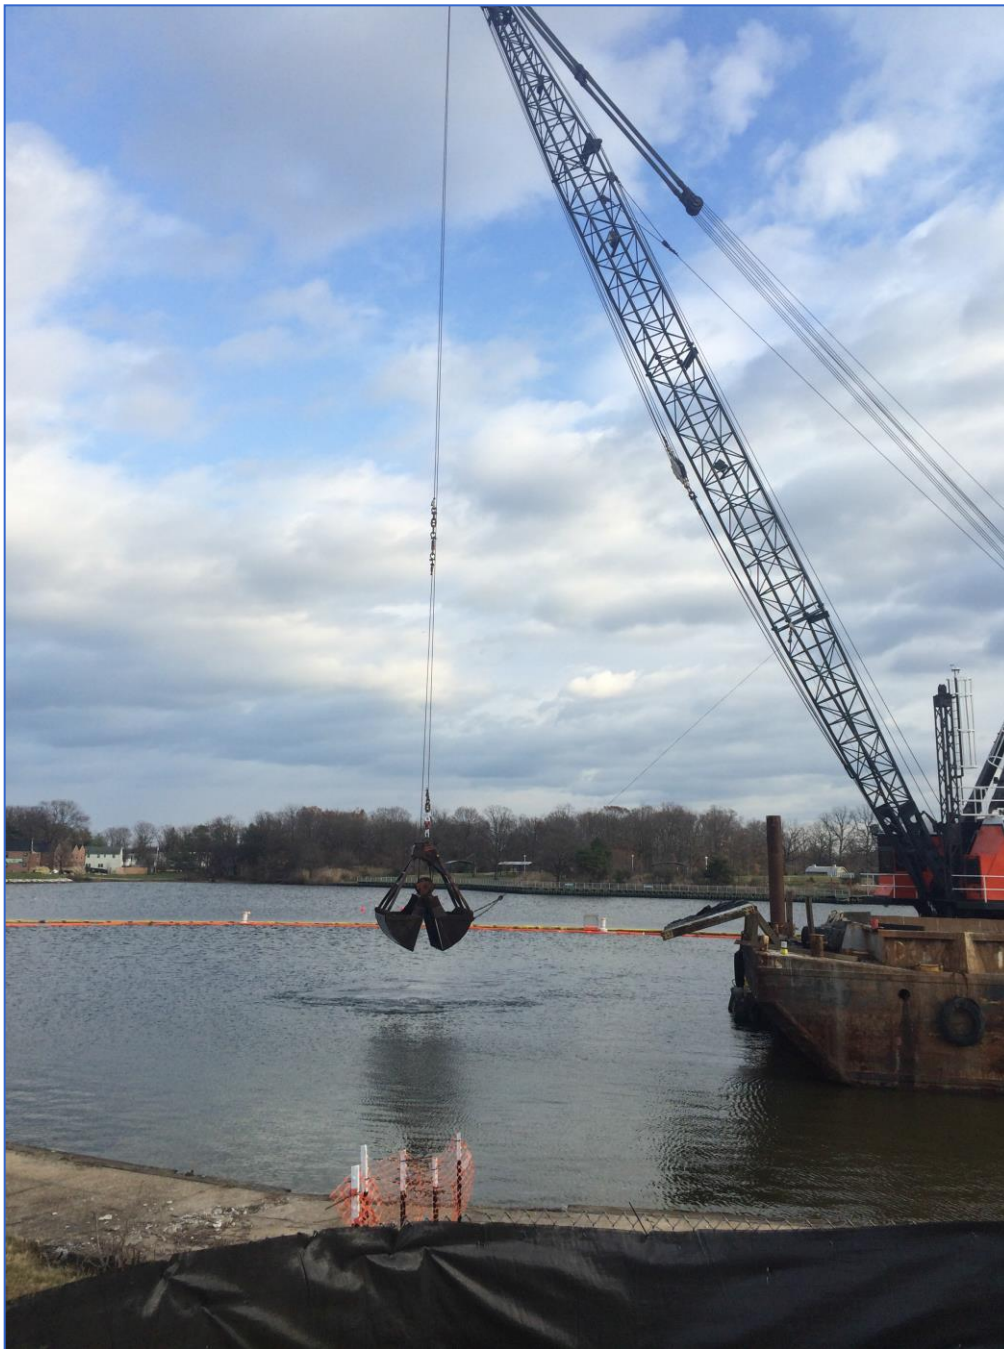
Constructing sediment dewatering pad.

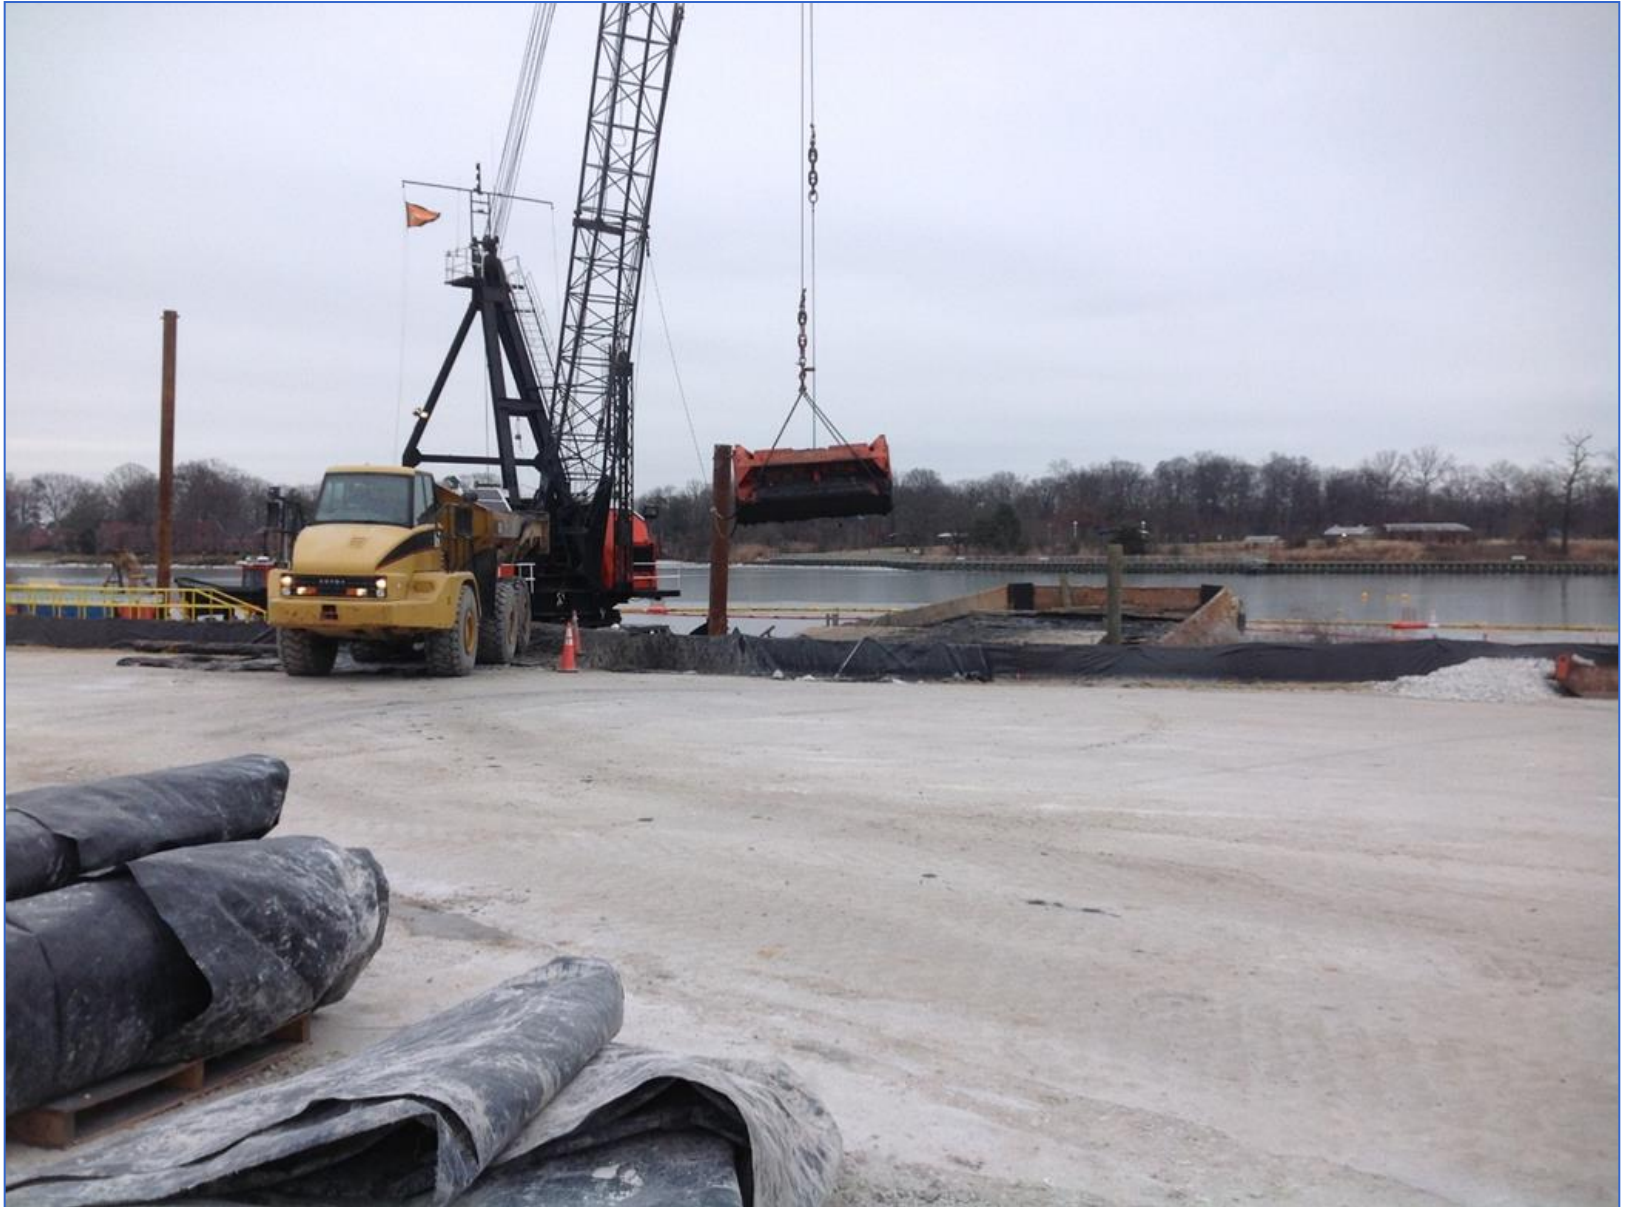
Transferring sediment from barge to dump truck.
