Sediment Removal at Outfall 005 in Dark Head Cove - 2014-2015

Project Photo Tour

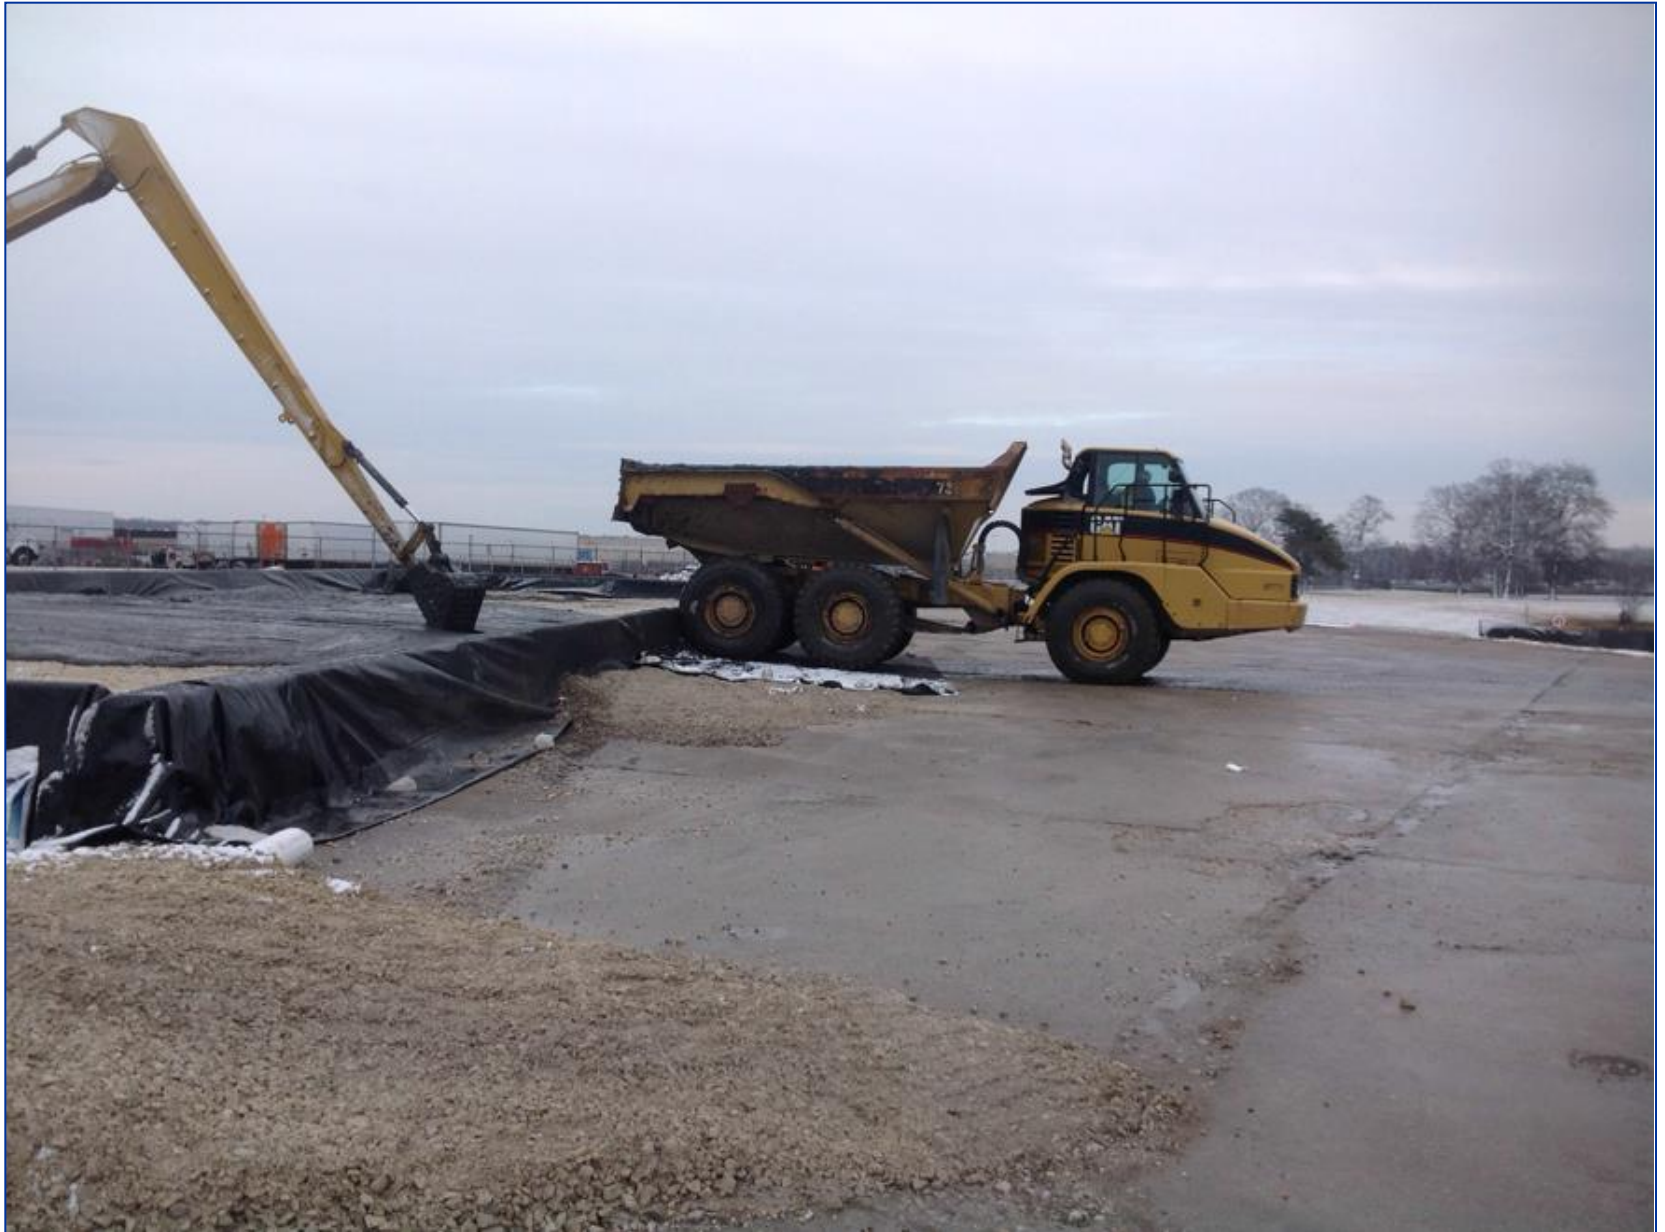
Transferring sediment from dump truck to dewatering pad.

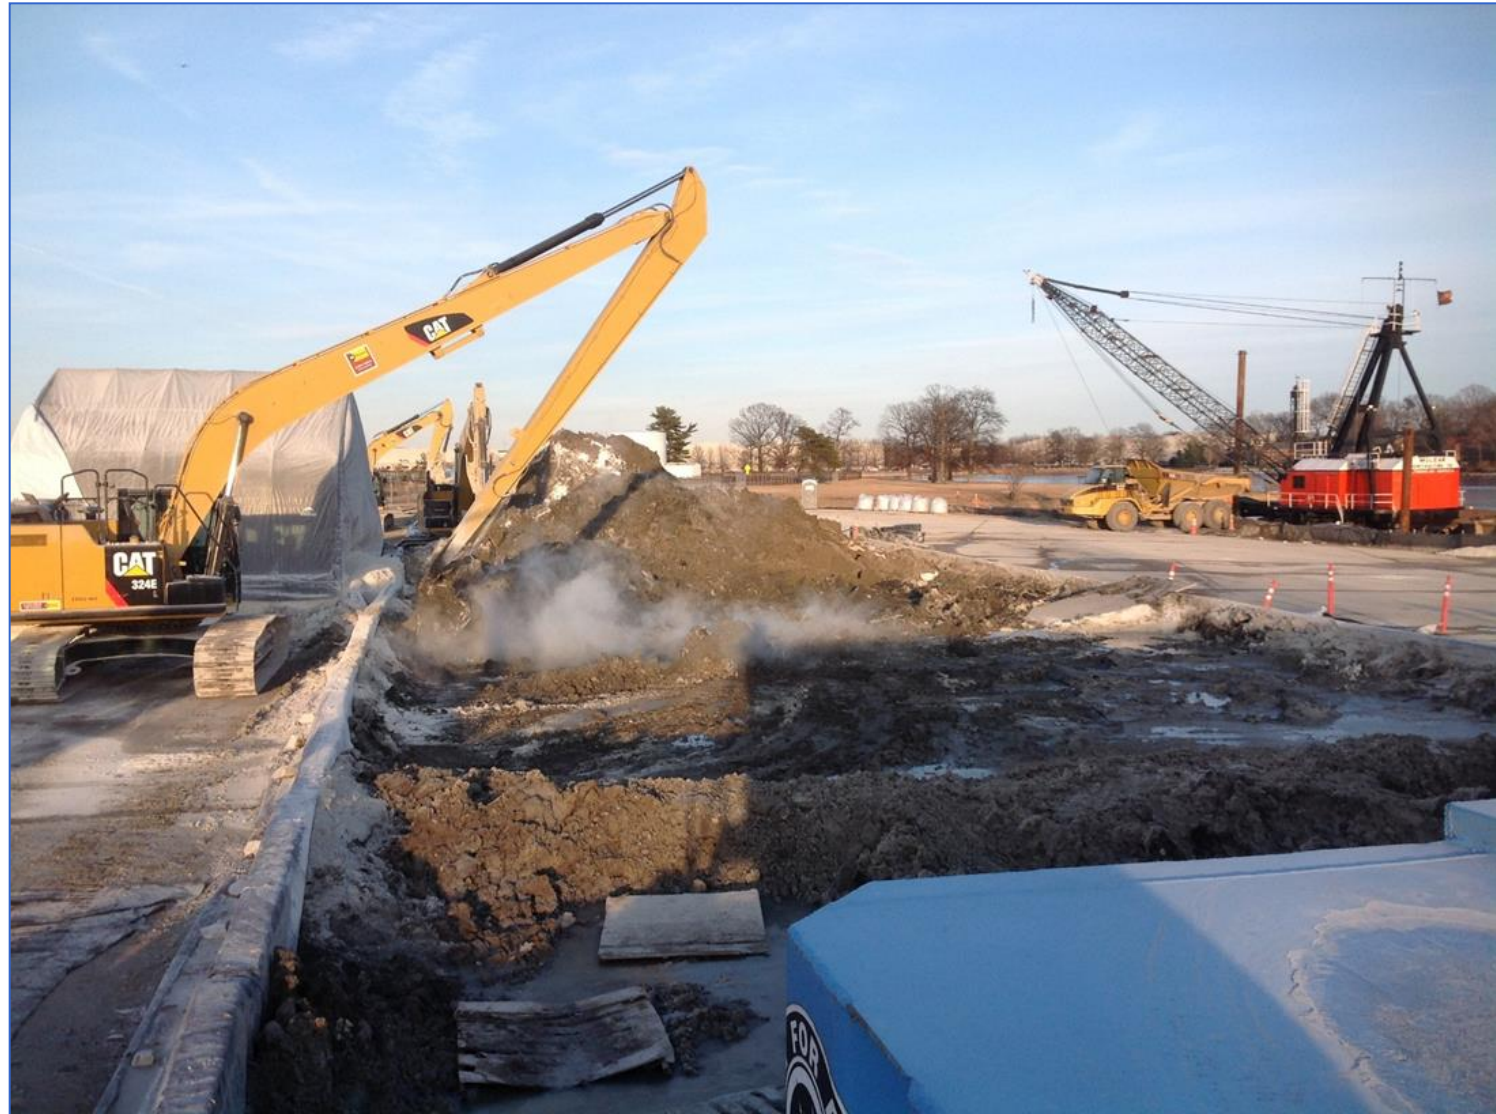
Sediment was mixed with Calciment and Quicklime in the dewatering pad. These additives reduced the moisture, and provided strength and body to the sediment, allowing it to be safely transported and properly disposed in a licensed landfill.

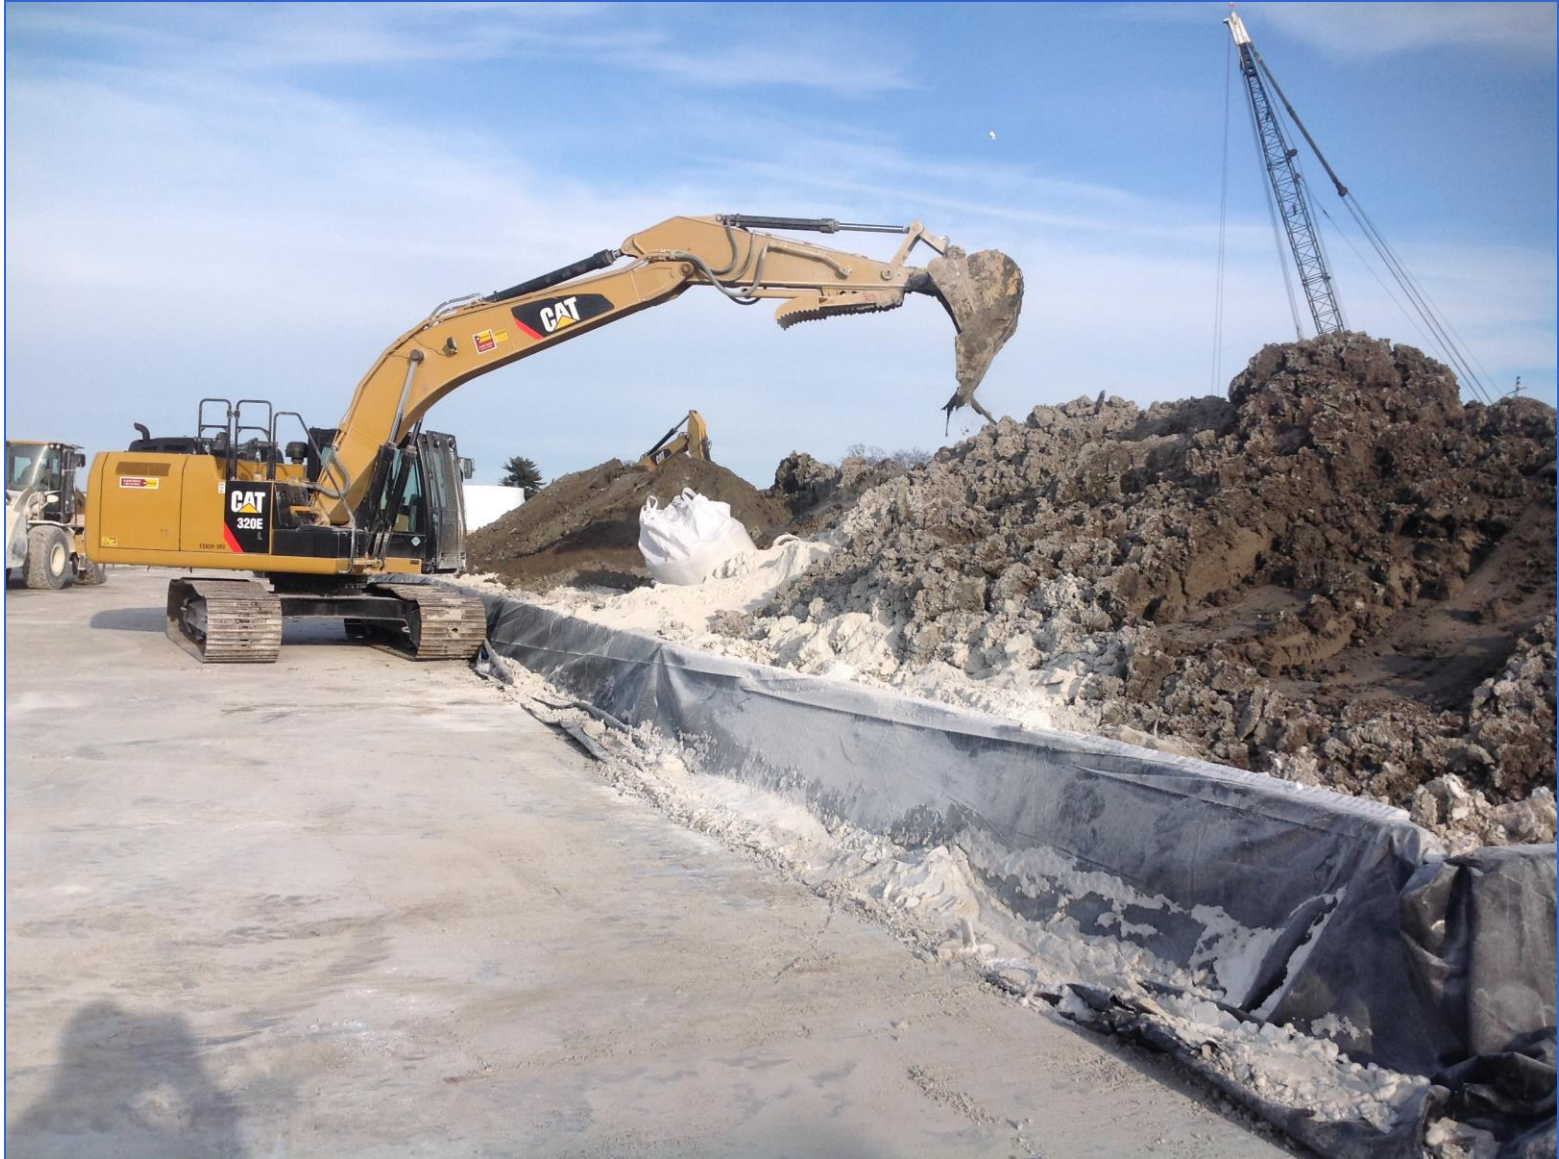
Portland cement amendment, loaded in a super sack, was added to provide strength and body to the sediment in preparation for proper landfill disposal.

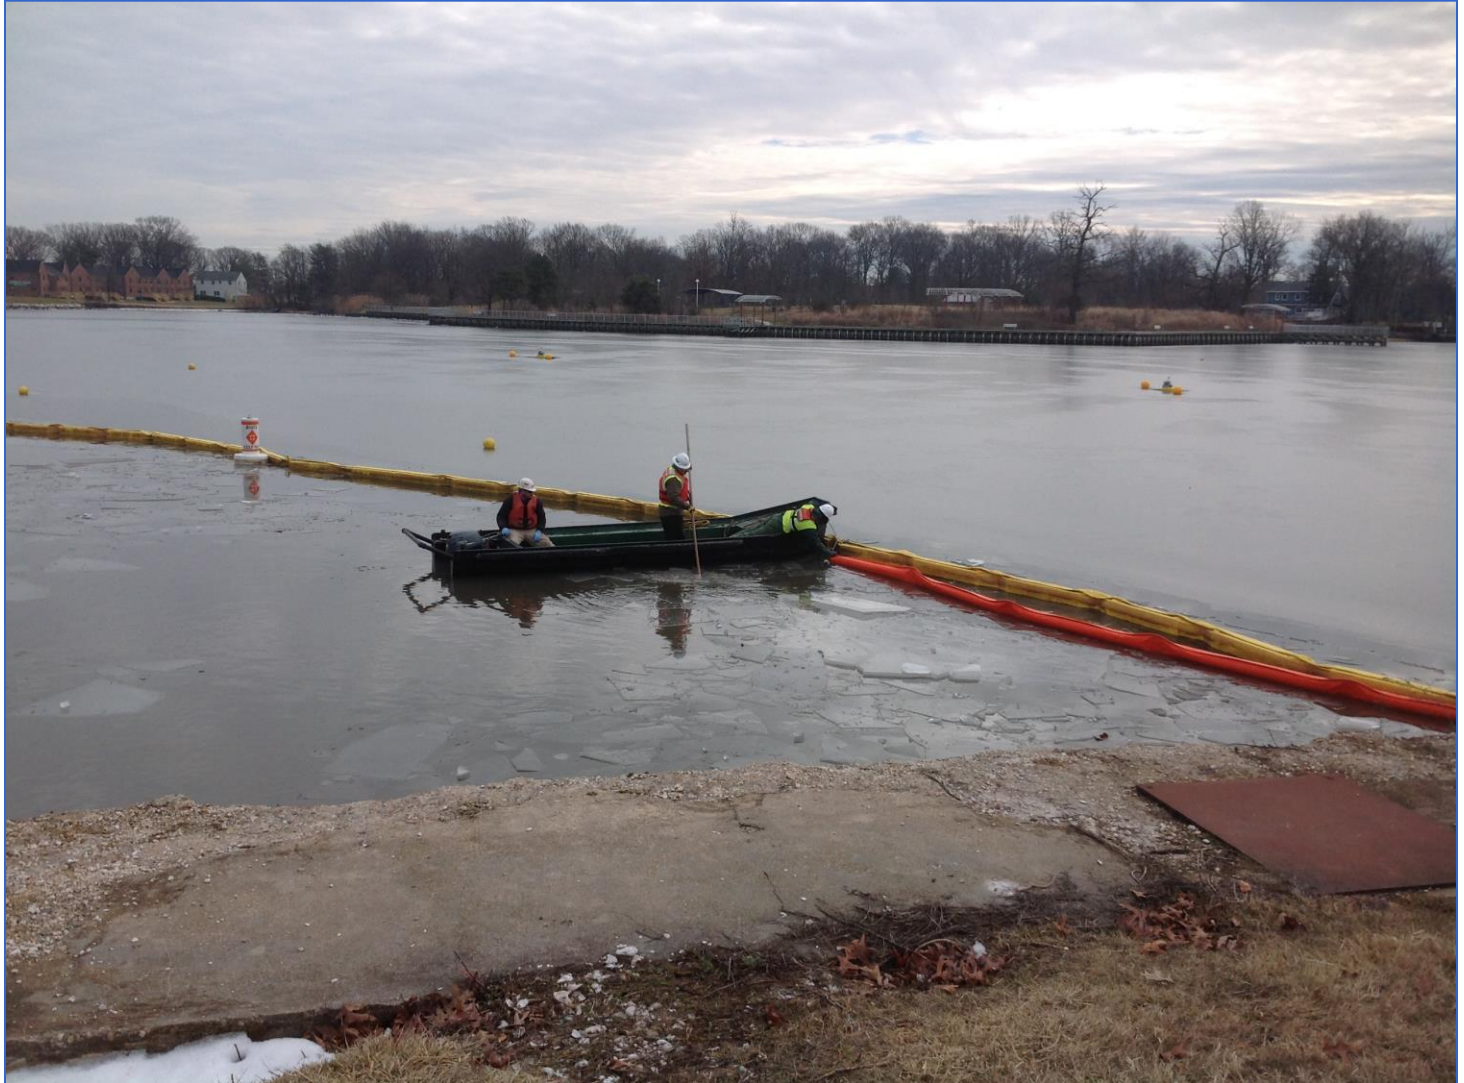
As the dredging equipment moved from area to area, the silt curtains were moved to continue surrounding work zones. Icing within the work area was managed by dredge equipment movement.

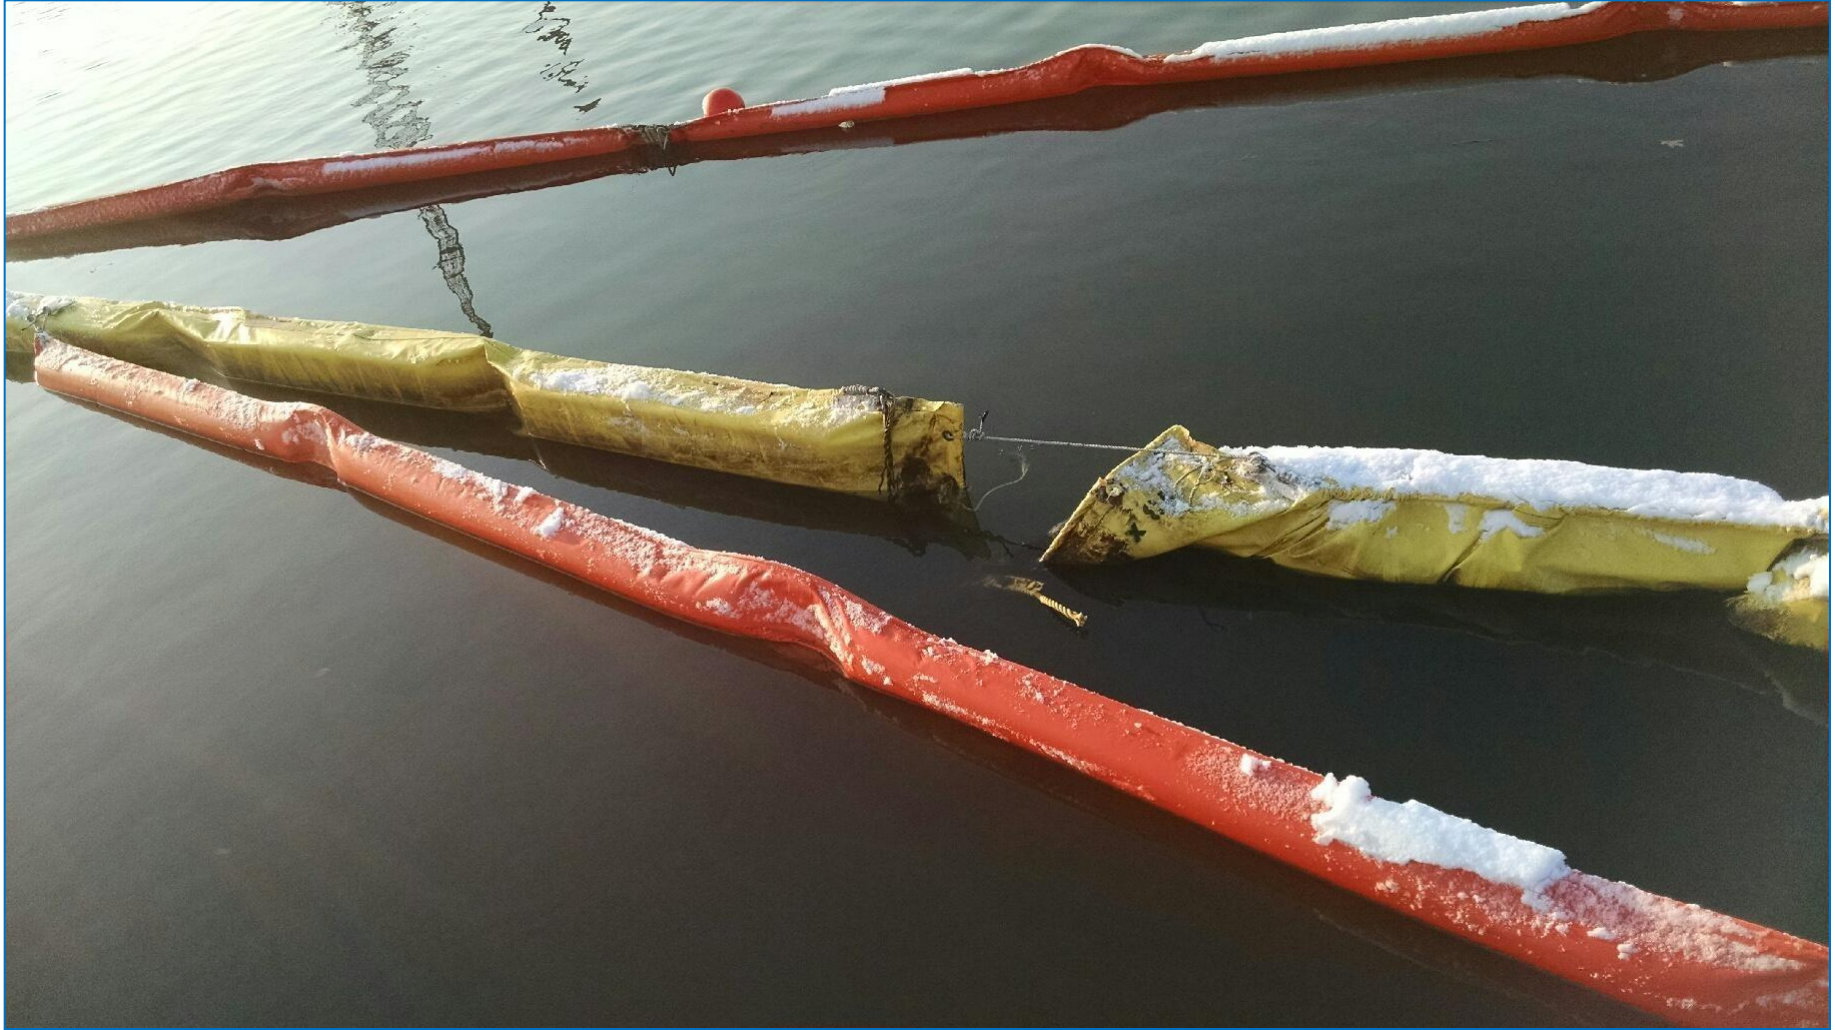
Monitoring showed that the silt curtain was in need of replacement.

Replaced silt
curtain

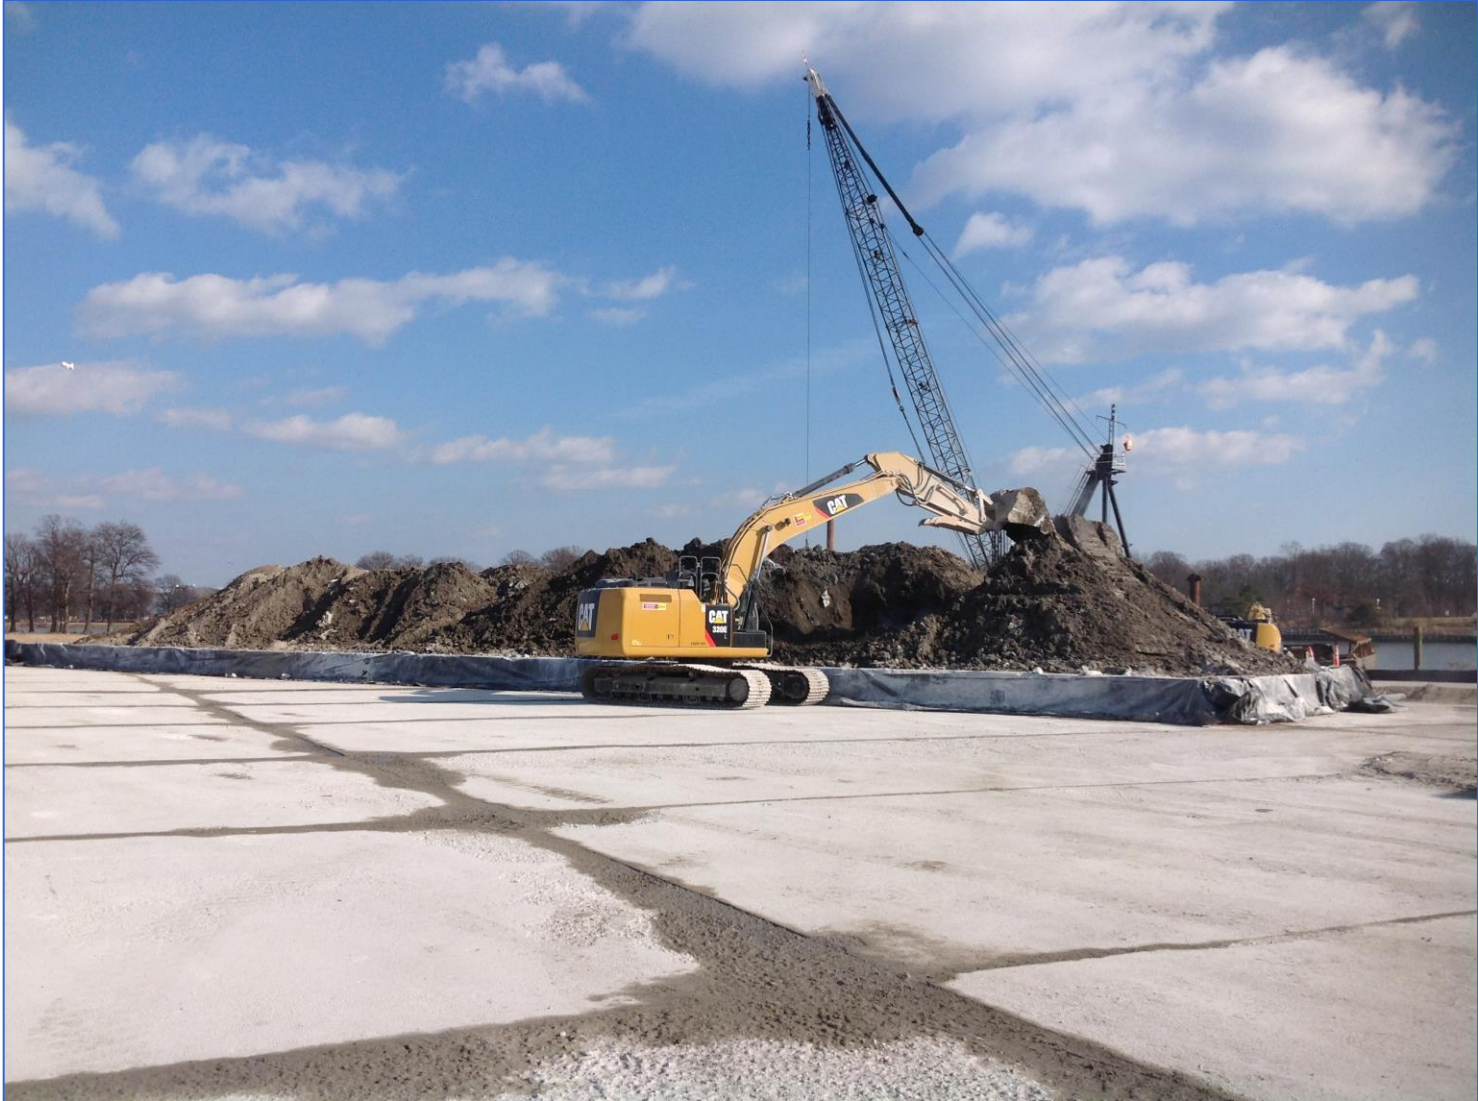
A fully loaded sediment dewatering pad with cement and Calciment amendments added was tested, confirmed to have strength and body, and ready for loading onto dump trucks to leave the site.

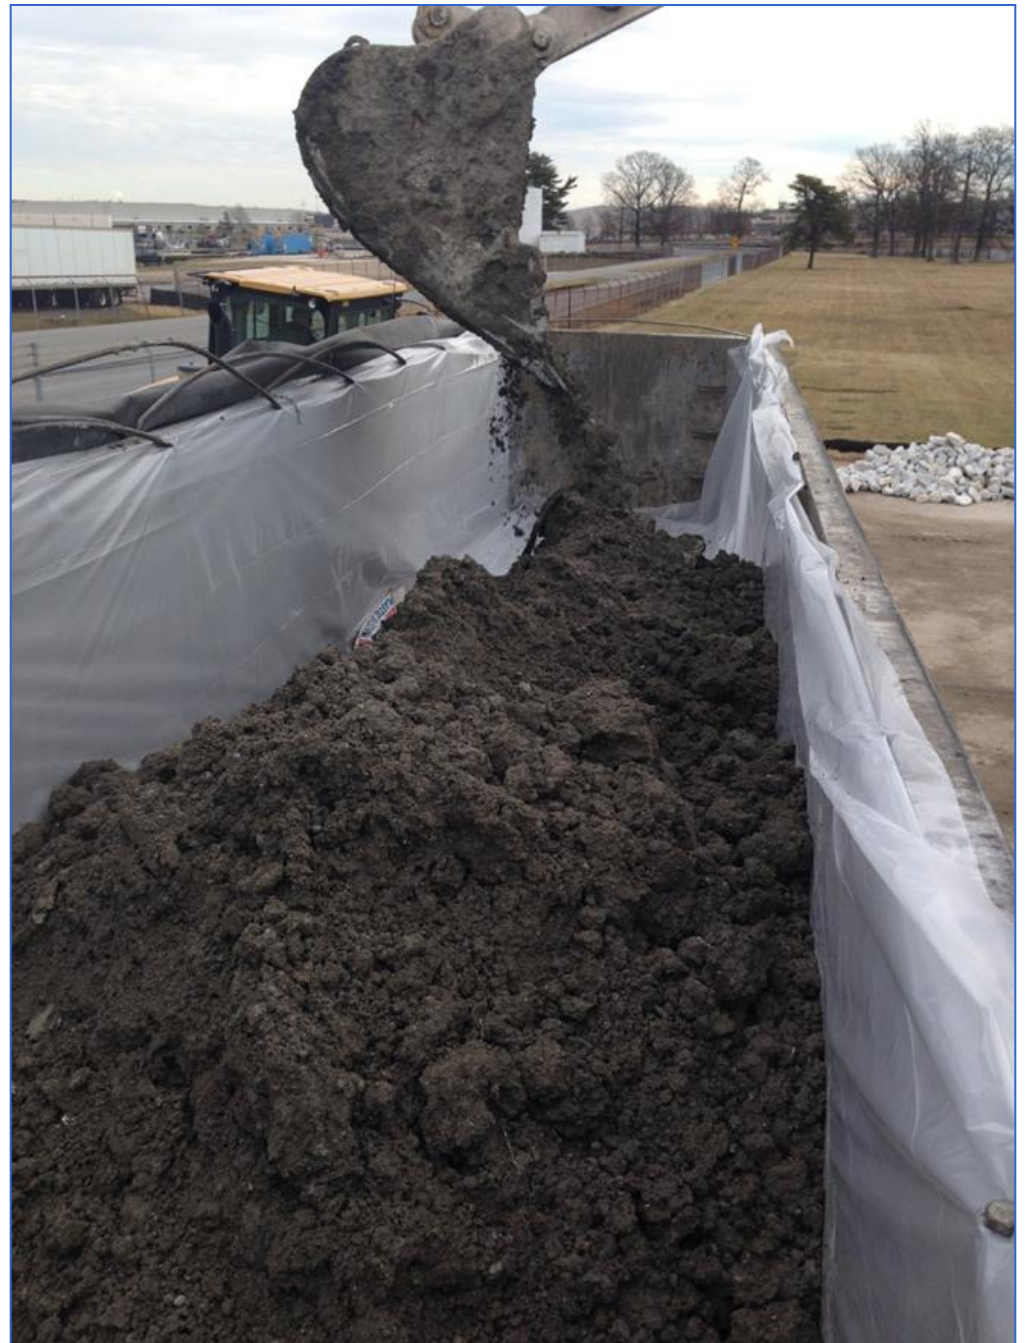
When sediment met landfill disposal criteria, it was loaded into lined dump trucks and covered for transportation.

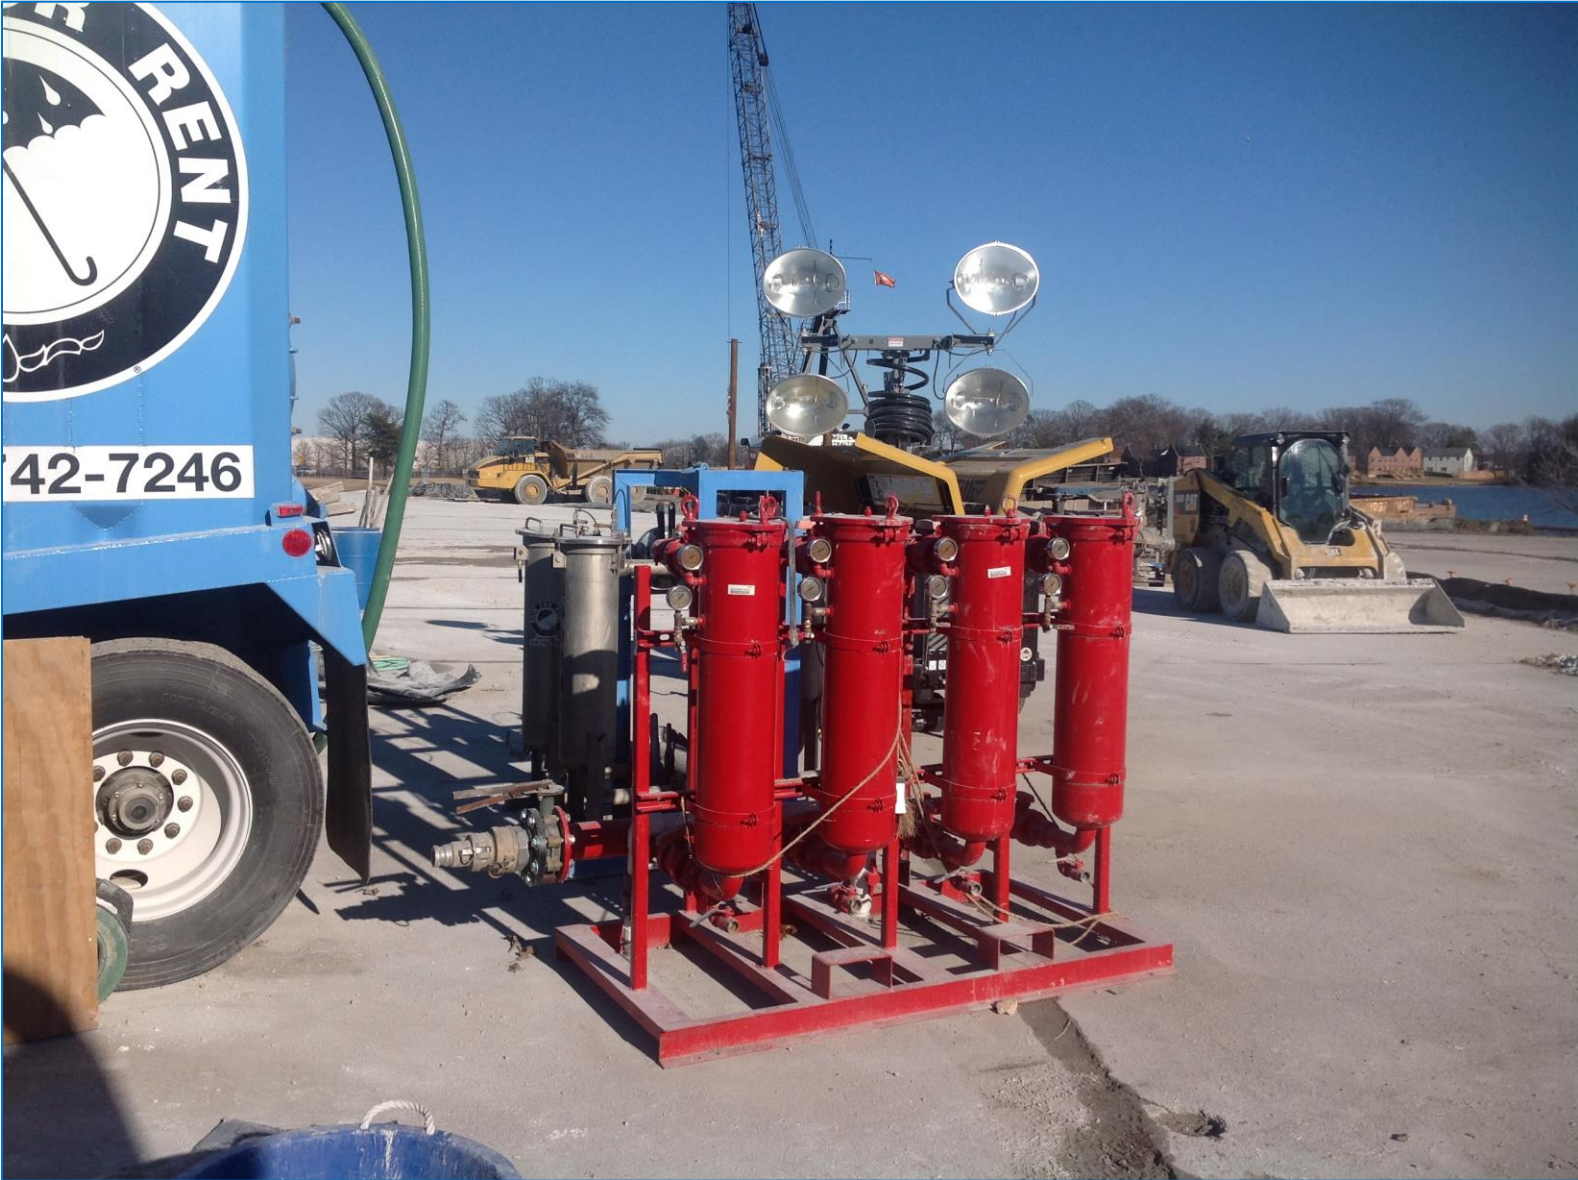
Once water was removed from sediment, it was pumped through water treatment vessels, shown in red.

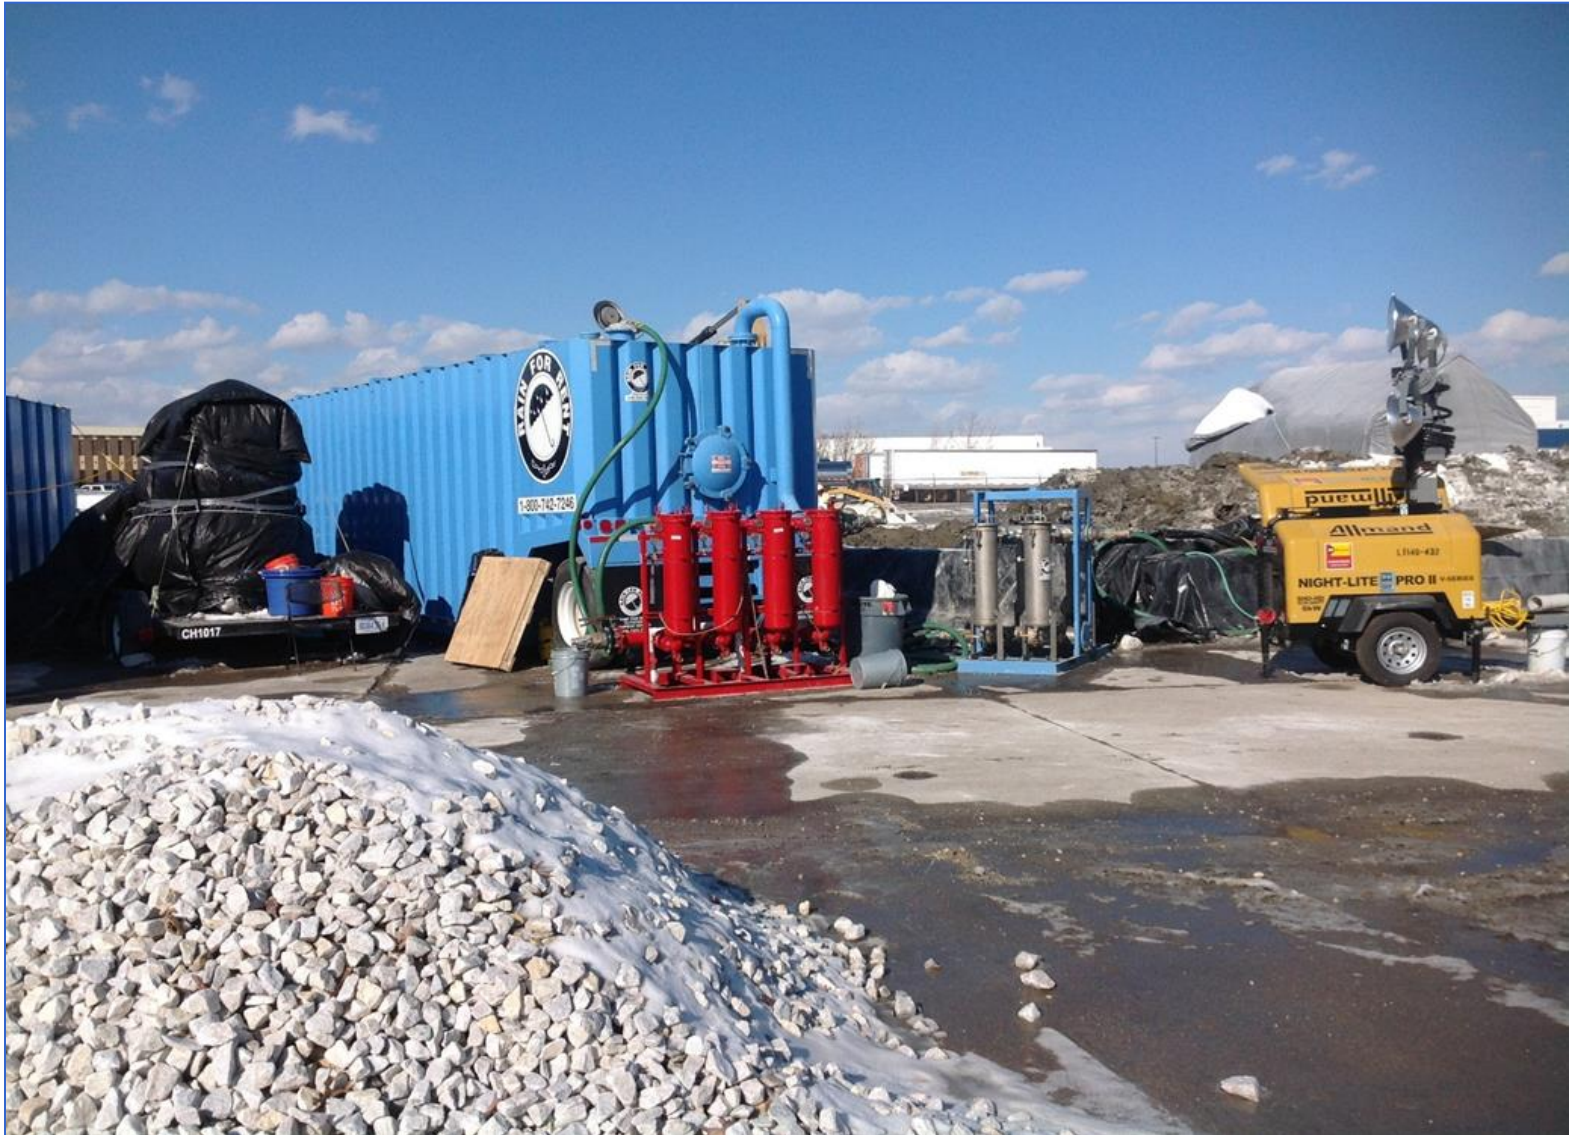
After treatment, the water was stored in tanks, shown in blue, where it was sampled to confirm that the water could be discharged to the sewer system in compliance with applicable regulations.

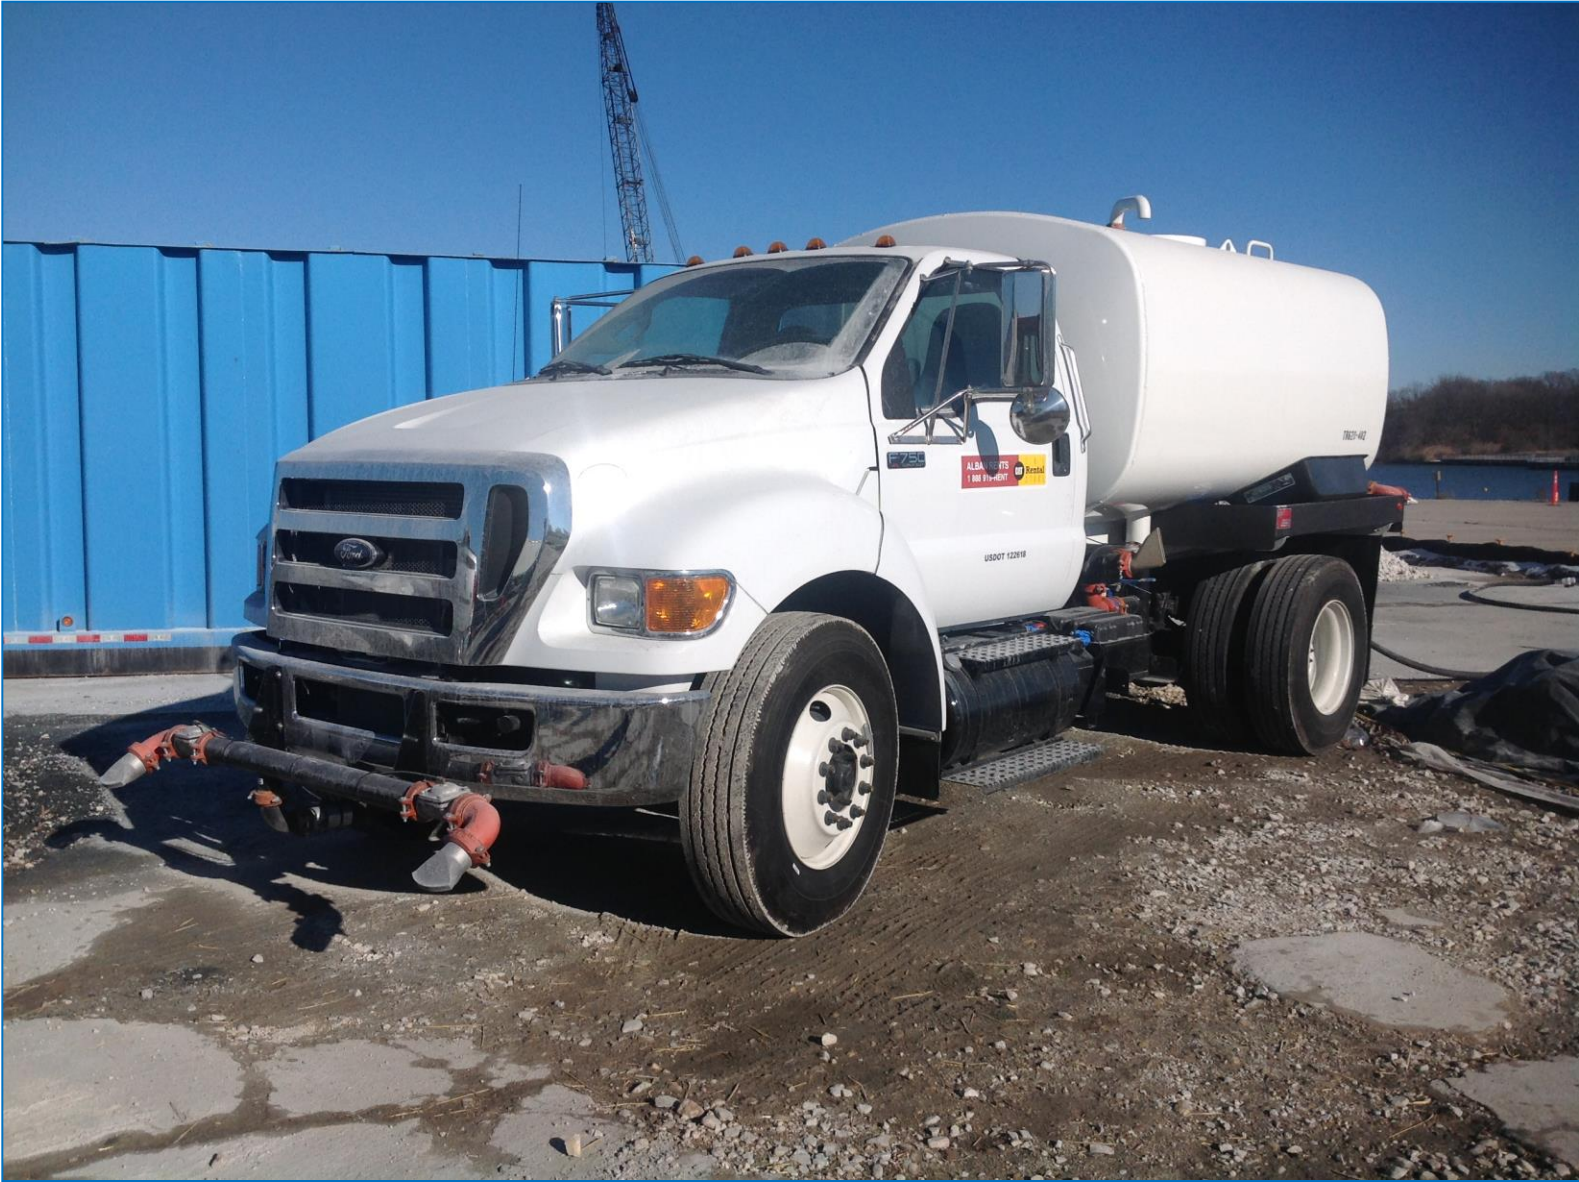
After confirming that treated water met all required criteria, it was pumped from holding tanks into a transport truck, to pump to the sanitary sewer system, which was allowed by permit.

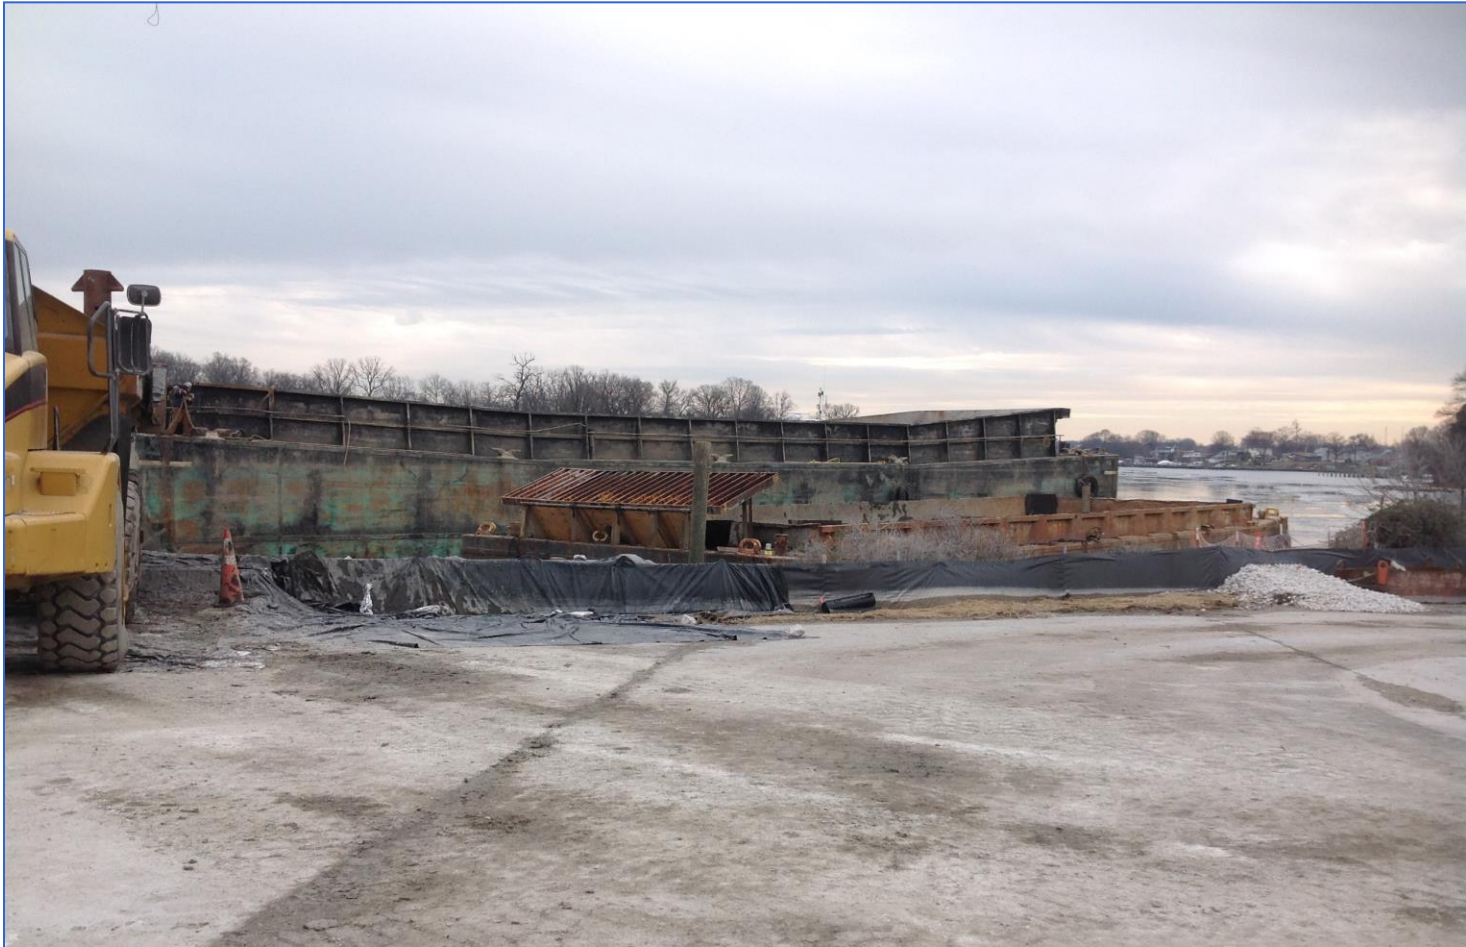
A second, larger barge (seen in the background) arrived January 21, 2015 to store 5-6 times more dredged material than the first barge, while upland activities continued. Slower dewatering and increased need for amendments slowed the ability to transport sediments offsite. With the larger barge, dredging was completed by February 15th, the end of the allowable dredging work window. Upland work continued several weeks longer than in-water work.

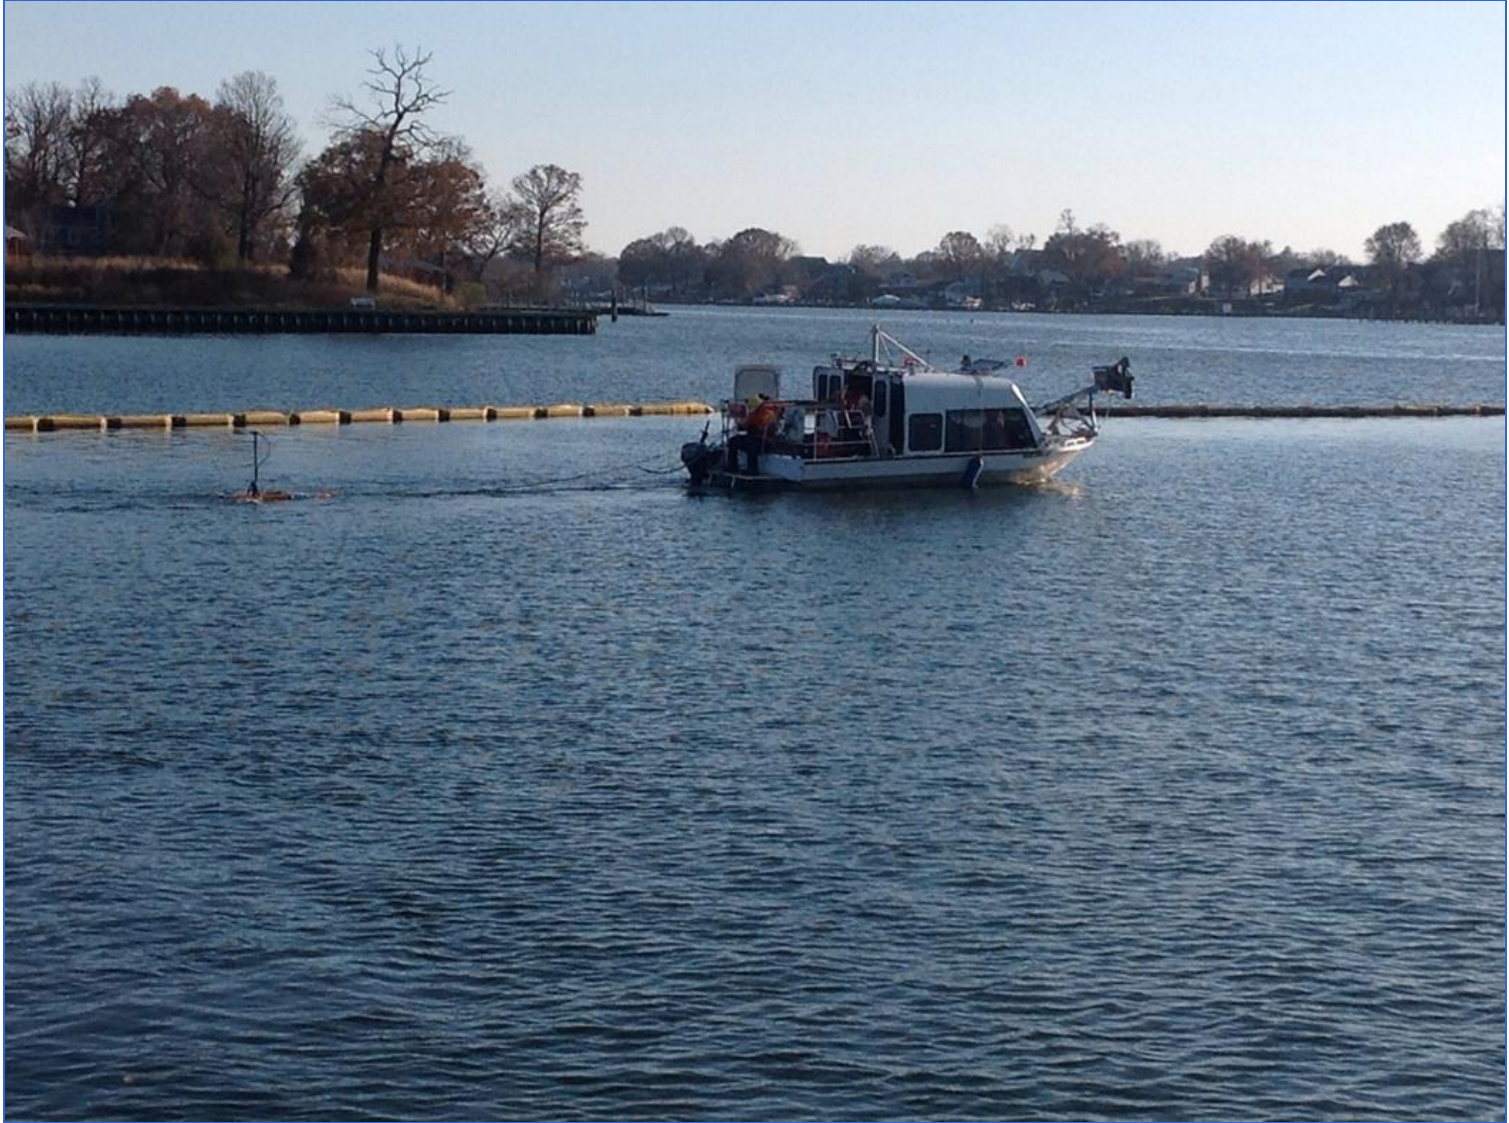
A survey vessel is shown – monitoring of turbidity and surveying for dredging completion were ongoing throughout the project and sampling results were reported to regulators.

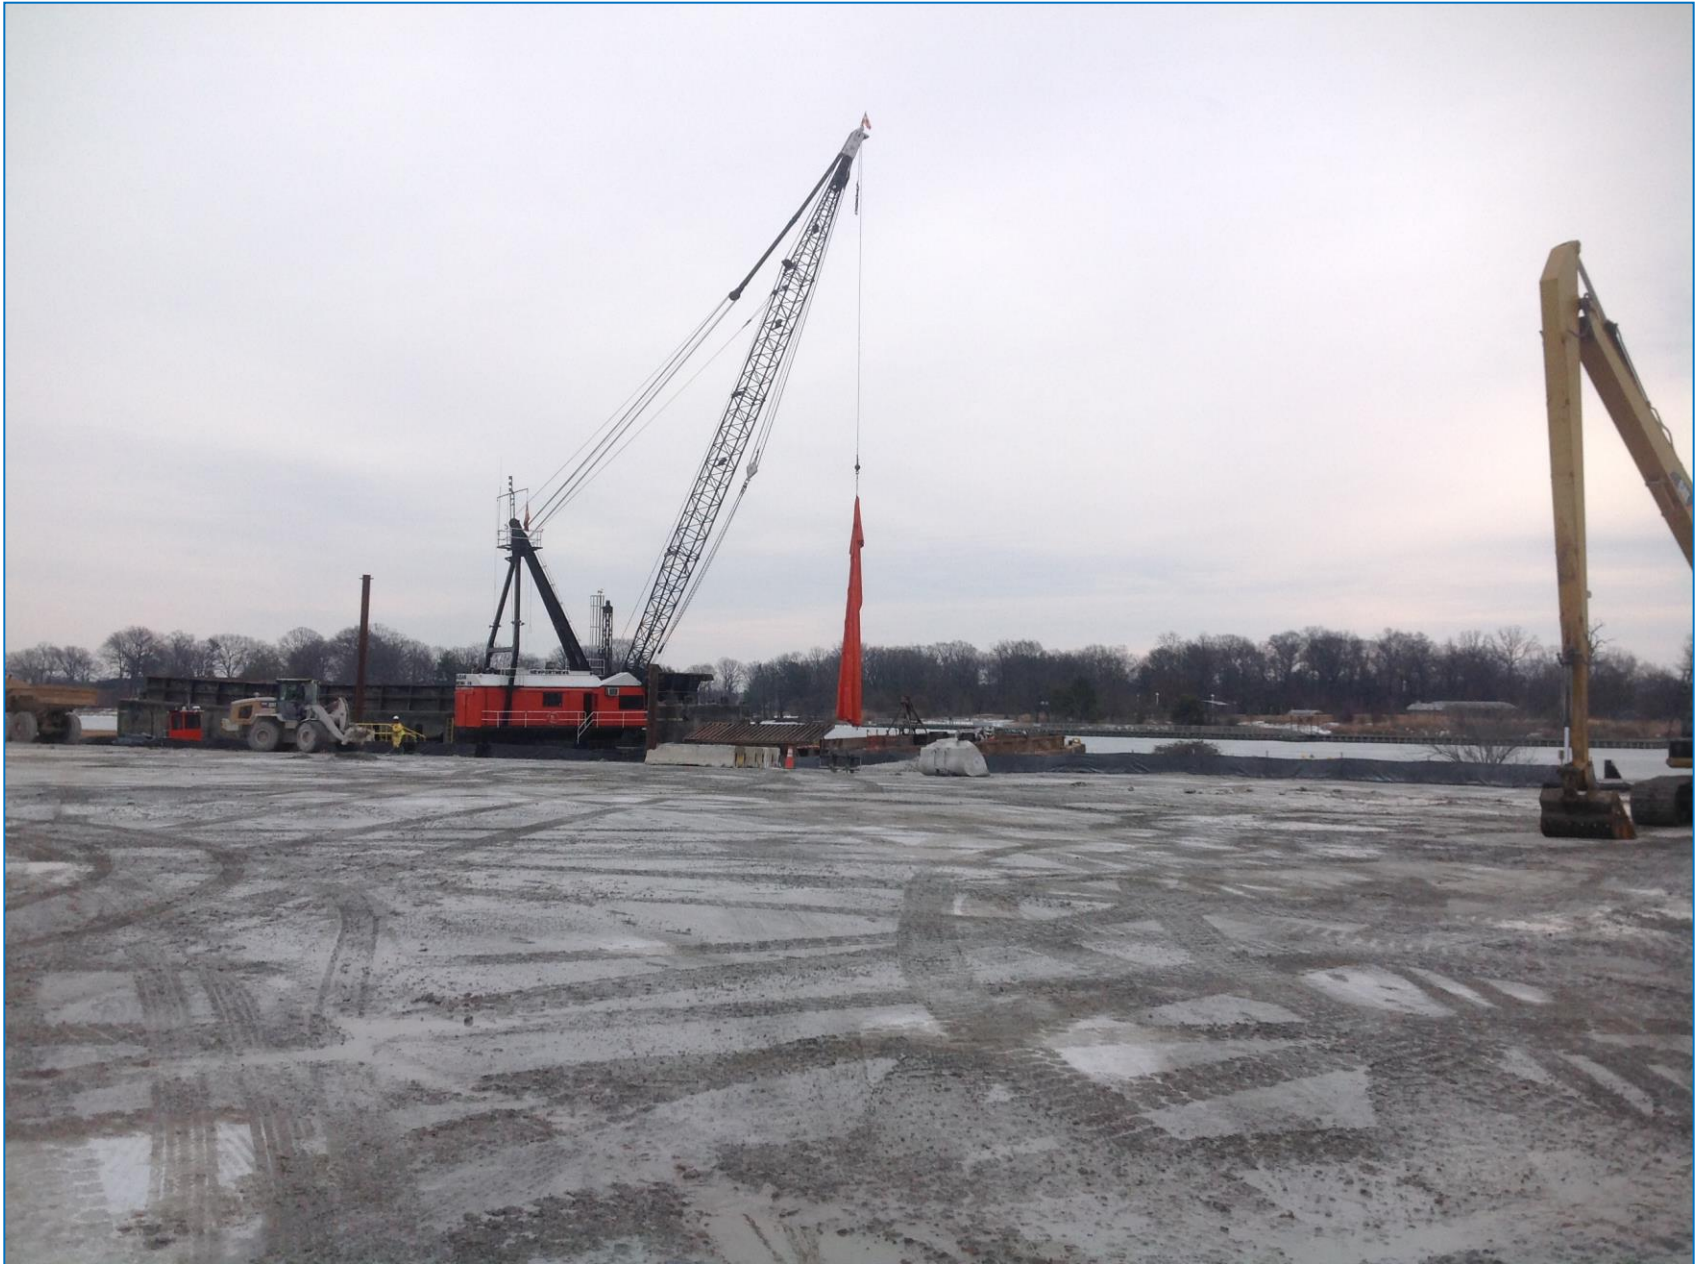
The silt curtain was removed by crane.
