# Soil Remedial Actions at Middle River Complex - 2015

Project Photo Tour  
Updated September 15, 2015

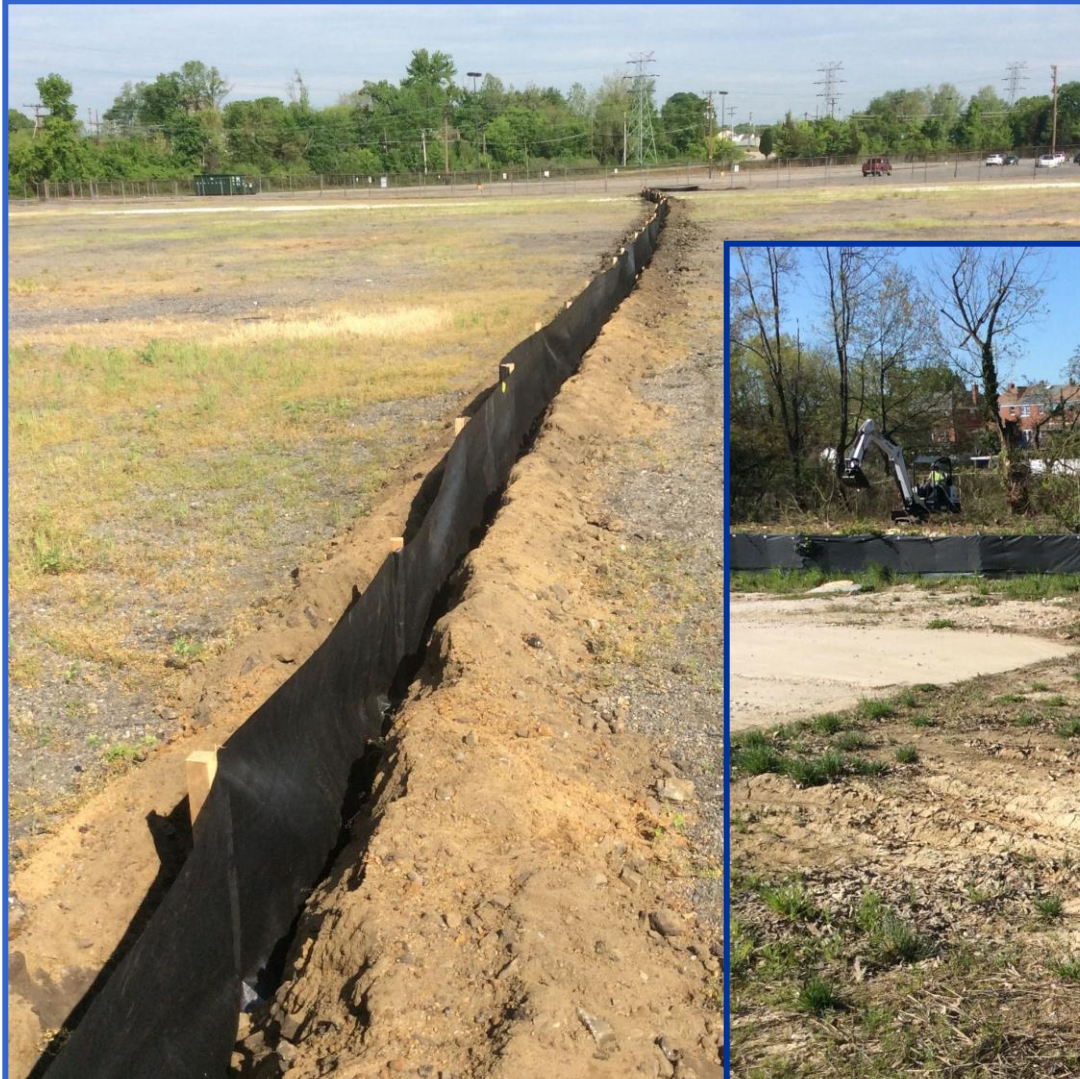
**Silt fencing was installed to control erosion.**

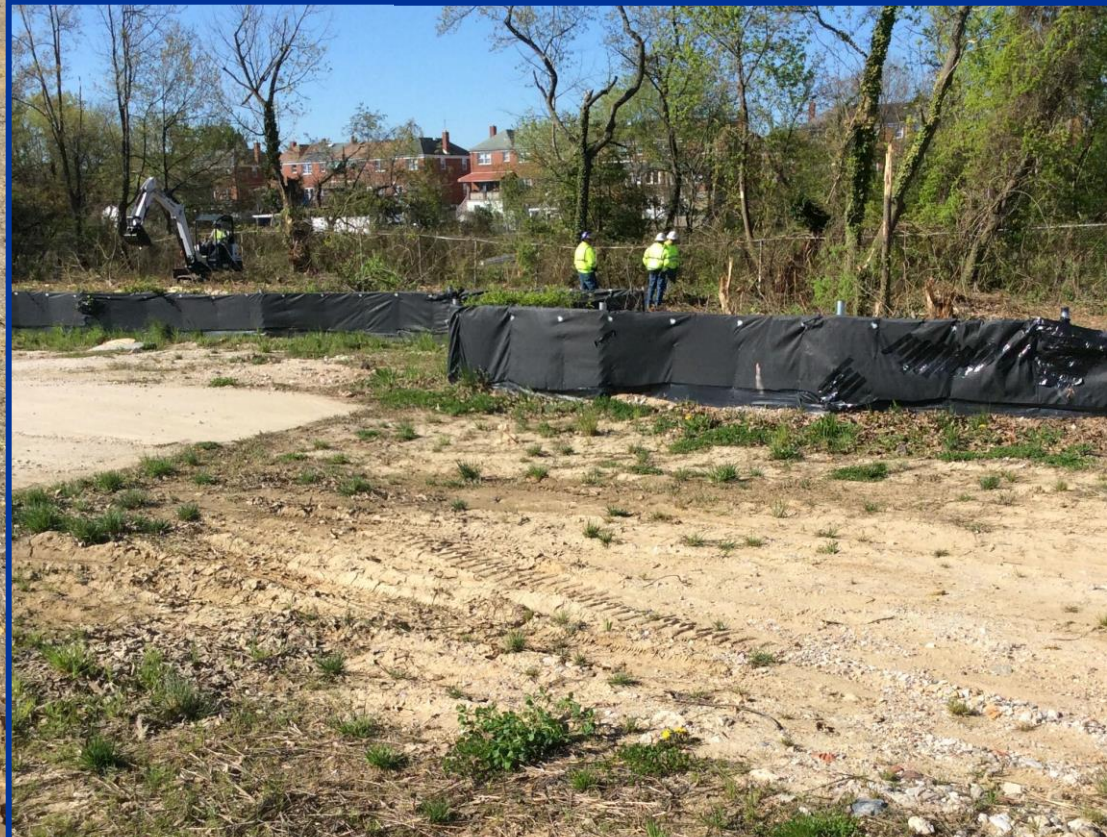
**Temporary fencing and construction signage maintains a secure site, and protects neighbors and others using the property.**

**Fencing of excavation at Block H**

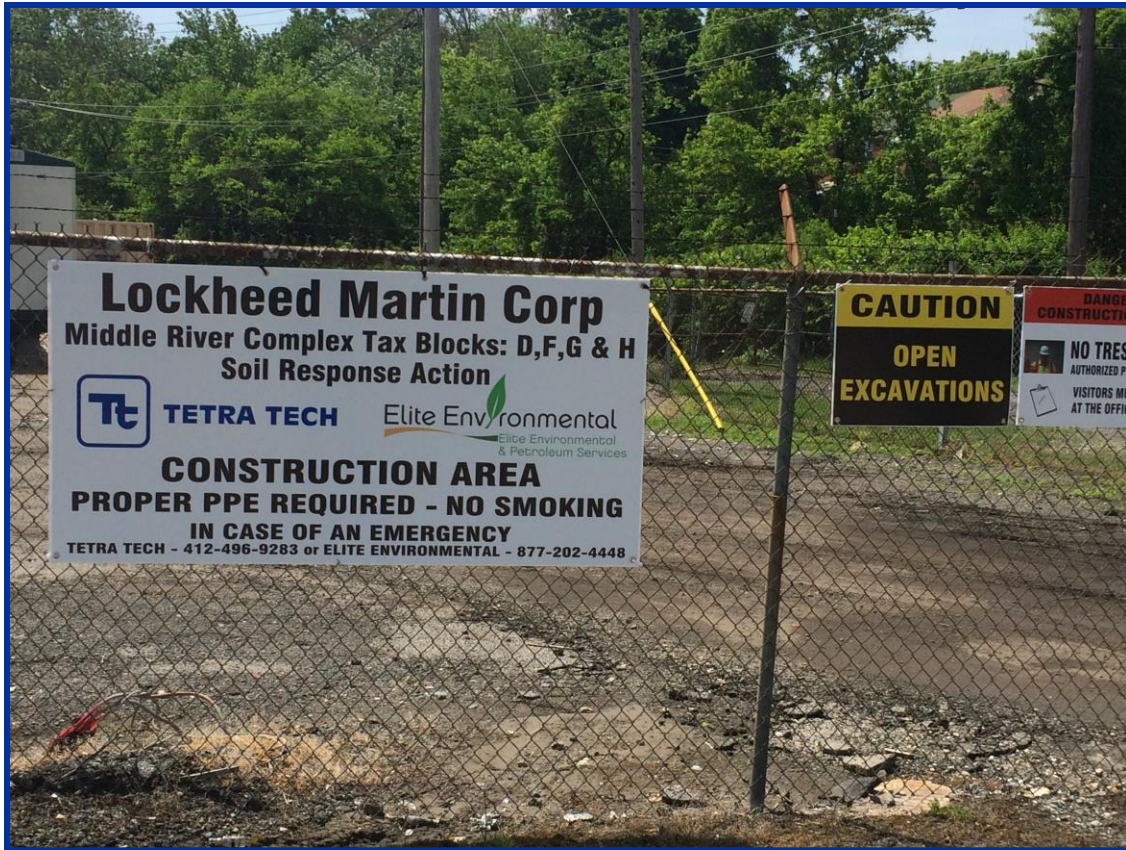
**Fencing and trailer at Block G**

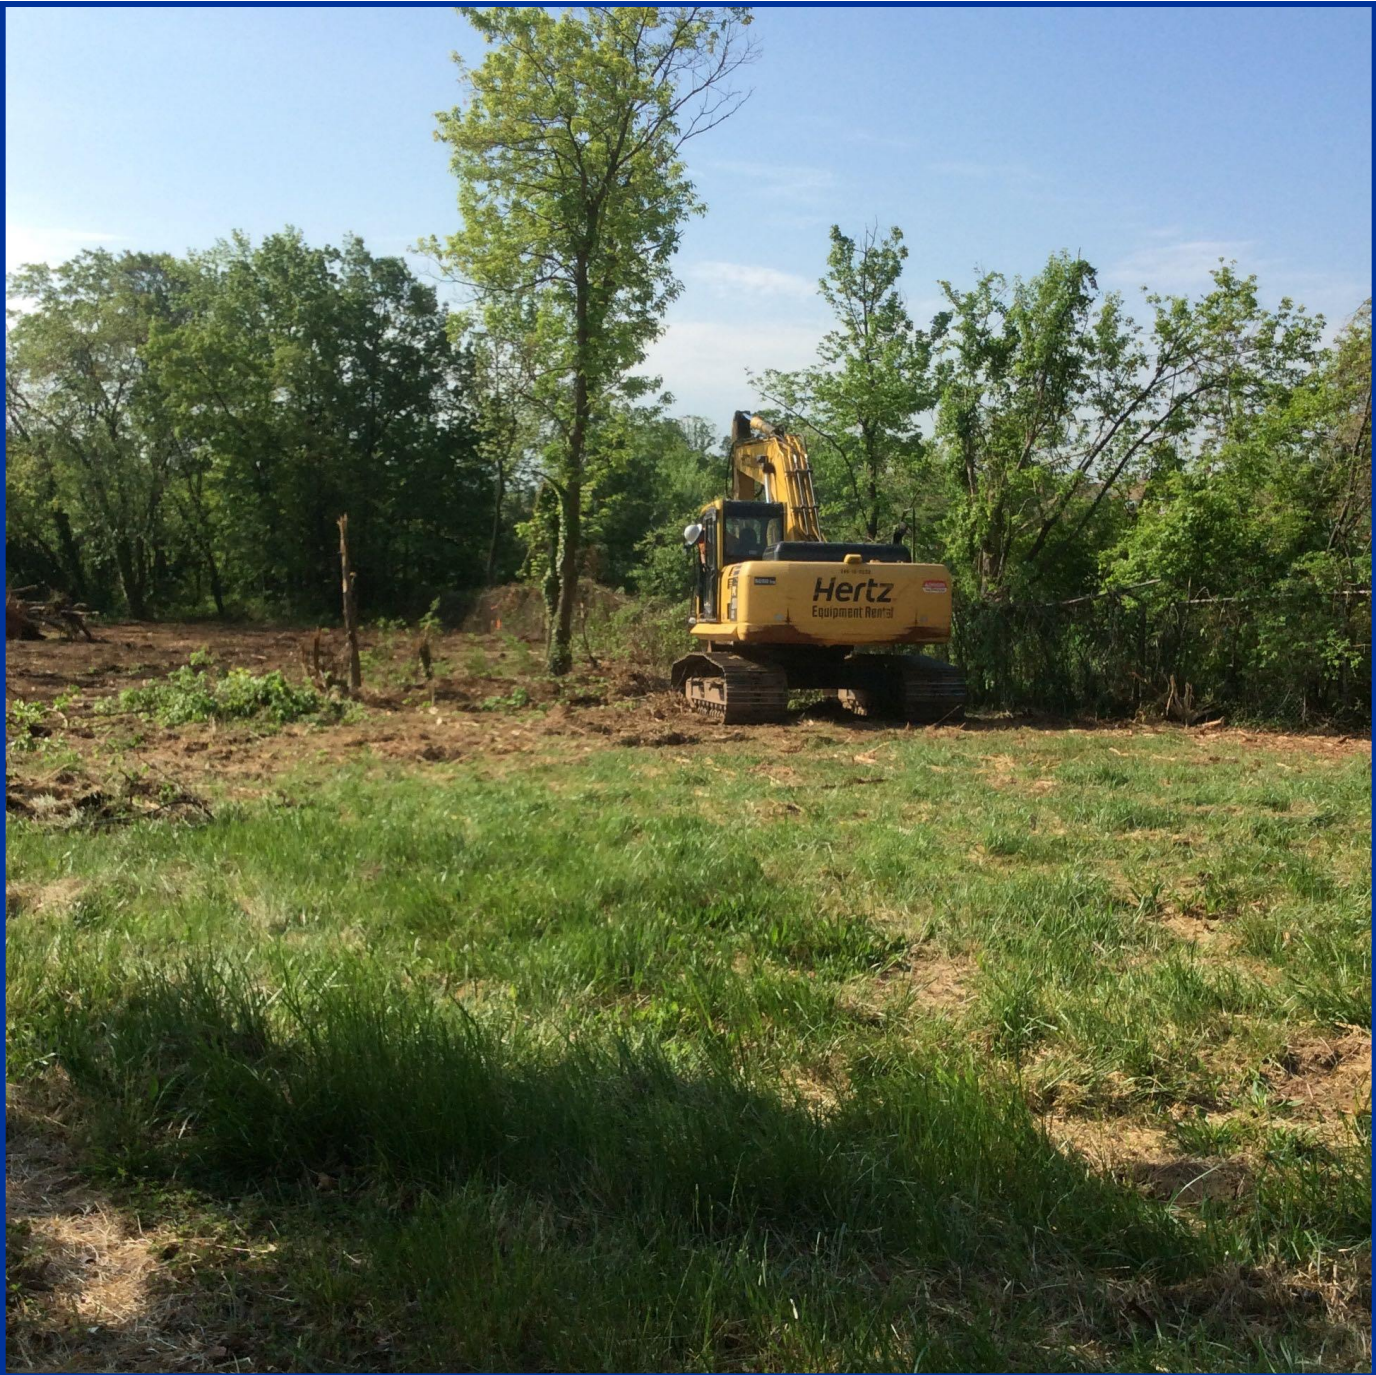
**A worker installed a “super silt fence” at Block G along the north shore of Cow Pen Creek. This stronger silt fence clips geotextile fabric to steel fencing.**

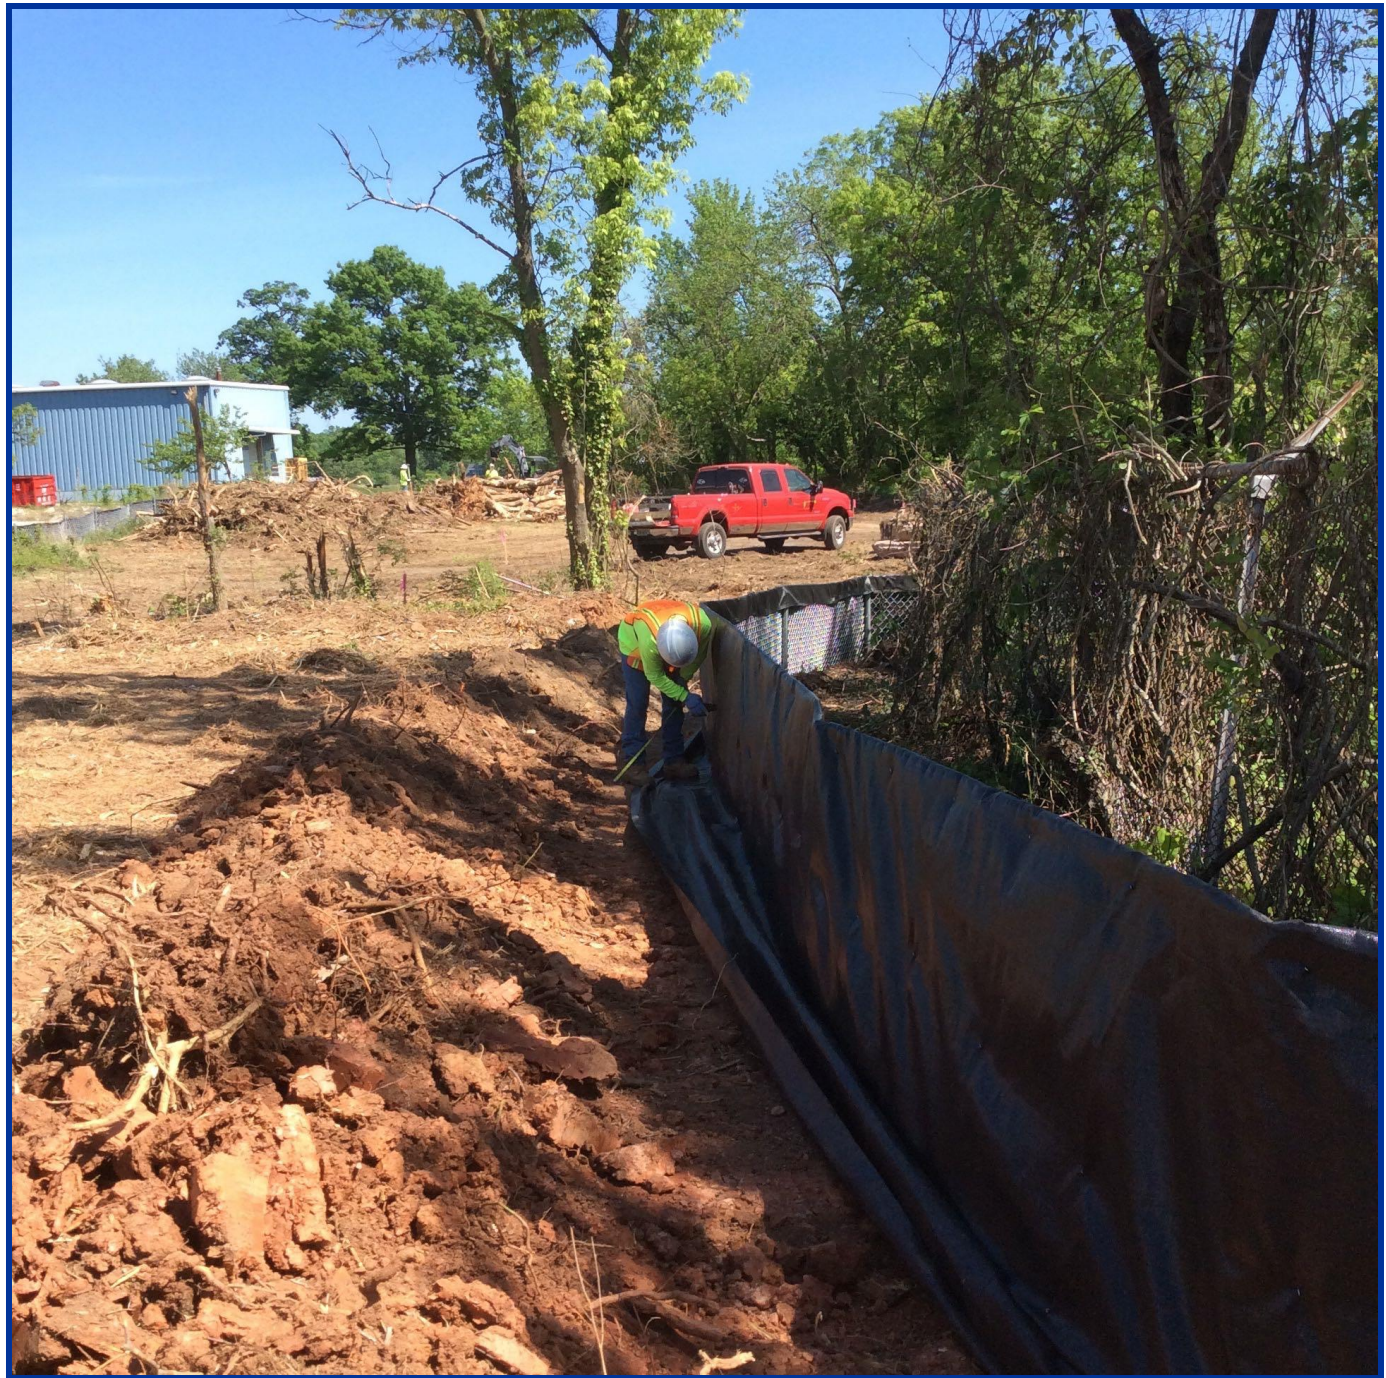
**Completed  
silt fencing is  
shown in  
Block G near  
Cow Pen  
Creek,  
ready for  
digging work  
to begin.**

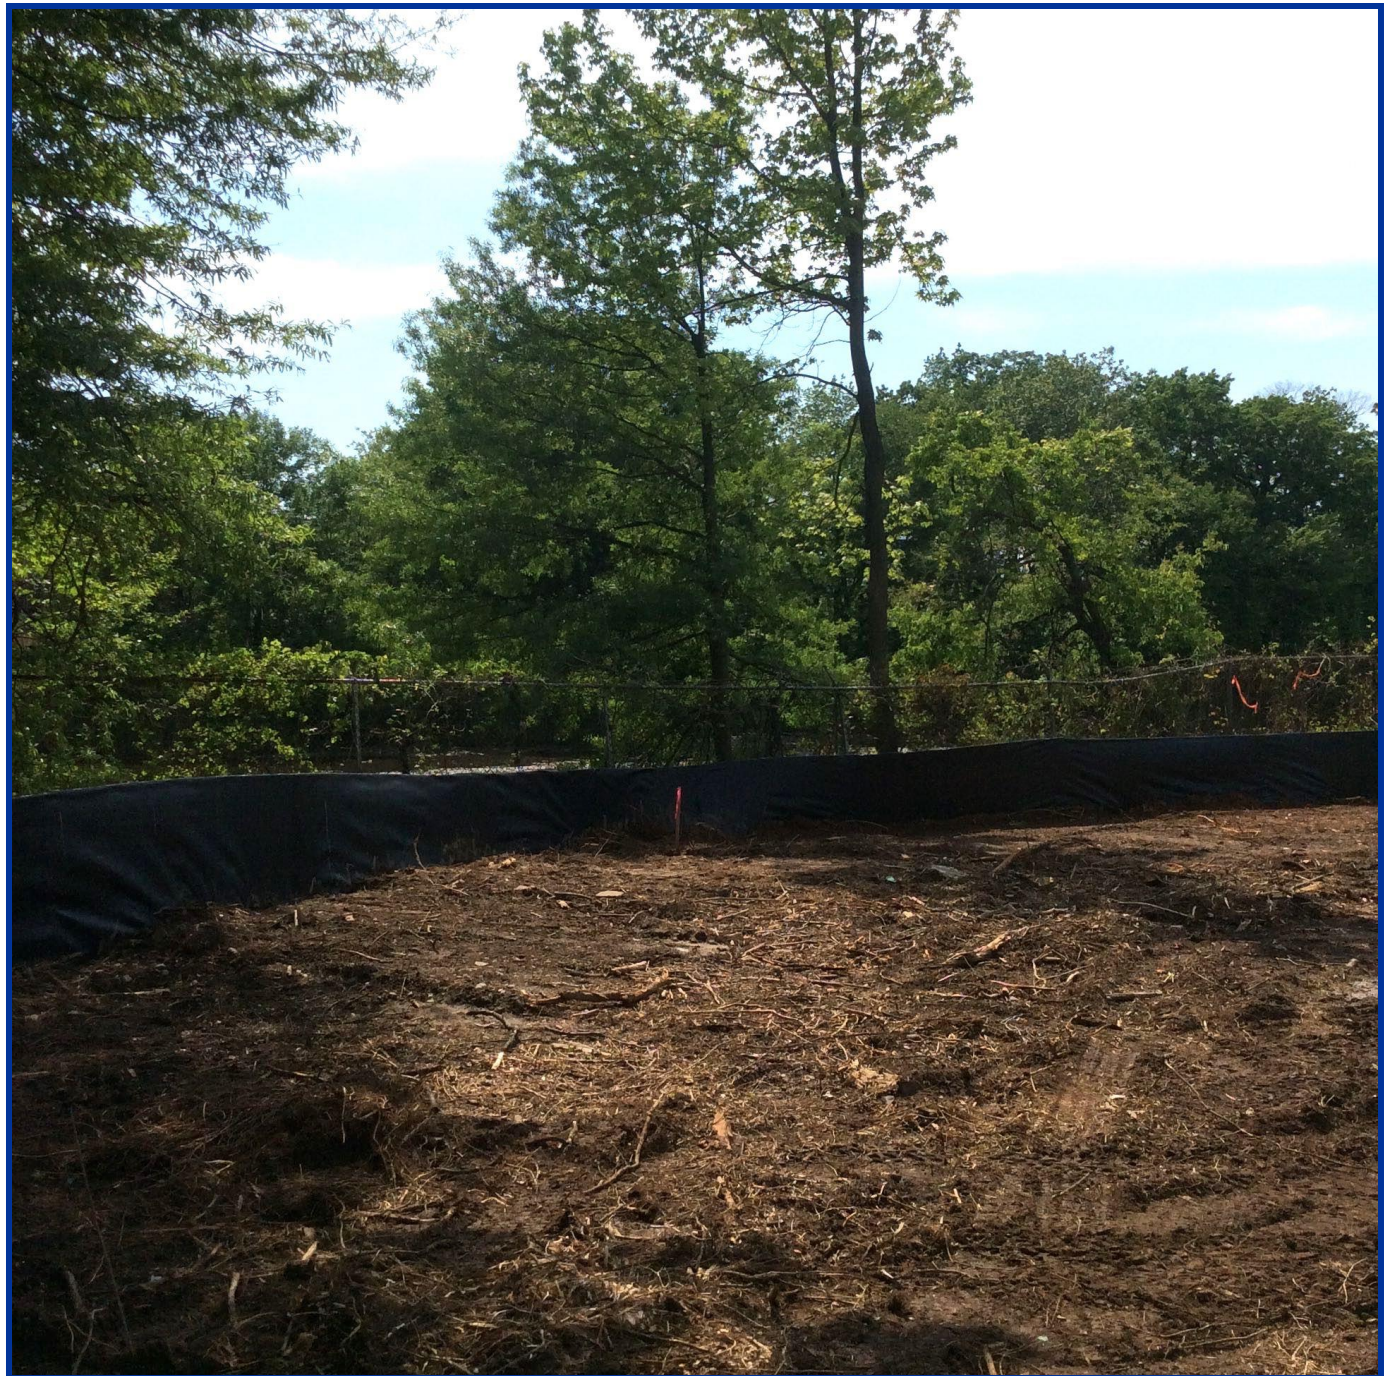
**The first soil removal area was in the parking lot of Block H. Asphalt was removed for recycling. Soil was then removed for proper disposal at a licensed soil reuse facility.**

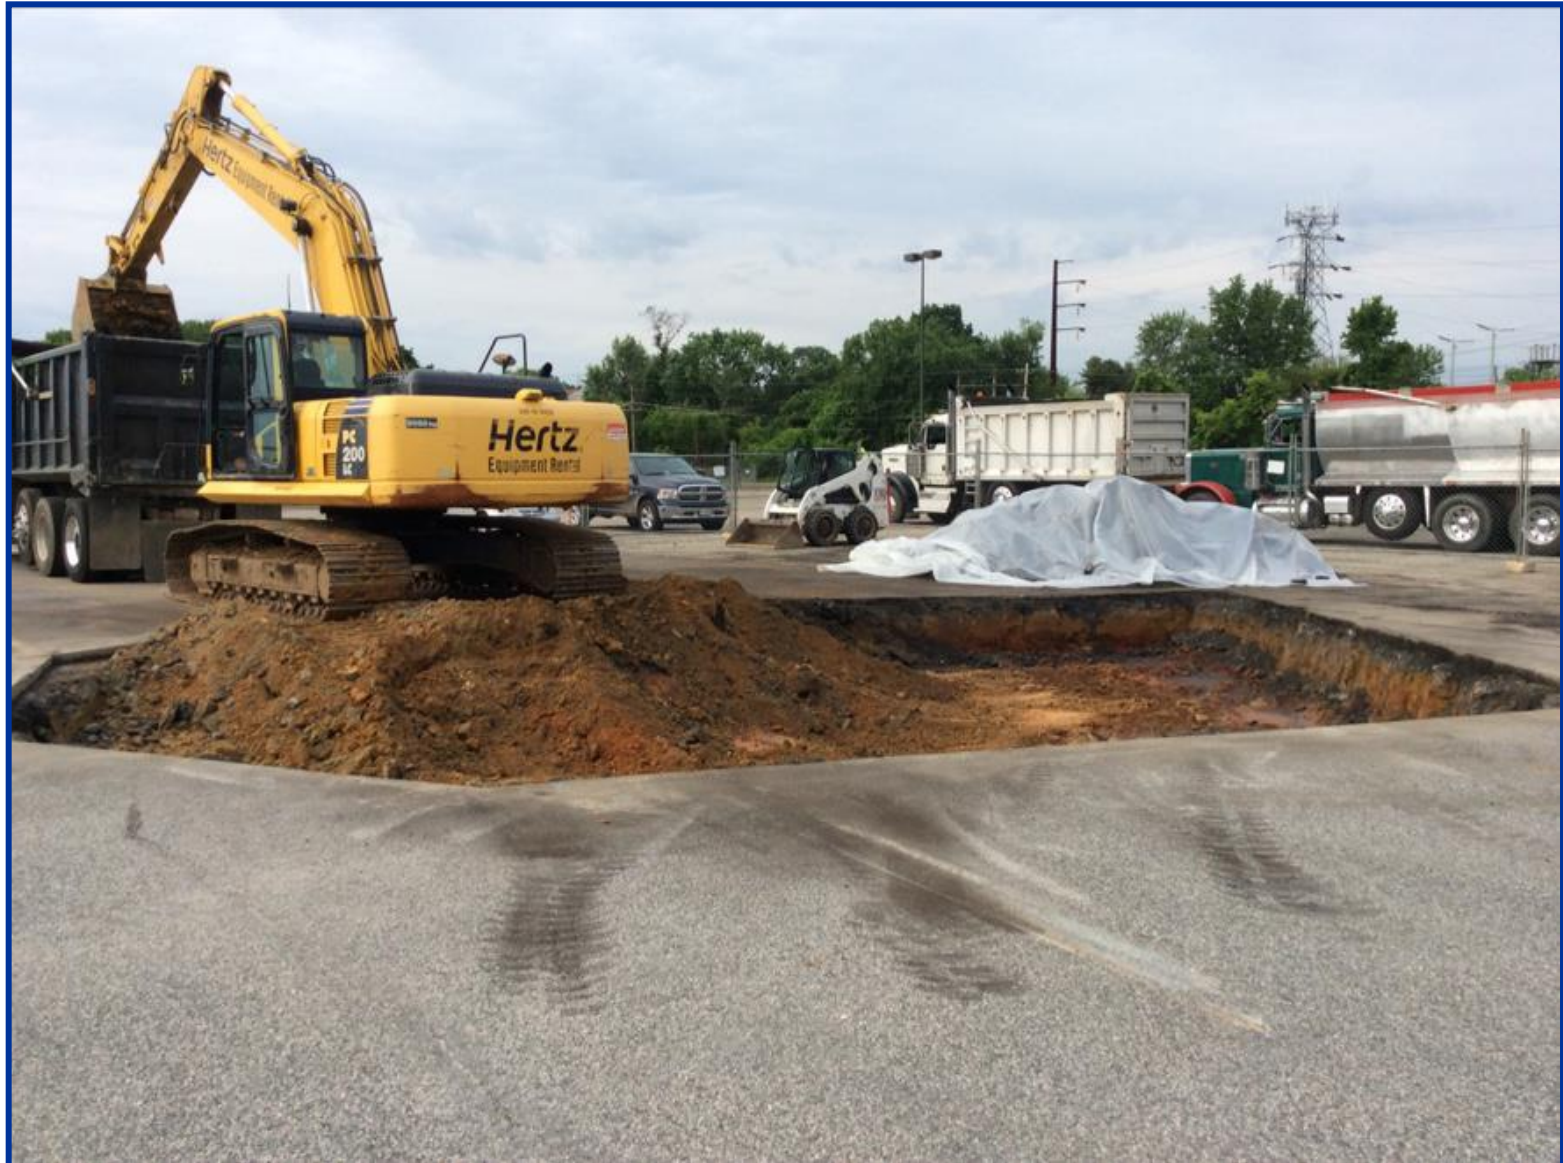
**Once soil is removed to the planned depth, samples are taken from the excavation sides and bottom and sent to the lab to confirm cleanup goals are met. Two such areas were excavated in Block H. The hole in Block H was then refilled with crushed rock.**

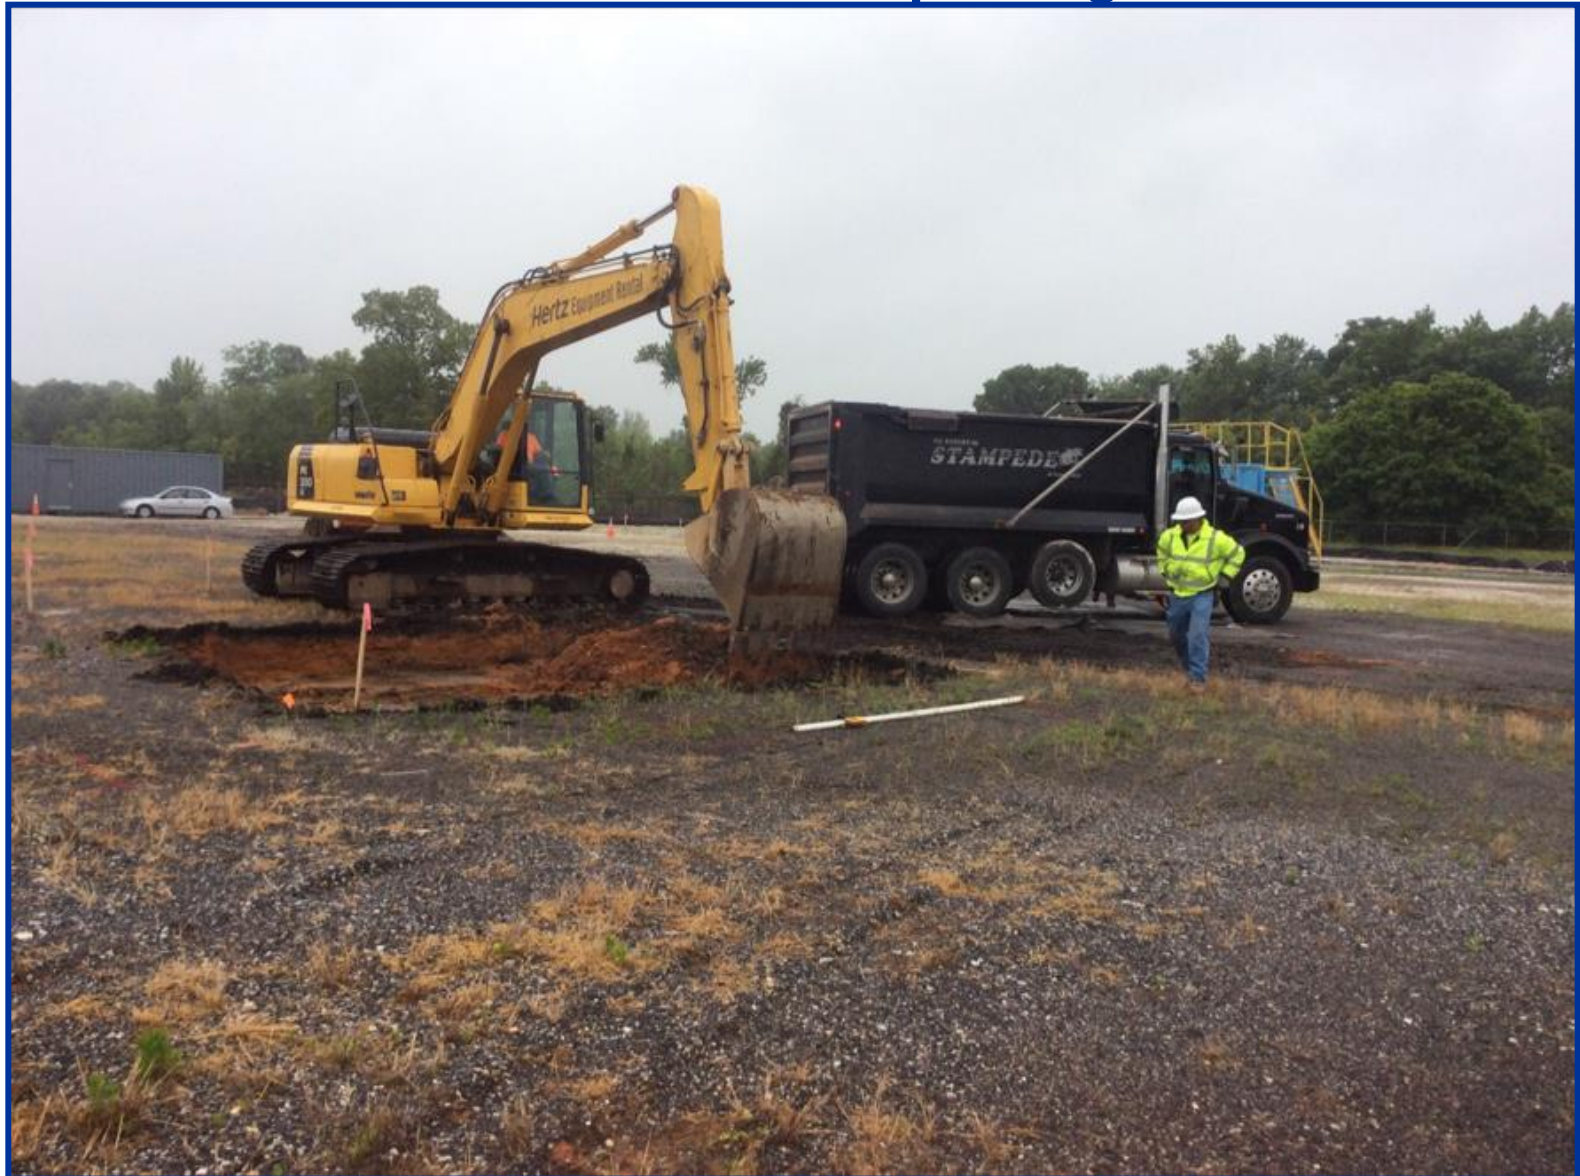
**Planned work next moved to Block G. A truck was loaded with soil dug from one of the seven planned excavation areas, located in a former parking lot.**

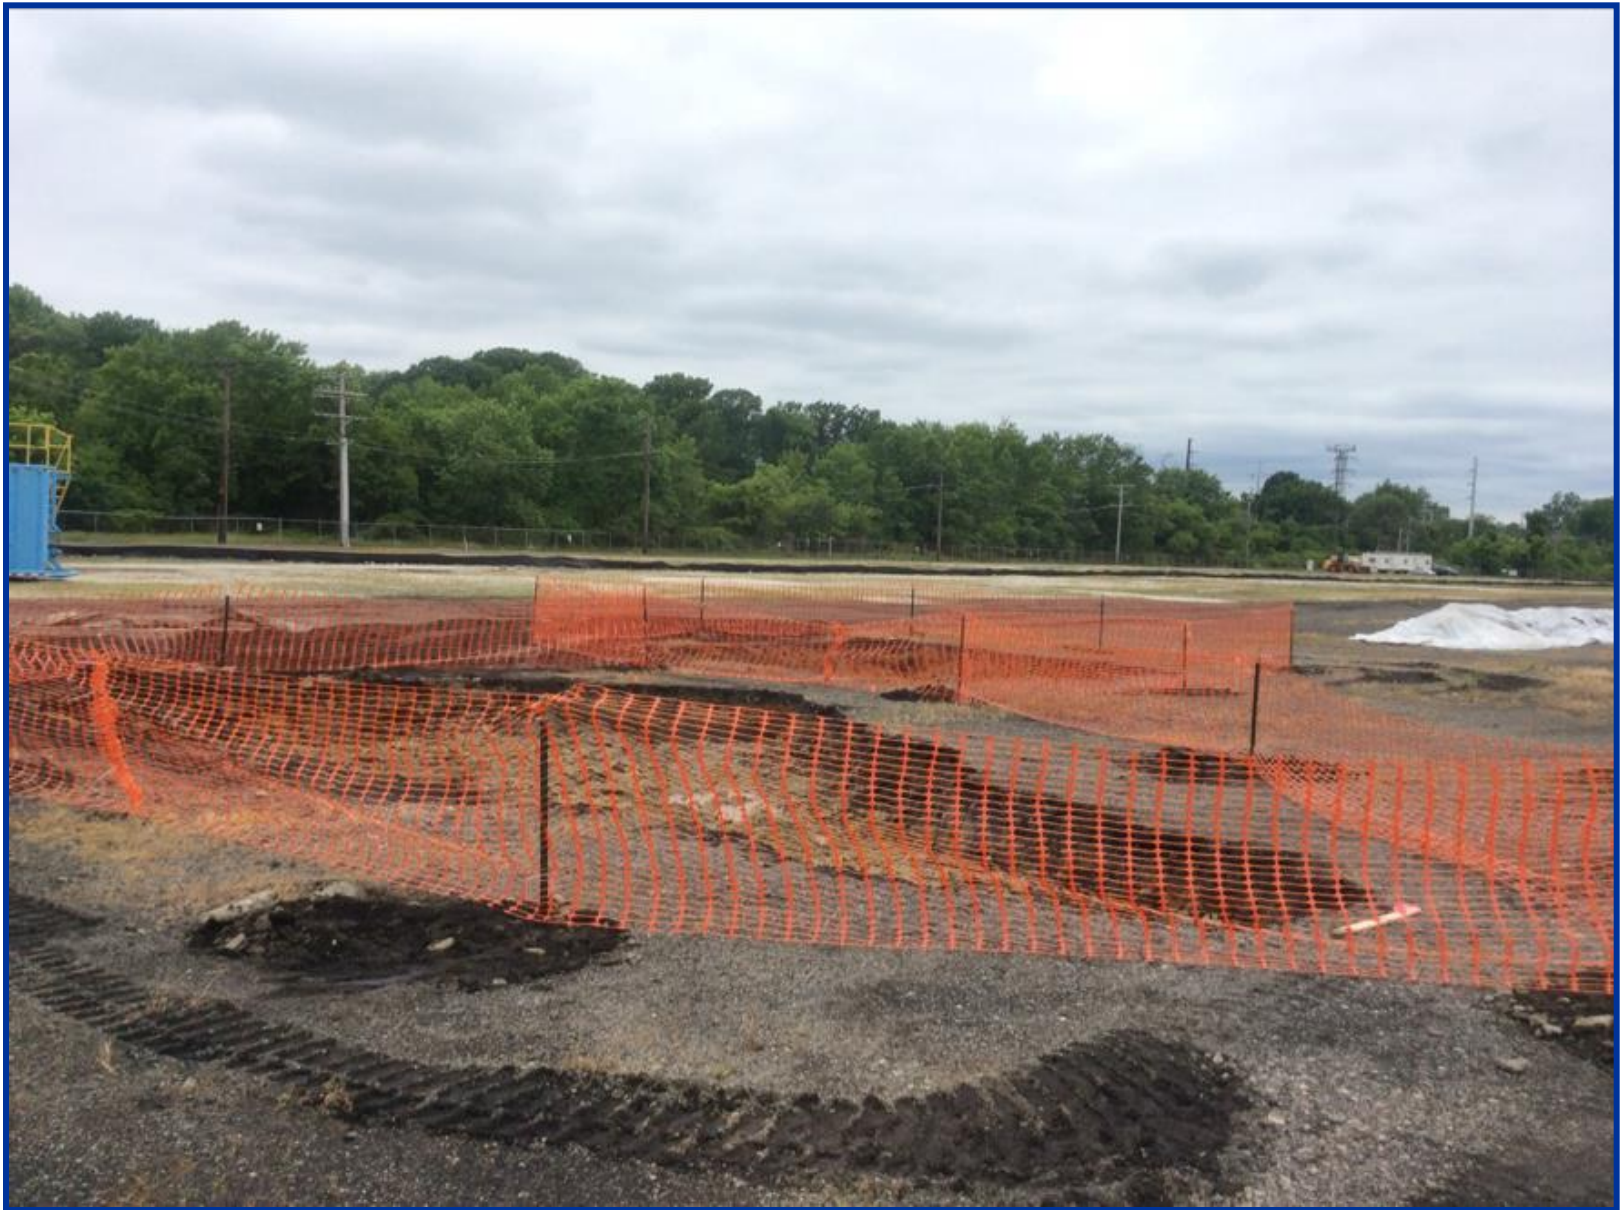
**An excavated area in Block G awaited lab confirmation that cleanup goals were met before backfilling. Safety fencing protected the area.**

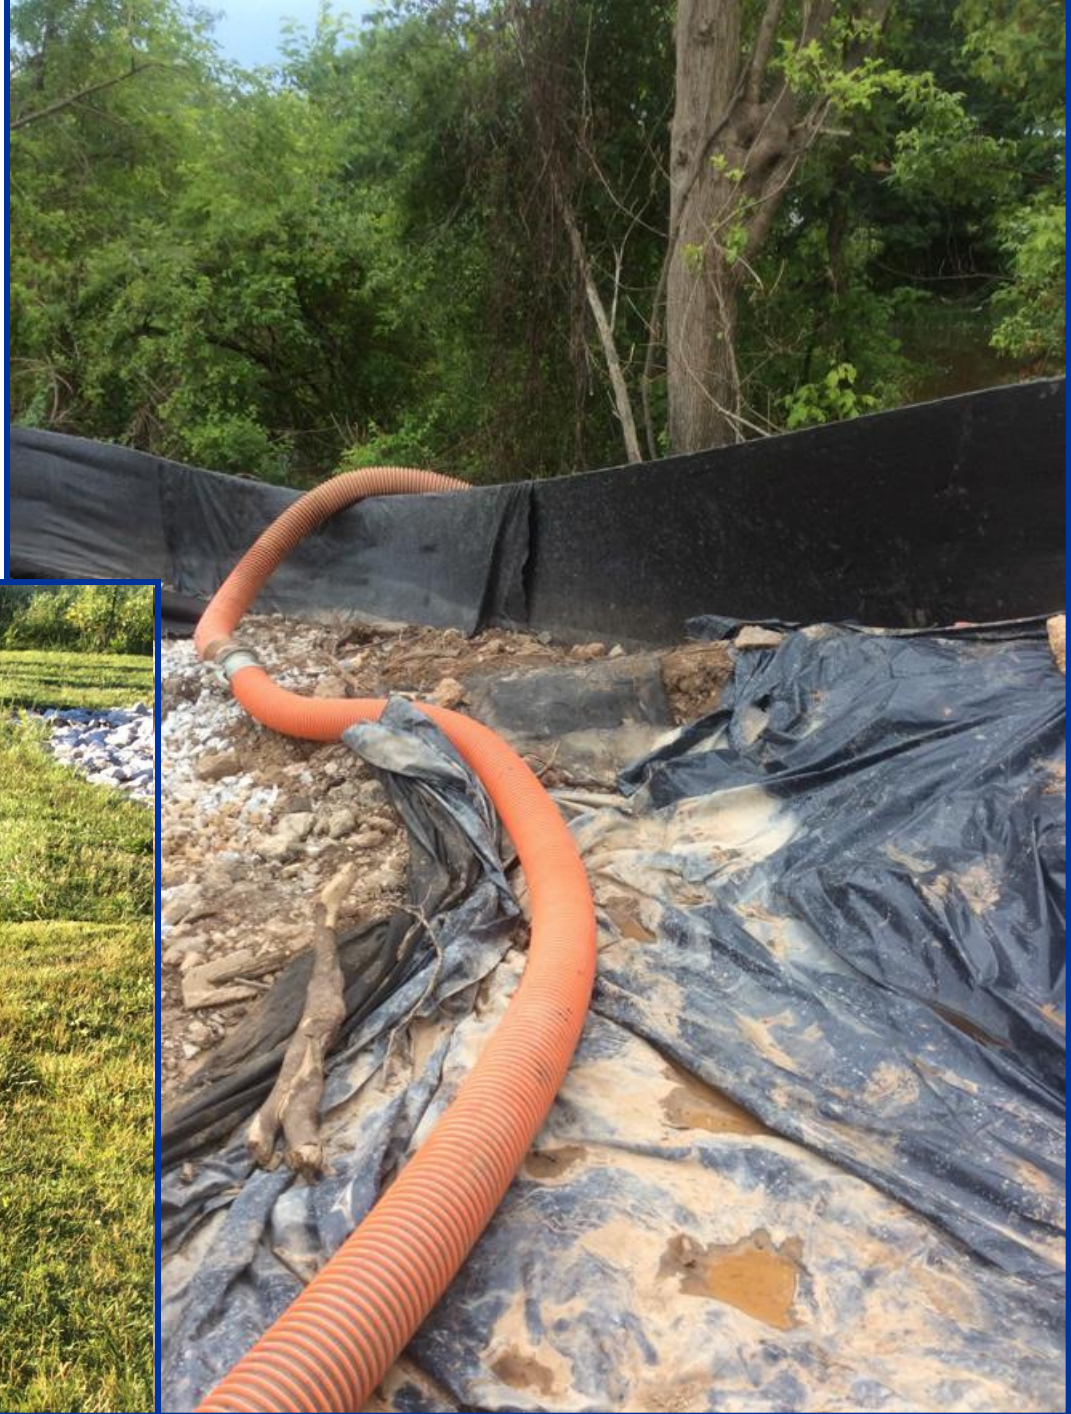
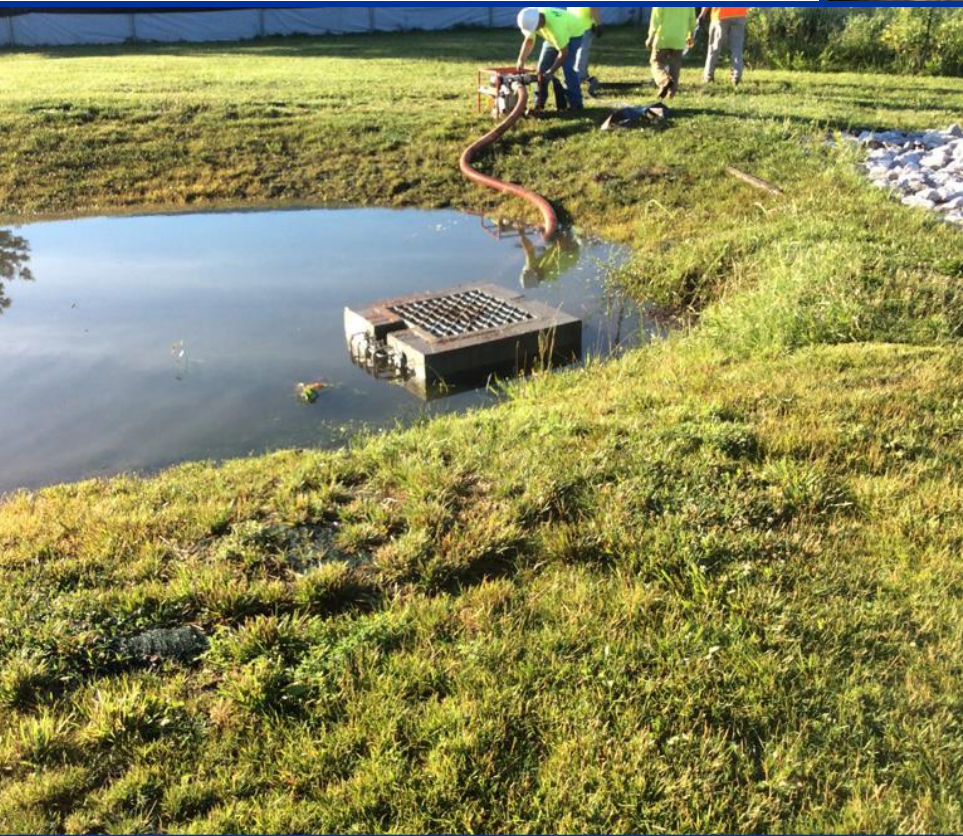
**June brought 15" of heavy rain and storm water was diverted from a swale, around an excavation area, to Cow Pen Creek, which is the normal discharge point for storm water from this swale.**

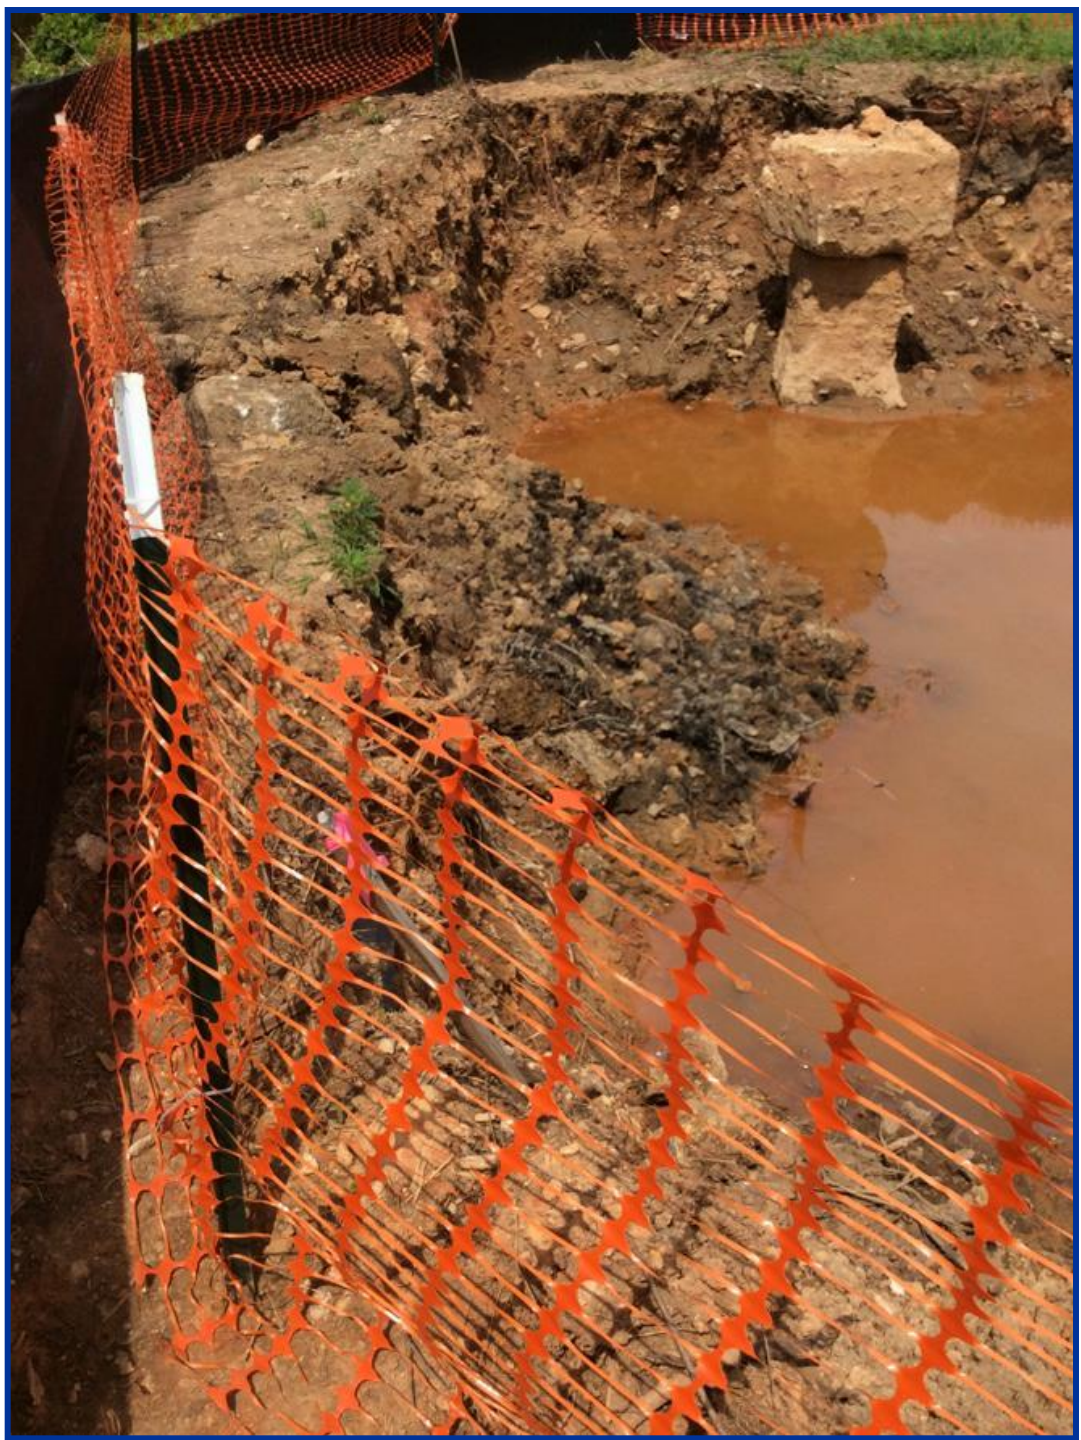
**A significant amount of rainfall had to be pumped from excavation areas in Block G, then stored in tanks. Water removed from excavation holes is being handled as contaminated (whether it is or not), unlike storm water at other areas of the property.**

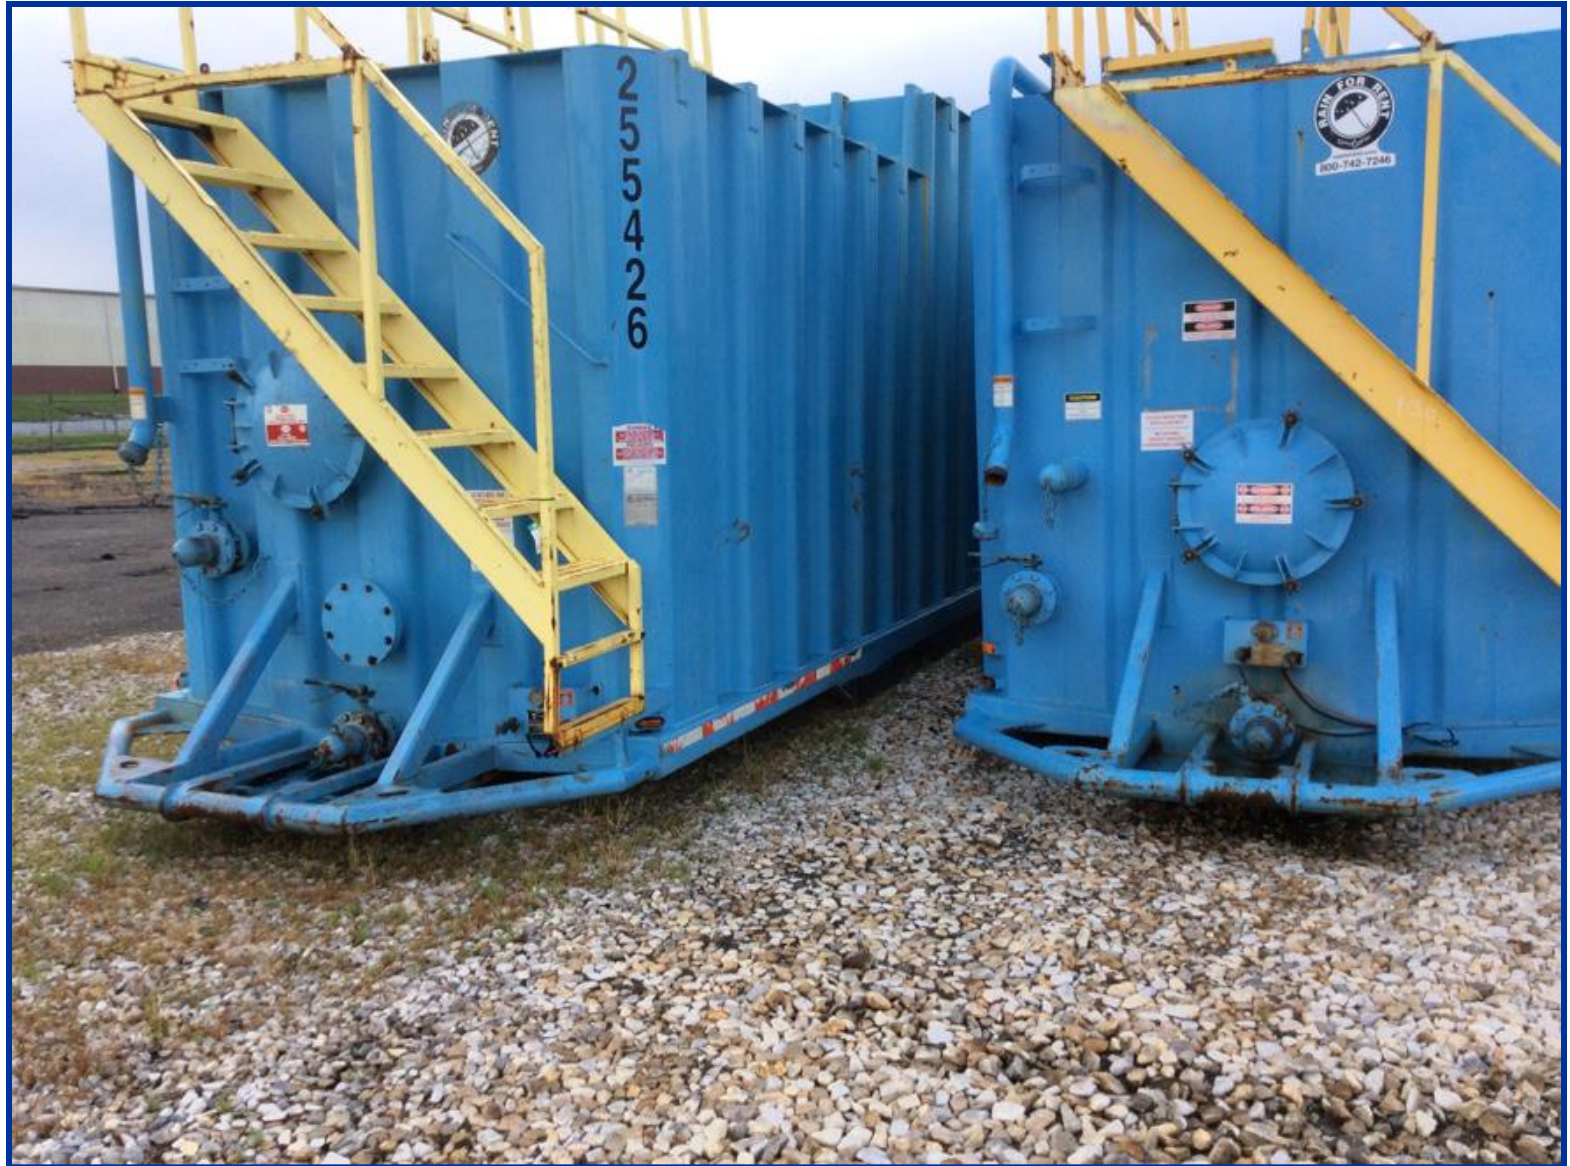
**Temporary storage tanks are used to store water and were brought onsite to pump water into after collecting in excavation holes, followed by proper treatment at a licensed treatment facility.**

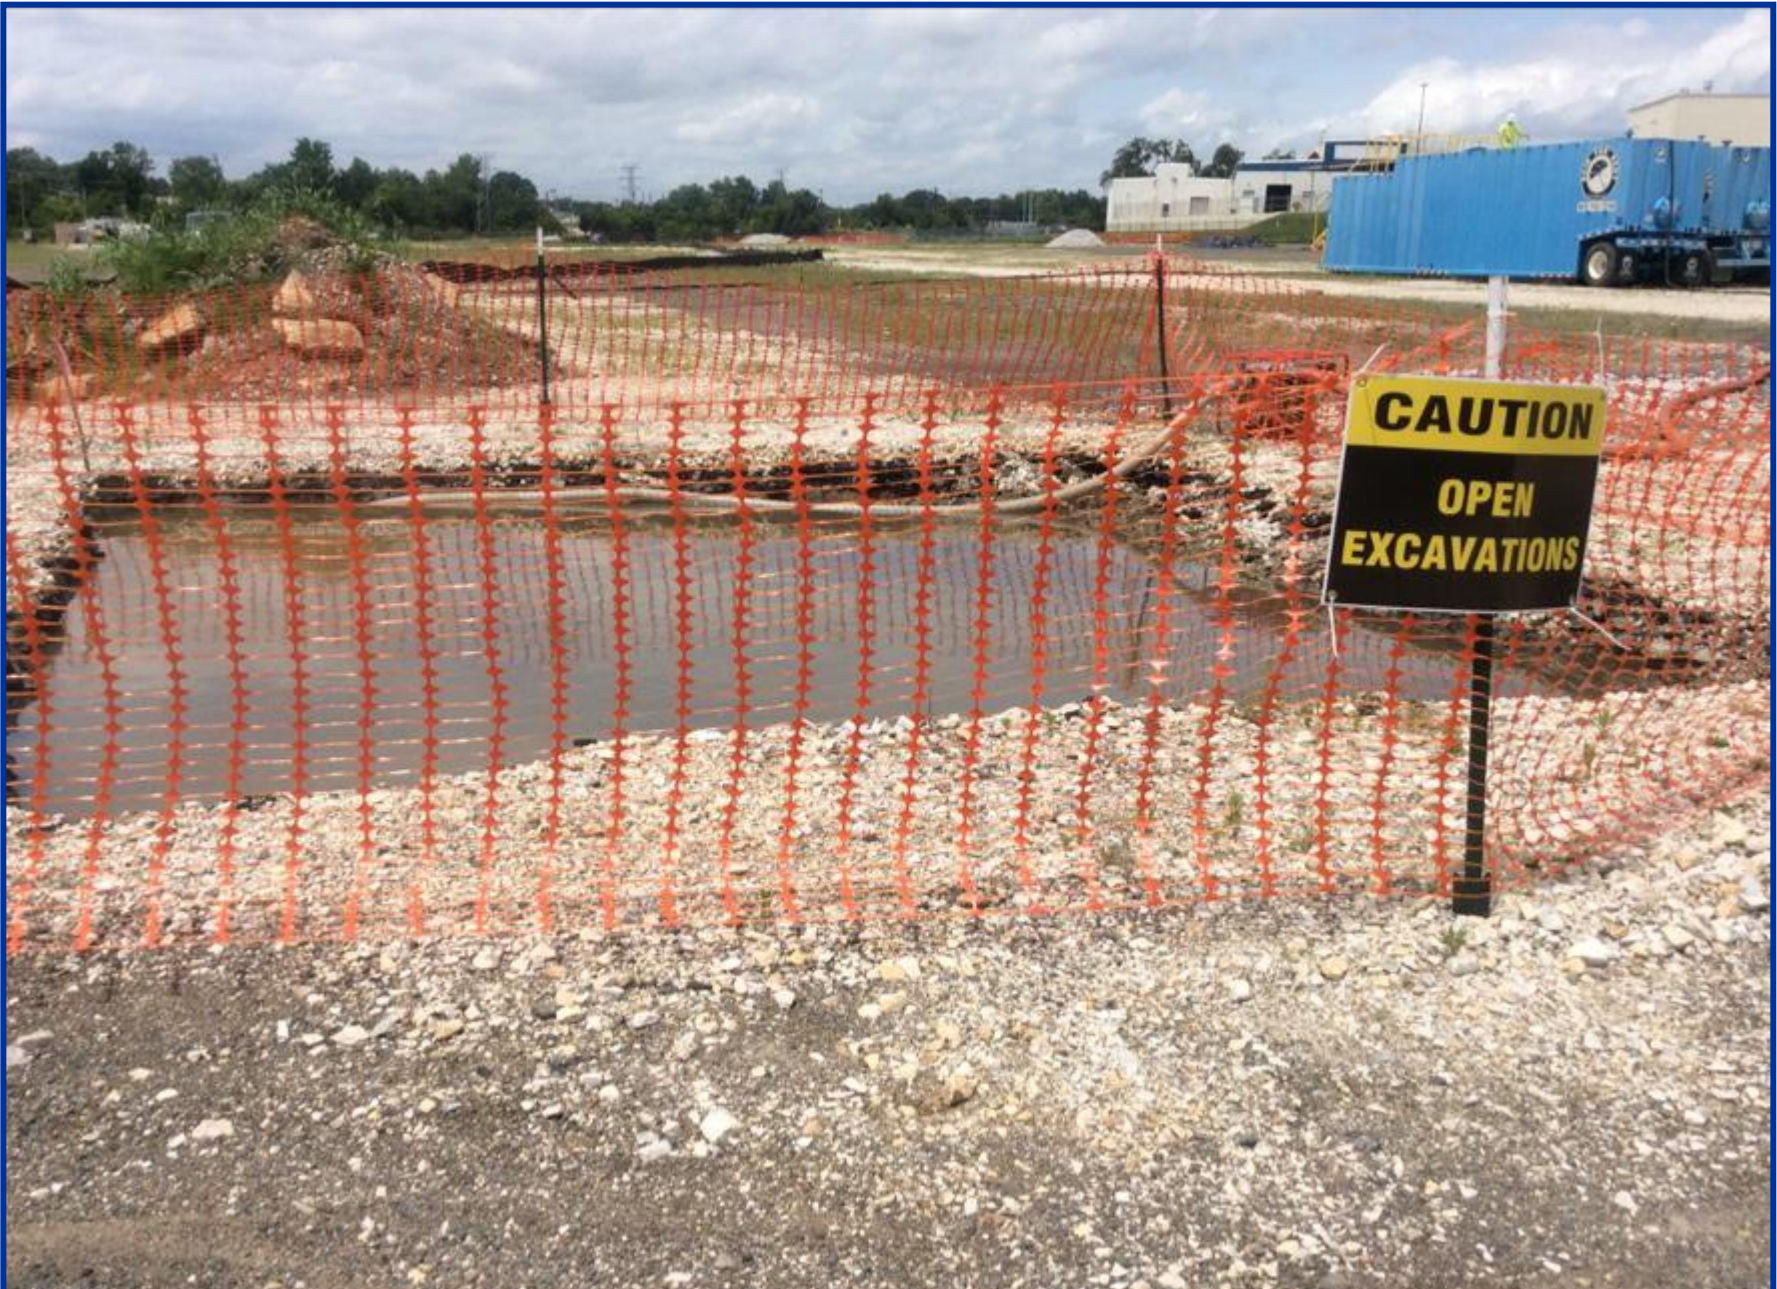
**Storm water was pumped out and sent to storage tanks located in Block G.**
