# Soil Remedial Actions at Middle River Complex - 2015

Project Photo Tour  
Updated September 15, 2015

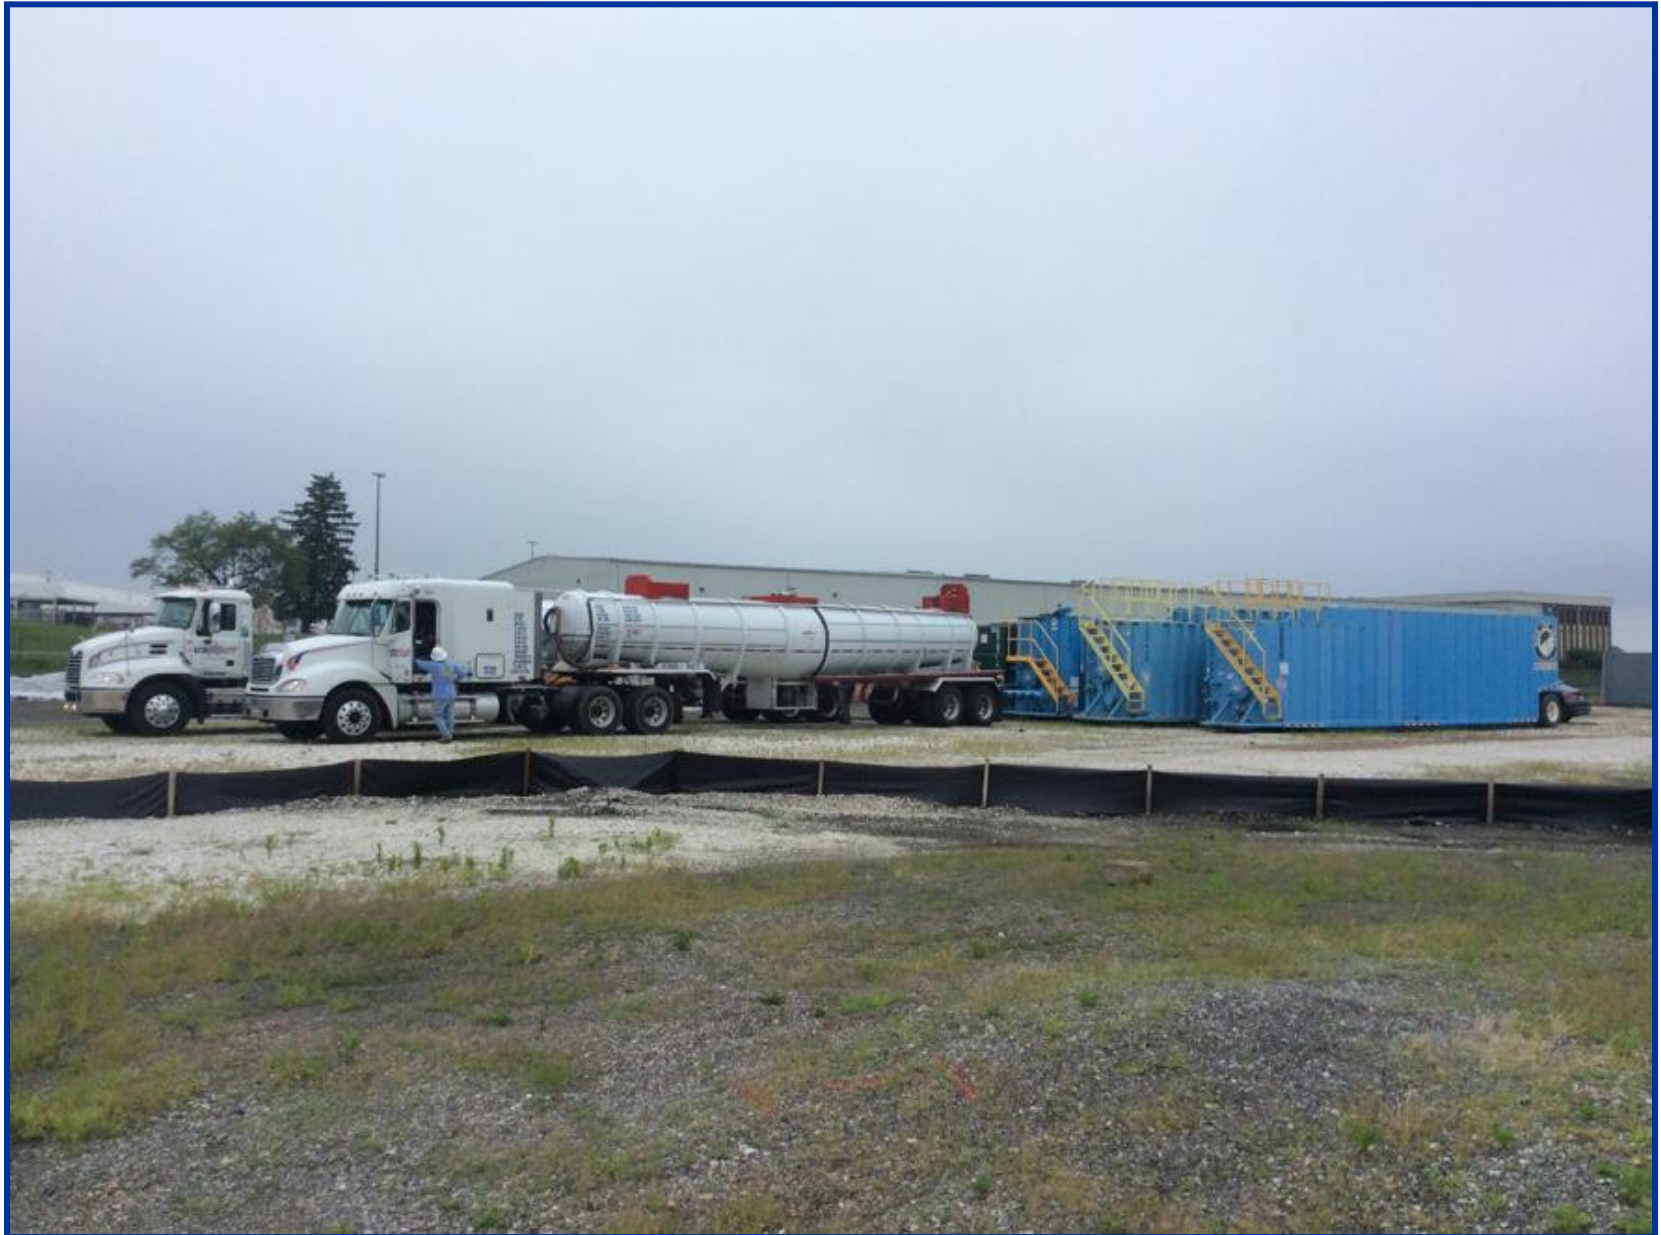
**Tanker trucks transferred water from storage tanks in Block G to transport for proper treatment at Clean Harbors' Baltimore Facility.**

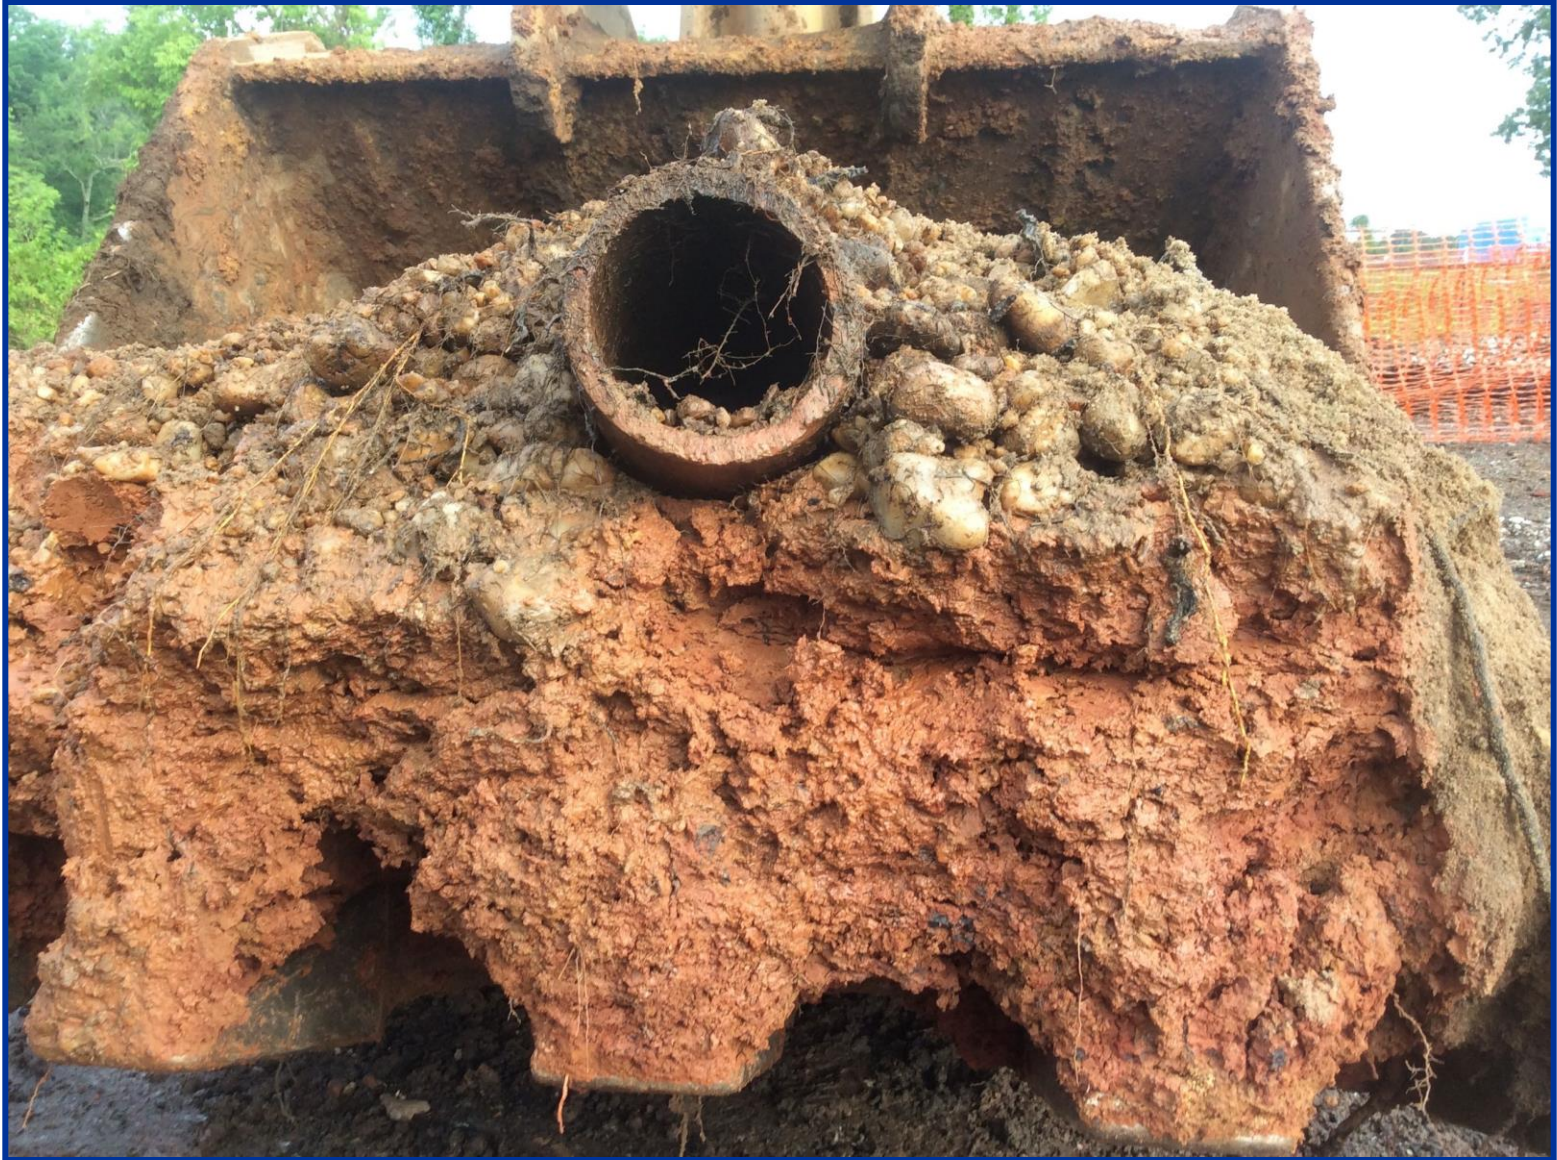
**Soil surrounding a suspected Underground Storage Tank (UST) area in Block G shows terra cotta piping with pebble fill material and a clay layer underneath. Soil samples were taken from this clay layer. No UST was found in the original search.**

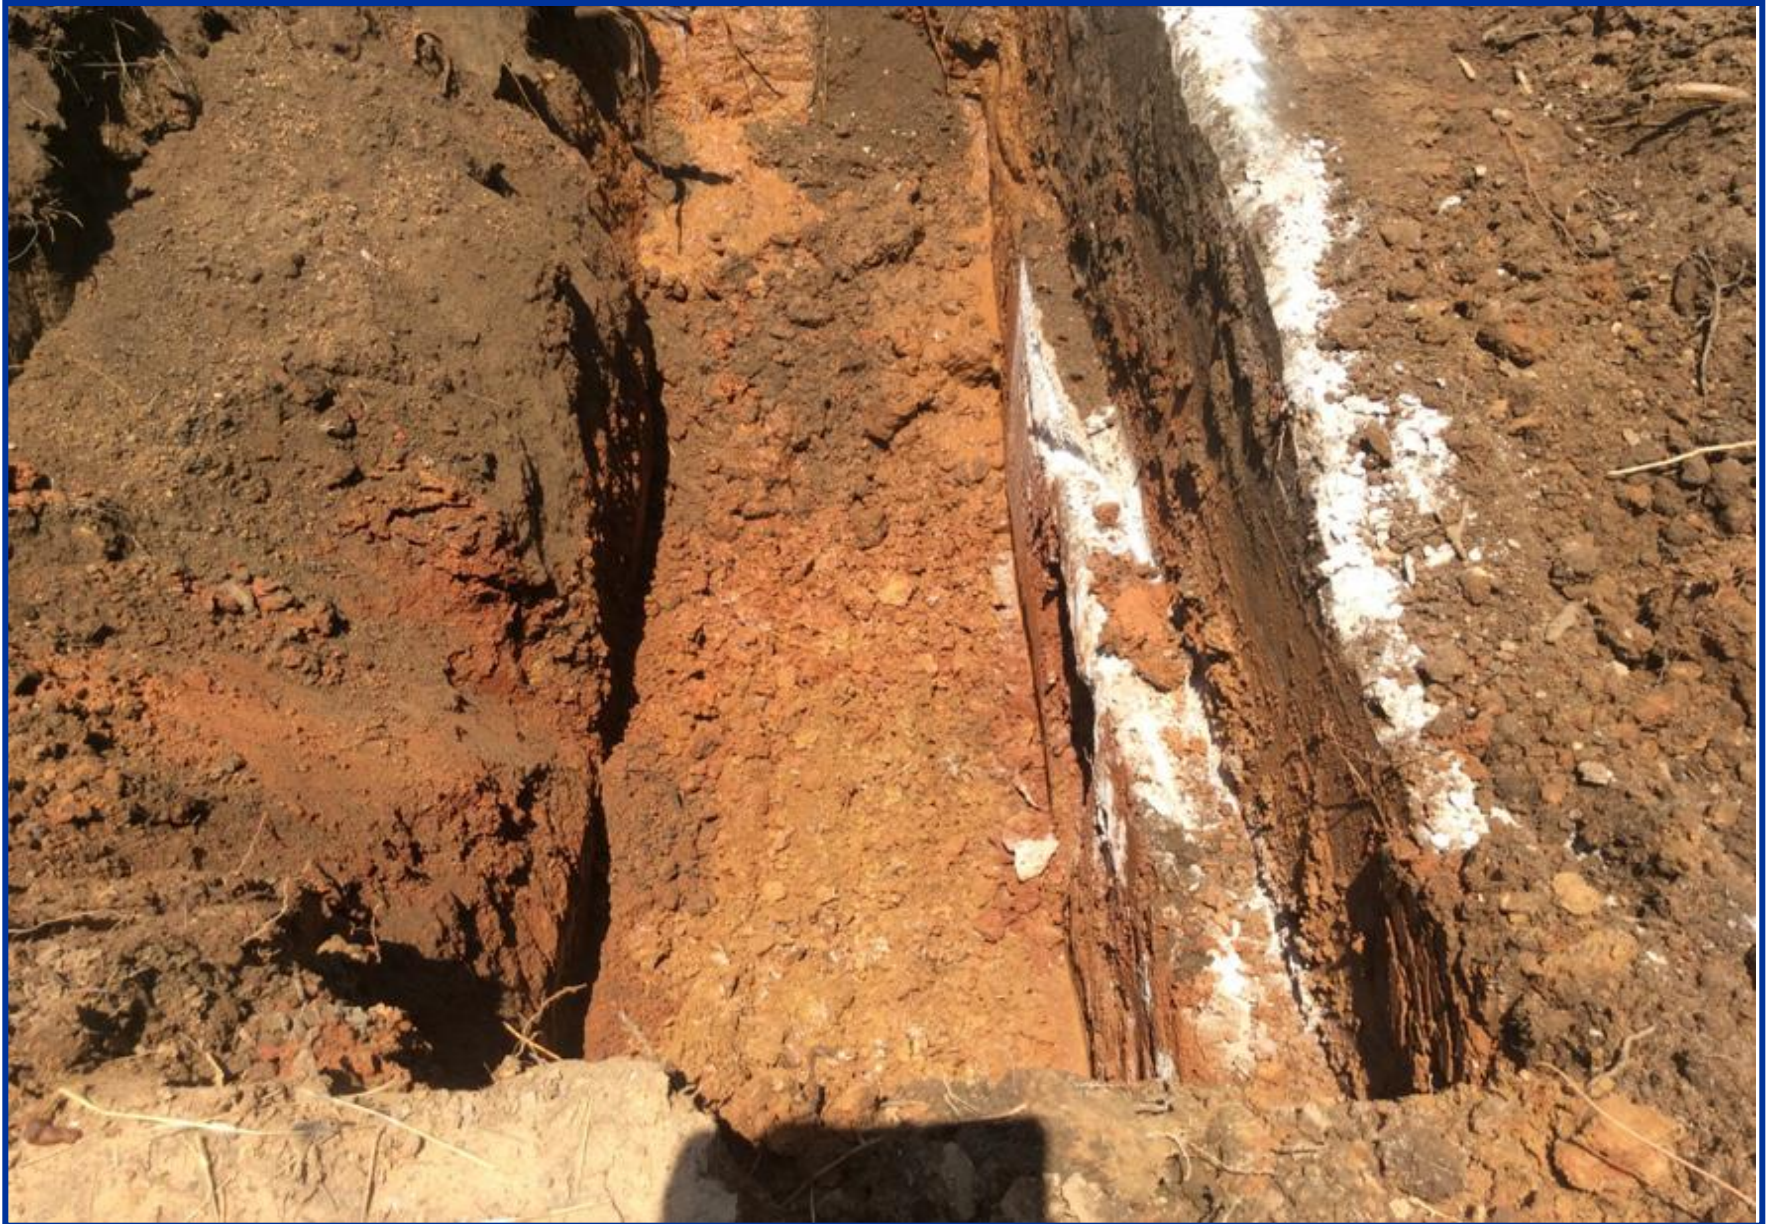
**Exploratory digging for a suspected Underground Storage Tank (UST) in Block G is shown, however no UST was found.**

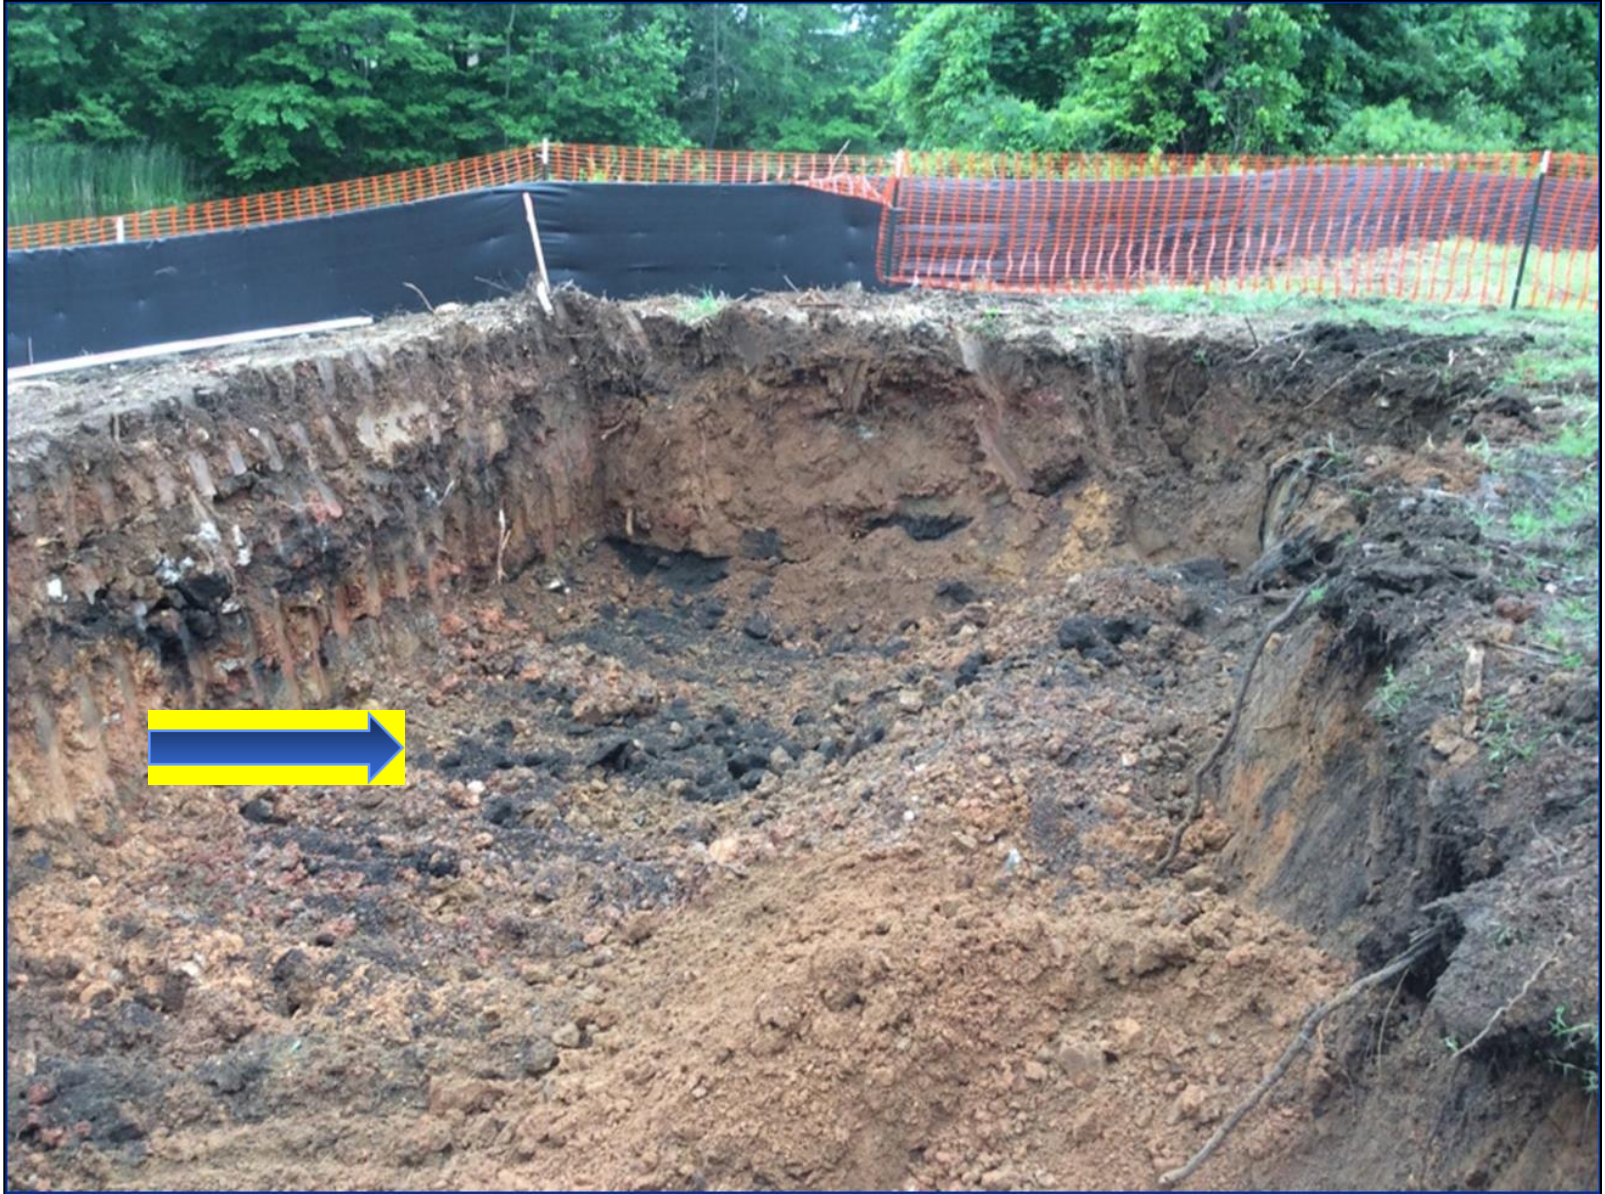
**At one Block G excavation area an asphalt layer was uncovered, seen at approximately 3 feet below ground surface (bgs) on the left sidewall and approximately 5 feet bgs on the front sidewall.**

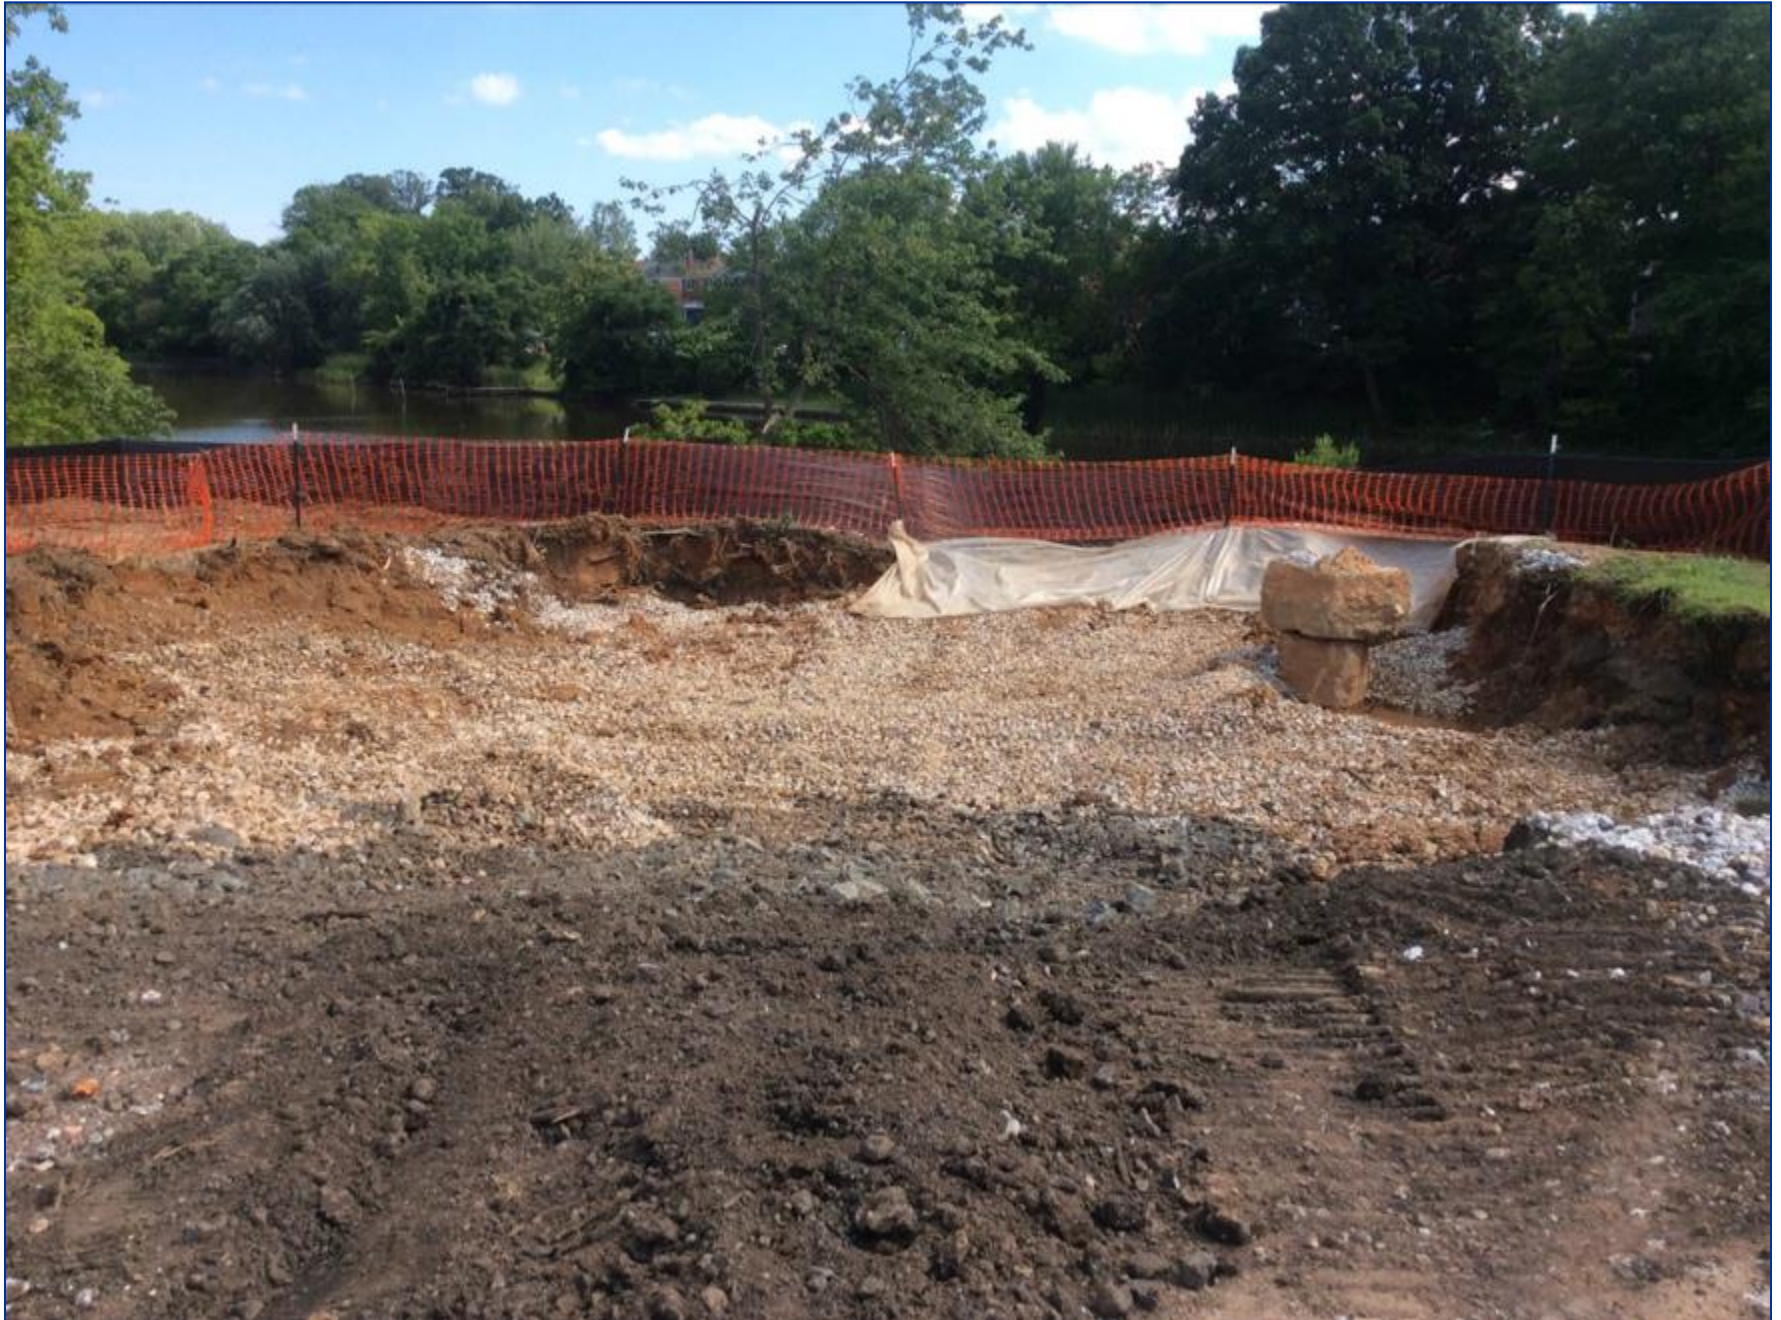
**The Block G excavation area was partially backfilled with stone.**

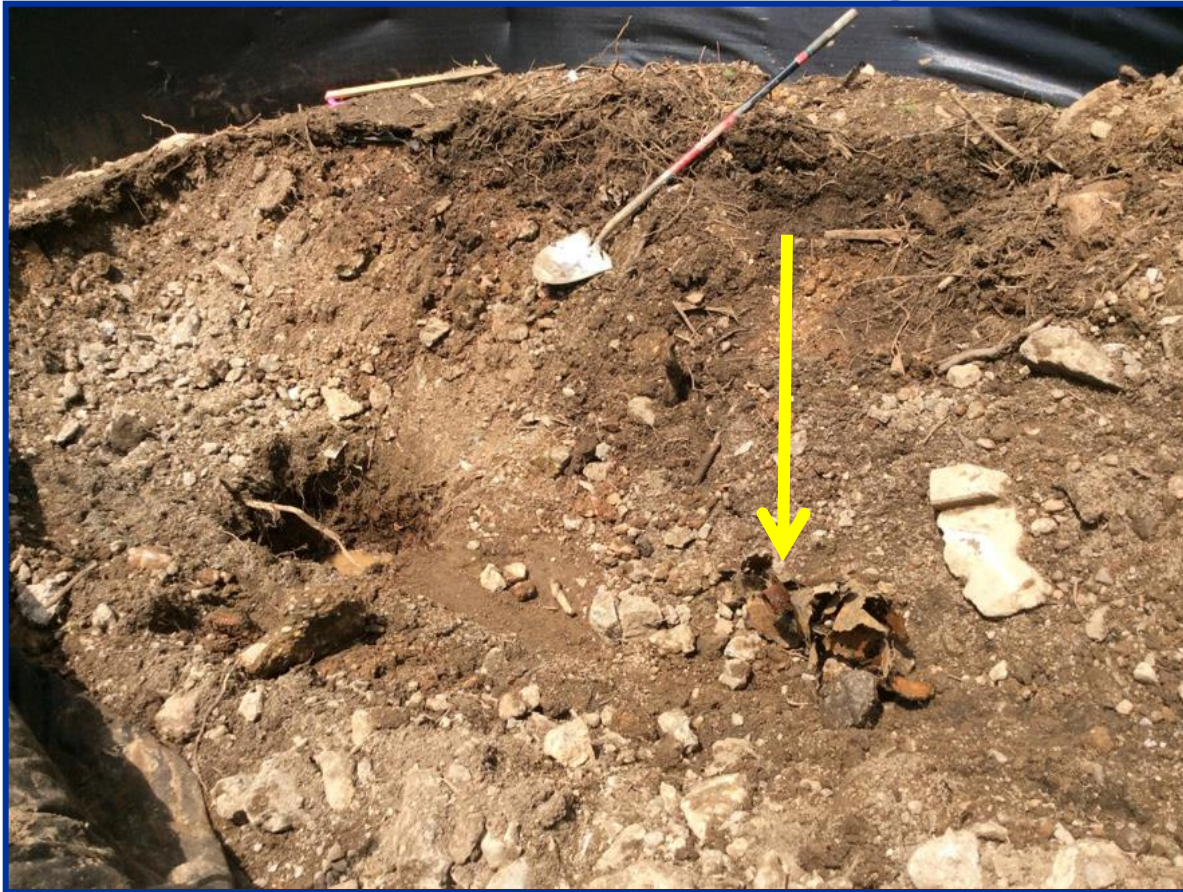
**Transformer parts were discovered when installing a storm water discharge ditch. Residual metal from a transformer housing is shown in the lower right. Historic interviews with a retired employee revealed that such parts might exist.**

**Since transformers may have originally held polychlorinated biphenyls (PCBs), surrounding soil was analyzed and PCBs were found at low concentrations, which may or may not relate to transformer parts.**

**Additional investigation had to be planned for later in 2015, and is resuming now that permits are in hand to allow for expanded work areas toward Cow Pen Creek in Block G. Pending the results of those investigations, additional work may be required in the future.**

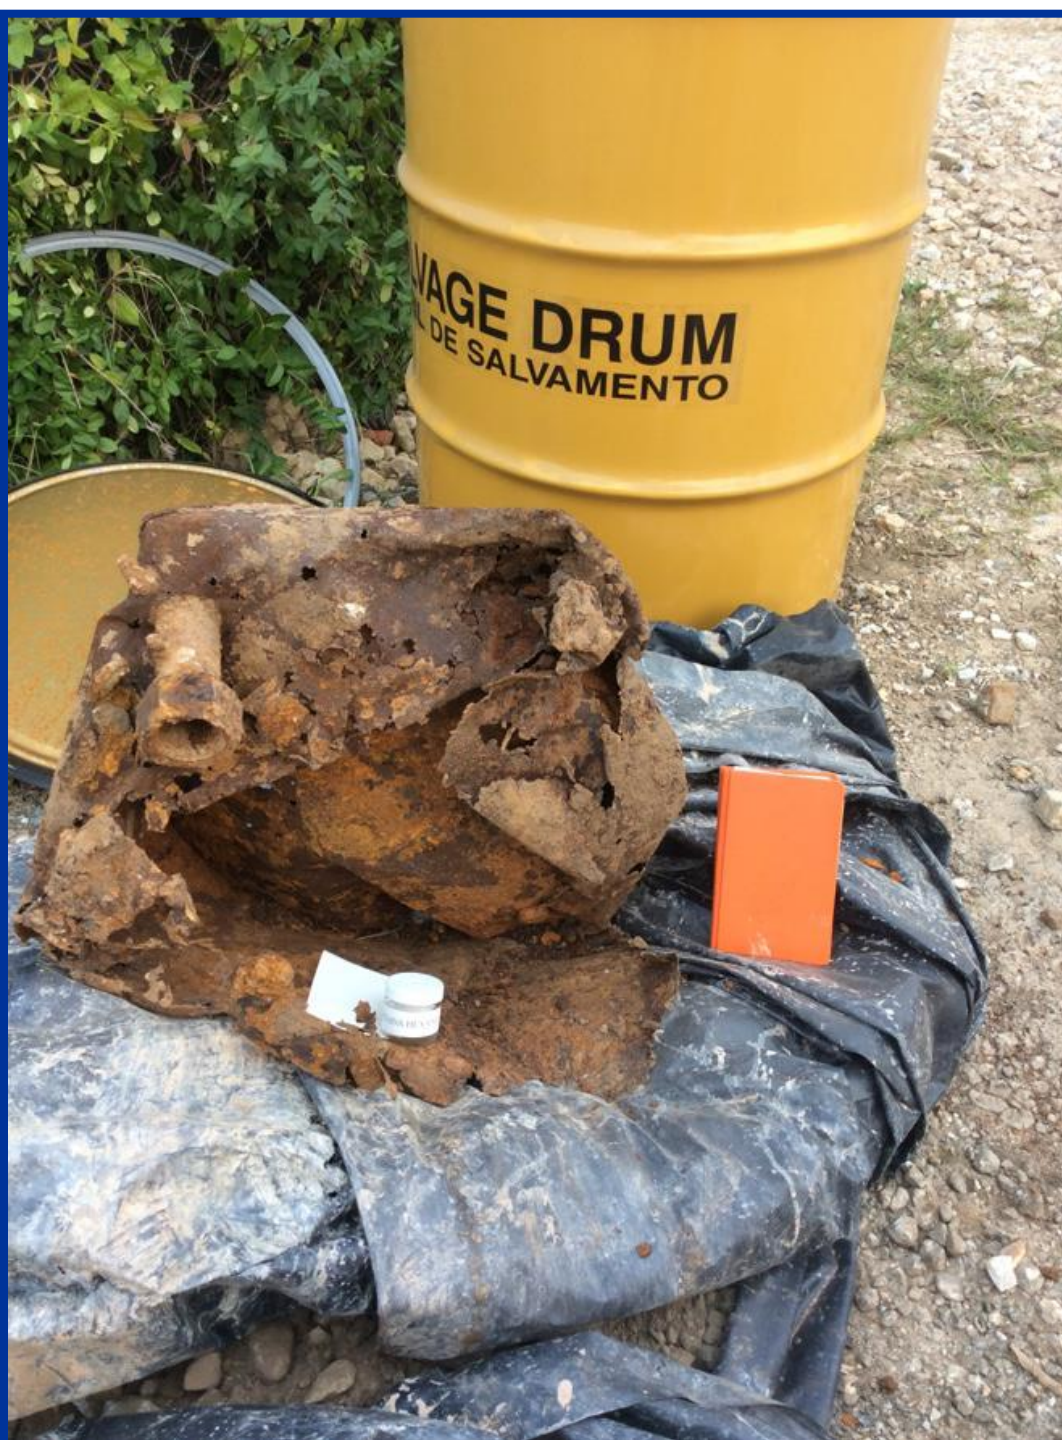
**The transformer housing found was sampled to determine whether polychlorinated biphenyls (PCBs) contamination is present, so it can be disposed properly.**

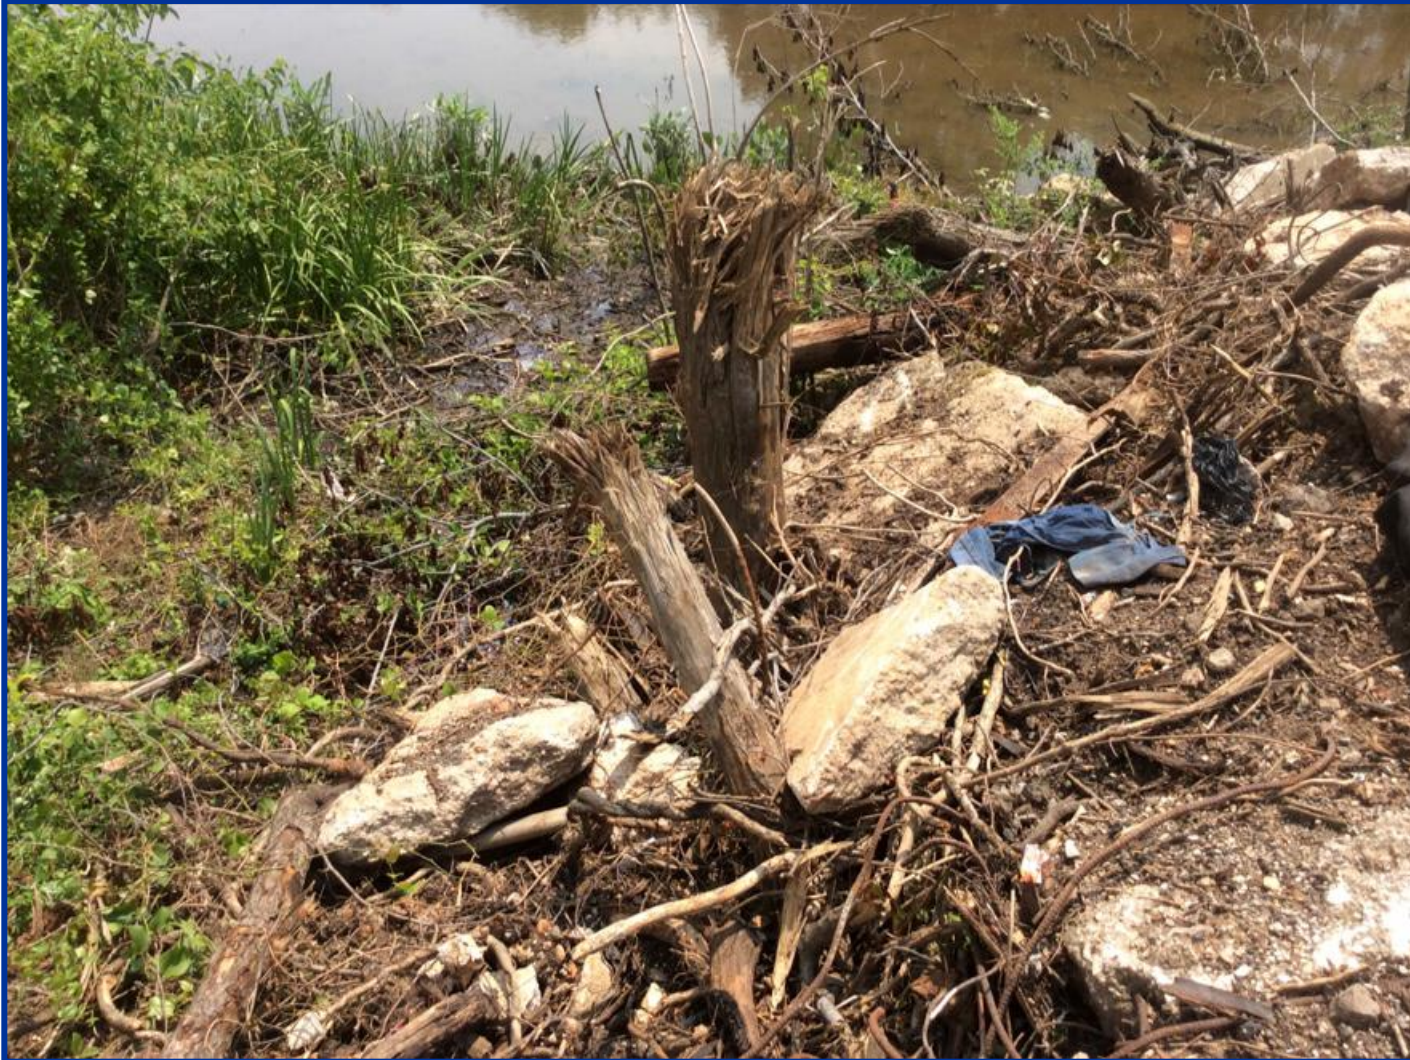
**The area near Cow Pen Creek was filled with rubble and debris, including large concrete pieces, which are assumed to be the foundations of a former facility. Partial removal of this debris is planned for 2015, but excavation efforts revealed a larger project than could be accomplished with current planned work.**

**Future  
Planned Work  
is required to  
address the  
entire debris/  
transformer  
area.**

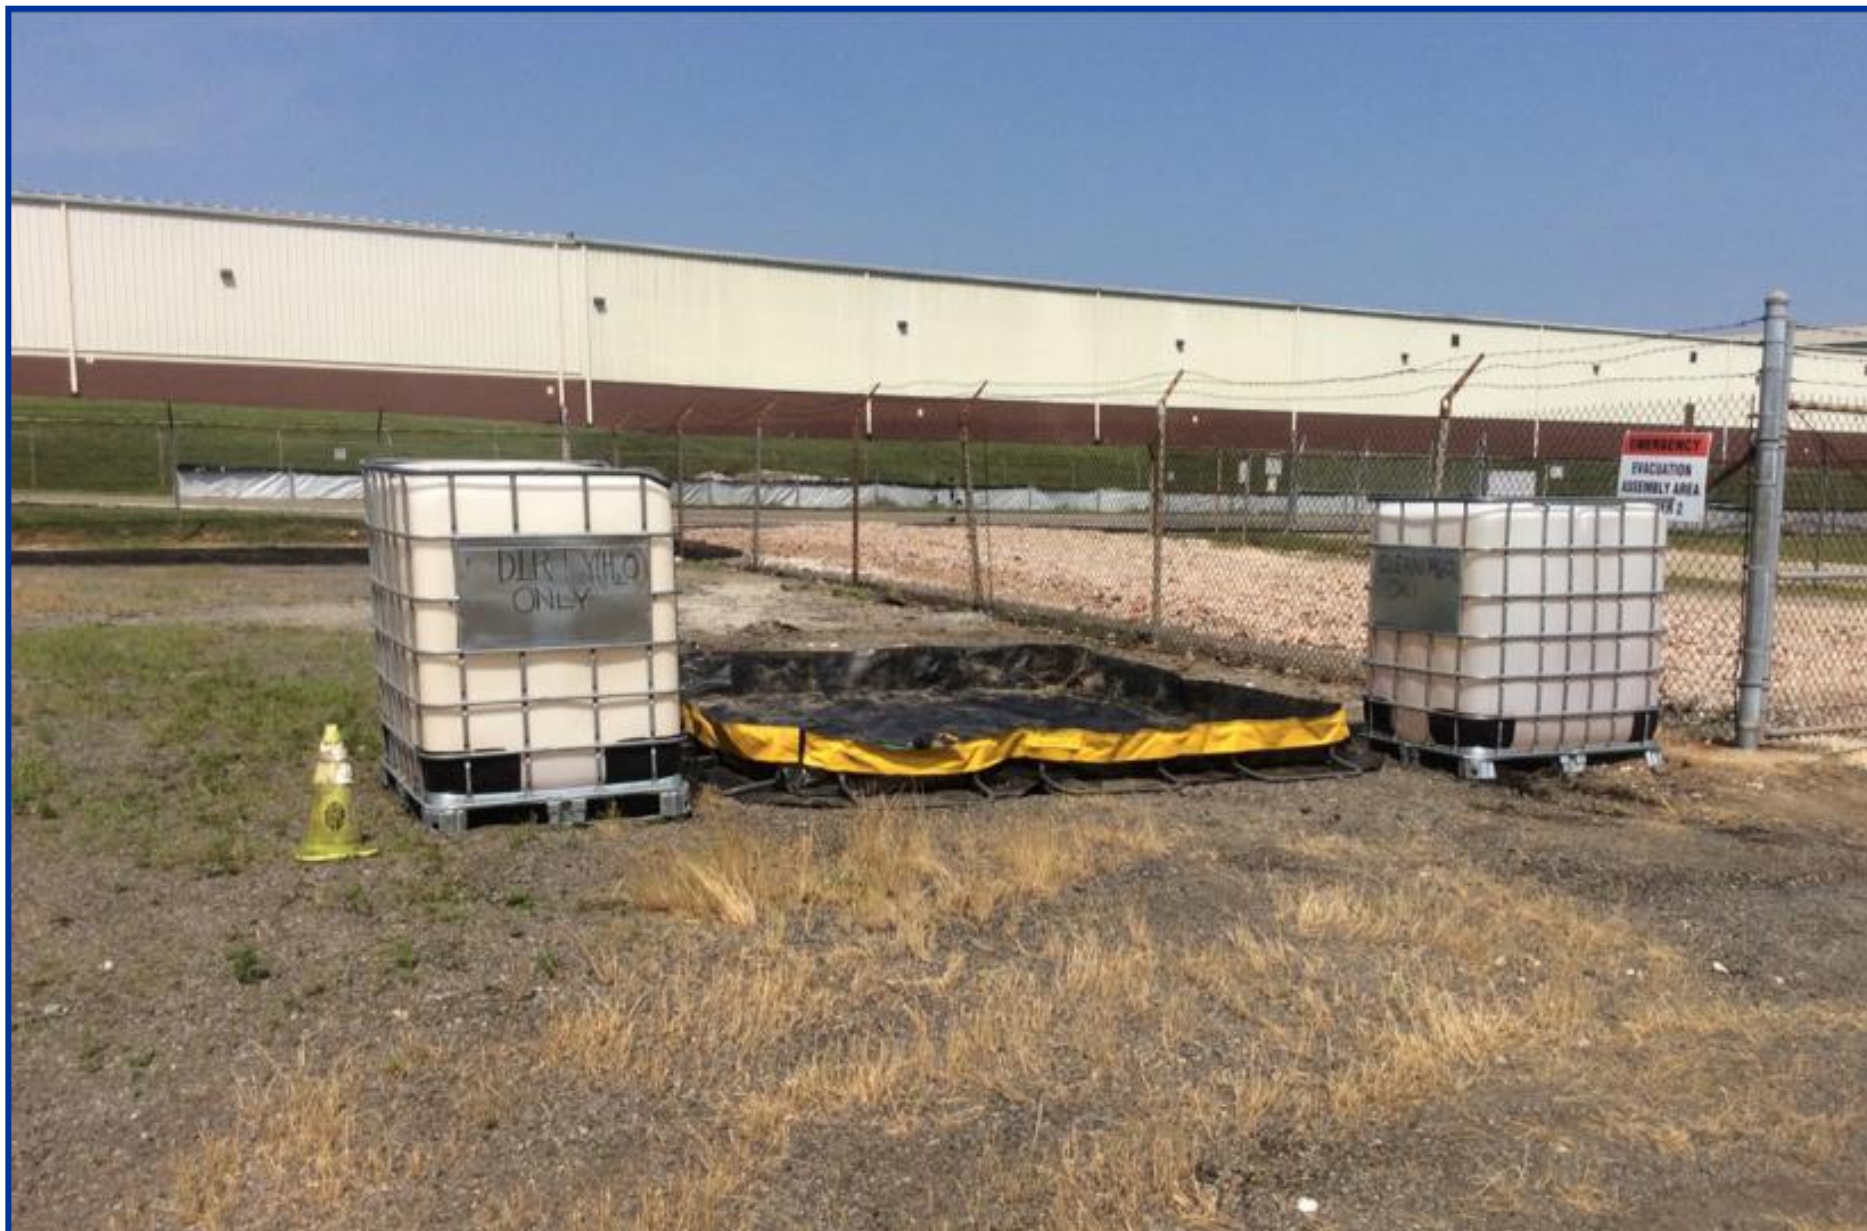
**As work progresses to each work area, the equipment must be decontaminated. A decontamination area was set up in Block G.**

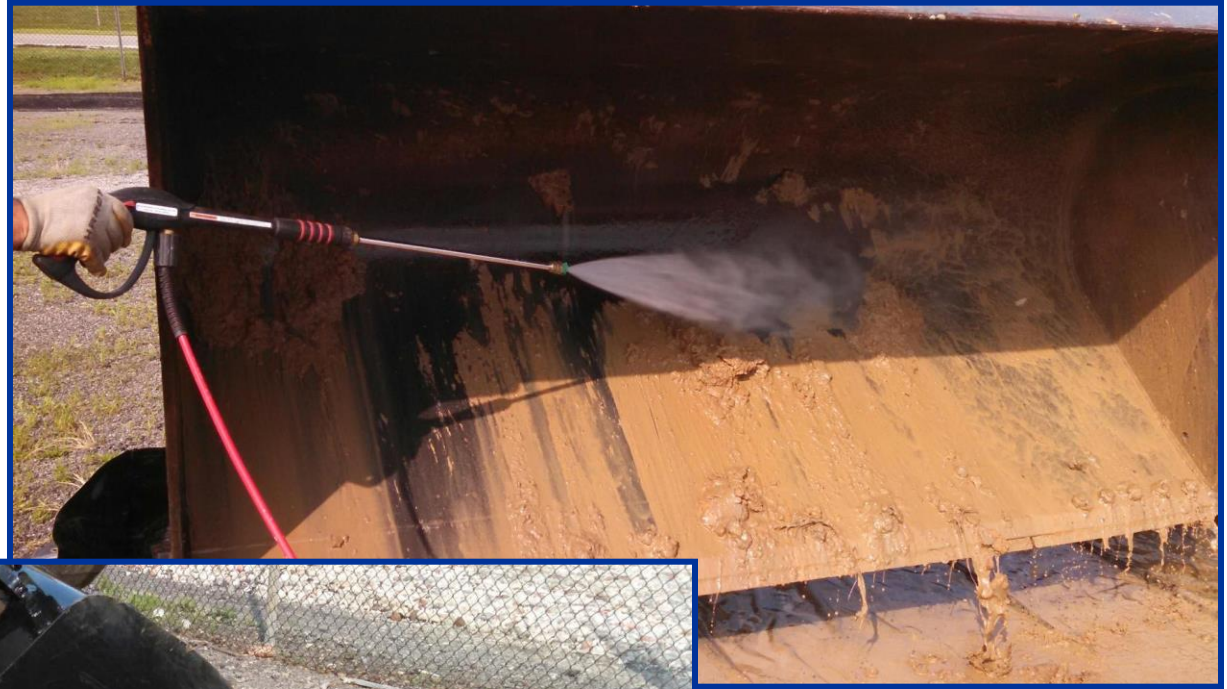
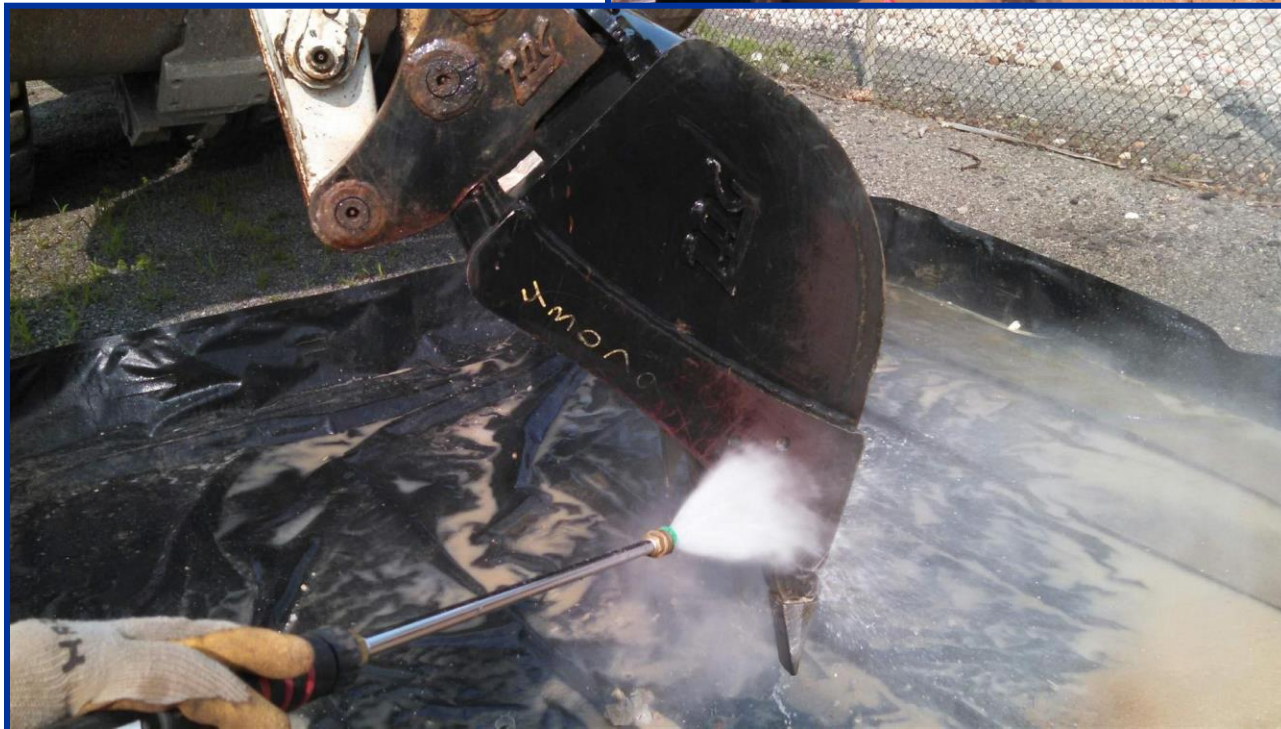
**Cleaning of all equipment occurs before leaving any work area. Shown here are a mini-excavator bucket and front end loader being cleaned.**

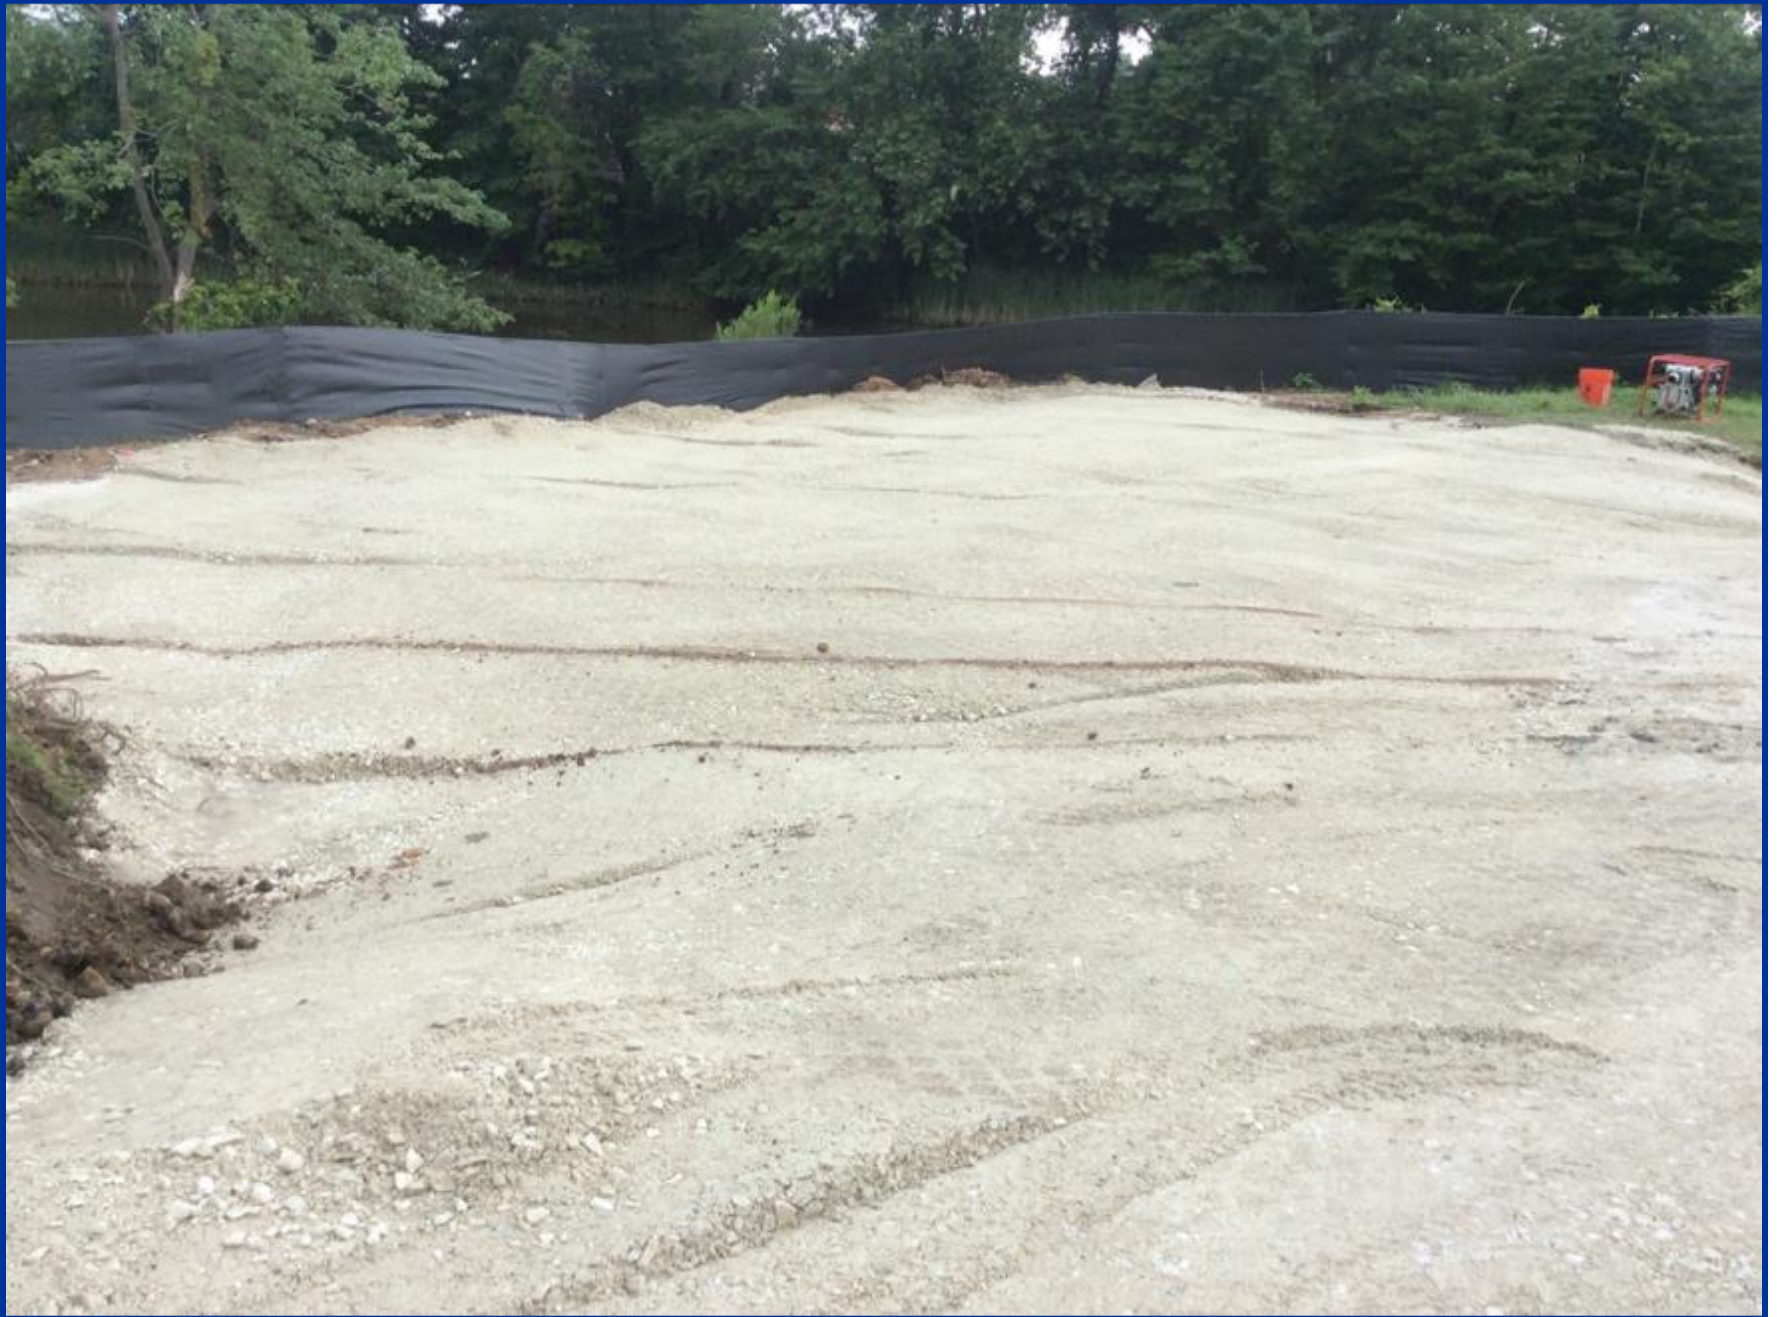
**One completed area in Block G was backfilled with crushed rock.**

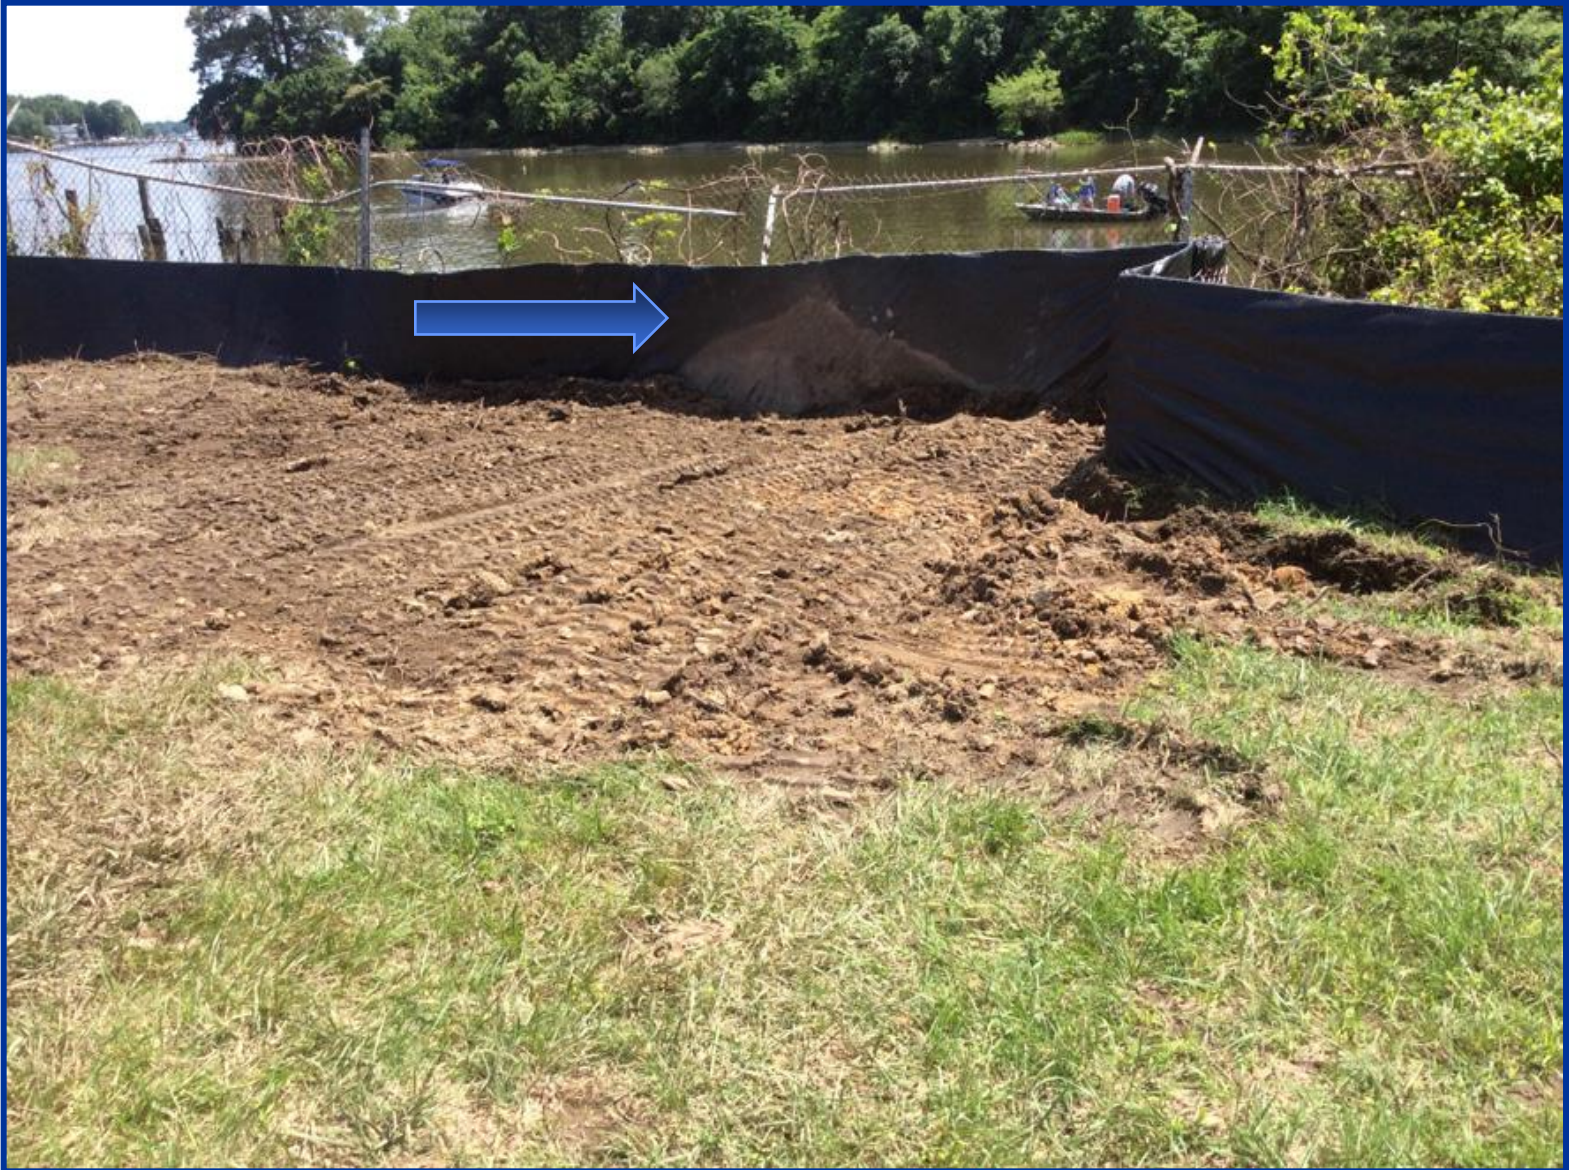
**Block F work followed Block G. With high rains, the installed silt fence needed repair in Block F. Note high water mark on fencing due to sheet flow through grass.**
