# Soil Remedial Actions at Middle River Complex - 2015

Project Photo Tour  
Updated September 15, 2015

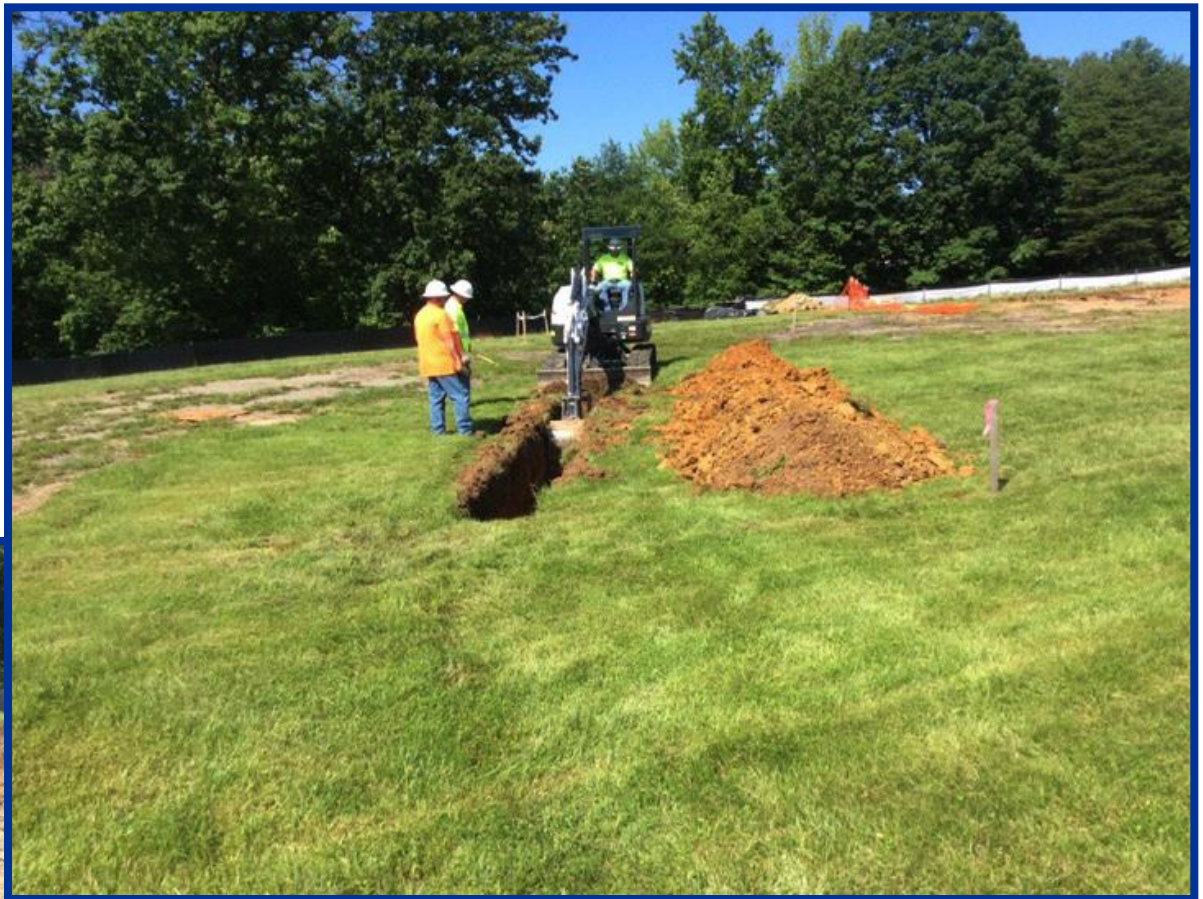
**In Block F test pits were dug searching for storm drain pipelines.**

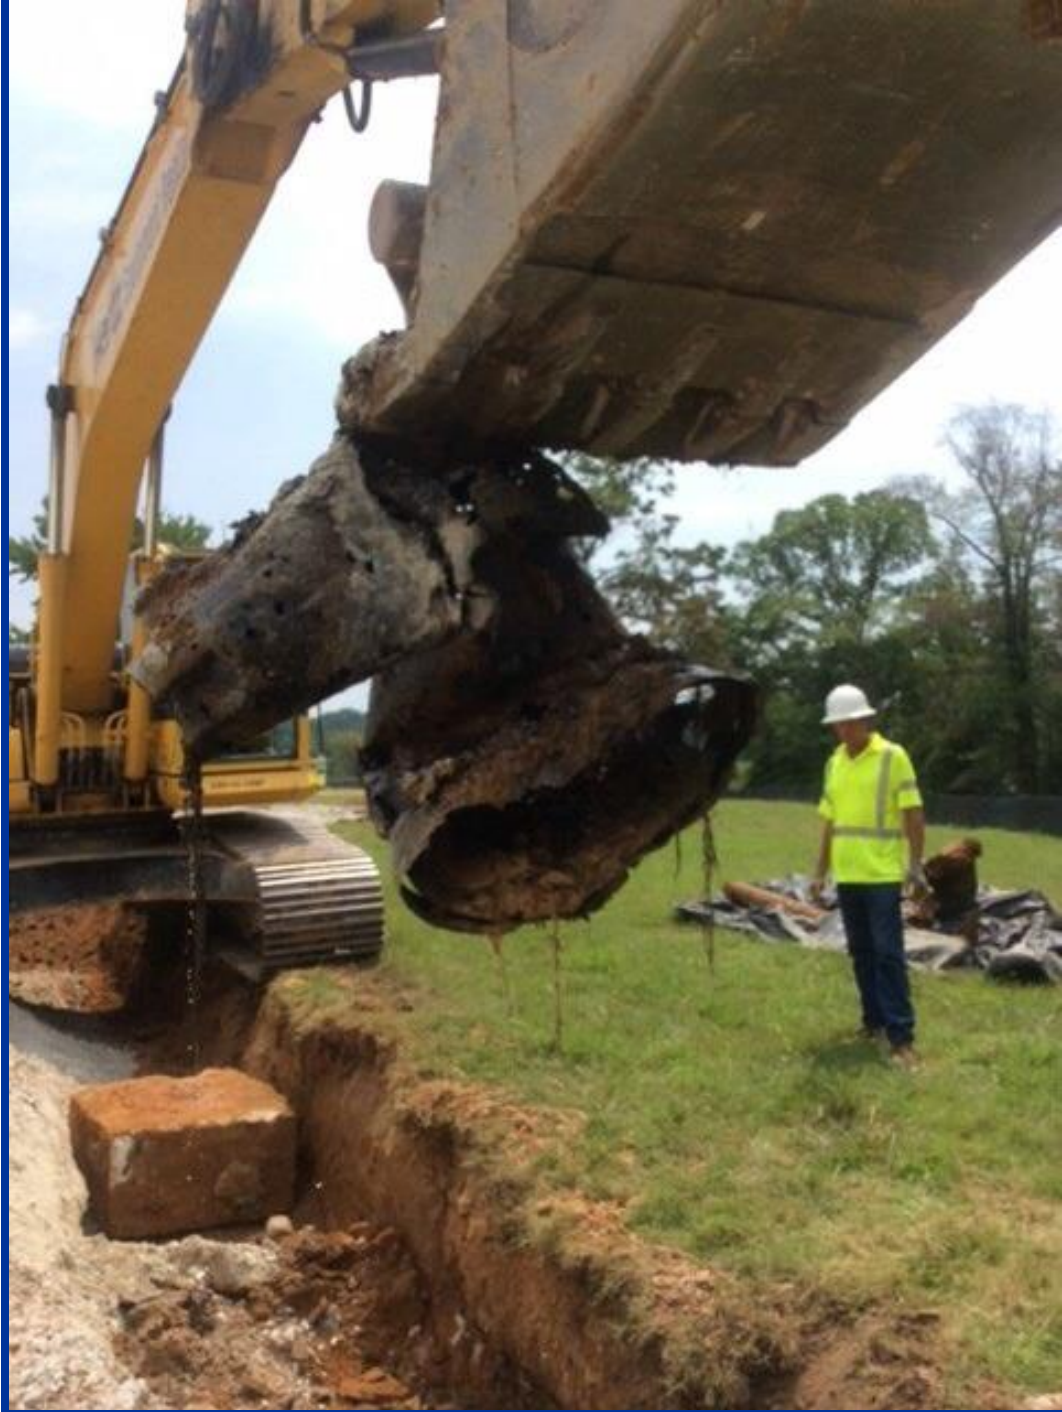
**The test pit was dug to verify the presence of a storm drain that was identified on construction plans, so it could be protected during soil removal activities if it was still in use.**

**Buried debris found in Block F included a cement block. Also removed was piping associated with an abandoned storm drain line.**

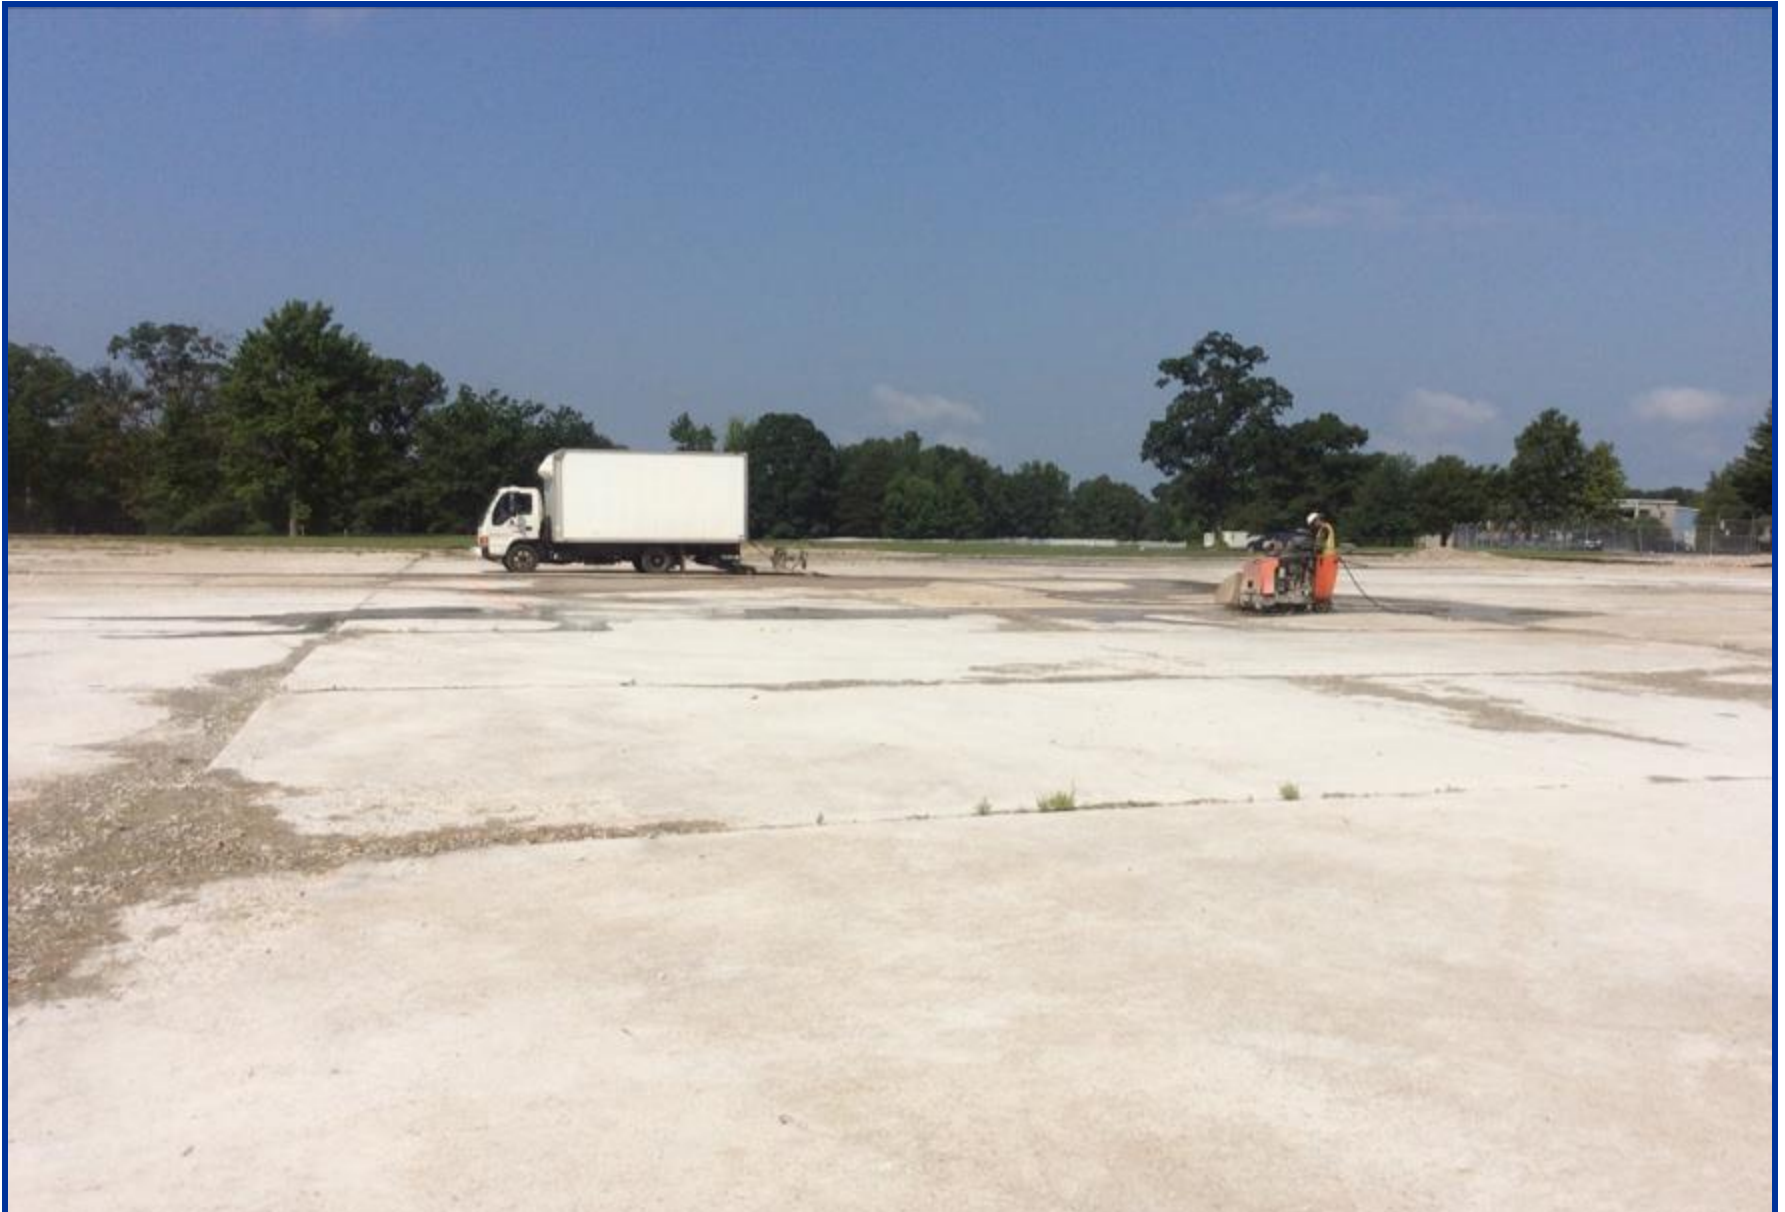
**Shown here is saw cutting of areas in Block F to be excavated where seven Underground Storage Tanks (USTs) were anticipated. Six were found; and a seventh tank is still being sought.**

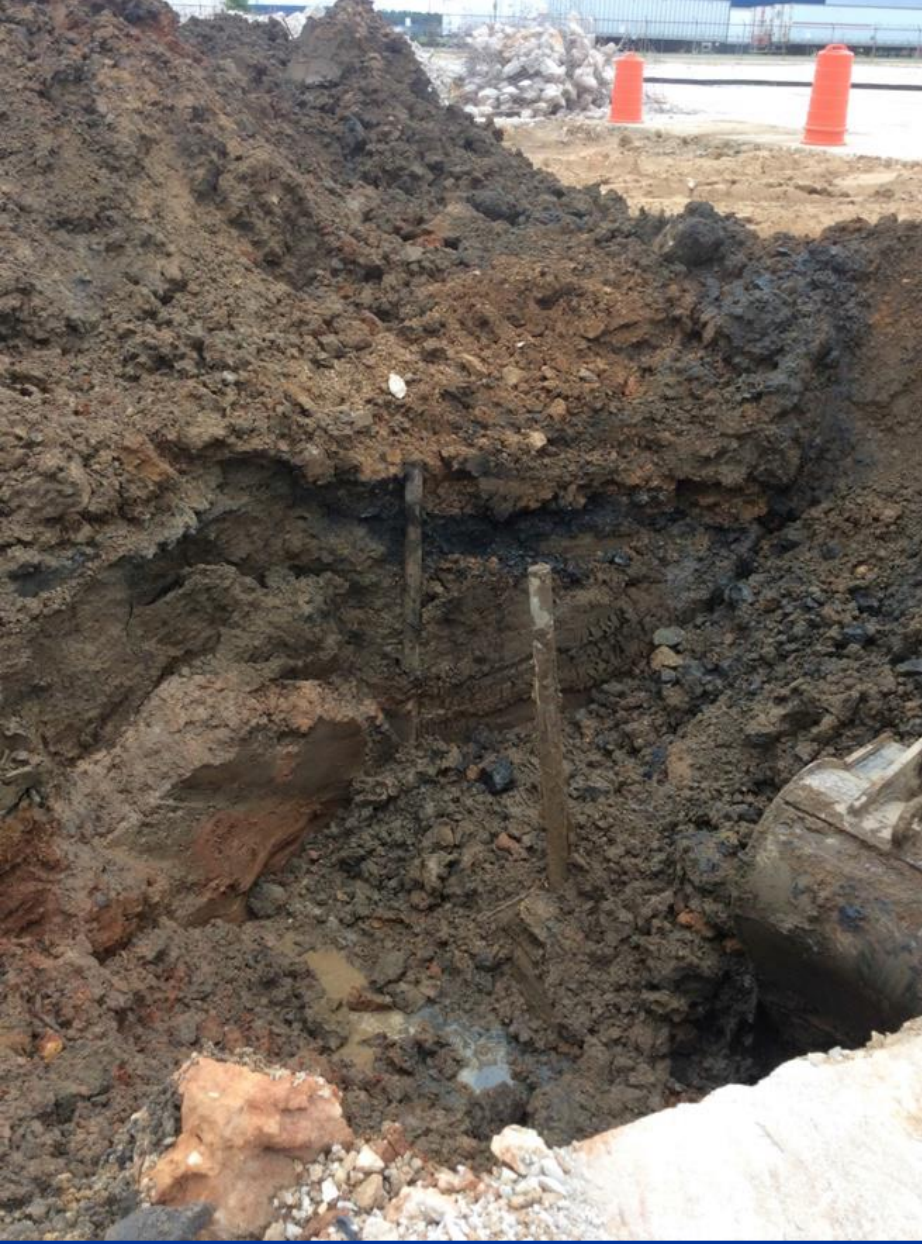
**Associated UST parts such as this piping and valve fitting were uncovered**

**Six Underground Storage Tanks were located in Block F in August. Shown at left are two riser pipes from two steel tanks; both appeared to be installed into a concrete pad.**

**Permitting regulators will approve the planned tank removal work.**

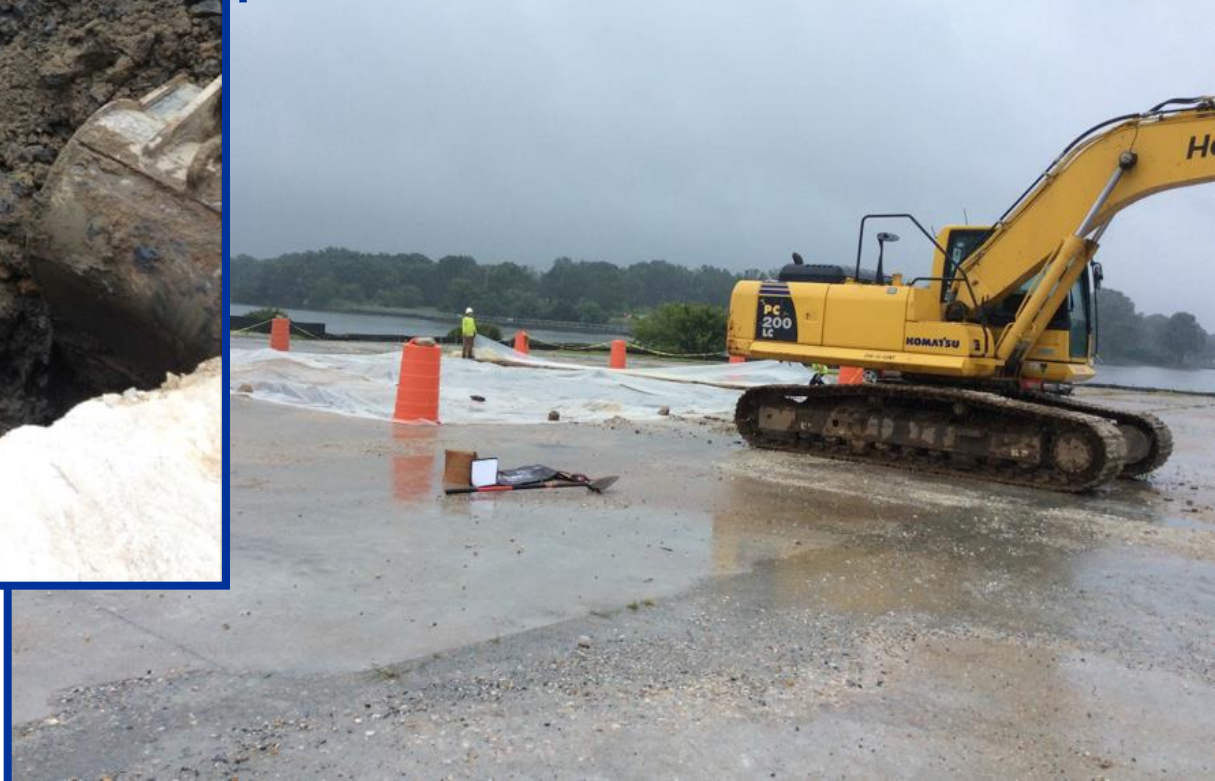
**Shown below, the tank excavation was plastic covered awaiting a planned excavation later in 2015.**

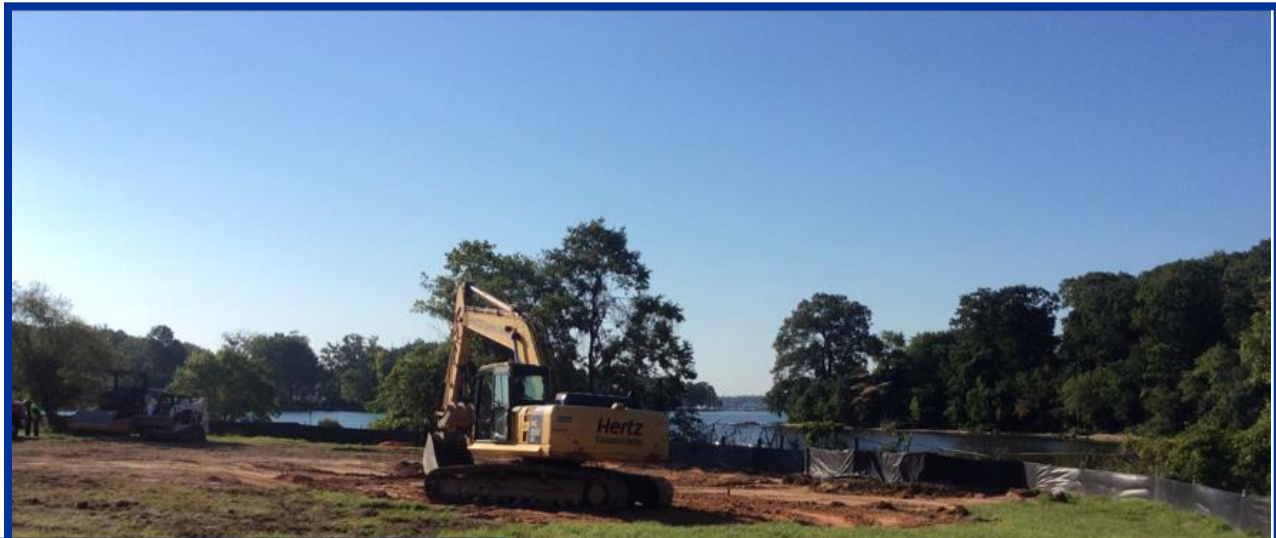
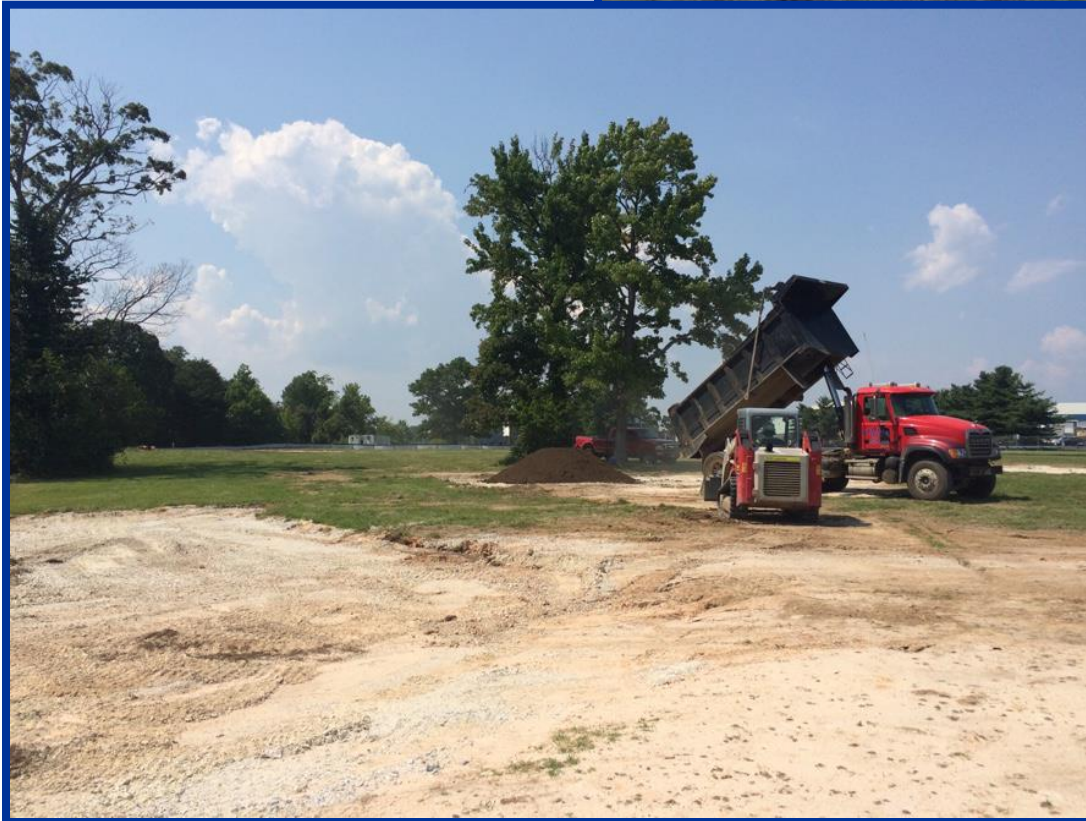
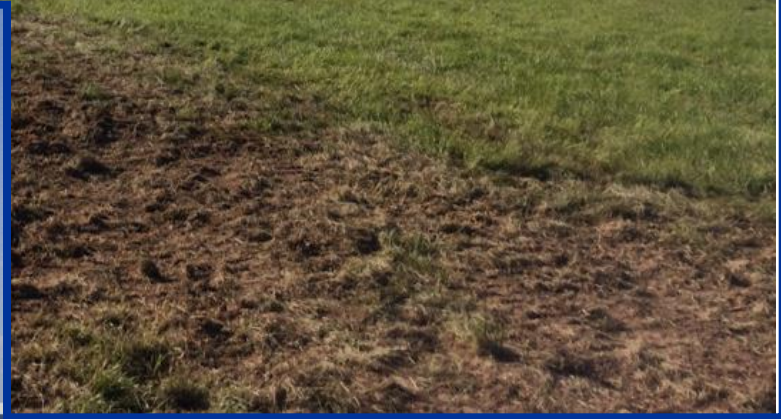
**Grassy areas in Block F were returned to original condition. Shown here cover soil is being smoothed.**

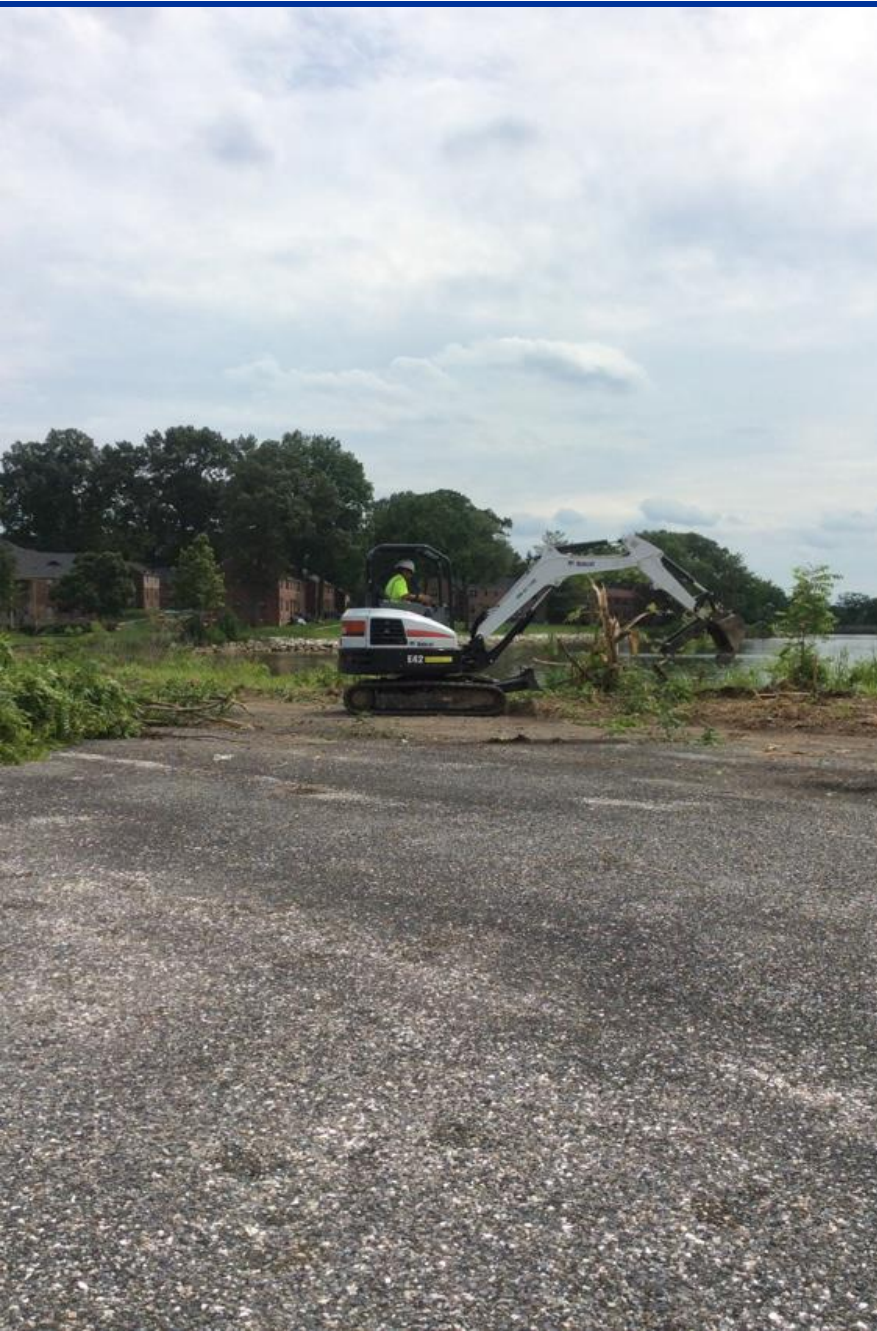
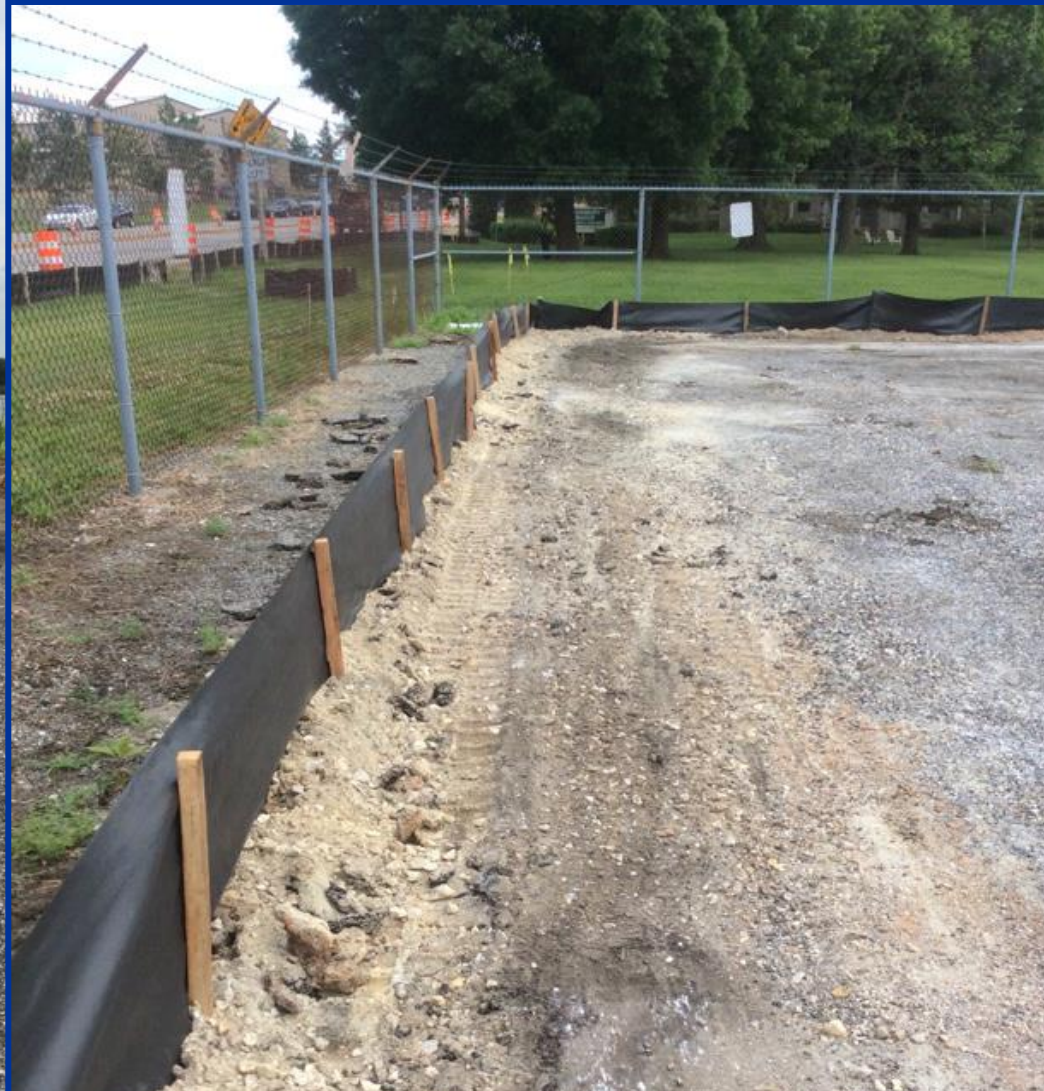
**Work at Block D Panhandle began with clearing and grubbing to remove brush and roots, followed by installing a silt fence along Wilson Point Road.**

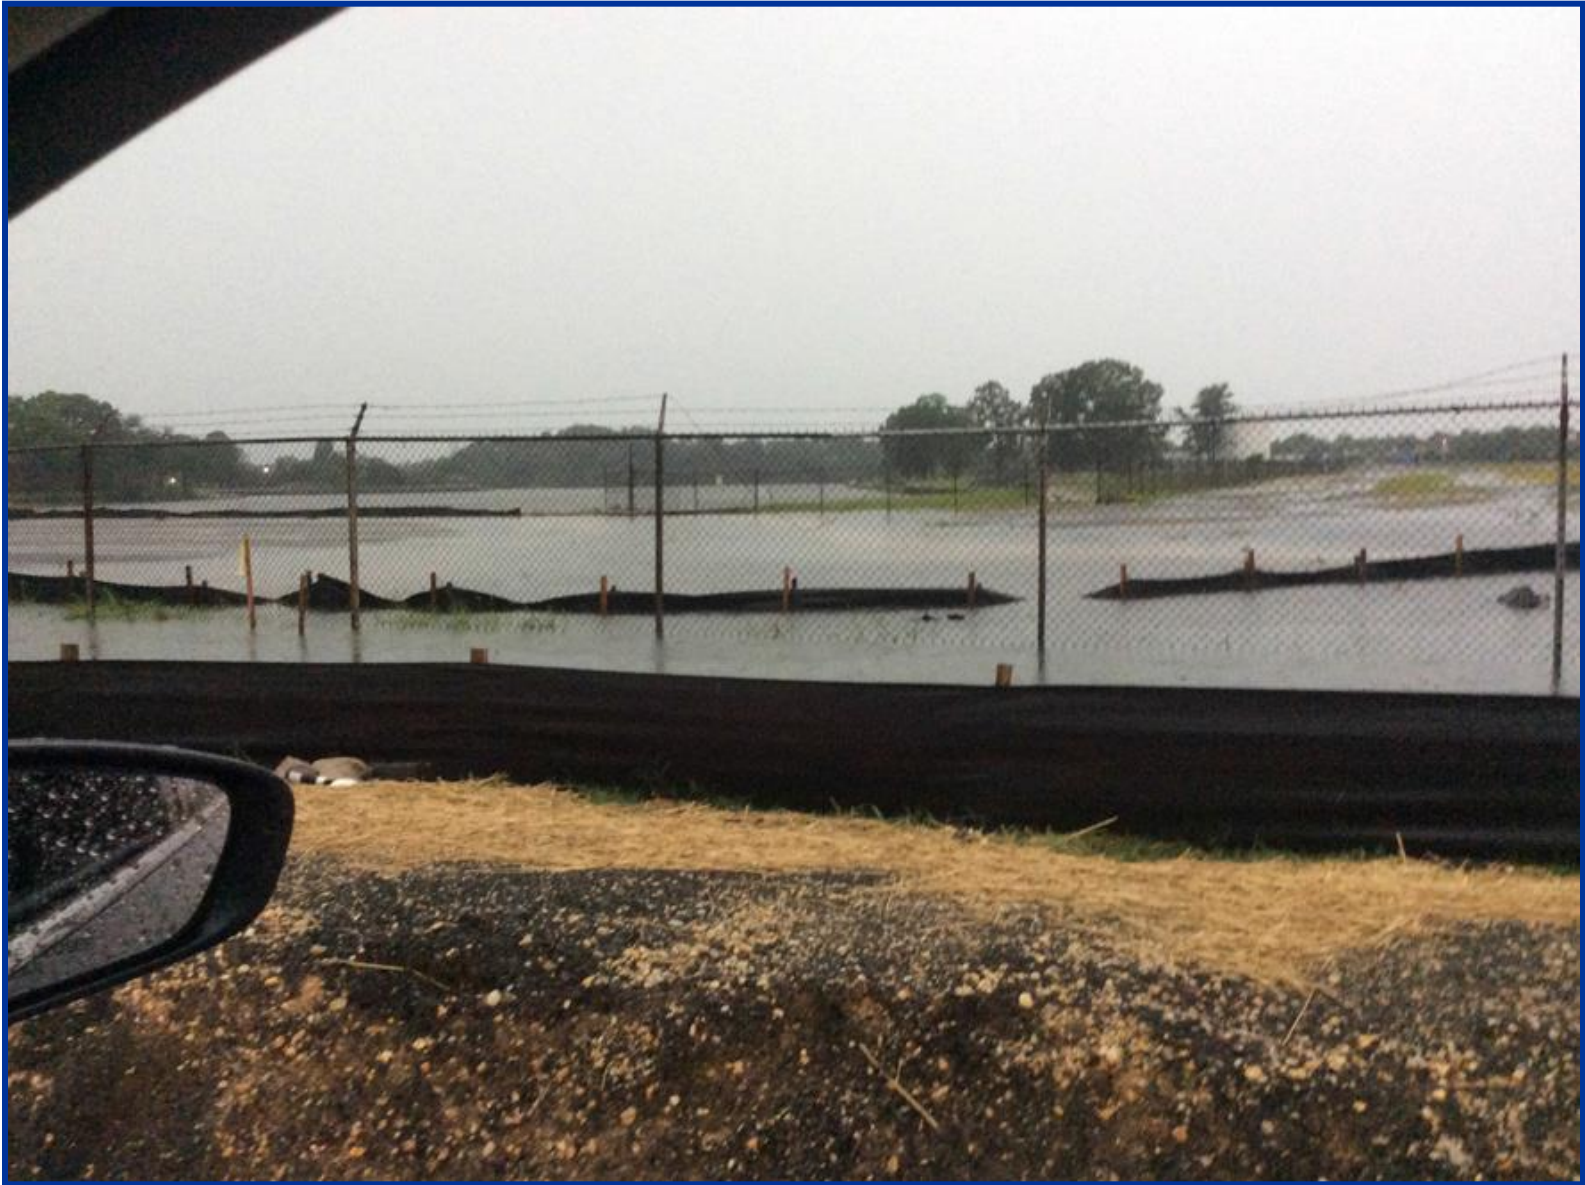
**Heavy rains during a thunderstorm created “sheet flow” of water over the silt fence in Block D Panhandle before excavation was underway. Immediate fence repairs occurred after the rain stopped.**

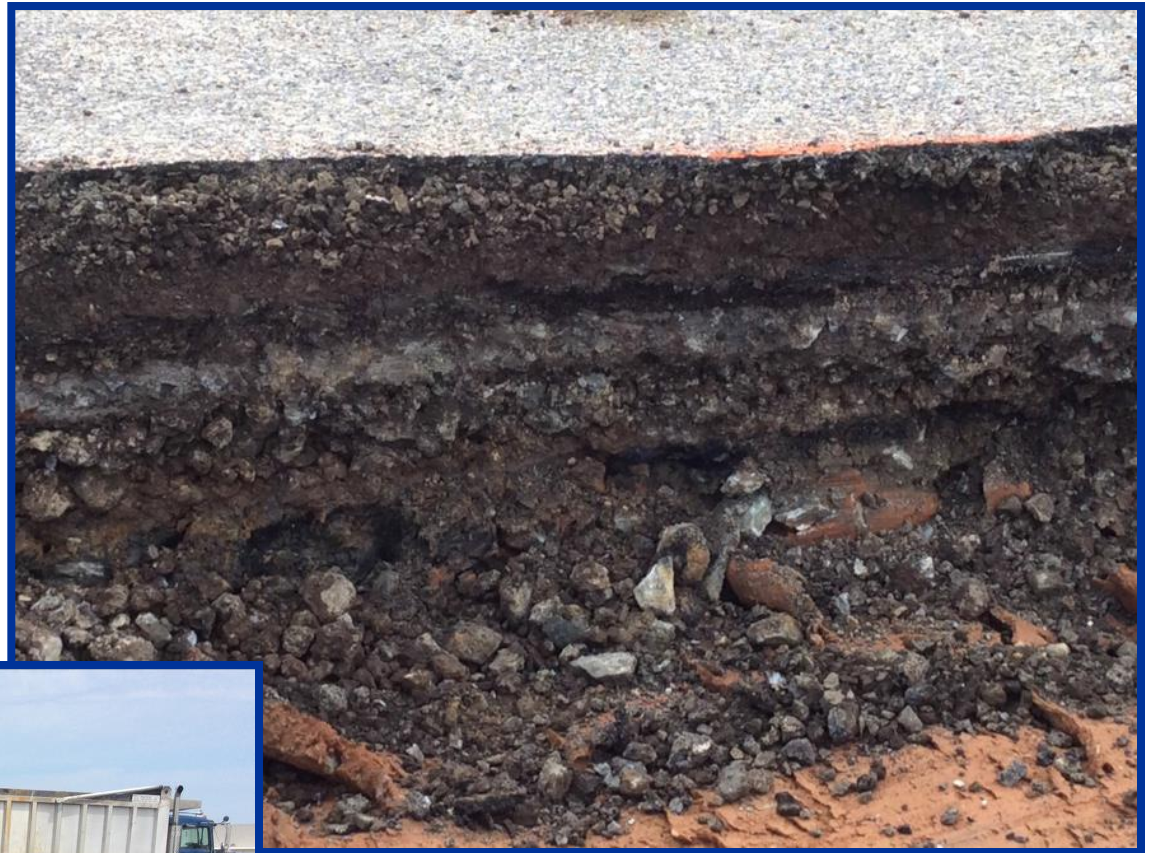
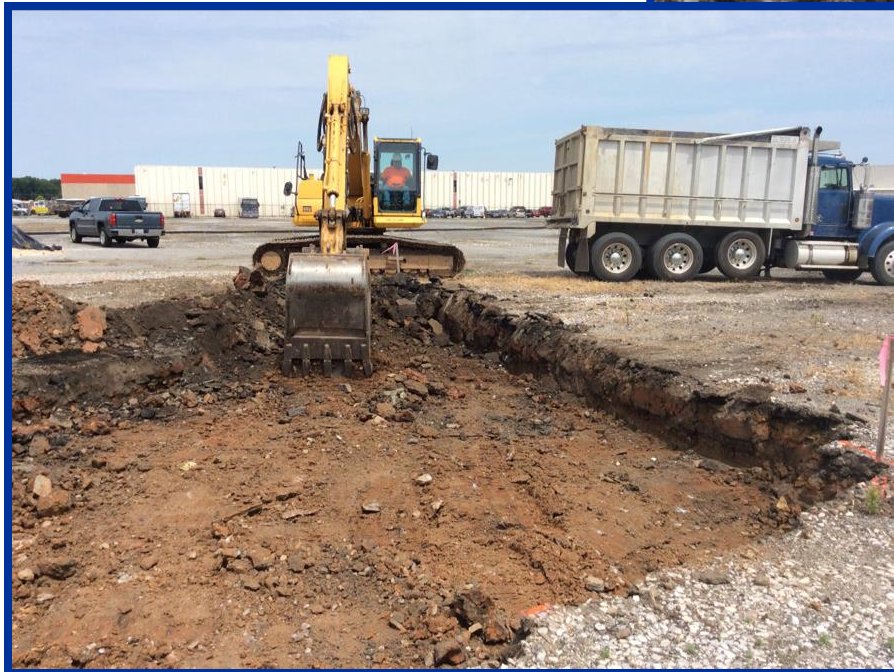
**Digging in Block D  
former parking lot  
areas uncovered  
layers of asphalt  
down to 2 feet deep.**

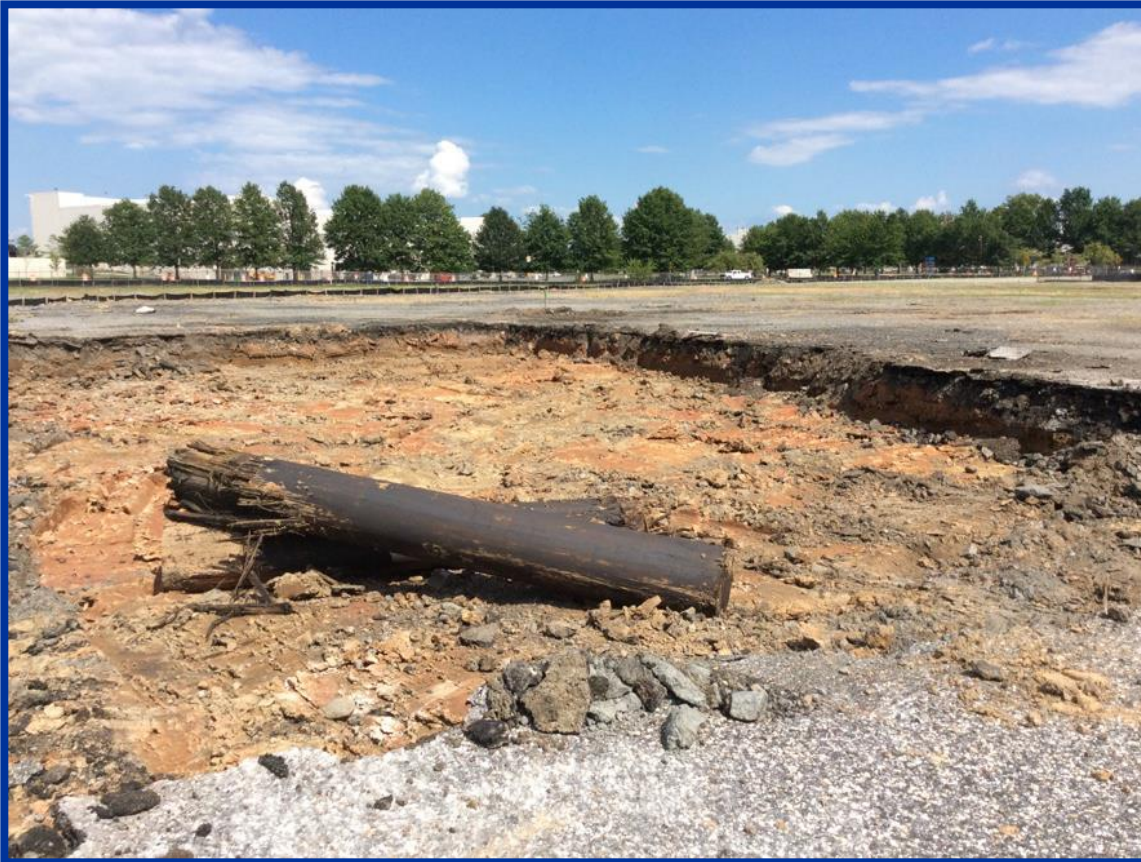
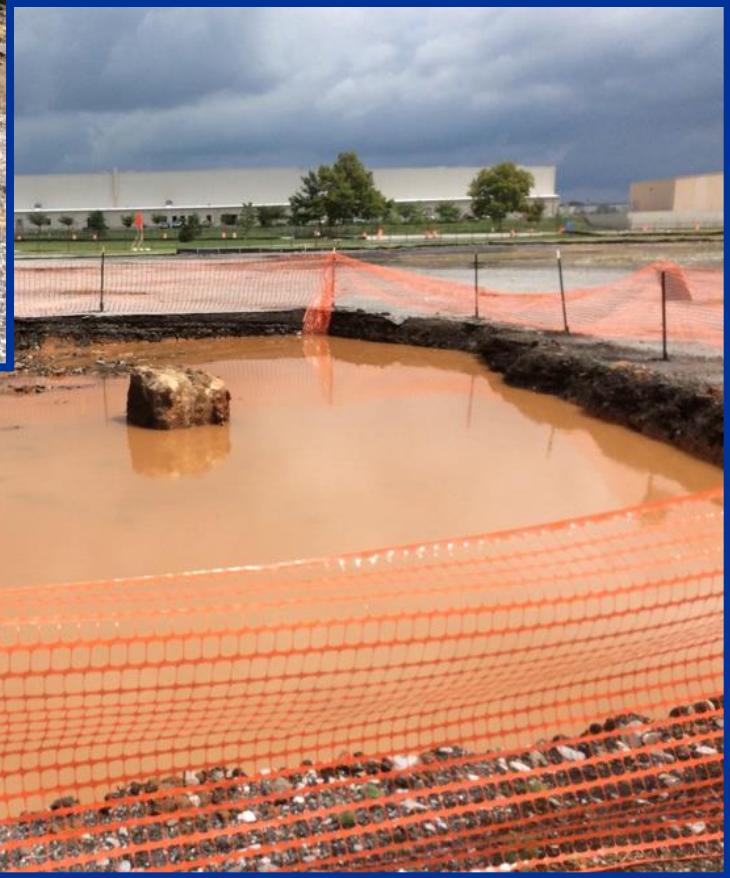
**Debris found in Block D  
included telephone poles.**

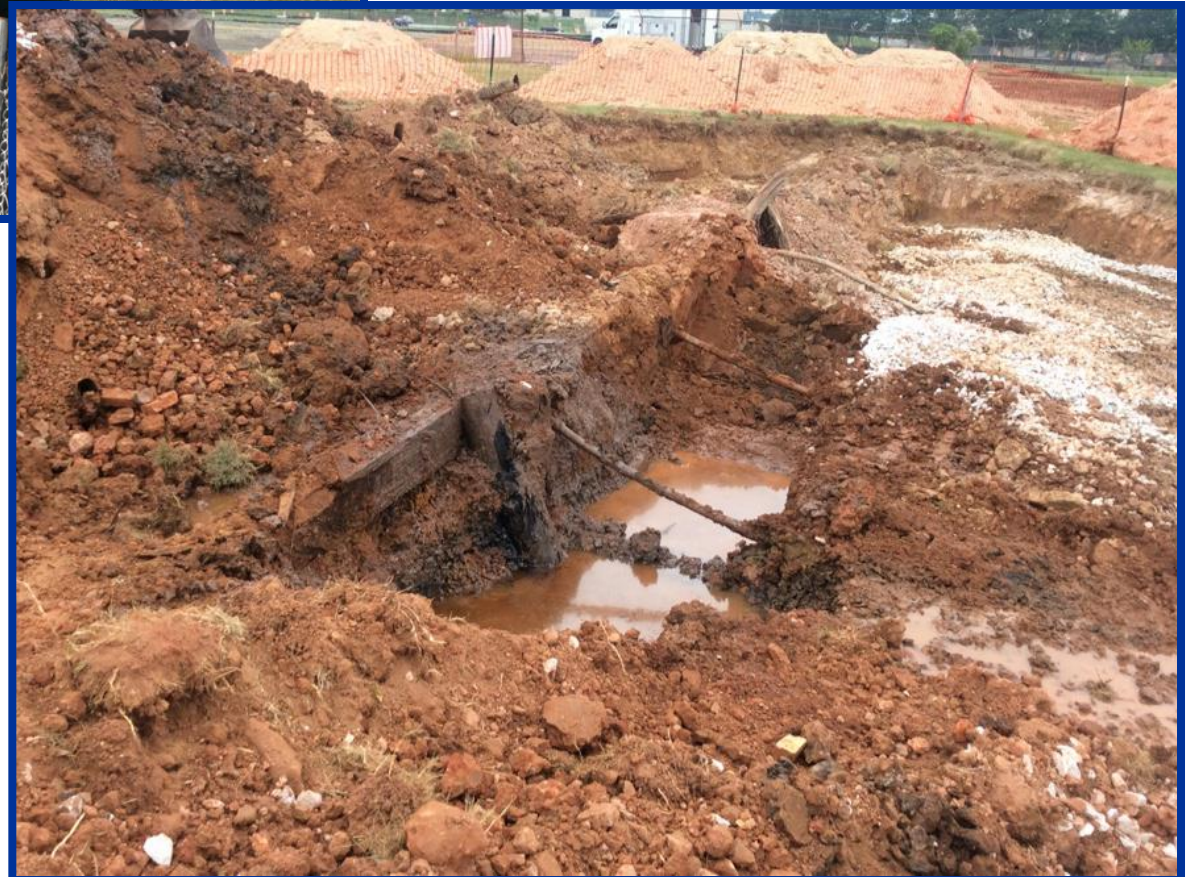
**Air monitoring equipment is in operation along the construction perimeter while digging occurs in Block D.**

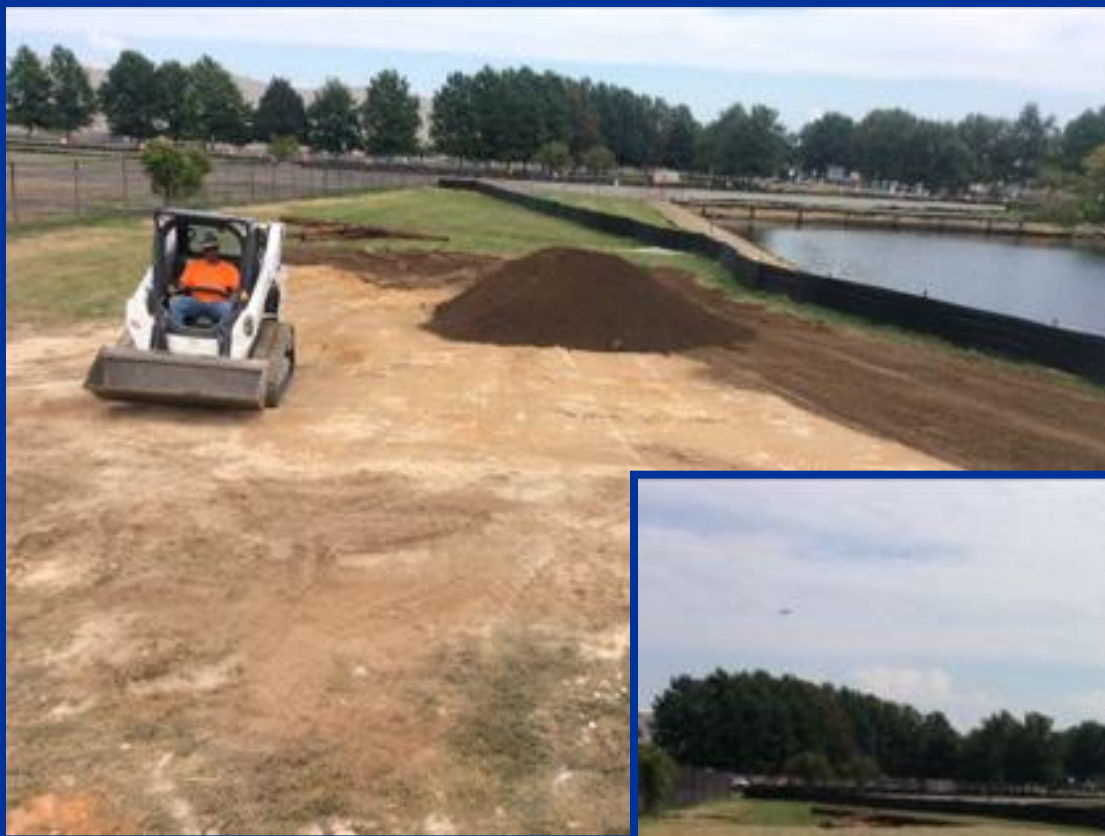
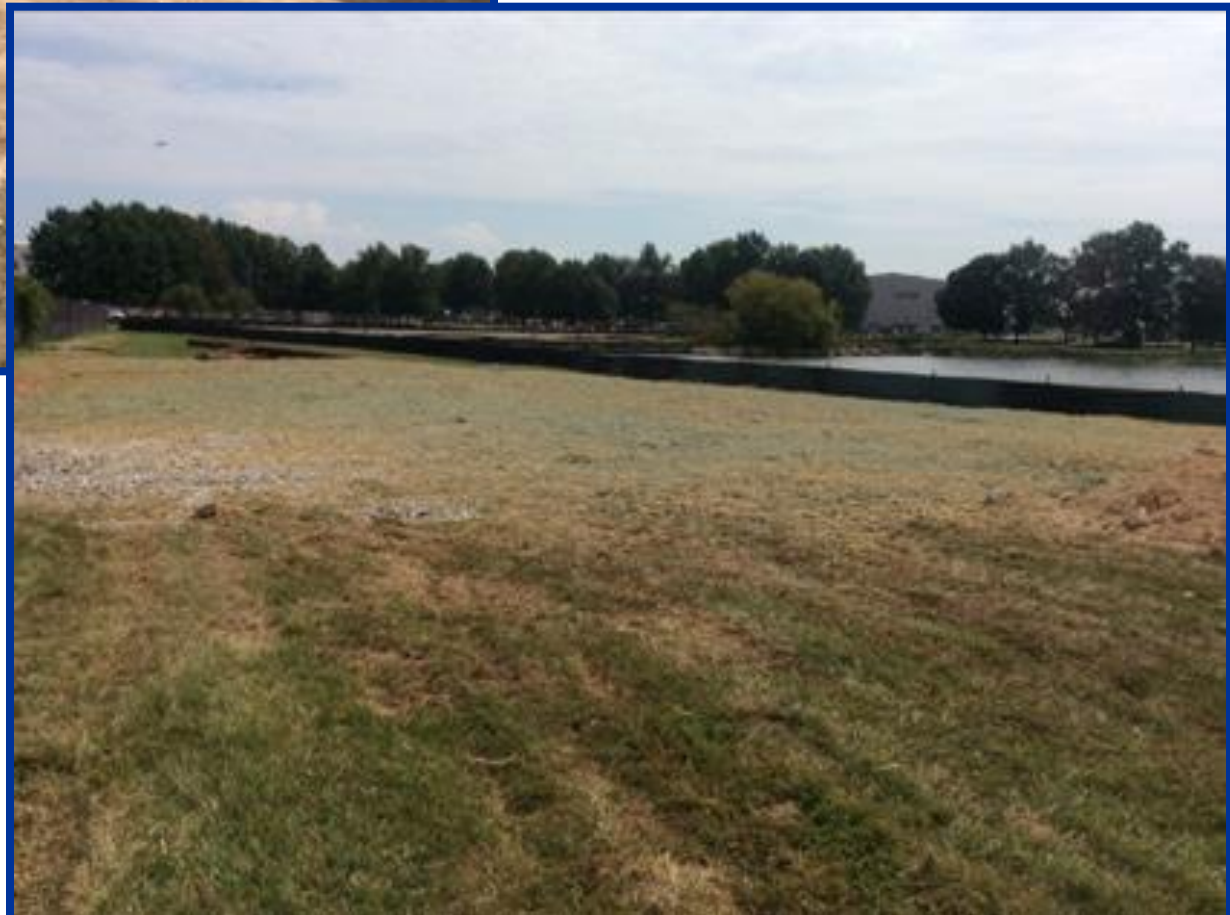
**Top Soil was the final cover in grassy areas of Block D.**

**A restored area in Block D is shown which has been seeded with grass. Also paved areas were re-surfaced with recycled asphalt millings.**

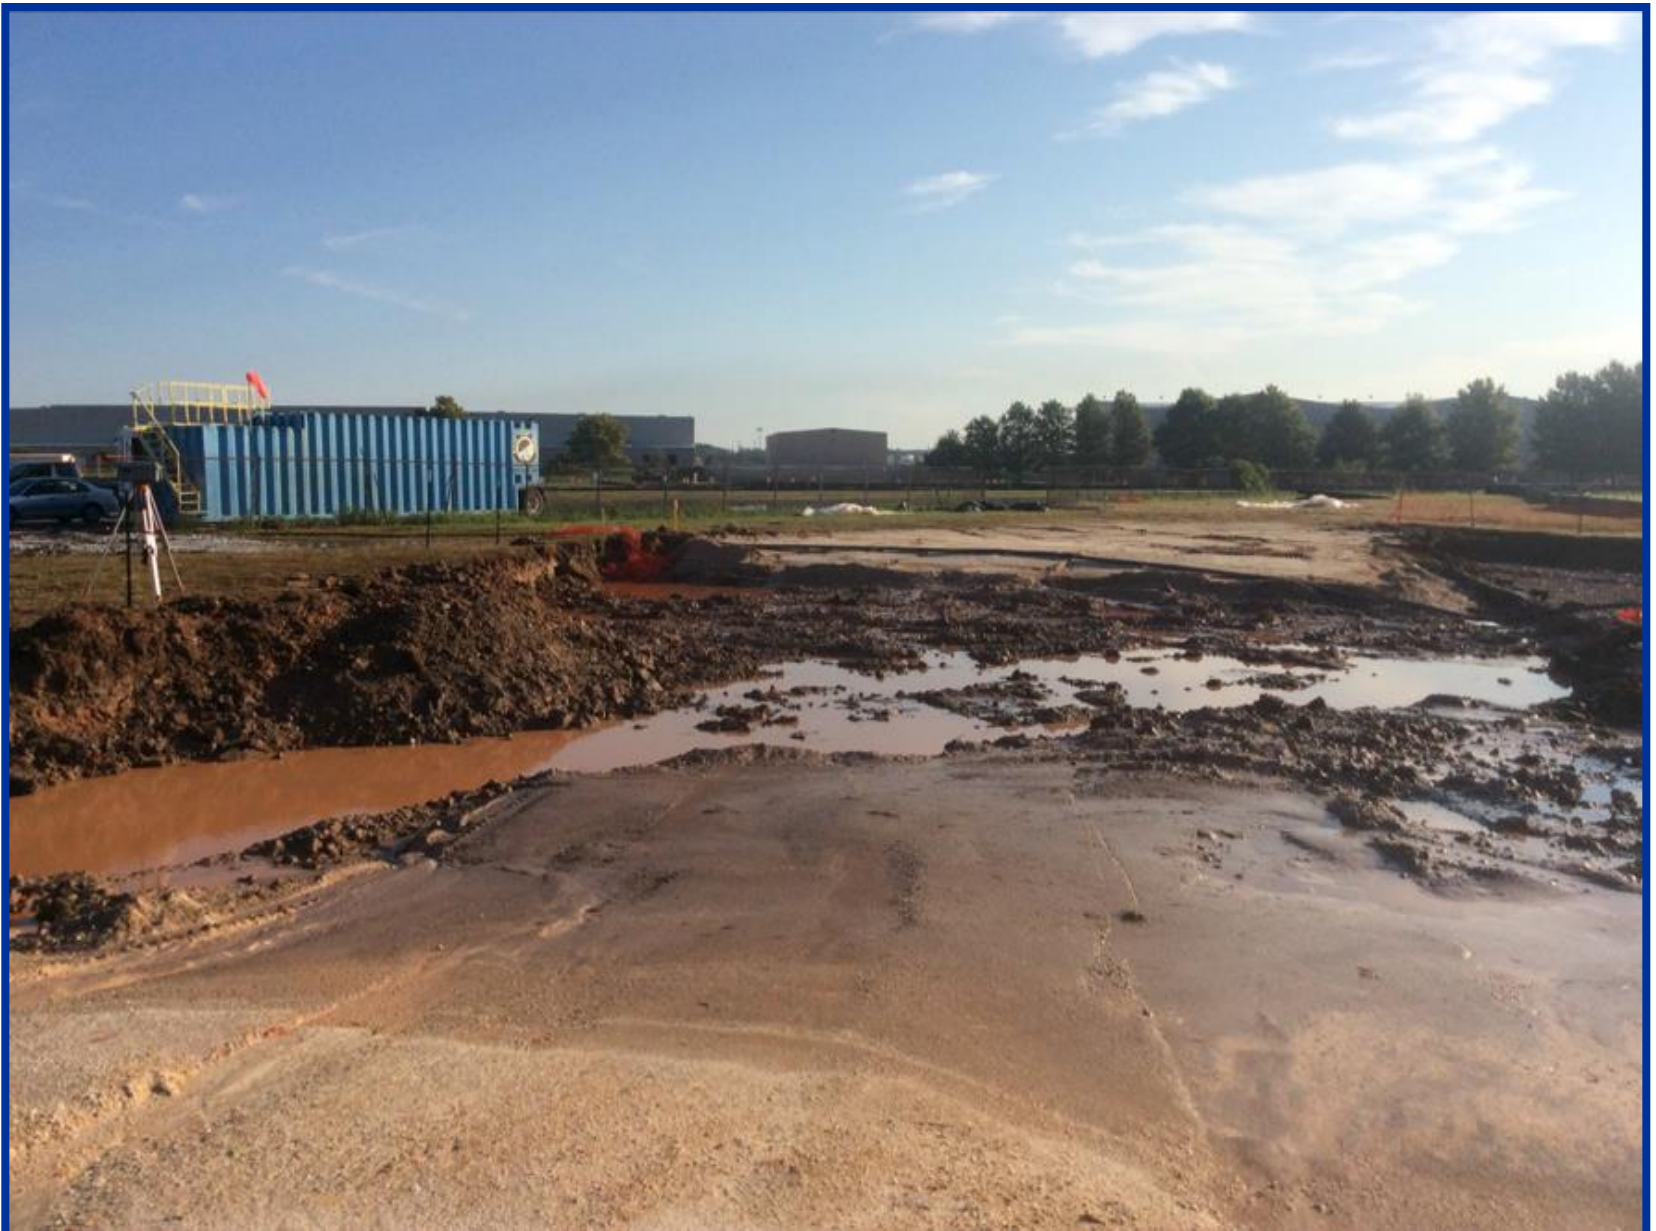
**Storm water continues to be an issue while Block D work occurred. Water is pumped for storage in “frac” tanks, shown in upper left, followed by off-site treatment.**
