# Soil Remedial Actions at Middle River Complex - 2015

Project Photo Tour  
Updated September 15, 2015

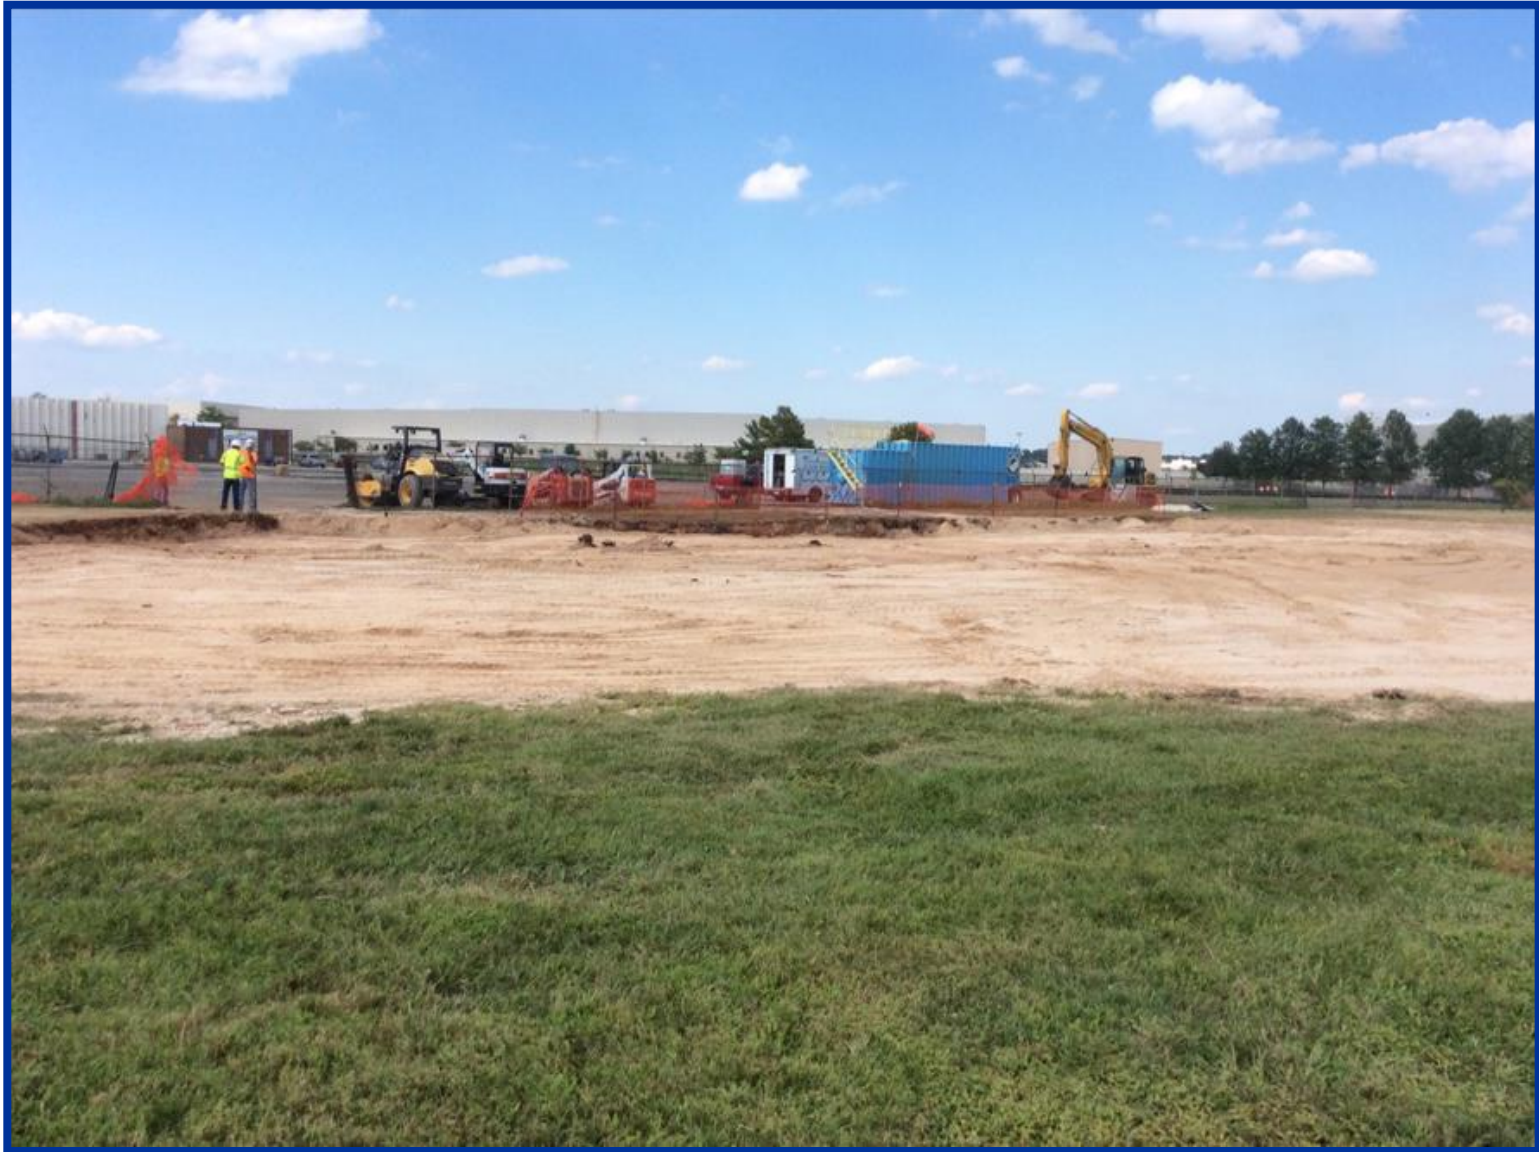
**Work at Block D is mostly completed. Soil backfilling is shown here. Block D Panhandle work will begin soon following further exploration for the locations of suspected tanks and transformers in Block G.**

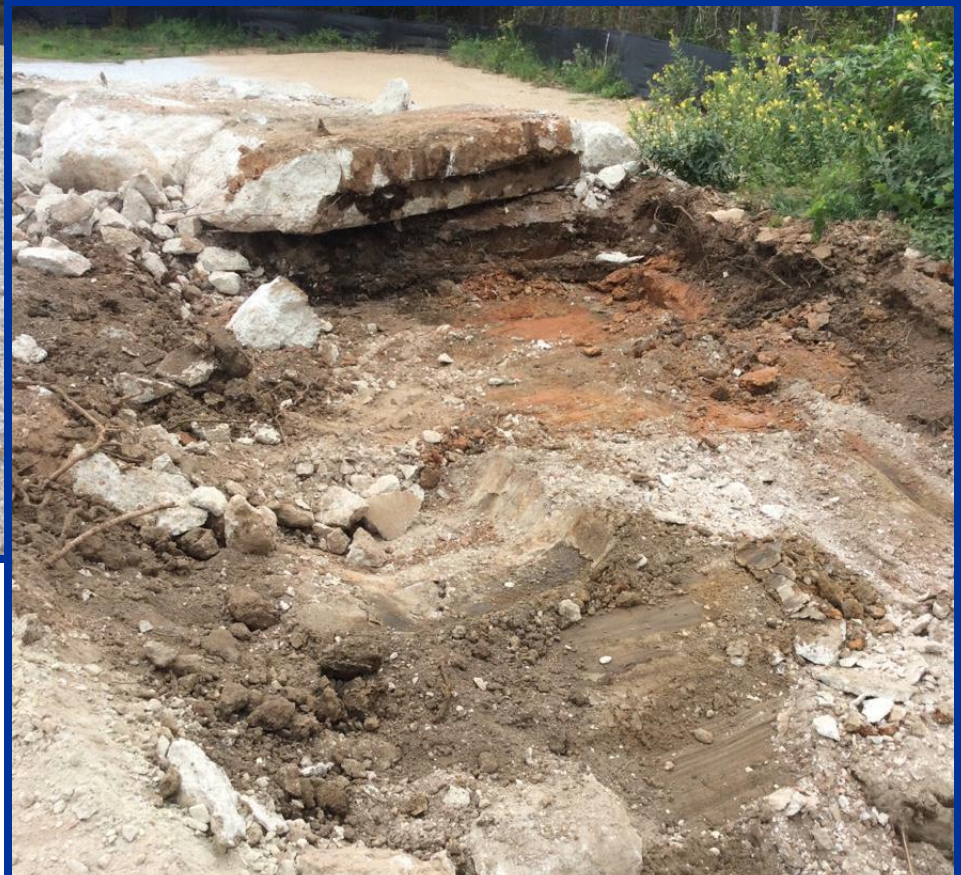
**Work resumed in Block G and began by breaking up large concrete pieces, which were foundation slabs from a former building, exposing soil in the areas where underground tanks are possibly located.**

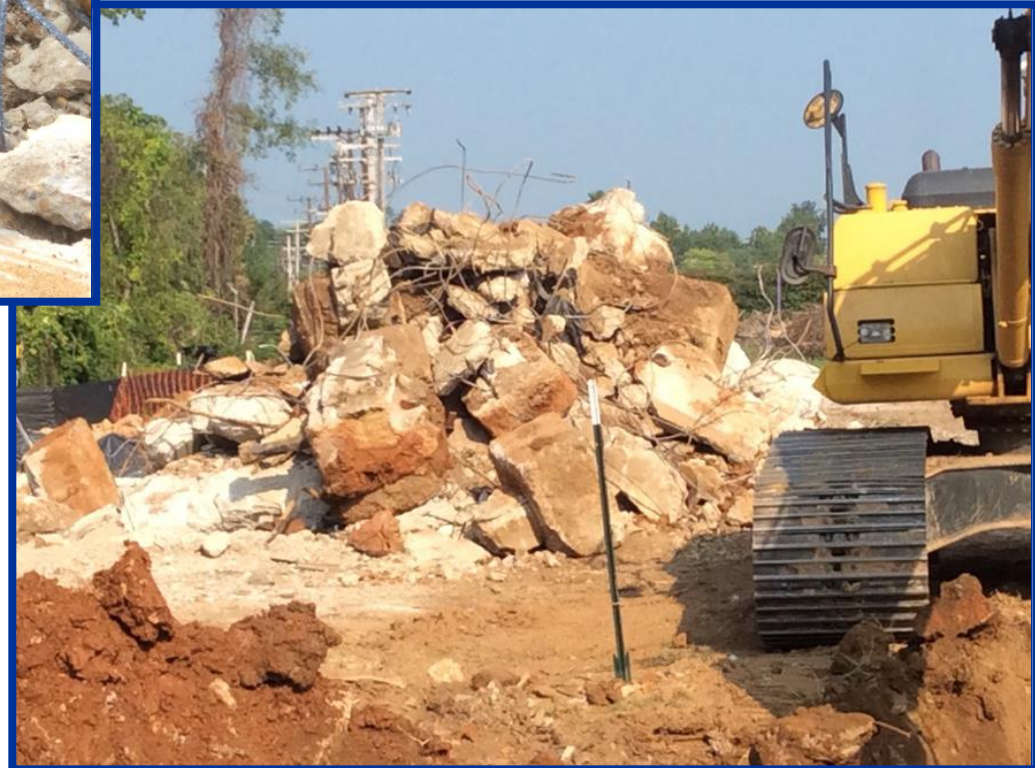
**The former building foundation was first pulled up to examine soil beneath it, then it was removed. We await sampling results of organic material identified beneath one building.**

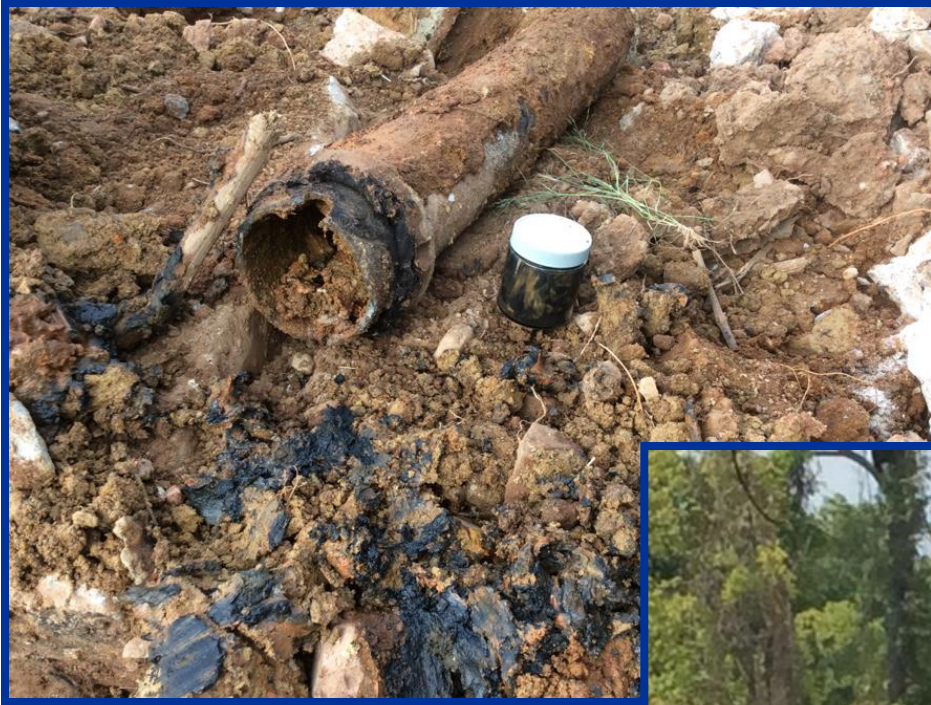
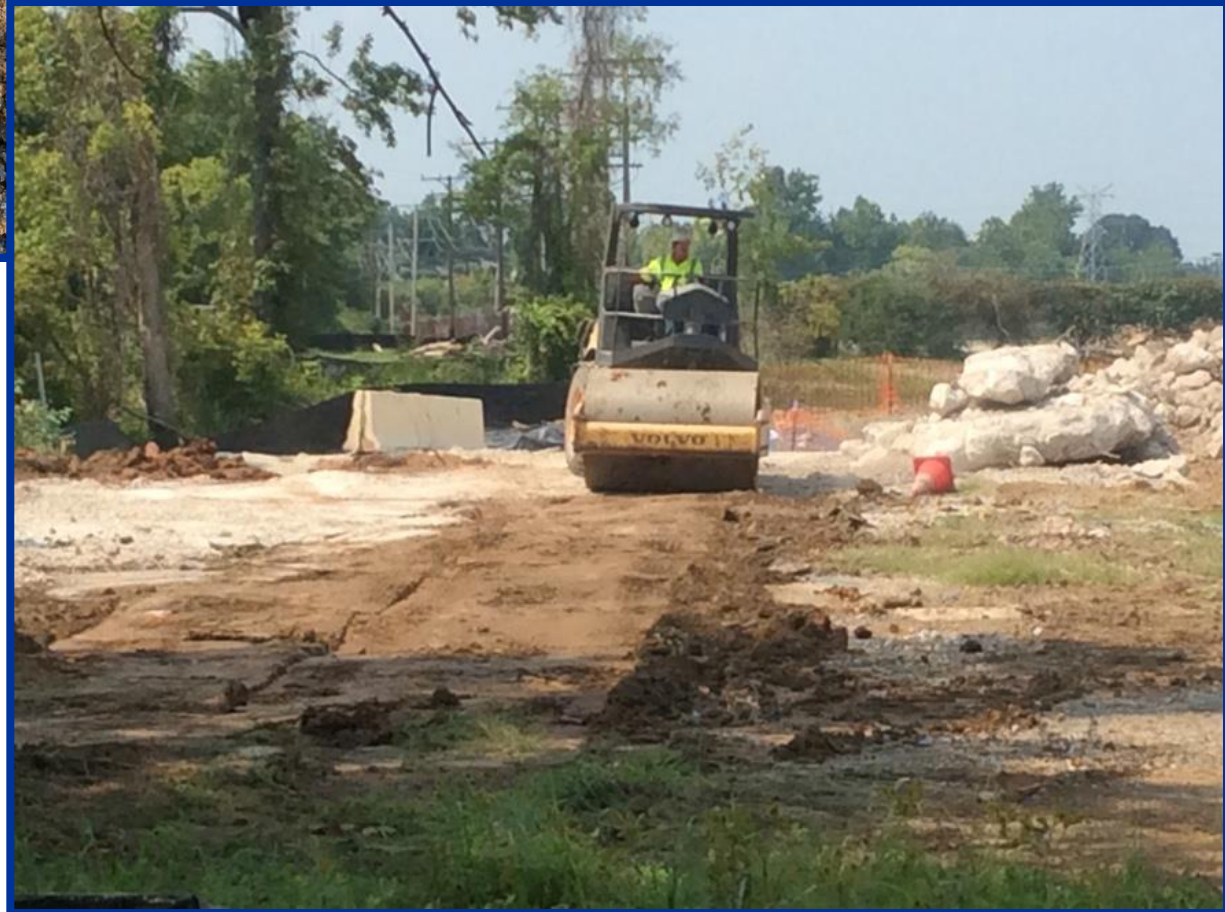
**Three of four anticipated test pits were dug in Block G and no underground tanks have been located. Debris found included pipes with sludge, which were removed, then the pits were backfilled and compacted.**
