# Review and Analysis of Historical Aerial Photographs of Martin State Airport 701 Wilson Point Boulevard Middle River, Maryland

Lockheed Martin Corporation

Tetra Tech, Inc.

February 2013

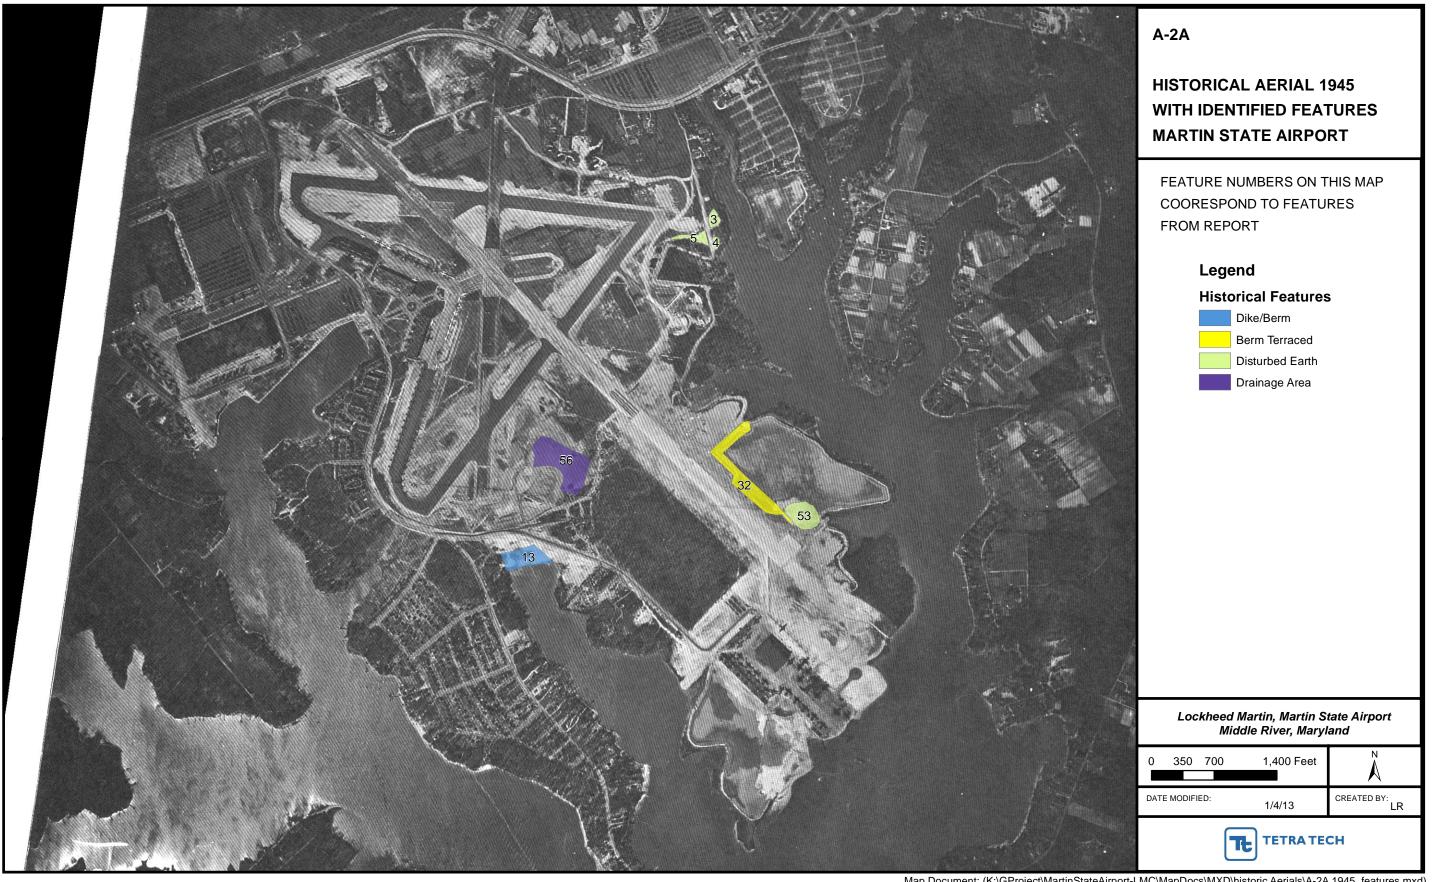
Map Document: (K:\GProject\MartinStateAirport-LMC\MapDocs\MXD\historic Aerials\A-2A 1945\_features.mxd) 1/10/2013 -- 8:54:59 AM

1945 (A-2): Between 1938 and 1945, substantial earthwork, including filling and berming, took place around the perimeter and in low areas of SP. The large cove on the northeast shoreline of SP in 1938 is no longer evident in the 1945 aerial; it had been replaced by the southern end of the seaplane runway. The western shoreline in 1938, particularly along the northwestern edge of the peninsula, had a lobe extending west into Stansbury Creek, leading out to adjacent sandbars that appear to nearly connect SP to the opposite shoreline. Also in the 1938 aerial, a smaller former cove that was partially filled and reshaped by 1956 is evident along the western shoreline of SP immediately south of this lobe feature.

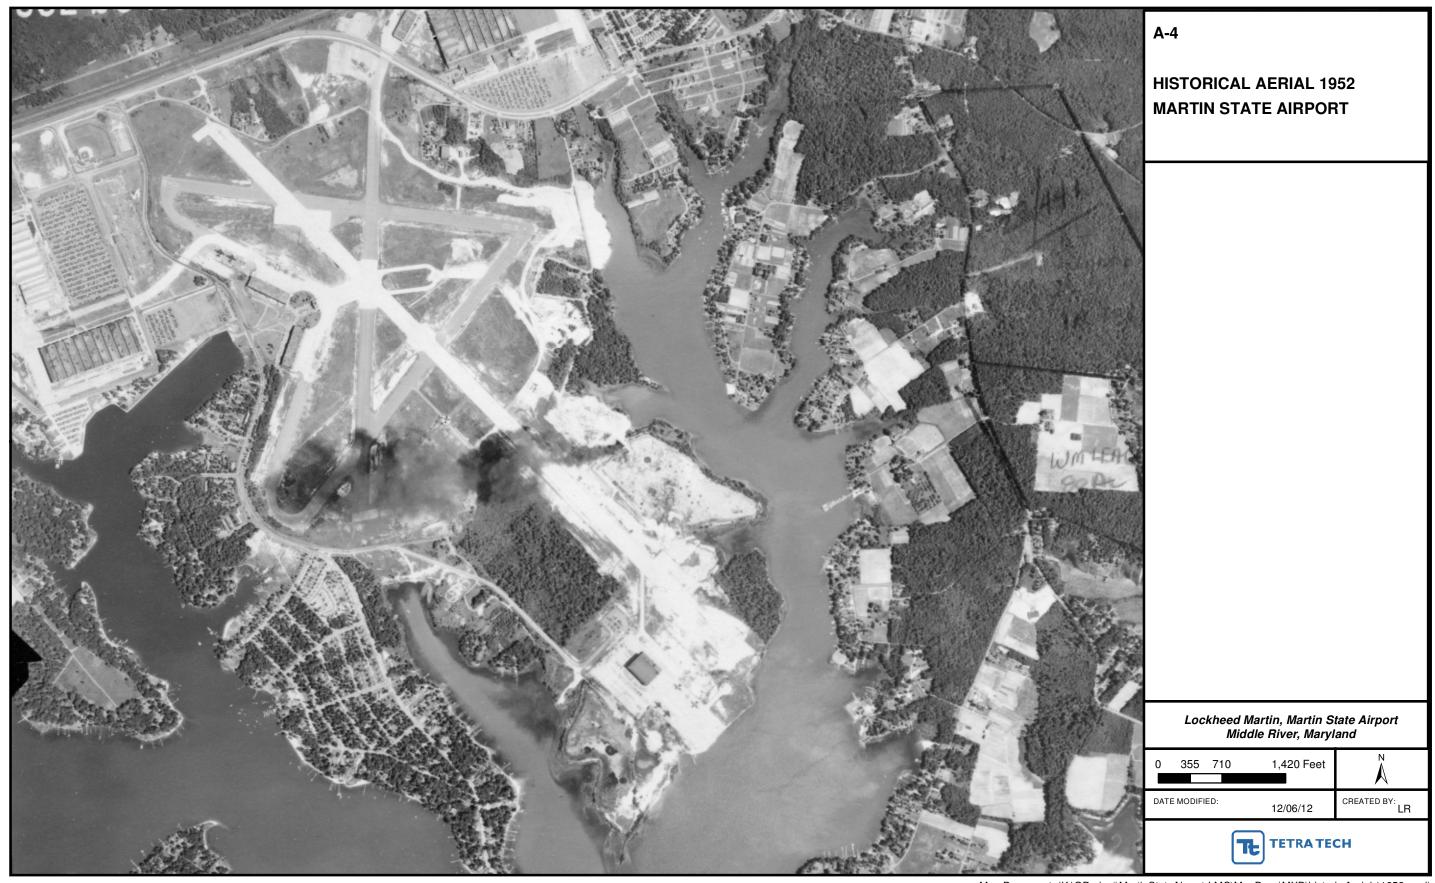
Map Document: (K:\GProject\MartinStateAirport-LMC\MapDocs\MXD\historic Aerials\1952.mxd) 12/06/2012 -- 2:10:51 PM

1952 (A-4): Partially established vegetation has replaced the bare soil along the edges of the runways and taxiways seen in earlier photographs. Land has been cleared at the current locations of the Black & Decker and Lockheed Martin hangars. The Stansbury Creek ponded area that extended into the southern portion of the MT area from 1938–1945 has been covered with fill material. The entire ponded area of Stansbury Creek was filled to allow construction of a runway/taxiway. Features in the eastern portion of the MT area appear to have been used as temporary ammunition bunkers (#20 and #26 on Figure 4-1).

1952 (A-4): Earthen berms still enclose the area of the DRA south of the Limehouse Cove shoreline and the CRA. A large pit is visible south of the southern shoreline of the DRA cove, at the location of the proposed oil and acid pit shown in the undated design drawing above. The pit appears to be mostly empty, with some possible liquids at the bottom (indicated by a dark area in the center of the pit). Burning (#15) is visible west of this pit.
