Lockheed Martin Corporation Wetlands Monitoring Report July 2011 through June 2012 Tallevast, Florida

ARCADIS U.S., Inc.

August 29, 2012

FDEP Site No. COM_169624

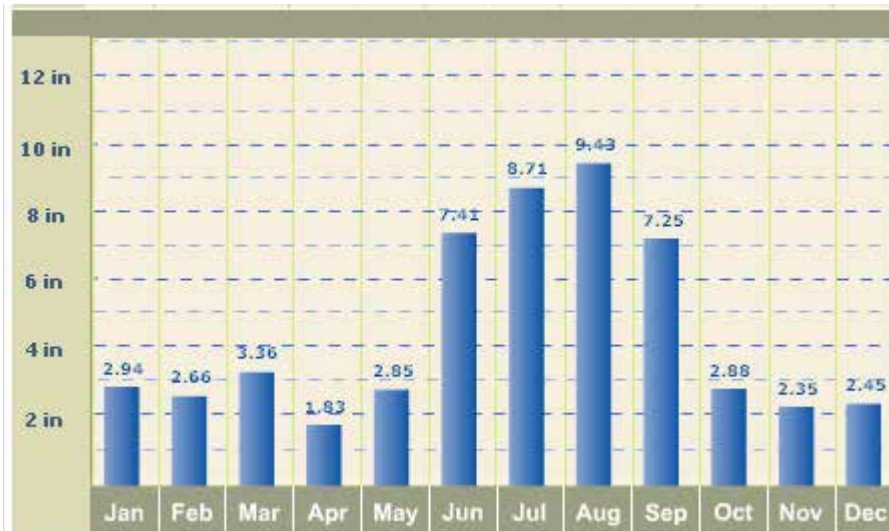
Figure 6-2
Historical Precipitation Trends in the Tallevast Area

Annual rainfall totals average 54 inches (1.37 meters). The rainy season generally occurs in the summer in the Tallevast area, with frequent afternoon thunderstorms of short duration. As shown on Figure 6-2 (below), August is usually the wettest month of the year, with an average of 9.43 inches of rain (approximately 24 centimeters). April is generally the driest month of the year, with an average of 1.83 inches of rain (approximately 4.5 centimeters). Hurricane season in Florida occurs from June through the end of November.

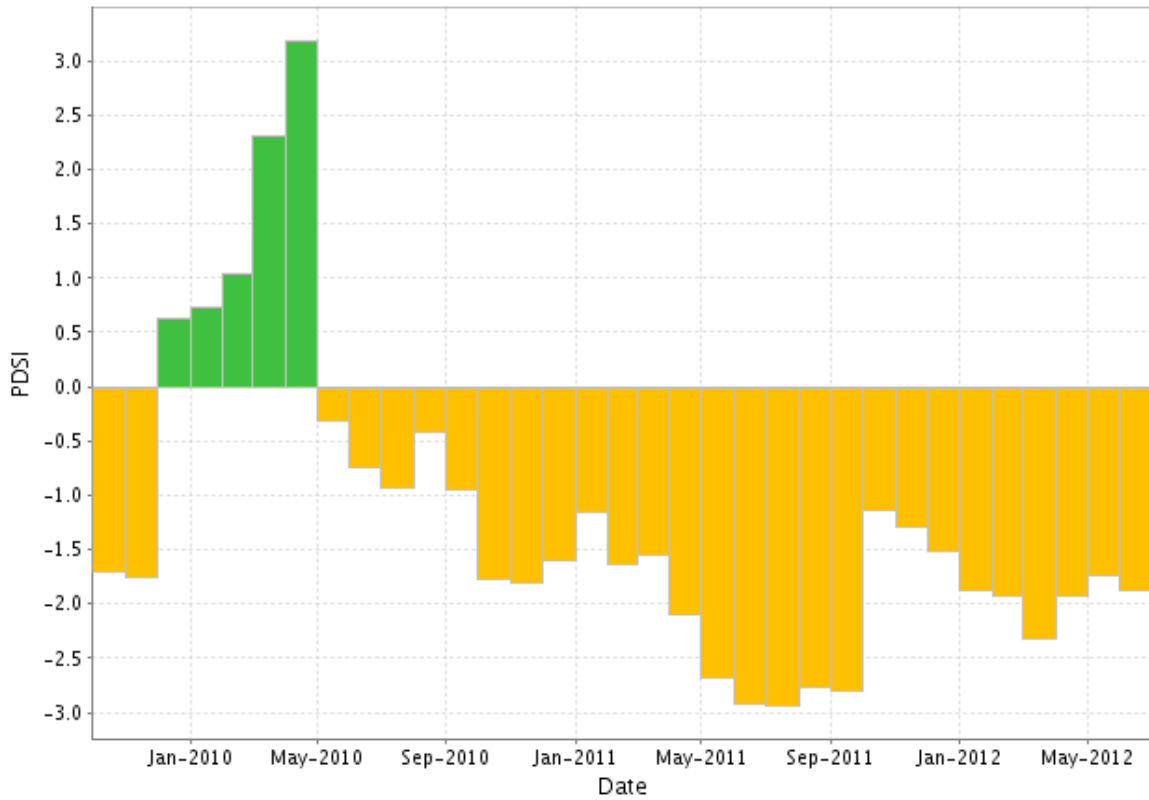
FL Everglades and SW Coast - PDSI 200910 - 201207

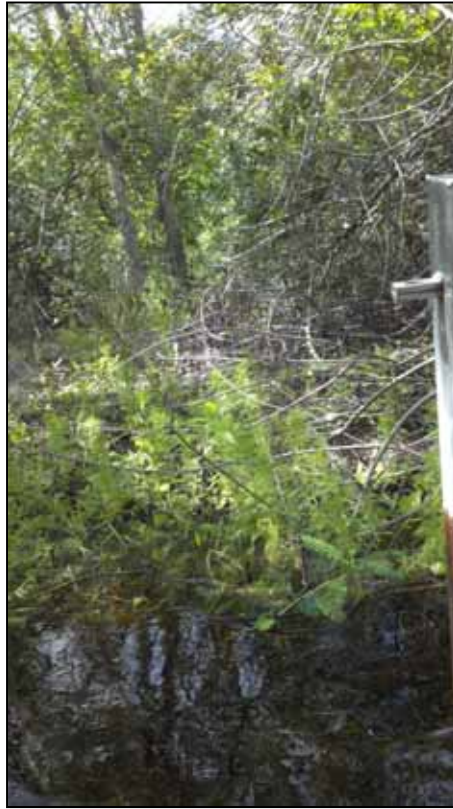
Photo 9 – TW6 Facing North

Soil Subsidence	
New signs of oxidation/subsidence?	<input type="checkbox"/> No <input checked="" type="checkbox"/> Yes
Explanation	
Subsidence observed within forested portion of wetland.

- RAP injection well installation commencing adjacent to TW-6 at time of 2012 assessment.
 - Most typical wetland characteristics of wetland observed within the pond bed/emergent portion.
 - Evidence observed of recent heavy rainfall/runoff into Transitional zone, above NP-6 (i.e., isolated areas of standing water <1" deep)

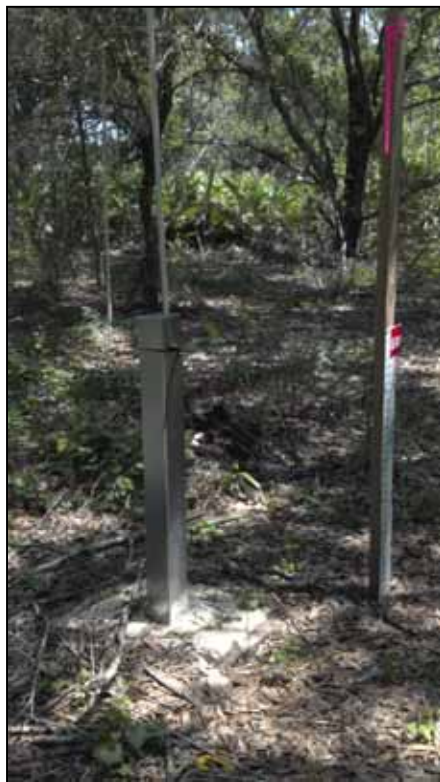
Photo 13 – TW18 Facing North

Some soils within the historic wetland area lack hydric indicators. Up to 12 inches of subsidence within the wetland interior was observed. Prominent hummocks on otherwise sandy, flat surface suggests subsidence is not recent.

TW-18 has not likely been altered since available 2003 aerial photography. Observed impacts primarily due to historic regional groundwater draw-down and accelerated evapotranspiration by punk trees have reduced site's value and definition as a viable WAP resource.

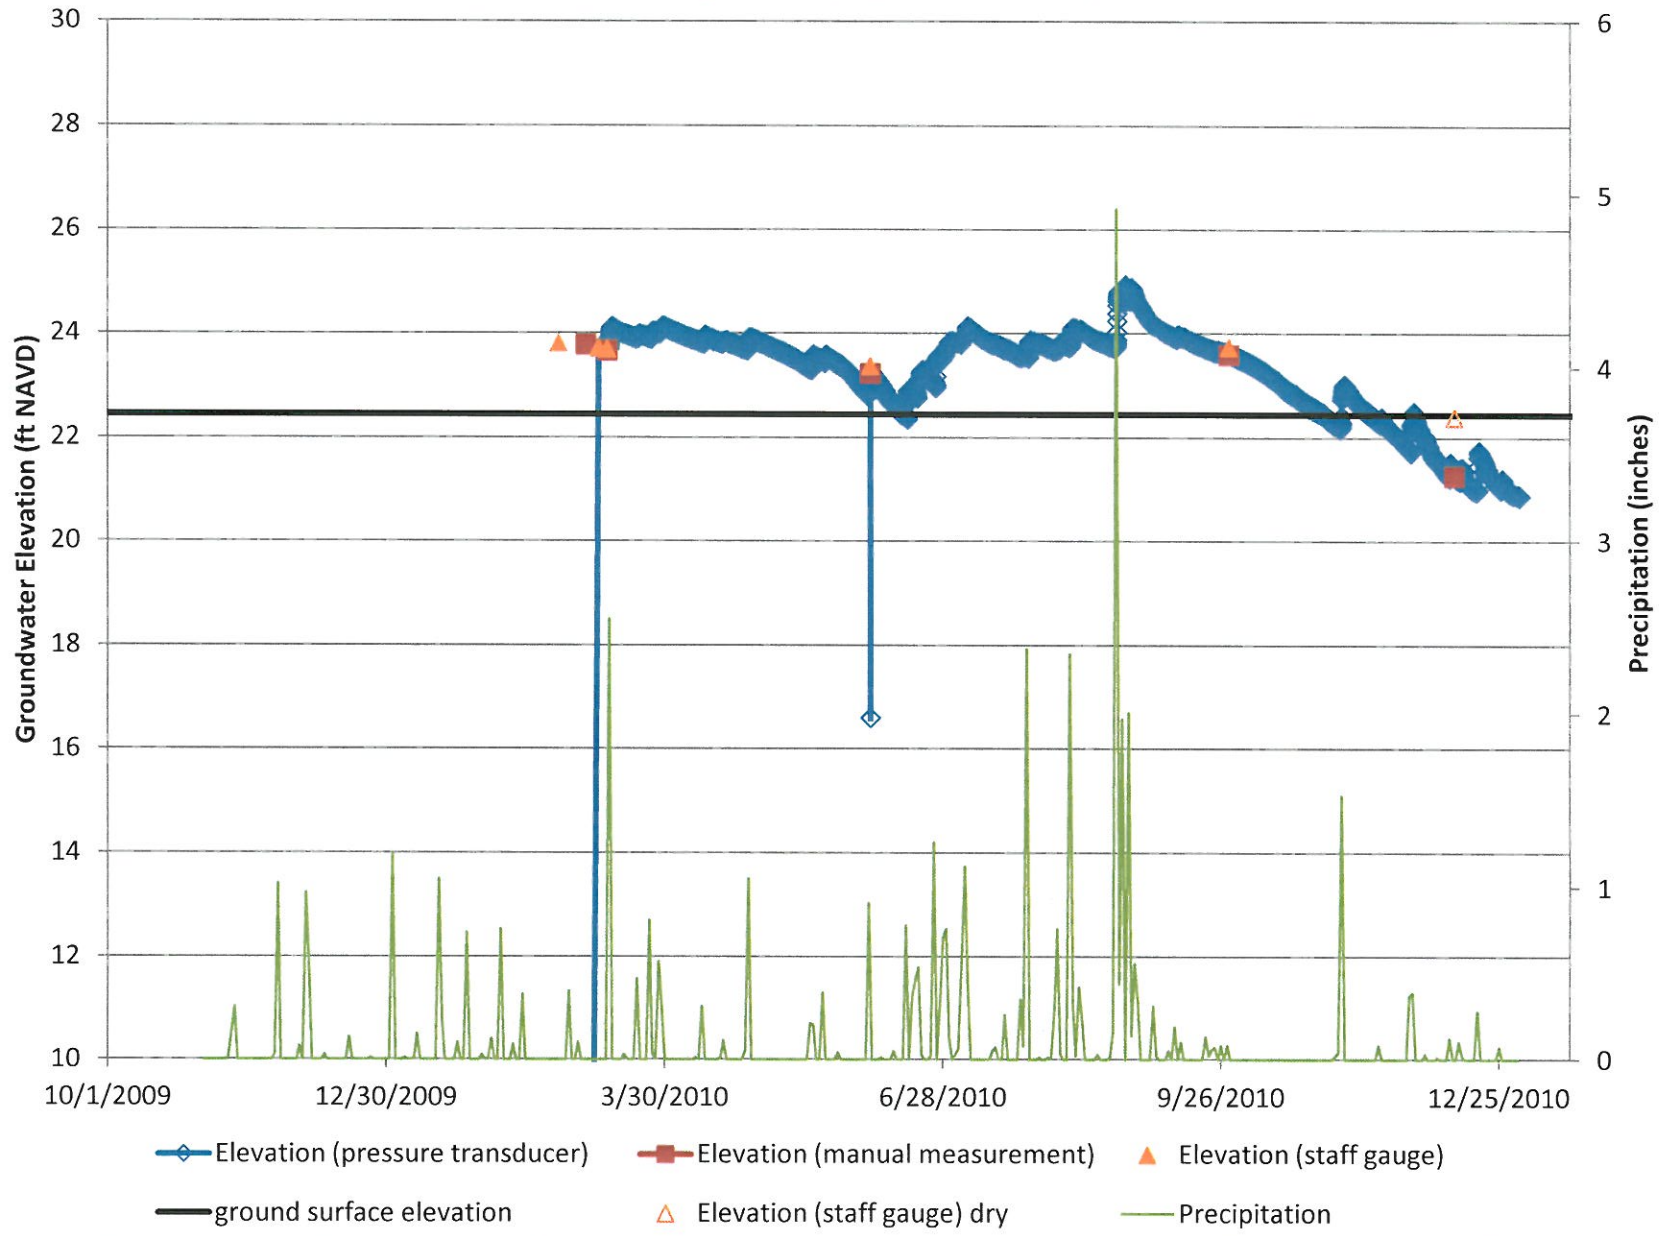
MW-TW-1 2009 - 2010

The transducer for well MW-TW-1 was installed on February 23, 2010 and was subsequently replaced on March 8, 2010 due to a sensor malfunction. Groundwater elevations at MW-TW-1 indicate that the groundwater levels ranged from about 3 feet bgs to about 2 feet above ground surface since monitoring began. During the current monitoring period (July 2011 to June 2012), groundwater elevations rose from about 3 feet bgs to about 1.5 feet above ground surface during the heavy rainfall period between July and September, then gradually fell down to ground surface by January 2012. They were generally at (within 1 foot or less bgs) or above ground
