# Lockheed Martin Corporation Wetlands Monitoring Report July 2014 through June 2015 Tallevast, Florida

AECOM Technical Services, Inc.

August 27, 2015

FDEP Site No. COM\_169624

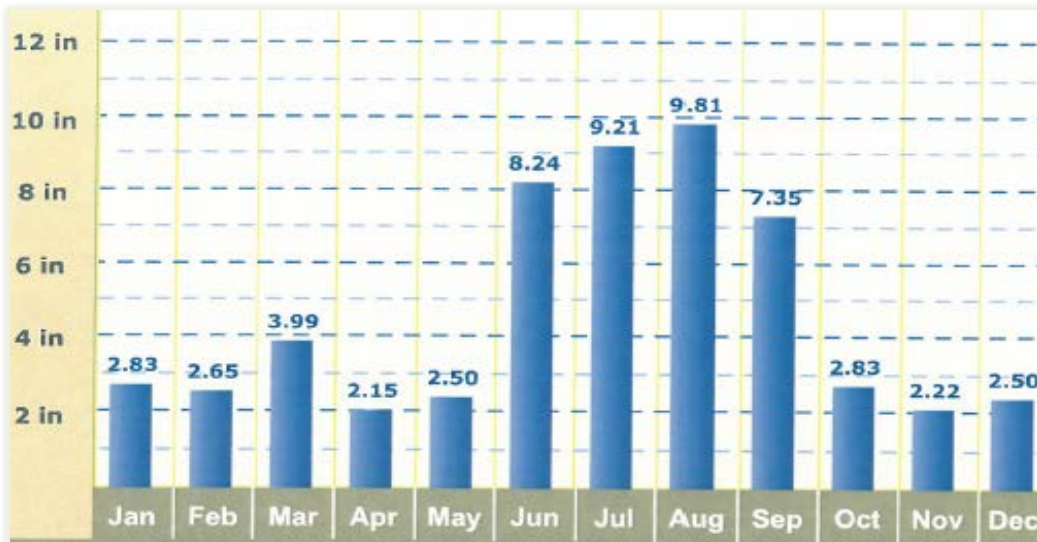
**FIGURE 6-3**  
**Historical Precipitation Trends in the Tallevast Area**

Annual rainfall totals average 54 inches (1.37 meters). The rainy season generally occurs in the summer in the Tallevast area, with frequent afternoon thunderstorms of short duration. As shown on Figure 6-3 (below), August is usually the wettest month of the year, with an average of 9.81 inches of rain (approximately 24 centimeters). April is generally the driest month of the year, with an average of 1.83 inches of rain (approximately 4.5 centimeters). Hurricane season in Florida occurs from June through the end of November. Figure 6-4 (below) shows the cumulative monthly precipitation occurring from July 2014 to June 2015 compared to the historical monthly precipitation trend for each month.

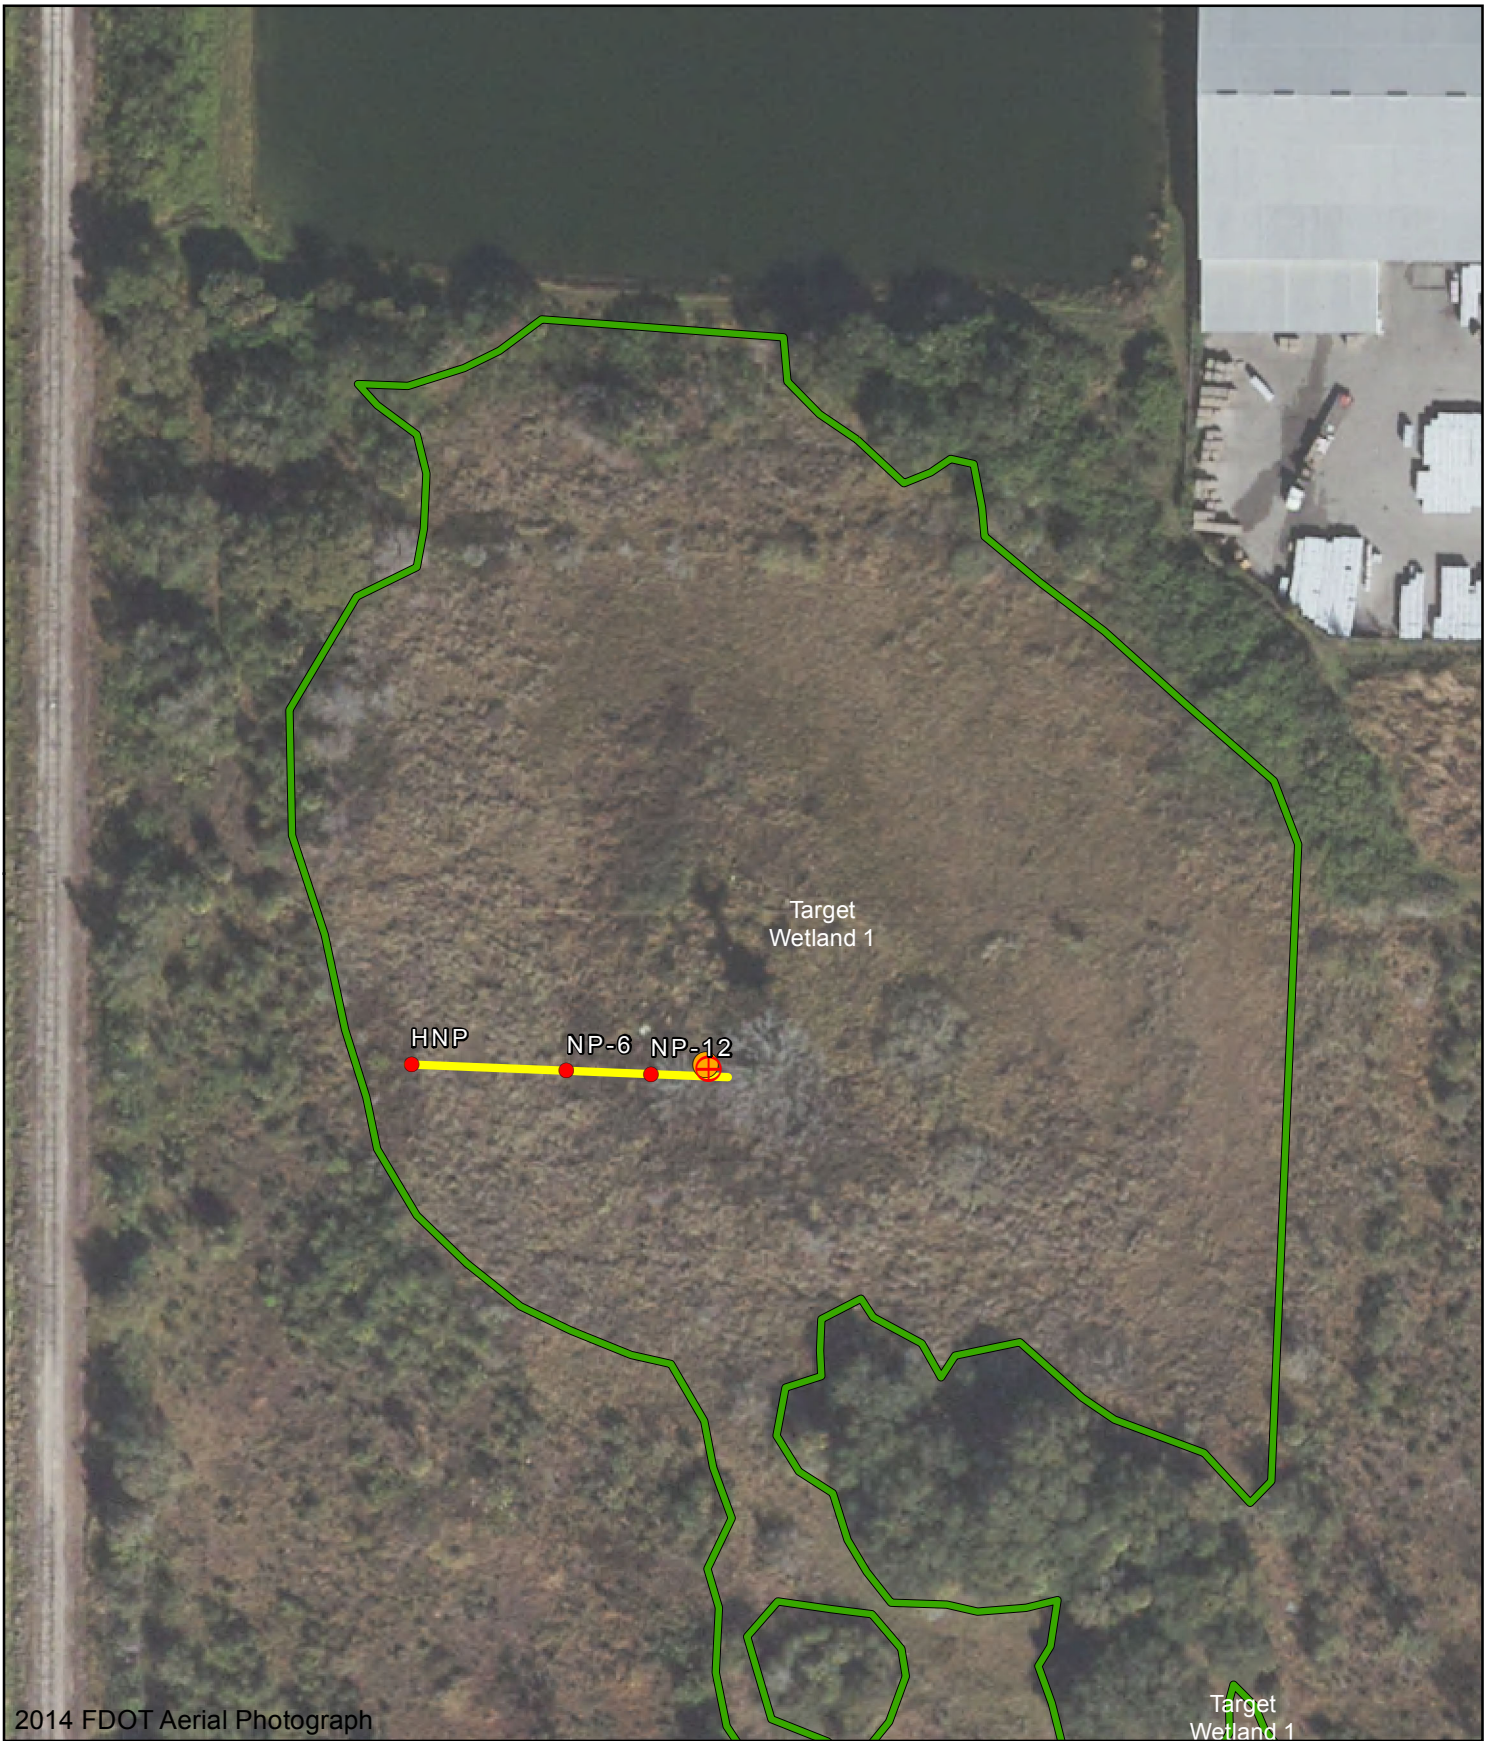
FIGURE  
7-1

Permanent monuments were placed in the field to identify these transects during baseline monitoring of wetland conditions. Monuments composed of steel rebar fitted with a sleeve of polyvinyl chloride (PVC) pipe were installed at the HNP and at elevations of 6 and 12 inches below the HNP and were labeled HNP, NP-6, and NP-12, respectively. Monuments marking the HWE have not been installed to date, however, the WAP recommends installing it if possible. During a June 2008 Site visit with the FDEP, vegetative, hydrologic, and soil indicators were used to establish the HNP elevation within the TWs. These same factors were used during transect placement in both TWs and RWs during the subsequent 2009 field season. Subsequent to monument placement and monitoring well installation, the HNP, NP-6, NP-12, staff gauge, and monitoring well locations were professionally surveyed (March 2010). Transect access locations are shown in Figure 7-1.

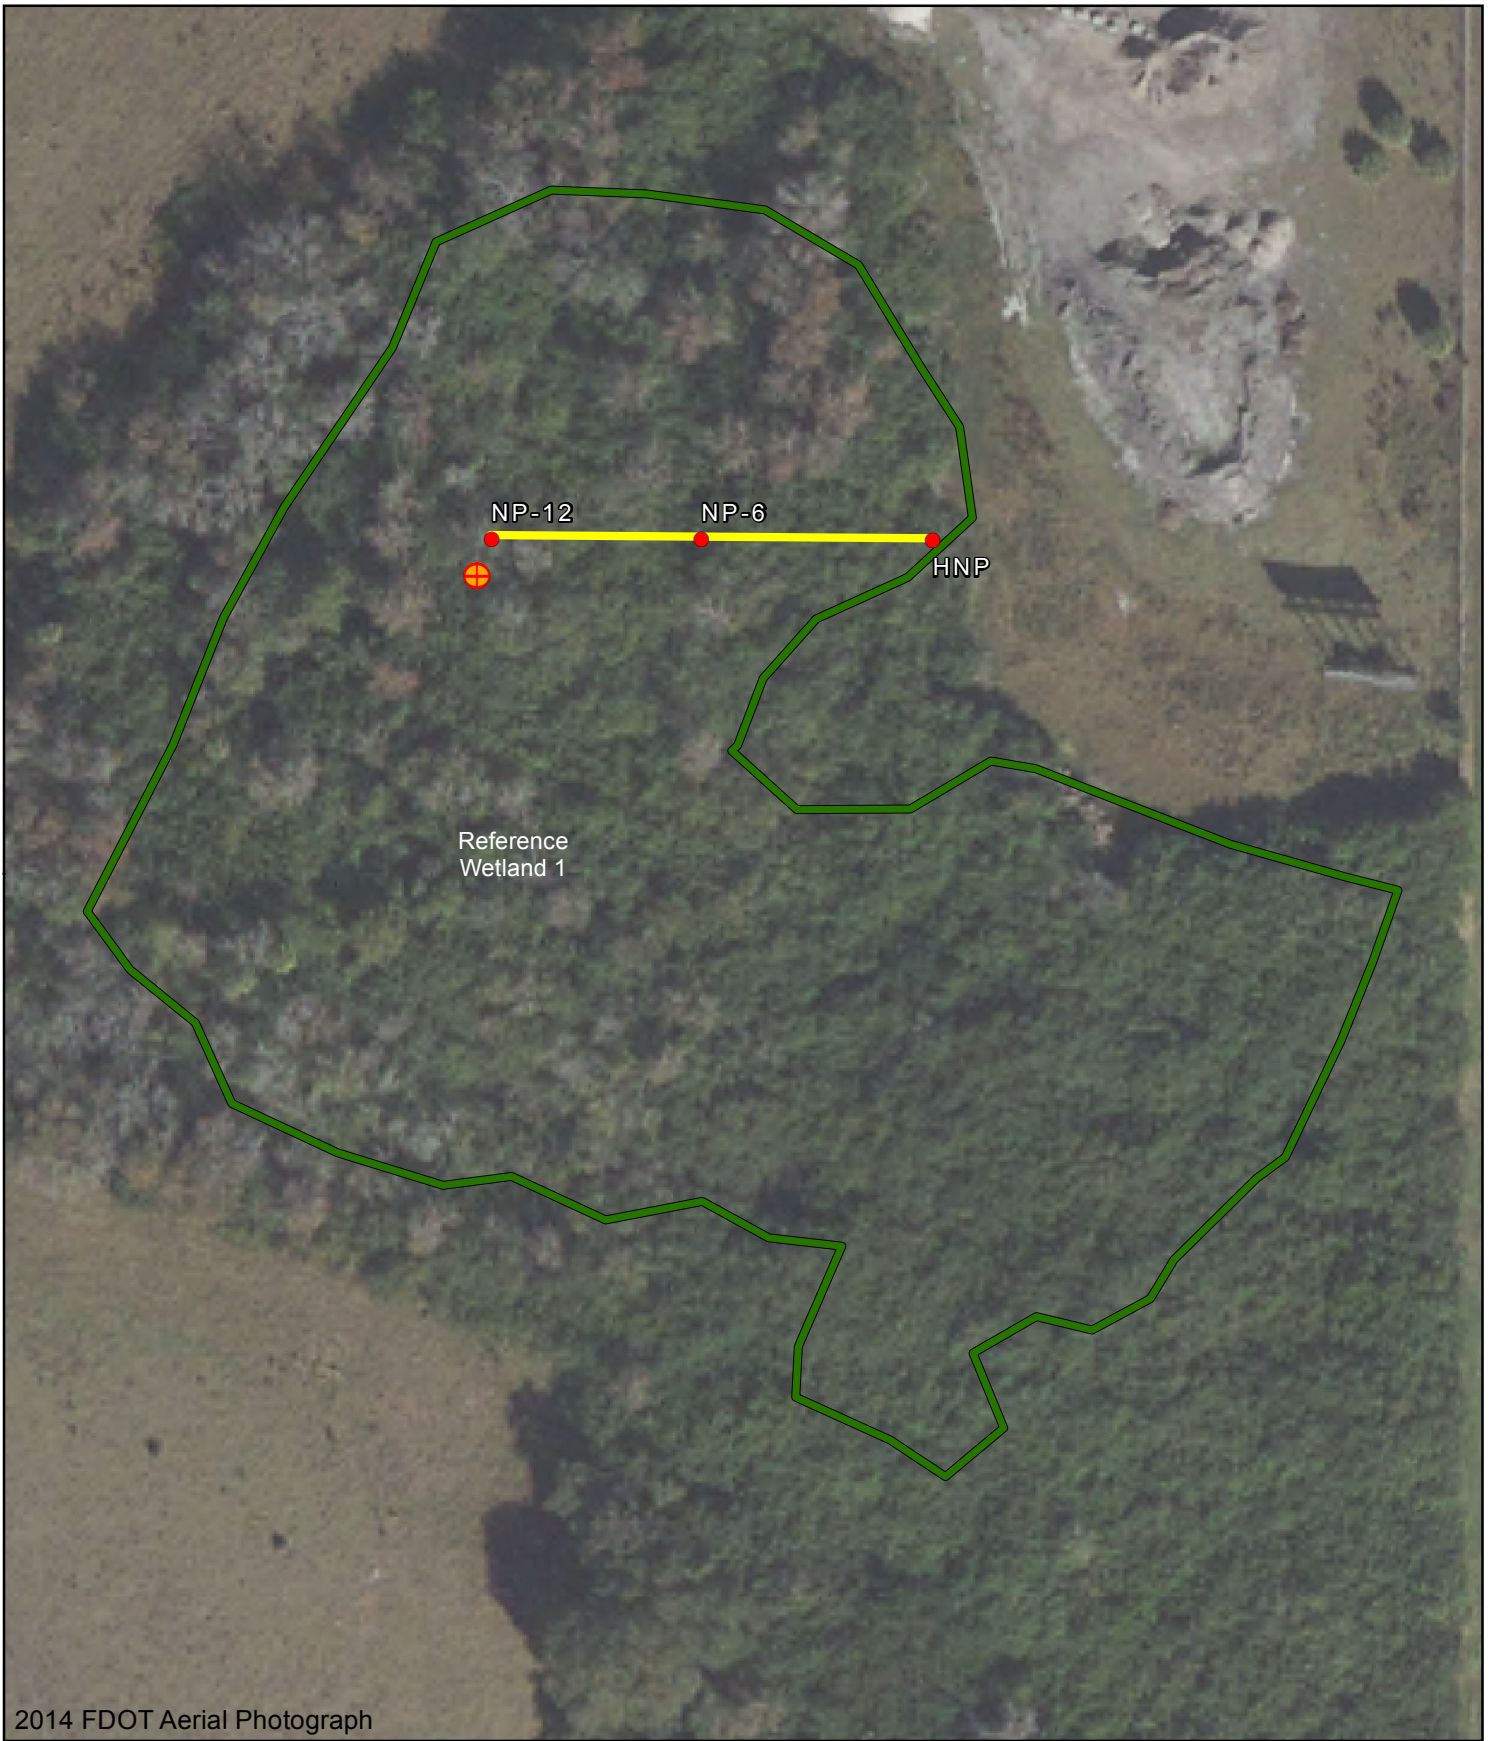
LOCKHEED MARTIN TALLEVAST SITE TALLEVAST, FLORIDA 2015 WETLAND MONITORING	
<b>TARGET WETLAND 18                  TRANSECT MAP</b>	
	FIGURE 9-4

The TW-18 monitoring transect is oriented from south to north, beginning at the collocated monitoring well/staff gauge (installed February 22, 2010) and extending to the HWE in the northern portion of the historical wetland (Figure 9-4).

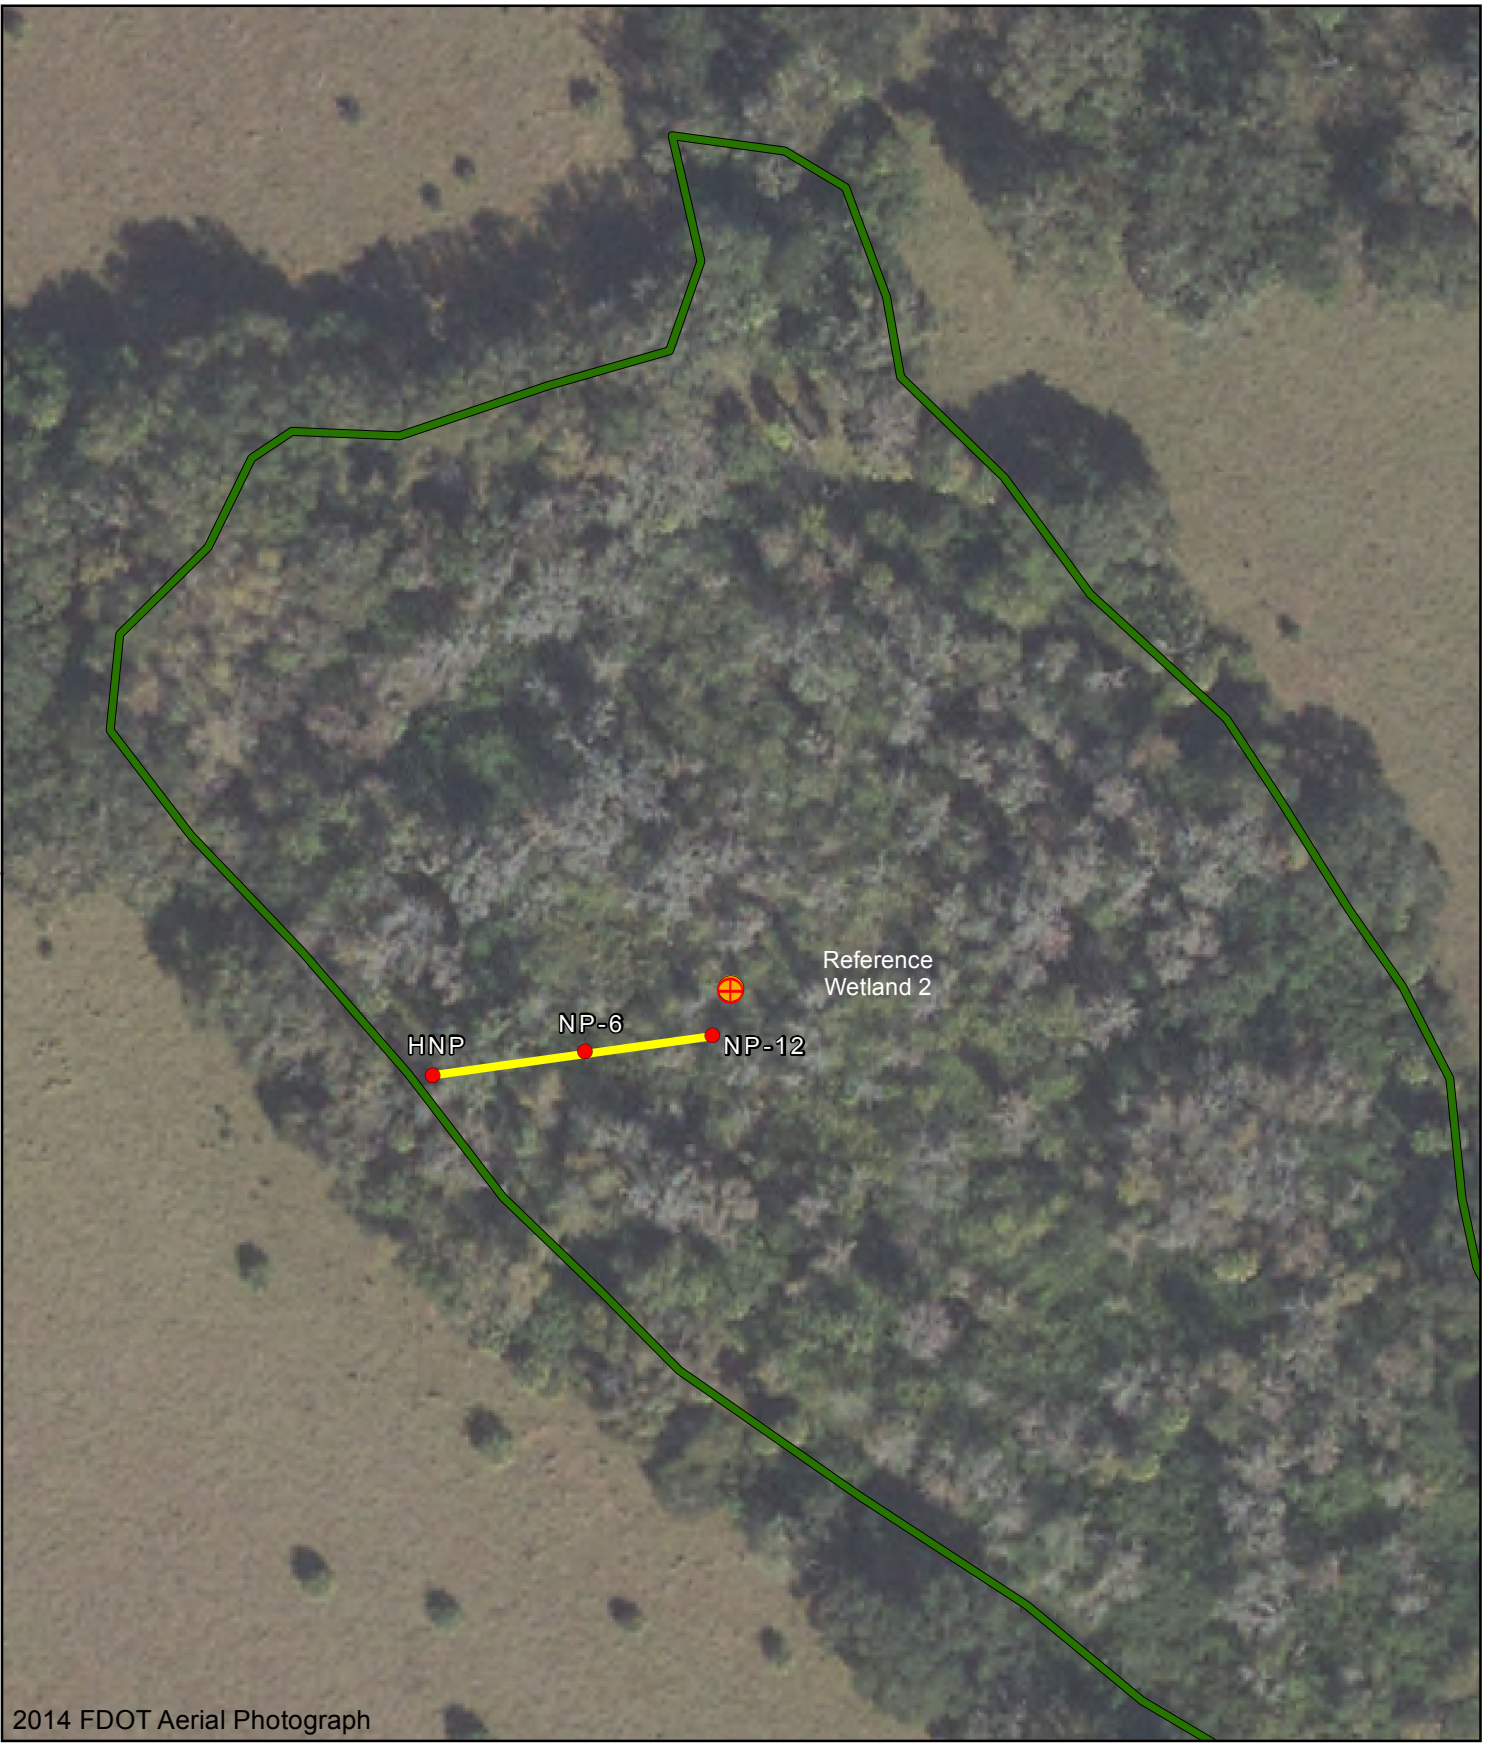
FIGURE 9-5

The RW-1 monitoring transect is oriented from west to east beginning at the collocated monitoring well/staff gauge (installed November 3, 2009) and extending to the HWE in the eastern portion of the wetland (Figure 9-5).

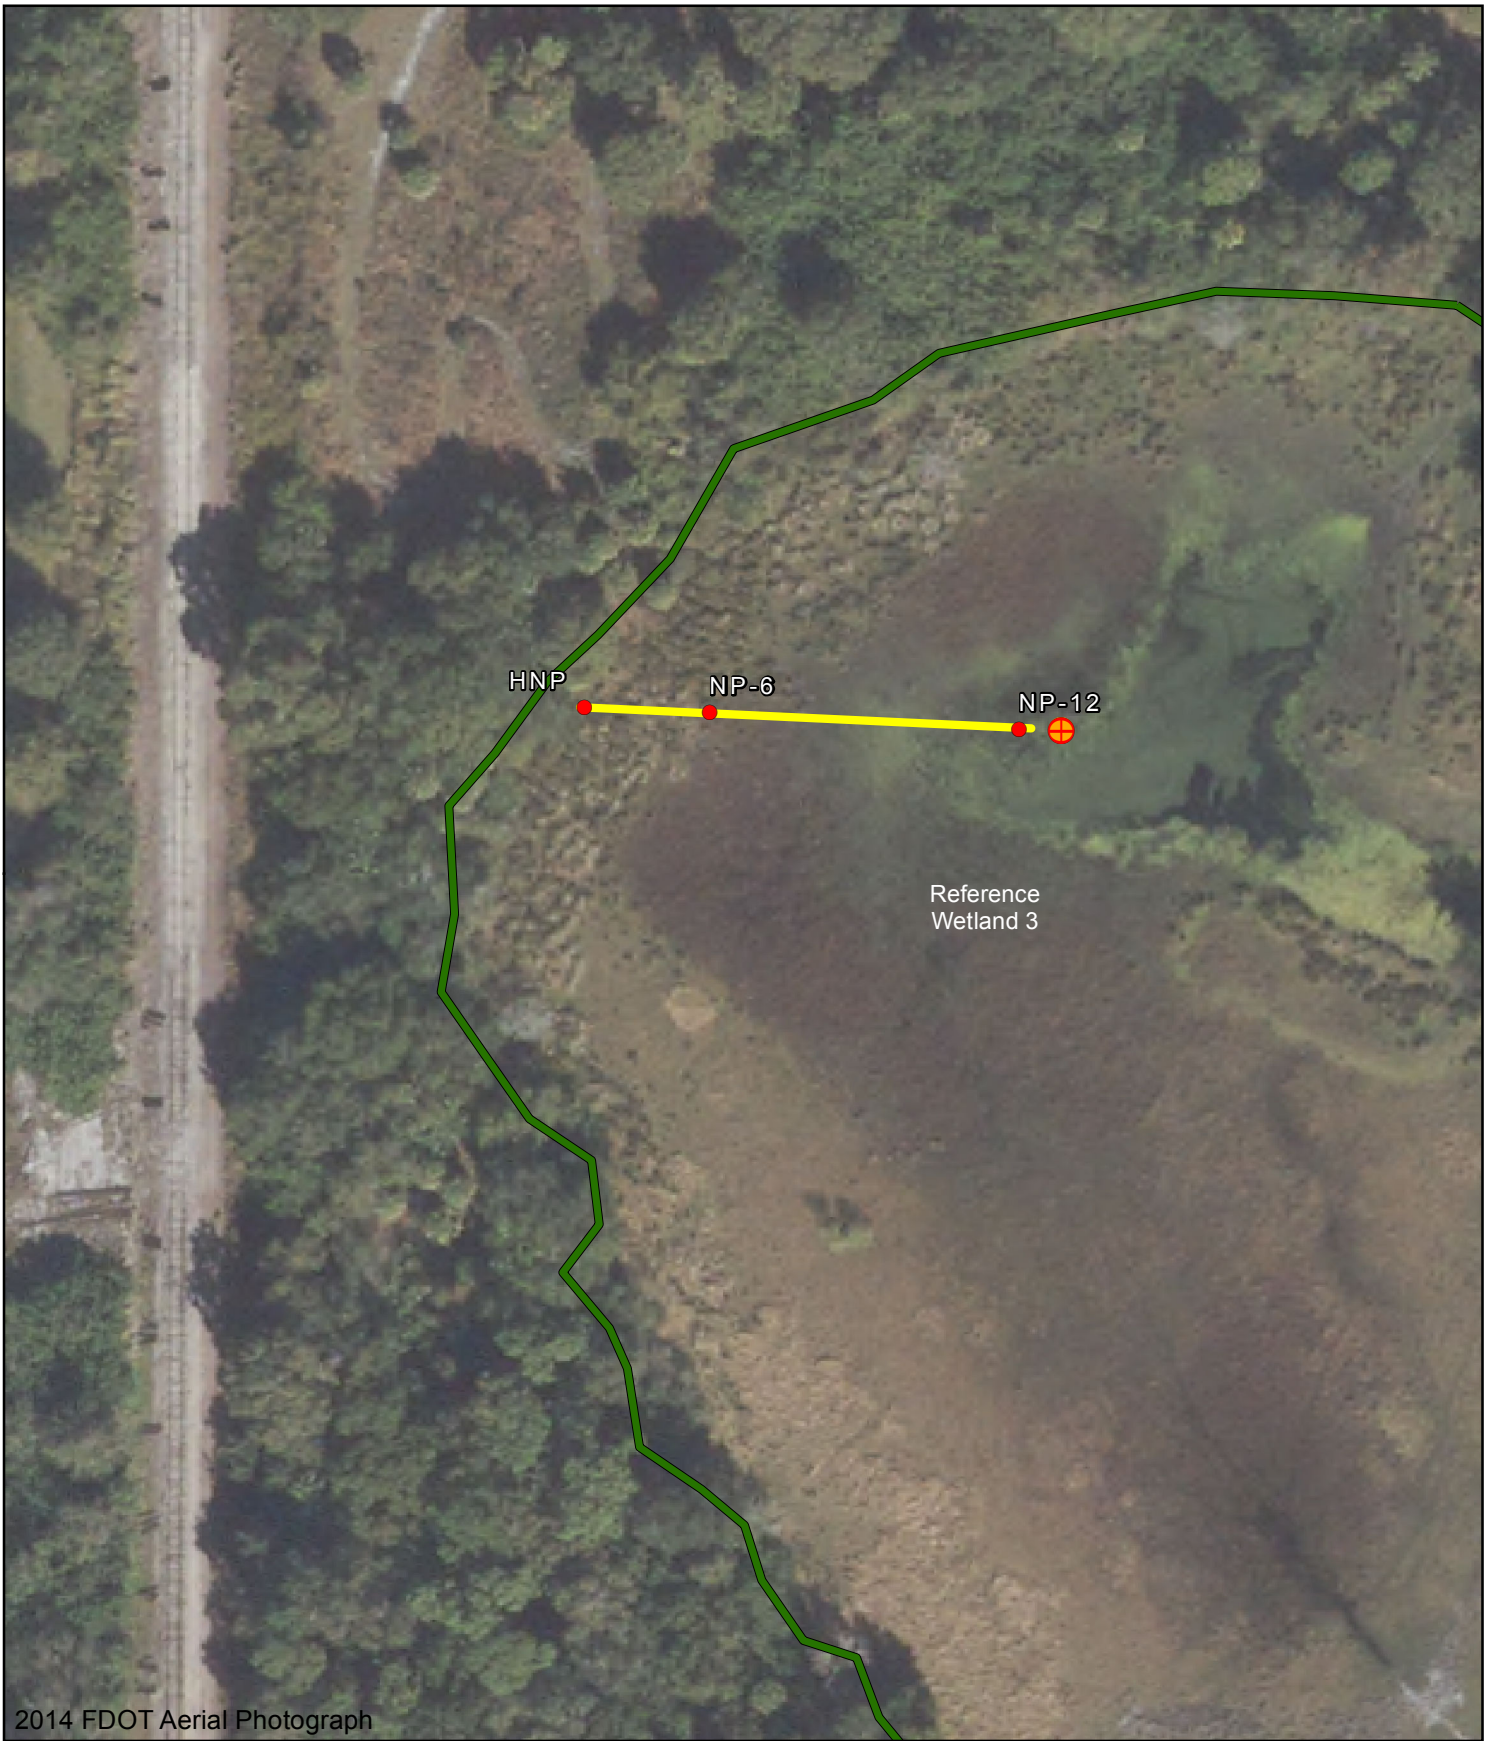
LOCKHEED MARTIN TALLEVAST SITE TALLEVAST, FLORIDA 2015 WETLAND MONITORING	
REFERENCE WETLAND 2 TRANSECT MAP	
 	FIGURE 9-6

The RW-2 monitoring transect is generally oriented from east to west beginning at the collocated monitoring well/staff gauge (installed November 3, 2009) and extending to the HWE on the western portion of the wetland (Figure 9-6).

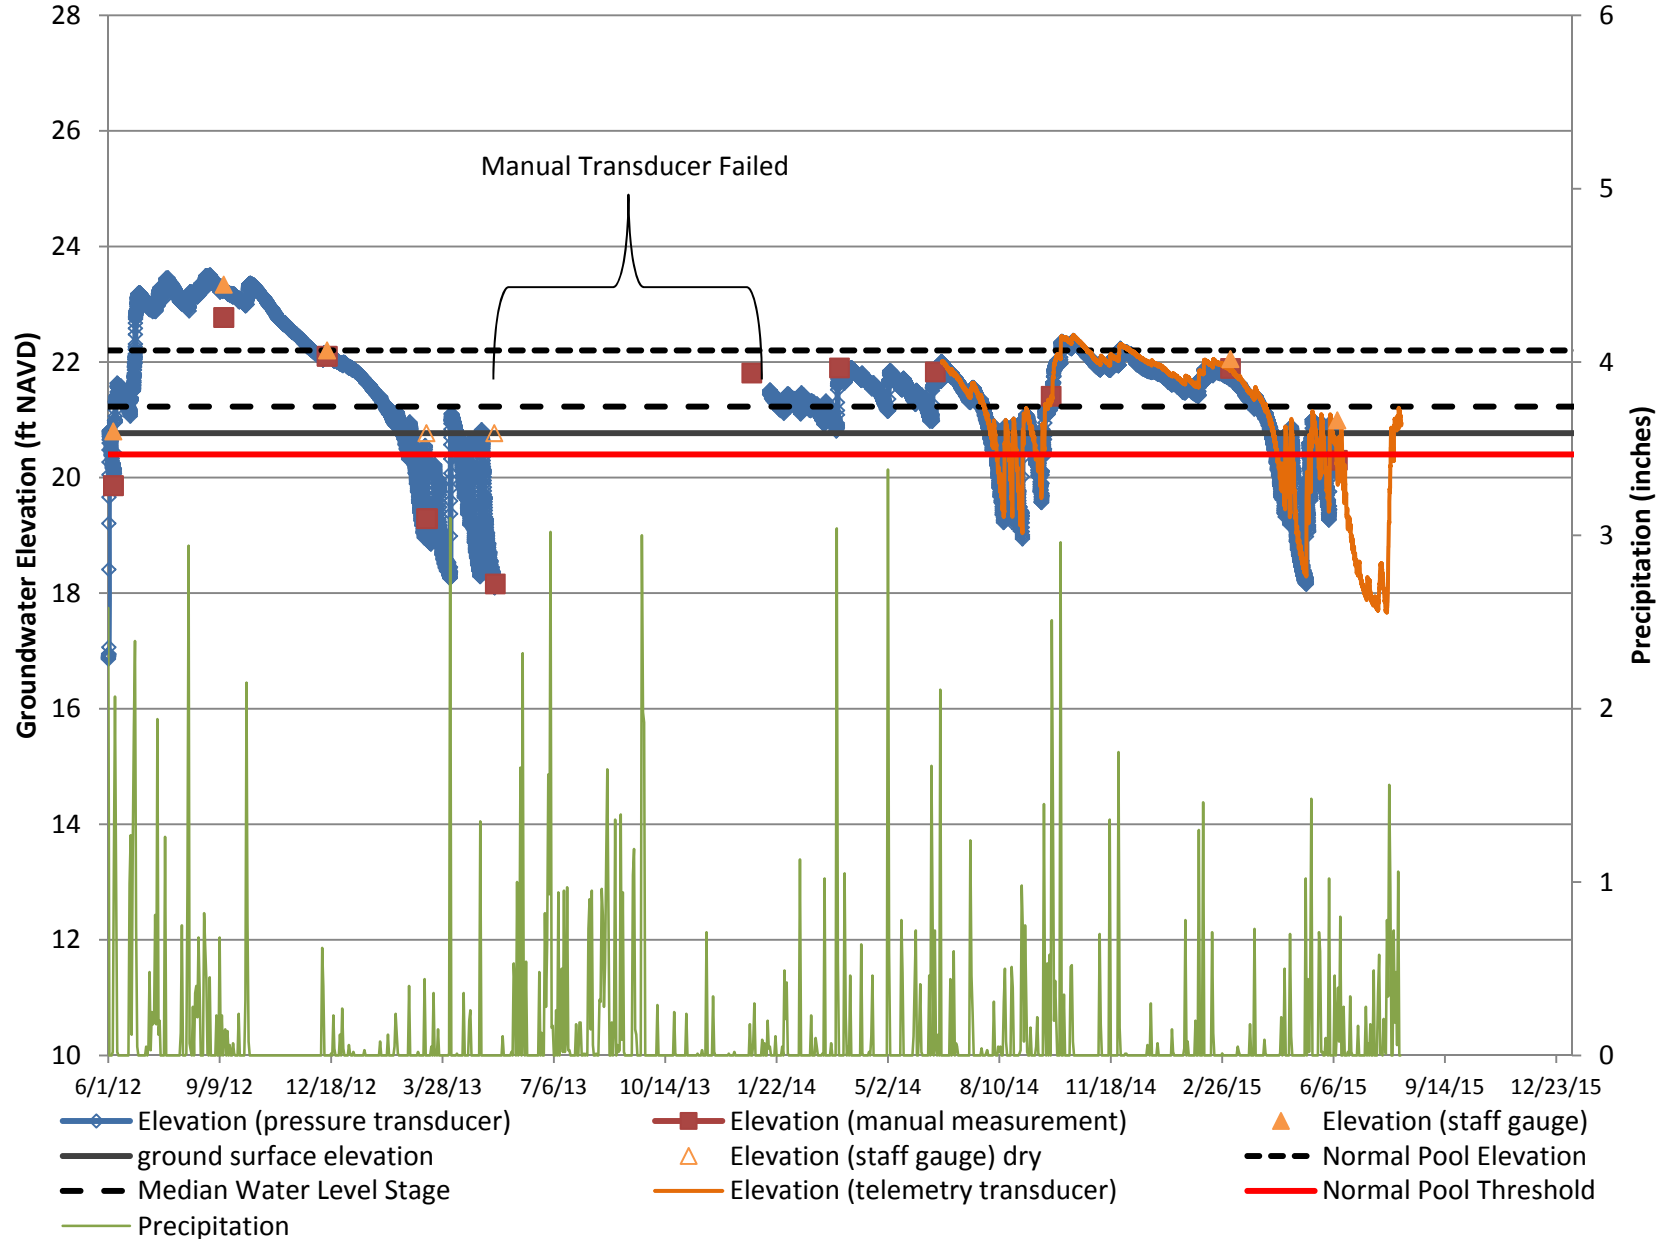
# MW-RW-3 2012 - 2015

The transducer for well MW-RW-3 was installed on November 6, 2009. Groundwater elevations varied between 4 ft bgs to 3 ft ags since monitoring began in November 2009. No data was collected by the transducer between May 2013 and January 2014 due to a low transducer battery. In addition, staff gauge data was not collected between May 2013 and December 2014 due to the staff gauge being damaged. A new transducer was installed on January 15, 2014 and a new staff gauge was installed and surveyed in October 2014. During the current monitoring period (June 2014 through June 2015), groundwater elevations decreased from 1 ft ags to approximately 1.5 ft bgs in June 2014, followed by several rapid fluctuations between ground surface and 1.5 ft bgs in August and September 2014. In late September, groundwater elevations rapidly increased to the normal pool elevation (approximately 2 ft ags), followed by a slow decrease to ground surface between October 2014 and April 2015. Between April and June 2015, groundwater elevations fluctuated rapidly from 0.5 ft ags to approximately 1.5 - 2.0 ft bgs. Observations made during the semi-annual transducer download events in September 2014 and March 2015, as well as during annual wetland assessment conducted in June 2015, indicated standing surface water at this location (see Appendix B). Groundwater and surface water responses to precipitation events are evident throughout the data collected to date (Appendix D).

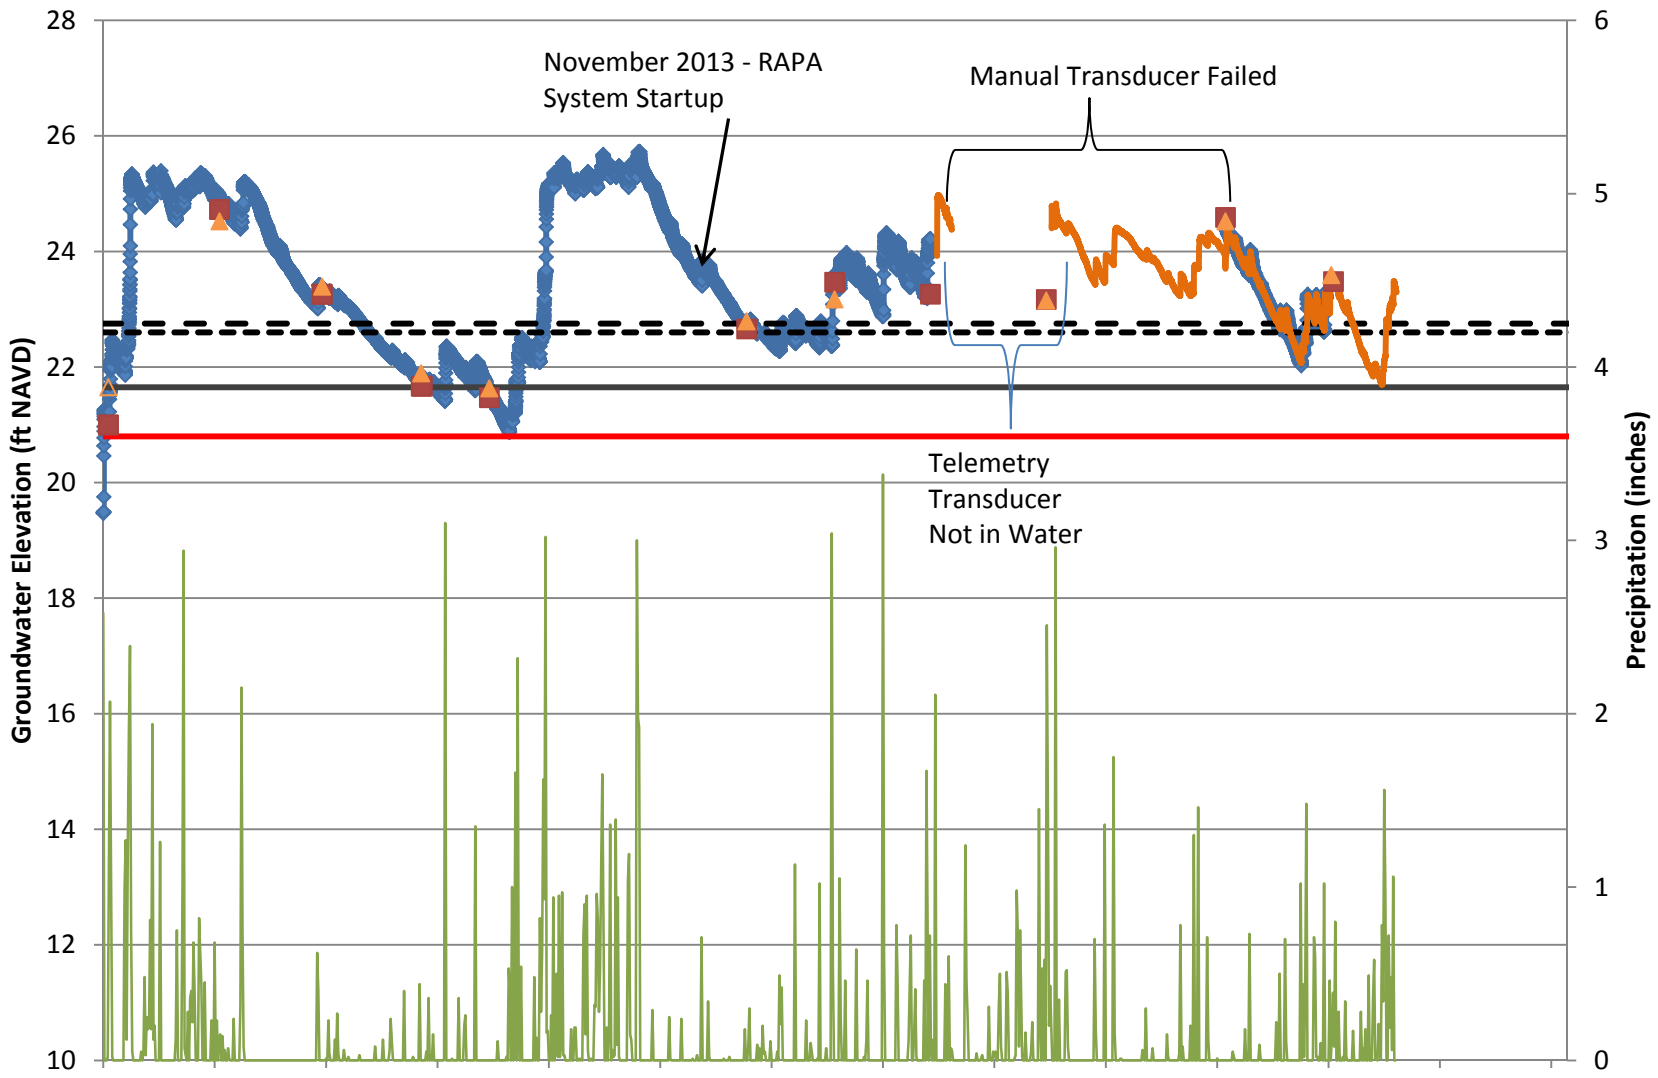
# MW-TW-2 2012 - 2015

3 ft ags in June 2014. Due to failure of the manual transducer and improper deployment of the telemetric transducer, no data was collected from June 27, 2014 to September 30, 2014, when the telemetric transducer was properly deployed. Groundwater elevations fluctuated between approximately 3 ft ags and 2 ft ags from October 2014 through March 2015, followed by a steady decrease to approximately 0.5 ft ags between March and May 2015. By the time of the June 2015 assessment, groundwater elevation had increased to just above the normal pool elevation (1 ft ags). Staff gauge measurements collected during wetland transducer downloads in September 2014, March 2015 and June 2015 indicated standing surface water at this location (see Table 9-2). Standing surface water was observed in TW-2 (Appendix B) during the annual wetland assessment conducted on June 10, 2015. Groundwater and surface water responses to precipitation events are evident throughout the data collected to date (Appendix D).
