**Re: 2020 Annual Wetlands Monitoring Report
Lockheed Martin Tallevast Site
FDEP Site No. COM_169624/Project No. 238148
Tallevast, Manatee County, Florida**

WETLANDS MONITORING REPORT – JUNE 2019 THROUGH JUNE 2020 – TALLEVAST SITE

FDEP Site No. COM_169624
FDEP Project No. 238148

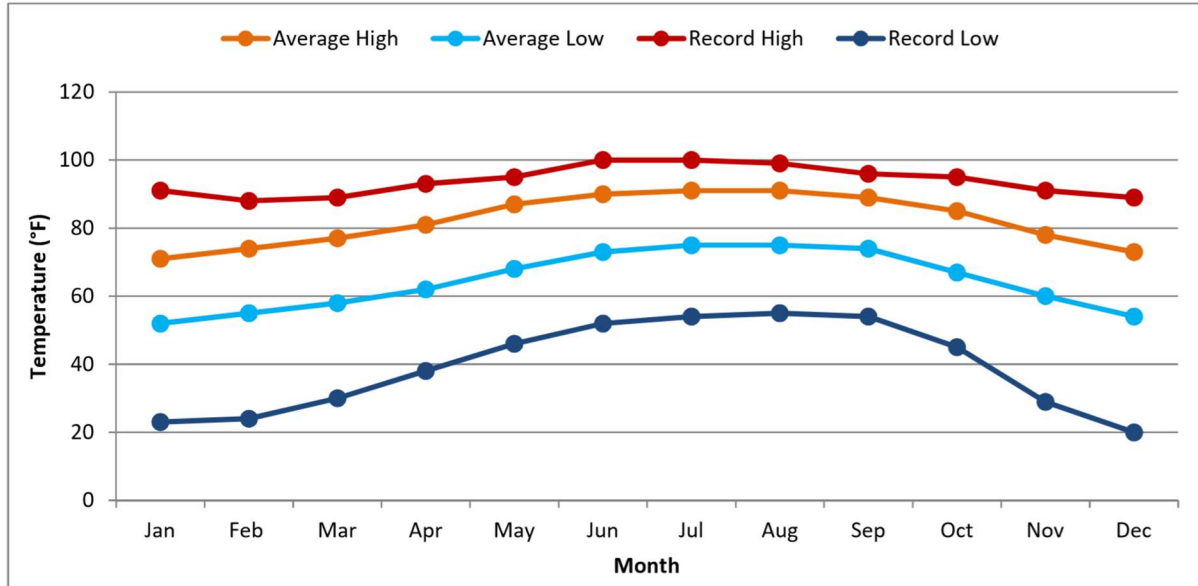
FIGURE 6-2
Historical Temperature Trends in the Tallevast Area

Source: The Weather Channel, 2020, Tallevast, FL

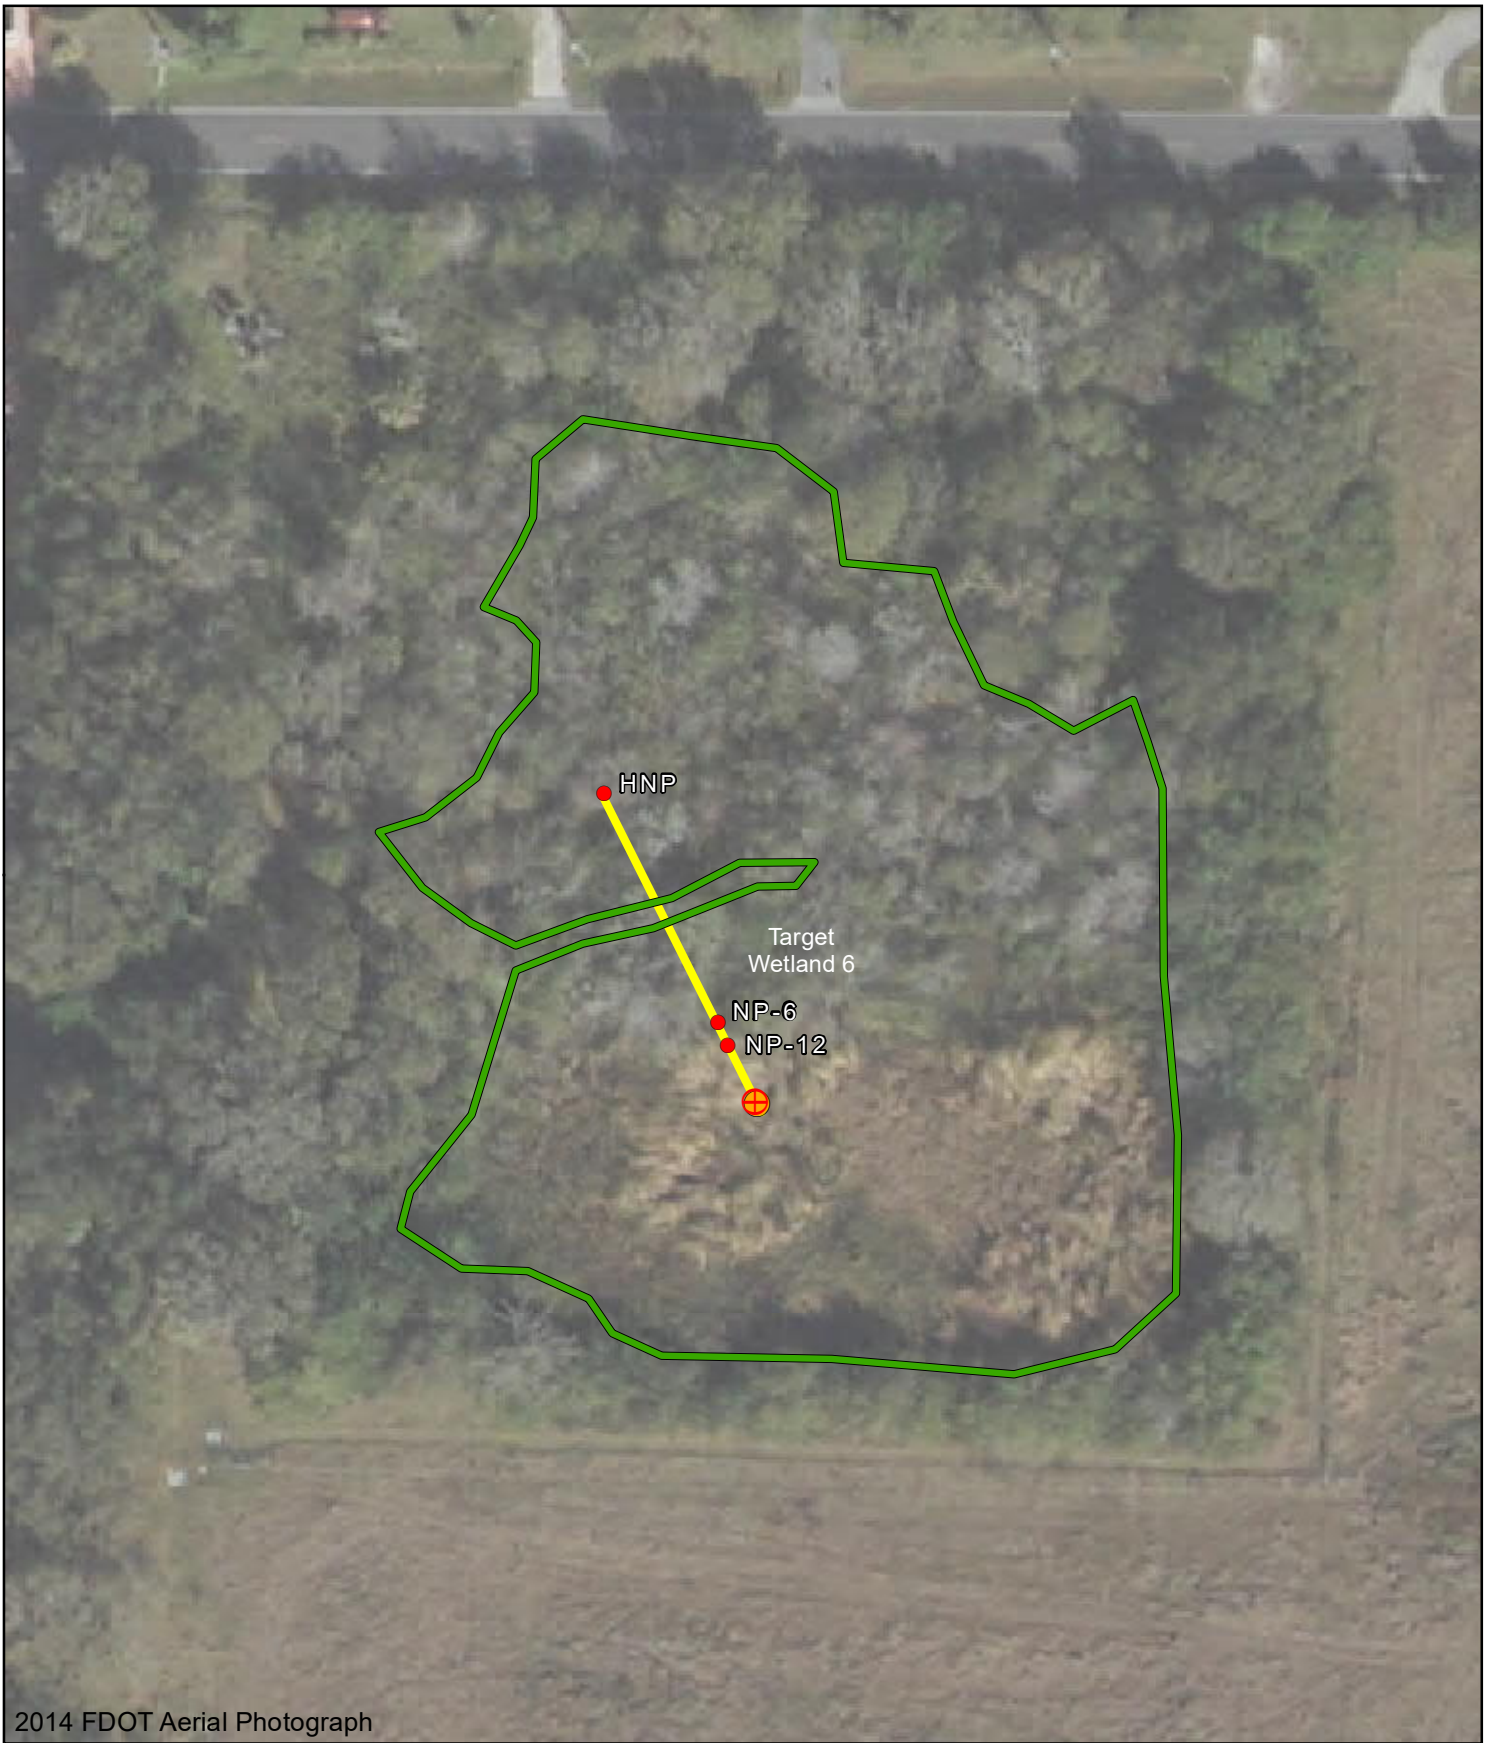
Figure 9-1 Target Wetland 6 – Transect Map

No major alteration or conversion of previously reported land use or vegetative cover types in TW-6 was observed during this monitoring period. Observed hydrology during previous monitoring events suggests that groundwater is a partial source to the pond, but it is also fed by stormwater runoff from nearby Tallevast Road and other sources described previously. Rust, stains, and residues on the staff gauge continue to indicate persistent water volumes in the excavated pond. During the June 2020 assessment, surface water was not observed in the Deep Zone. This wetland was experiencing dry conditions associated with the lack of precipitation prior to the June 2020 assessment. Based on water level data collected during this current monitoring period, the minor amount of treated effluent water recharged to RC-7002 during winter 2019 and spring 2020 augmented groundwater recharge entering TW-6 but did not buffer the wetland from drawdown associated with the GRTS.

During the June 2020 assessment, the vegetation in the excavated portion of TW-6 continued to consist of predominantly Outer Deep Zone species. Vegetation of the wetland area north of the pond continued to be dominated by Outer Deep Zone and Transitional Zone species. Adaptive and Transitional Zone species have historically been noted in the Deep Zone, but no Adaptive or Transitional Zone species were observed within the Deep Zone during the 2020 event. A minor amount of the Upland Zone species, Caesar's weed, was observed within the Deep Zone during

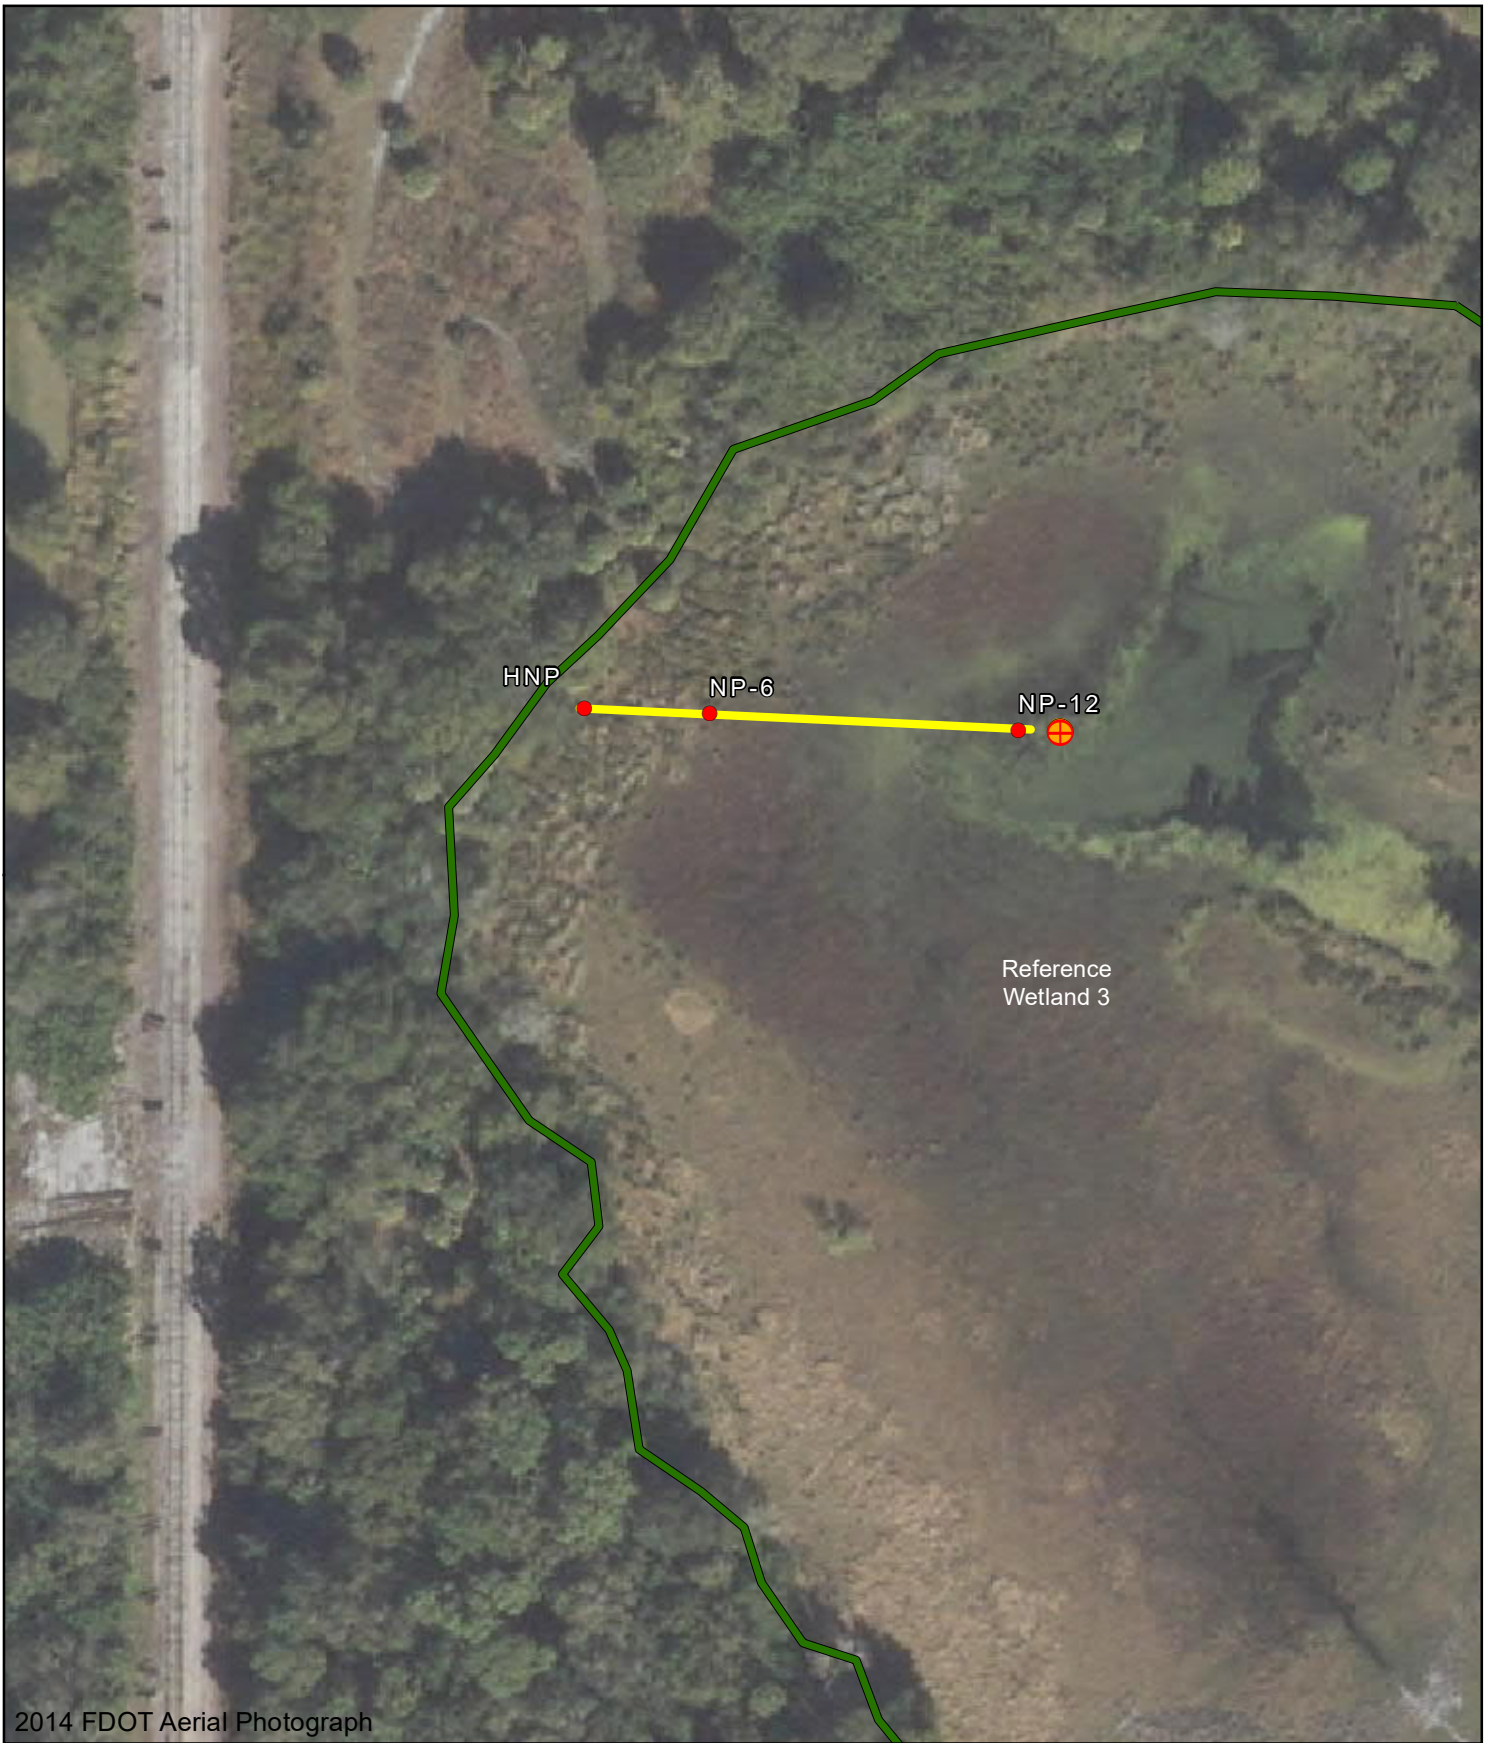
Figure 9-2 Reference Wetland 3 – Transect Map

No major alteration or conversion of previously reported land use or vegetative cover types in RW-3 was observed during this monitoring period. Evidence of prior conversion of RW-3 to upland prairie, as previously reported in the baseline reports, was not observed. The 2013 baseline report indicated that the lower half of RW-3 was rapidly transitioning to upland. This may have been due to hydrologic and vegetative evidence resulting from drought conditions preceding the monitoring event. During the June 2020 monitoring event, this wetland did not contain standing water within the monitoring transect. This wetland was experiencing dry conditions associated with the lack of precipitation prior to the June 2020 assessment. Hydrologic and vegetative evidence indicates WAP scores similar to the previous monitoring event for RW-3. The groundcover WAP score for RW-3 remains a 5, indicating a normal zonation pattern. While there was an absence of woody vegetation in the Outer Deep and Deep Zones, the shrub/small tree WAP score for the June 2020 assessment was 5, indicating a normal zonation pattern. The tree WAP score for the June 2020 assessment was Not Applicable due to the absence of trees in the Transitional, Outer Deep, and Deep Zones.
