Wetlands Monitoring Report

Tallevast, Florida

Lockheed Martin Corporation

ARCADIS

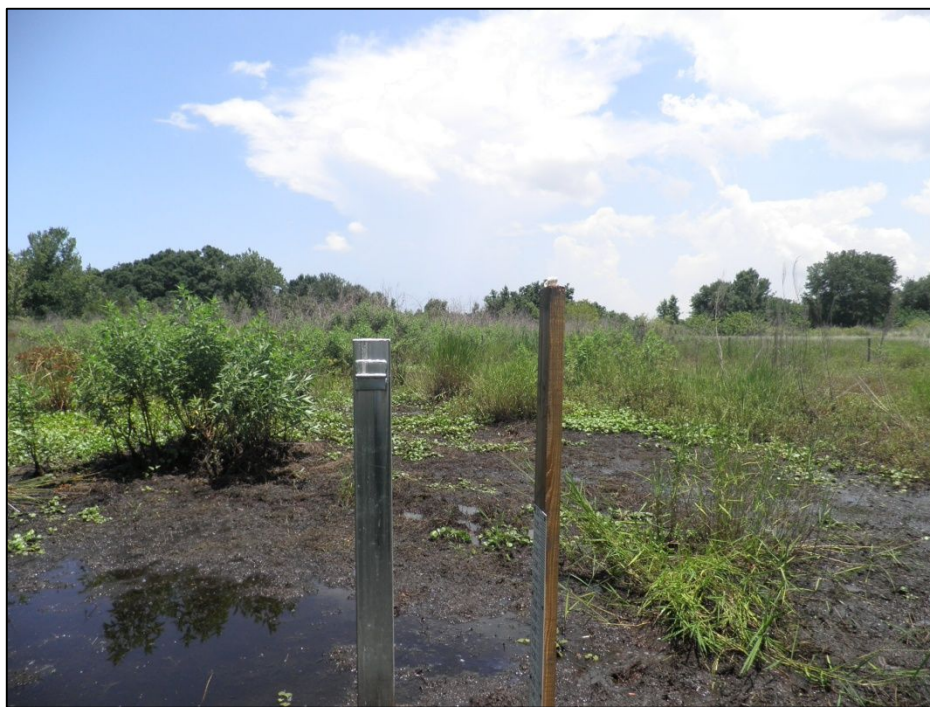
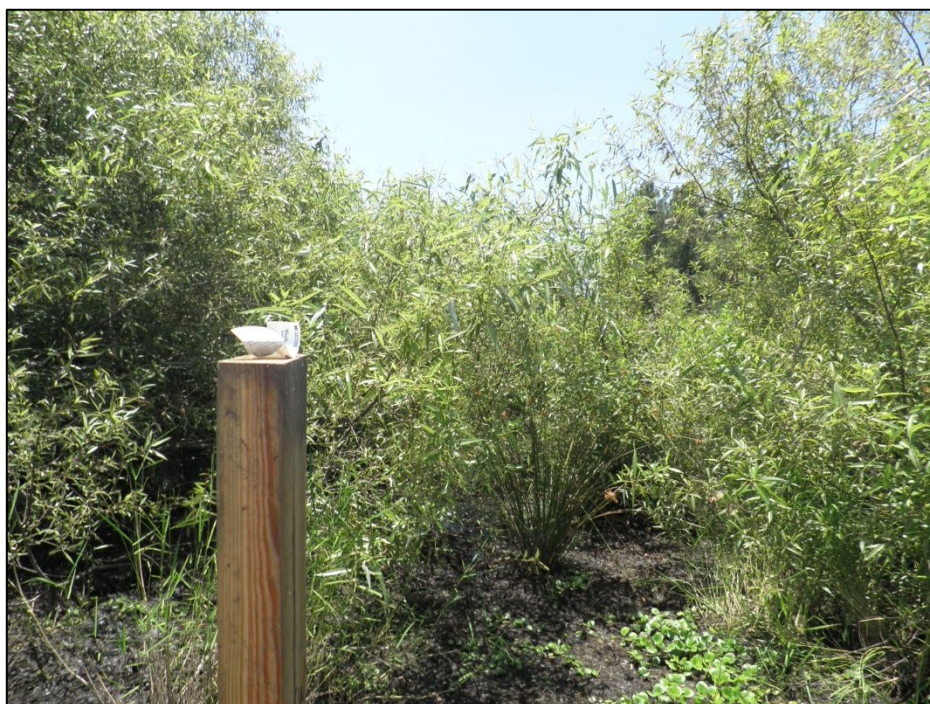
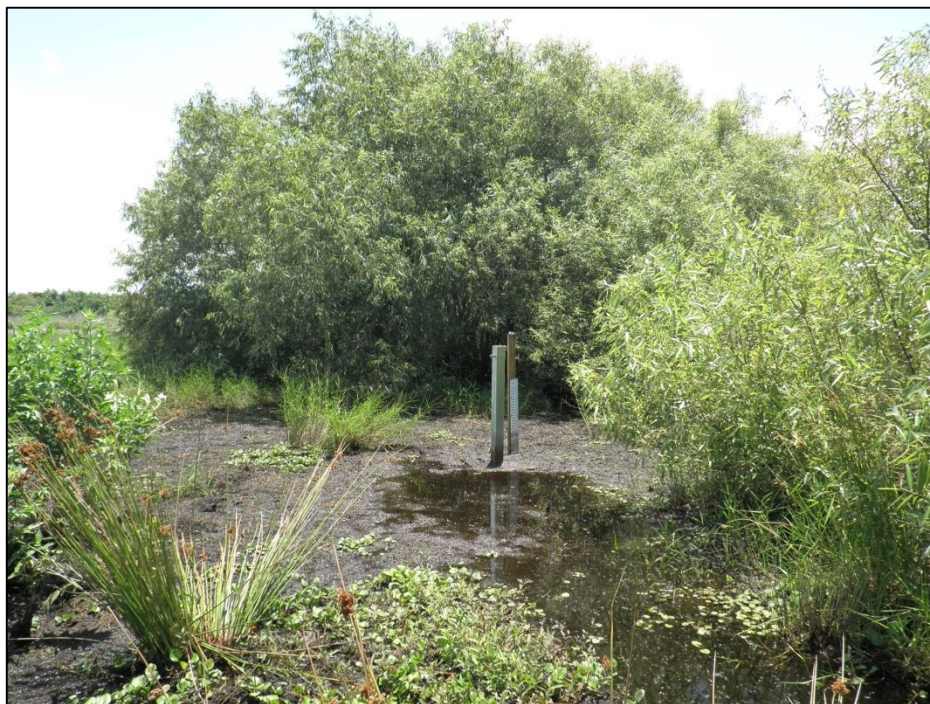
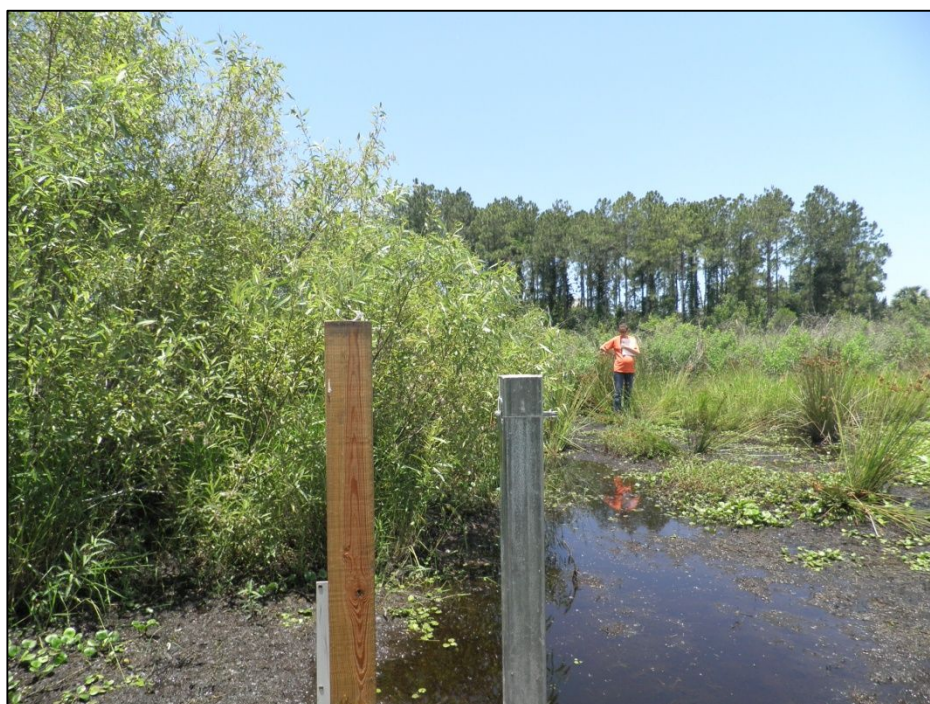
No inundated areas were observed within the established bounds of TW-1 during the June 2009 site visit. Conditions during a subsequent November 4, 2009 site visit, as well as during the February 2010 monitoring well and staff gauge installation, included normal seasonal inundation to the HNP elevation that was sufficient to submerge most of the previously exposed deep zone, where indicators of wetland soil subsidence caused by oxidation and gasification of carbon that result from drought and drying conditions were observed during the June 2009 site visit. Similarly, while site conditions during the June 2010 transect assessment included observed drawdown and drying of the wetland, partially inundated pools still occurred in the deep zone, below the NP-12 elevation. The area of previously reported wetland soil subsidence, observed in June 2009, was in the portion of remaining inundated deep zone during the June 2010 assessment.

No conspicuous hydrologic alterations were observed along the surface area in or near the TW-1 transect. However, the previously reported 5.25-acre stormwater retention pond, associated with an industrial facility adjacent to the northern boundary of TW-1, exhibited surface-water elevation changes similar to TW-1 during the November 2009, February 2010, and June 2010 site visits. This indicates a potential hydrologic relationship between these two areas.

Photo 1 – TW1 Facing North

Photo 2 - TW1 Facing South

Photo 3 – TW1 Facing East

Photo 4 – TW1 Facing West

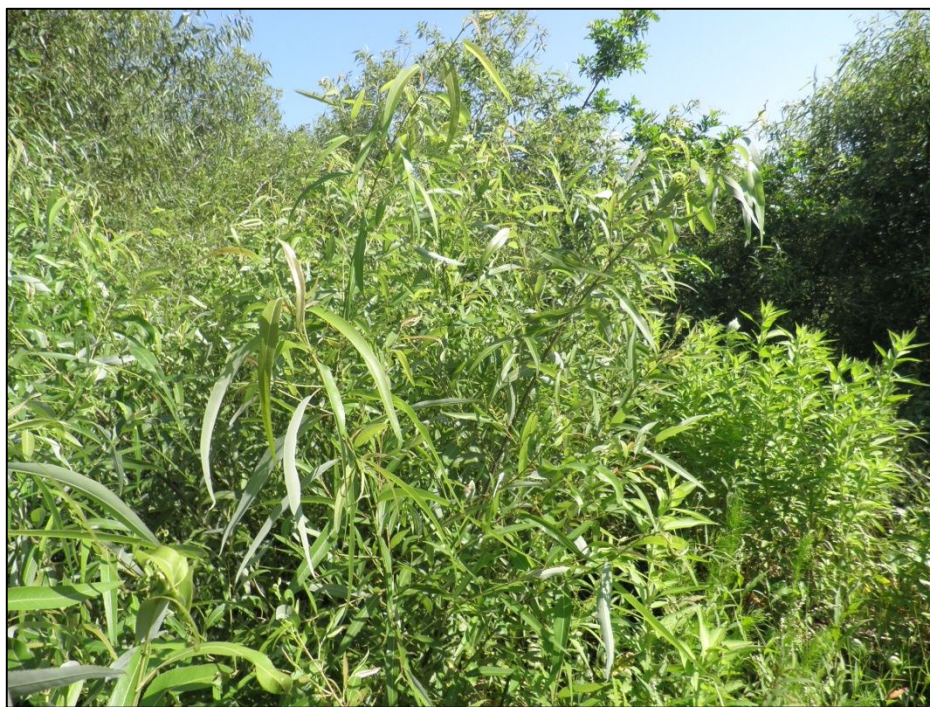
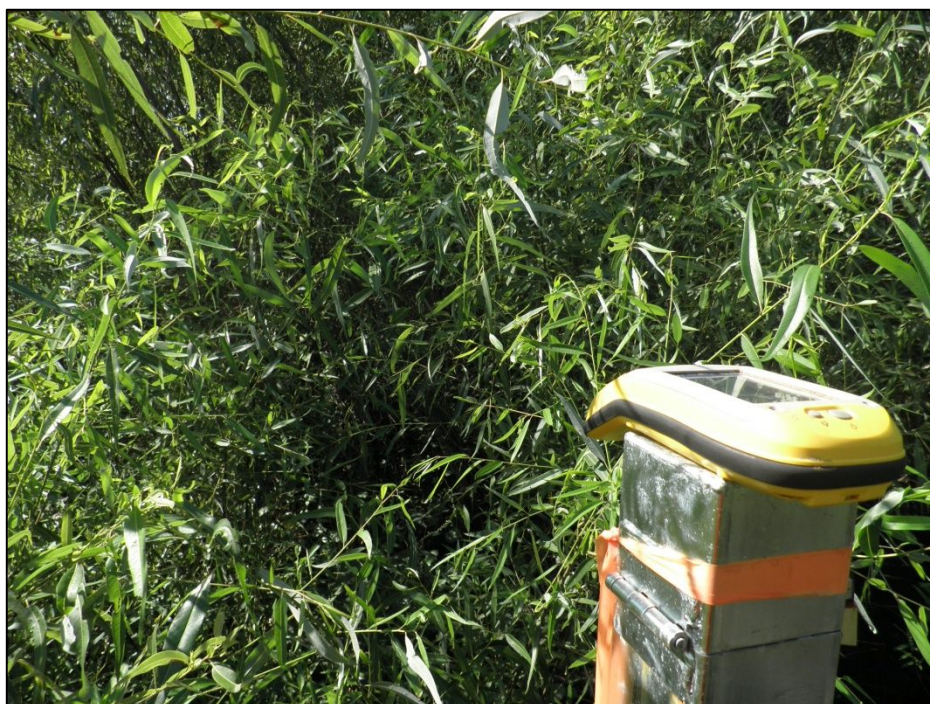
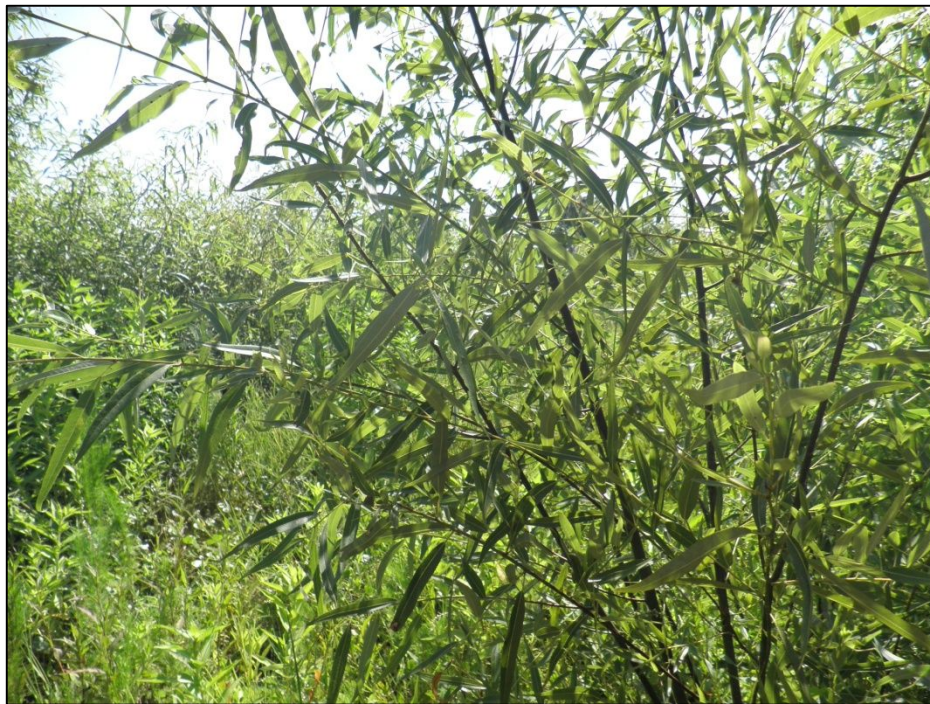
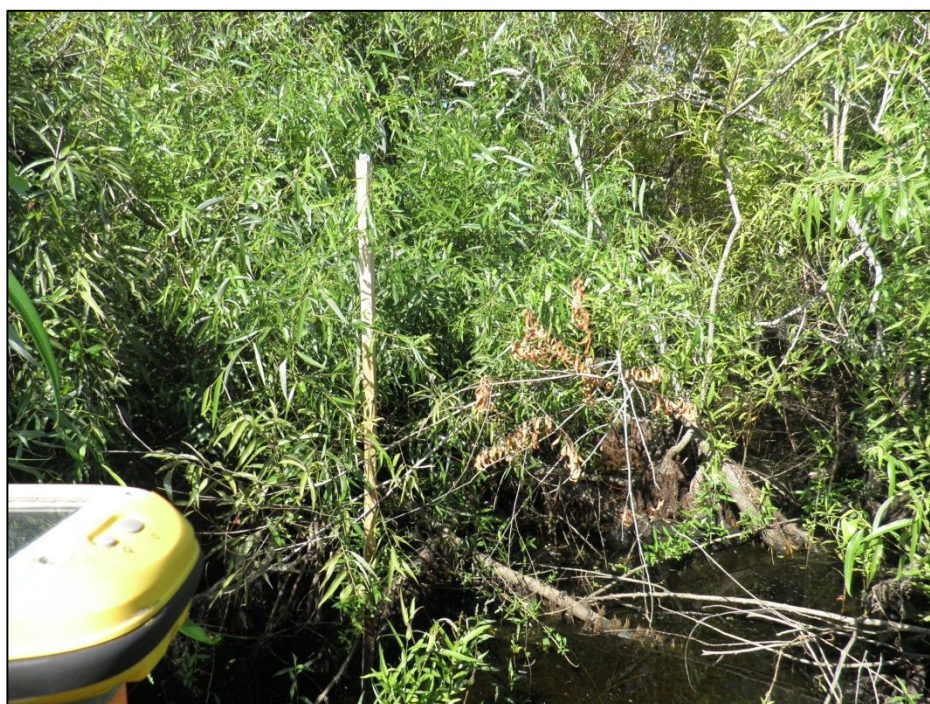
No major alteration or conversion of previously reported land use or vegetative cover types in TW-2 was observed between the June 2009 preliminary investigation and the June 2010 transect assessment. The TW-2 area displayed signs of prior and ongoing conversion to upland forested and prairie habitats. A dense stand of Carolina willow (*Salix caroliniana*) trees and shrubs lies west and southwest of the historically inundated wetland area. This wooded wetland area was dominated by OD and deep zone floral species, but several transitional and adaptive species are growing on hummocks in the interior of the deep zone. As much as 20 inches of wetland soil subsidence caused by oxidation and gasification of carbon that result from drought and drying conditions was observed in the forested core of TW-2. However, conditions during November 2009 monitoring well and staff gauge installation (MW-TW-2 and SG-TW-2), as well as during the June 2010 transect assessment, included normal inundation that was sufficient to submerge most of the subsided deep zone. Vegetation in the area shown as inundated in the 2003 aerial photograph consists of transitional grass species and a minimal number of small shrubs.

Although no longer inundated, a staff gauge (Staff Gauge-8) and a monitoring well (Stilling Well-3) are currently located within the historically ponded area of TW-2. No other evidence of inundation was observed within TW-2, which is likely due to unknown hydrological alterations that may have occurred in the past few years. Lower than normal precipitation could be another variable that negatively impacted water levels at TW-2. The most typical wetland area of TW-2 occurs near willow trees, and the wetland portion dominated by grasses is in the final stages of upland transition. Soils of the wetland area are sandy and contain organic streaking, as well as other hydric soil indicators. Soils of the wetland area exhibiting signs of upland transition consist of loamy upland sands. The monitoring transect established for TW-2 roughly incorporates an axis that includes the existing historical wetland area staff gauge and monitoring well.

Photo 5 – TW2 Facing North

Photo 6 – TW2 Facing South

Photo 7 – TW2 Facing East

Photo 8 – TW2 Facing West

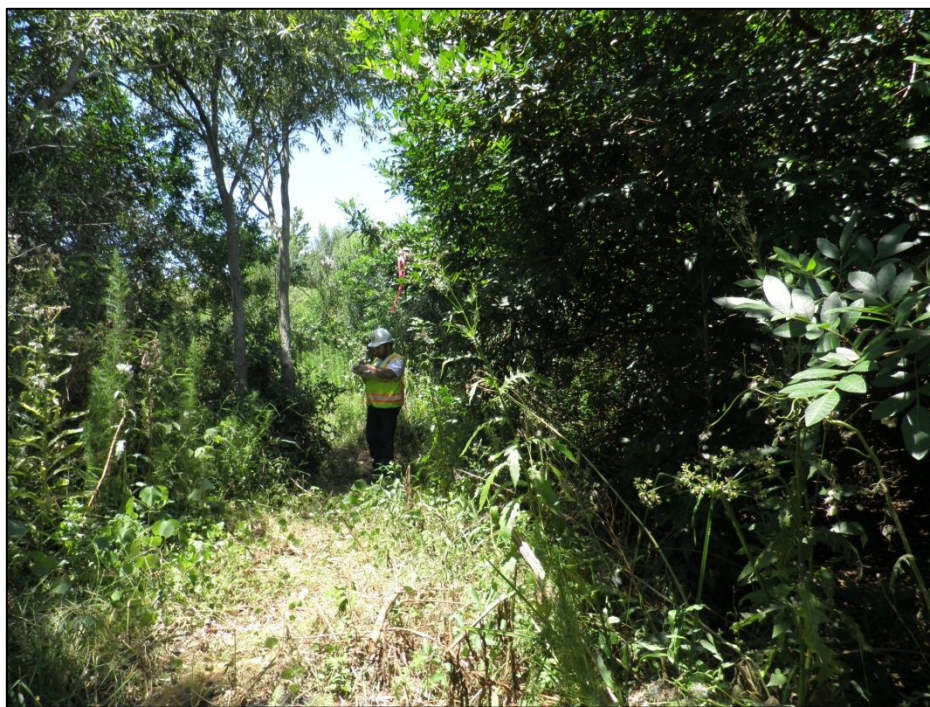
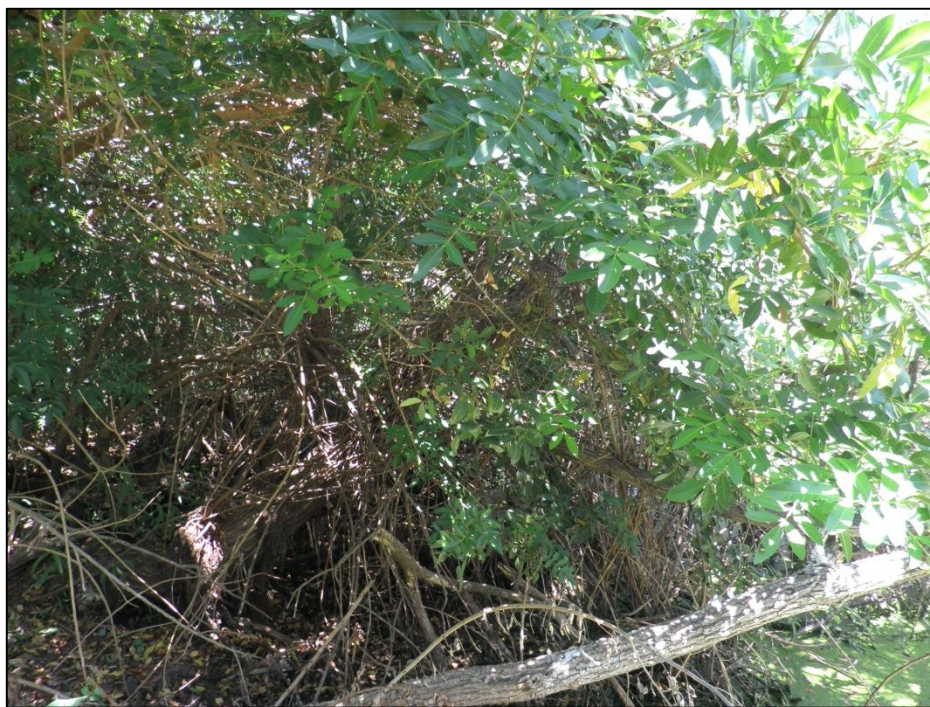
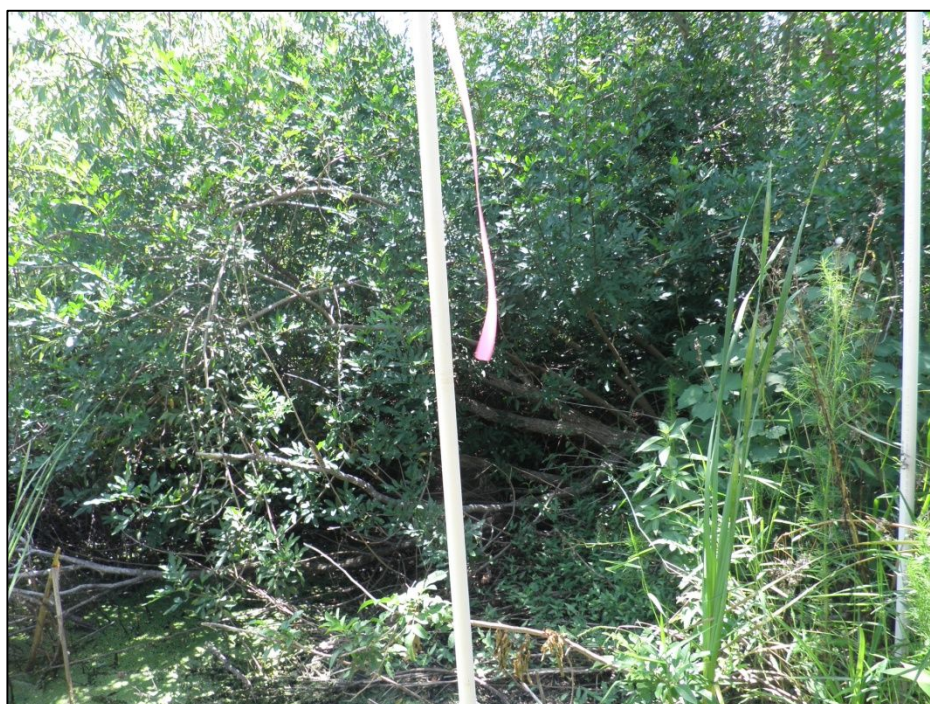
No major alteration or conversion of previously reported land use or vegetative cover types in TW-6 was observed between the June 2009 preliminary investigation and the June 2010 transect assessment. The section of TW-6 north of the historically inundated area displayed evidence of conversion to upland forested scrub. Soils in this area are composed of sand and loamy sand, with marginal hydric soil indicators.

Conditions during November 2009 monitoring well and staff gauge installation, as well as during the June 2010 transect assessment, included normal inundation that was sufficient to submerge most of the excavated pond and prohibited access to the previously described deep organic, mucky surface soils. This area was holding up to a 2-foot water column at the time of the June 2010 observations, with small duckweed (*Lemna valdiviana*) dominating the water surface. Vegetation in the excavated pond predominantly consists of OD and deep zone species. Vegetation of the wetland area north of the pond is dominated by outer deep zone and transition zone species, but migration of adaptive and upland species was noted. A minimal amount of wetland soil subsidence was observed within the wetland area outside of the pond, and no wetland soil subsidence was observed within the bed of the pond.

Observed hydrology suggests that groundwater is a partial source to the pond, but it is also fed by rainfall. An eroded, north-to-south oriented stormwater conveyance channel lies along the western boundary of TW-6. This eroded channel is likely a hydrological remnant of the historical stormwater flow path that fed the pond. Normal and capacity pool events in the pond are likely due to elevated groundwater in the areas of TW-6 to the north. These elevated groundwater events could have created the wetland conditions apparent in the northern section of TW-6. A small berm exists at the northern edge of the pond, which could have slowed stormwater sheet flow into the pond to create wetland conditions outside of the pond boundary. Lower than normal precipitation could be another variable that negatively impacts TW-6.

Photo 9 – TW6 Facing North

Photo 10 – TW6 Facing South

Photo 11 – TW6 Facing East

Photo 12 – TW6 Facing West

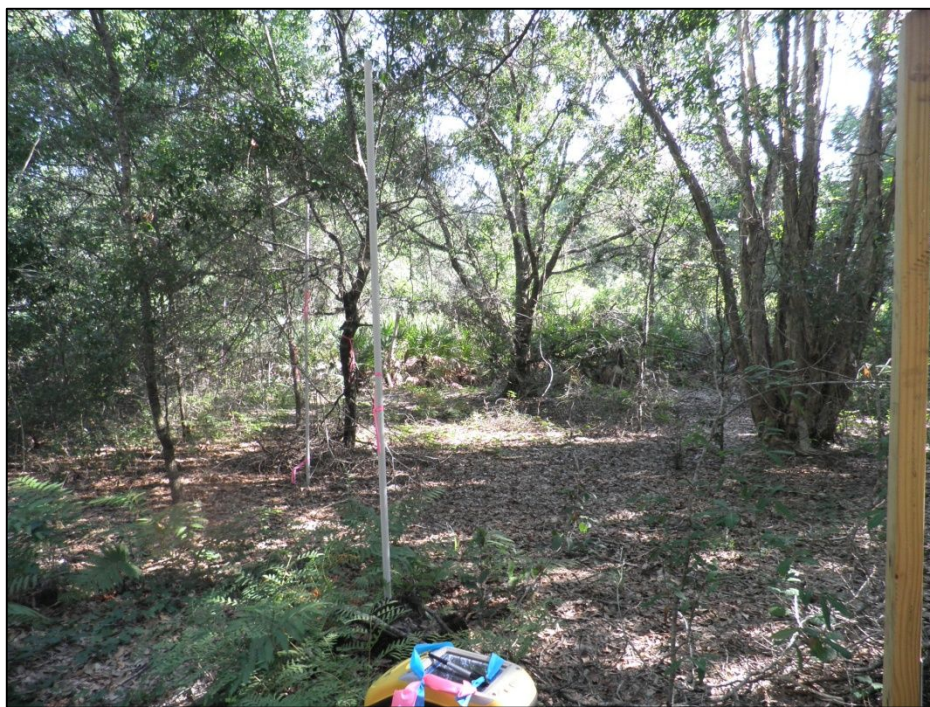
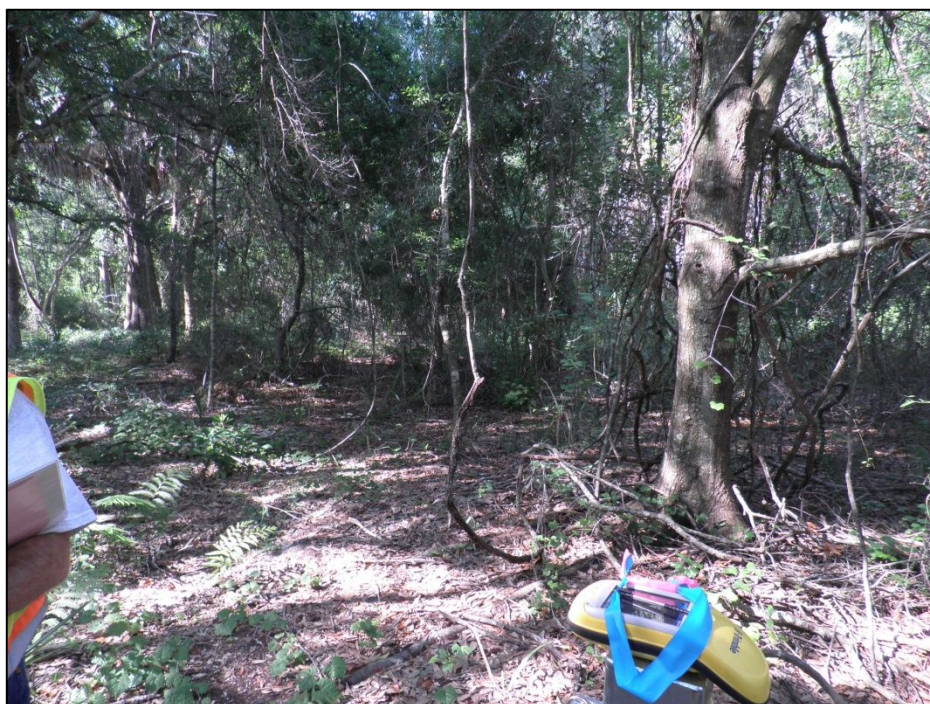
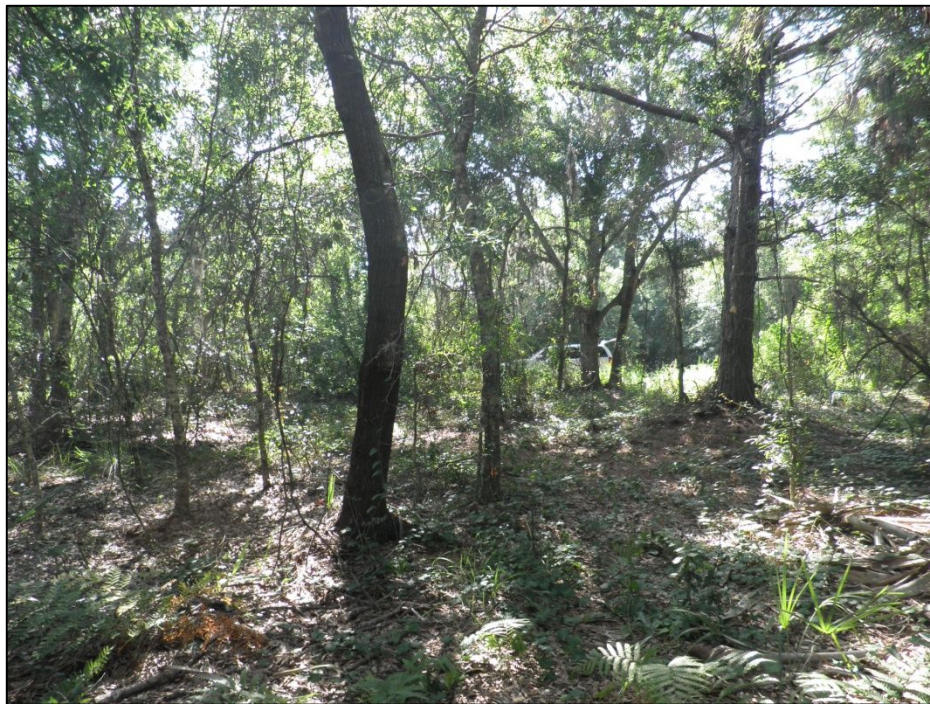
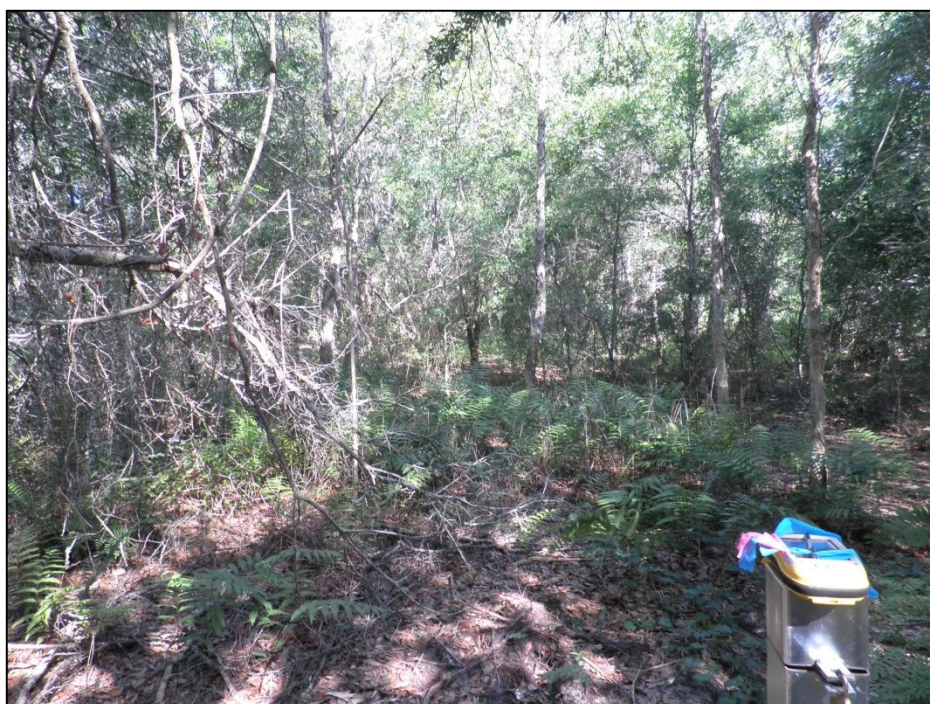
No major alteration or conversion of previously reported land use or vegetative cover types in TW-18 was observed between the June 2009 preliminary investigation and the June 2010 transect assessment. Vegetation within the historical wetland interior of TW-18 consists of a forested upland hammock of 15- to 20-year-old oak/hardwood and introduced mature punk trees (*Melaleuca quinquenervia*). Due to the elevated evapotranspiration rate of the species, which is hypothesized to “dry out” wetlands, the occurrence of punk trees within TW-18 may indicate prior habitat alteration. A minimal number of relict obligate-wetland ferns, including royal fern (*Osmunda regalis*) and Virginia chain fern (*Woodwardia virginica*), occur on hummocks within the historical wetland interior. A dense saw palmetto (*Serenoa repens*) thicket is encroaching along the northern, western, and southern borders of the HWE.

Up to 12 inches of wetland soil subsidence caused by oxidation and gasification of carbon that result from drought and drying conditions was observed within TW-18 and relict wetland vegetation is restricted to hummocks that protrude above the historical wetland floor following exposure by erosion. Soils at the TW-18 site consist of a loamy sand matrix typical of upland forested habitats in this region of Florida. TW-18 no longer contains hydrological indicators consistent with a functional wetland. The wetland habitat at TW-18 likely began transitioning to upland more than 20 years ago and is now devoid of active wetland characteristics.

Photo 13 – TW18 Facing North

Photo 14 – TW18 Facing South

Photo 15 – TW18 Facing East

Photo 16 – TW18 Facing West

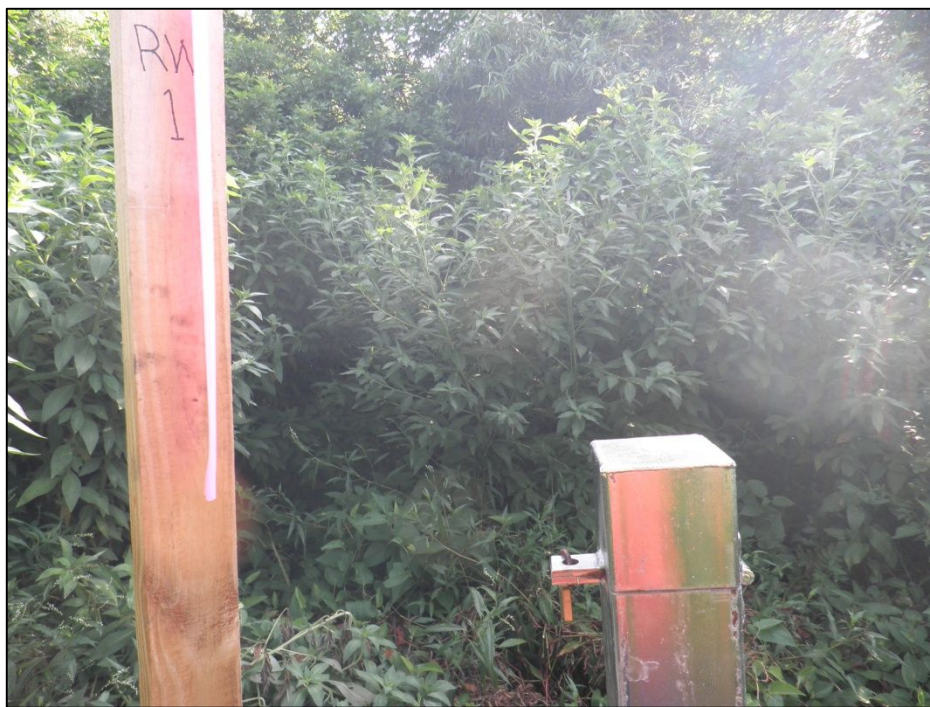
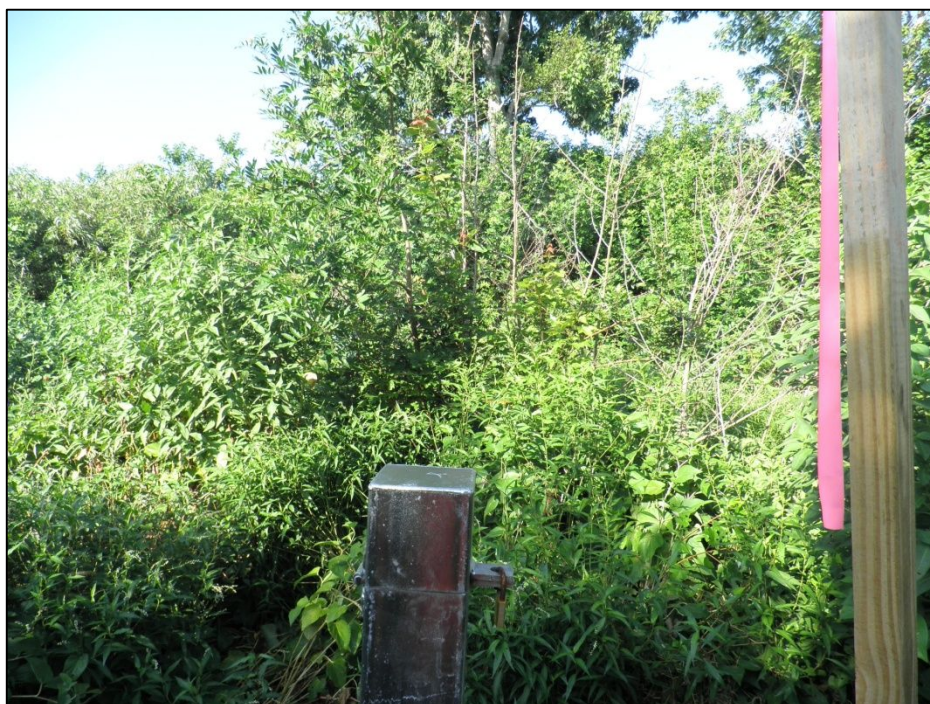
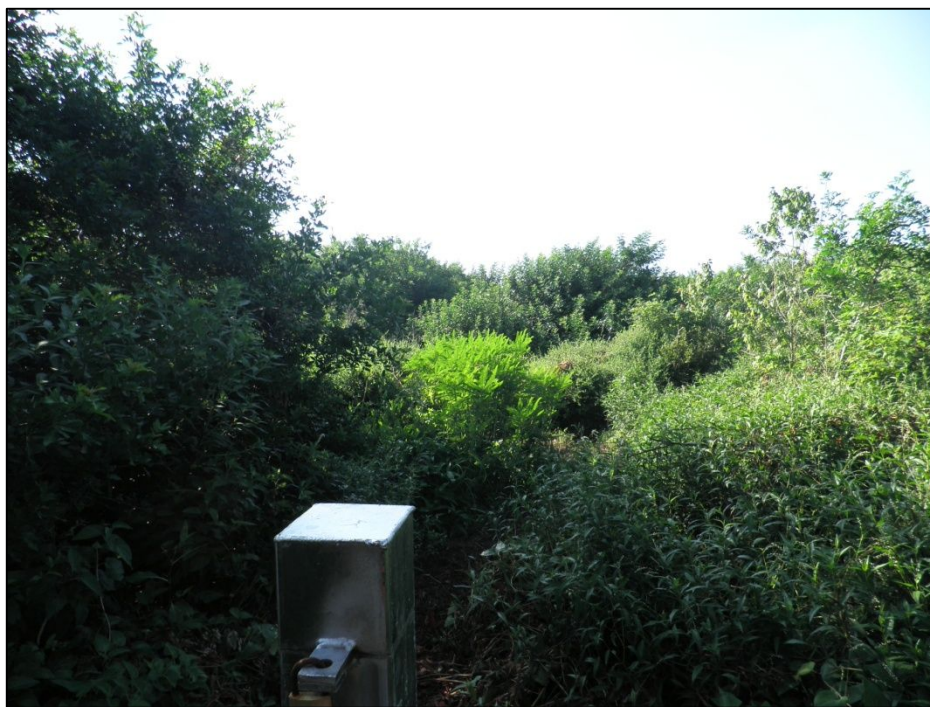
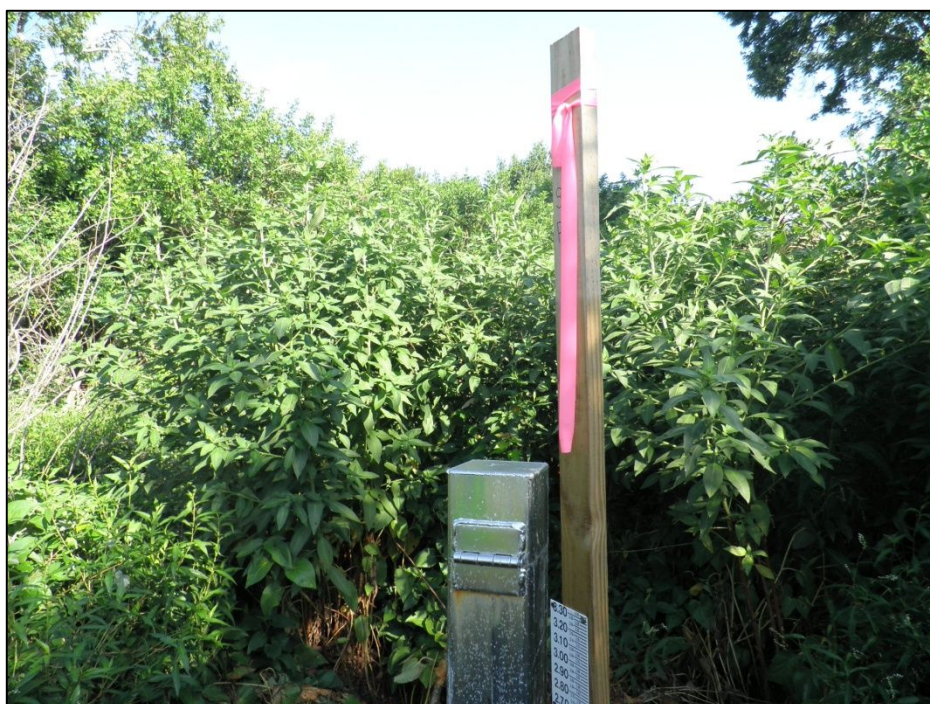
No major alteration or conversion of previously reported land use or vegetative cover types in RW-1 was observed between the June 2009 preliminary investigation and the June 2010 transect assessment. Vegetation of RW-1 is dominated by a 20-year-old stand of Brazilian pepper (*Schinus terebinthifolius*) shrubs and small trees. Brazilian pepper is an AD species, which is a facultative

Up to 14 inches of wetland soil subsidence caused by oxidation and gasification of carbon that result from drought and drying conditions was observed within RW-1, and relict herbaceous wetland vegetation (i.e., Virginia chain fern) is restricted to hummocks that protrude above the historical wetland floor following exposure by erosion. Soils observed within RW-1 consist of a loamy sand matrix typical of more upland forested habitats within this region of Florida. Empirical hydrologic indicators at RW-1 are no longer consistent with those typical of a functional wetland. This wetland likely began its transition to upland more than 20 years ago due to undetermined impacts. However, USGS 7.5-minute topographic quadrangle mapping (USGS 1994) depicts the presence of a surface conveyance draining southeast to the nearby Pearce Canal. The overall character of observed hydric soil (wetland) indicators at RW-1 indicates a transition to a successively drier habitat.

Photo 17 – RW1 Facing North

Photo 18 – RW1 Facing South

Photo 19 – RW1 Facing East

Photo 20 – RW1 Facing West

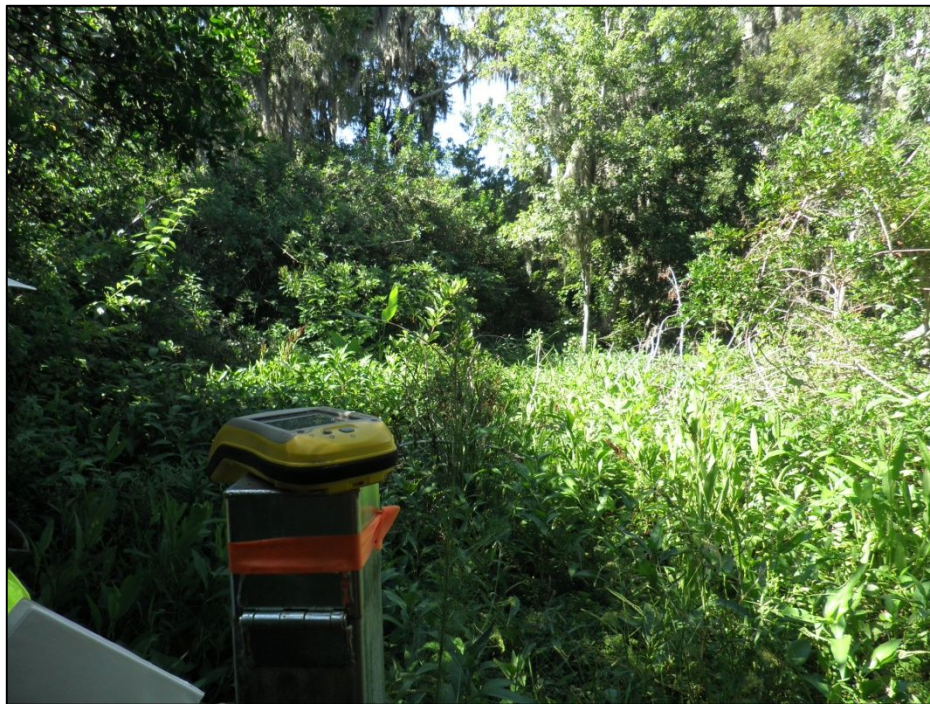
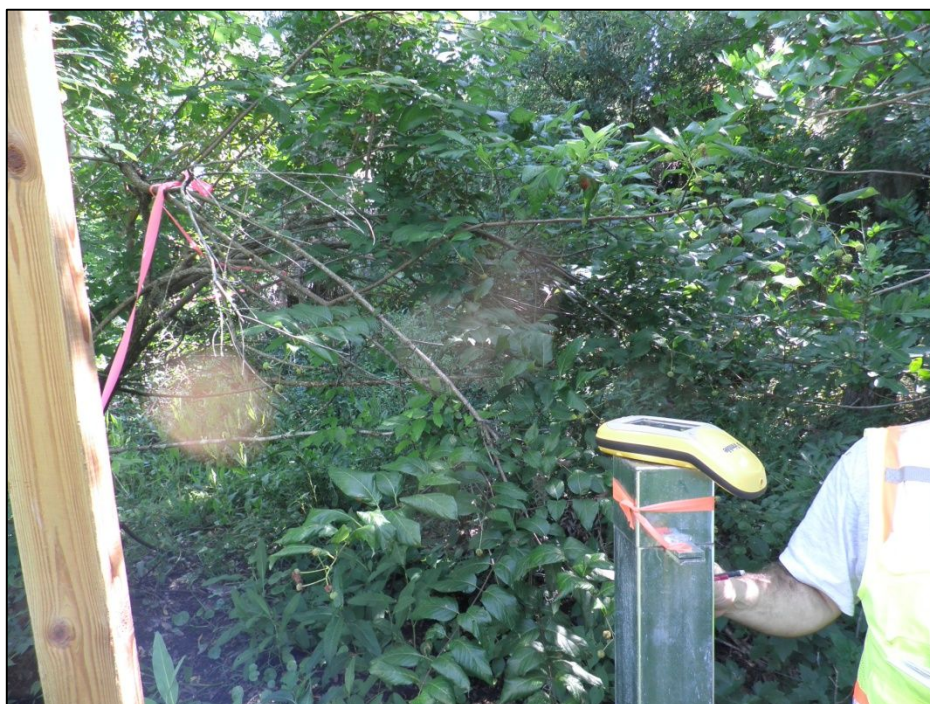
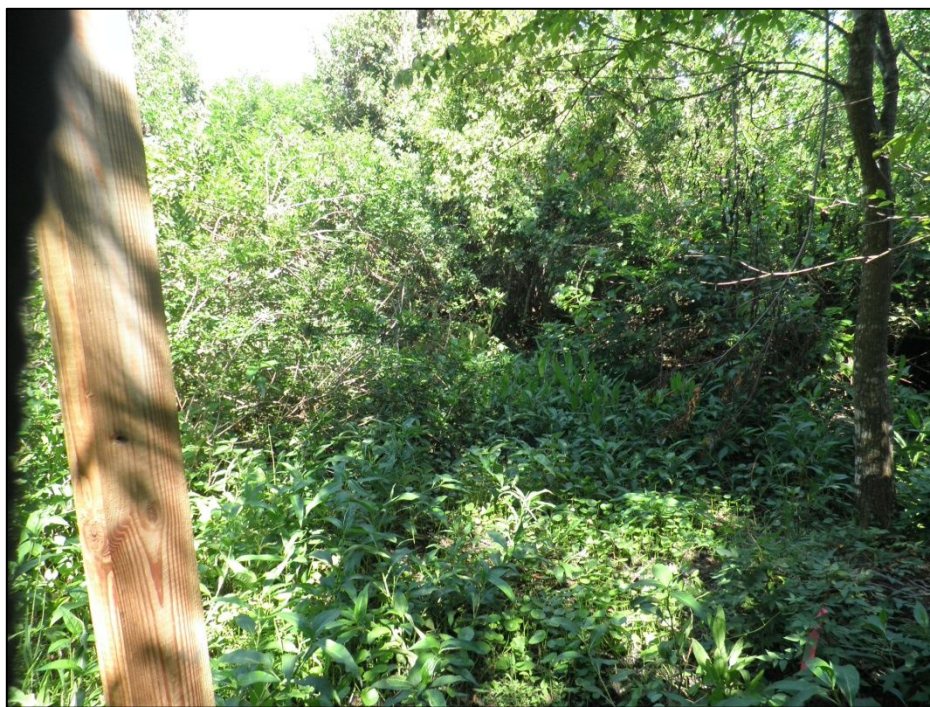
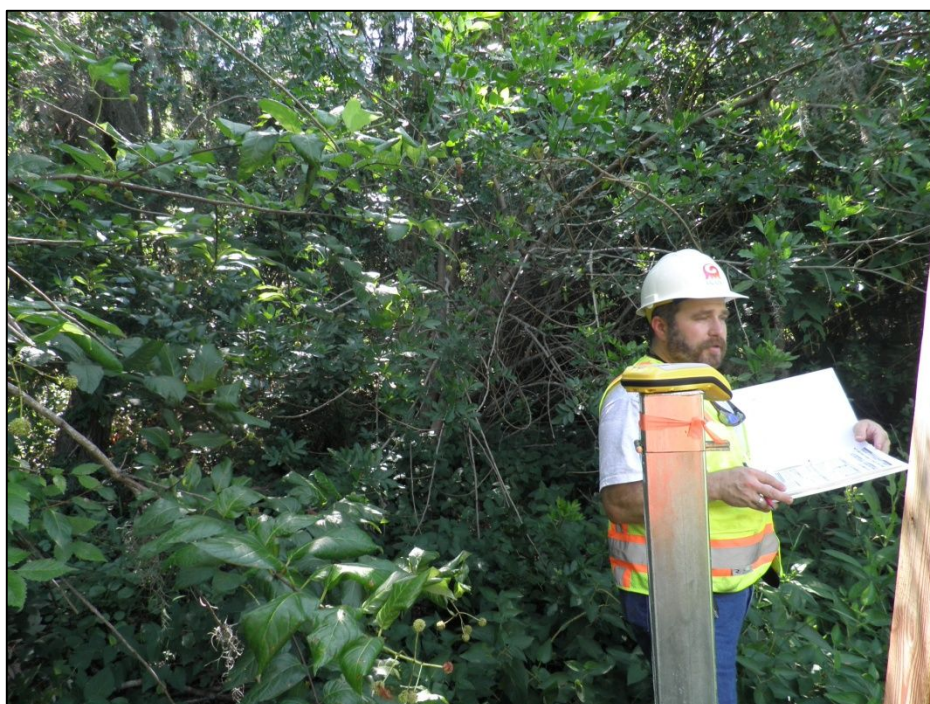
No major alteration or conversion of previously reported land use or vegetative cover types in RW-2 was observed between the June 2009 preliminary investigation and the June 2010 transect assessment. Several deep zone and aquatic floral species occur in the interior of RW-2, but vegetation of this wetland is increasingly dominated by outer deep zone and transition zone species. Evidence of prior conversion of RW-2 to upland forest was observed during the June 2009 field investigation. Of the 8.20-acre wetland parcel originally identified, 4.9 acres are currently functional wetland habitat.

his livestock. A small concrete weir constructed to dam this excavated area has failed and is no longer functional, which has allowed most of this wetland to return to upland habitat.

Up to 20 inches of wetland soil subsidence caused by oxidation and gasification of carbon that result from drought and drying conditions was observed within RW-2. The subsidence of this wetland area is likely due to hydrological alterations of both surface and groundwater. Livestock appear to frequent this area of RW-2 and have increased the rate of wetland soil subsidence through soil compaction. Lower than normal precipitation could be another variable that negatively impacts RW-2.

Photo 21 – RW2 Facing North

Photo 22 – RW2 Facing South

Photo 23 – RW2 Facing East

Photo 24 – RW2 Facing West

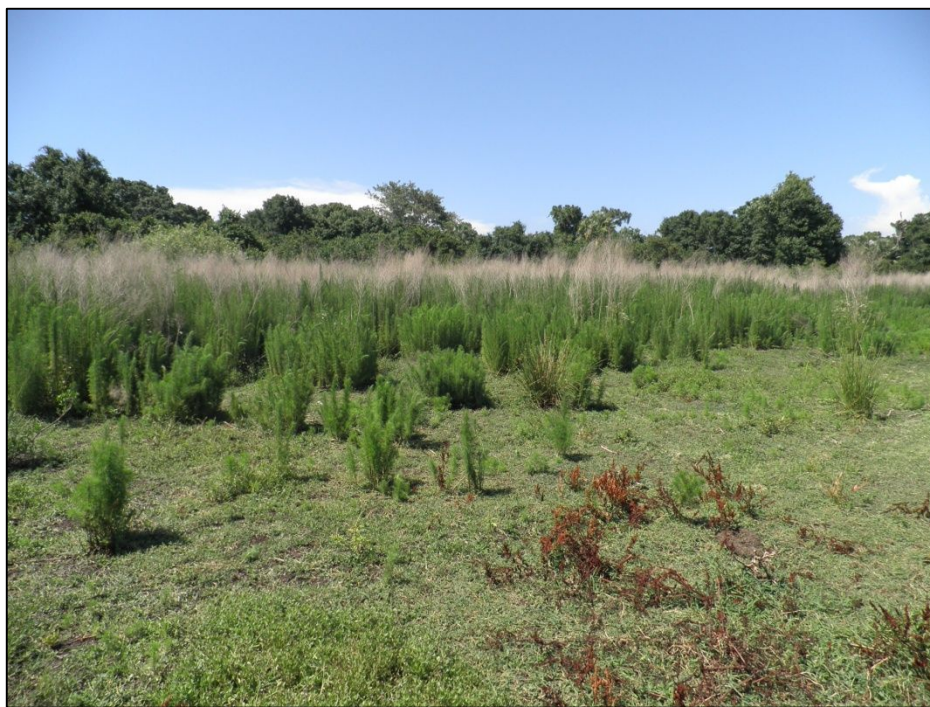
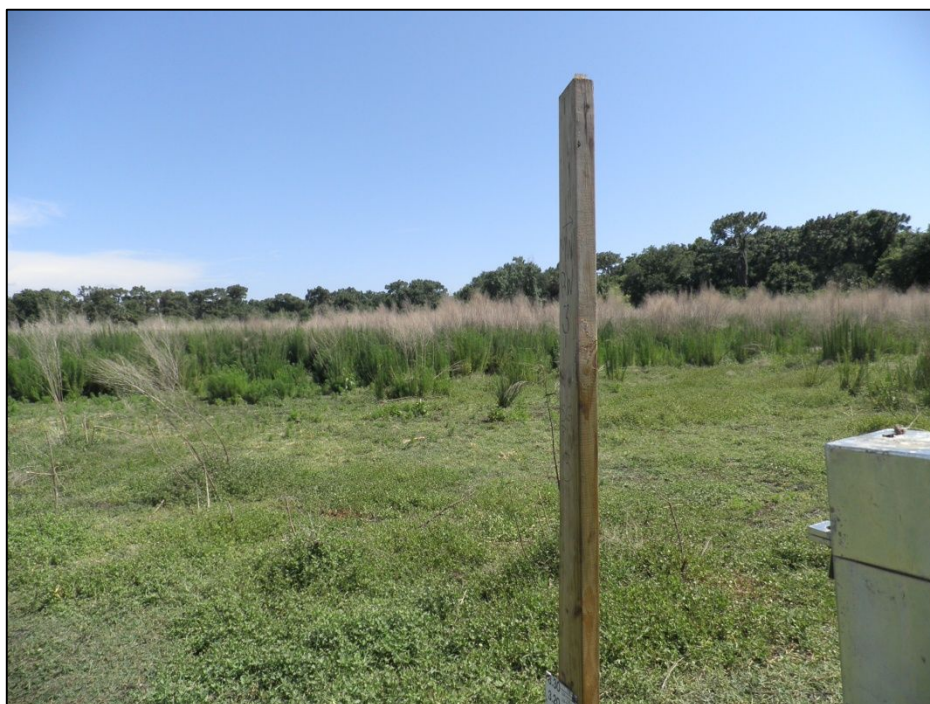
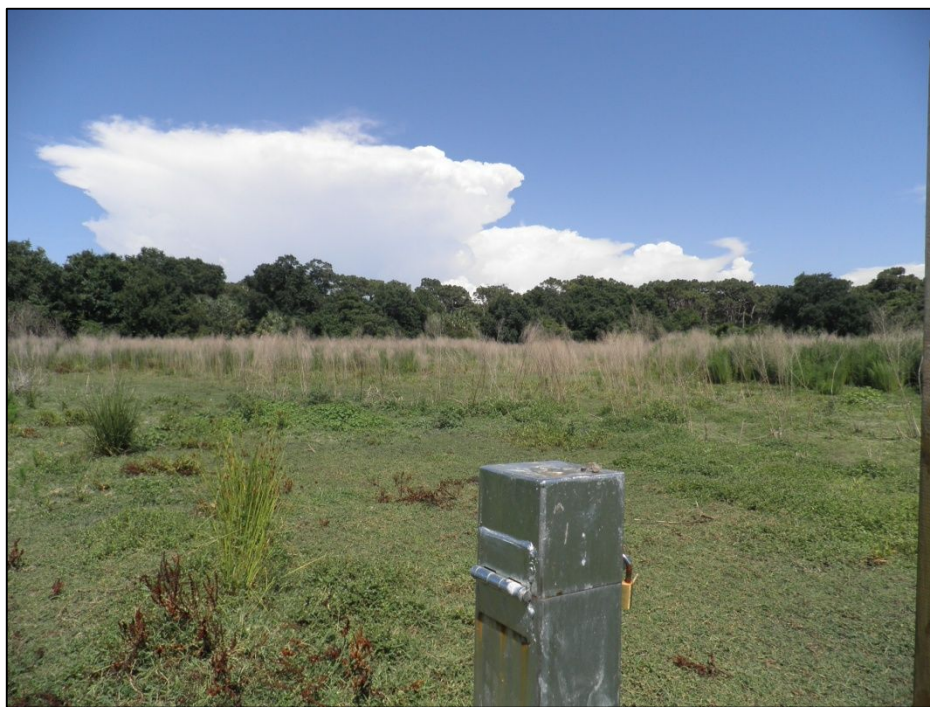
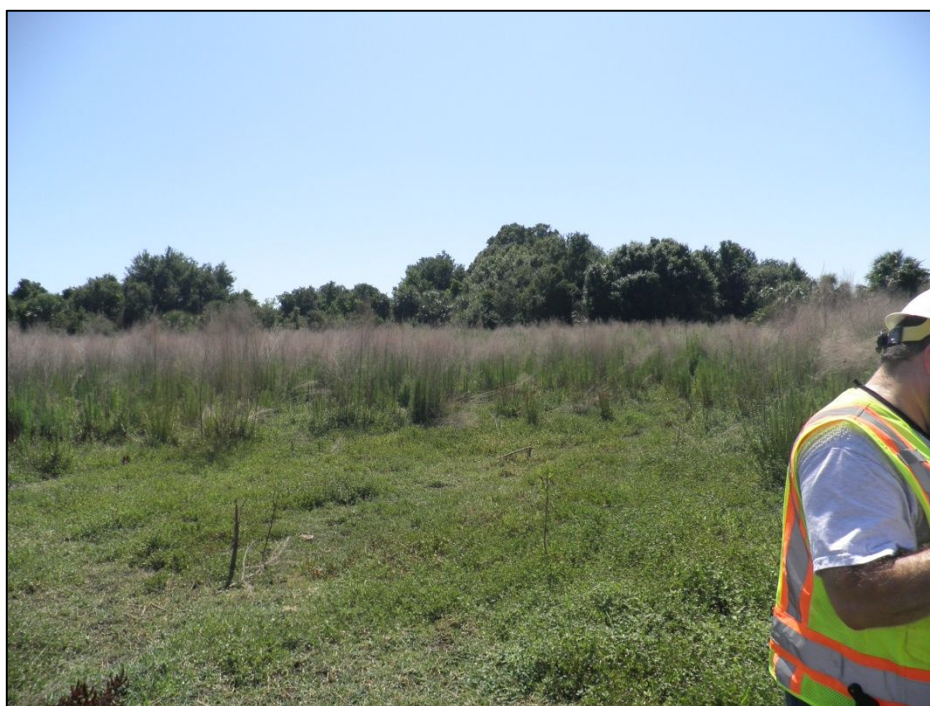
No major alteration or conversion of previously reported land use or vegetative cover types in RW-3 was observed between the June 2009 preliminary investigation and the June 2010 transect assessment. Evidence of prior conversion of RW-3 to upland prairie was observed. Of the 10.45-acre wetland parcel identified, approximately 6.3 acres are currently functional wetland habitat. The lower one-half of RW-3 is rapidly transitioning to upland.

A small amount of wetland soil subsidence caused by oxidation and gasification of carbon that result from drought and drying conditions was observed in the interior of the western wetland boundary; however, indicators of active wetland soil subsidence were obscured by previous landowner attempts (confirmed) to excavate areas within the deep zone to dewater the site and create wallows for livestock. No obvious evidence of surficial hydrological impacts was observed, but lower than normal precipitation could be another variable that negatively impacts RW-3.

Photo 25– RW3 Facing North

Photo 26– RW3 Facing South

Photo 27 – RW3 Facing East

Photo 28 – RW3 Facing West
