Wetlands Monitoring Plan

**Lockheed Martin Tallevast Site**

Tallevast, Florida

July 14, 2009

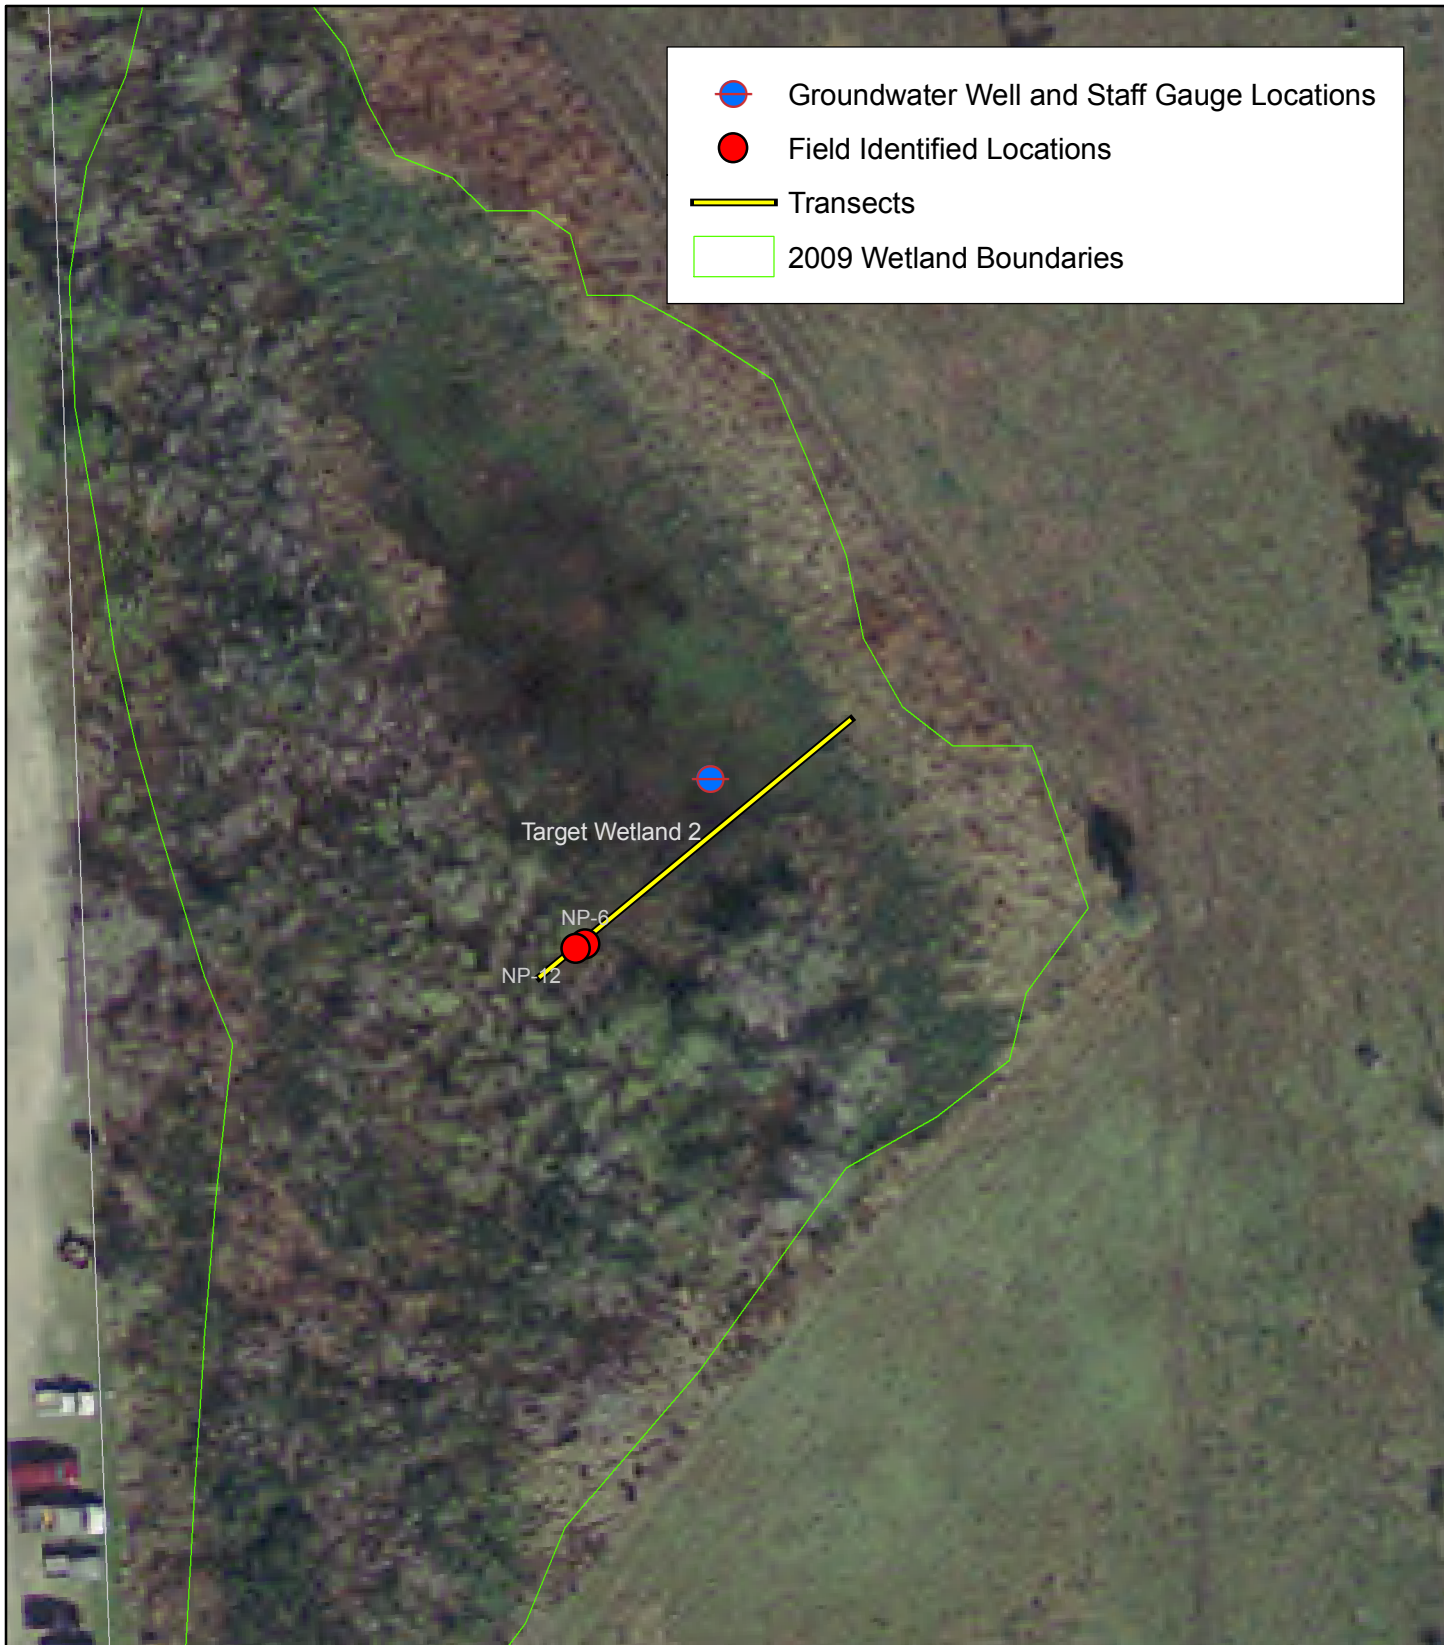
Figure 2-3

Target Wetland 2 displayed signs of prior and ongoing conversion to upland forested and prairie habitats. The June 2009 field effort determined that 1.66 acres of the 1.87-acre wetland parcel identified in the June 2008 meeting can currently be considered wetland habitat (Figure 2-3). No major alteration or conversion of historic land use or vegetative cover types within TW-2 was observed during the June 2009 field investigation. A thick stand of Carolina willow (*Salix caroliniana*) trees and shrubs lies west and southwest of the historically inundated wetland area. This wooded wetland area is dominated by outer deep and deep zone floral species, but several transitional and adaptive species are growing on the hummock in this area. As much as 20 inches of subsidence was observed in this forested segment of TW-2. Vegetation in the area shown as inundated in the 2003 aerial photograph consists of transitional grass species and a minimal number of small shrubs.

Although no longer inundated, a staff gauge (SG-8) and a sampling well (SW-3) are currently located within the historically ponded area of TW-2. No other evidence of inundation was observed within TW-2, which is likely due to unknown hydrological alterations that may have occurred in the past few years. Lower than normal precipitation could be another variable that negatively impacts TW-2. The most typical wetland area of TW-2 occurs in the area of willow trees, and the wetland portion dominated by grasses is in the final stages of upland transition. Soils of the wetland area are sandy and contain organic streaking, as well as other hydric indicators. Soils of the wetland area exhibiting signs of upland transition consist of loamy upland sands. The monitoring transect established for TW-2 incorporates the existing staff gauge and sampling well.

Target Wetland 2 Transect

Field studies identified one well (Stilling Well-3) and staff gauge (Staff Gauge-8) at TW-2, which were incorporated into the location of the proposed, transect and assessment area. However, these devices are located in the outer transition zone, rather than the wetland's deep zone. Existing wells and staff gauges were not found at the other wetlands.

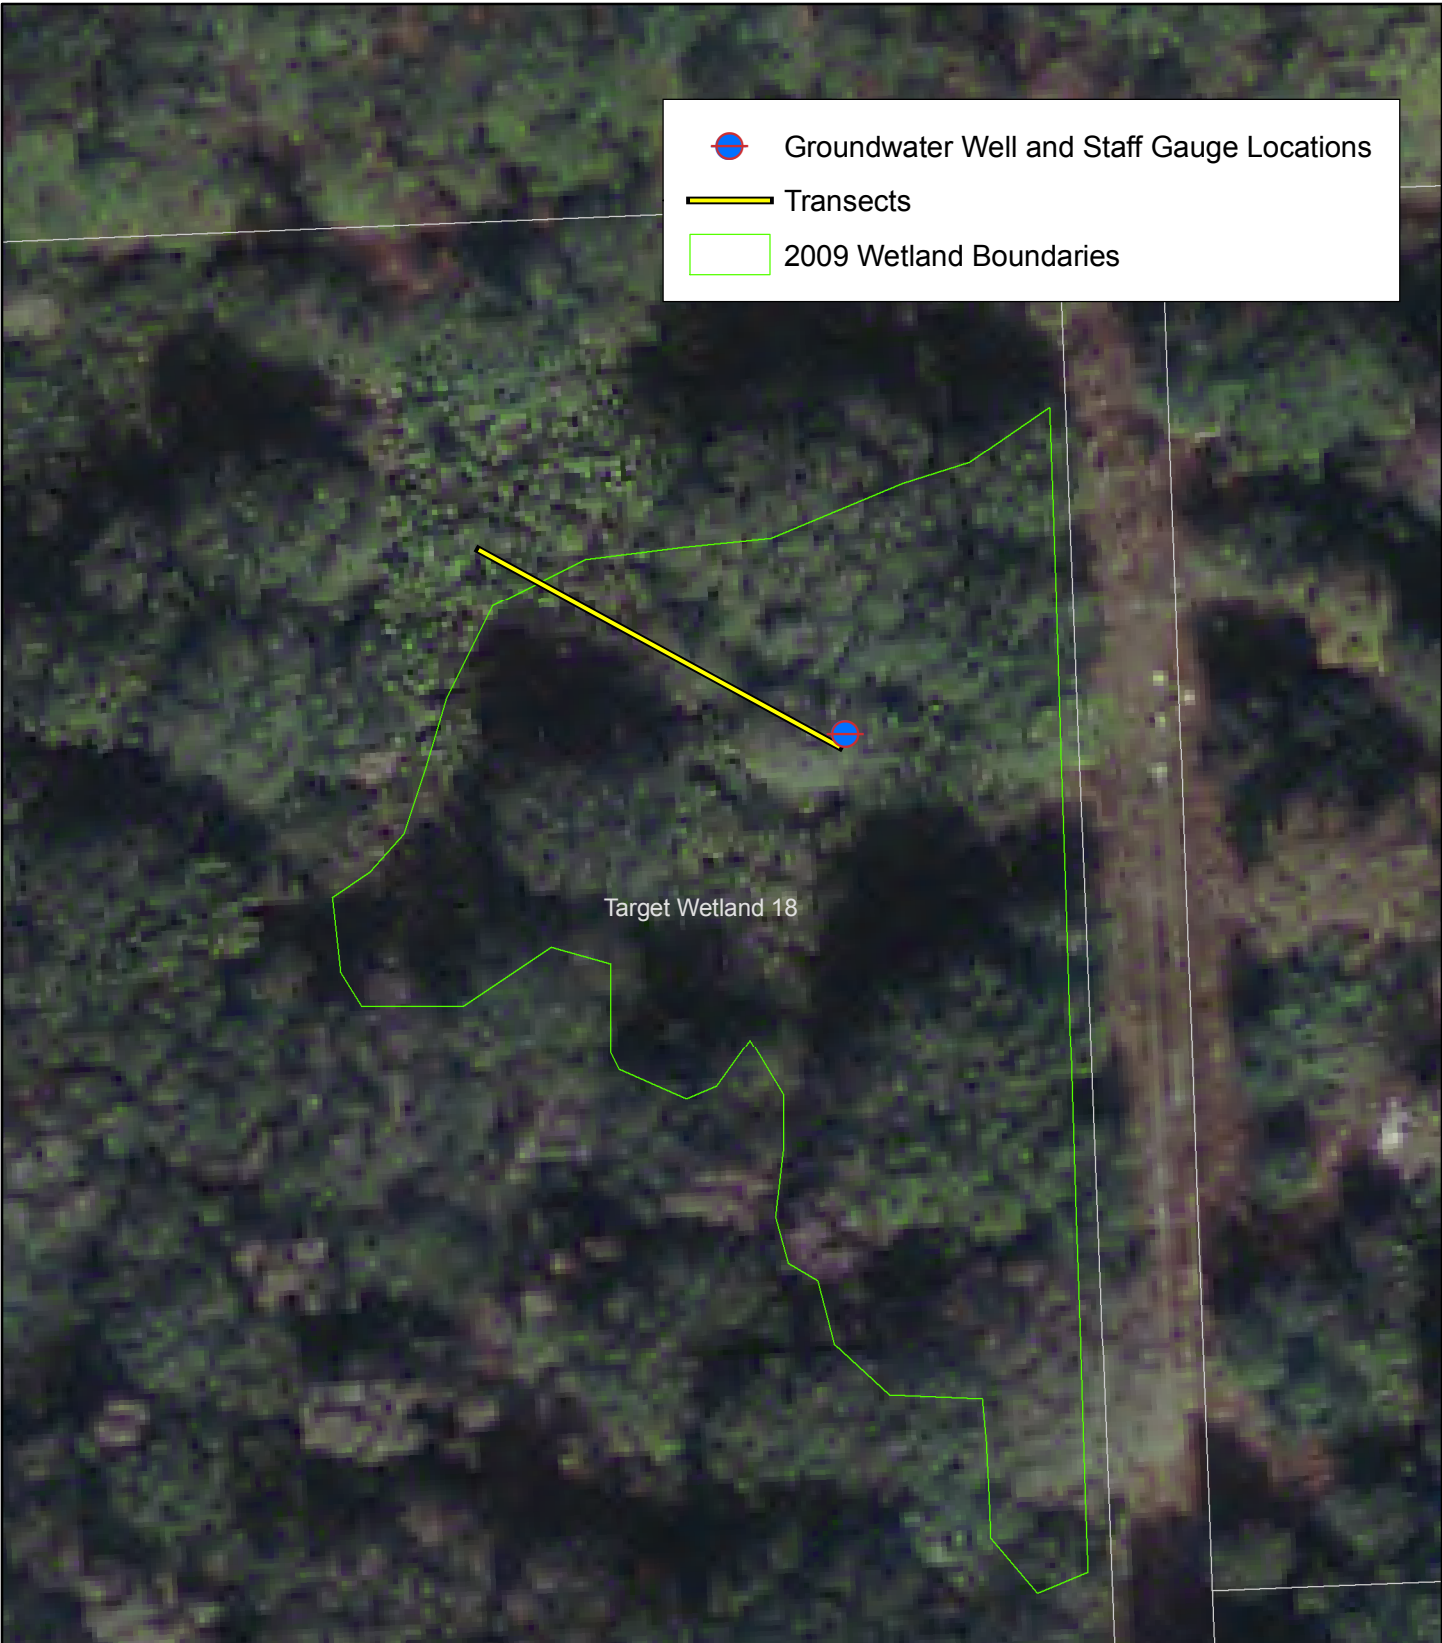
Figure 2-5

Subsidence up to 12 inches was observed within TW-18 and relict wetland vegetation is restricted to hummocks that protrude above the historic wetland floor following exposure by erosion. Soils at the TW-18 site consist of a loamy-sand matrix typical of upland forested habitats in this region of Florida. TW-18 no longer contains hydrological indicators consistent with a functional wetland. The wetland habitat at TW-18 likely began transitioning to upland more than 20 years ago; and is now devoid of active wetland characteristics. Lower than normal precipitation could be another variable that negatively impacts TW-18. The June 2009 field effort determined that 0.39 acres of the 4.08-acre wetland parcel identified by the June 2008 meeting are currently functional wetland habitat (Figure 2-5).

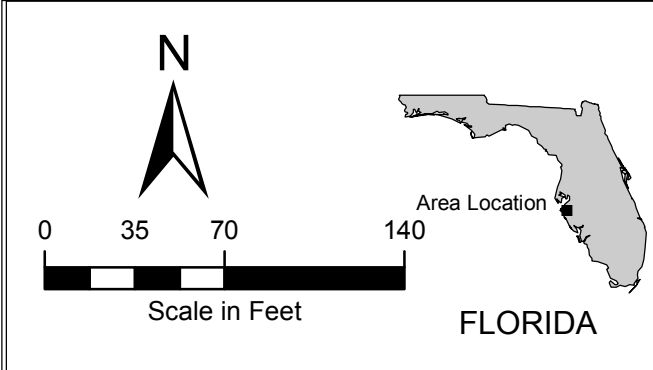
Figure 2-7

No major alteration or conversion of historic land use or vegetative cover types in RW-2 was observed during the field investigation. Several deep zone floral species occur in the interior of RW-2, but vegetation of this wetland is dominated by outer deep and transitional zone species. Evidence of prior conversion of RW-2 to upland forest was observed during the field investigation. Of the 8.20-acre wetland parcel identified

Up to 20 inches of subsidence was observed within RW-2. The subsidence of this wetland area is likely due to hydrological alterations of both surface and groundwater. Livestock appear to frequent this area of RW-2 and have increased the rate of subsidence through soil compaction. Lower than normal precipitation could be another variable that negatively impacts RW-2. The RW-2 transect location was established in the northwestern section of the wetland and follows a northeasterly path.

Reference Wetland 2 Transect

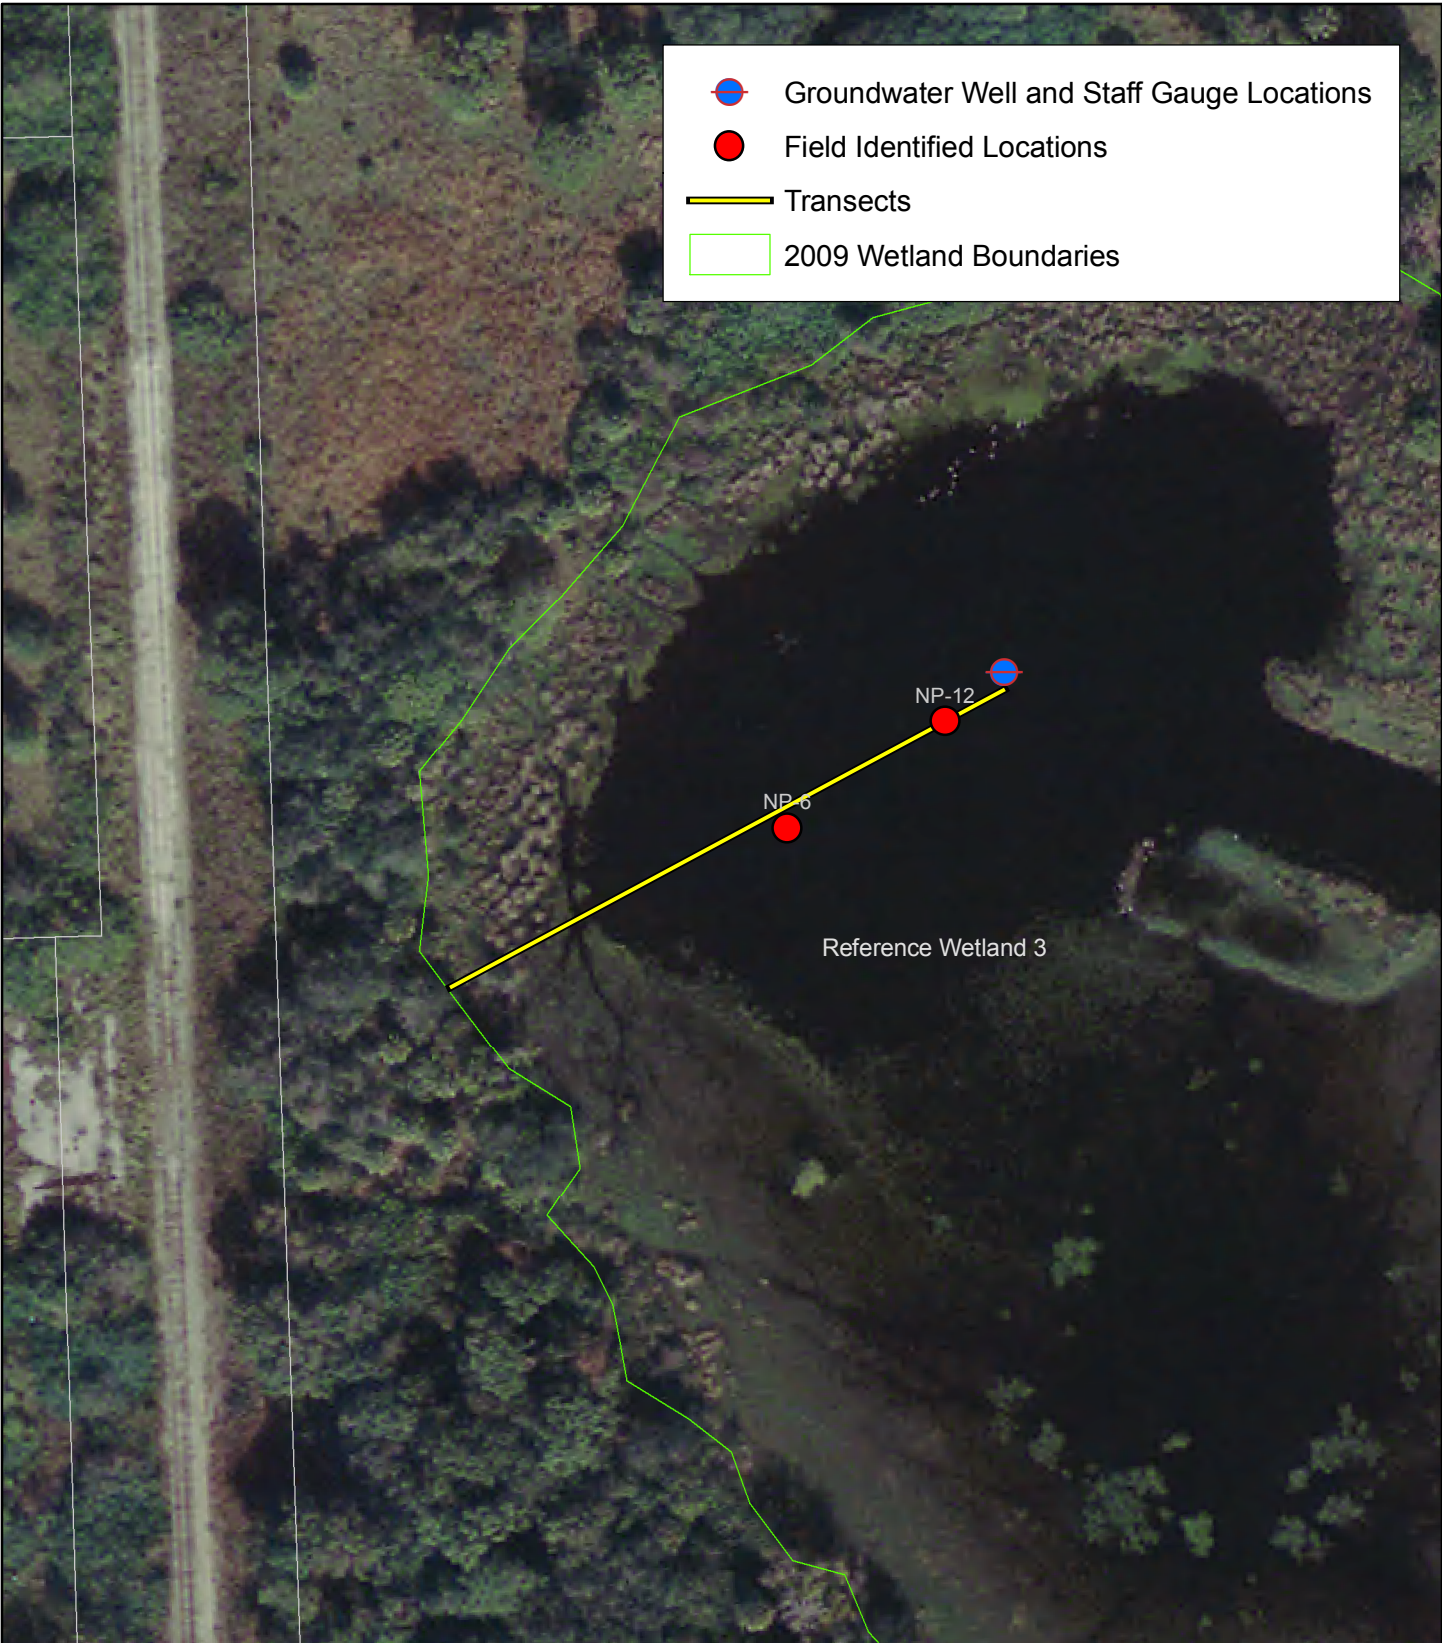
Figure 2-8

No major alteration or conversion of historic land use or vegetative cover types within RW-3 was observed during the field investigation. Evidence of prior and ongoing conversion of RW-3 to upland prairie was observed. Of the 10.45-acre wetland parcel identified in the June 2008 meeting, 6.3 acres are currently functional wetland habitat (Figure 2-8). The lower half of RW-3 is rapidly transitioning to upland.

A small amount of subsidence was observed in the interior of the western wetland boundary. No obvious evidence of surficial hydrological impacts was observed, but lower than normal precipitation could be another variable that negatively impacts RW-3.

Reference Wetland 3 Transect

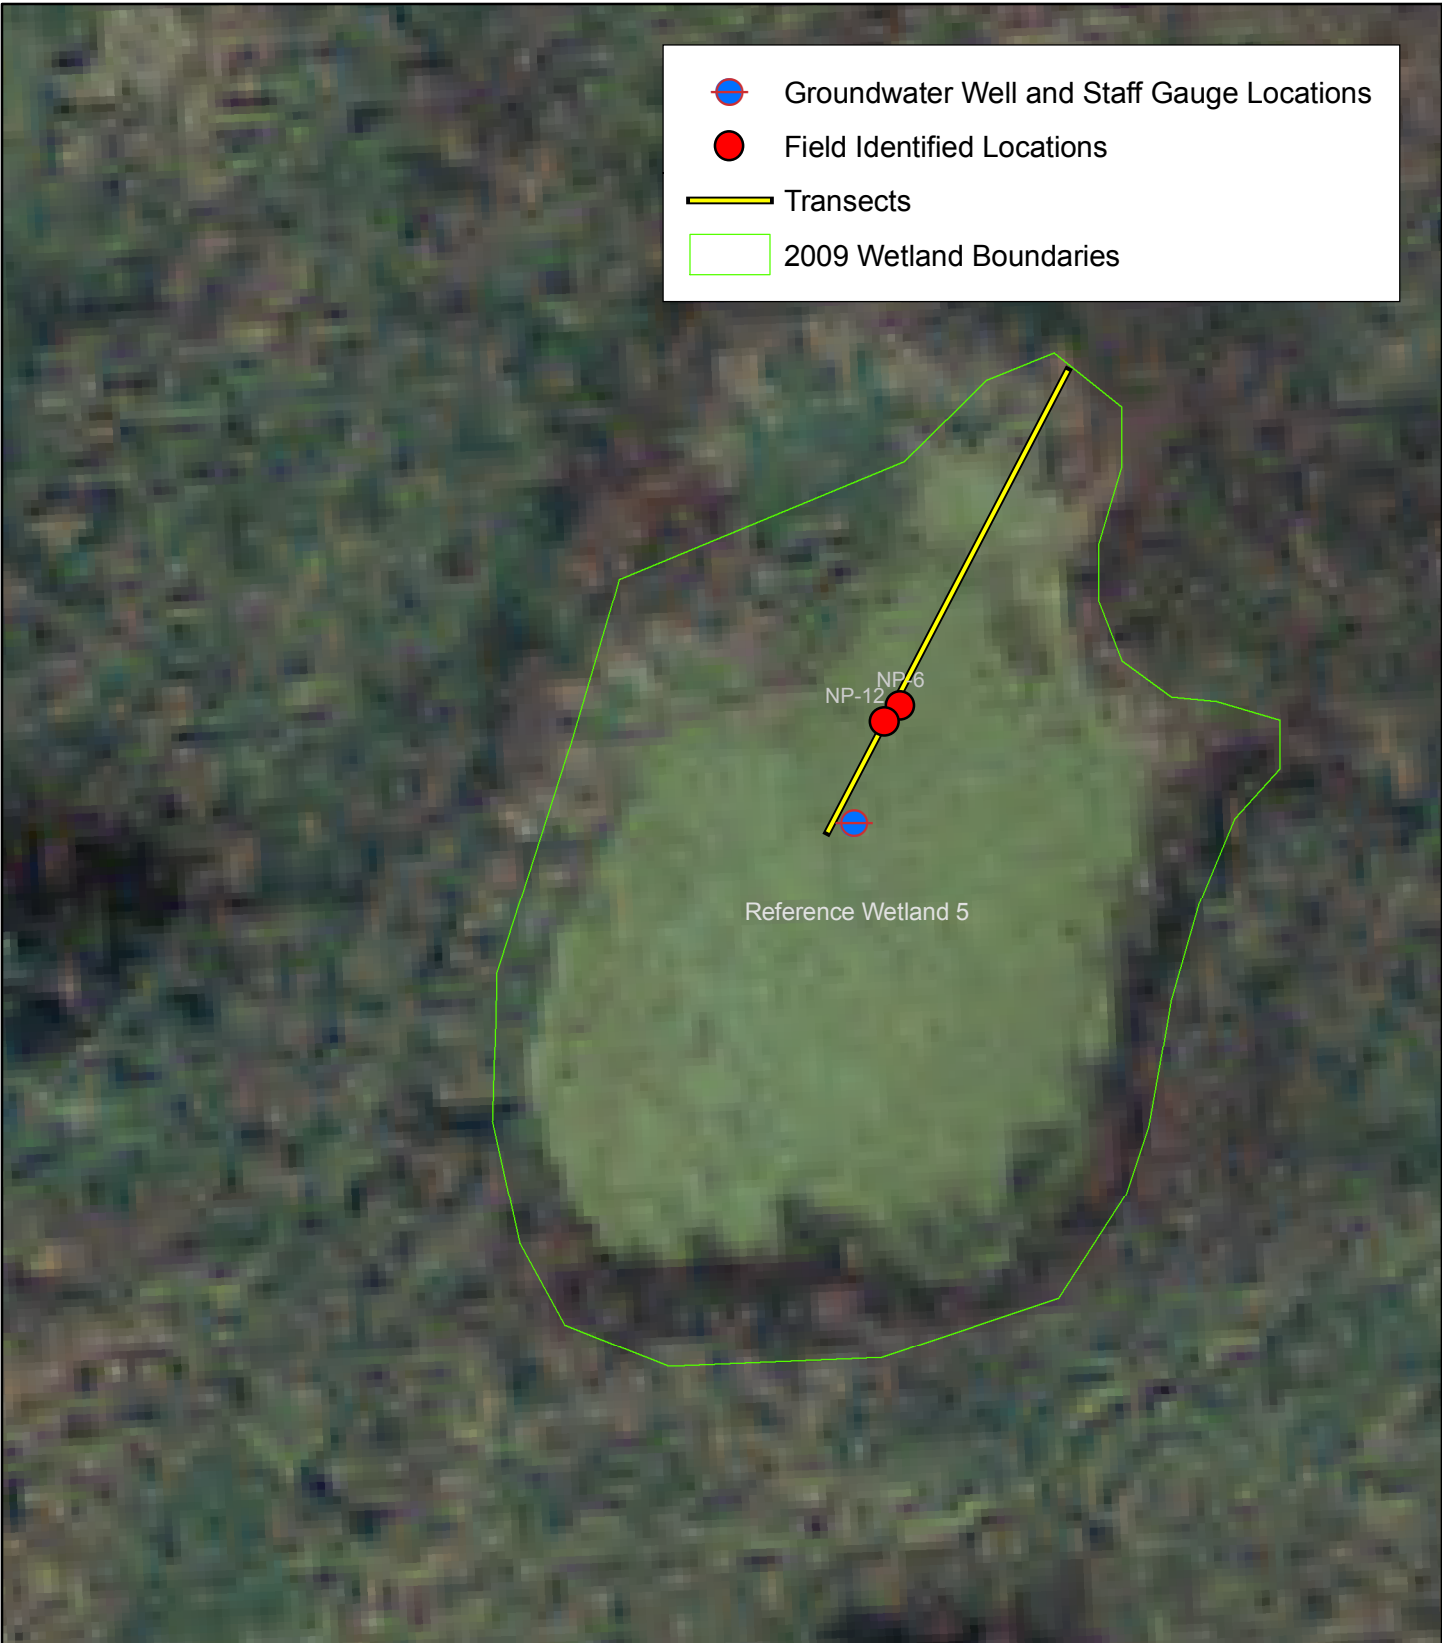
Reference Wetland 5 Transect

Hydrological indicators observed in the 2003 aerial photograph of RW-5 suggest that this wetland was primarily fed by a groundwater interface, but also received stormwater. The inundated area of RW-5 appeared to be at full pool, and was bordered by emergent and shrubby vegetation. Floating and rooted vegetation were absent in the inundated wetland area. The area of inundation appeared to be within the confines of an excavated pond, and did not display hydrological indicators typical of a palustrine emergent wetland.

No major alteration or conversion of historic land use or vegetative cover types in RW-5 was observed during the field investigation. Evidence of the upland conversion of the immediate area outside of the excavated pond was observed. Approximately 0.4 acres of the 0.86-acre wetland parcel identified in the June 2008 potential monitoring location proceedings is currently functional wetland habitat (see Figure 2-9). The pond displayed evidence of a reduced pool elevation and upland floral species are migrating into the historic wetland area.

No subsidence was observed within RW-5. Lower than normal precipitation could be another variable that negatively impacts RW-5.
