**West Lot Site
Supplemental Investigation Report**

West Lot Site
Utica, New York

April 2009

Prepared for:
Lockheed Martin Corporation

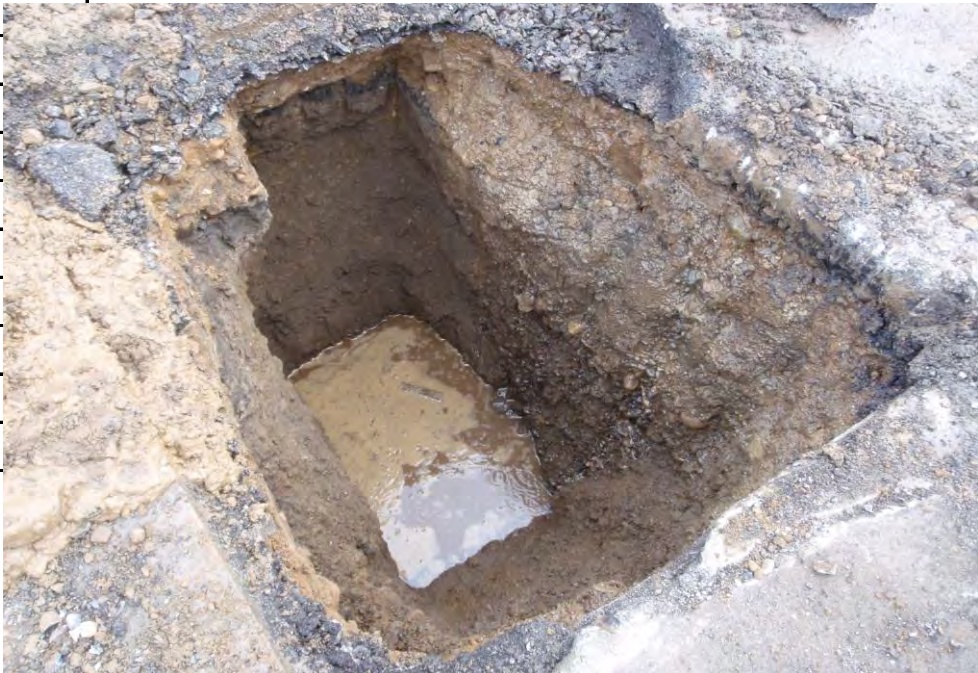
From	To	Sample/	PID (ppm)
0	8'	Sand, fine to course; and Gravel; Brown	
		Silty Clay deposits at 2-4' bls	
		Water table at approx 7.5' bls	
		All PID readings = 0 ppm	
		Small metal and brick piece observed at 2 ft	
		Water entering hole from entire south excavation wall. North wall was	
		dry.	
		Sample 2.5' - 3.0' at 1255	
		Sample 6.5' - 7.0' at 1245

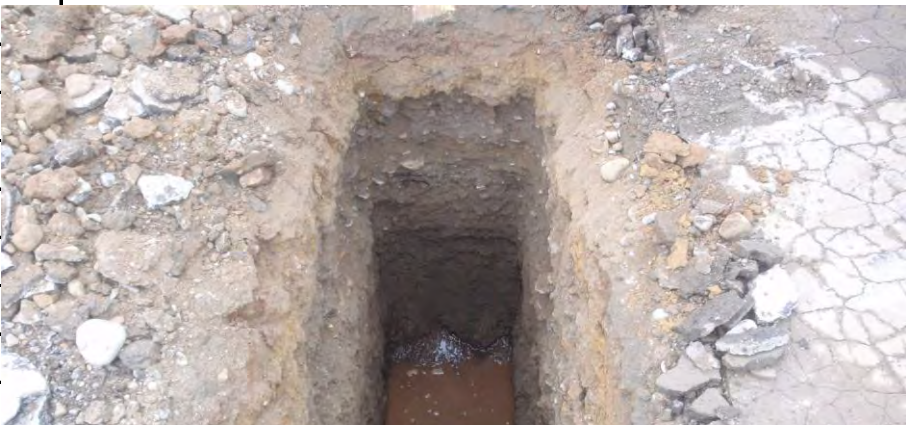
From	To	Sample/	PID (ppm)
0	8.0'	Sand, fine to course; and Gravel; Brown	
8.0'	9.0'	Same with less Gravel	
		Silty Clay deposits at 2-4' bls	
		Water table at approx 8.5' bls	
		All PID readings = 0 ppm	
		Metal wire debris observed	
		Water entering hole from entire south excavation wall. North wall was	
		dry.	
		Sample 3.0' - 3.5' at 1505	
		Sample 7.5' - 8.0' at 1455

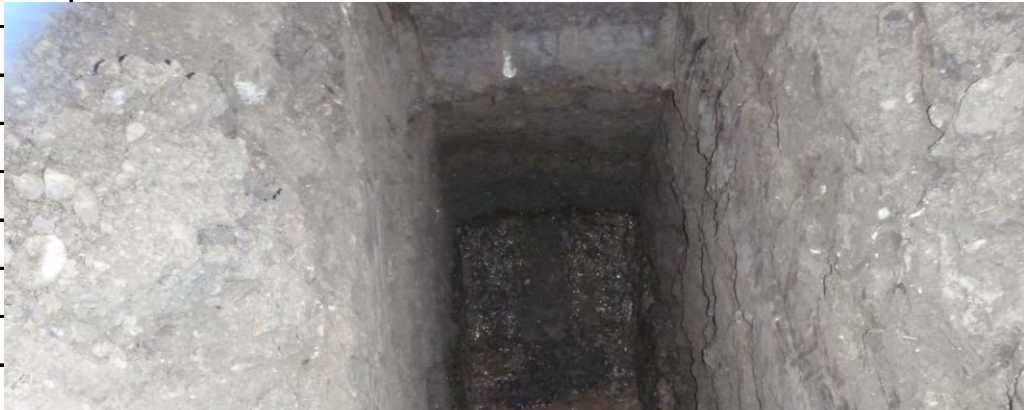
From	To	Sample/	PID (ppm)
0	8.5'	Sand, fine to medium; some Silt; some Gravel; Brownish-black	
		Pockets of Silty Clay throughout	
		Clay at 8.0' bls	
		Water table at approx 8.0' bls	
		All PID = 0ppm	
		Piece of mangled metal at 2.0' bls (about 2 feet long)	
		Water seeping into excavation from all walls at 7.5' bls	
		Sampled 2.5' - 3.0' at 1600	
		Sampled 7.0' - 7.5' at 1550

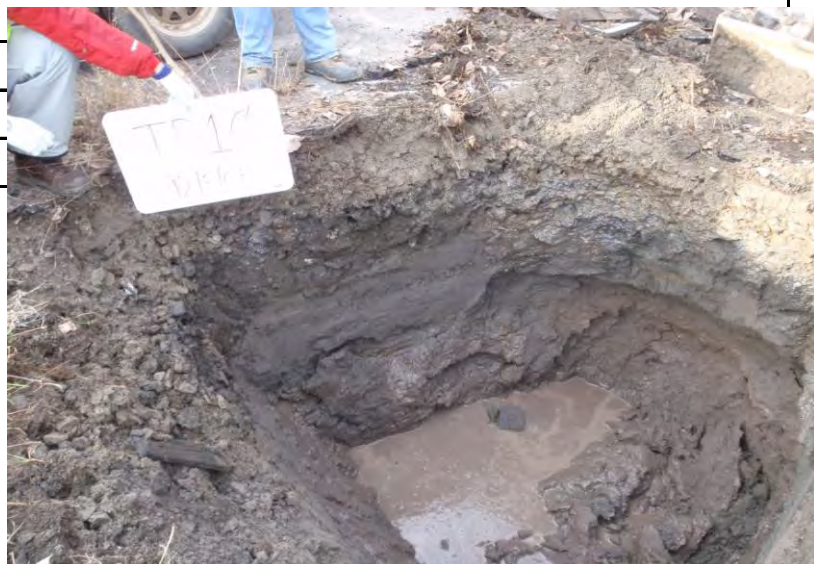
From	To	Sample/	PID (ppm)
0	8.0'	Sandy Silt; some Gravel and Cobbles; Dark brown; Moist	
		Dense Clay-Silt pockets throughtout	
		Water table at approx 7.5' bls	
		Water entering hole from N/NW wall at approx 1.0' bls	
		Small piece of mangled metal observed at 3.0' bls	
		Slight fuel oil odor around metal - PID = 0ppm	
		Wood debris and small metal pieces at 3.0' bls	
		Pieces of what appeared to be fiberglass circuit board at 3.0' bls	
		All PID readings = 0 ppm	
		Sample 2.0' - 2.5' at 0955	
		Sample 6.5' - 7.0' at 0945	
		Samples collected from the areas that contained the above mentioned	
		materials

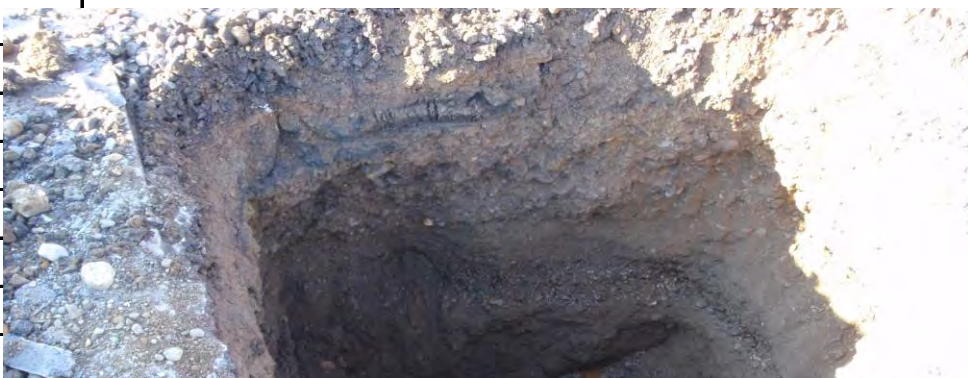
From	To	Sample/	PID (ppm)
0	7.0'	Sand, fine to medium; and Gravel; Brown	
		Gravel Layers at 3.0' bls and 5.0' bls	
		Water table at approx 7.5' bls	
		No clay observed	
		All PID = 0ppm	
		Sample 3.0' - 3.5' at 1140	
		Sample 6.5' - 7.0' at 1130

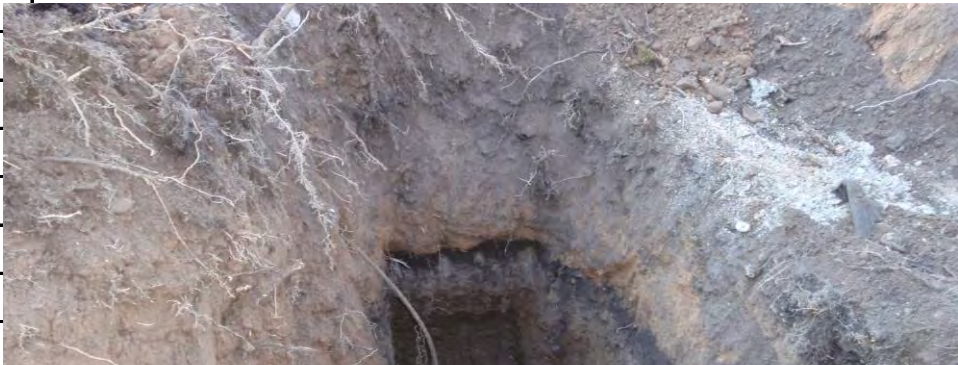
From	To	Sample/	PID (ppm)
0	8.0'	Sandy Silt; little Gravel; Brown; Organic Odor	
		Large metal box and concrete block on the surface of the ground	
		Grey ash layer at 2.5' bls. Very thin layer. Small pocket of material	
		Large pieces of concrete pipe encountered 2.5' - 6.0'	
		All PID = 0ppm	
		Sample 3.0' - 3.5' at 1415*	
		Sample 6.5' - 7.0' at 1405	
		* Sample collected of and directly below the ash layer

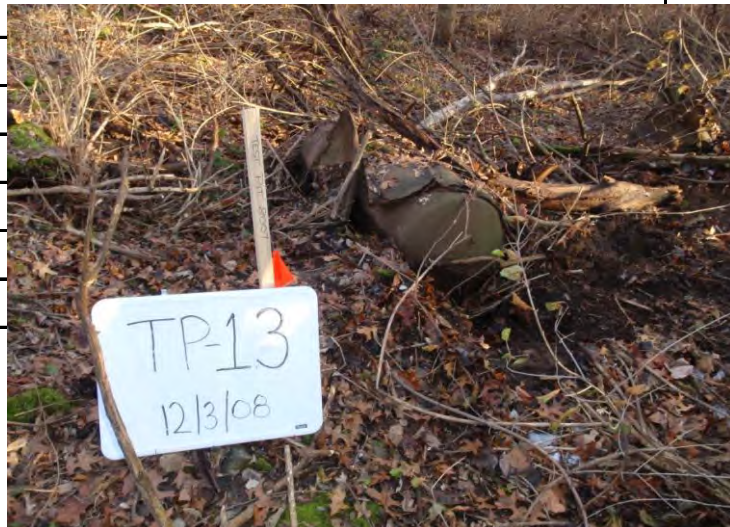
From	To	Sample/	PID (ppm)
		Directly in front of the test pit location is a series of random berms	
		with household trash on the surface. These berms were	
		opened up with the excavator to reveal a clean sandy soil.	
		Test pit advanced under a 75-100 gallon AST	
		Other household/white goods debris scattered around	
0	9.0'	Sand, fine to medium; trace Gravel; Brownish orange	
		Same homogeneous soil throughout. No debris	
		Water table at approx 9.0' bls	
		All PID = 0 ppm	
		Sample 2.5' - 3.0' at 1540	
		Sample 7.5 - 8.0' at 1530

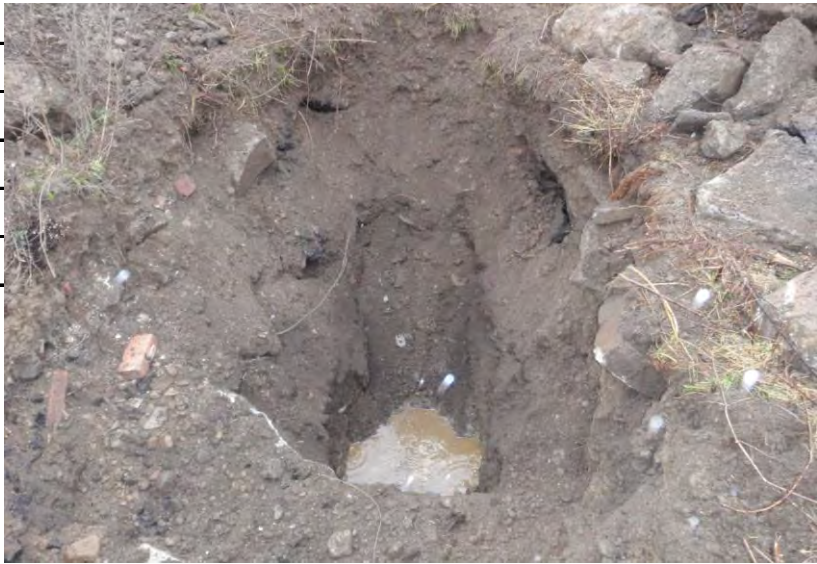
From	To	Sample/	PID (ppm)
0	7.0'	Sand, fine to medium; some Gravel; Brown/Black	
		Water table at approx 7.0' bls	
		Lots of construction debris 0 - 4.0' bls	
		Bricks, concrete and conduit	
		Large pieces of concrete pipe with embedded 1-4" metal pipes	
		All PID = 0ppm	
		Sample 4.0' - 4.5' at 1250	
		Sample 6.5' - 7.0' at 1240	
		Sample collected directly below construction debris

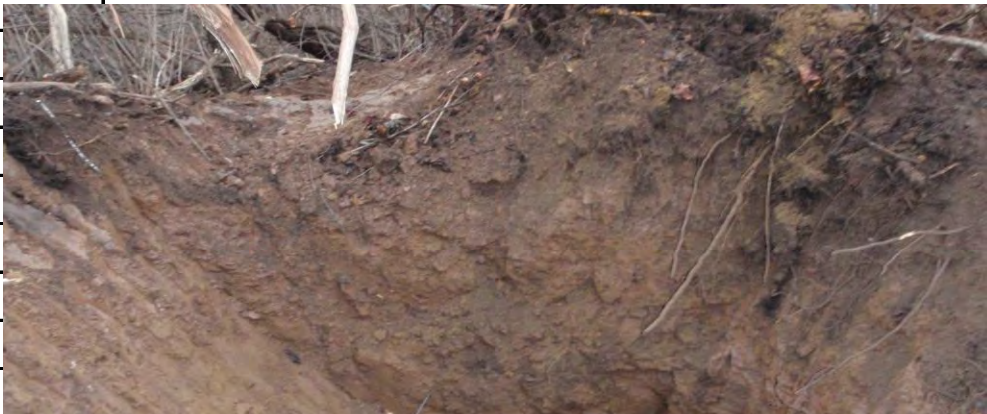
From	To	Sample/	PID (ppm)
		Test pit excavated into large berm from the top	
0	13.0'	Sand, very fine with clay deposits throughout	
		Some of the clay was silty and moist	
		Very fine sand content increased with depth	
		All PID = 0ppm	
		Sample 2.5' - 3.0' at 1550	
		Sample 13.0' - 13.5' at 1540

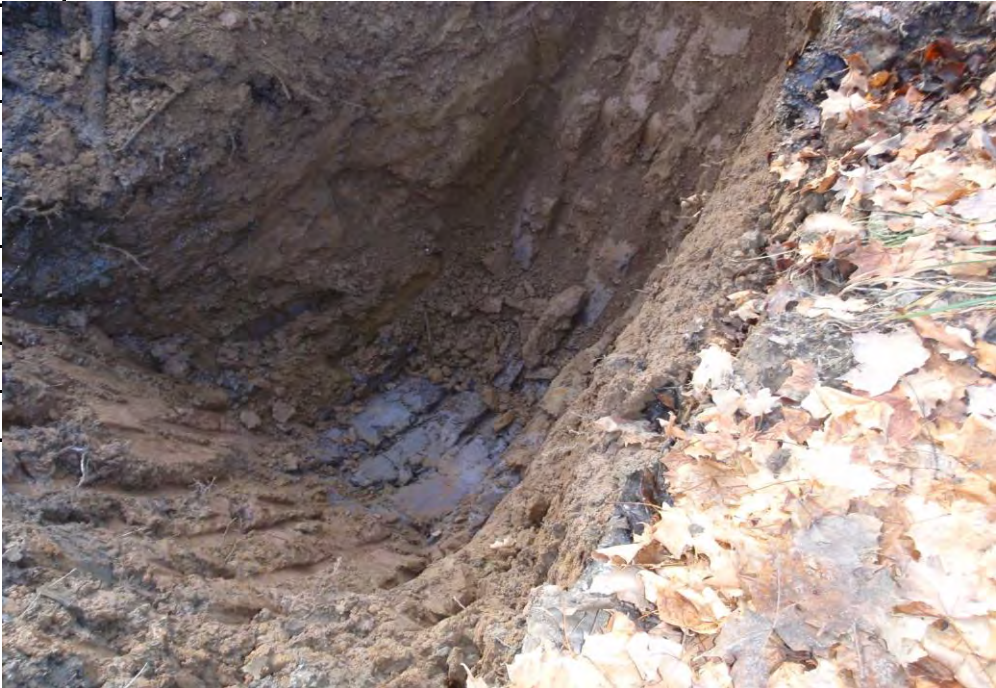
From	To	Sample/	PID (ppm)
0	6.0'	Sand, very fine to fine; and Clay; Moist	
6.0'	7.0'	Clay; Maroon color	
		Water seeping from Clay at 7.0' bls	
		All PID = 0ppm	
		Sample 2.0' - 2.5' at 1005	
		Sample 5.5' - 6.0' at 0955
