#### SCOPE OF WORK

#### COMPLETION OF INVESTIGATIONS REQUIRED TO DESIGN

#### REMEDIAL ACTIONS TO ALLEVIATE ON-SITE CONTAMINATION

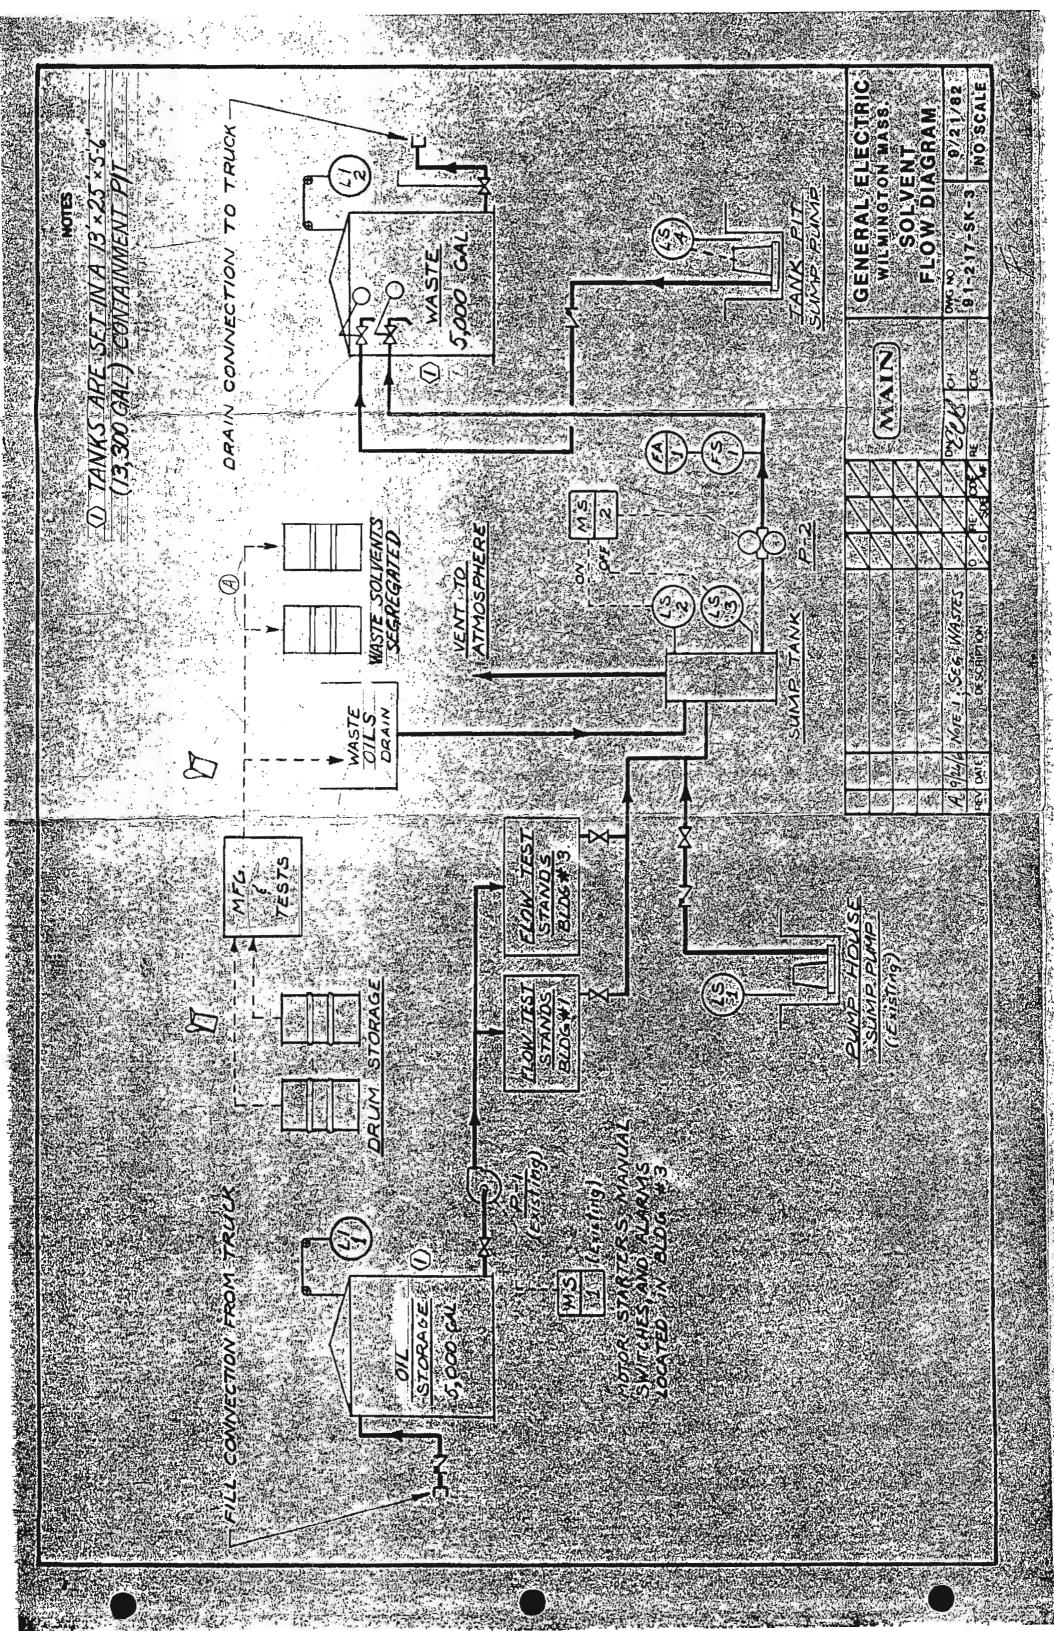
Flowmeter test oil is received in bulk quantities and is pumped into the 5,000-gallon oil storage tank located in the "Flammable Substance Storage Facility," commonly called the "Oil

House" (see Figure 2-3). The circulating system conveys the oil to the Flow Test Stands in Buildings 1 and 3. All wastes from these test stands are drained to the pump house pump and accumulated in the 5,000-gallon waste oil tank which is located in the Oil House.

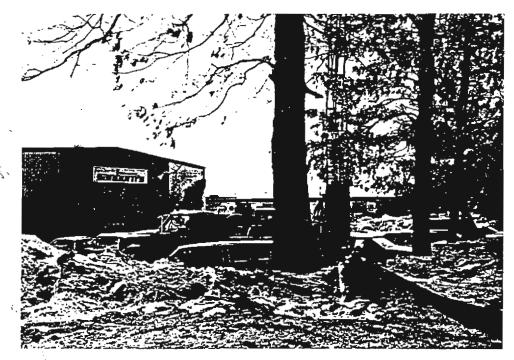
Drilling rig in front parking lot. 2/27/87
