Lockheed

SERVICE NEWS

VOL. 10, NO. 1, JANUARY—MARCH 1983

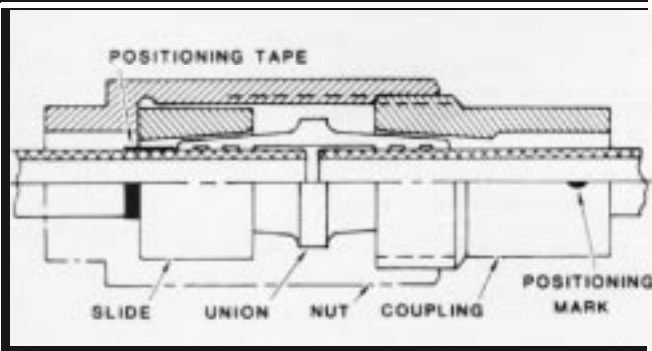
Figure 1. "H" fitting components in position for the swaging action.

A cross section of the "H" fitting assembly is illustrated in Figure 1, which shows the positions of the parts before installation is complete. Figure 2 shows the union swaged permanently to the ends of the tubing.

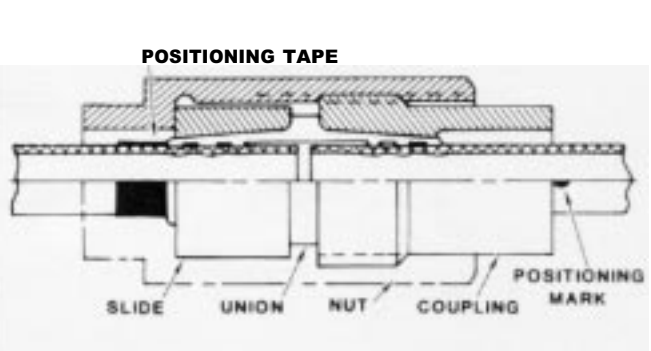
Figure 2. "H" fitting assembly after completion of swaging.
