SERVICE NEWS

VOL. 10, NO. 2, APRIL—JUNE 1983

Engine-Driven Hydraulic Pumps

Vol. 10, No. 2, April-June 1983

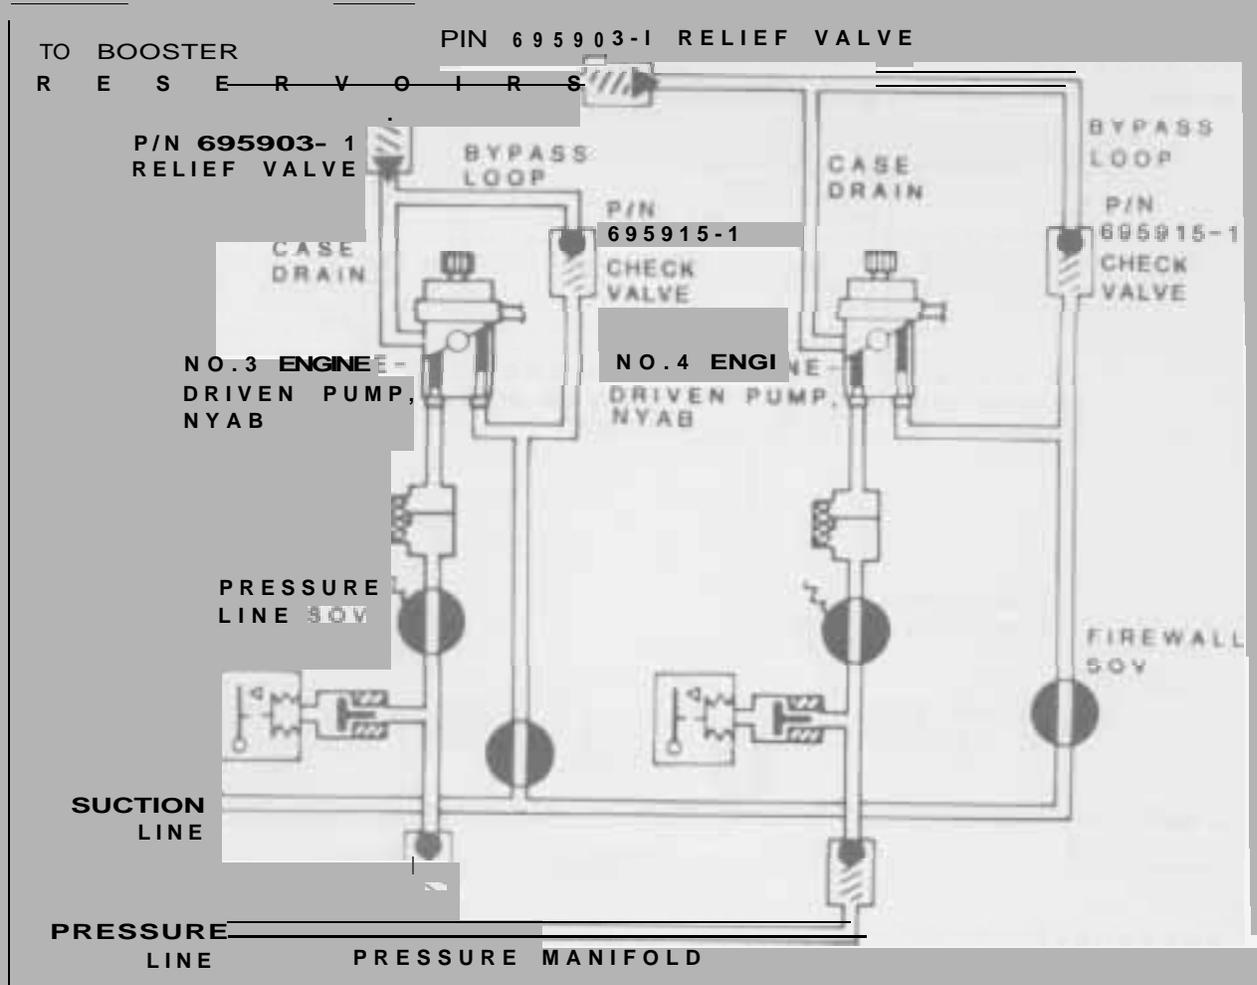
Figure 1. Baseline hydraulic configuration on Hercules aircraft LAC 3501 to LAC 4181.

with P/N 66WBD300 New York Air Brake Company engine-driven hydraulic pumps. The New York Air Brake (NYAB) pump requires a bypass loop connecting the case drain line and the suction line (Figure 1). The bypass loop is required because the design of the pump is such that it receives its lubrication from the hydraulic fluid in the suction line. This causes no difficulty unless one of the engine-driven pump switches on the copilot's instrument panel is placed to OFF or the fire emergency handle for an engine is pulled. When this happens, the normal source of lubricating fluid for the affected pump is no longer available even though the need for lubrication is still present.

pump was incorporated in the system's plumbing for the specific purpose of maintaining lubrication to the pump when the firewall and pressure line shutoff valves are closed. The bypass loop routes case drain fluid back into the suction line and thereby provides the necessary lubrication. A P/N 695903-1 relief valve in the case drain line set to open at 22 psi ensures that hydraulic fluid will be forced into the bypass loop whenever loss of pressure in the suction line caused by the closing of the firewall shutoff valve allows the P/N 695915-1 check valve to open.

This plumbing configuration is the only one of those found on Hercules aircraft that will keep the NYAB engine-driven hydraulic pump lubricated and within its temperature design limit when it is operating and the firewall and pressure line shutoff valves are closed.

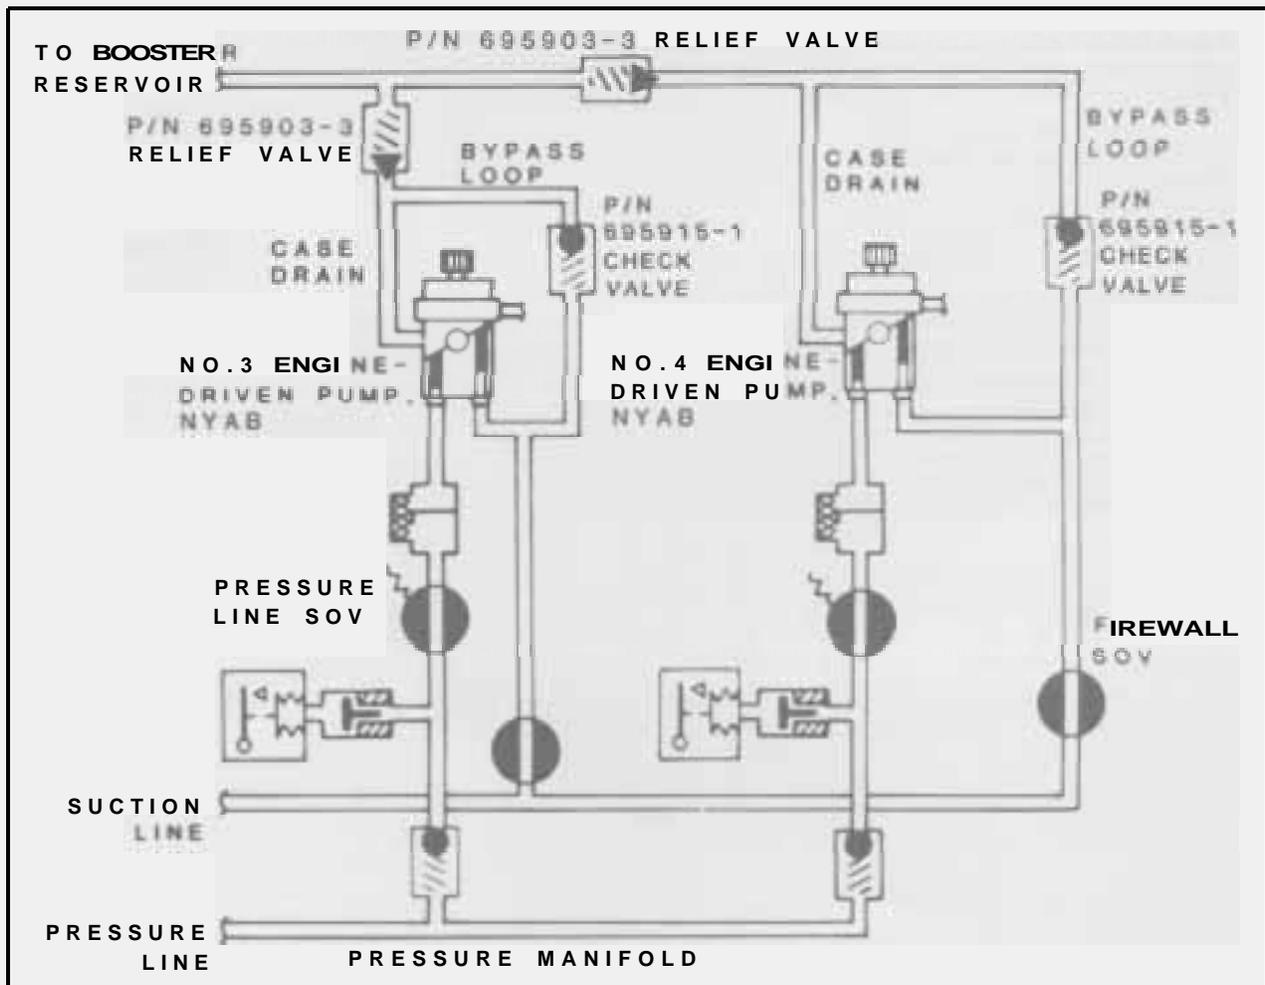
Figure 2. The baseline configuration of LAC 4182 to LAC 4429; note relief valve change.

There was one minor change to the NYAB plumbing at Lockheed serial number LAC 4182. The 695903-1 relief valve was replaced by an improved relief valve, P/N 695903-3 (Figure 2). The change in relief valves did not affect the pump itself.

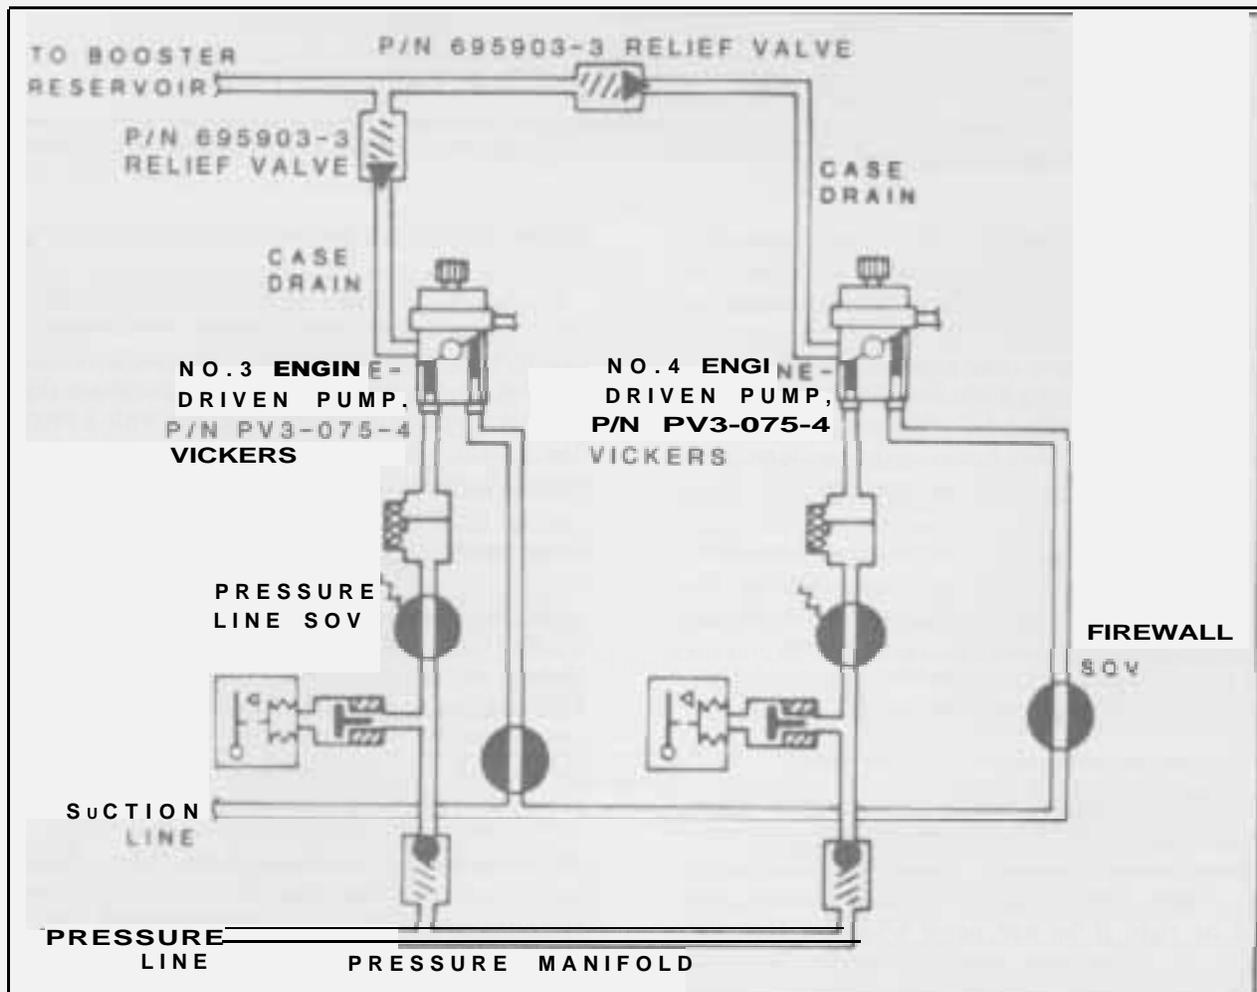
Figure 3. At LAC 4430, Vickers pumps were introduced and the bypass loops deleted.

The P/N PV3-075-4 Vickers engine-driven hydraulic pump is an in-line pump whose design is such that it uses the fluid that has been forced into the case drain line for internal lubrication. Tests showed that with the firewall and pressure line shutoff valves closed, the use of a bypass loop caused the Vickers pump to generate an operating temperature that exceeded the permissible value. The bypass loop was therefore deleted from the plumbing configuration (Figure 3). The new arrangement allowed the Vickers pump to remain within safe temperature limits under all operating conditions.

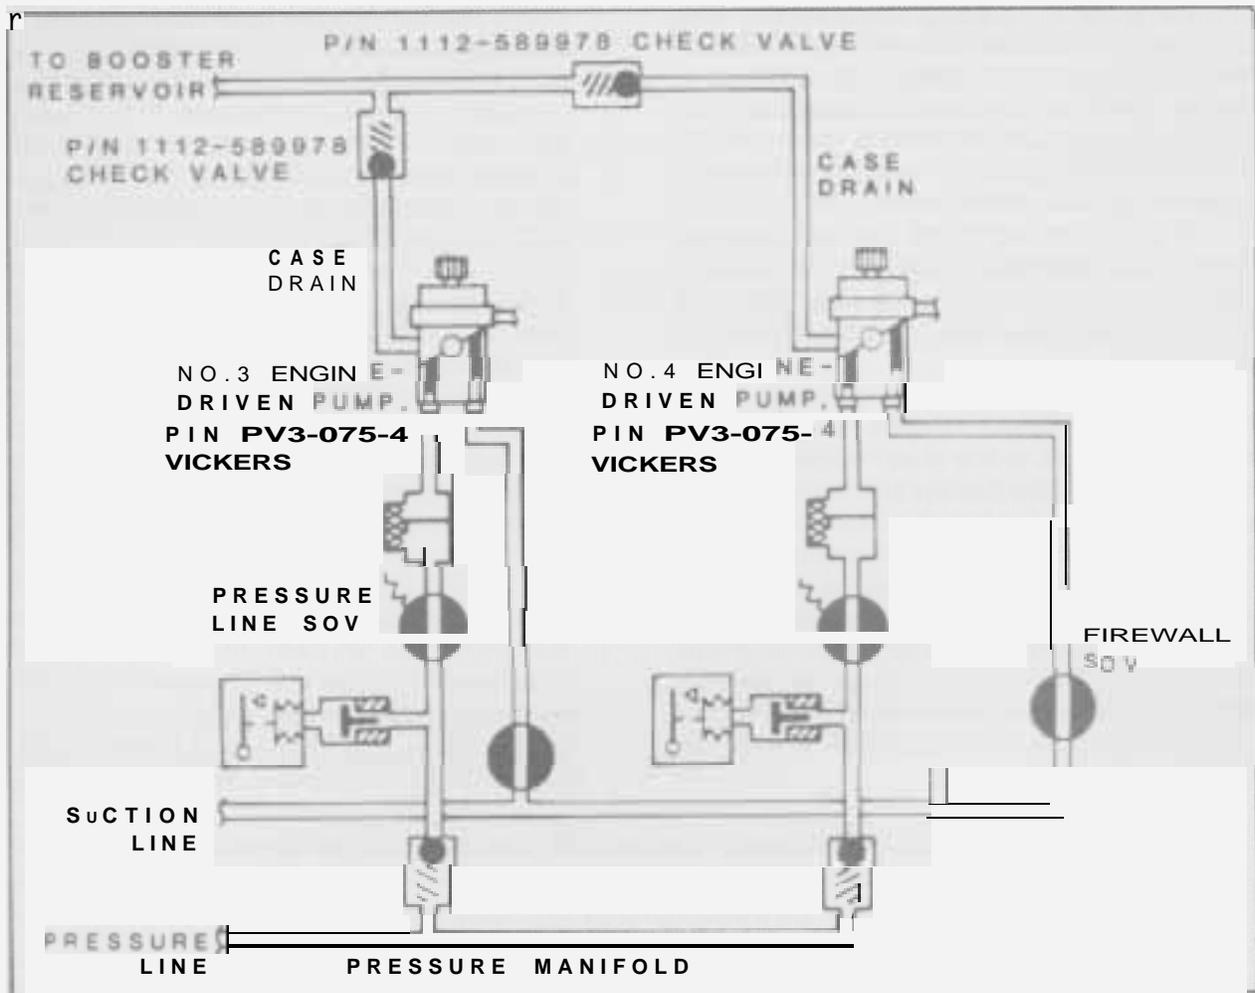
Figure 4. The baseline configuration of LAC 4458 to LAC 4652. The globe valves have been replaced by check valves.

Note that the 695903-3 relief valve remained in the case drain line in this configuration. Tests performed at Lockheed later determined that a check valve could be installed in place of the 695903-3 relief valve, and that a cost saving would result. The relief valve was therefore deleted, and a P/N 1112-589978 check valve used in its place starting with Lockheed serial number LAC 4459 (Figure 4).

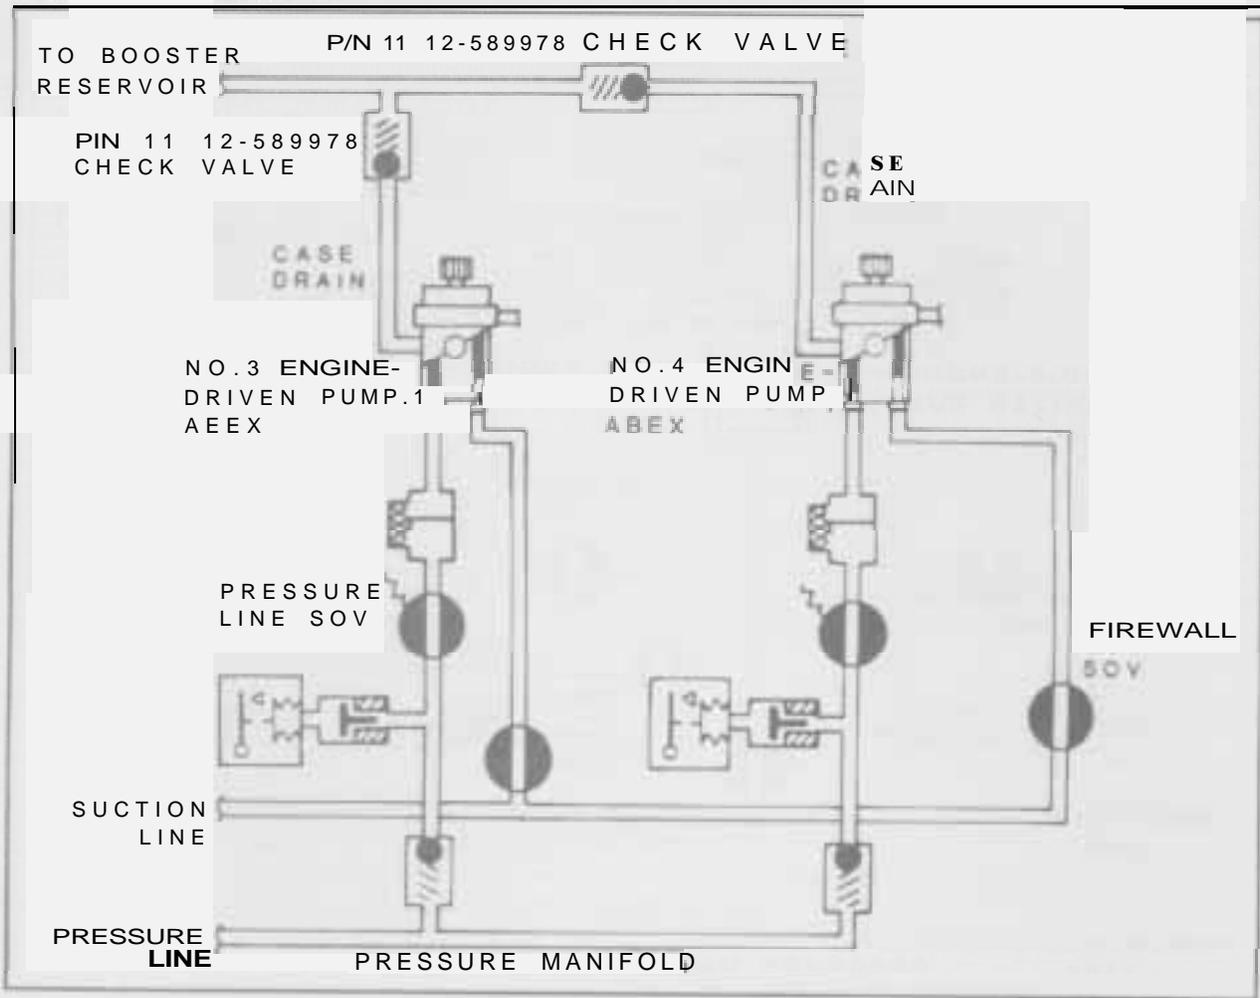
Figure 5 The Abex pump was introduced at Hercules aircraft LAC 4653 No changes were required in the basic system design.

pumps (Figure 5). The P/N 66039 Abex pump contains a thermal off-stroke feature which allows it to be used in any of the four hydraulic plumbing configurations we have previously described. It can be used with or without a bypass loop, and with either a relief valve or check valve in the case drain line. The baseline configuration starting with LAC 4653 and presently in effect uses the 66039 Abex pump, no bypass loop, and a 1112-589978 check valve in the case drain line.

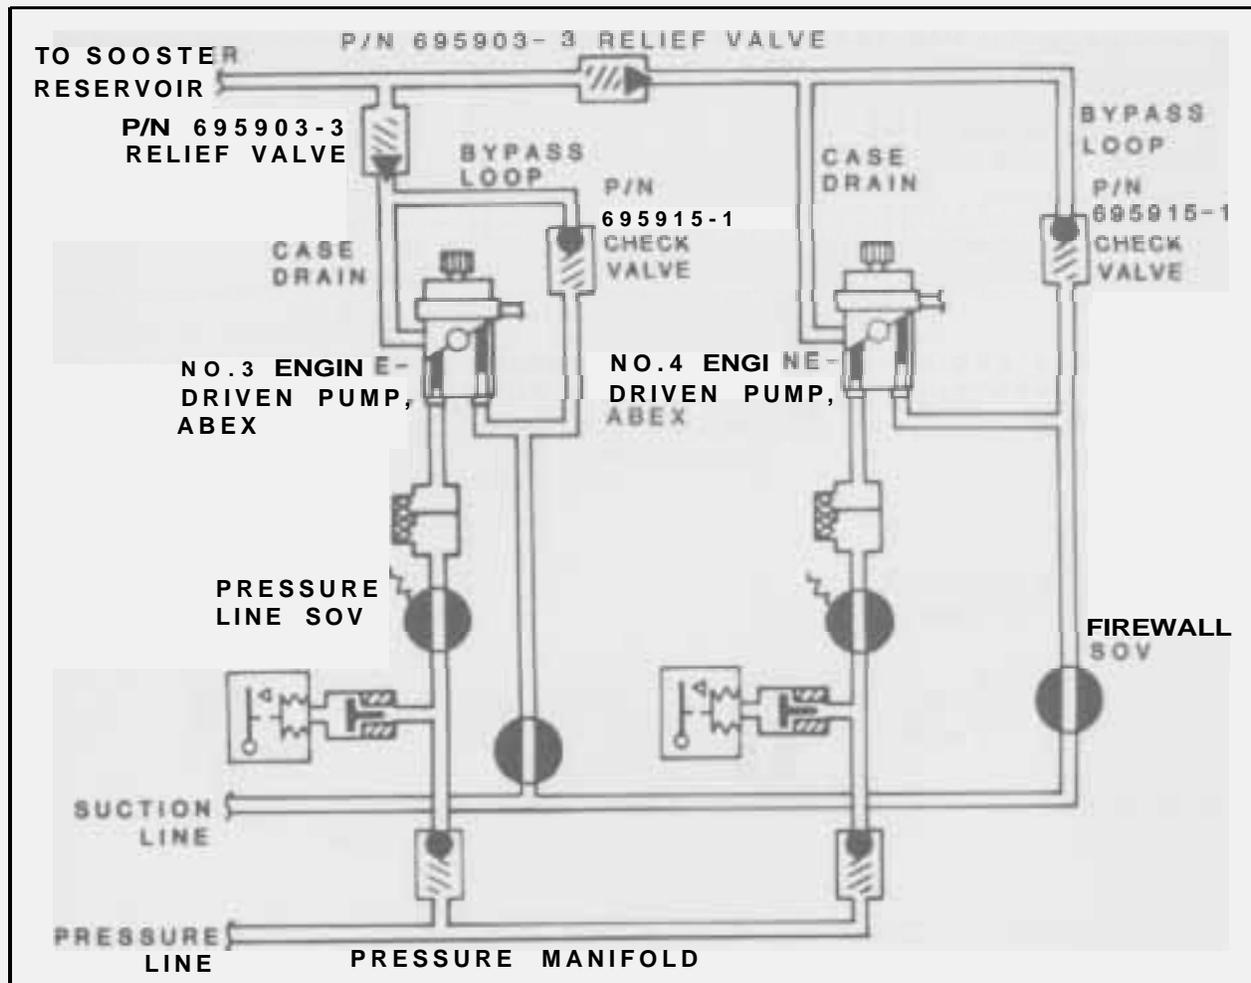
Figure 6. System plumbing configured for use with either NYAB or Abex pumps.

If a repeat customer originally bought Hercules aircraft equipped with NYAB pumps, Abex pumps with bypass loops and 695903-3 relief valves would be installed on the subsequent aircraft purchase (Figure 6). This would provide the customer with a Hercules fleet in which NYAB or Abex pumps could be used interchangeably.

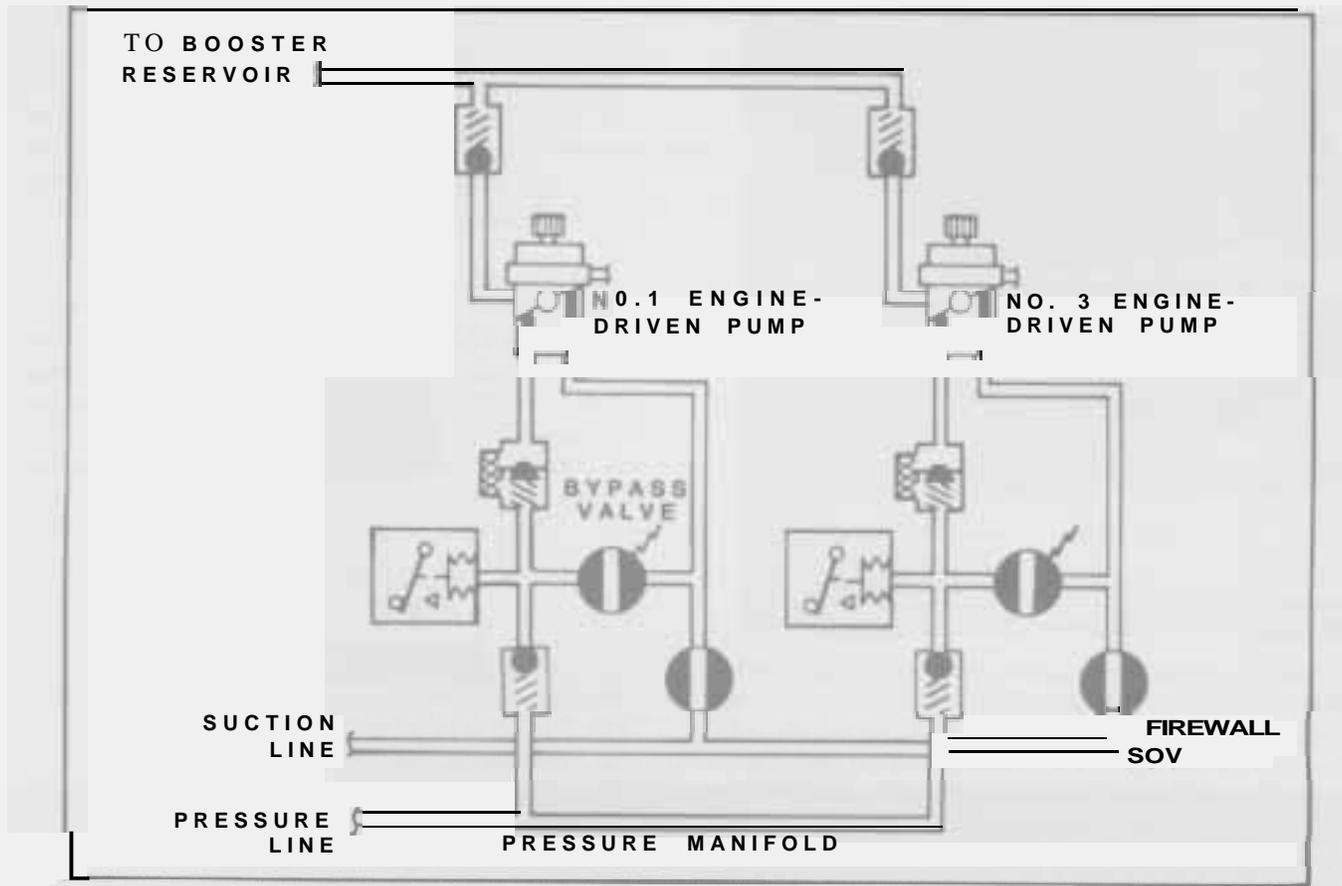
Figure 7. C-130A plumbing configuration; note bypass valves

We have not up to this point made any mention of the engine-driven hydraulic pumps of the C-130A. The reason is that the interchangeability of pumps on the A-model Hercules aircraft is not governed by the internal lubricating characteristics of the pump themselves. C-130As, originally equipped with NYAB pumps, have a bypass valve connecting the pressure and suction lines (Figure 7). The bypass valve will open to allow lubricating flow through the pump anytime the engine-driven pump switch is placed to OFF or the fire emergency handle is pulled. This plumbing configuration never changes, regardless of the type of replacement pump that might later be installed.

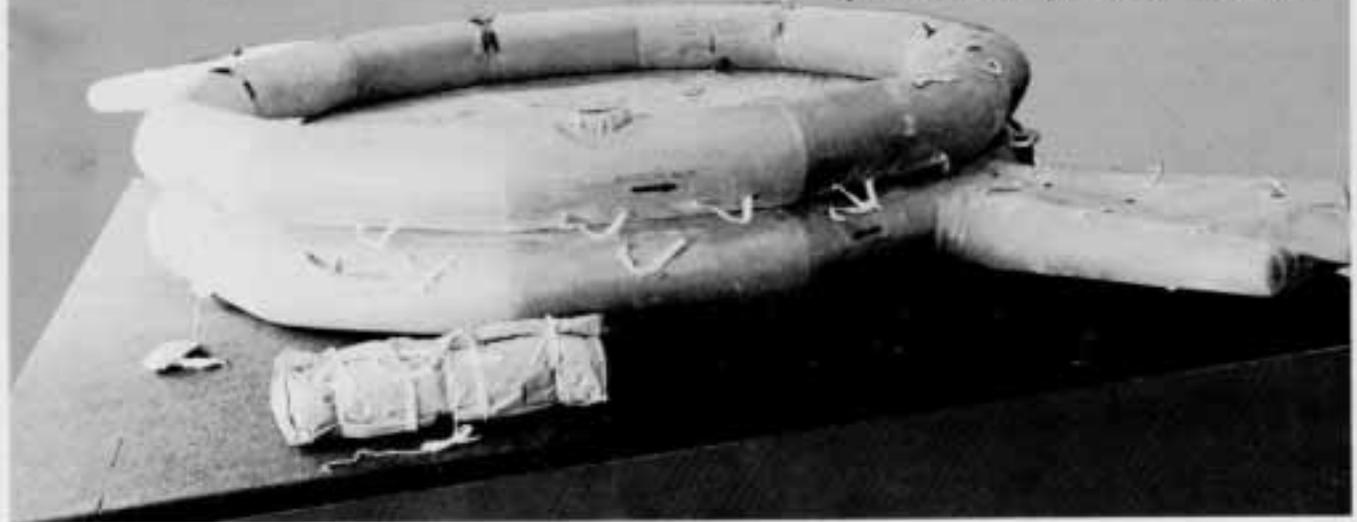
Figure 1. Vent valve positions.

this partial inflation occurs. Lockheed engineering has long suspected that the majority of these unscheduled life raft deployments occur either because the raft was incompletely evacuated prior to installation, or because the P/N 9153 vent valve on rafts so equipped has been left in the closed position. Figure 1 illustrates the appearance of the vent valve in both the closed (SHUT) and open (VENT) positions.

position. The raft appeared to have been properly evacuated and installed, except for the valve position, but the access door clearly showed signs of damage. Each time the aircraft went to altitude, the air trapped in the raft expanded, pushing on the door latches. How long the raft had been installed could not be determined, but loss of the life raft appeared imminent because of bending of the door latches.

It is very important that the vent valve be left in the open (VENT) position once the life rafts are installed in their compartments. The porosity of the life raft material will not permit the raft to remain evacuated indefinitely, and venting of the raft is therefore required to avoid expansion at altitude. Also, if the vent is left closed, any leakage from the CO2 cylinders used to inflate the rafts for use cannot escape to the atmosphere and will enter the raft itself.

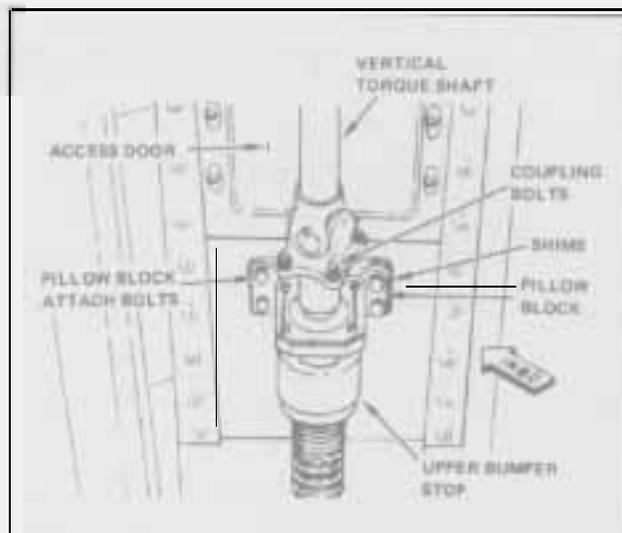
Figure 1. Remove the access door to reach the vertical torque shaft and the upper bumper stop.

Recently, a military operator whose Hercules aircraft were in virtually continuous operation carrying heavy loads into areas where extreme weather conditions prevailed noted a significant increase in discrepancies involving excessive axial play in the MLG upper bumper stop assemblies. Some of the ballscrew assemblies had only recently been installed and were apparently in good condition otherwise.

Investigation determined that in each of the cases the ring spring assembly had jammed, which accounted for the excessive axial clearance. The exact cause of the condition was more difficult to pinpoint, but it appears that heavy loads, harsh climatic condi-

When the ring spring assembly is exposed, check to see if the spring elements are still stuck together. If they are, you should be able to separate them by lightly tapping on the outer ring with a mallet. Once the elements are freed, examine them for corrosion, scored surfaces, nicks, chipped mating surfaces, and broken parts. Serious damage will require that the ring spring assembly be replaced, which should be done in the shop after removal of the ballscrew assembly from the airplane.

Minor damage can be much easier to correct. If corrosion is only minor and there are no signs of permanent physical damage, the only repair that will be necessary is to clean all grease from the mating surfaces of the ring spring elements and remove any corrosion with emery cloth. Avoid “polishing” the
