VOL. 8, No. 2, APRIL-JUNE 1981

*Lockheed*  
**SERVICE  
NEWS**

**3 Troubleshooting RPM Fluctuation**  
Understanding and troubleshooting  
the propeller control system.

## ***Troubleshooting RPM Fluctuation***

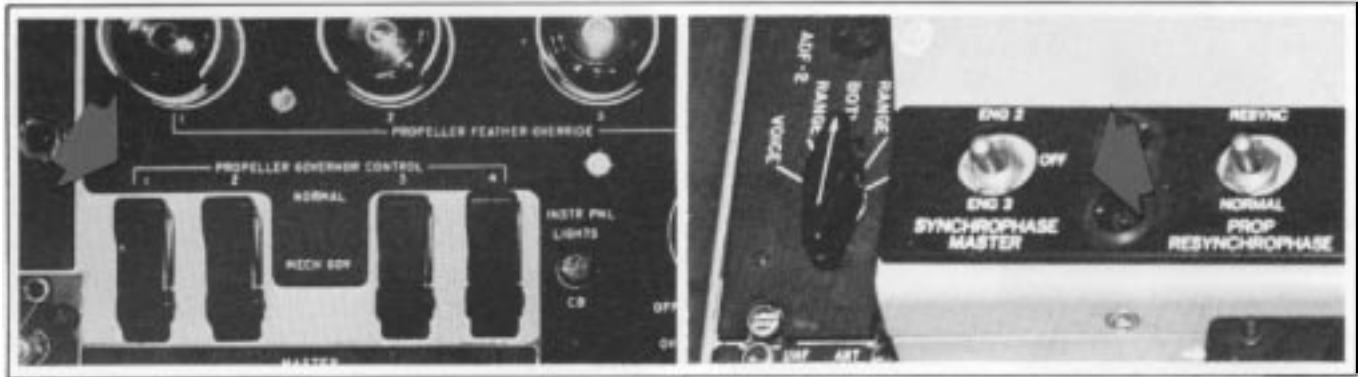
Figure 1. Left: Propeller governor control switches on the copilot's side shelf. Right: Synchrophase master switch, located on the engine control quadrant.

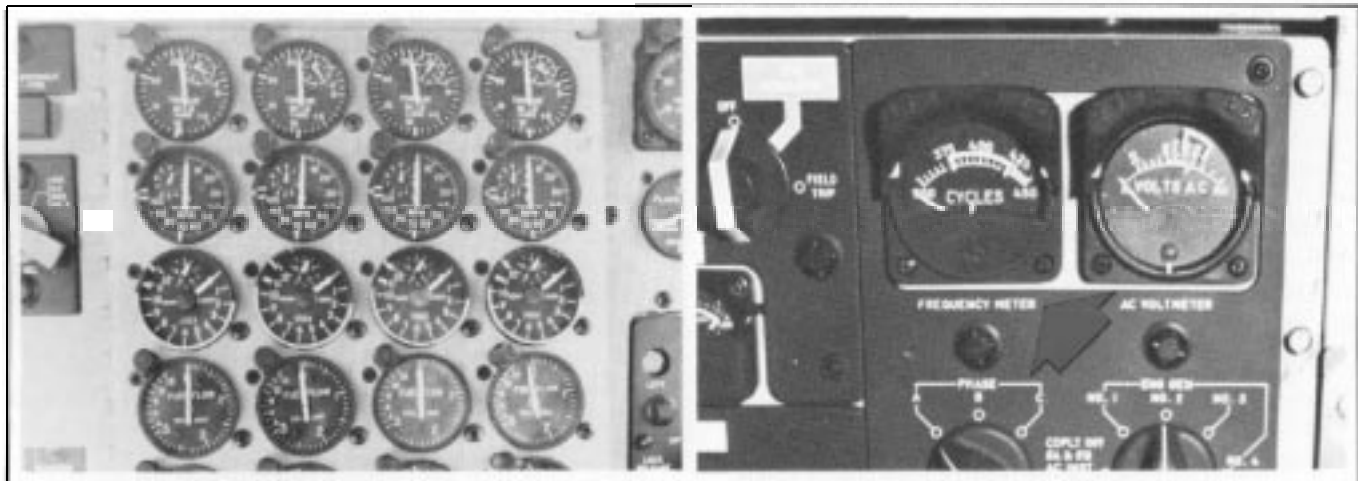
RPM fluctuation is indicated when the engine RPM cannot be maintained within a cyclic variation of plus or minus 0.5 percent RPM as indicated by the tachometer located on the engine instrument panel (Figure 2). RPM fluctuation can be further verified by observing the frequency meter on the overhead electrical control panel. A 0.5 percent RPM fluctuation will be displayed on the frequency meter as a variation of 2 cycles per second.

Figure 2. Left: Engine instrument panel. Right: Overhead electrical control panel.

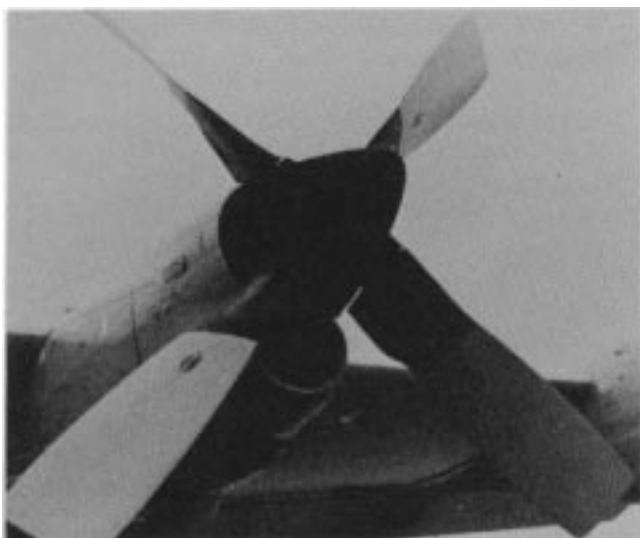
With engine static, propeller blade feathering is accomplished by use of the propeller auxiliary pump.
