SERVICE NEWS

Vol. 8, No. 4, October - December 1981

Troubleshooting Pressurization Problems

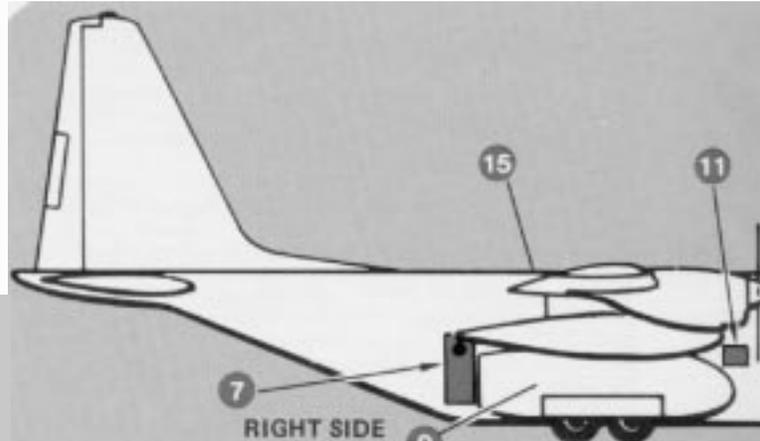
Figure 4. Pressurization Leak Locator Chart.

If the timed pressure decay leakage test is unsatisfactory, the cabin is leaking excessively. To find where the leaks are, pressurize the aircraft to 2 to 3 in. Hg (0.98 to 1.47 psi) and inspect the fuselage door seals, exterior surfaces, and joints. Leaks can be located by feel or by using an approved liquid leak detector or soapy solution. Figure 4 shows those areas of the Hercules aircraft which tend to leak most often. In the table, these areas are listed in the approximate order of their susceptibility to the kinds of wear and damage that can result in pressure leakage problems. A systematic approach to finding a pressure leak in an unknown location would be simply to start at the top of the list and work down.

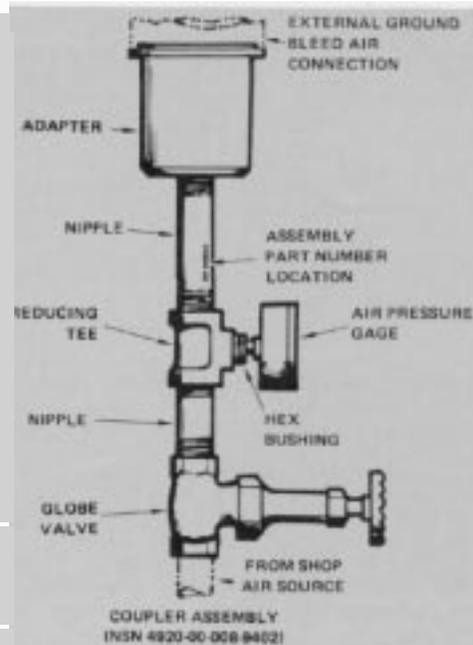
Figure 7. Ground bleed air coupler assembly.

An alternate method of checking heat exchangers for leaks is available to Hercules operators who have access to the U. S. Air Force supply system. Shop air can be made to serve in place of the GTC/APU or MA-1A compressor through the use of the ground bleed air coupler assembly shown in Figure 7. This device can be obtained as a unit from normal Air Force sources. A satisfactory substitute can be locally manufactured for use with the NSN 4920-00480-6191 adapter or the equivalent (see materials list, Figure 7).

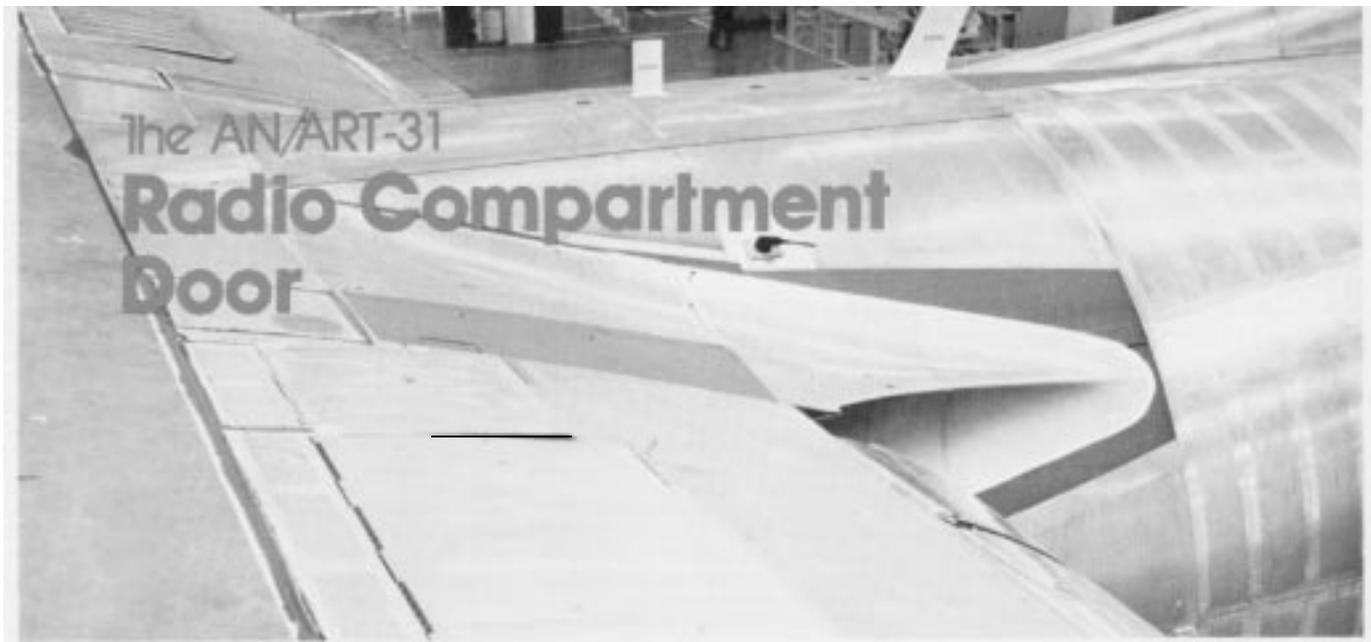
Starting with Hercules aircraft LAC 3609, Lockheed began replacing P/N 363676-1L left wing fillet, located between fuselage stations 617 and 667 and between left buttock lines 61.625 and 77.42, with a compartment installation, P/N 388152-1. The purpose of this compartment was to provide a space for installation of the AN/ART-31 emergency radio. Since that time, the AN/ART-31 radio has been replaced on Hercules aircraft by a more compact radio, which is now stowed in the life raft compartment; Even so, the Hercules is still being built with the AN/ART-31 emergency radio compartment in place. Since the AN/ART31 radio is no longer being used and the compartment remains empty, its existence is sometimes forgotten. Unfortunately, neglect of this area may be causing some of our Hercules operators problems.

6. Mount the nut plate, using two MS20426AD3 rivets.

7. Secure the access door closed by installing the NAS517-3-3 screw.

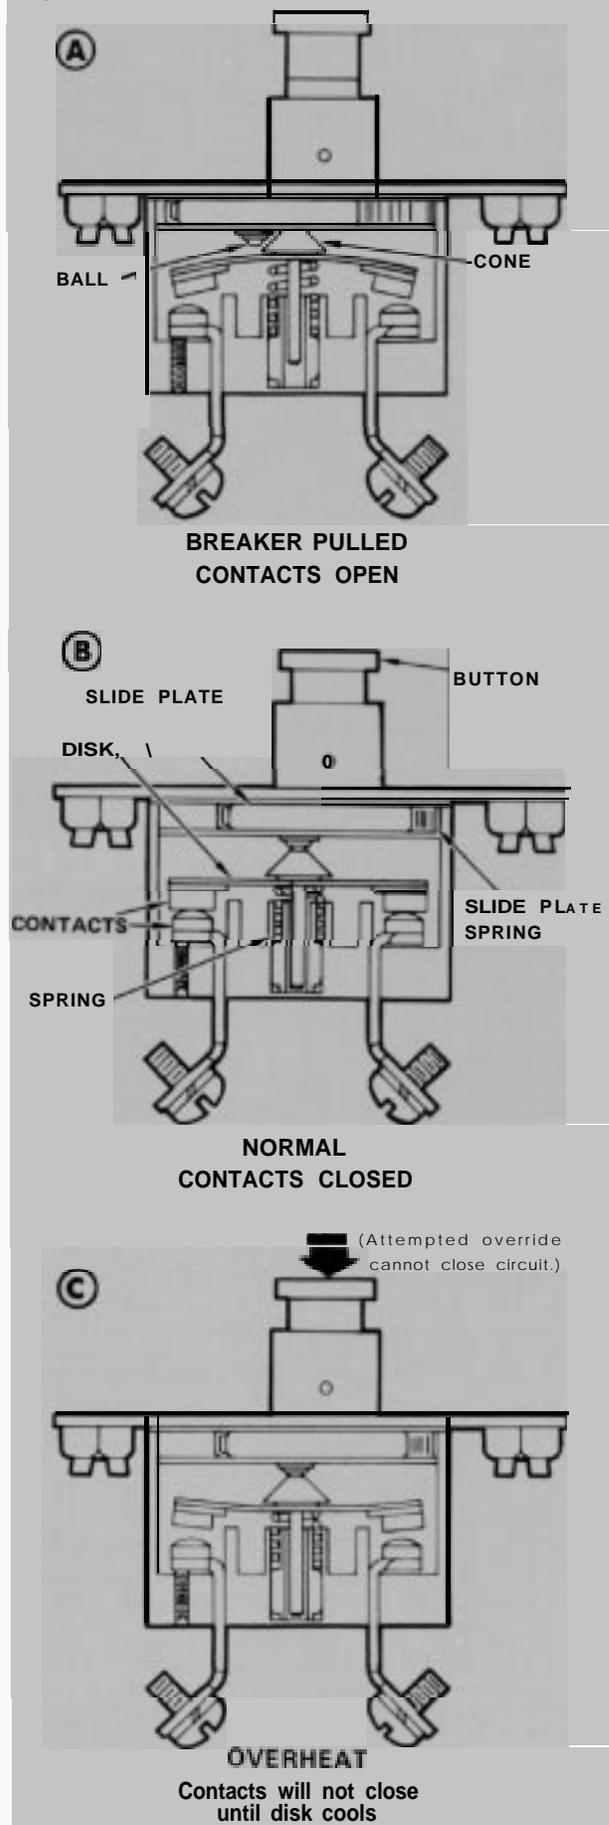
Figure 2. Circuit breaker: three operational conditions.

If a fault occurs in a circuit and the temperature of the upper contacts starts to increase, the ends of the disk will snap upward when the precalibrated temperature is reached (Figure 2C). When both ends of the disk snap up, the slight spring tension present because of the small downward bend of the disk supporting the upper contacts (when cool) is relieved. This allows the ball to be pushed out of the cone socket by the slide plate spring.

It should be mentioned at this point that if a circuit breaker pops, the cause should be determined before resetting it. Often only a minimum amount of troubleshooting actually takes place before an attempt is made to

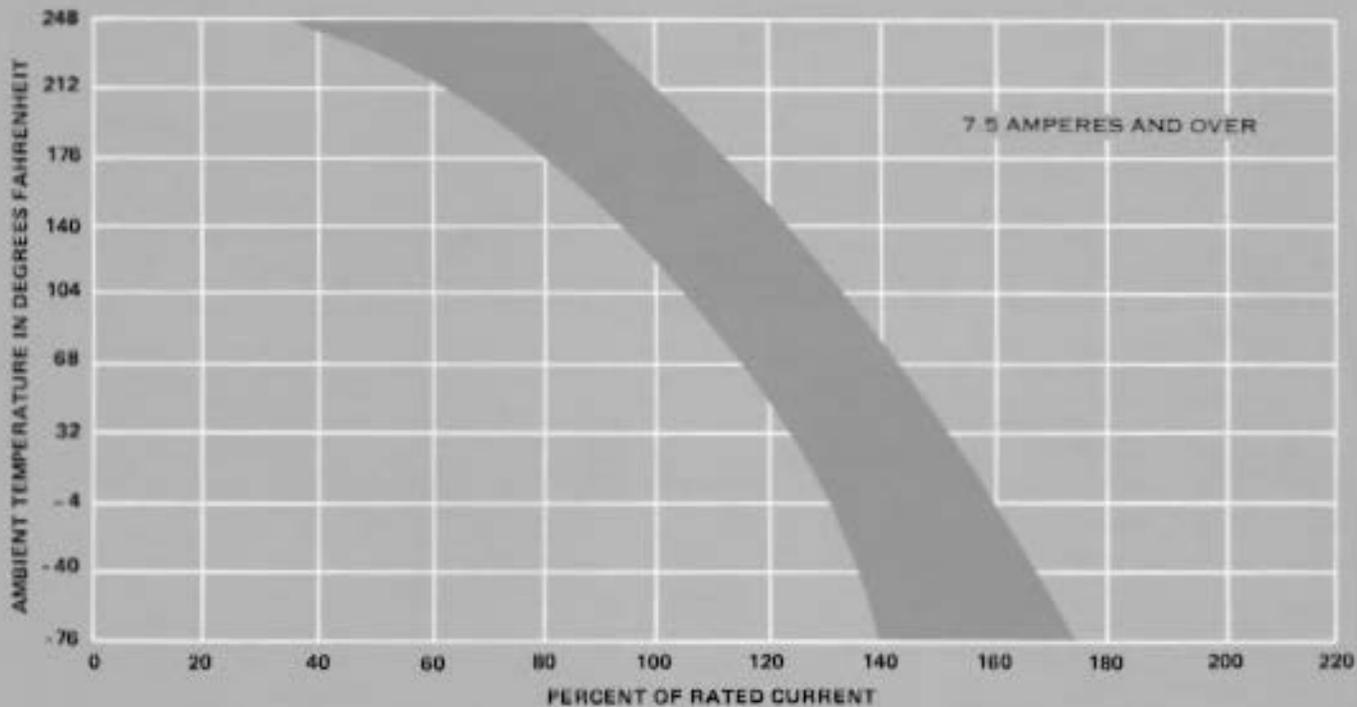
Figure 3. Ambient temperature versus percentage of rated load that can be carried.

Figure 3 indicates the ultimate trip current in percent of rated current at various ambient temperatures. This shows the percent of rated current at which the circuit breaker will operate indefinitely at a given ambient temperature without breaking the circuit. As the ambient temperature rises, the percent of rated capacity lowers towards 100% and drops below 100% at approximately 140 degrees F. In other words, more current can flow in the conductor at low temperatures without breaking the circuit.

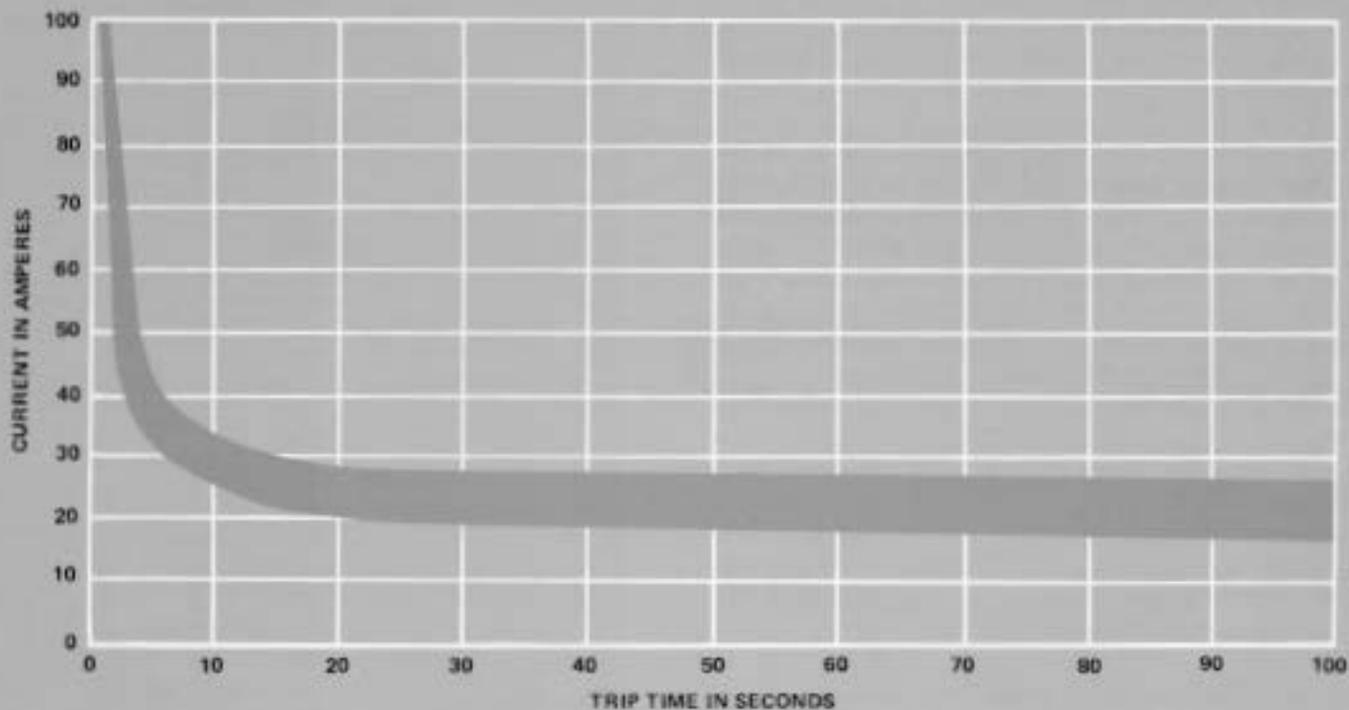
Figure 4. The relationship between current load and trip time.

Figure 4 shows the trip time in seconds with respect to the actual number of amps flowing through a 10-amp circuit breaker at 77 degrees F. You can see from the chart that a 10-amp circuit breaker can carry a load of approximately 15 amps for an extensive period of time, and higher amperages for progressively shorter periods of time.

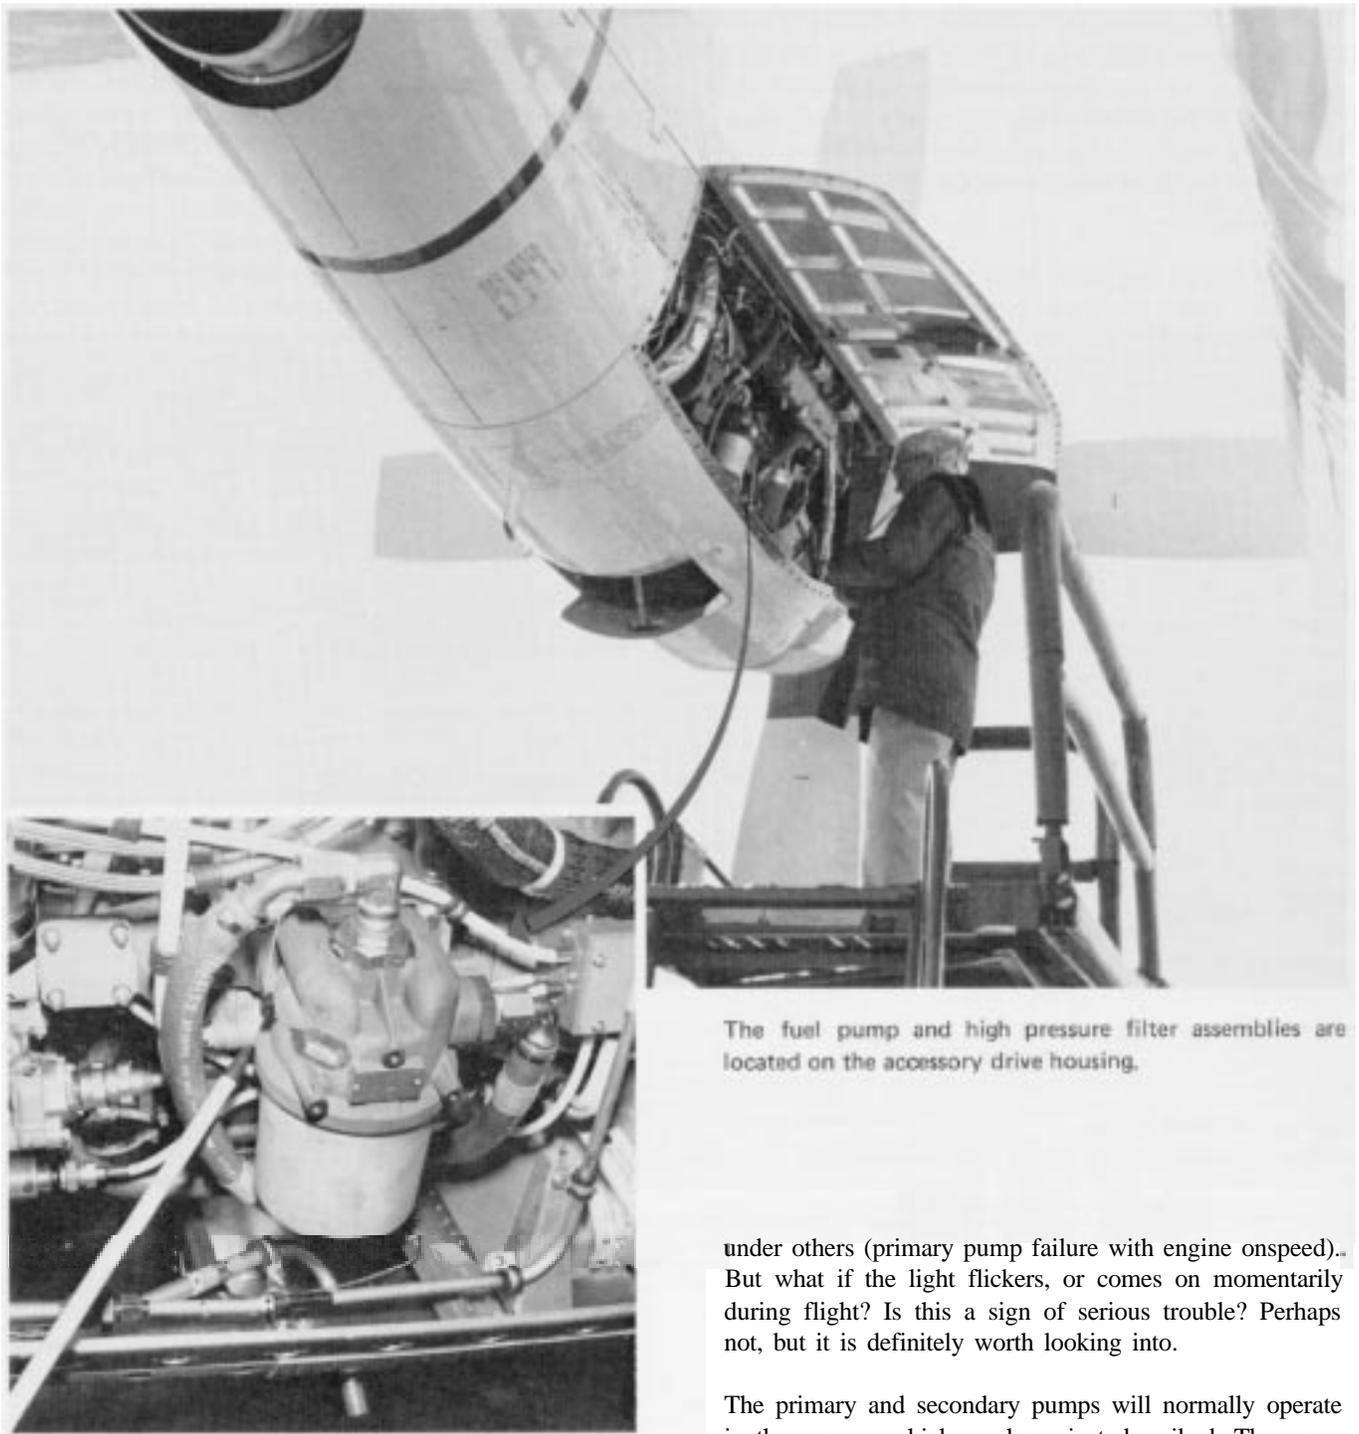
The fuel pump and high pressure filter assemblies are located on the accessory drive housing.

will then pass through a check valve and on to the engine fuel control, thus maintaining fuel flow to the engine. Under these conditions too, the rise in fuel pressure in the secondary pump output circuit will cause the secondary fuel pump pressure switch to close and illuminate the light in the flight station. The indicator lamp will burn steadily in cases of primary pump failure.

And finally, keep in mind that the high-pressure signals that show up at the flight station in the form of an illuminated secondary fuel pump pressure light originate in the secondary fuel pump pressure switch. It follows, therefore, that this unit itself should not be overlooked as a possible source of trouble. Improper adjustment of the pressure switch can cause the indicator light to flicker or illuminate even though the pressure in the secondary pump circuit is actually within tolerances. If misadjustment is suspected, remove the pressure switch and bench check it. The switch should not close until the pressure has increased to 150 (+ 10) psi. The switch should open before the pressure has decreased to 90 psi. Replace the switch if it does not meet these criteria.
