SERVICE NEWS

VOL. 9, NO. 3, JULY-SEPTEMBER 1982

3 Thermocouples and TIT

Understanding thermocouples and their relationship to engine overtemperature conditions.

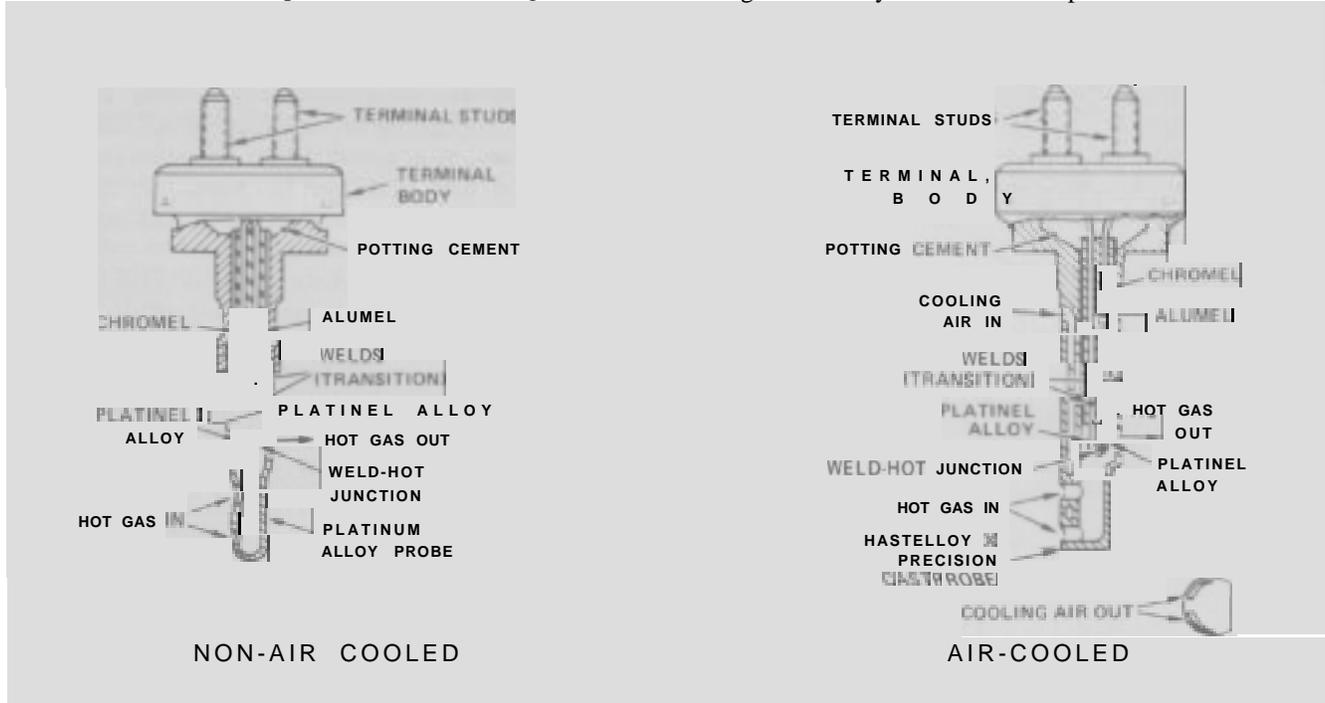
Figure 1. Principal features of non-air-cooled and air-cooled thermocouples.

Two basic types of thermocouples are used in 501/T56 engines, one that has no special provision for cooling and one that is air-cooled (Figure 1). A somewhat awkward convention in terminology has become established in which the one type is referred to as “non-air-cooled,” and the other as air-cooled. Note in particular that there are two configurations of the non-air-cooled type of thermocouple. One is used with T56-A-9, T56-A-7, and 501-D22 engines, and the other was installed in earlier T56-A-15, T56-A-16, T56-A-423, and 501-D22A engines. The two configurations are physically similar but functionally distinct. They should never be intermixed in any installation.

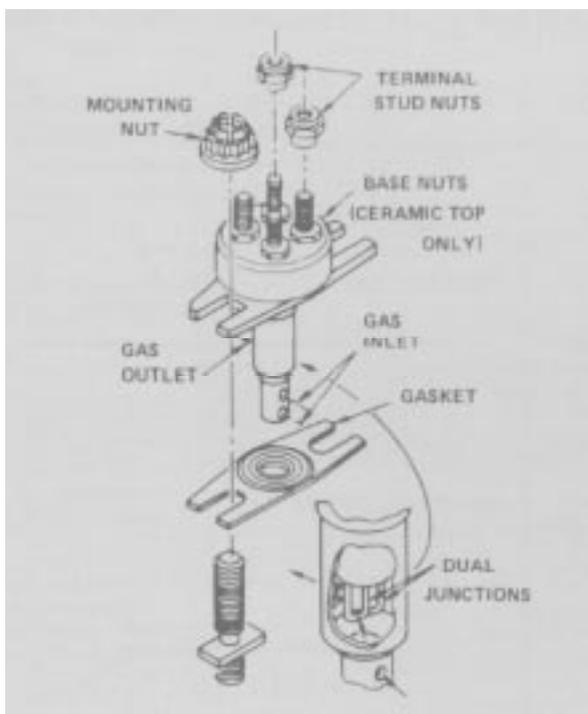
The thermocouples used in 501/T56 engines have two separate sensing elements (Figure 2). One sensing element of each of the 18 thermocouples is connected in

Figure 2. A typical thermocouple: note the two sensing elements (dual junctions).

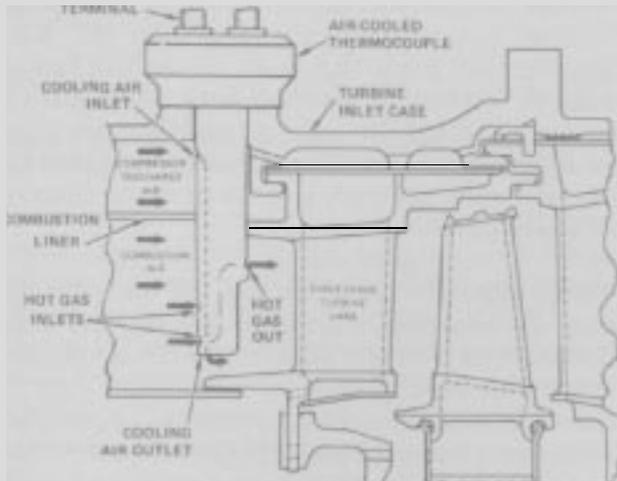
The reason that aft probe tip wall erosion can have this effect is related to specific features of the thermocouple design. Fundamentally, the thermocouples used in 501/T56 engines are temperature-sensing, gas-sampling devices. Their bimetallic junctions are not exposed directly to the hot gas, but are instead enclosed in a probe. This probe is designed to obtain samples from two different immersion levels in the gas stream, mix the samples, and then direct the composite sample over the sensor junctions within the probe. After the temperature of the composite sample has been measured, the gas is exhausted from the downstream side of the probe (Figure 6).

Figure 6. Air-cooled thermocouple installed, showing combustion gas and cooling air flows.

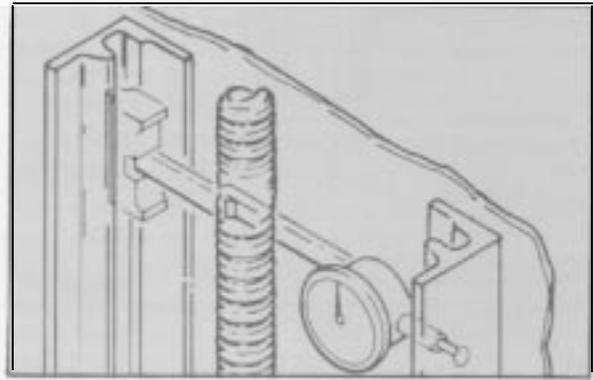
Last, but by no means least, the clearance between the tracks and shoes should be checked frequently. A minimum of 0.010 inch fore and aft clearance should be maintained at the minimum clearance location. (The original minimum of 0.005 inch was revised several years ago.) The procedure for checking the track clearances on C-130A aircraft involves the use of a feeler gauge, but the preferred method of checking and adjusting tolerances on B, E, and H models is to

Figure 1. Track width indicating tool.

use a track width indicator, P/N 3402044-1 (Figure 1). Detailed instructions for checking shoe-to-track clearances are contained in the authorized landing gear maintenance manuals. Further information can also be found in an article entitled "MLG Track Shoe Clearances," which appeared in Volume 6, Number 1 (January – March 1979) of *Service News*.

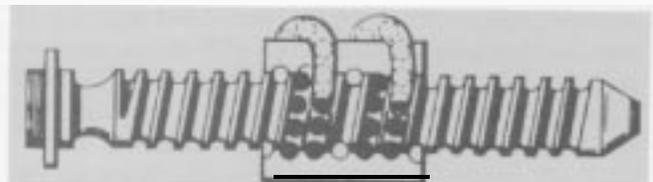
In order to ensure proper extension and retraction of the C-130 main landing gear, the ballscrews should be inspected frequently for cleanliness, condition, and adequate lubrication. Most reported cases of binding gear have been corrected by cleaning and lubricating the ballscrews in conjunction with cleaning the tracks. If an inspection discloses rough areas on the ball thread, there may be problems inside the ball nut. Foreign matter such as dirt or grit may be present inside the nut, and the recirculating balls inside the nut may be damaged (Figure 2).

Figure 2. Cross-sectional view of ball nut (typical).

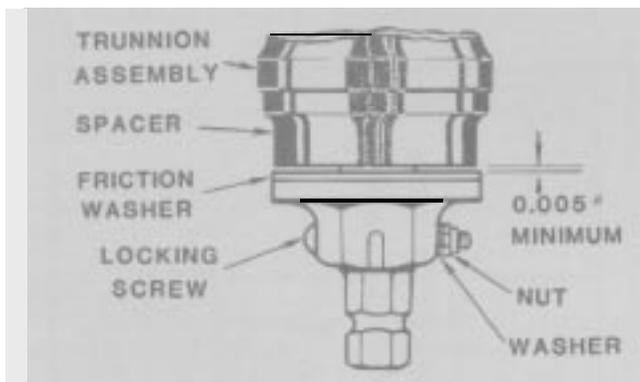
Insufficient clearance between the main landing gear friction washer and the spacer located next to the trunnion assembly will prevent gear retraction. The minimum clearance between the washer and the spacer is 0.005 inch. If the clearance is 0.005 inch and the locking bolt hole in the ballscrew is not aligned with a locking slot, the adjusting nut should be backed off (counterclockwise) to the nearest slot on the nut that will align with this bolt hole. A new locking screw, washer, and self-locking nut should be installed (Figure 3). The nut on the locking screw should be tightened to a torque value of 12 to 15 inch-pounds.

Figure 3. Lower portion of ballscrew assembly, showing friction washer to spacer clearance and locking screw.

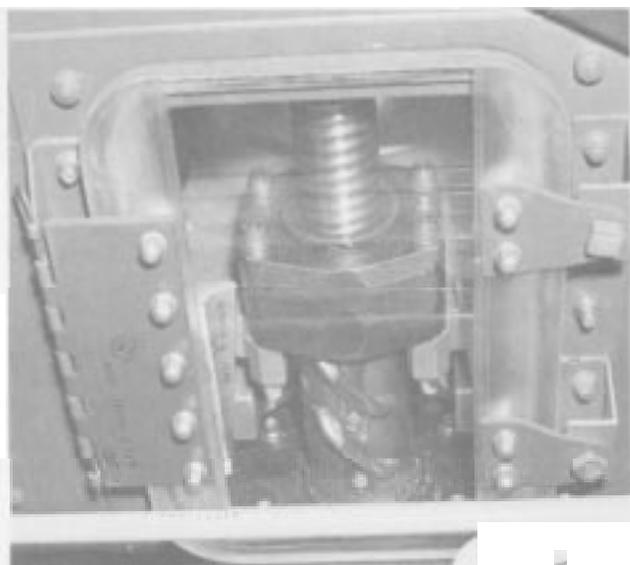
Most military versions of the Hercules aircraft are equipped with MLG inspection windows located in each wheel well side wall at FS 522 and FS 583. It is a good idea for all flight crew personnel to be familiar with the appearance of the main landing gear in the down position when viewed through these windows (Figure 4). A potential cause of gear malfunction can sometimes be detected visually well before trouble actually develops, permitting timely corrective action.

Figure 4. MLG inspection window-gear in down position.

If your aircraft is equipped with landing gear inspection windows, they should be cleaned as often as necessary to ensure a clear view. Remove dust from the surface of the plastic windows with a soft, clean cloth that has been saturated with clear water. Do not use a dry cloth. Wipe the windows carefully with a soft, damp cloth or sponge. Keep the cloth or sponge free from grit by rinsing frequently in clean water. Finish up by cleaning the windows with an approved non-abrasive plastic polish.

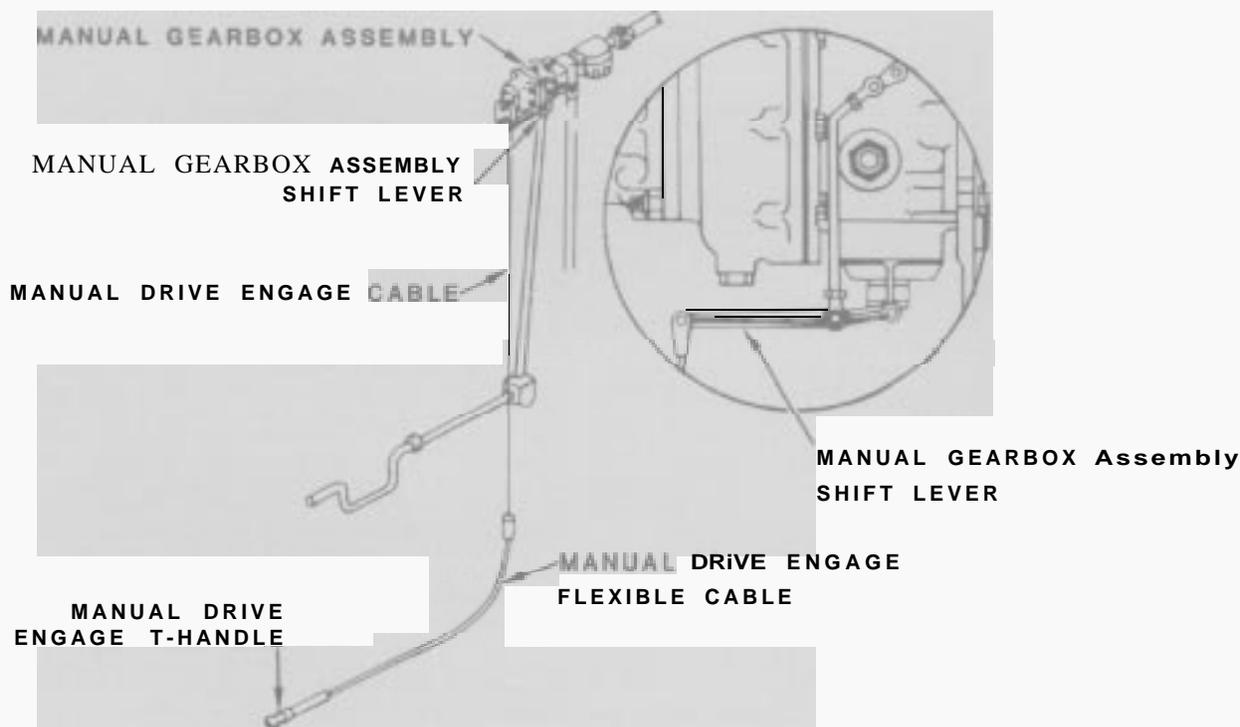
Figure 5. MLG manual extension system components.

1. Carefully disconnect the T-handle cable from the manual gearbox assembly shift lever (Figure 5).
2. Operate the T-handle several times to check that the cable is free to move.
3. Reconnect the T-handle cable to the shift lever.
