***T56 Oil System
Maintenance***

Lockheed SERVICE NEWS

Vol. 18, No. 3, July-September 1981

A Guide to Oil Loss Prevention

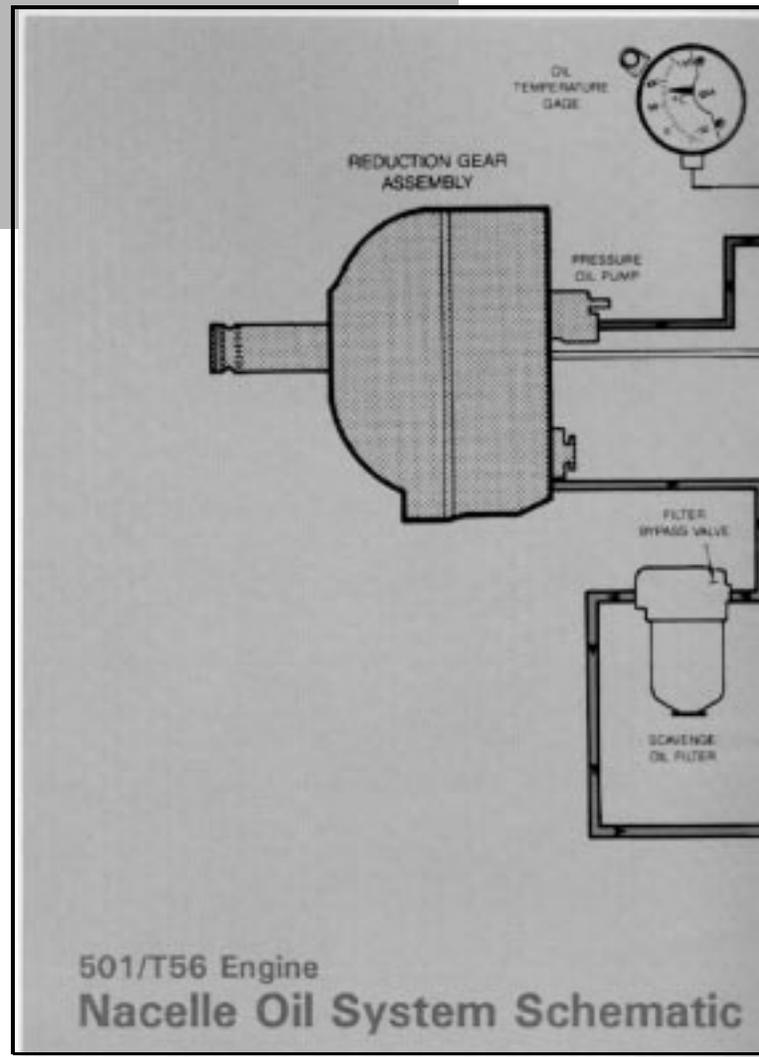
Figure 1.

The overall 501/T56 engine lubrication system consists of two essentially independent systems (Fig. 1). They are the pressure lubrication system and the dry-sump scavenge recovery system. These two systems, commonly known as the “pressure side” and the “scavenge side,” actually have only one thing in common, and

There are three components in the oil system that are directly affected by altitude (Fig. 1). The oil tank pressurization valve is a spring-loaded valve that controls the amount of pressure in the oil tank. The spring tension on the valve may become too weak and possibly cause a change in oil tank pressure, or the valve could stick open or closed and cause problems. As a practical matter, there is not too much that can go wrong with this valve because of its simplicity. Replacing it does not often correct an oil dumping problem. It is a factor which should be considered, however.

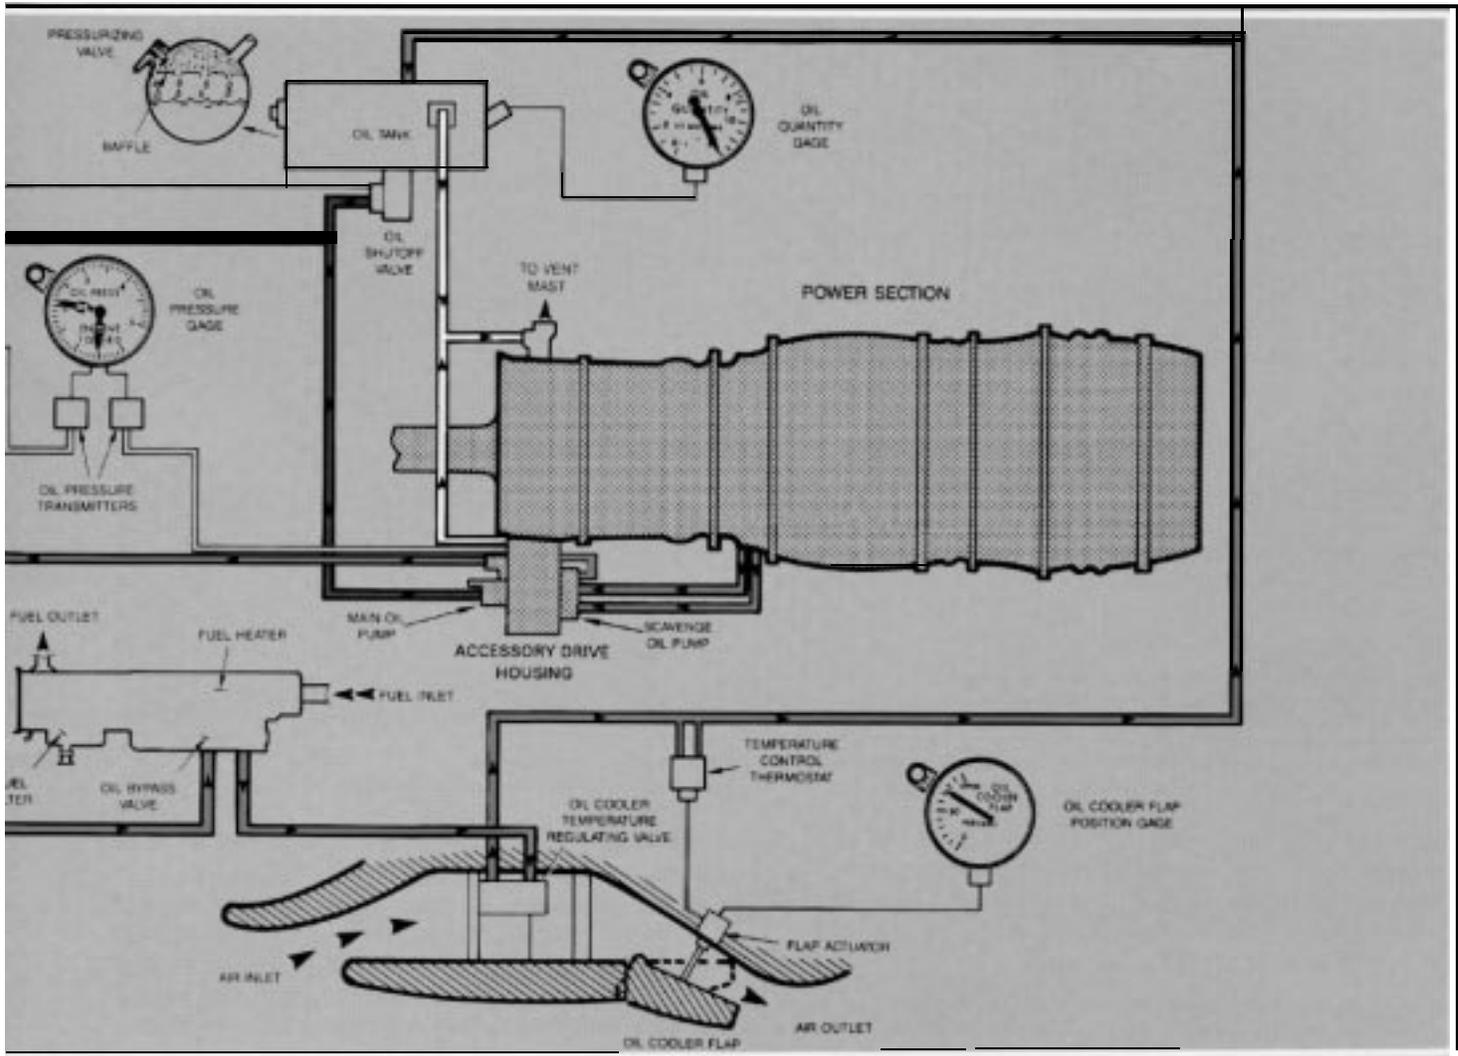
The most common cause of static leakage, also called gravitational flooding, is an improperly functioning oil retention check valve. This may occur either in the power section oil filter assembly or in the reduction gearbox oil pump assembly (Fig. 2).

Figure 2. Improperly functioning oil retention check valves are a common cause of static oil leakage.

When a static leak is suspected, perform the following confirmation check. Verify that the oil quantity gage of the affected engine shows at least four gallons present to provide lubrication, and then motor the engine briefly.
