Akron Airdock PCB Exterior Remediation Strategy

June 22, 2007

Lockheed Martin Corporation
1210 Massillon Road
Akron, Ohio 44315

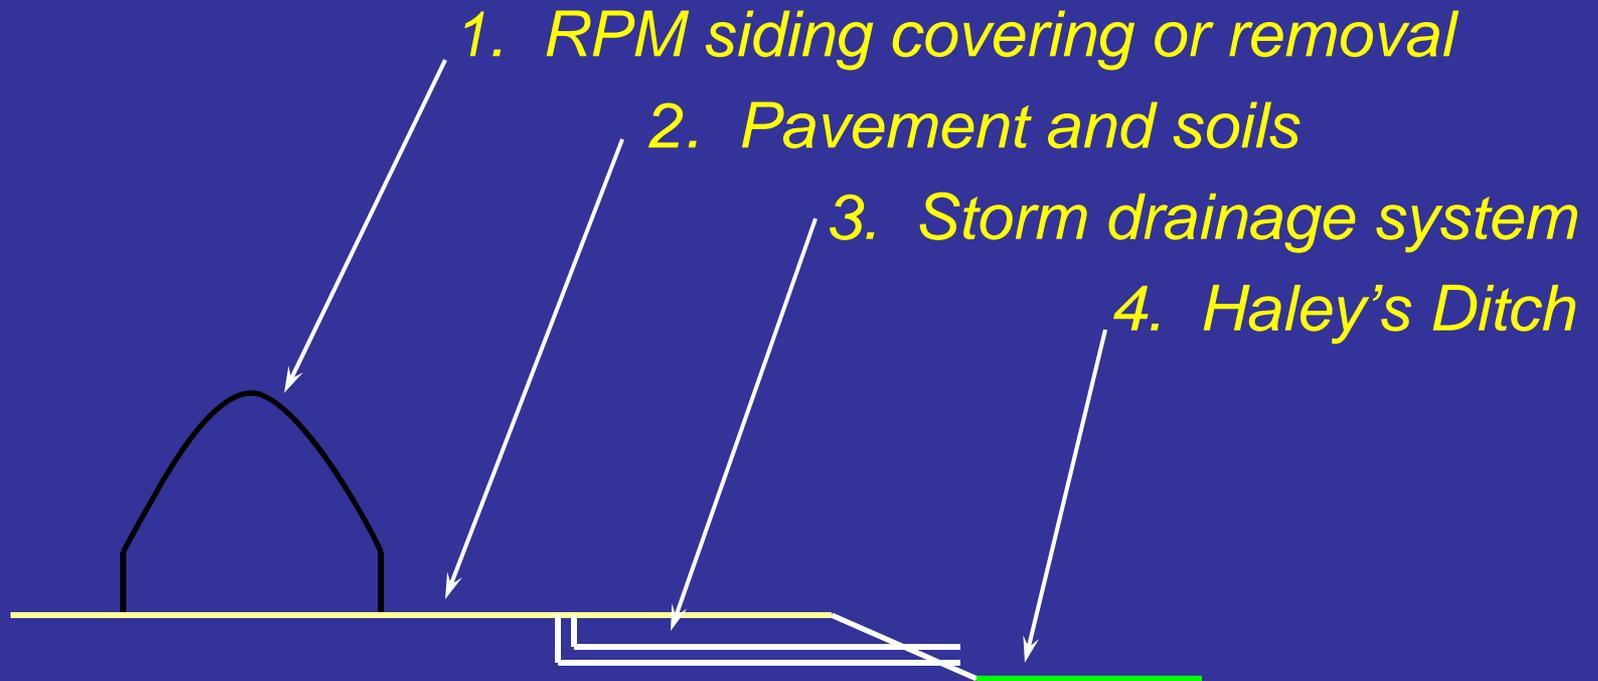
Exterior Progress to Date

- *Removed visible surface debris from around the Airdock, cleaned accessible storm drain manholes and installed and maintained storm drain filters*
- *Replaced Gutters (1,920 feet) and completed roof and door covering with rubber membrane (693,000 sq.ft.)*
- *Completed Vertical siding replacement (2,400 feet, 24 feet tall equal to 57,600 square feet) and replaced siding on two south motor houses and substation*
- *Demolished Plant M link and Northeast Loading Dock*
- *Collected and analyzed samples to characterize concrete, soils, pavement and other media to develop action plans as needed*

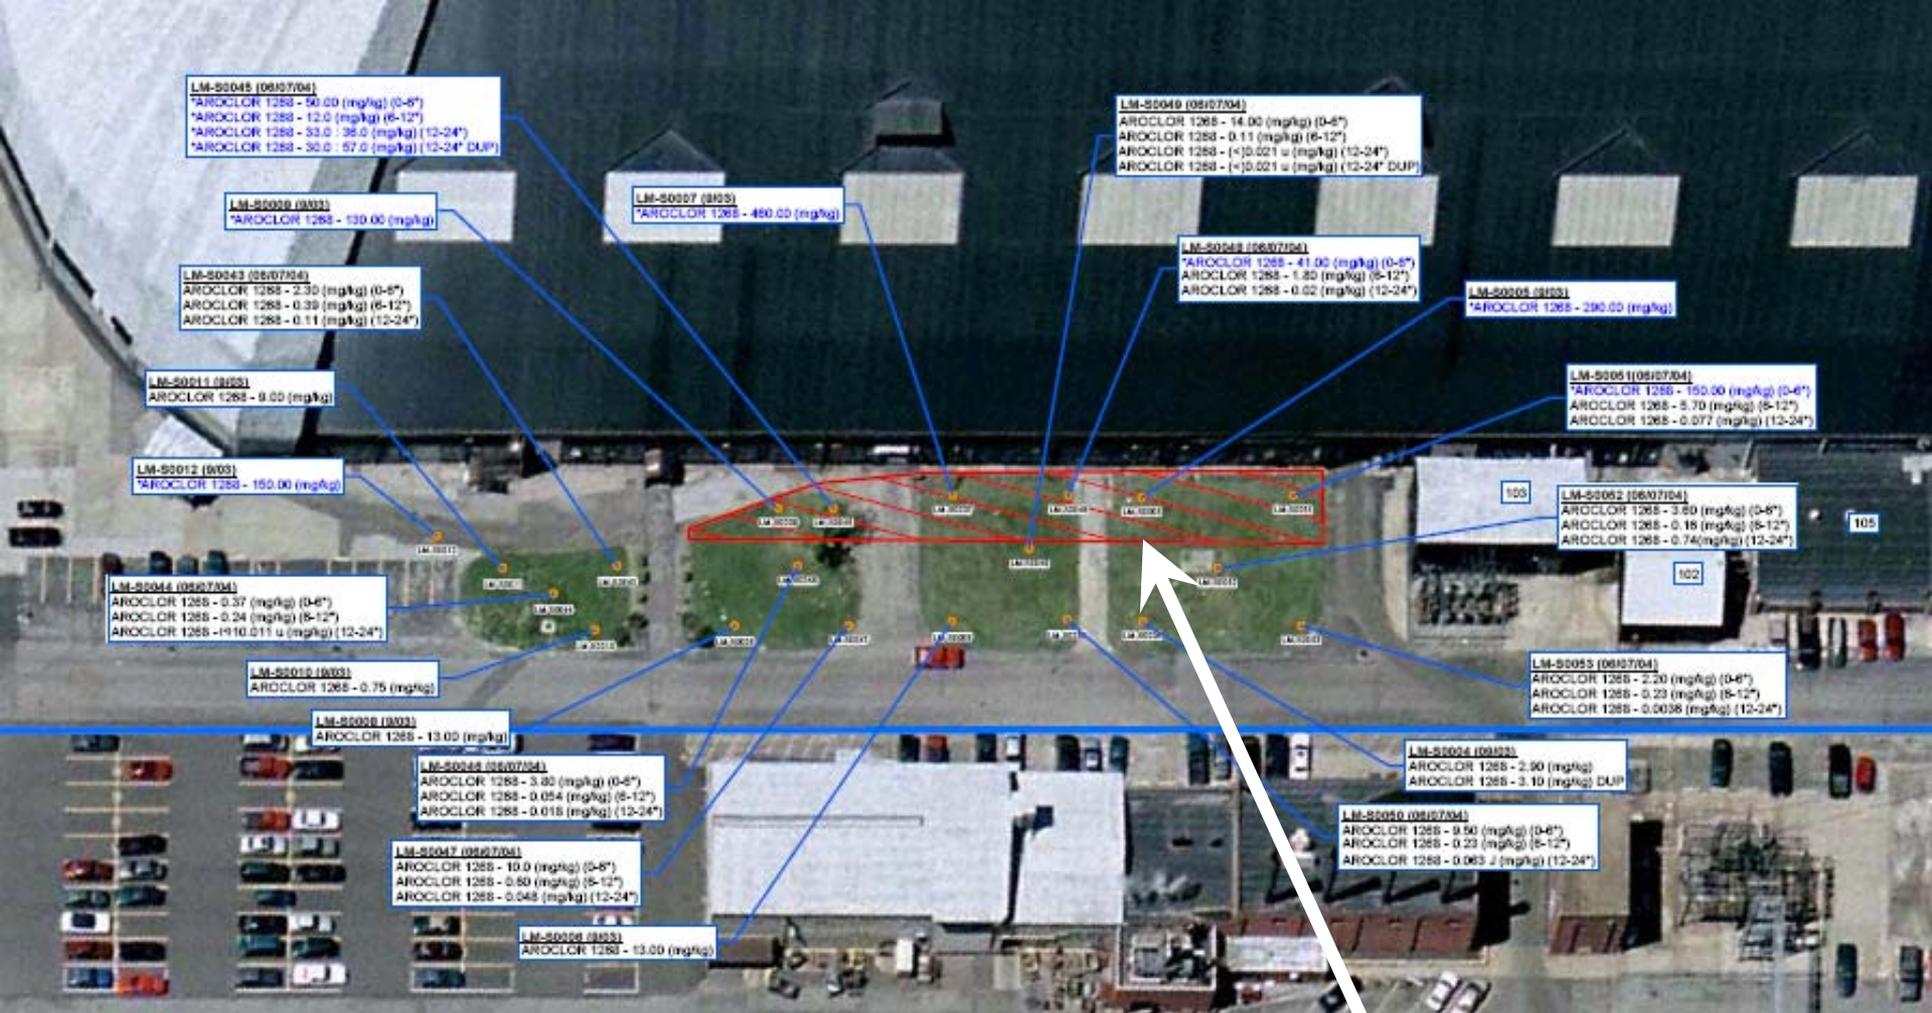
Soil Excavation Area

Pavement Cleaning Area

- *Removing soil on SE of the Airdock*
- *Cleaning pavement surrounding the Airdock*

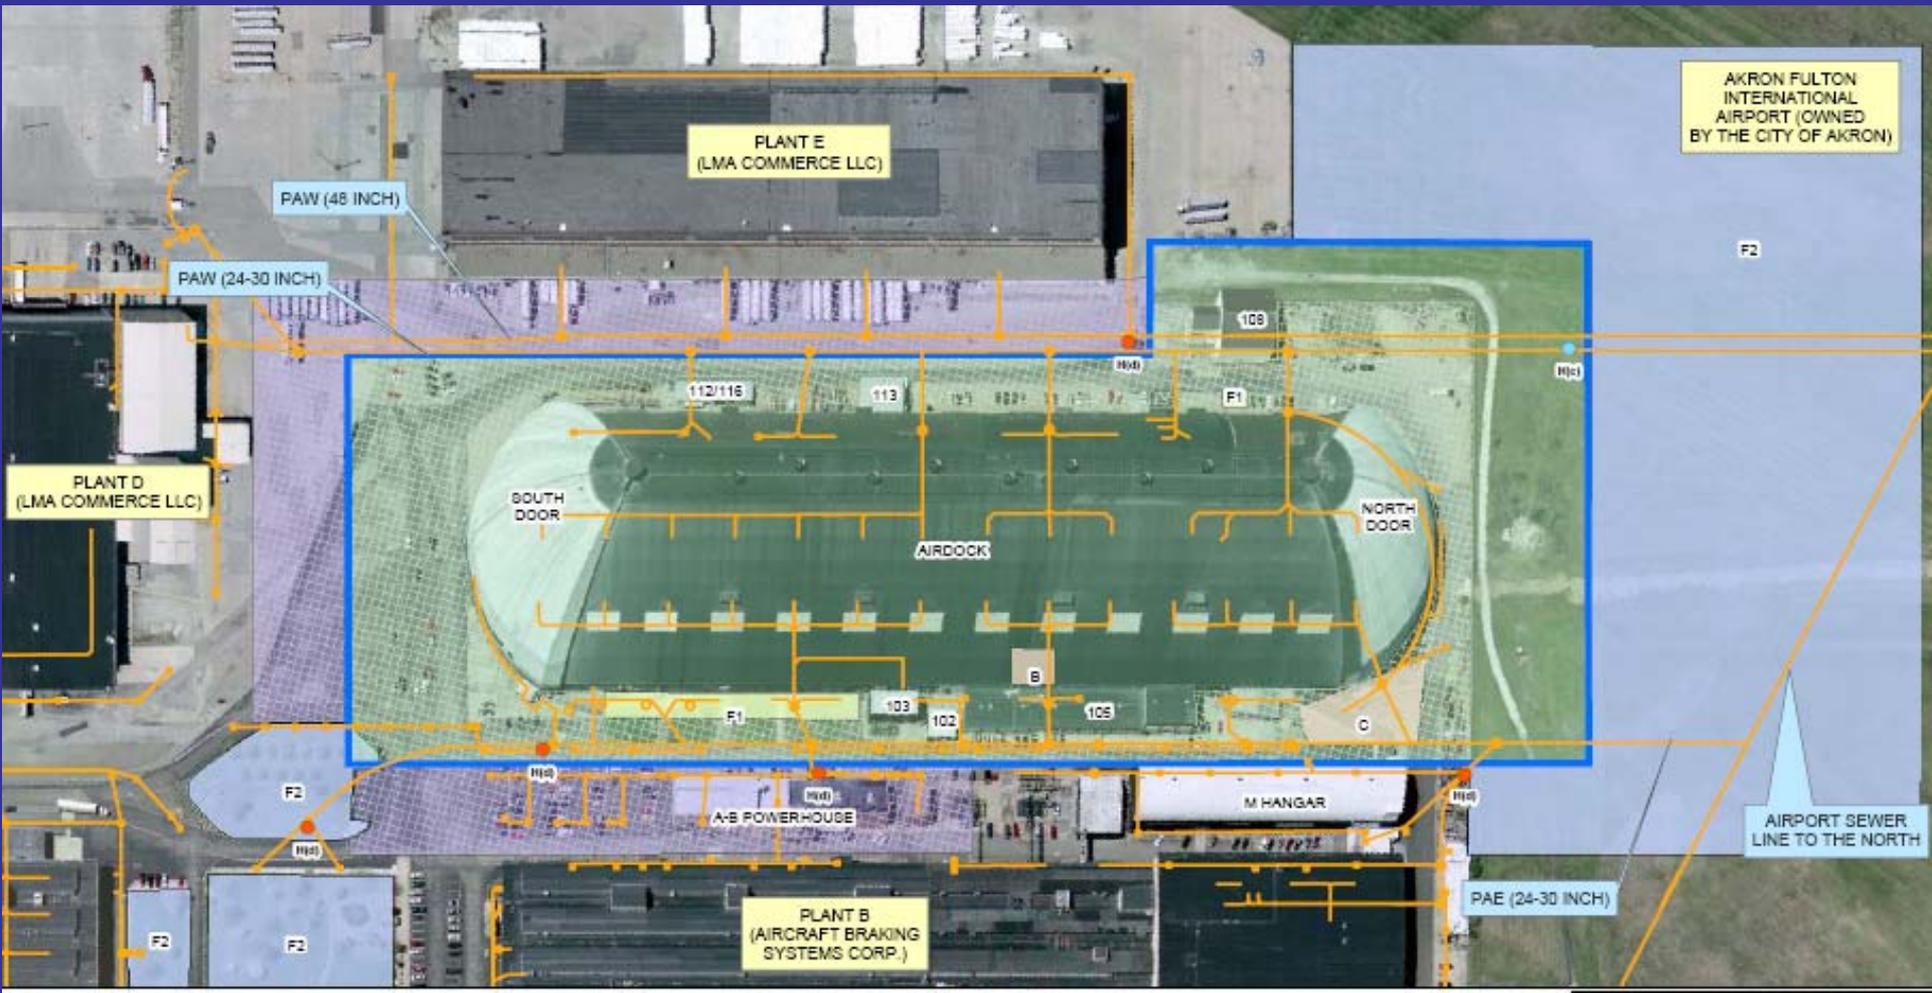
Current Assessment Of Risk

- *Receptors – restricted on-parcel to occupational exposures; potential unrestricted access on adjoining parcels*
- *Followed standard risk assessment methods utilized by Ohio EPA under the VAP and US EPA guidance*

Soil Samples Collected 2003-2006

*Preliminary Risk Assessment Sample Data Set
156 samples on-parcel; 34 samples off-parcel*

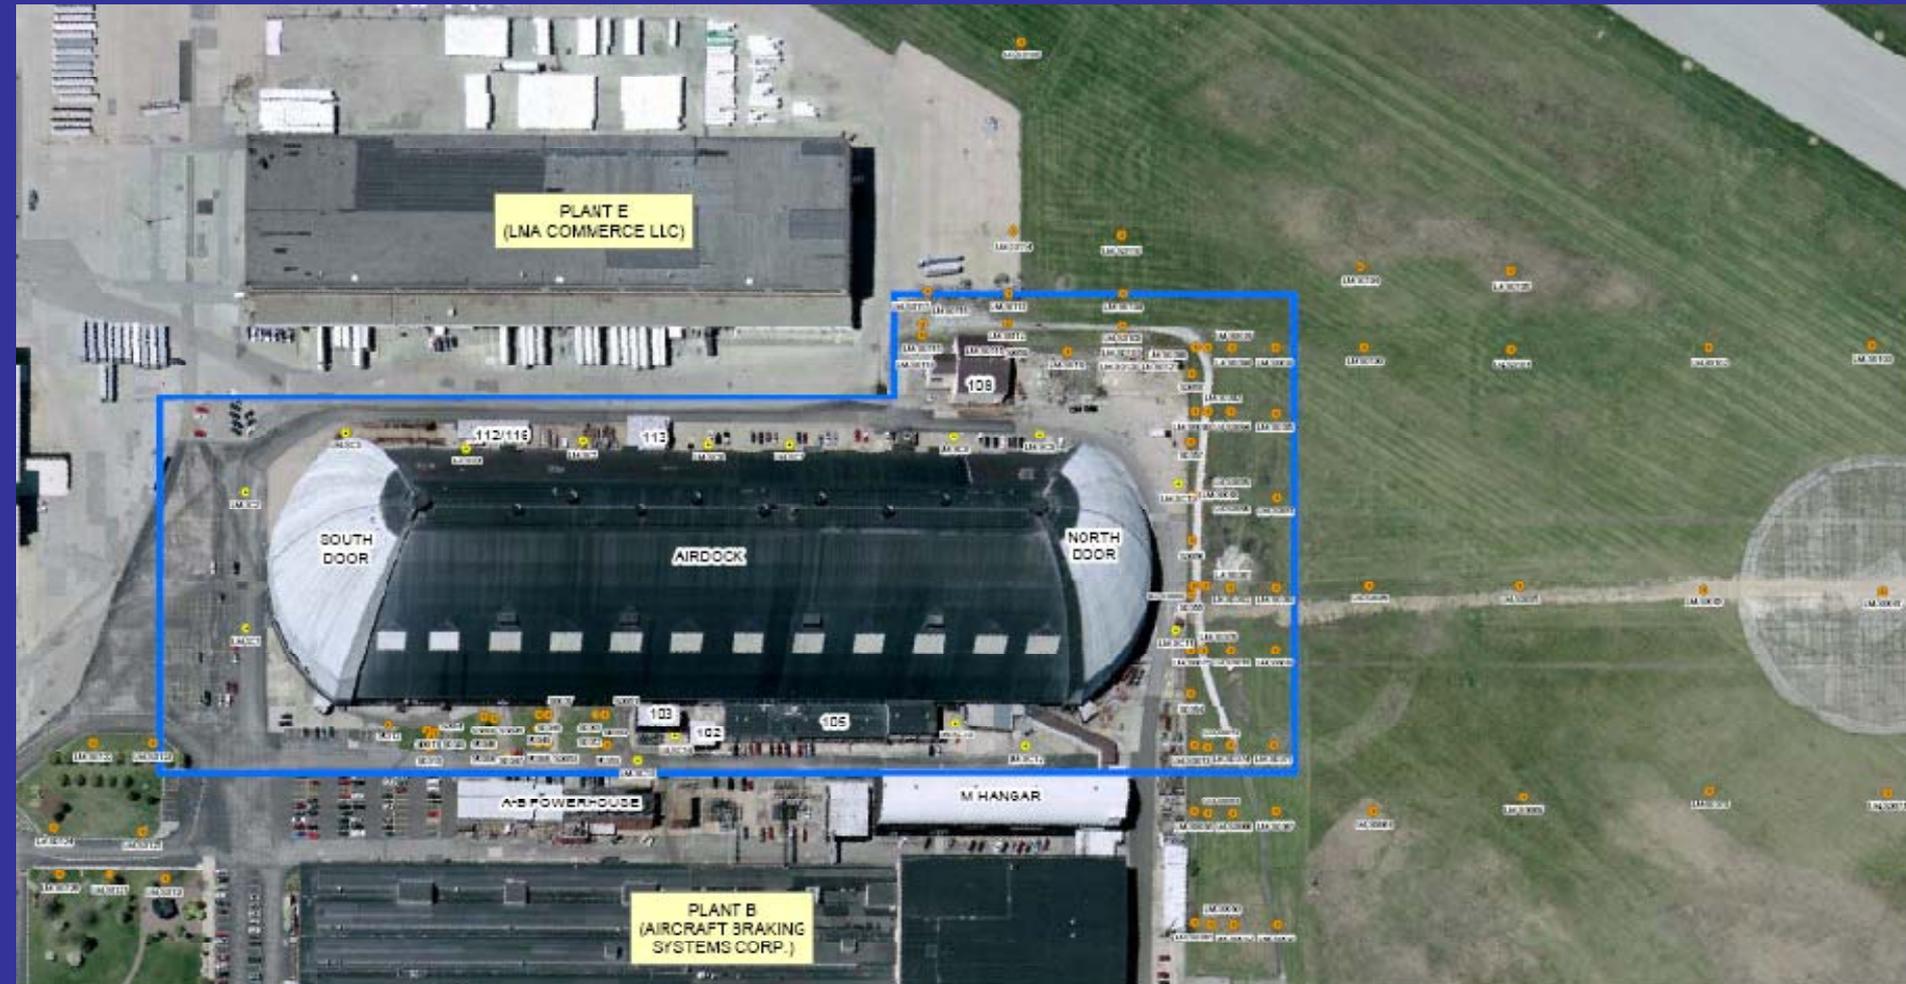
Current Residual Risk (Industrial Workers)

Analysis Of Parcel Other Than Areas Intended For Excavation

<i>On Parcel</i>	<i>Off Parcel</i> No further action planned
<i>Average PCB in Soil (ppm)</i>	1.8	0.34
<i>Risk</i>	2E-06	4E-07
<i>Hazard Index</i>	0.17	0.031
