Lockheed Martin Corporation Beaumont Site 1 & 2 Safety & Toxics Assessment Beaumont, California

March 19, 2003

TC 12866-03

Tetra Tech, Inc.
San Bernardino, California

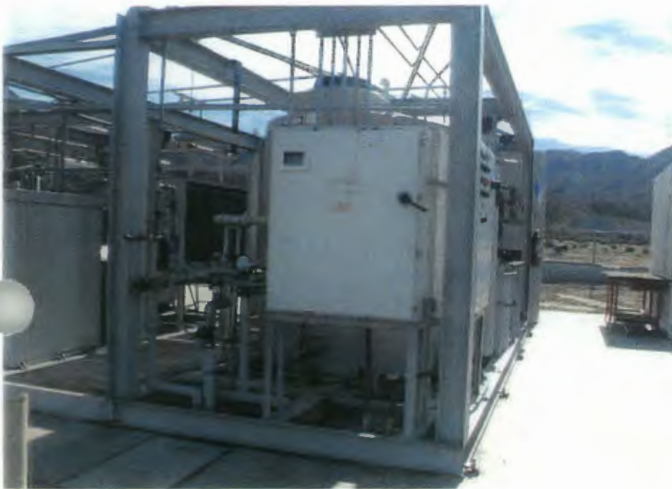
Site 1, Lead Paint on all Steel/Metal Components
