SUMMARY REPORT

FOLLOW-ON MUNITIONS AND EXPLOSIVES OF CONCERN (MEC) EVALUATION

AREA C– PROPELLANT BURN PIT AREA

**Lockheed Martin Corporation
Former Beaumont Site No. 1
Beaumont, California**

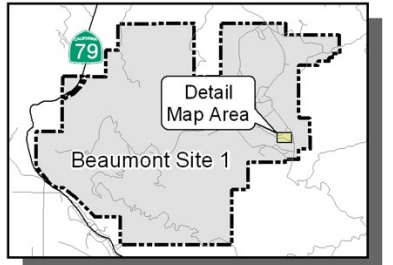
Figure ES-1
Burn Pit Area
Evaluation Summary

During the evaluation, approximately 25% (about 4 of 16.75 acres) of the BPA was surface swept and approximately six percent (about 1 acre) of the BPA was intrusively evaluated including a perimeter transect just outside of the area boundary. A total of 1,997 anomalies, approximately six percent of an estimated 33,000 anomalies in the BPA were identified and 911 were intrusively investigated. Nineteen of the items excavated were identified as MD including 3 pieces of projectile fragmentation (frag), 6 small pieces of unidentified frag and 10 empty, non-ferrous 30mm casings. All MD was found at depths \leq 12 inches bgs, with 16 of the 19 items being \leq 6 inches bgs. No MEC was found during the evaluation. The results of the MEC Evaluation are shown on Figure ES-1 and summarized in Table ES-1.

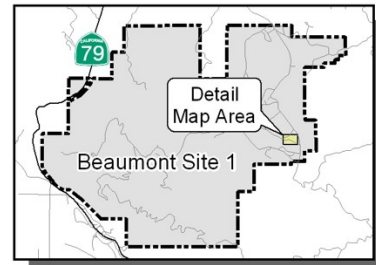
Figure 4-1
Burn Pit Area
Evaluation Summary

Eight of the 30mm shell casings were found near the previously identified location of a lone burn pit located in the northeastern corner of the BPA (See Figure 4-1). One shell casing was found in the eastern central portion of the BPA and the final casing was found in the southeastern corner of the area. There were no historical burn pits near the locations where these last two shell casings were found. Two pieces of frag identified as projectile frag were found on two adjacent transects near the southern edge of the BPA, about 300 feet apart. There were no historical burn pits in or near this area. The third piece of projectile frag was found near the eastern central portion of the site on Transect 20. A second piece of unidentified frag was found about 100 feet west along this same transect. Both pieces of frag were located near a former burn pit. Two pieces of unidentified frag were found on Transect 25, approximately 100 feet north of Transect 20. These items were also located near a former burn pit. The final three

Figure 4-1 shows the areas of the BPA that were evaluated, along with the locations of the MD items found. The results of the MEC evaluation are summarized in Tables 4-1 and 4-2. Daily Reports and Quality Control Reports for the MEC evaluation are included in Appendix B and photographs showing items of interest from the evaluation are presented in the photo log in Appendix C.
