# **RADIOLOGICAL SURVEY REPORT FOR FORMER BUILDING D LOCKHEED MARTIN MIDDLE RIVER COMPLEX**

**2323 Eastern Boulevard  
Middle River, Maryland**

Environmental Engineers & Scientists  
TC#13724-01/April 2004

**Final  
Radiological Survey Report for Former Building D  
Lockheed Martin Middle River Complex  
2323 Eastern Boulevard  
Middle River, Maryland**

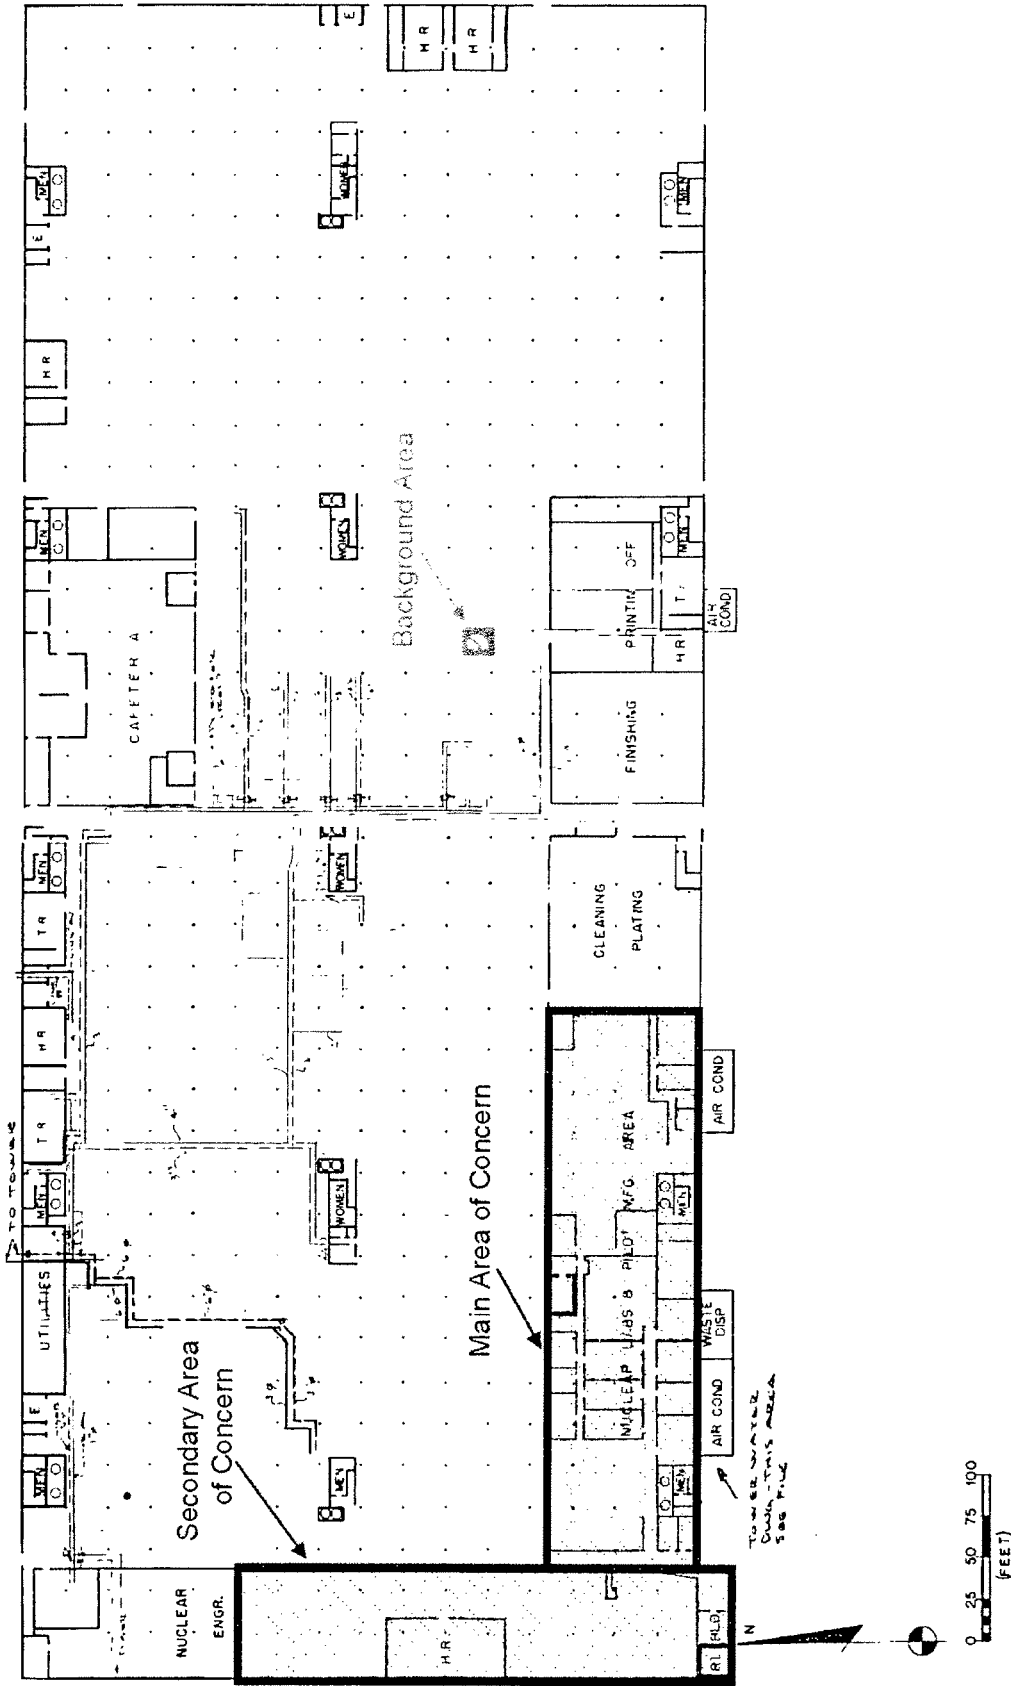
Figure 1 Middle River Radiological Survey – Building D  
 Areas of Concern

The nuclear activities began in the early to mid-1950's and were focused on research involving the uranium-aluminum fuel elements. The location of these operations is identified as the secondary area of concern and is shown in Figure 1 included in Attachment A. Figure 1 was generated using a 1969 building plat of the Building D basement. A pilot manufacturing lab was opened in the late 1950's (called the New Nuclear Labs) where activities involving the uranium-aluminum fuel elements reportedly occurred. This area is identified as the main area of concern in Figure 1.

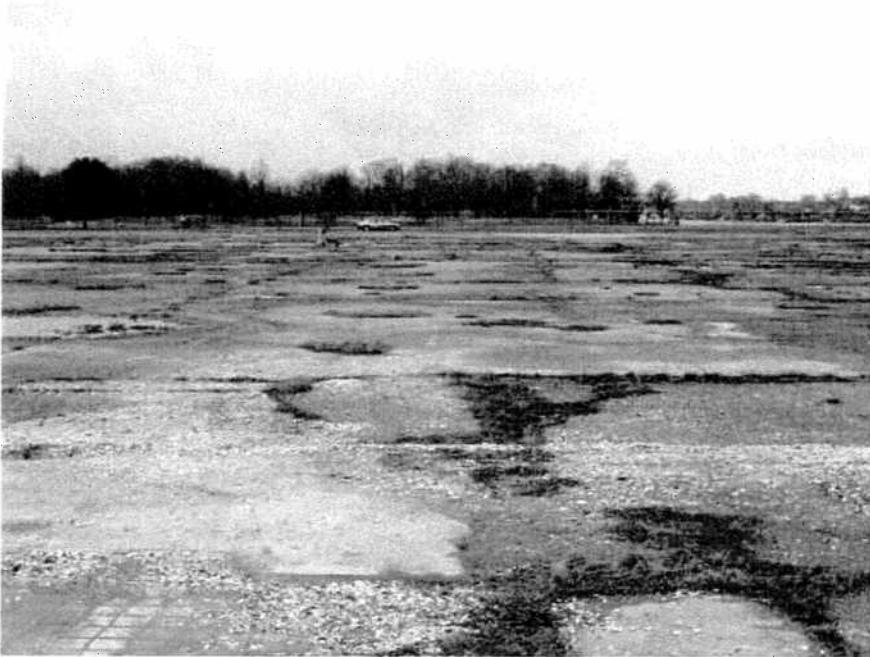
**Comments:** The view of the northwest corner of the slab from the middle of the foundation slab at the north edge. The gamma walkover survey of the grassy area in the left foreground of the picture had slightly elevated readings compared to background. The contact exposure rate was 7 to 8  $\mu\text{R/hr}$  and the background rate was 4 to 5  $\mu\text{R/hr}$ .

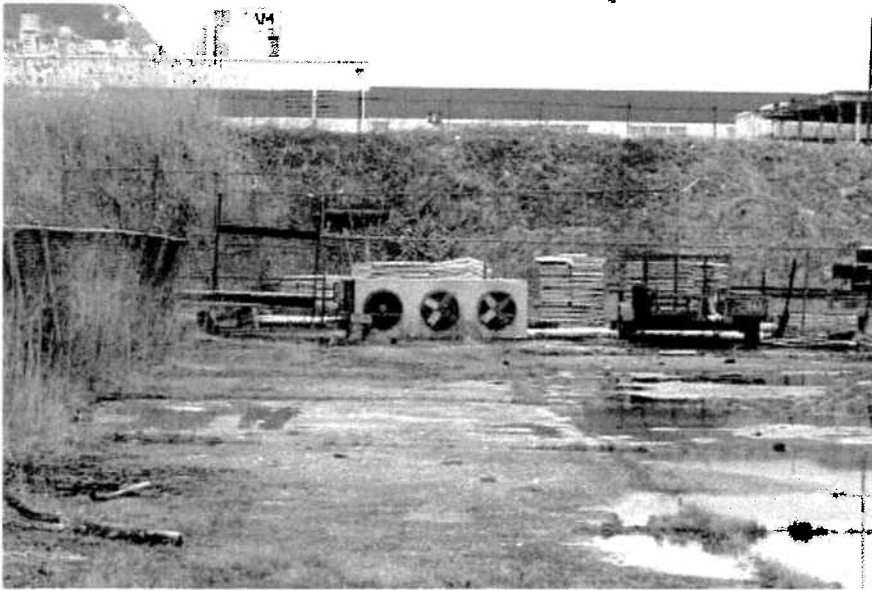
**Photo No.:** 19

**Comments:** The view looking north from the northwest corner of the main area of concern. The tunnel is visible beyond the fence just to the left of the middle of the picture. Brush and debris are blocking the entrance to the tunnel. The secondary area of concern is on the other side of the fence to the left of the photograph.
