Subject: Transmittal of the Cow Pen Creek Bank Stabilization and Floodplain Reconstruction Monitoring:
2019 Report
Lockheed Martin Corporation – Middle River Complex
2323 Eastern Boulevard, Middle River, Baltimore County, Maryland

**COW PEN CREEK
BANK STABILIZATION AND FLOODPLAIN
RECONSTRUCTION MONITORING: 2019 REPORT
LOCKHEED MARTIN MIDDLE RIVER COMPLEX
2323 EASTERN BOULEVARD
MIDDLE RIVER, MARYLAND**

Prepared by:
Tetra Tech, Inc.

January 2020

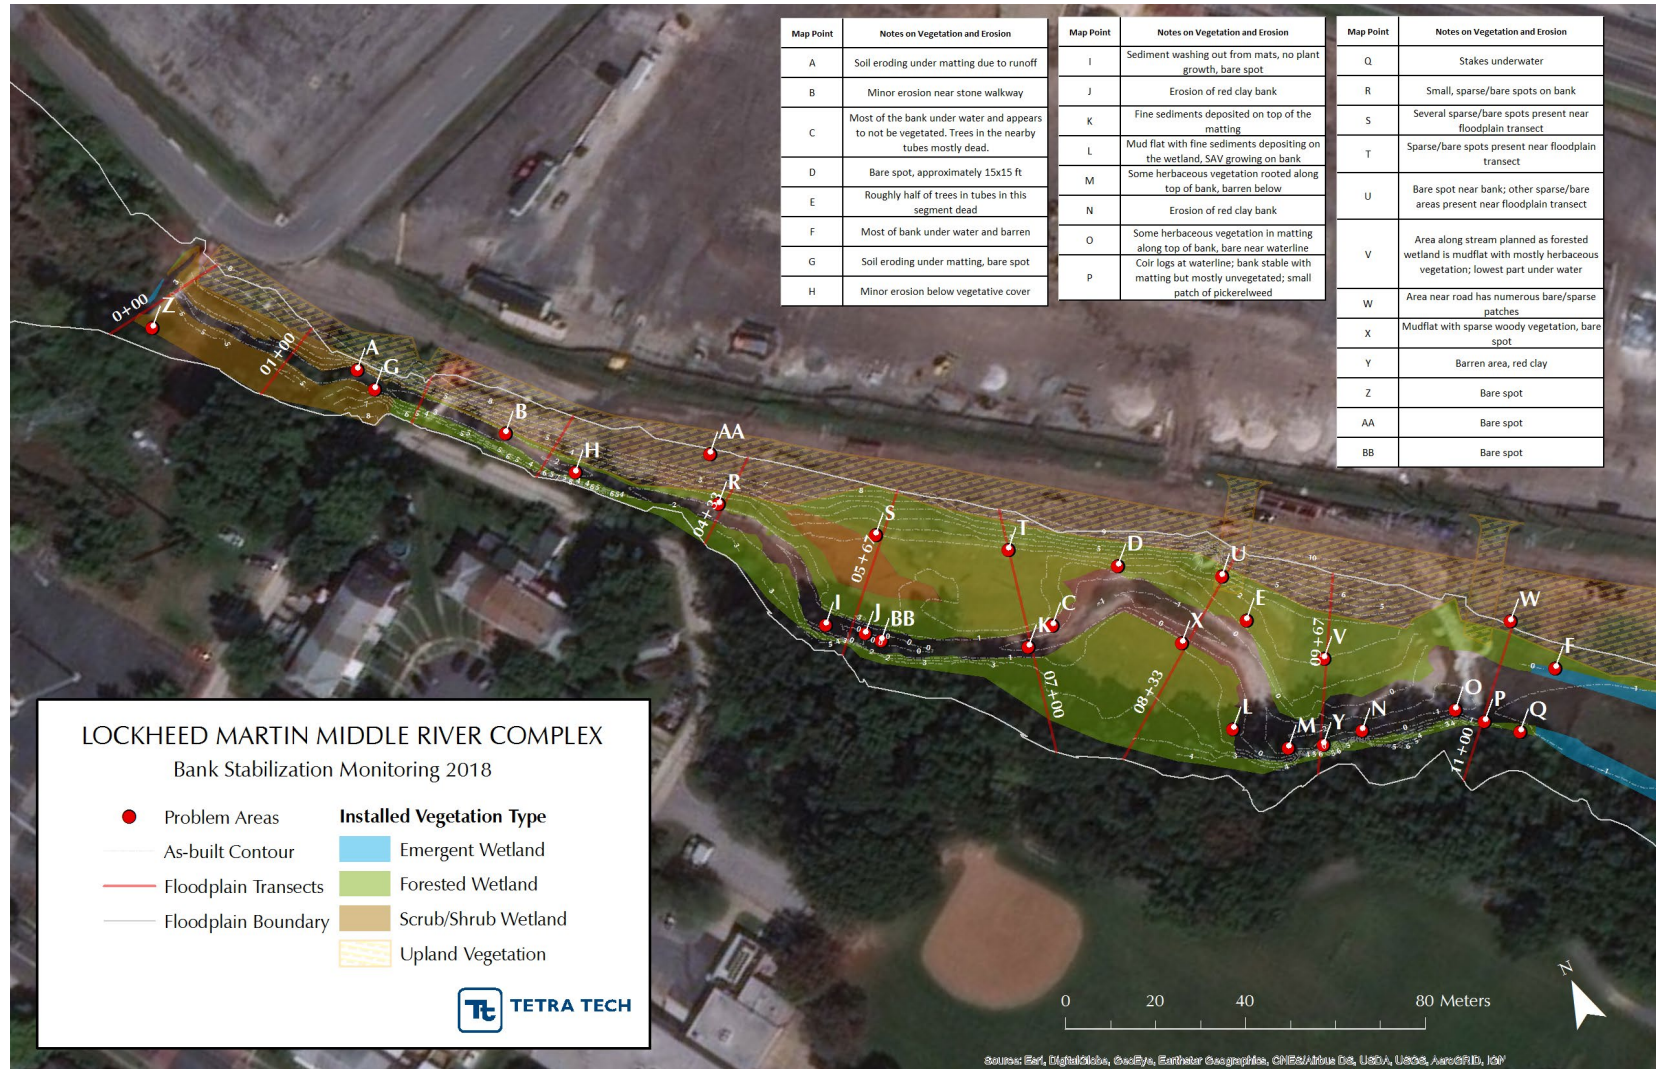
Figure 4-9. Map of Cow Pen Creek study area showing 2018 locations of areas noted based on concerns for erosion or vegetative cover condition. Upland and wetland vegetation types are from the November 2017 revegetation plan (Tetra Tech 2017).

Eight bare patches greater than 10 square feet were noted and photographed (Table 4-9), seven in wetland areas and one in the upland area. In addition to these areas, additional patches were noted where planted vegetation was sparse, and netting was visible. These areas of sparse vegetation were noted but not counted as individual bare patches since they were not completely bare. Locations of areas with noted erosion or vegetation cover concerns are shown on the map in Figure 4-9.

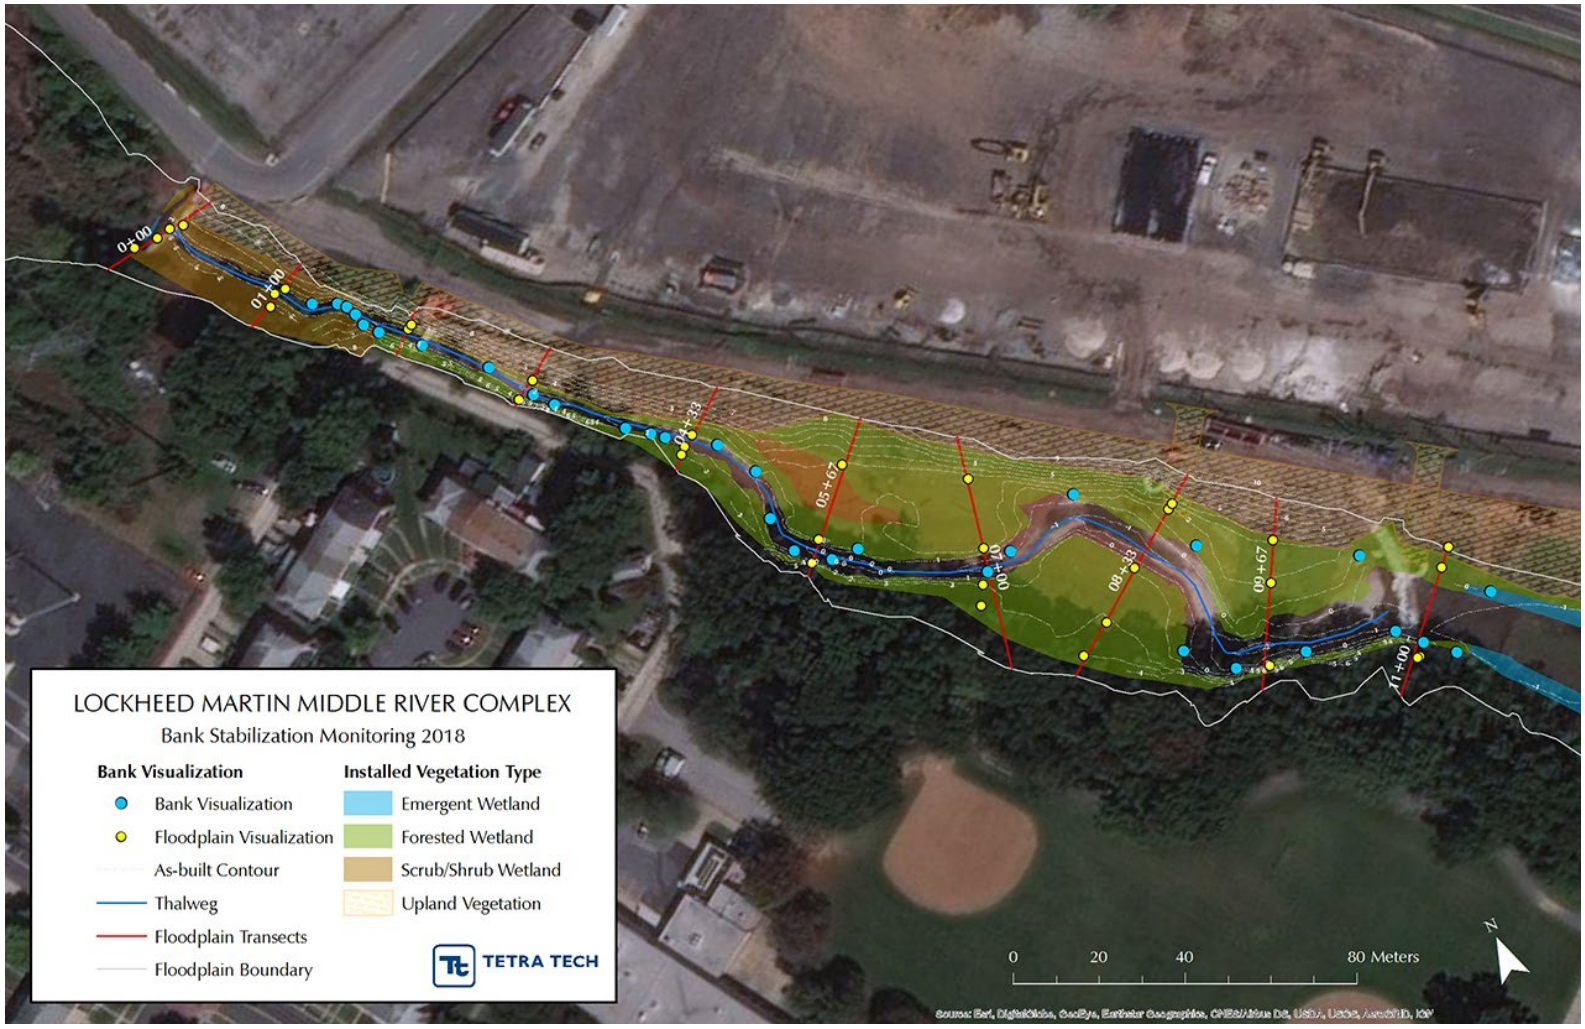
Start points of floodplain monitoring transects, which had been field-placed at the top of the bank on both sides of the stream, corresponded well with as-built survey contours, as illustrated in Figure 4-10. These benchmarks can be used during subsequent annual surveys to check for lateral erosion of the banks.

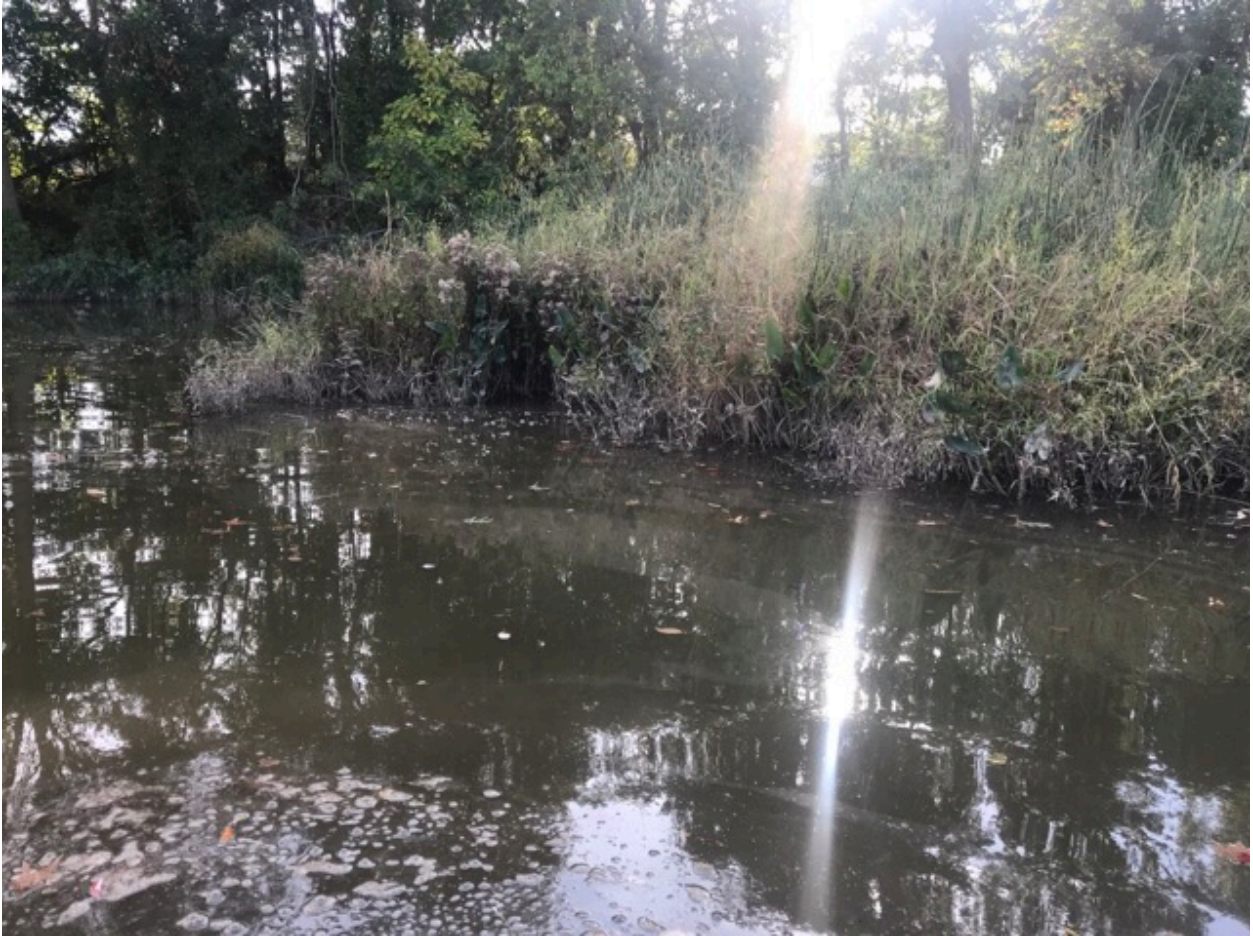
Figure A-27. Left streambank, in backwater area at Station 07+57.

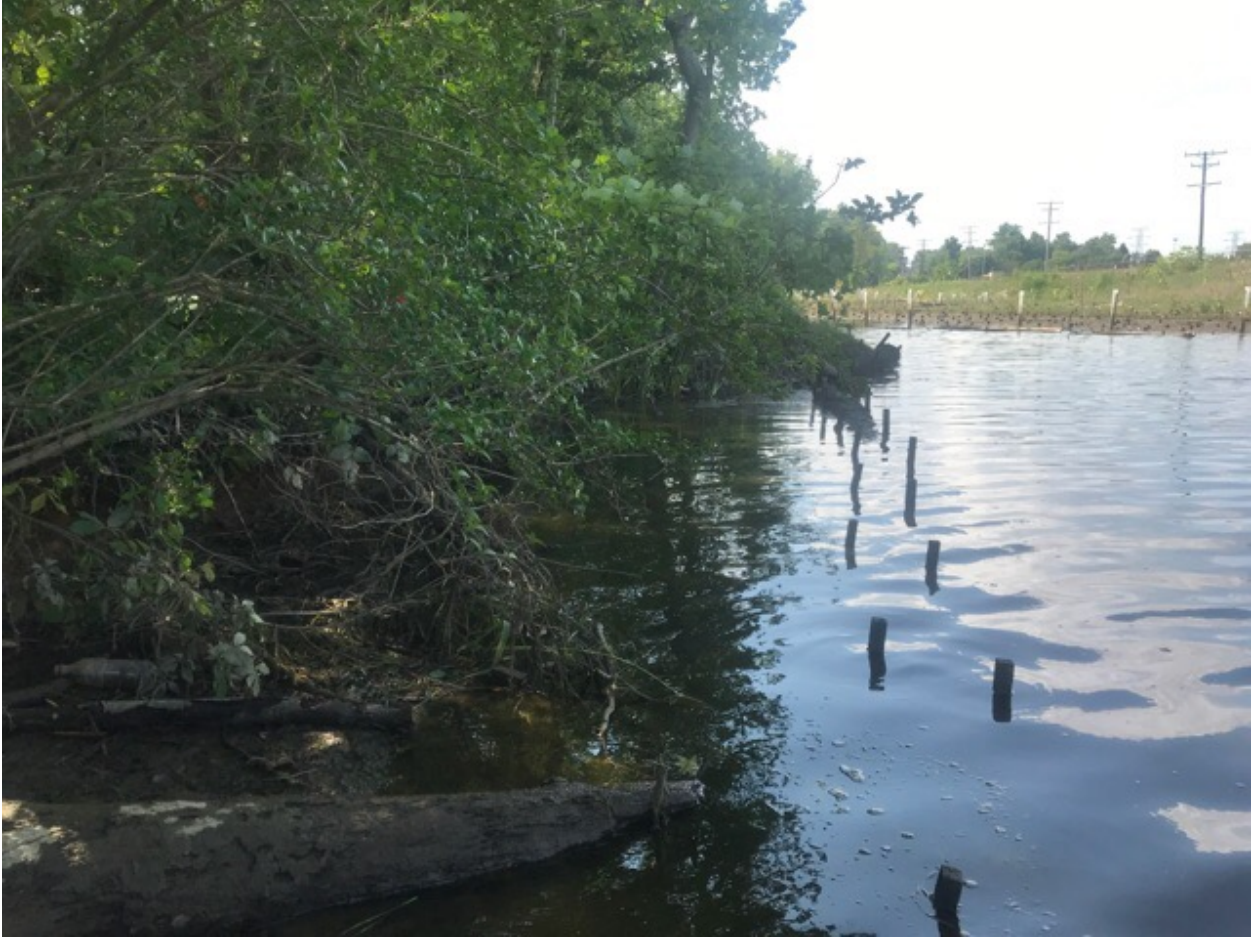
Figure A-28. Right streambank at Station 07+38.

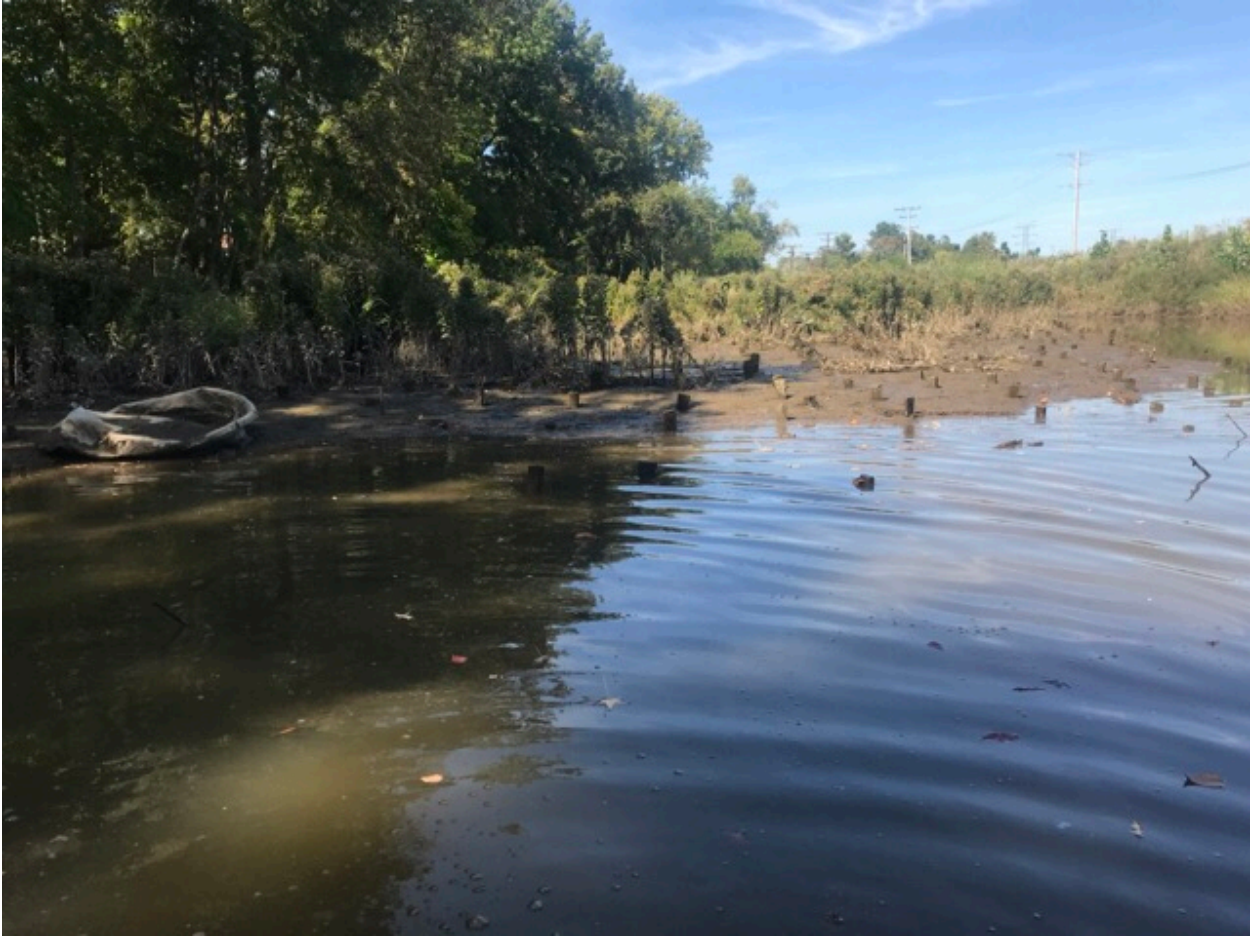
Figure A-29. Right streambank, upstream view at Station 09+26.

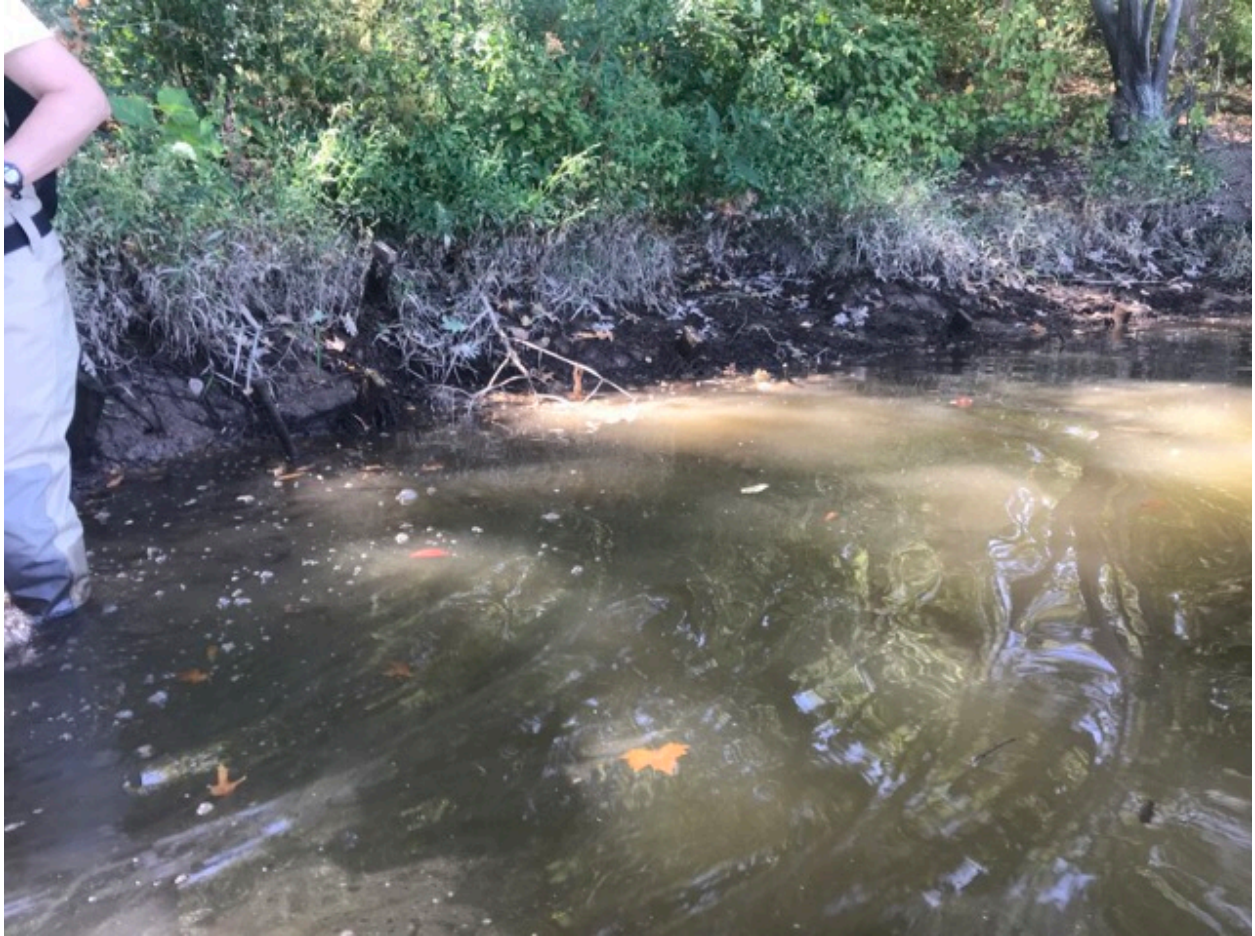
Figure A-31. Right streambank at Station 09+45.

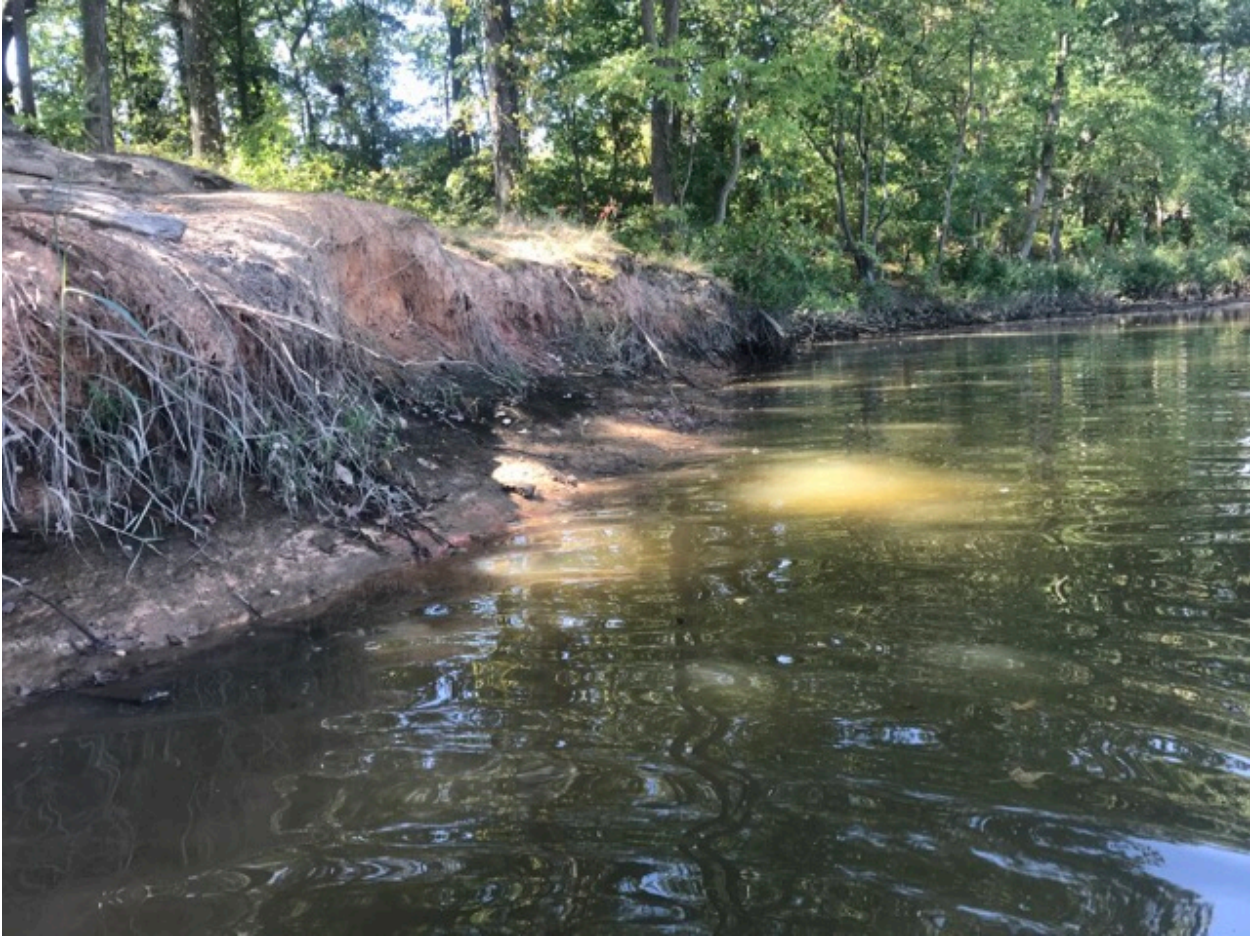
Figure A-32. Right streambank, upstream view at Station 09+98.

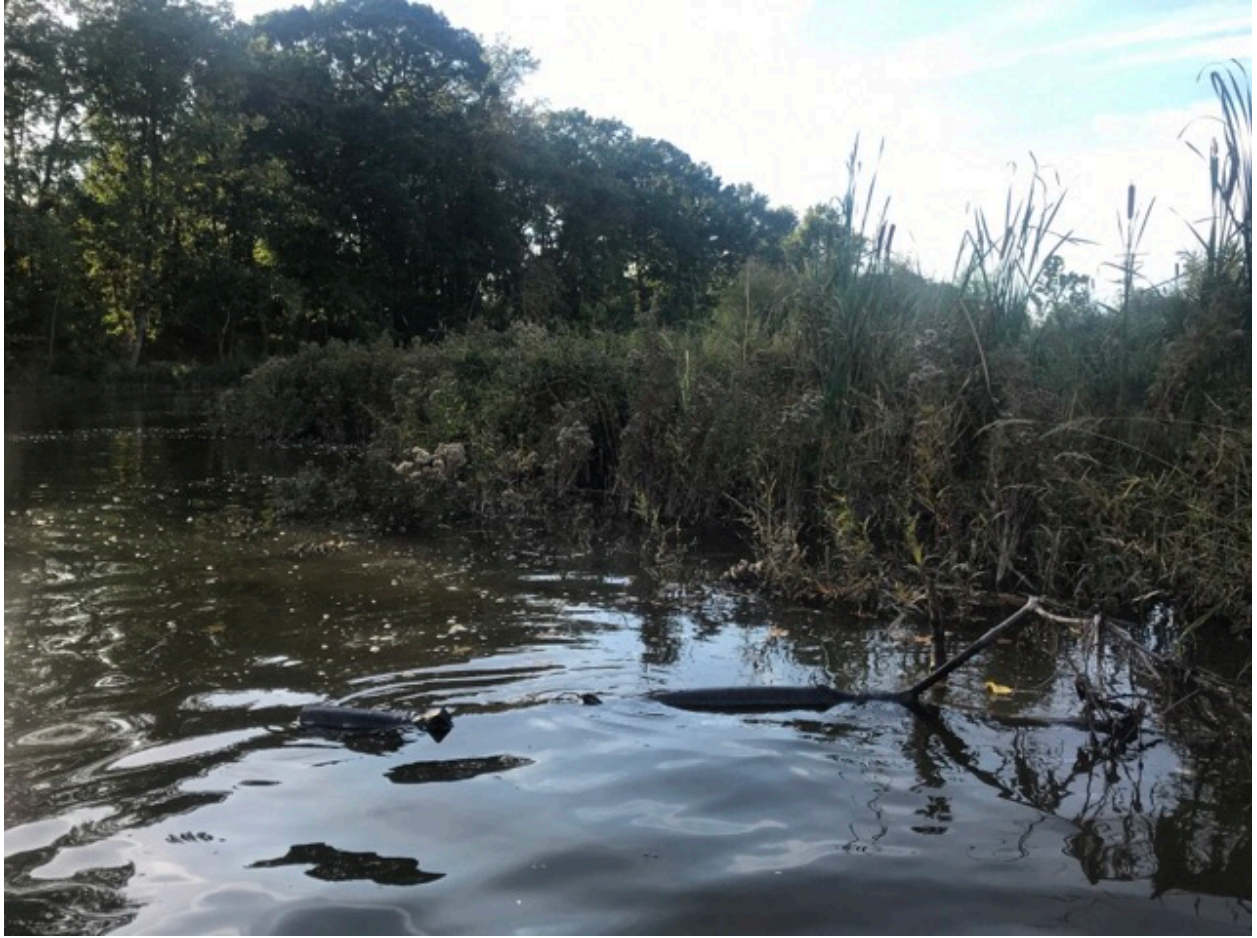
Figure A-33. Left streambank at Station 10+50.

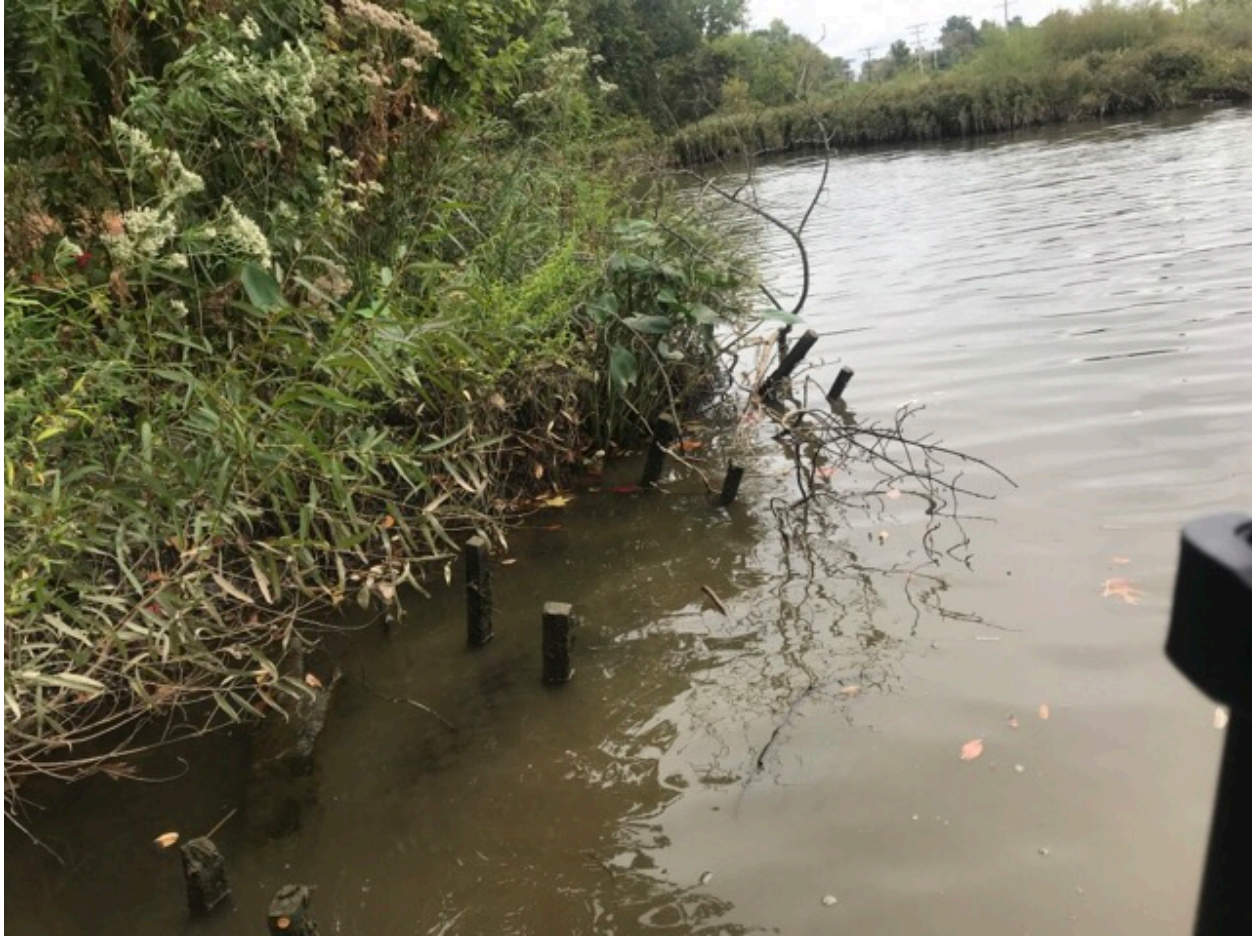
Figure A-34. Right streambank, upstream view at Station 10+97.

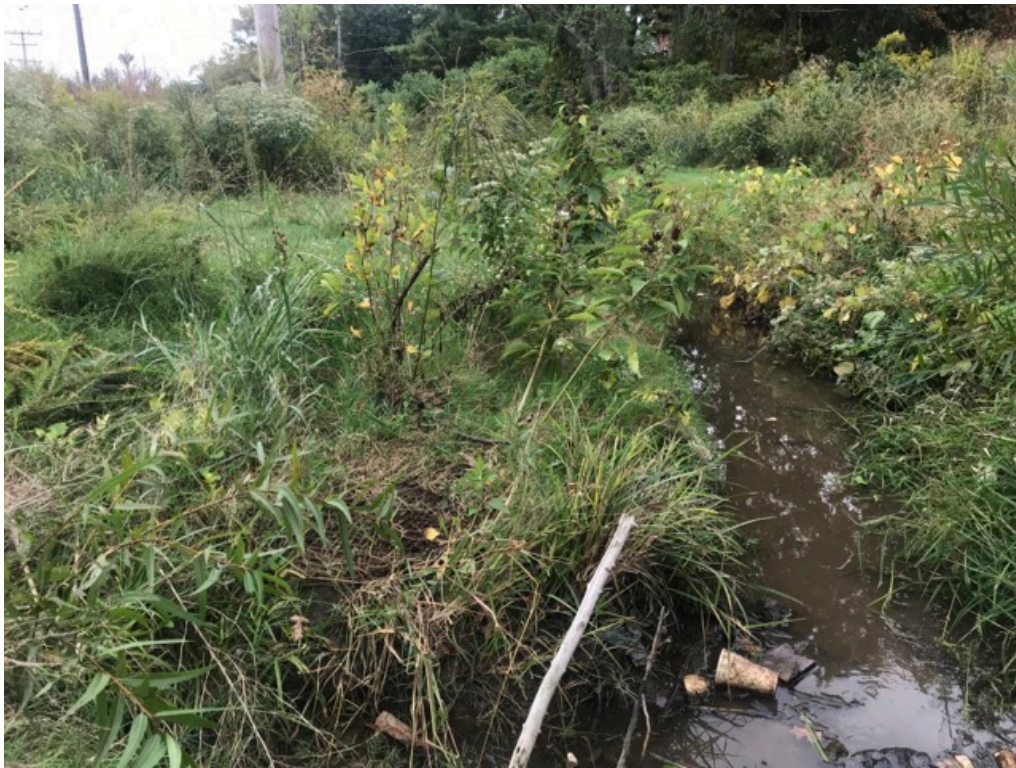
Figure A-67. Downstream view from thalweg at Station 00+00, 2018 (top) and 2019 (bottom).

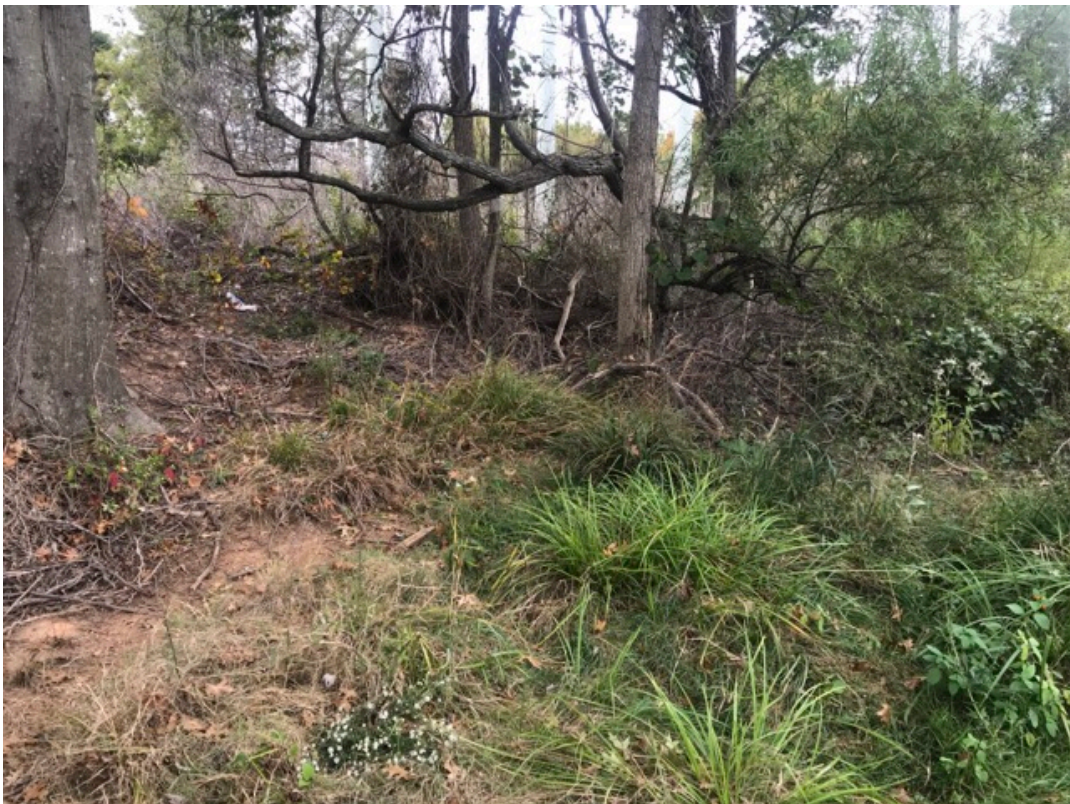
Figure A-69. Bare spot on the right streambank at Station 00+05, 2018 (top) and 2019 (bottom).

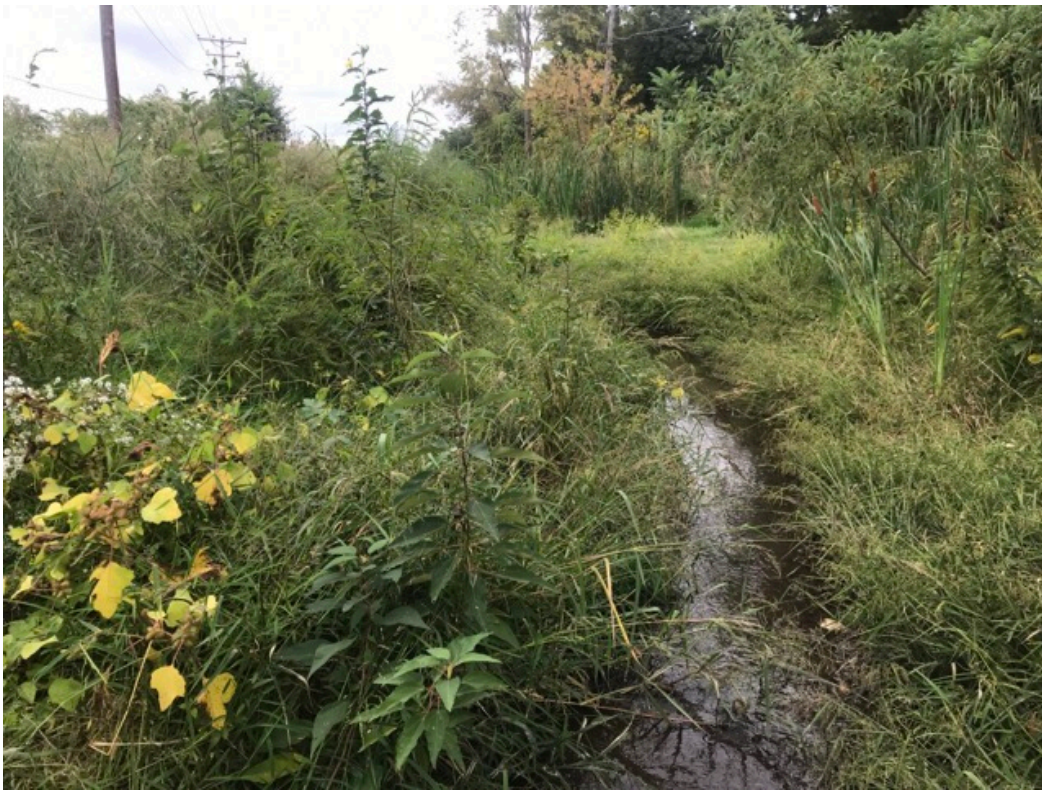
Figure A-70. Downstream view from thalweg at Station 01+00, 2018 (top) and 2019 (bottom).

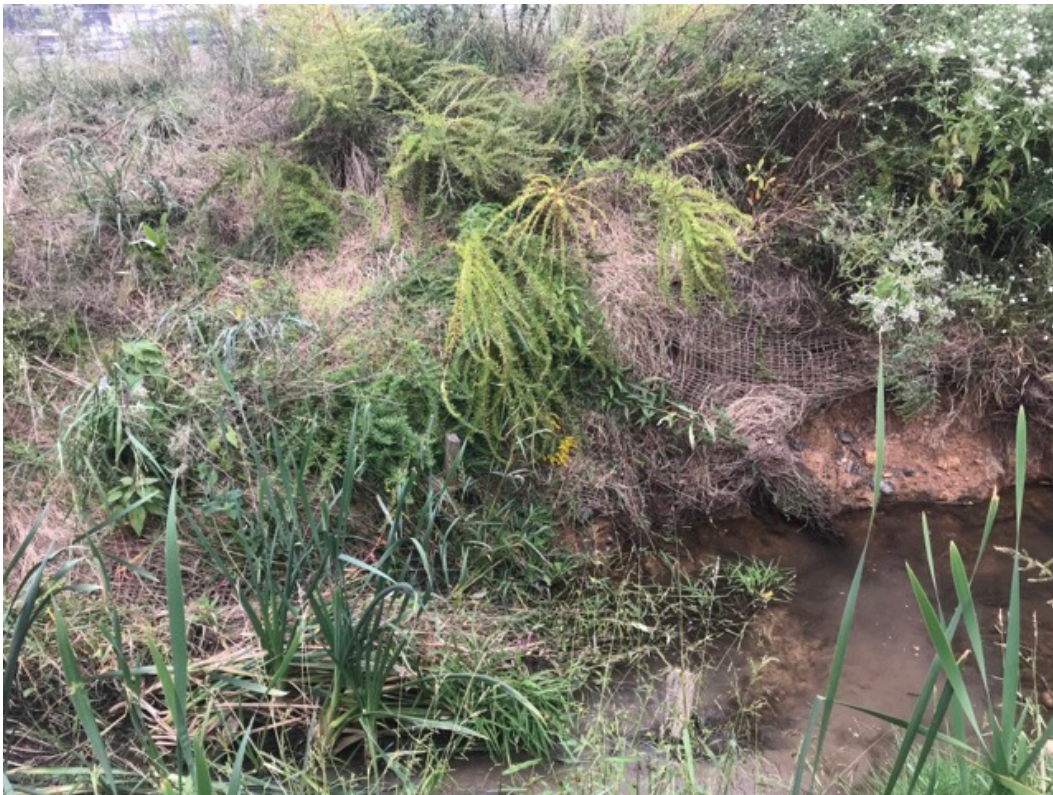
Figure A-72. Soil eroding from under the matting on the lower left bank at Station 01+55, 2018 (top) and 2019 (bottom).

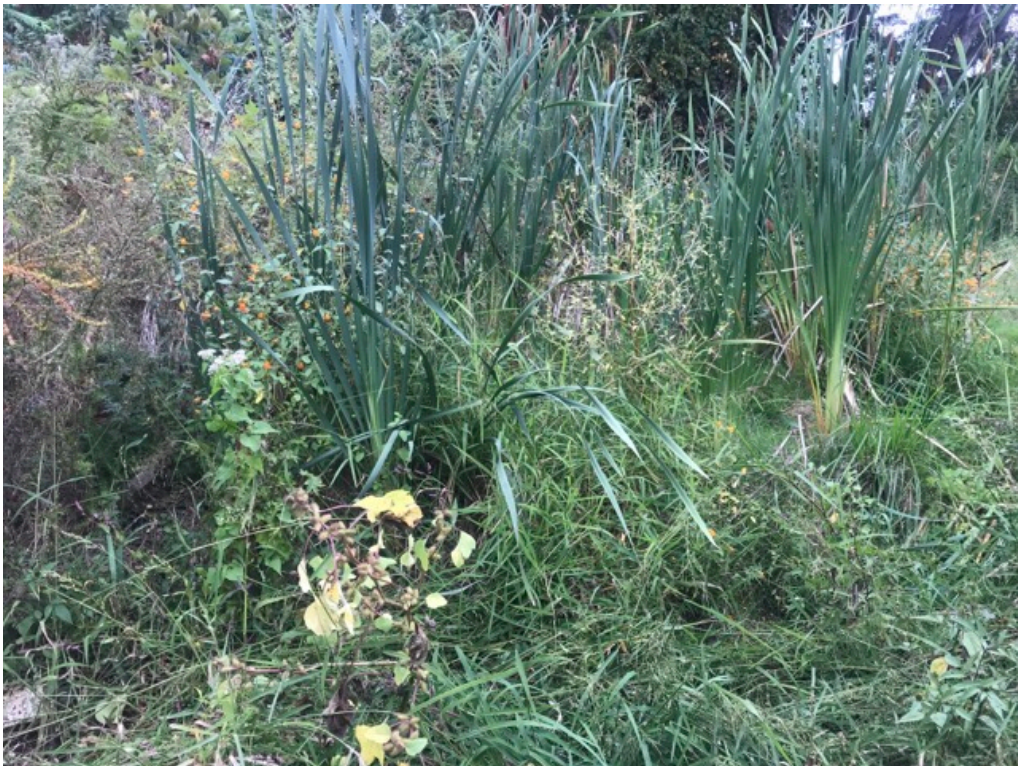
Figure A-73. Soil eroding from under the matting on the right bank at Station 01+67, 2018 (top) and 2019 (bottom).

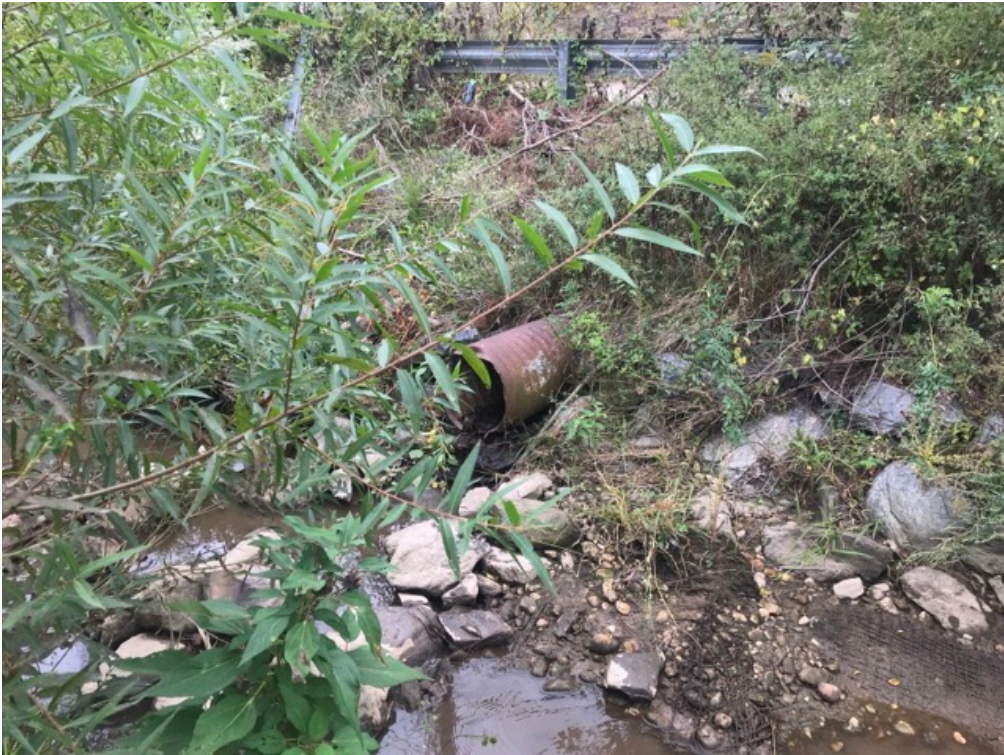
Figure A-74. Outfall and guard rail on the right bank at Station 01+99, 2018 (top) and 2019 (bottom).

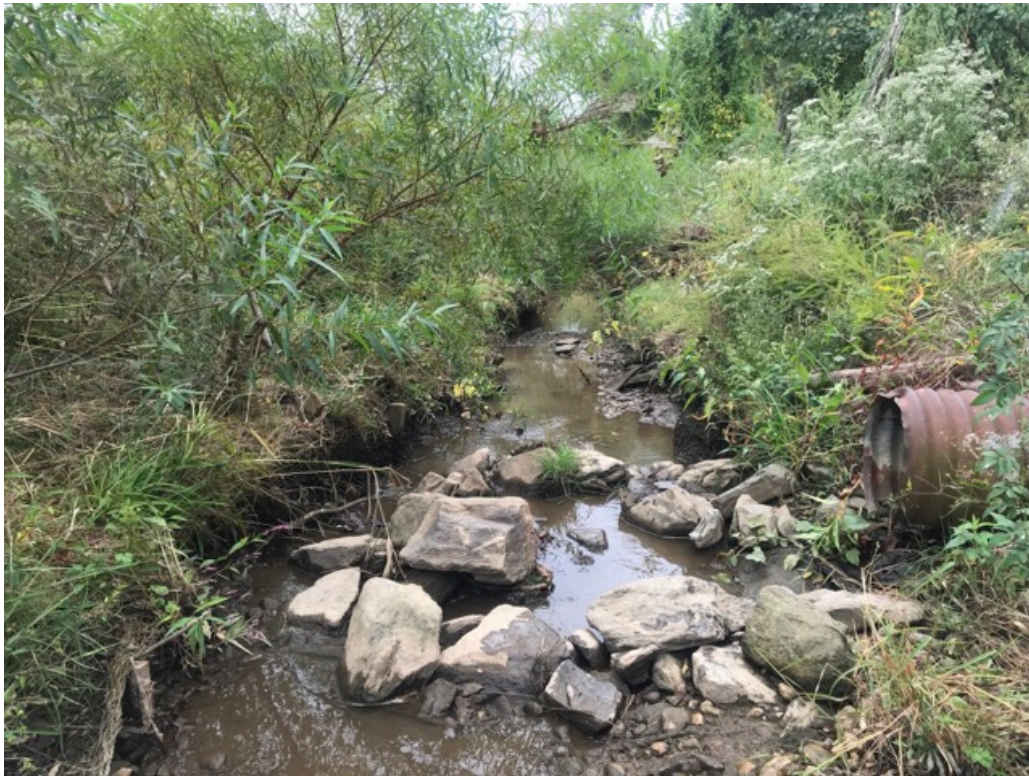
Figure A-75. Downstream view from thalweg at Station 02+00, 2018 (top) and 2019 (bottom).

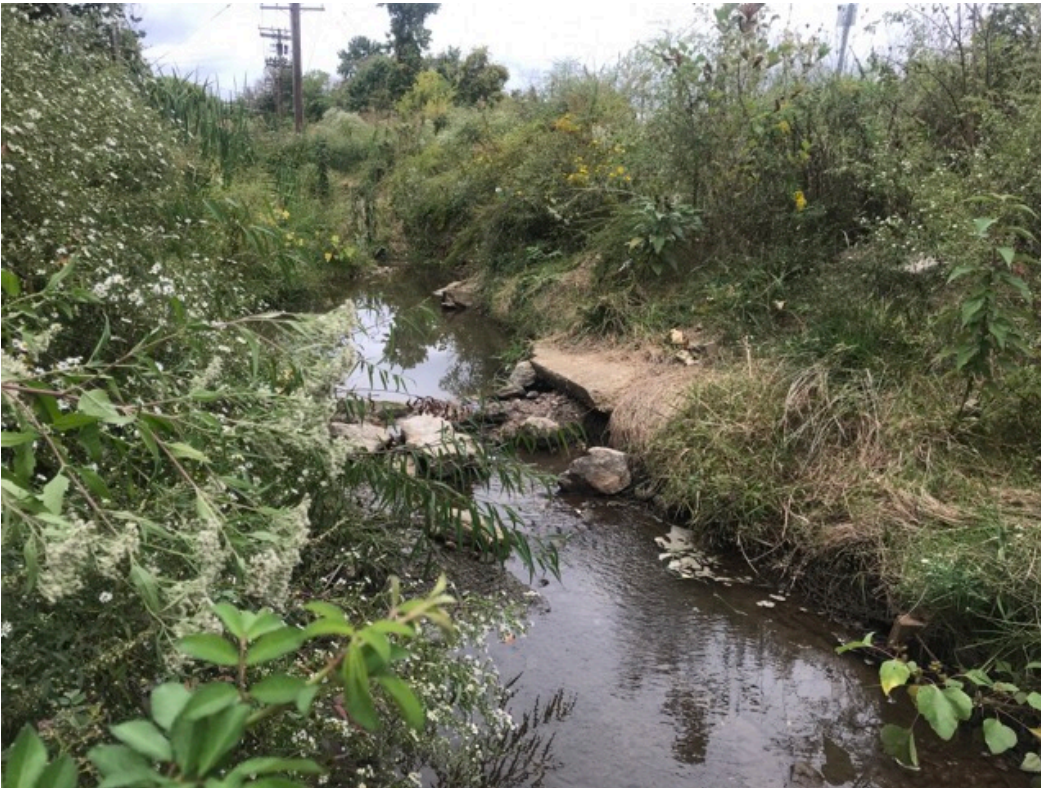
Figure A-77. Upstream view of both streambanks at Station 02+01, 2018 (top) and 2019 (bottom).

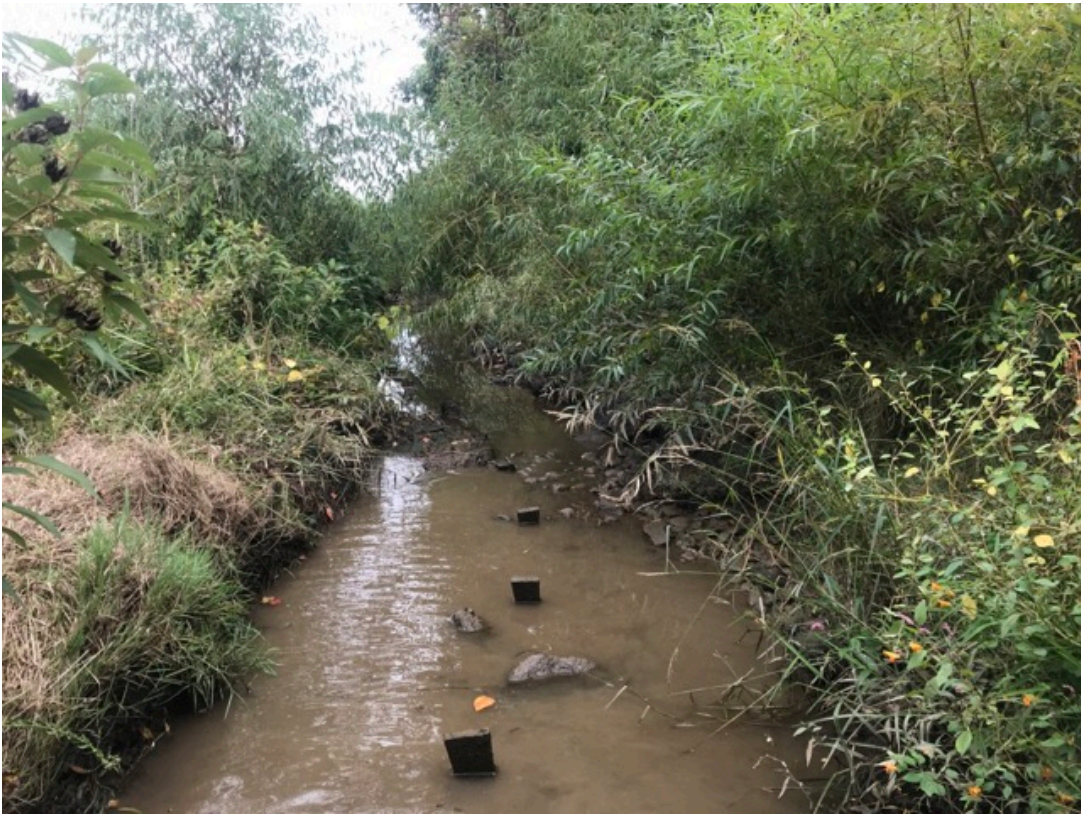
Figure A-78. Downstream view from thalweg at Station 03+00, 2018 (top) and 2019 (bottom).

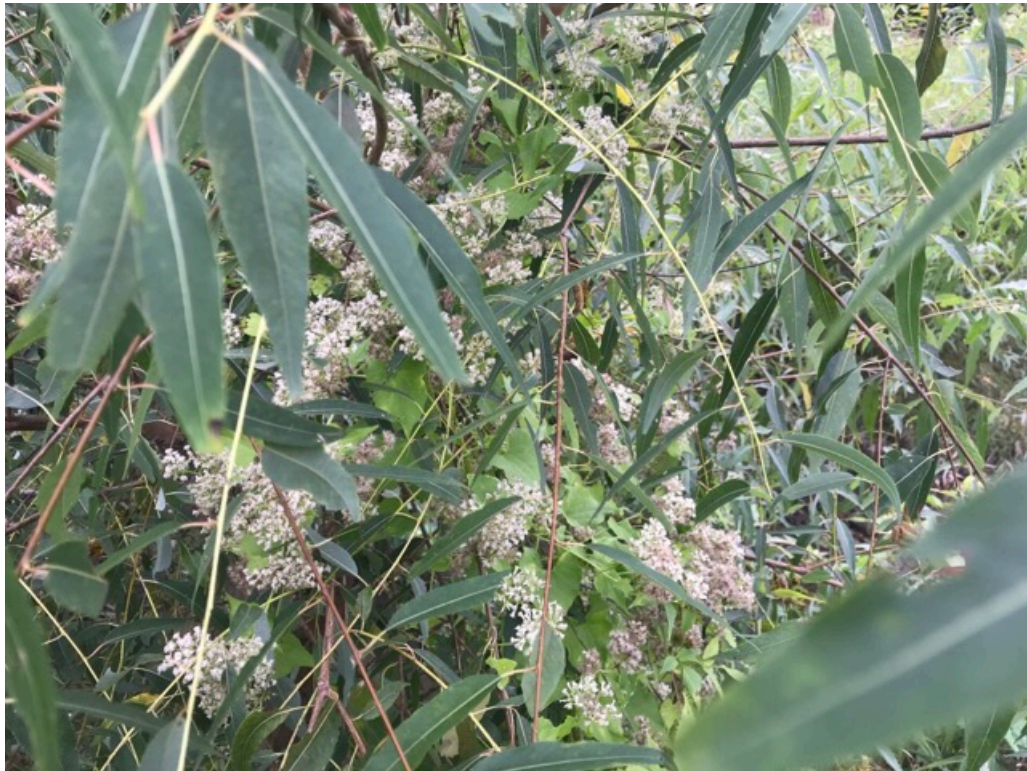
Figure A-80. Right streambank at Station 03+20, 2018 (top) and 2019 (bottom).

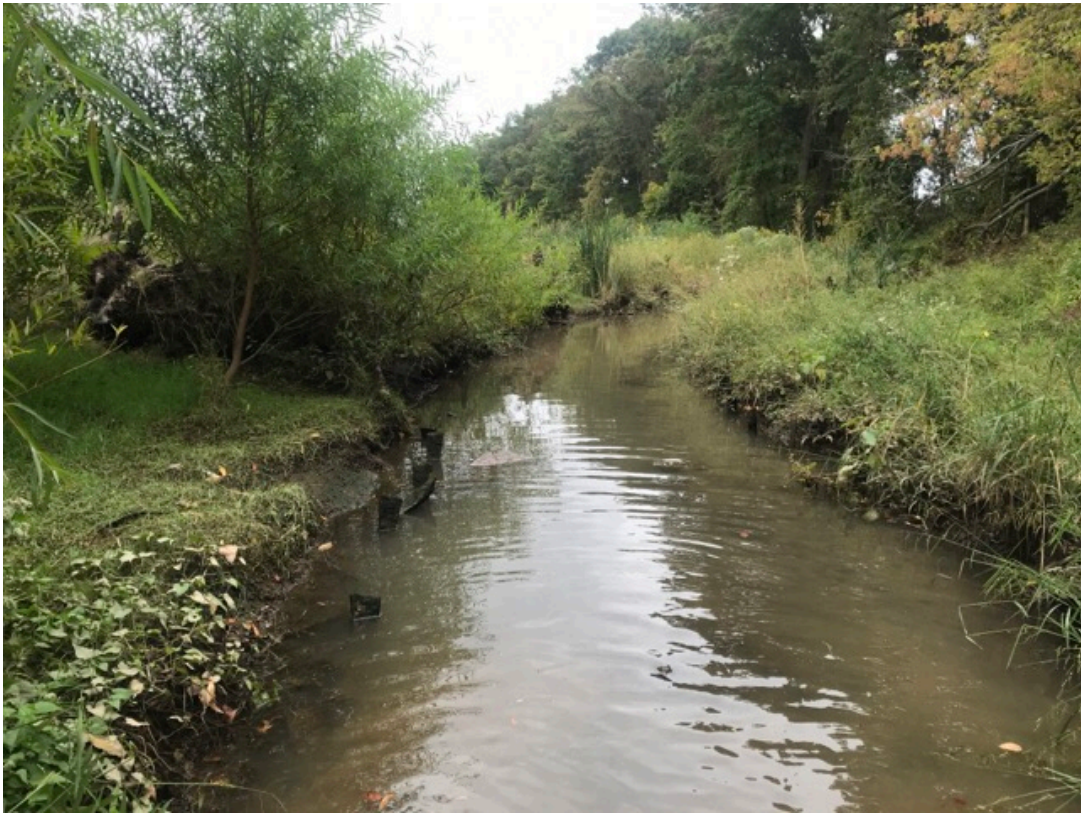
Figure A-81. Downstream view from thalweg at Station 04+33, 2018 (top) and 2019 (bottom).

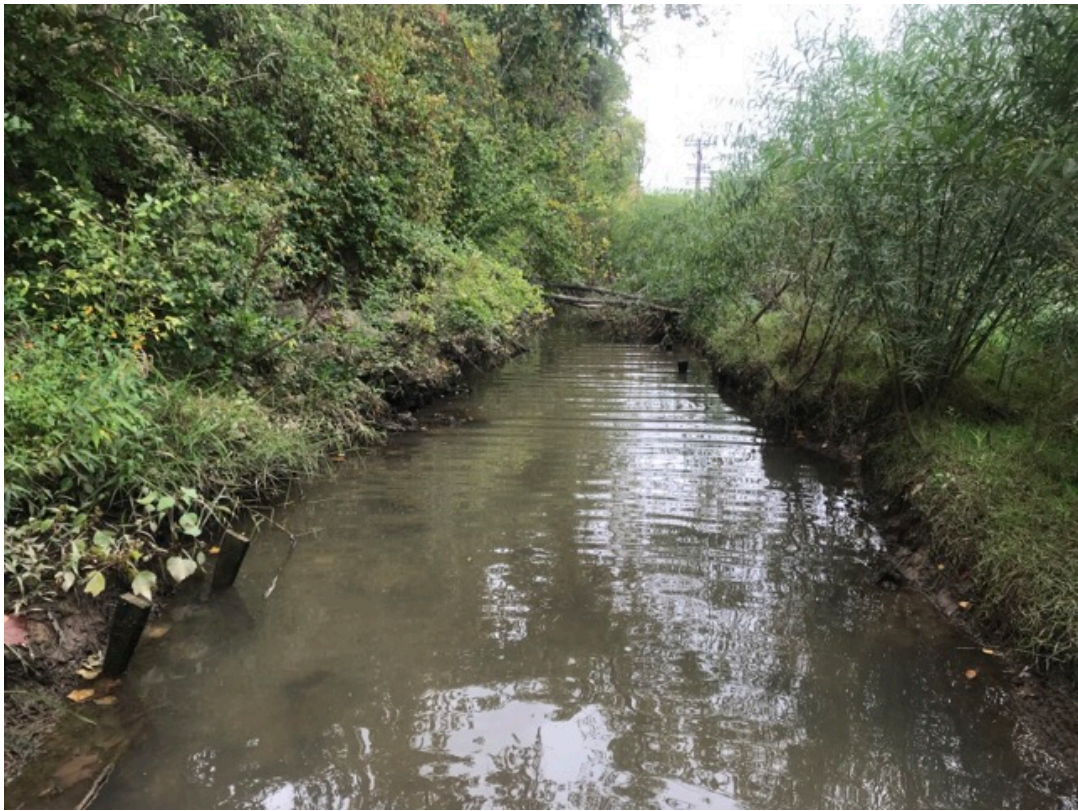
Figure A-82. Upstream view from the thalweg at Station 04+33, 2018 (top) and 2019 (bottom).

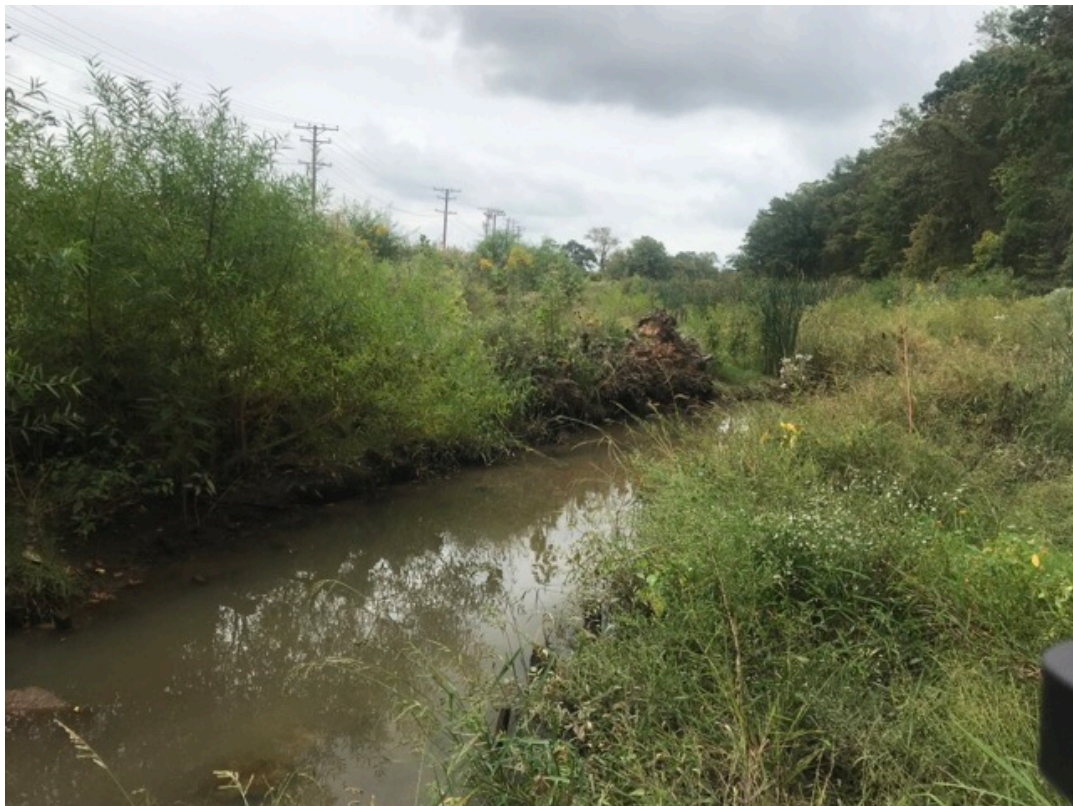
Figure A-83. View of root wad and left bank from Station 04+50, 2018 (top) and 2019 (bottom).
