Subject: Transmittal of the Cow Pen Creek Bank Stabilization and Floodplain Reconstruction Monitoring:
2019 Report
Lockheed Martin Corporation – Middle River Complex
2323 Eastern Boulevard, Middle River, Baltimore County, Maryland

**COW PEN CREEK
BANK STABILIZATION AND FLOODPLAIN
RECONSTRUCTION MONITORING: 2019 REPORT
LOCKHEED MARTIN MIDDLE RIVER COMPLEX
2323 EASTERN BOULEVARD
MIDDLE RIVER, MARYLAND**

Prepared by:
Tetra Tech, Inc.

January 2020

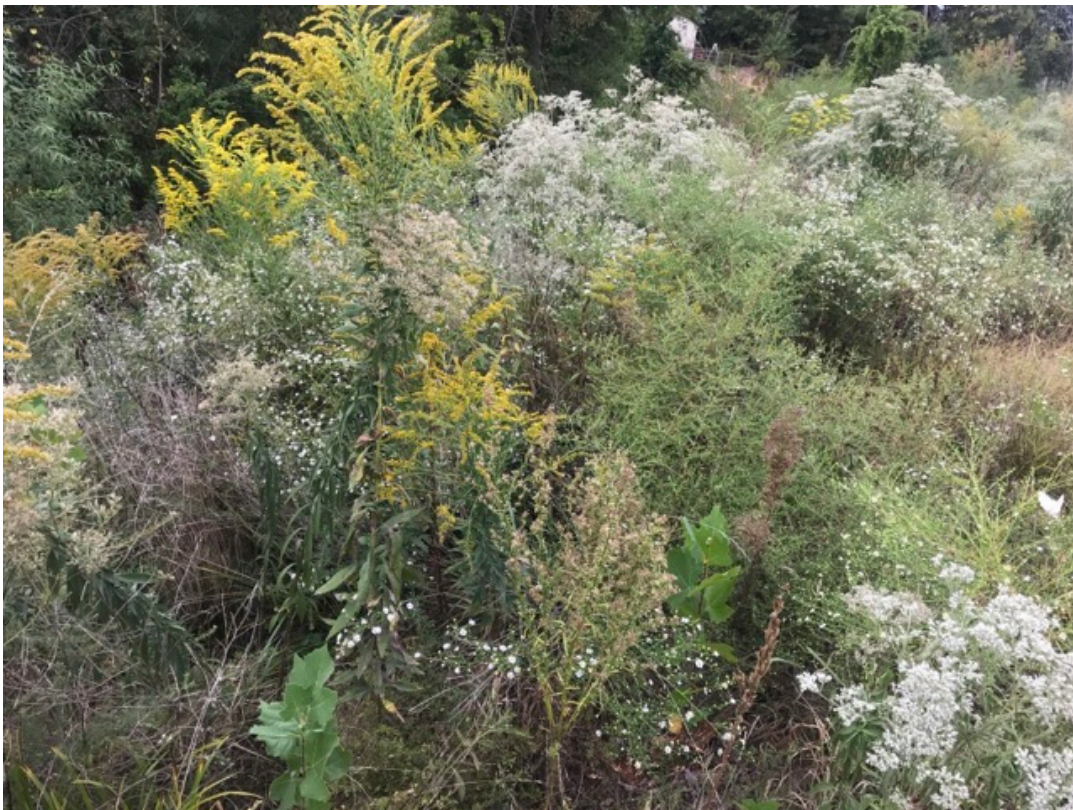
Figure A-84. Barren floodplain area on the left streambank at Station 04+15, 2018 (top) and 2019 (bottom).

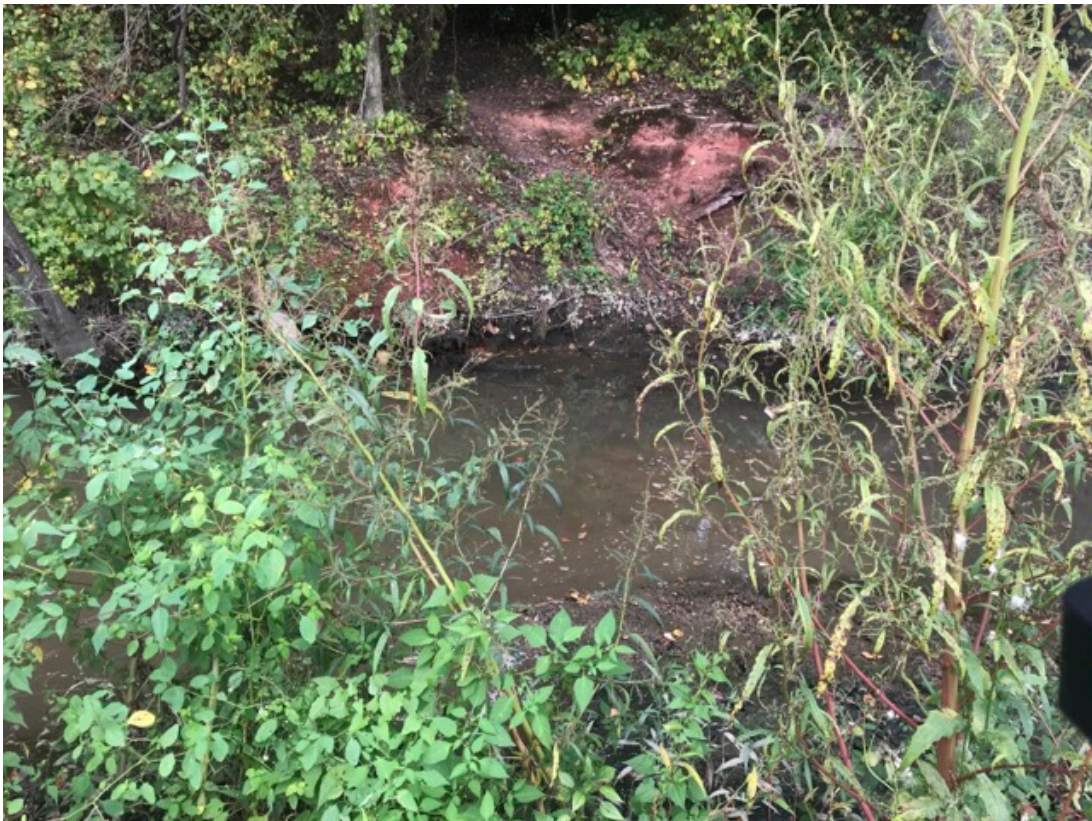
Figure A-85. Barren area on the right streambank at Station 05+25, 2018 (top) and 2019 (bottom).

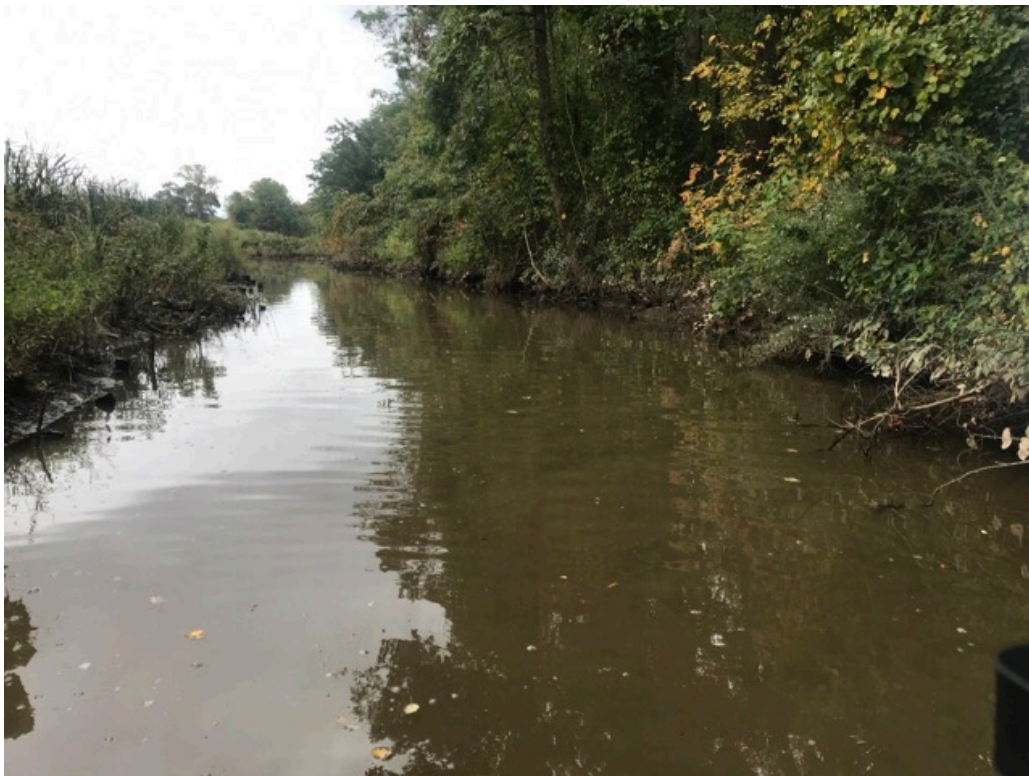
Figure A-86. Downstream view from thalweg at Station 05+67, 2018 (top) and 2019 (bottom).

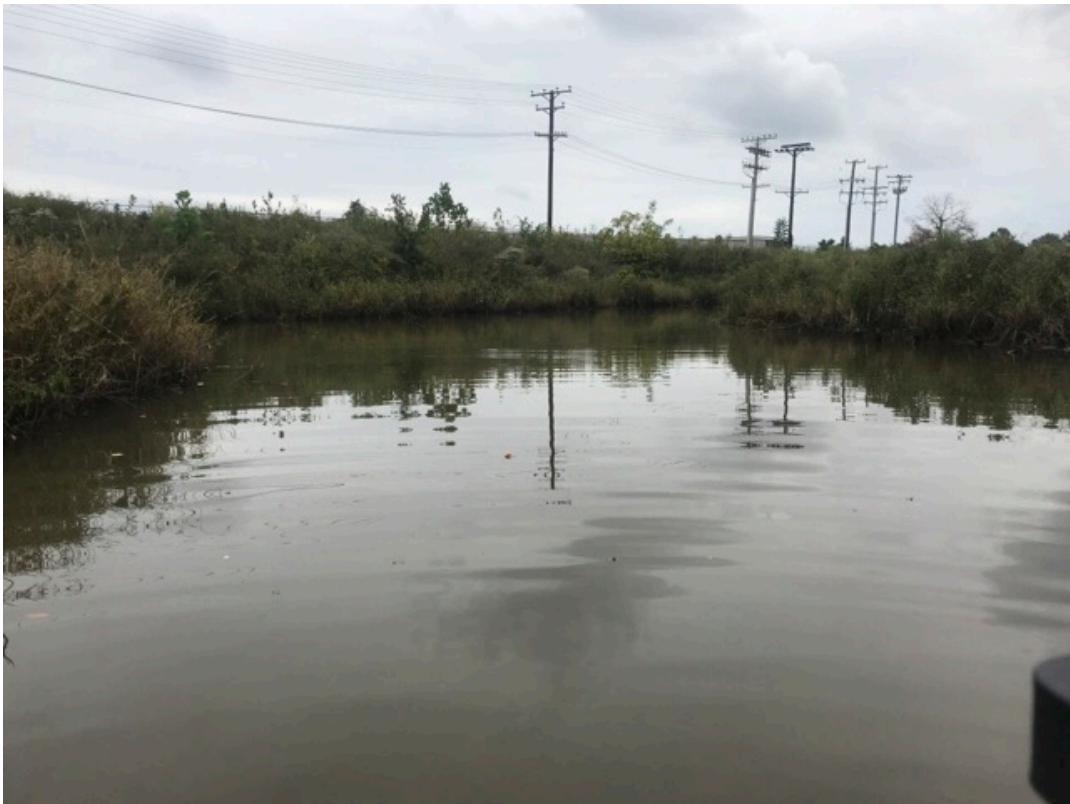
Figure A-88. Downstream view from thalweg at Station 07+00, 2018 (top) and 2019 (bottom).

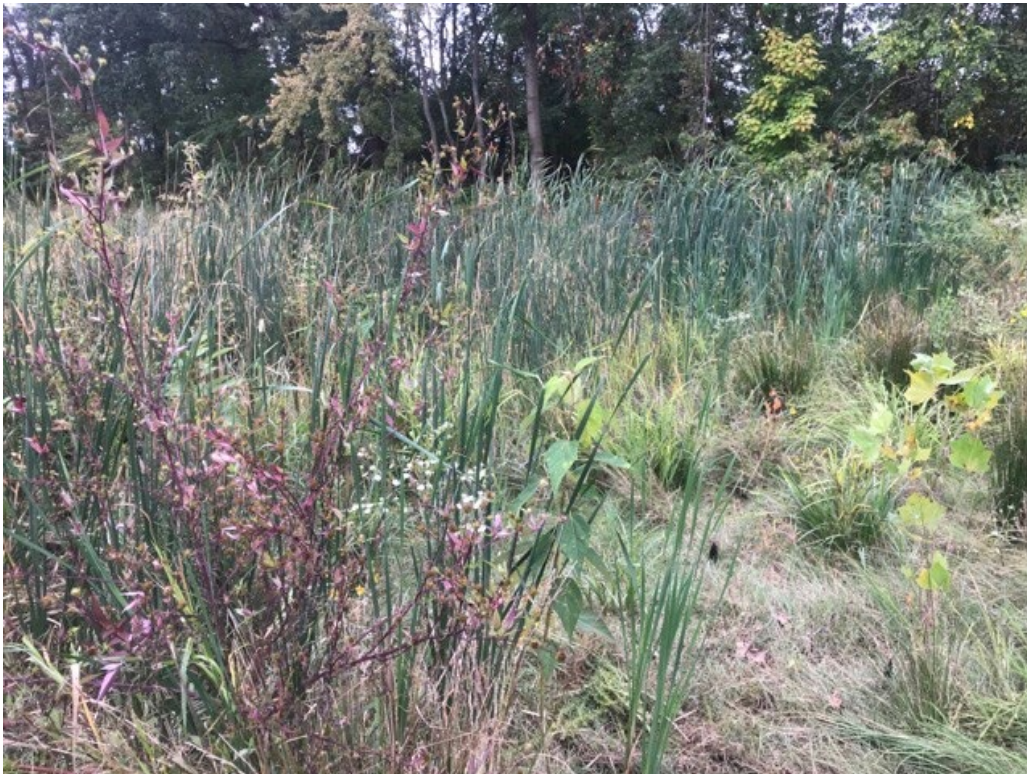
Figure A-90. Tree tubes and new vegetation on left bank at Station 07+03, 2018 (top) and 2019 (bottom).

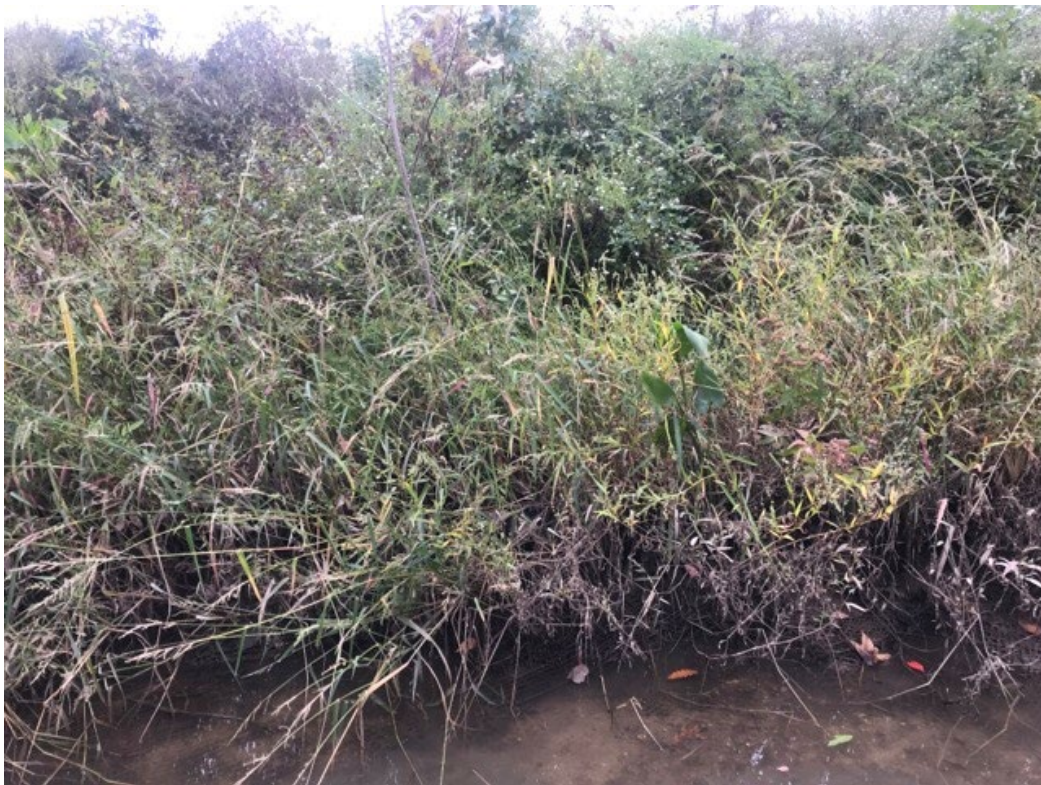
Figure A-91. Barren floodplain area and new vegetation on the left streambank at Station 07+71, 2018 (top) and 2019 (bottom).

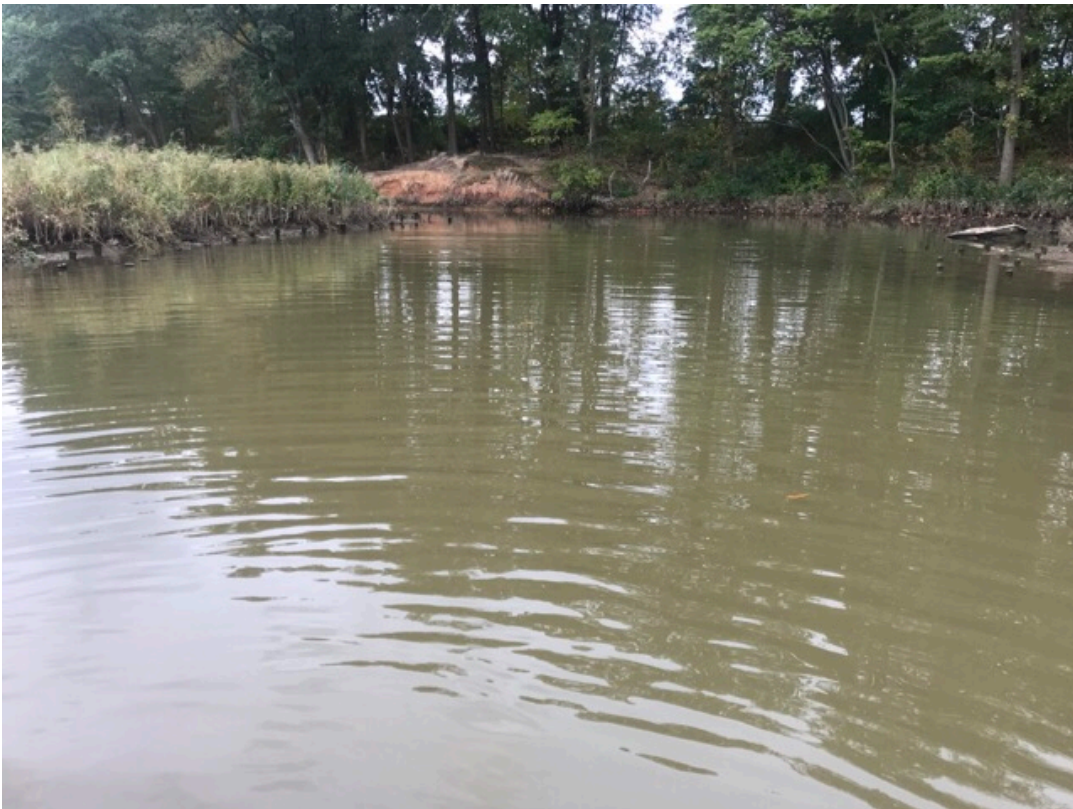
Figure A-92. Downstream view from thalweg at Station 08+33, 2018 (top) and 2019 (bottom).

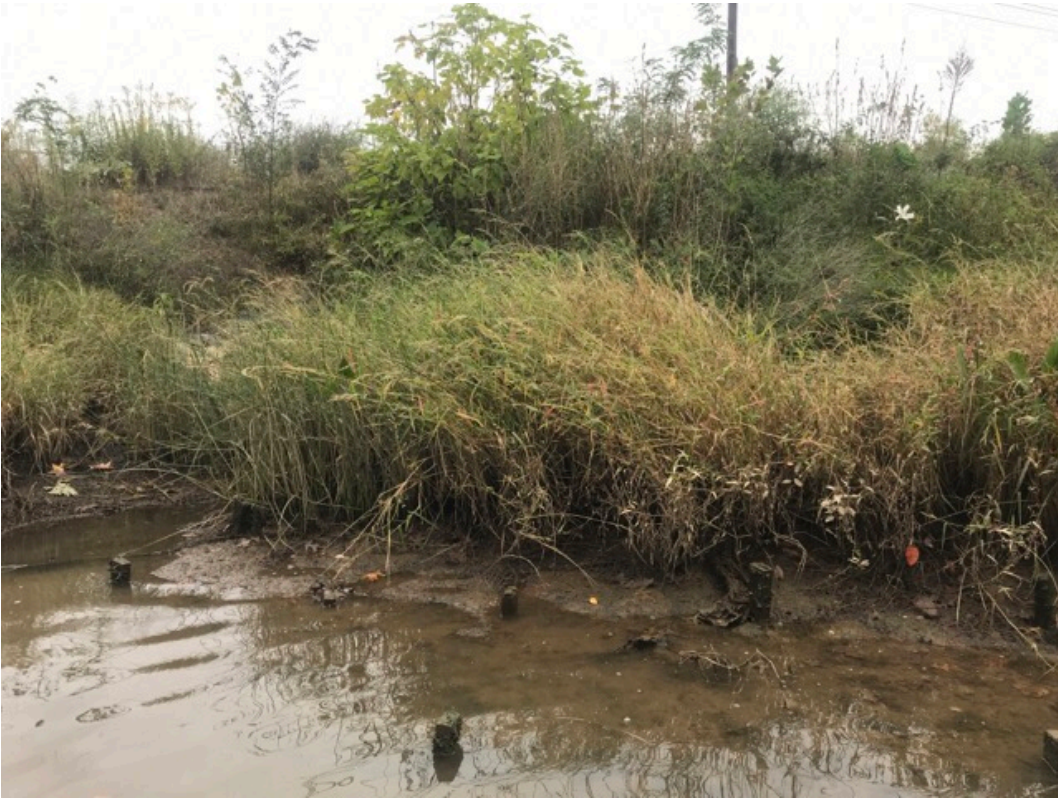
Figure A-94. Outfall / barren area and new vegetation on left streambank at Station 08+32, 2018 (top) and 2019 (bottom).

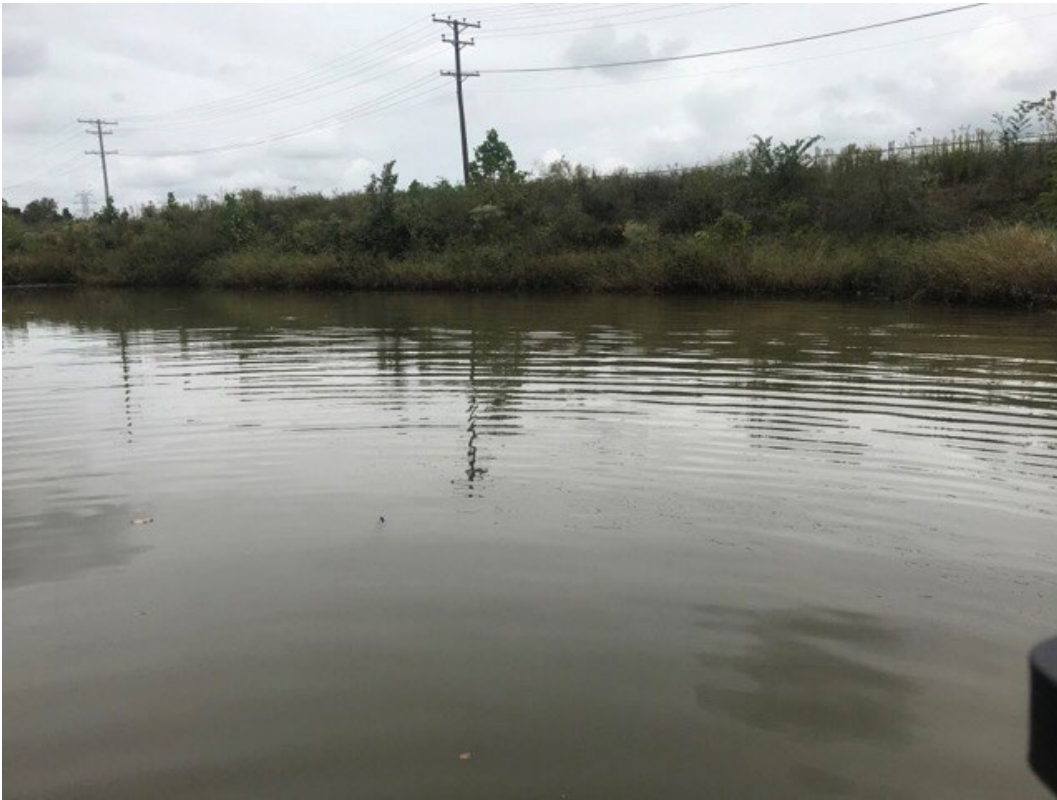
Figure A-95. Barren wetland area and new vegetation on the right streambank at Station 08+41, 2018 (top) and 2019 (bottom).

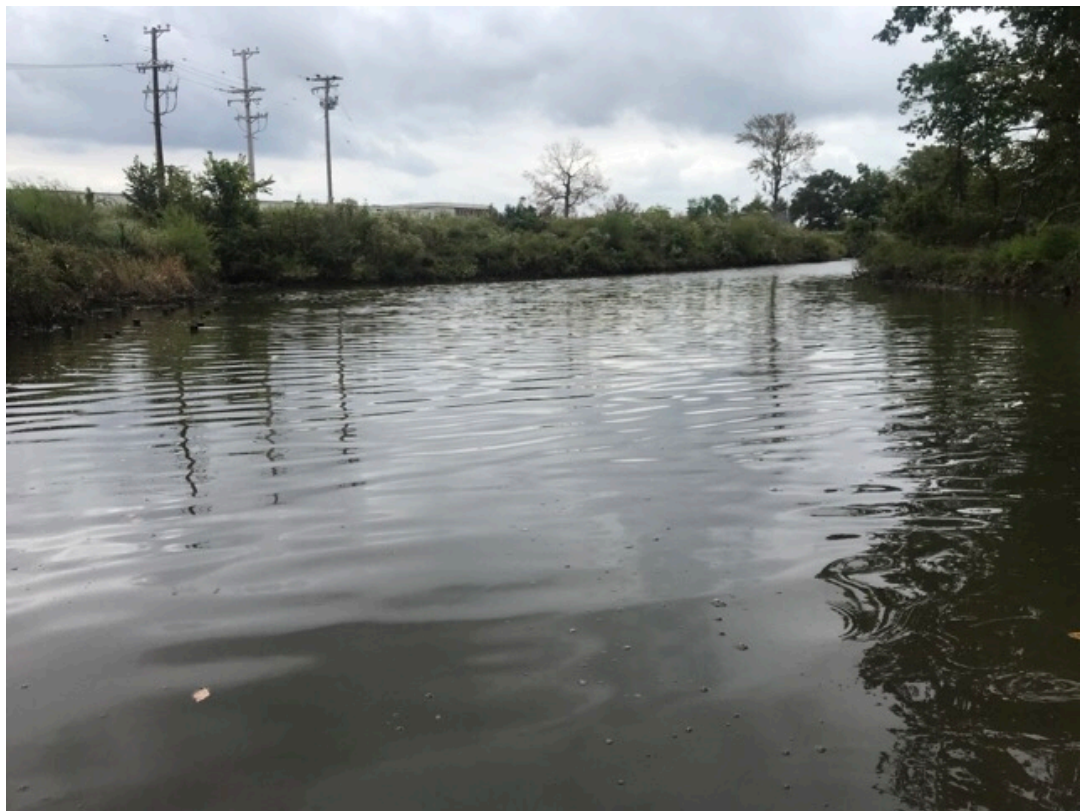
Figure A-96. Downstream view from thalweg at Station 09+67, 2018 (top) and 2019 (bottom).

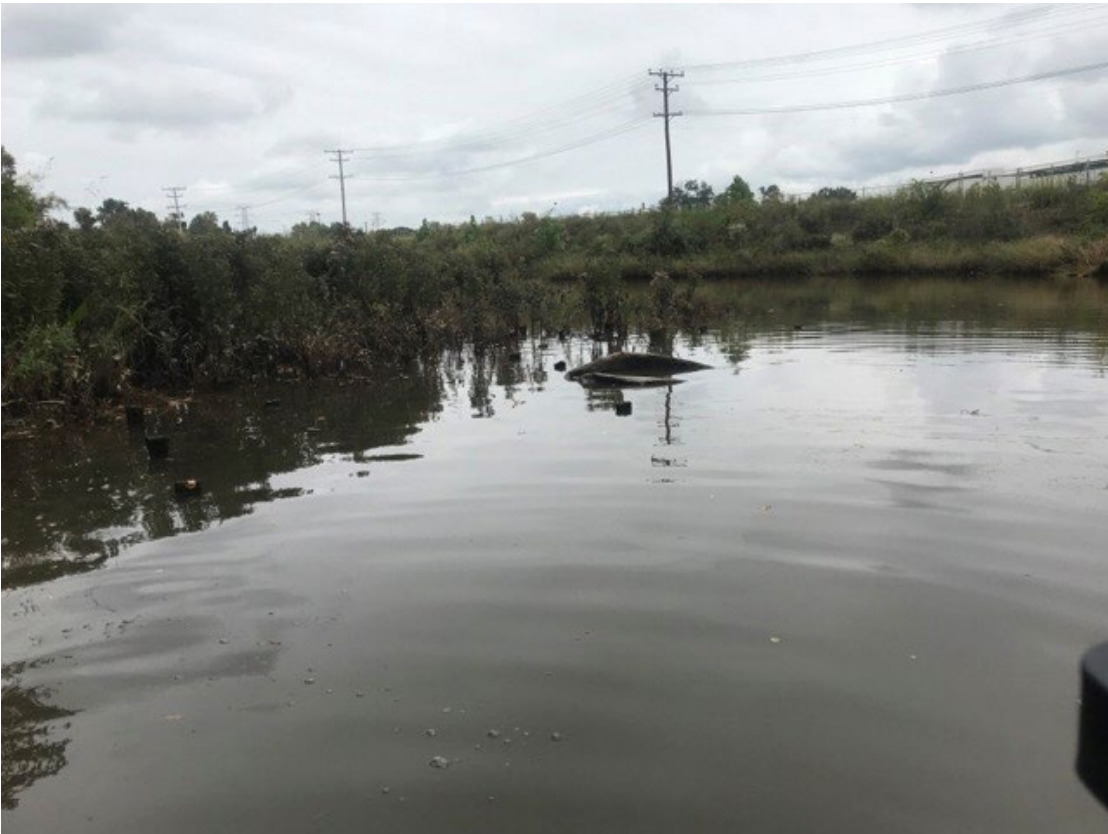
Figure A-98. Inundated tree tubes and new vegetation on the right streambank at Station 09+09, 2018 (top) and 2019 (bottom).

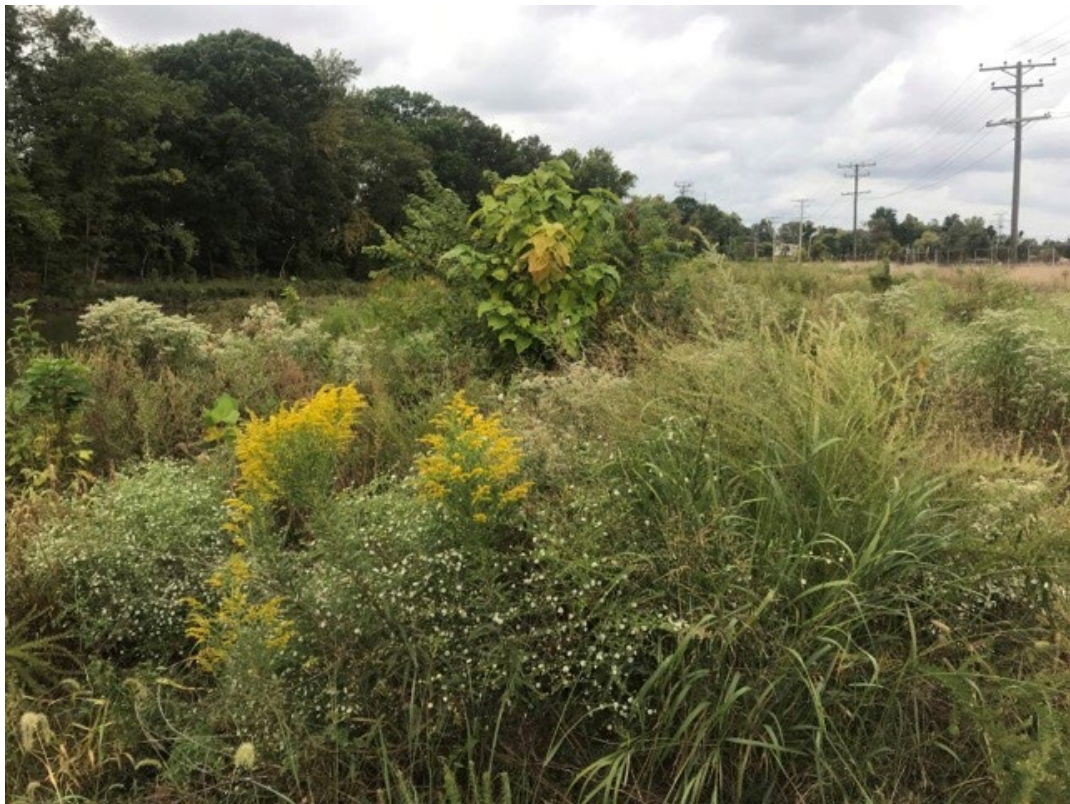
Figure A-99. Upstream view of wetland area at Station 10+00, 2018 (top) and 2019 (bottom).

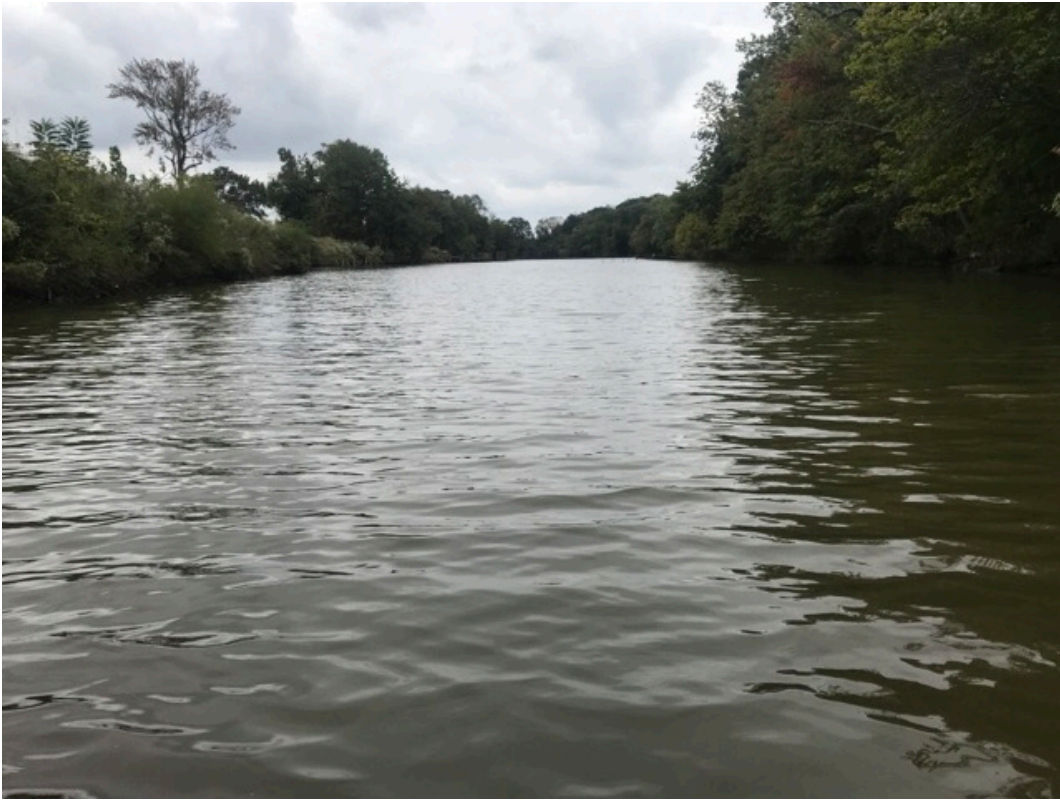
Figure A-100. Downstream view from thalweg at Station 11+00, 2018 (top) and 2019 (bottom).

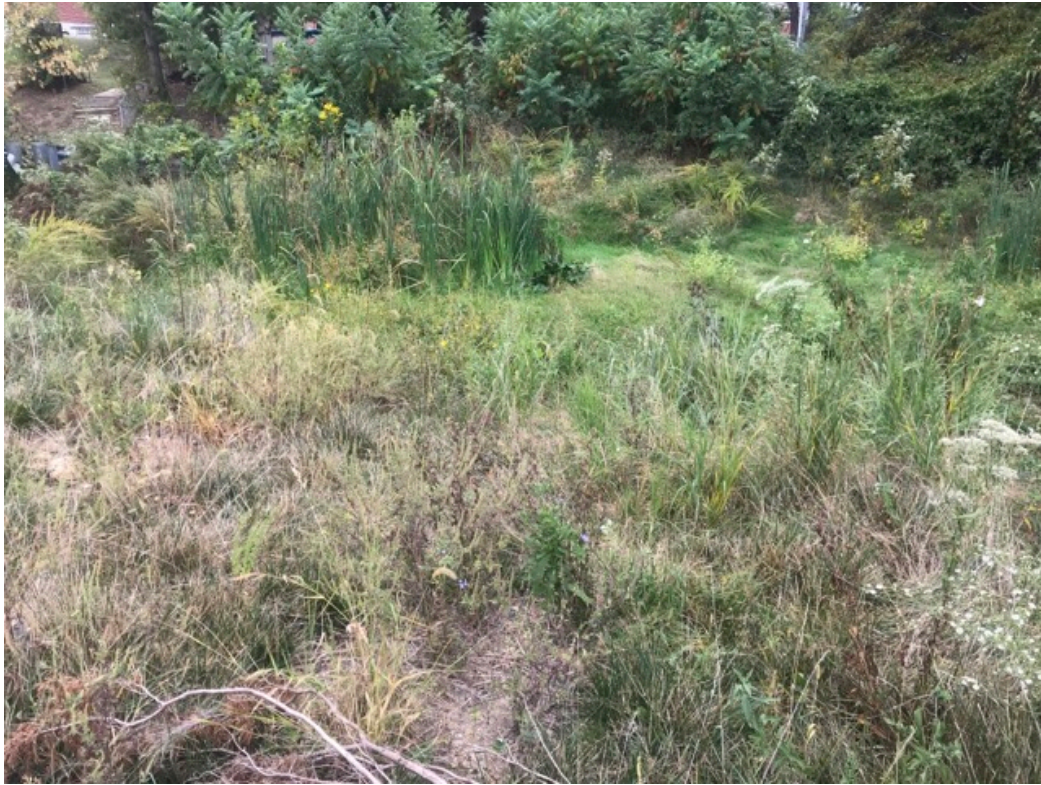
Figure A-102. View from top of floodplain, left streambank at Station 01+30, 2018 (top) and 2019 (bottom).

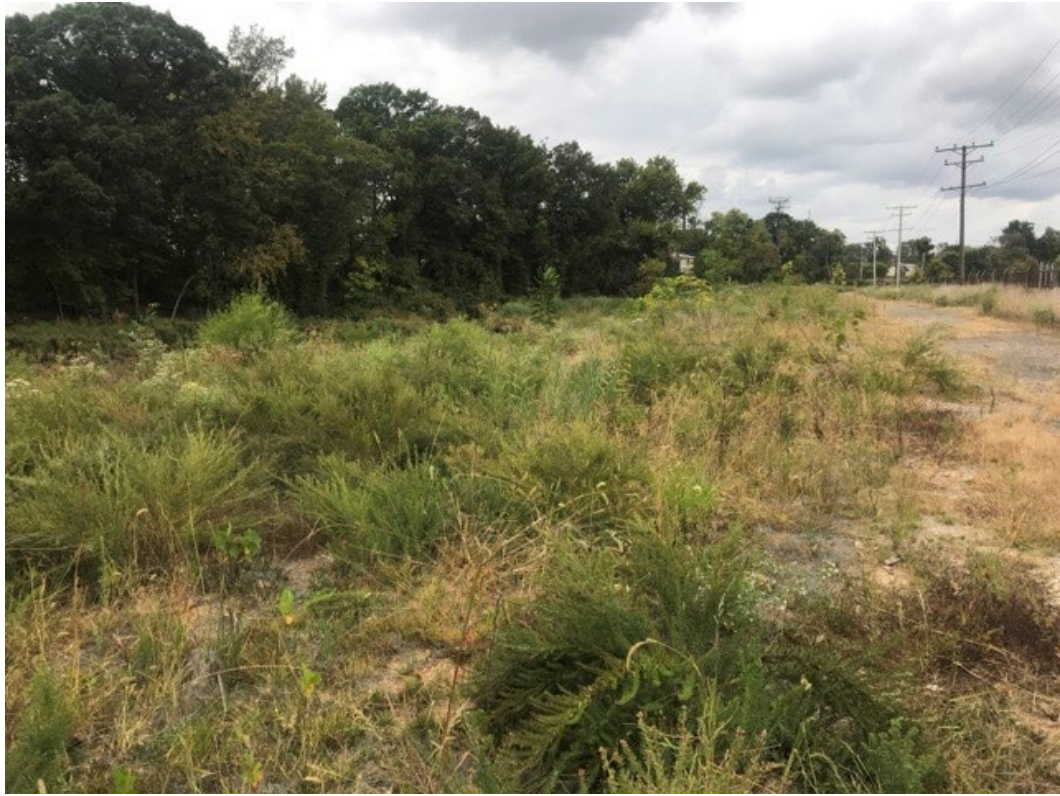
Figure A-103. Upstream view from top of floodplain, left streambank at Station 10+70, 2018 (top) and 2019 (bottom).
