**Lockheed Martin Corporation**  
**6801 Rockledge Drive MP: CCT-246**  
**Bethesda, MD 20817**  
**Telephone 301-548-2209**

**Subject: Building A Sub-Slab Depressurization-System Assessment and Indoor Air Quality Monitoring, Building A, Middle River Complex, Middle River, Maryland**

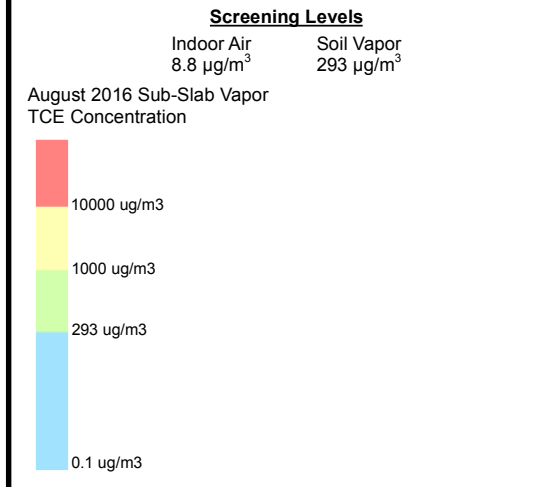
**FIGURE 1**  
**PID SURVEY, OCTOBER 2016**  
**BUILDINGS A AND B**

- near the MRAS equipment excavation in the Building A floor (shown in Figure 1)
- at locations in Building A and the Building A basement that historically have shown elevated trichloroethene (TCE) concentrations in air
- at the area surrounding sampling location SV-136-A, where new vertical extraction points were added during the recent SSDS expansion to remove sub-slab vapors from this area of Building A

Concentrations ranging from zero ppm to 3.2 parts per million (ppm) were detected in areas surrounding SV-136-A. The highest PID reading detected during the two surveys was in an open walkway west of SV-136-A. This concentration was greater than the PID results (0.3 ppm and 0.4 ppm) detected immediately adjacent to SV-136-A. The PID measured no detectable readings (0 ppm) at the MRAS excavation area north of the former plating shop. Indoor air sampling locations and rationales are in Table 1. Sampling locations and PID survey results are shown on Figure 1.
