Subject: Transmittal of the Bulkhead and Storm-Drain Assessment, Blocks D and F,  
Lockheed Martin Middle River Complex,  
2323 Eastern Boulevard  
Middle River, Maryland

# **Bulkhead and Storm-Drain Assessment, Blocks D and F, Lockheed Martin Middle River Complex 2323 Eastern Boulevard Middle River, Maryland**

Tetra Tech, Inc.

March 2016

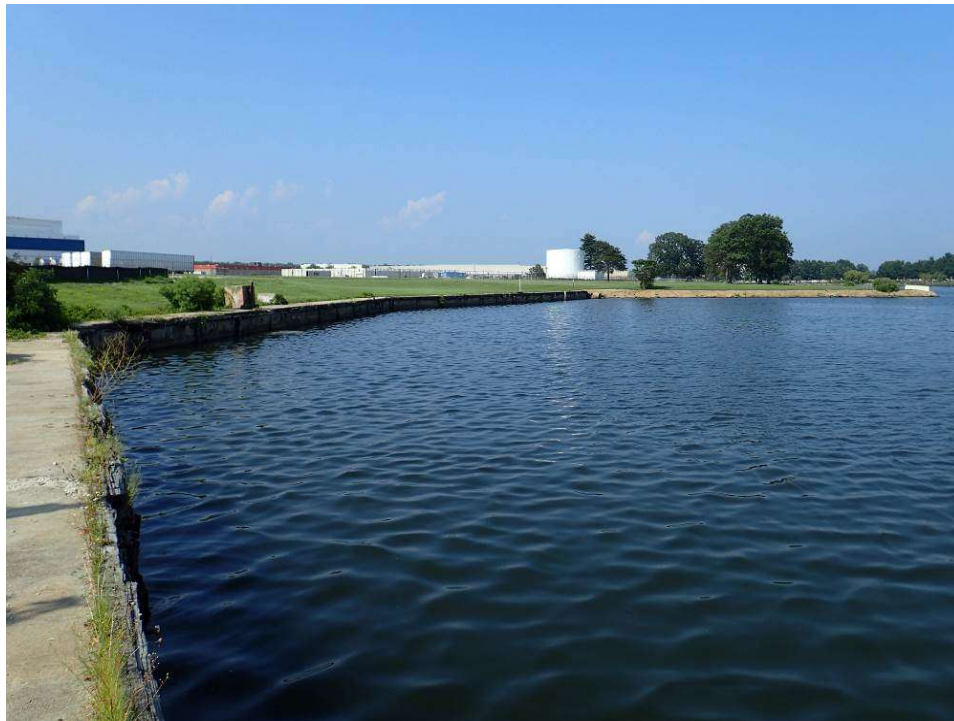
Photograph 2. Seawall Sections “E”, “F”, “G” and “H”, looking northeast.

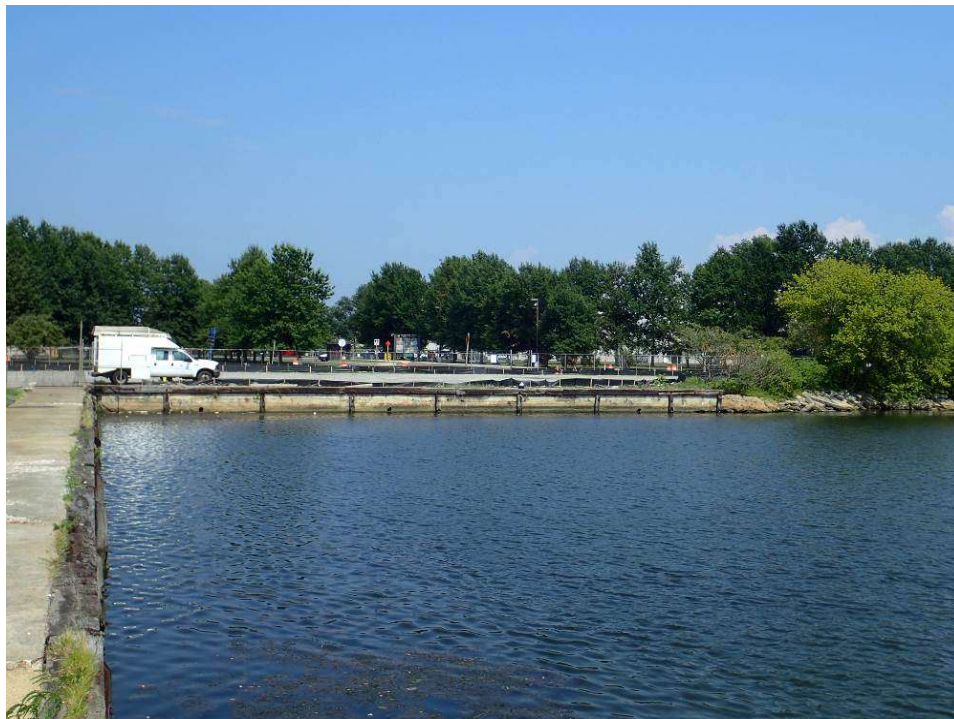
Photograph 4. Seawall Sections “A” and “B” (foreground), looking northwest.

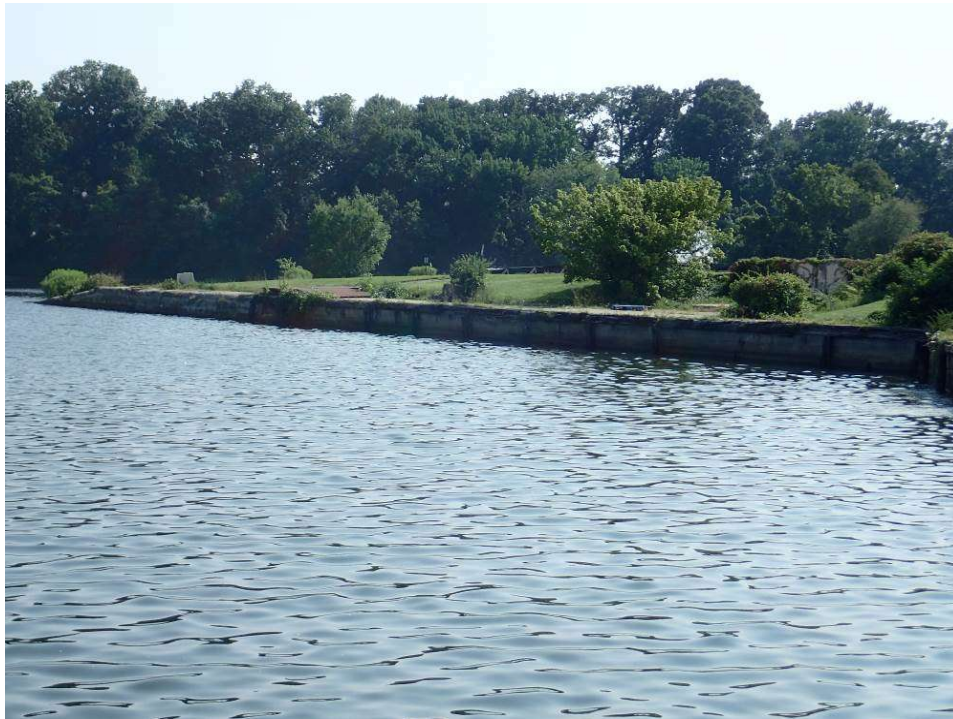
Photograph 5. Seawall Section “H”, looking west.

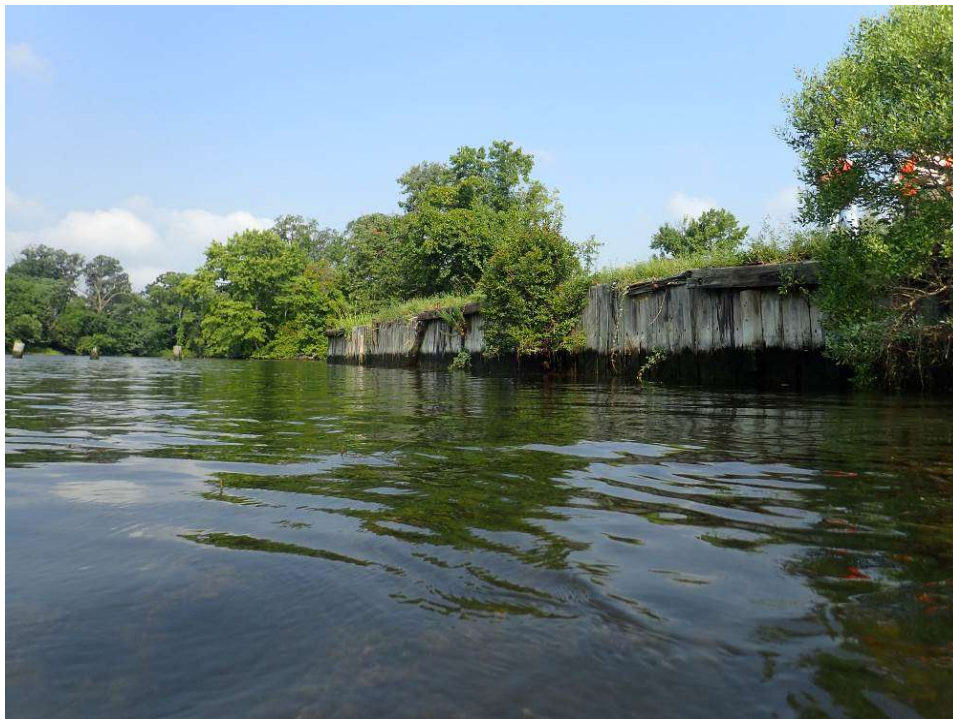
Photograph 6. Separate timber wall located west of Section “H”, looking north

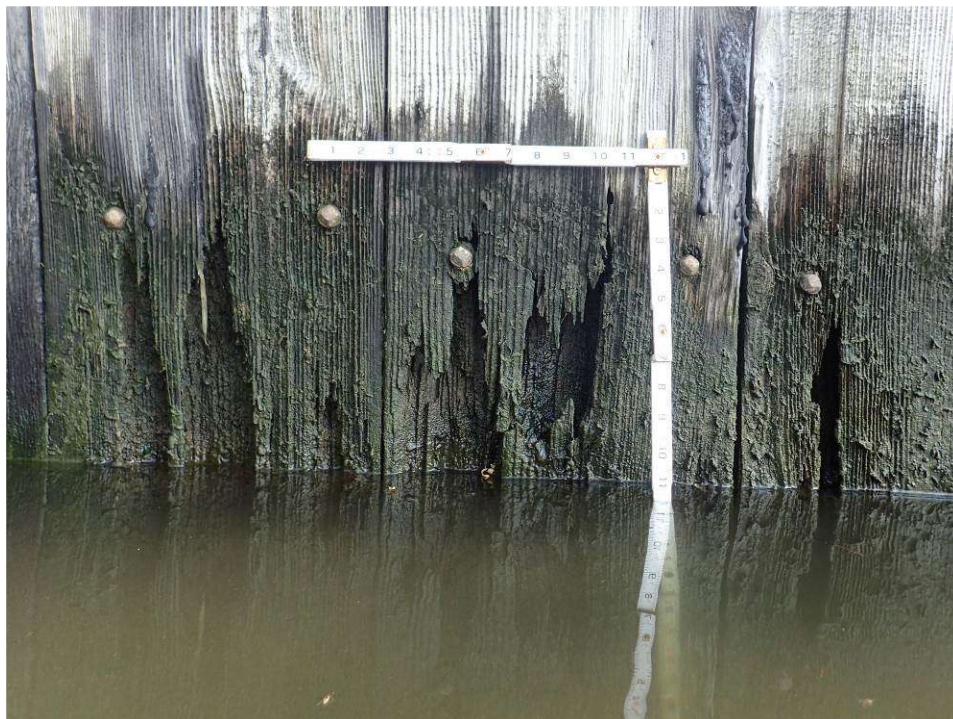
Photograph 8. Typical timber seawall detail at waterline.

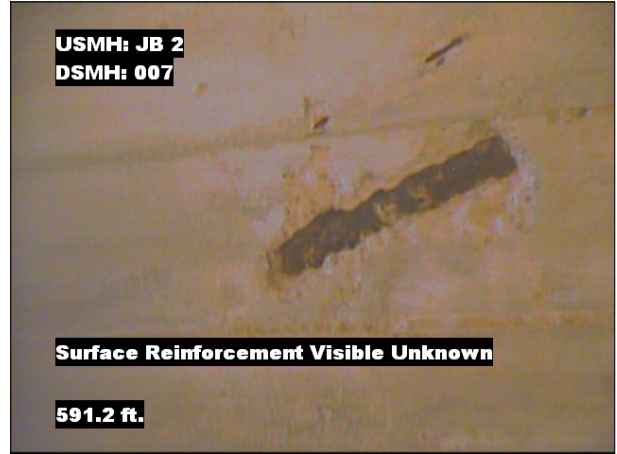
Photo: JB\_2\_007\_SRVZ\_591.2.jpg, VCR No.: 1  
591.2FT, Surface Reinforcement Visible Unknown, at 12 o'clock, within 8 inches: NO

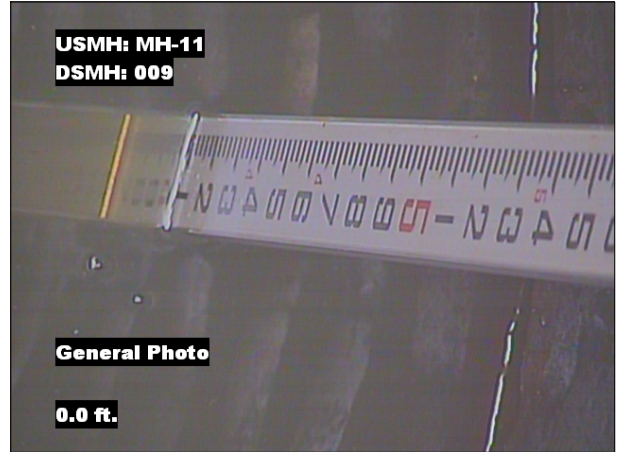
Photo: MH-11\_009\_MGP\_0.0.jpg, VCR No.: 1  
0FT, General Photograph

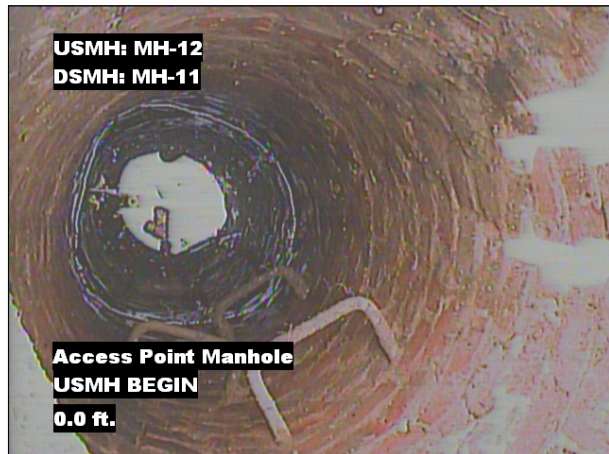
Photo: MH-12\_MH-11\_AMH\_0.0.jpg, VCR No.: 1  
0FT, Manhole
