Subject: Transmittal of Bulkhead Outfall-Sealing Completion Report  
Lockheed Martin Corporation – Middle River Complex  
2323 Eastern Boulevard, Middle River, Baltimore County, Maryland

**BULKHEAD OUTFALL-SEALING  
COMPLETION REPORT  
MIDDLE RIVER COMPLEX  
2323 EASTERN BOULEVARD  
MIDDLE RIVER, MARYLAND**

Prepared by:  
Tetra Tech, Inc.

June 2021

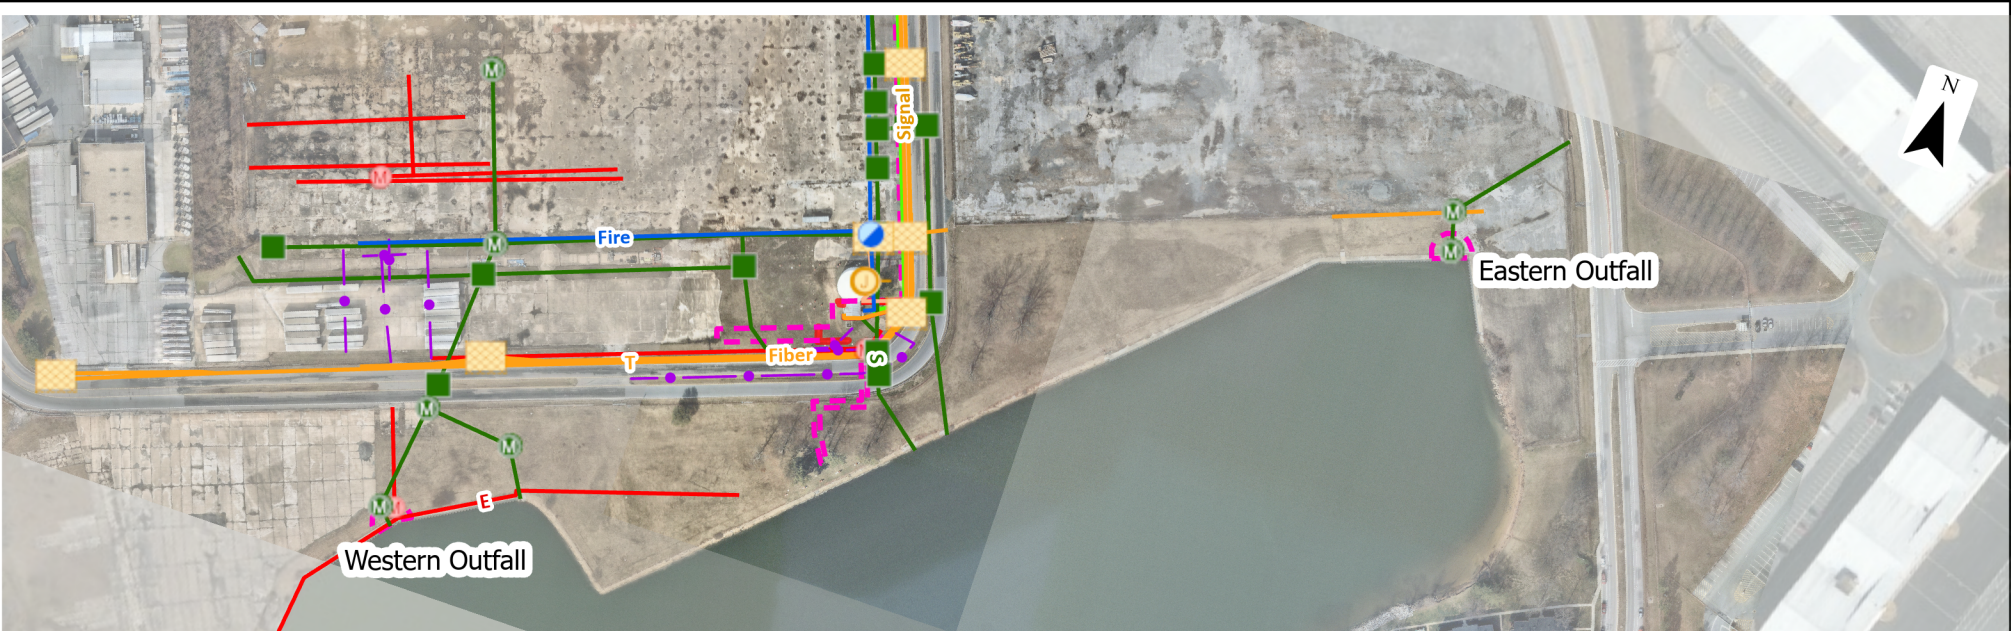
**Figure 1: Subsurface Utility Survey Results**  
**Storm Outfall Locations**  
Middle River Complex  
Middle River, MD

On July 9, 2020, Mr. Steinhart scanned a 40-foot area around each storm outfall location for utilities. One electric line was present at the western outfall. The results of the survey are depicted on **Figure 1**.
