Subject: Transmittal of the Infrastructure Abandonment Report
Lockheed Martin Corporation; Middle River Complex
2323 Eastern Boulevard, Middle River, Baltimore County, Maryland

**INFRASTRUCTURE ABANDONMENT REPORT
LOCKHEED MARTIN MIDDLE RIVER COMPLEX
2323 EASTERN BOULEVARD
MIDDLE RIVER, MARYLAND**

Prepared by:
Tetra Tech, Inc.

September 2018

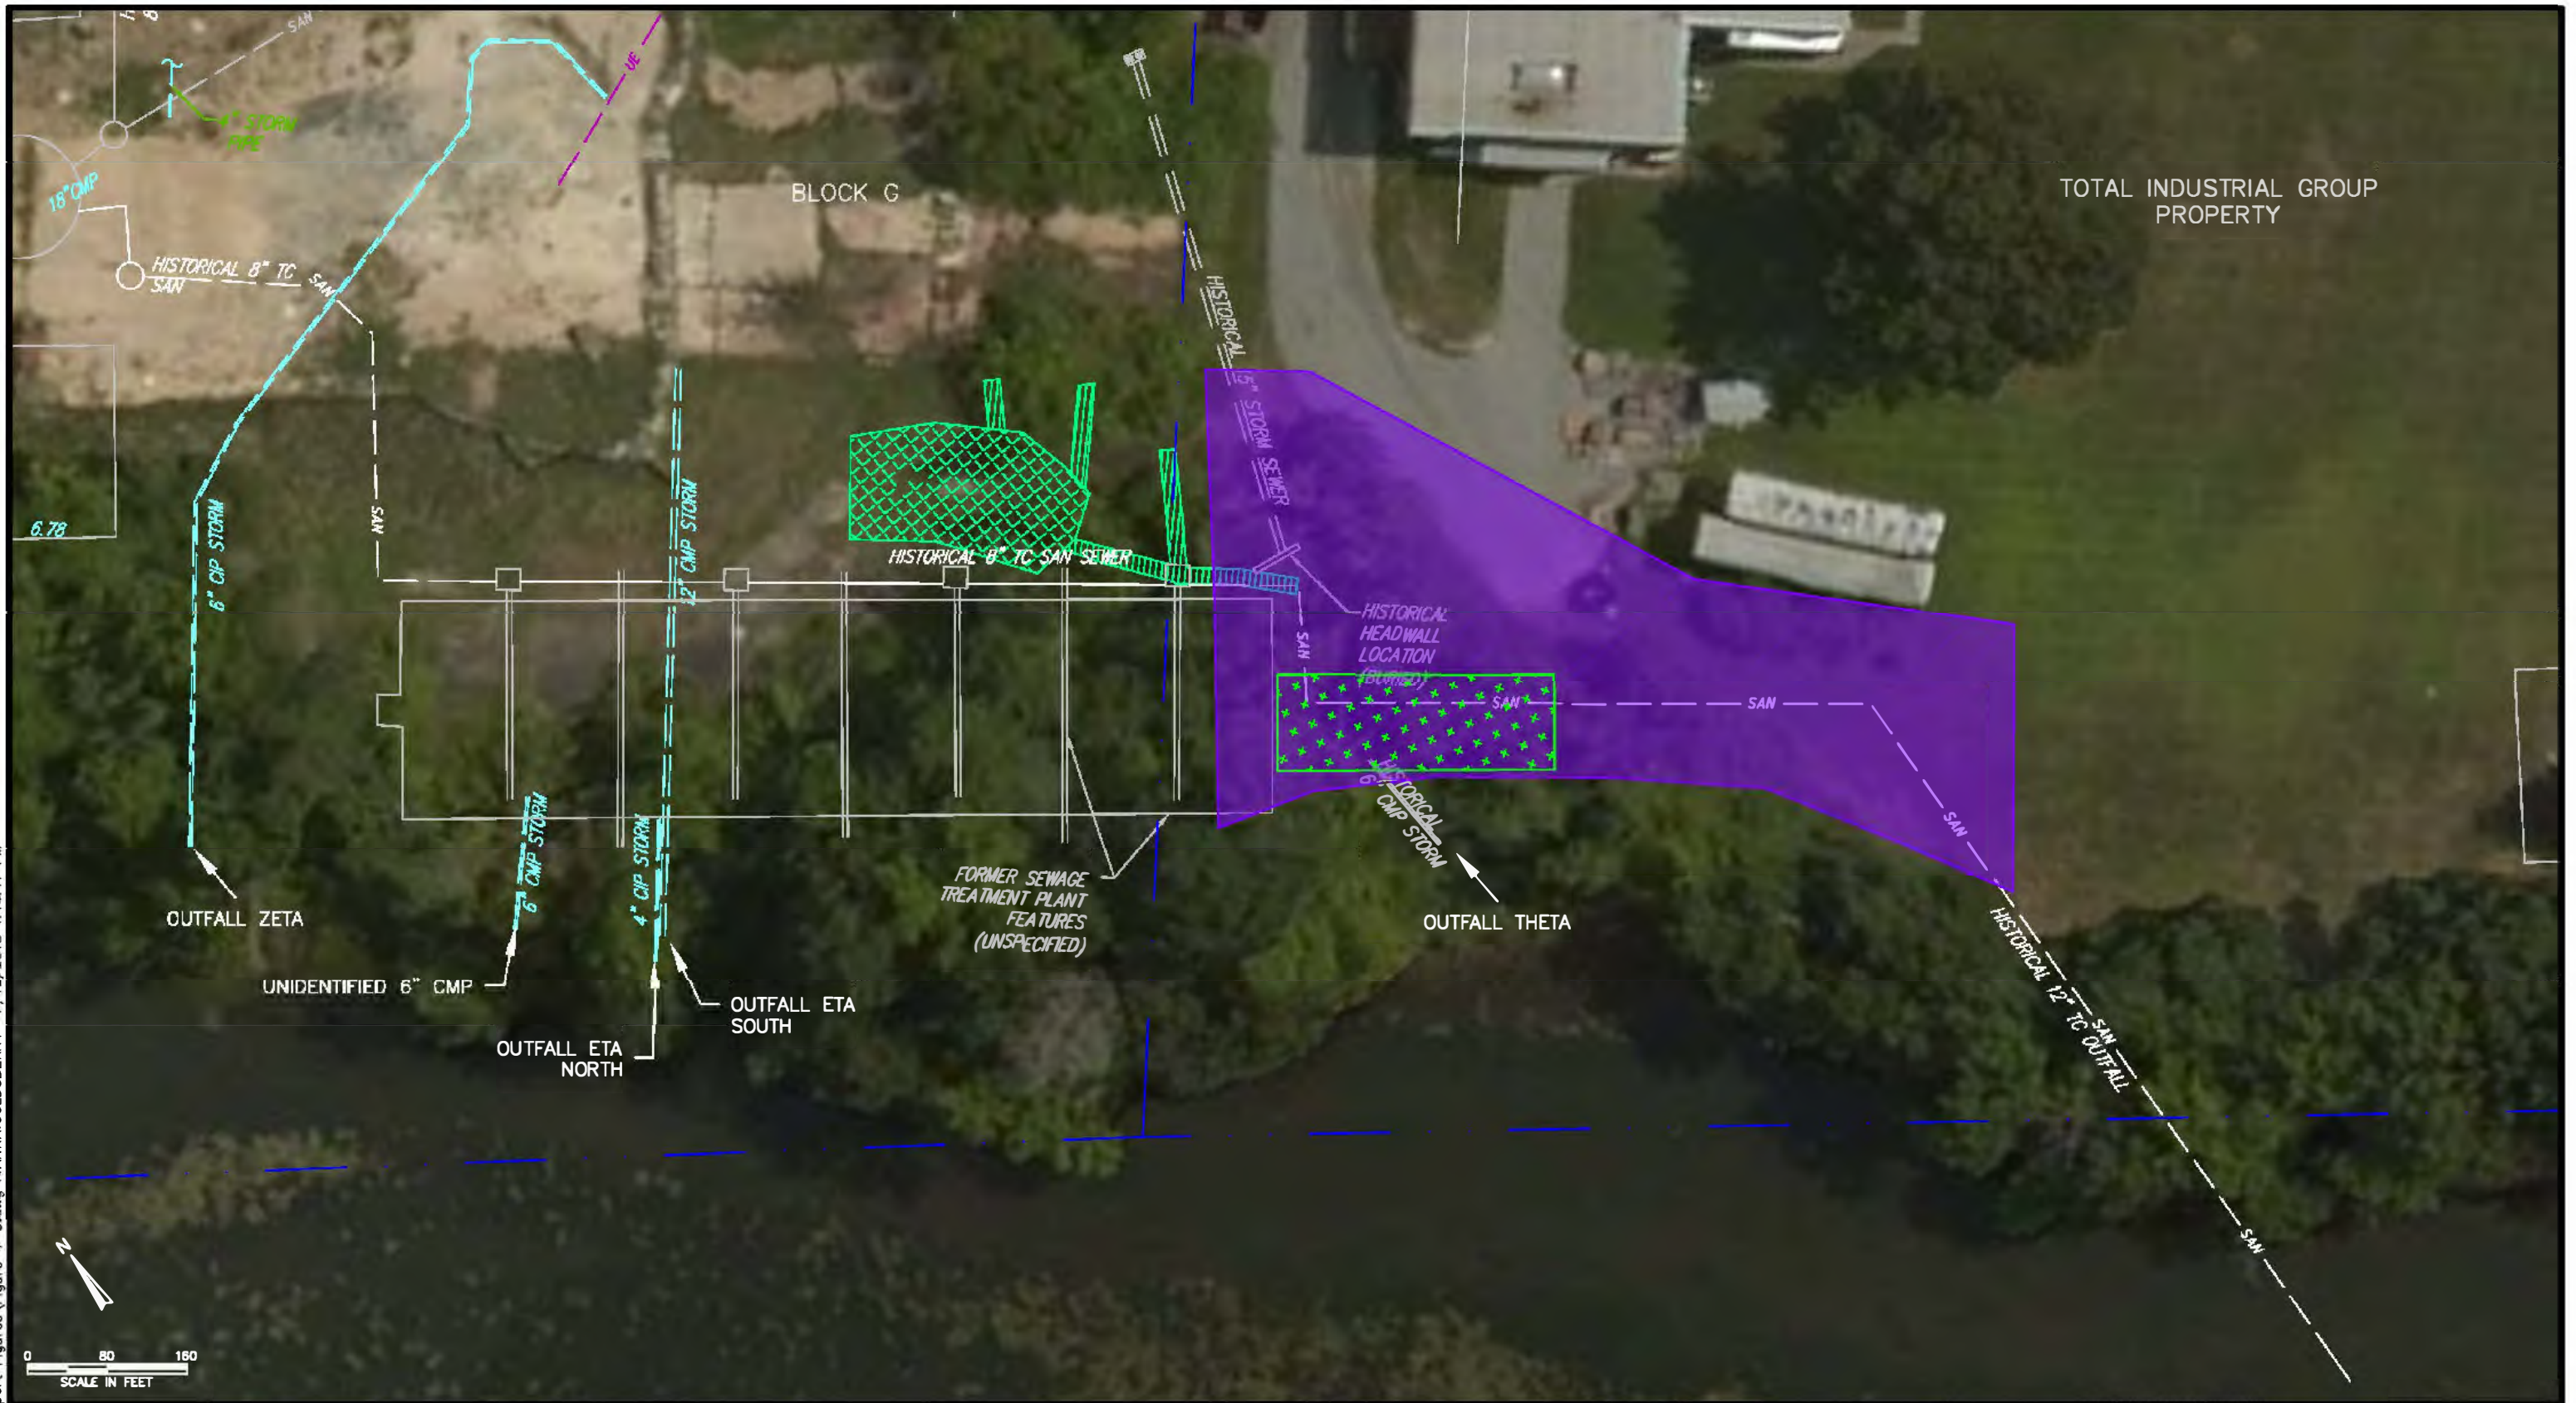
**Figure 4 Geophysical Survey Area—Outfall Theta and
Historical Features in Southern Area of Block G**

A six-inch-diameter corrugated metal pipe (CMP) was observed during the 2011 UCC survey (Tetra Tech, 2012). It was traced from the outfall and ended within the former sewage treatment plant leaching-field in Block G. It was likely associated with the historical sewage treatment plant (Figure 4).

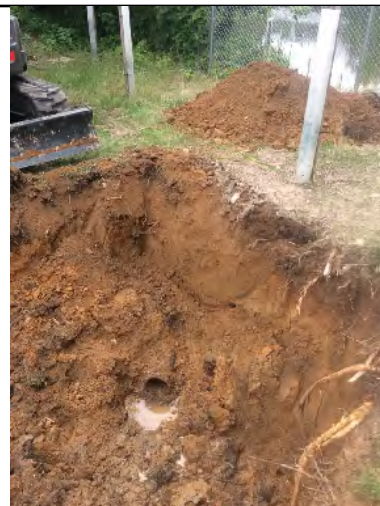
View of pipe running into bankside. Water seen is from groundwater seepage.
