Lineament Study Lockheed Martin Corporation, Beaumont Site 1 Beaumont, California

The primary objective of this investigation was to perform a structural analysis of Potrero Valley (i.e., lineament study and geologic mapping) to better understand the influence of local faulting and fracturing on groundwater flow in the area. Douglas M. Morton, PhD, a retired geologist from the U.S. Geological Survey and regional expert on the structural framework and geologic history of the Transverse and Peninsular Ranges of southern California, performed this lineament study under subcontract to Tetra Tech, Inc. The lineament study at Site 1 consisted of the following Tasks: Task 1 was an archival literature and stereographic aerial photography search followed by analysis of available literature; Task 2 was identification of lineaments on archival aerial photography; and Task 3 was a geologic field investigation of Site 1. This task included checking the location of previously mapped faults, examination of various lineaments, reconnaissance geologic investigation of Site 1 area and the area east of Site 1, and geologic mapping in selected areas. Emphasis was placed on the detection of faults tha

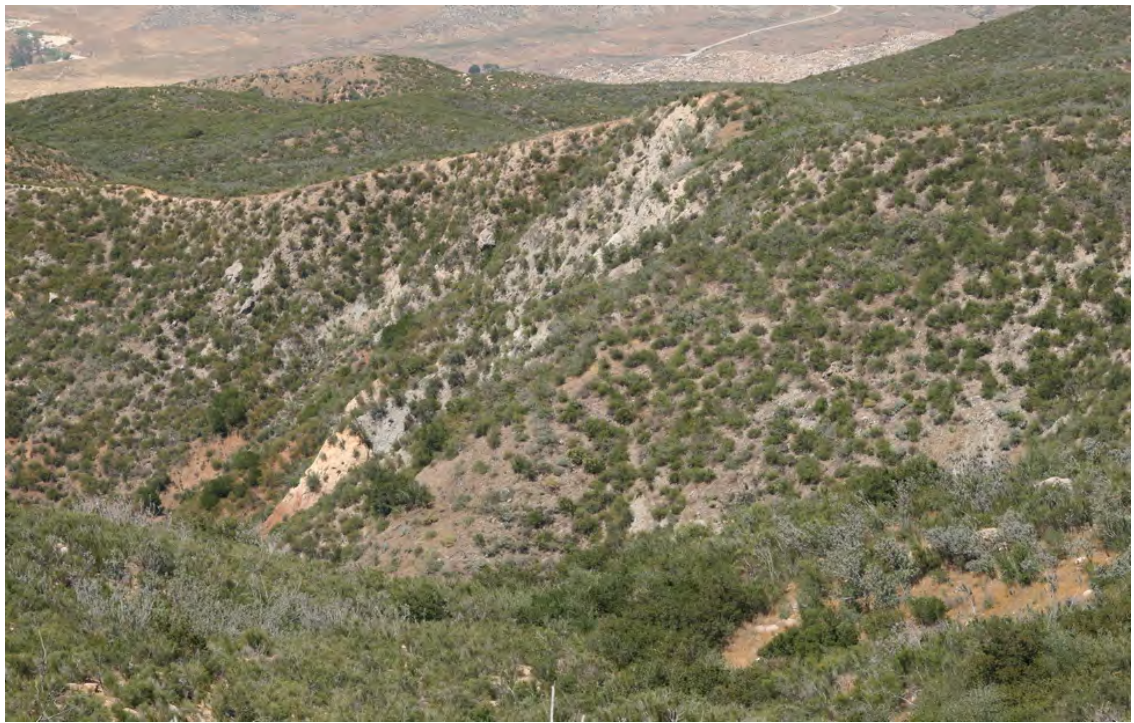
Photo 1. Example of extreme and varied facies changes within Mount Eden formation is the gray tonalite landslide deposit between red Mount Eden formation beds exposed on the north side of Claremont ridge. View looking east.

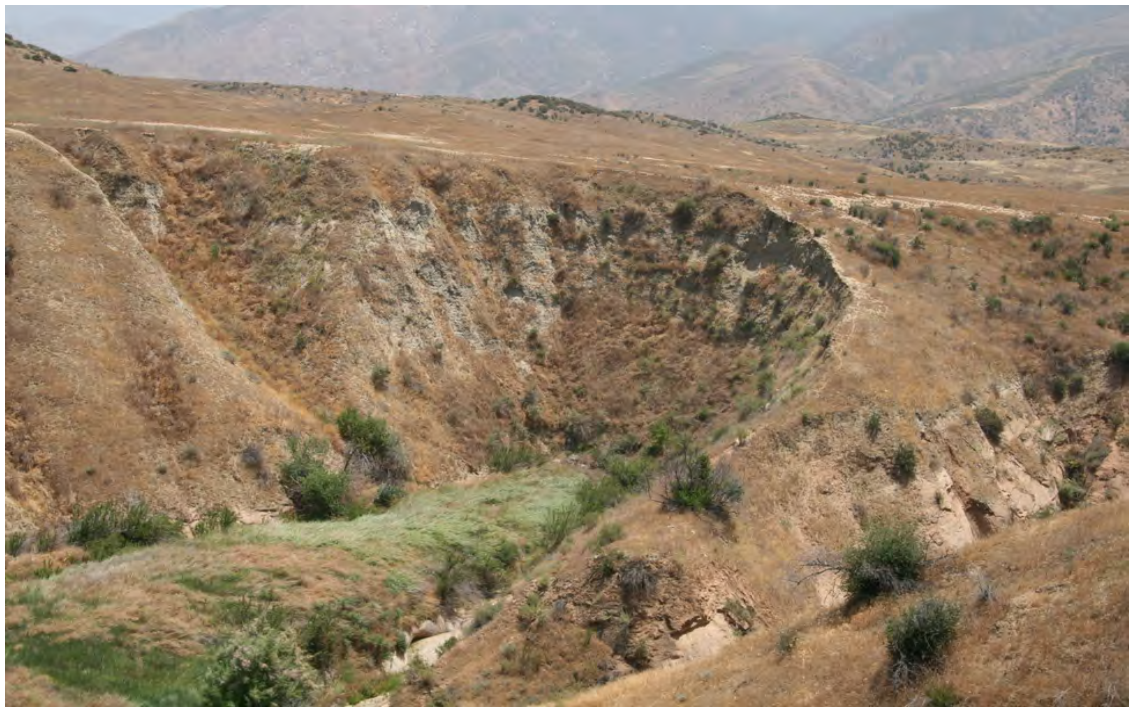
Photo 2. A thick channel deposit of San Timoteo formation resting on Mount Eden formation exposed on the wall of a canyon. Due to thin sedimentary deposits capping the upper surface any areal extension of the San Timoteo formation cannot be easily made. View is looking east.

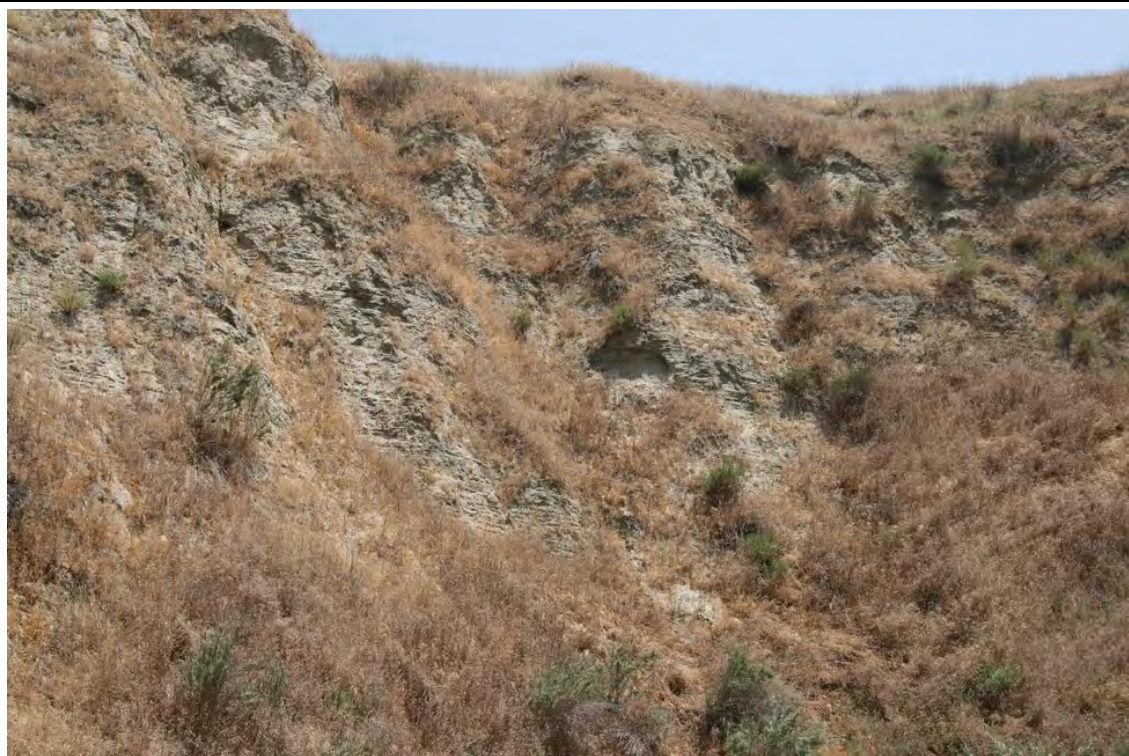
Photo 3. The thick, well-bedded San Timoteo formation. View is looking east.

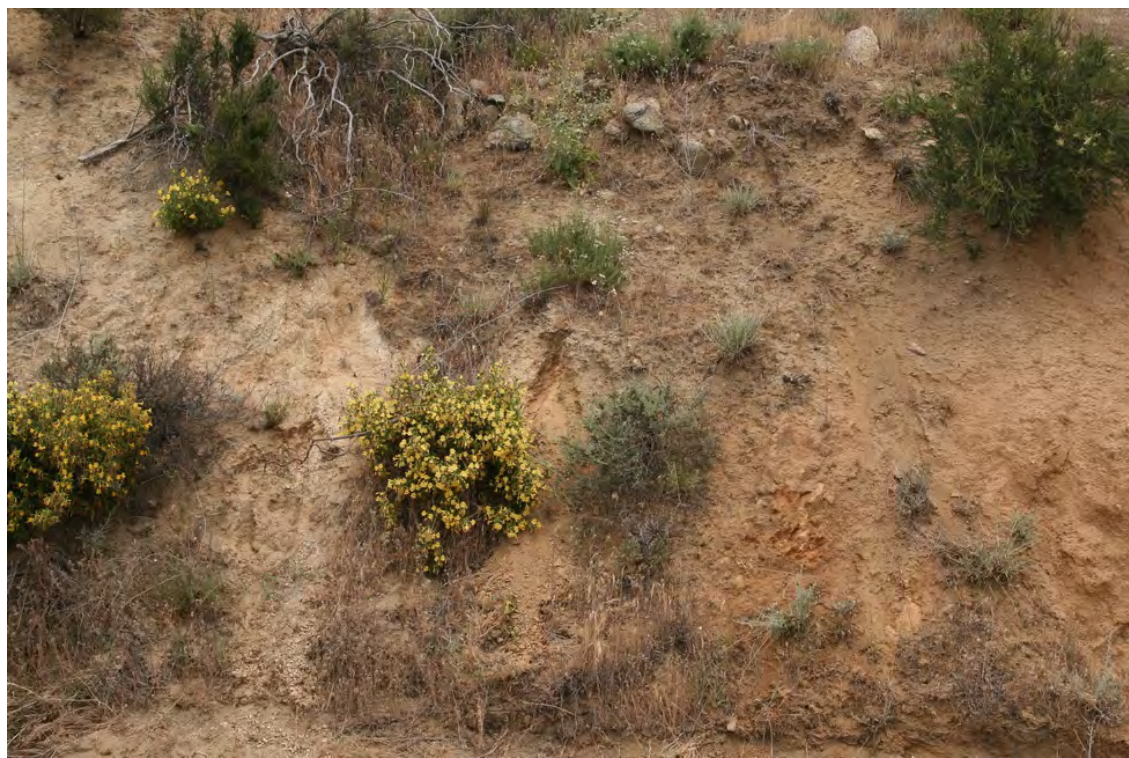
Photo 4. Fault A exposed to right of yellow-flowering bush in center of photograph on the north side of Claremont ridge. Gray-colored biotite monzogranite on the left is in fault contact with Mount Eden formation on the right. View looking southeast.

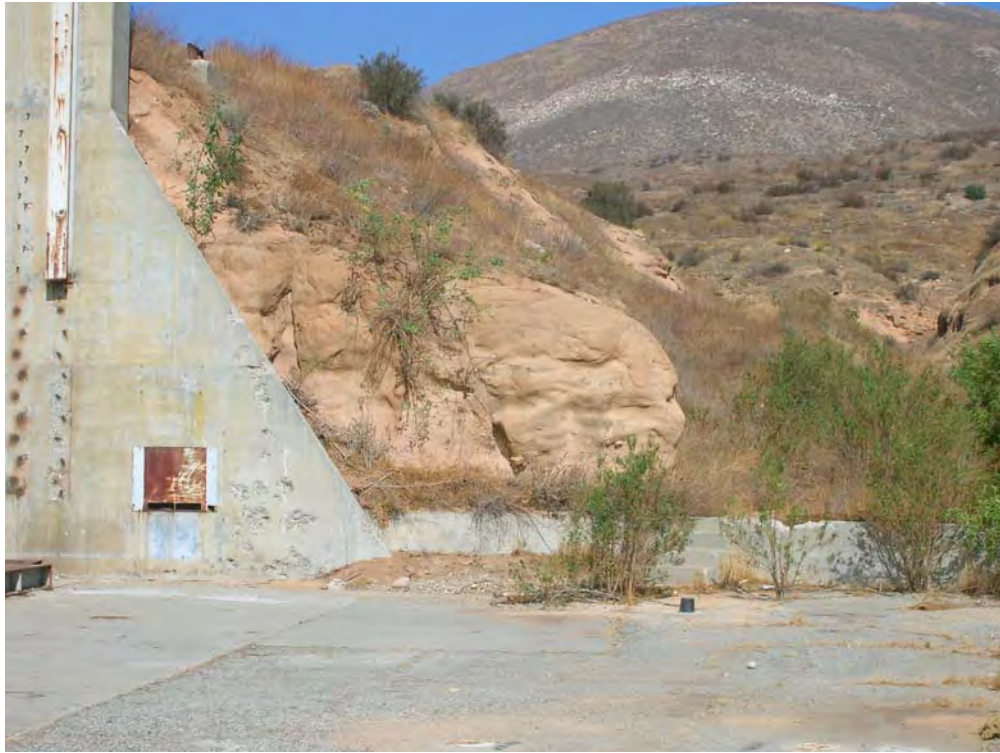
Photo 5. Branch of Fault B(?) exposed in the center part of the exposed Mount Eden formation on the east side of the large motor test bay. Photos 6 and 7 are close up photographs of the fault.

Fault B, located about 1,600 feet northeast of the Lower Potrero fault zone, has little expression north of Potrero Creek. Where Fault B is projected to cross Potrero Creek there is a major change in vegetation. One or both of 2 measured faults, one exposed on the northeast side of the 'Large Motor Test Bay (Feature F-39, Photographs 5, 6, and 7), and the other immediately east of the 'Small Motor Vertical Bay (Photograph 8), appear to be the northward continuation of Fault B.

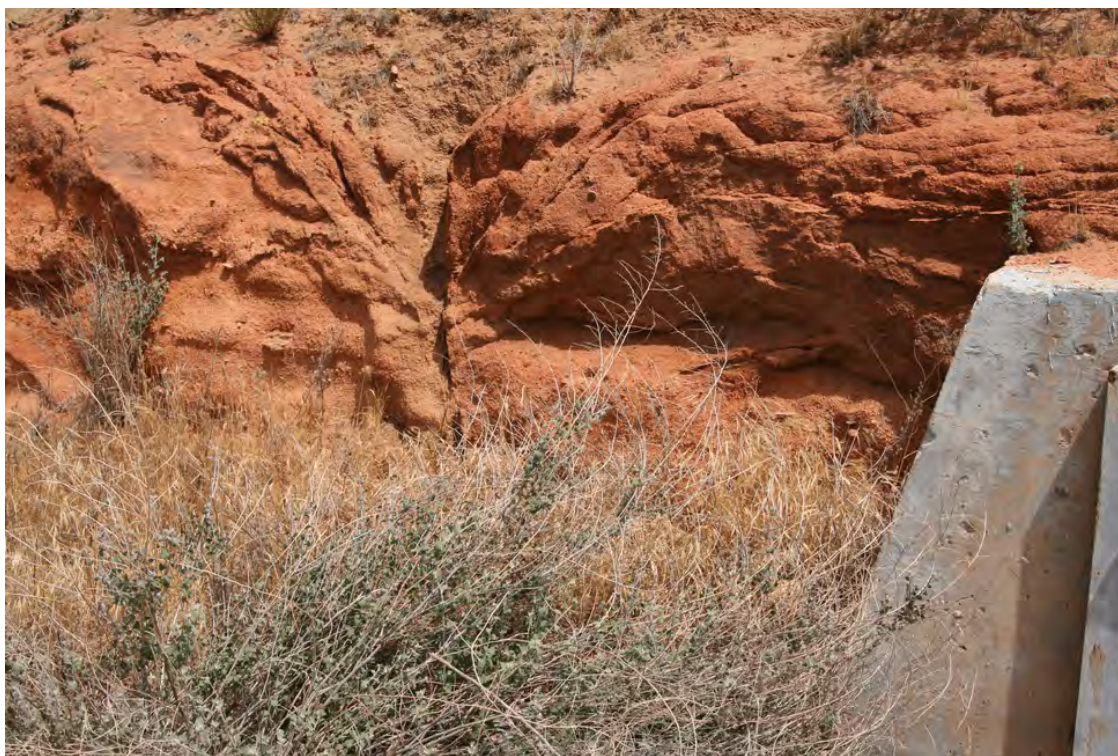
Photo 8. Branch of Fault B(?) exposed on the east side of the small motor vertical bay.

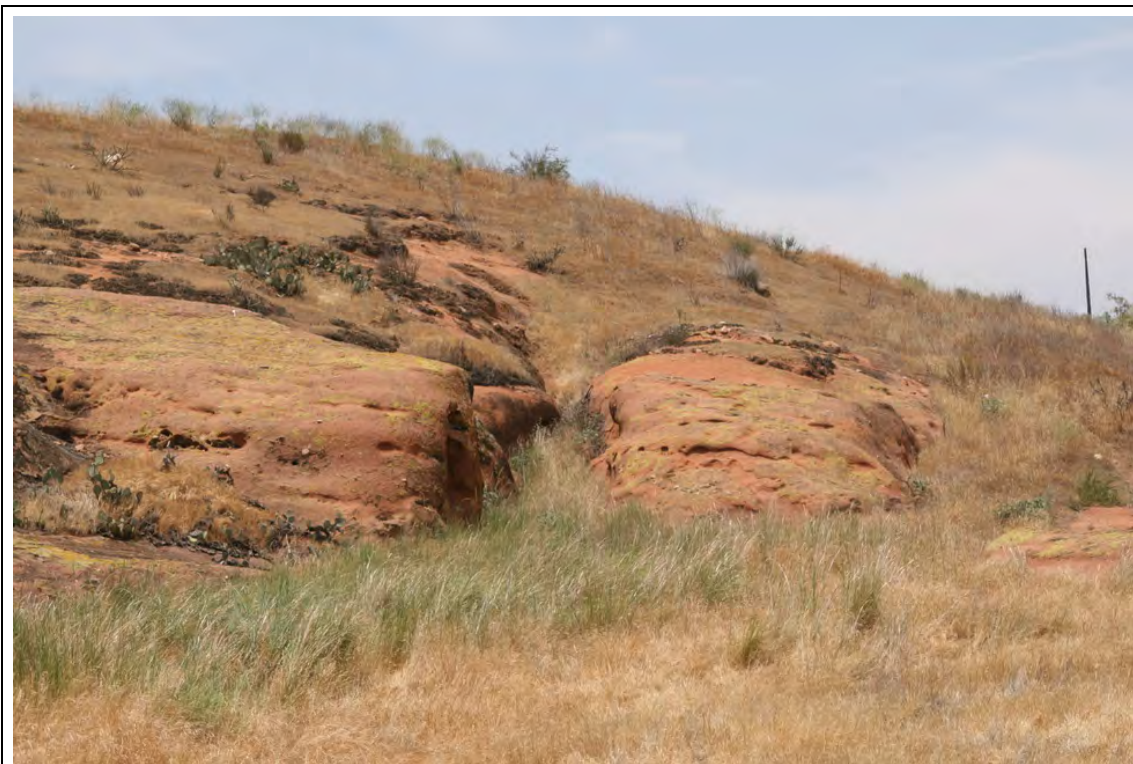
Photo 9. Projection of Fault C into the brush-covered linear depression in Mount Eden formation.

Fault C, located in the southwestern part of Site 1 has moderate erosional topographic expression and appears to form the contact between Mount Eden formation on the west and metamorphic rocks on the east. There appears to be little if any expression of a fault north of Potrero Creek. The fault is projected to coincide with a brush filled linear depression in Mount Eden formation (Photograph 9).

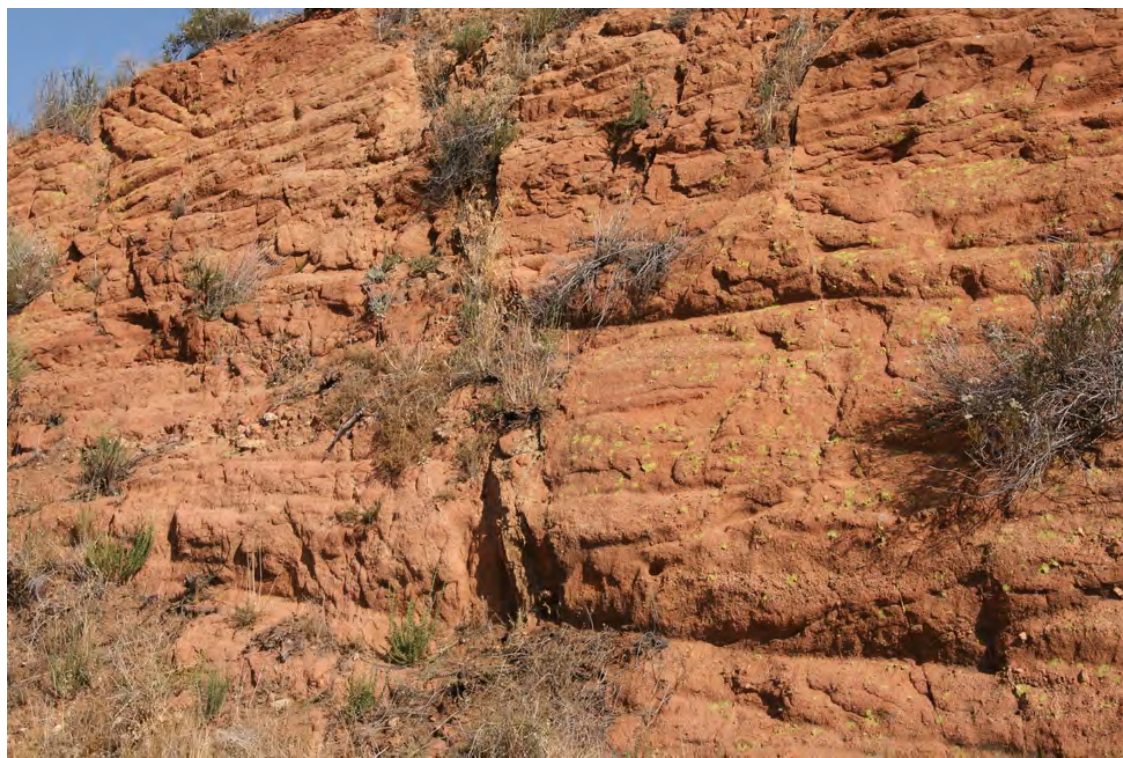
Photos 10, 11, 12, 13, and 14. Some of the individual faults interpreted as individual small faults of the major Dellamont fault exposed in Mount Eden formation just west of the entrance road to the Betatron. All photos are looking northwest. Photo 10 is the westernmost fault exposed in the road cut.

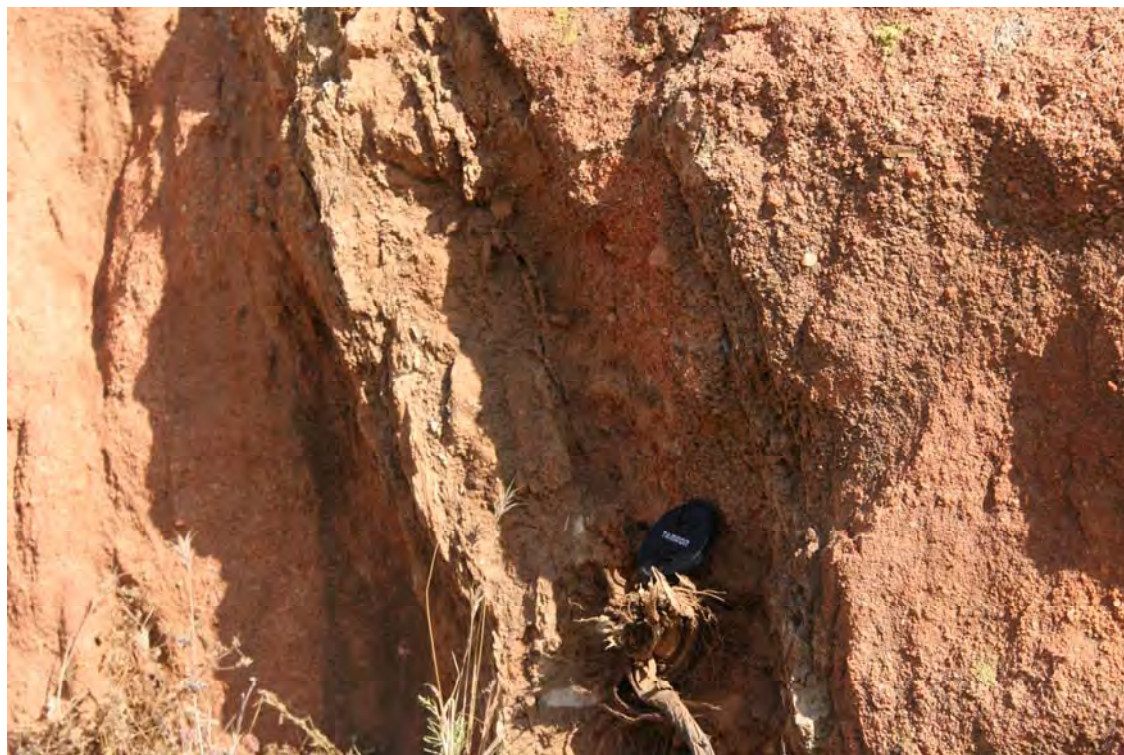
Photo 11. A close-up of a gouge within the fault in Photo 10.

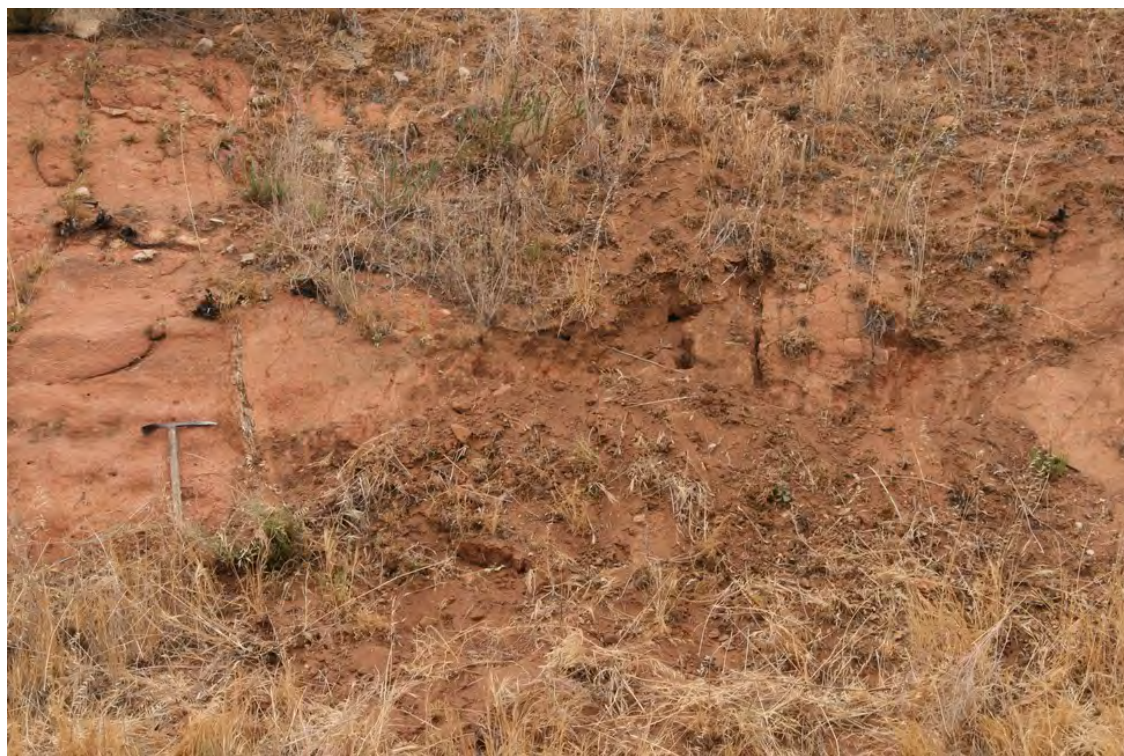
Photo 12. Three closely-spaced faults of the Dellamont fault. The fault to the right of the ice axe has carbonate filling. The other 2 faults are marked by soft zones (excavated here) along the faults.

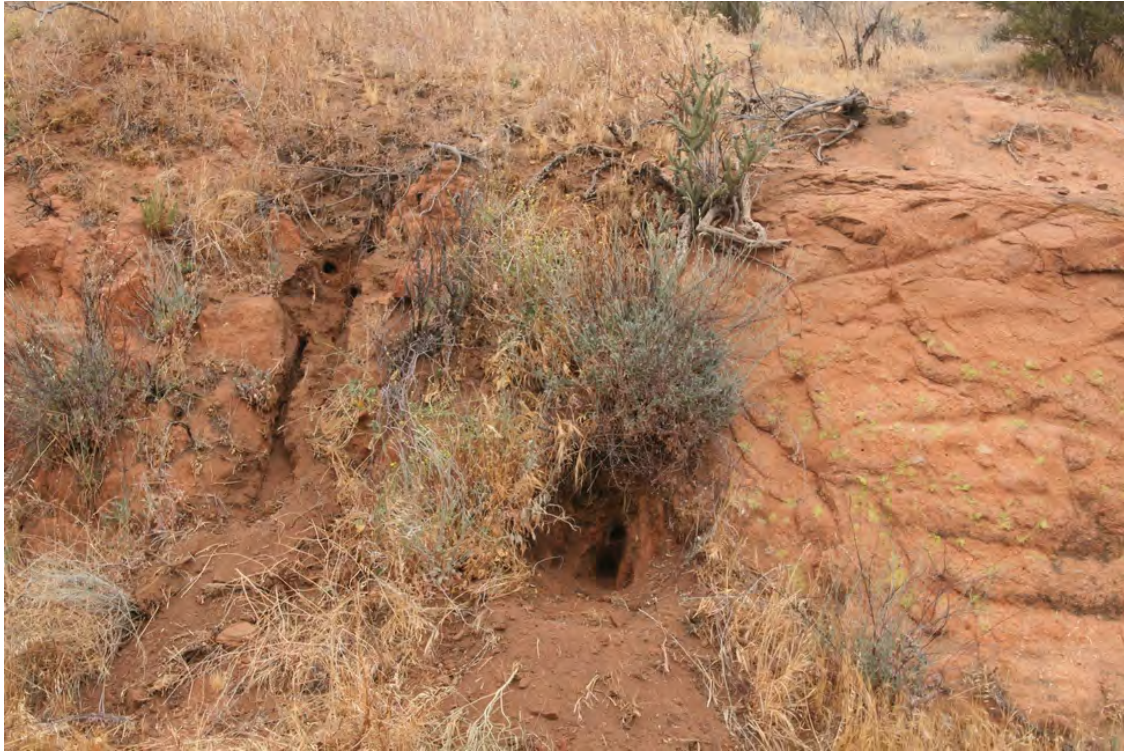
Photo 13. Two closely-spaced faults with decomposed and easily weathered Mount Eden formation along the faults.

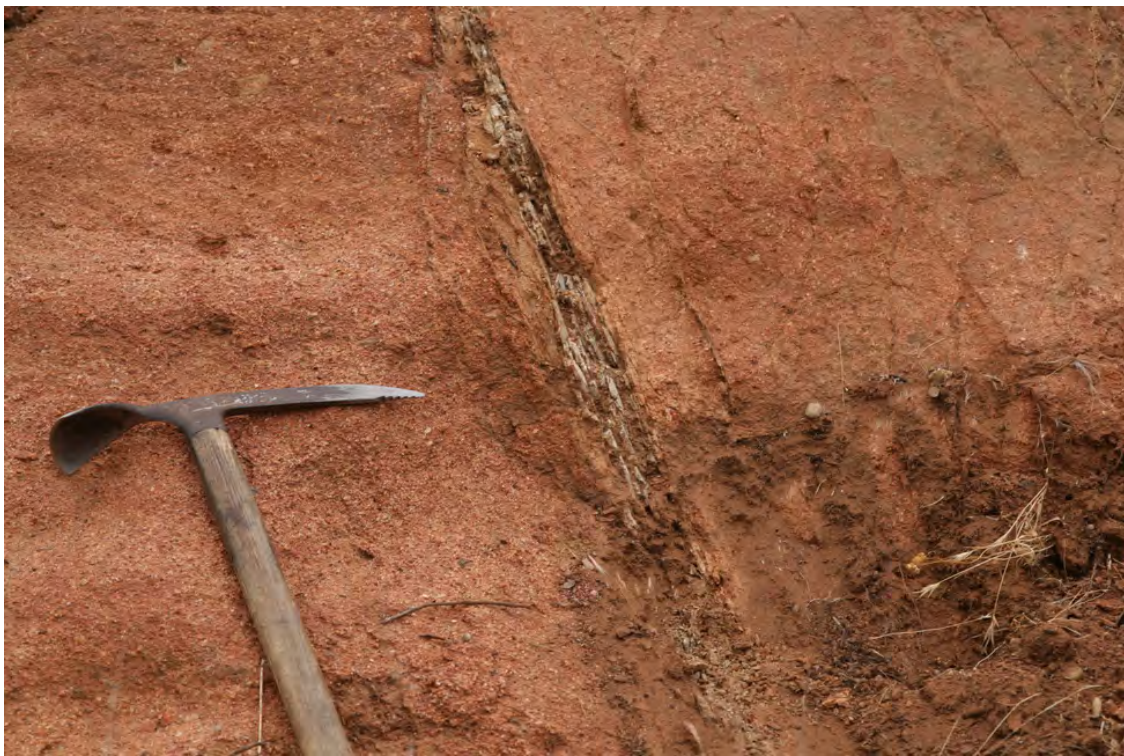
Photo 14. A close-up of the carbonate-filled fault.

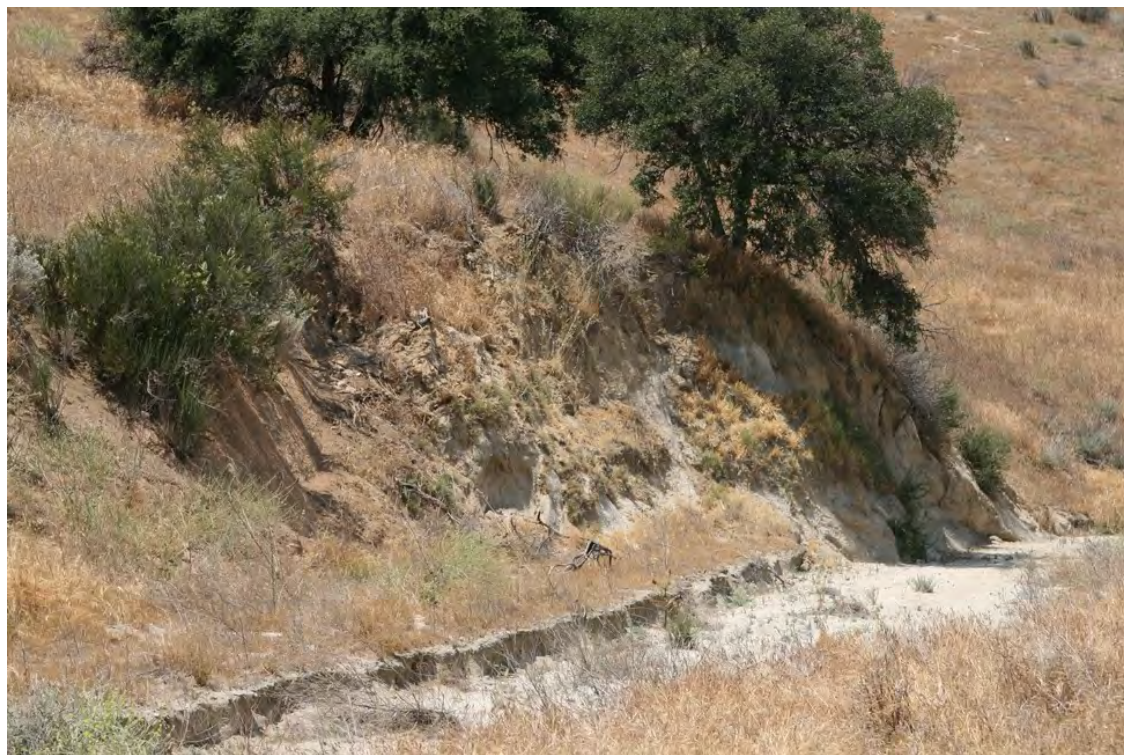
Photo 15. The Dellamont(?) fault northwest of the Betatron area exposed on the bank of a small stream. Fault juxtaposes red Mount Eden formation on the left with creamish-colored Mount Eden on the right. Fault dips about 80' to the northeast. View looking northwest

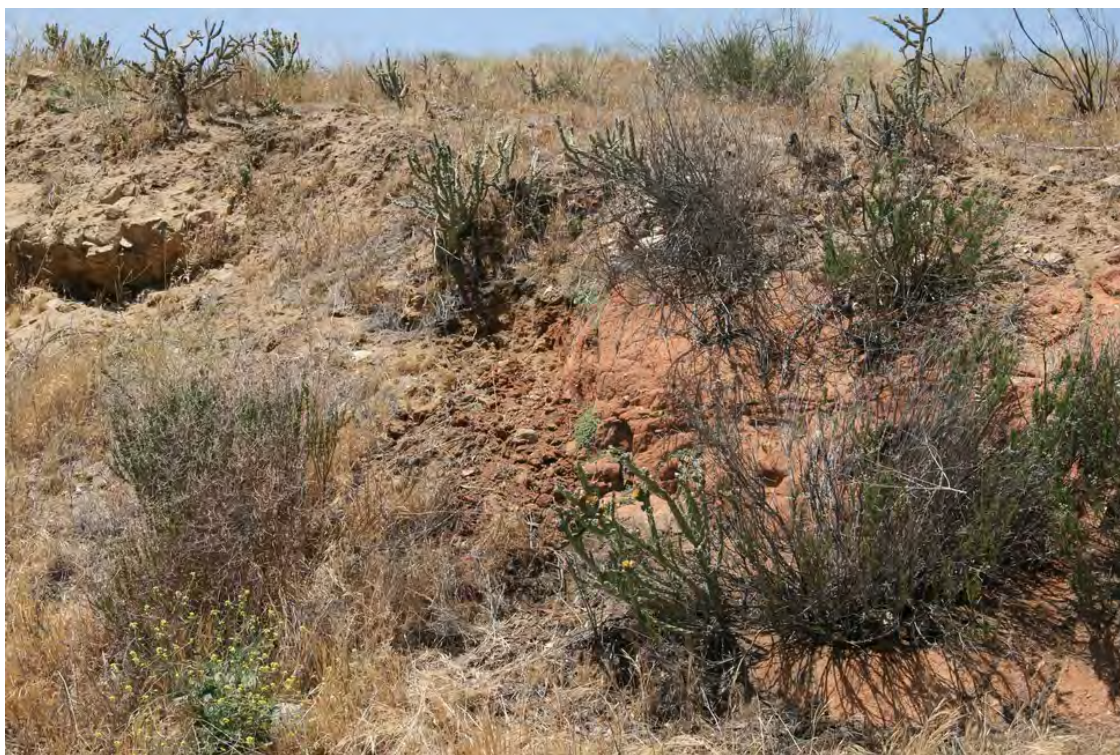
Photo 16. A branch of Fault D exposed at entrance road to Betatron. Fault juxtaposes reddish Mount Eden formation on the right with grayish Mount Eden formation on the left. View looking northwest.

The location of Fault D is poorly constrained on the north side of Claremont ridge. It apparently is located in a stream course before reaching Potrero. North of Potrero Creek, 2 parallel faults located just beyond the start of the road leading to the Betatron Building appear to be the northward extension of Fault D. The first fault seen on the entrance road has red-colored Mount Eden formation on the northeast side of the fault and greenish-tan Mount Eden formation on the southwest side (Photograph 16). The second fault has reddish-colored Mount Eden formation on the southwest side. A third fault well exposed immediately east of the Betatron building (Photograph 17) is probably the west side of the D Fault zone; this would make a 200 foot wide set of faults. Two faults exposed in young alluvium in a vertical bank of Potrero Creek appear to be faults associated with the Fault D zone (Photographs 18 and 19). About 600 feet northwest of the Betatron Building, Fault D appears to split with a western branch joining the Dellamont fault and an eastern branch continuing along strike. Locally the continuation of Fault D is well exposed in a gully as a 6-foot-thick zone that dips 77° to the northeast. Although the area where the splay of Fault D merges with the Dellamont fault is a topographic high, structurally it is a graben based on 2 occurrences of San Timoteo formation. The San Timoteo formation is restricted to the area between the 2 faults and does not occur on topographically high ground northwest of the Dellamont fault.

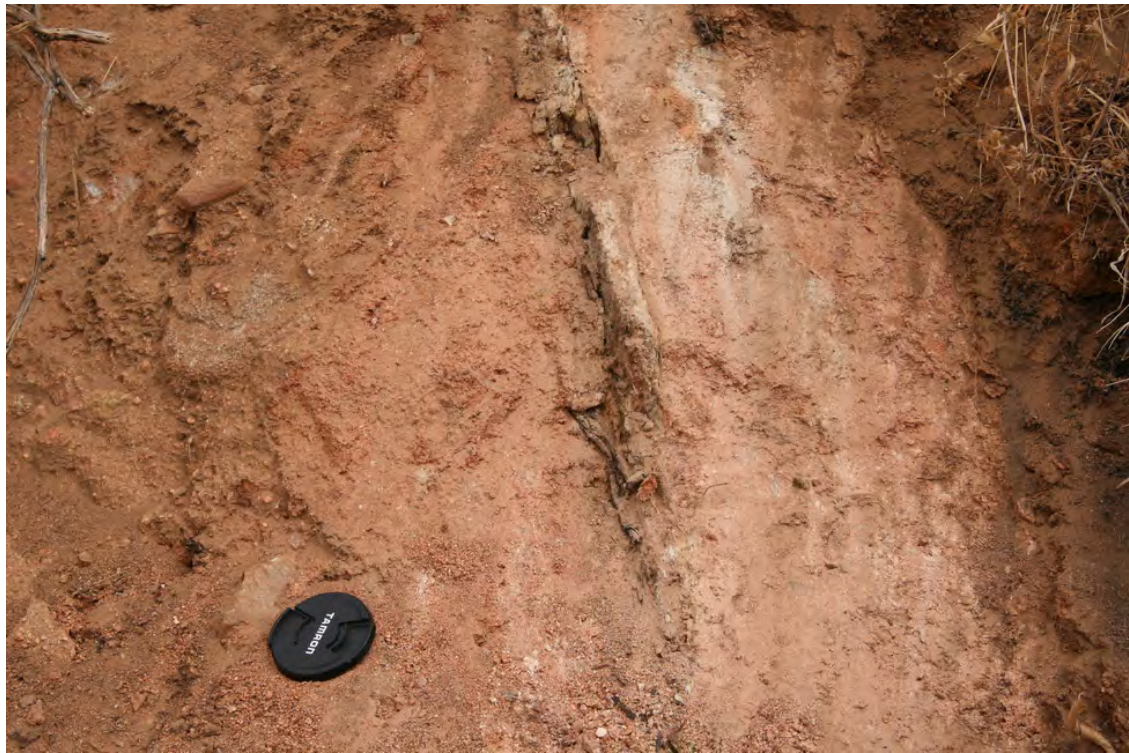
Photo 17. A branch of fault D exposed on the east side of Betatron. View looking northwest.

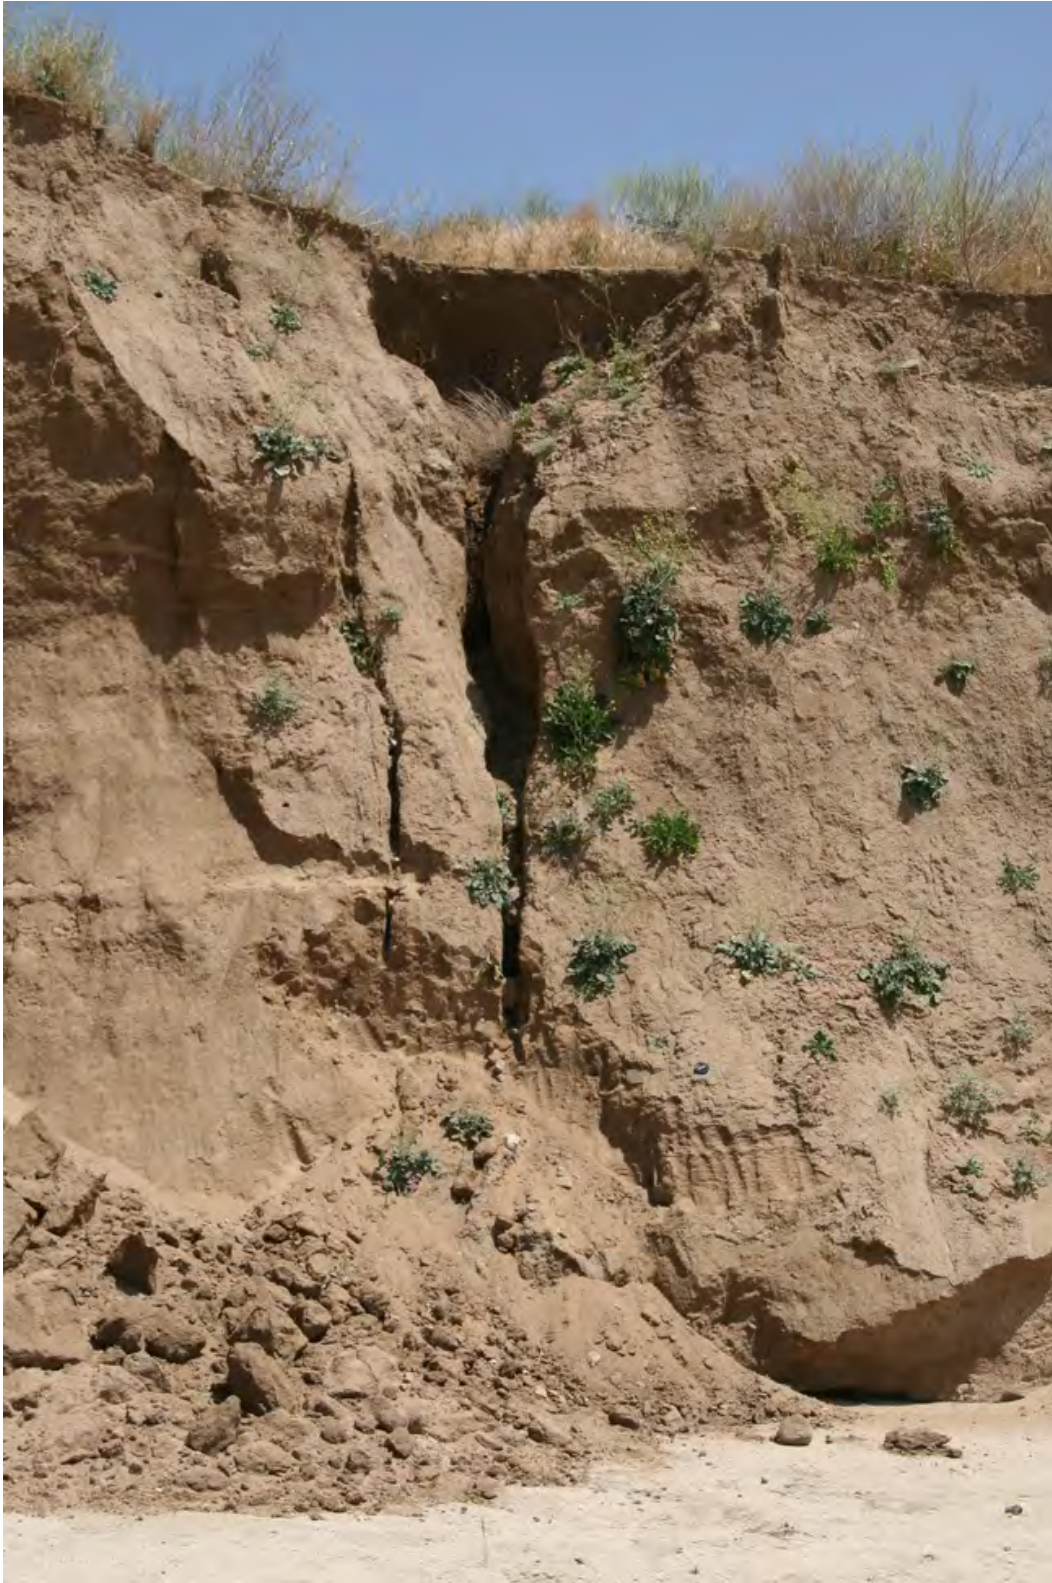
Photo 18. Two closely-spaced branches of fault D(?) exposed in Quaternary alluvium in bank of Potrero Creek southeast of Betatron. View looking southeast.

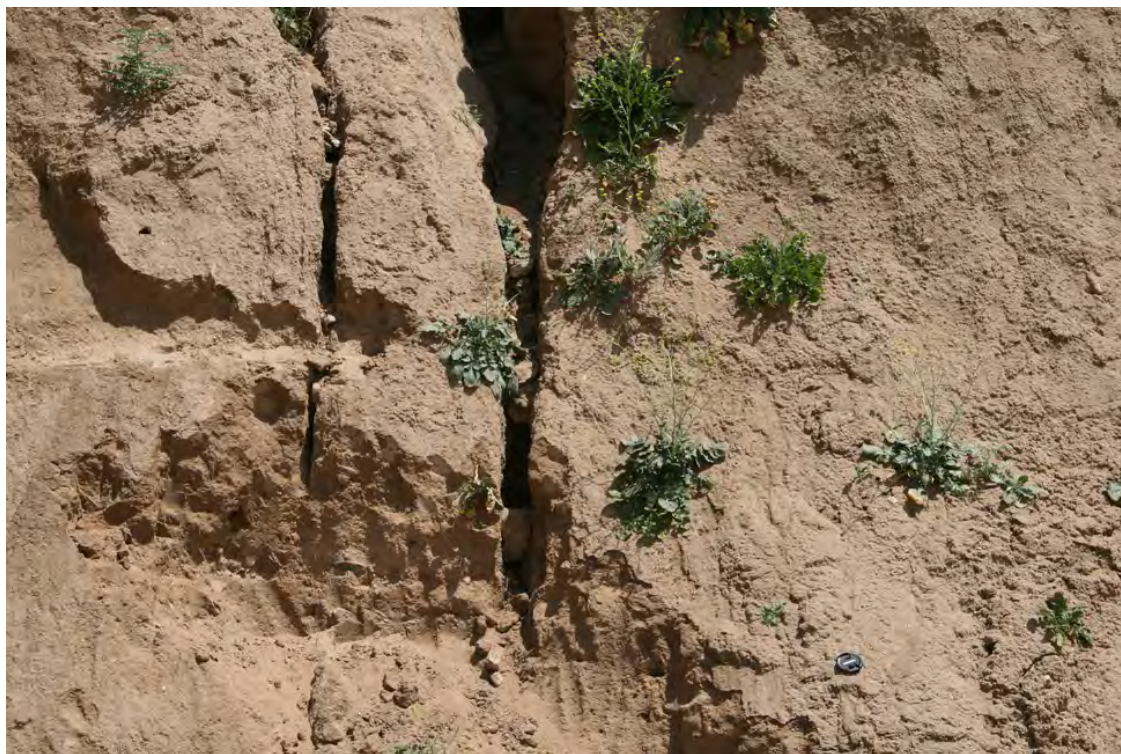
Photo 19. A close-up of the 2 breaks in Fault D; note the bed in the center of the photo does not appear to extend past the right break.

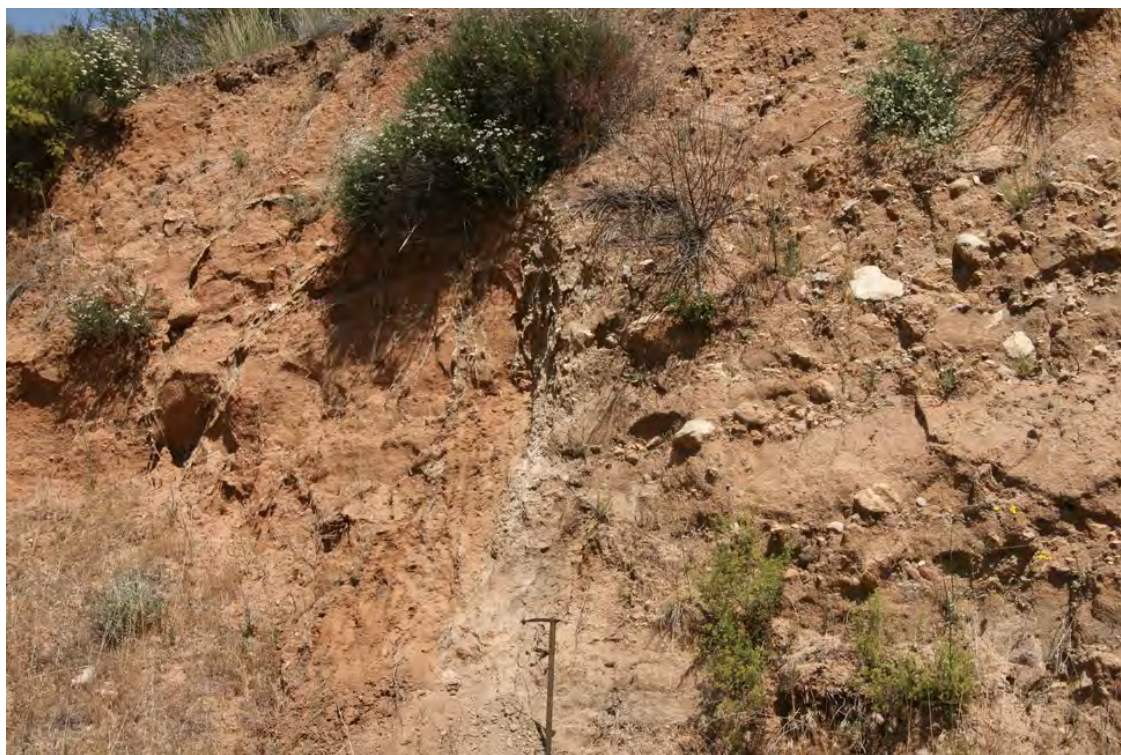
Photo 20. Fault located in the Potrero fault zone. Fault juxtaposes reddish arkosic Mount Eden formation with grayish conglomeratic sandstone. Fault is oriented about 45° from the strike of the Potrero fault zone.

Albeit troublesome, the best exposed fault located in at least close proximity to the Potrero fault is oriented about 45° to the strike of the Potrero fault (Photograph 20). The orientation of this fault may be a result of rotation between the 2 faults constituting the Potrero fault zone. A change in the nature of Mount Eden beds 2,000 feet northwest of the Potrero shaft is interpreted to be the location of the Potrero fault. The Potrero fault projects northwestward into Potrero Valley. Dense growths of sedges on a slightly elevated oxbow stream bed at 33° 51' 40.6" 116° 56' 27.2" suggests relatively high groundwater, likely due to a nearby fault. Geometrically the Potrero fault is the most likely fault in this area.

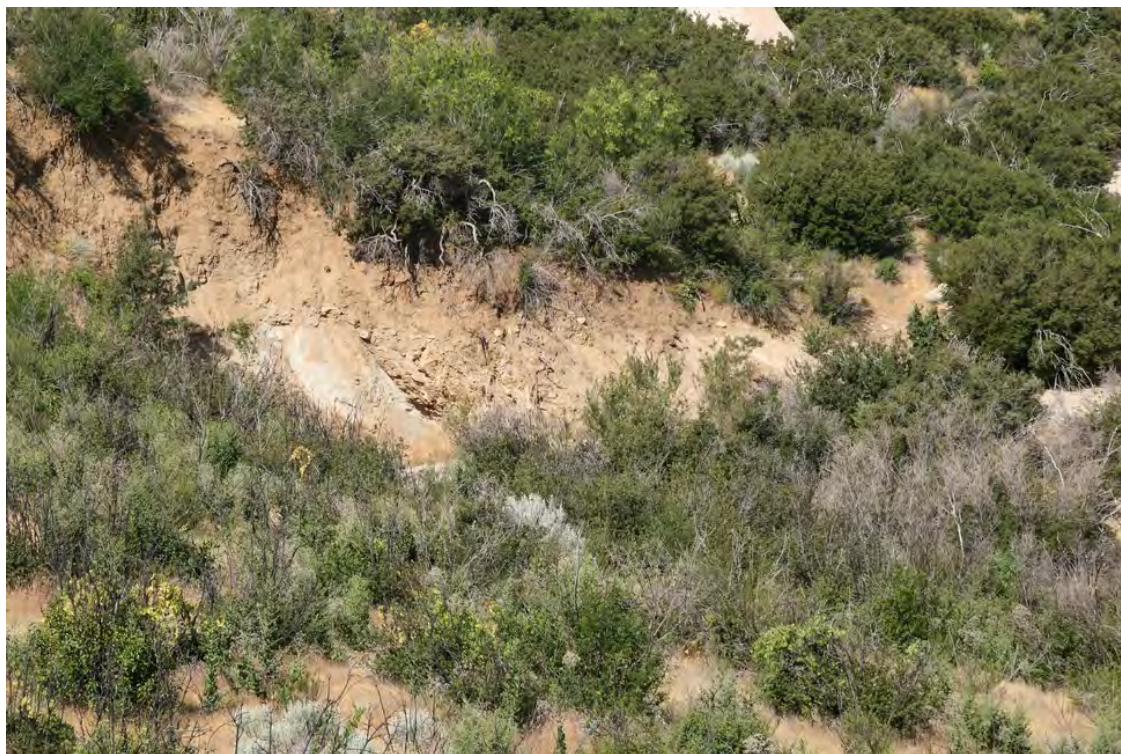
Photos 21, 22, and 23. Goetz fault zone. Photo 21. View looking west showing exposure of Goetz fault in stream bank. Fault is overlain by thin bed of basal conglomeratic stream sediments in turn overlain by colluvial debris.

A rather exhaustive search was made to locate Goetz faults. Only 2 Goetz fault exposures east of Site 1 were located. These 2 faults are very different from one another. The northern fault is the most planar fault seen in the area of Site 1 (Photographs 21, 22, and 23). The fault includes about 10 feet of brecciated rock and several inches of finely comminuted gouge. The fault juxtaposes schist on the south against tonalite on the north. The fault strikes $N 80^{\circ}-85^{\circ} E$ and dips 50° to the north. The low dip suggests this may be the surface expression of the northern low-angle hanging-wall fault encountered in the San Jacinto tunnel. The southern fault is a very unusual zone of disrupted rock with slickensides in a wide variety of orientations (Photographs 24 and 25). Measurements of a few slickensides are, $N65^{\circ}E$, $81^{\circ}NW$, $N47^{\circ}E$, $70^{\circ}NW$, $N48^{\circ}E$, $77^{\circ}NW$, $N13^{\circ}E$, $72^{\circ}NW$, $N80^{\circ}E$, $43^{\circ}NW$, Due North, dipping $52^{\circ}E$, $N5^{\circ}W$ $68^{\circ}NE$. Little confidence can be placed on the accurate orientation of this zone. Guilt by spatial association, this fault is drawn parallel to the northern fault. Both faults are interpreted as being terminated by Fault F.

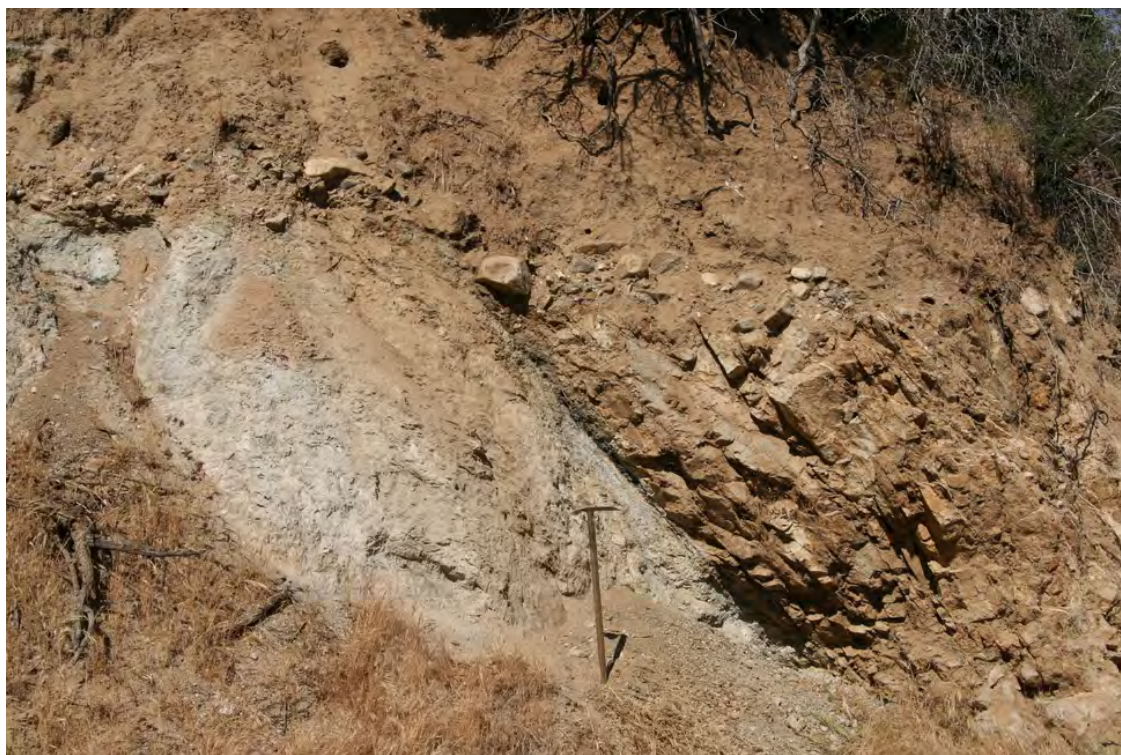
Photo 22. Goetz fault, dipping 50° north. The fault juxtaposes metamorphic rocks on the left with biotite-hornblende tonalite on the right. Fault zone is about 10 feet thick. Fault is overlain by conglomeratic stream deposit and colluvial material. Note offset basal bed with offset down to the right.

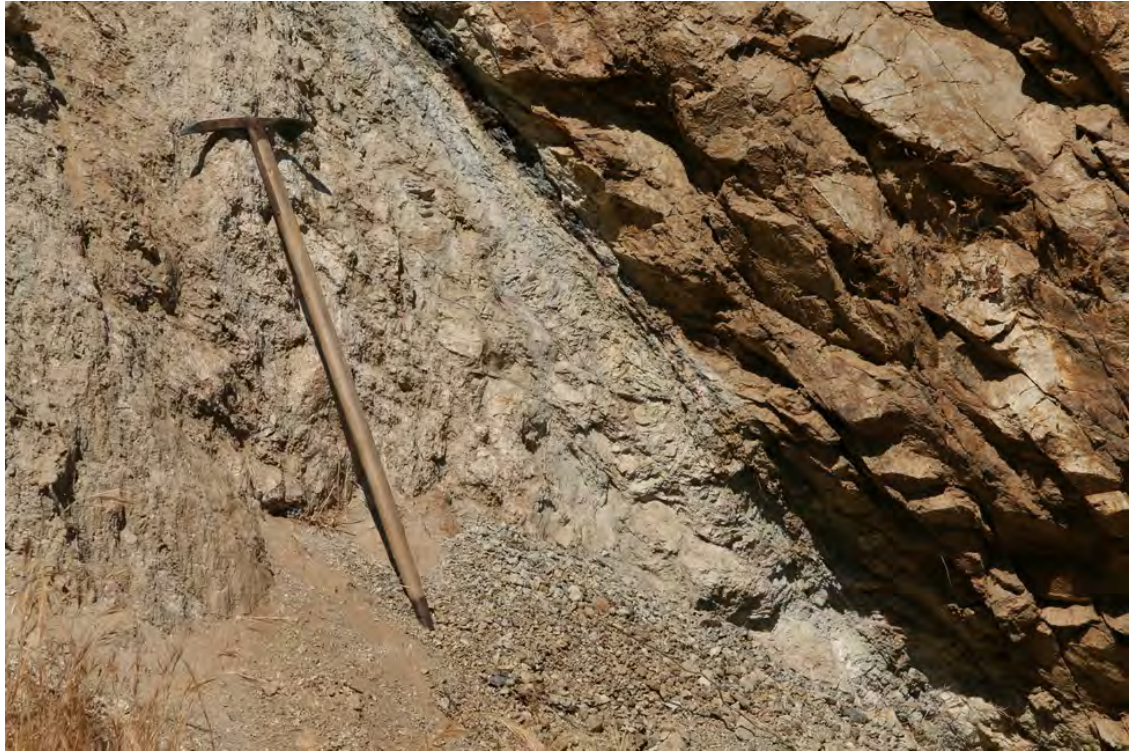
Photo 23. Close up of the Goetz fault showing 1-3-inch-thick dark-colored gouge.

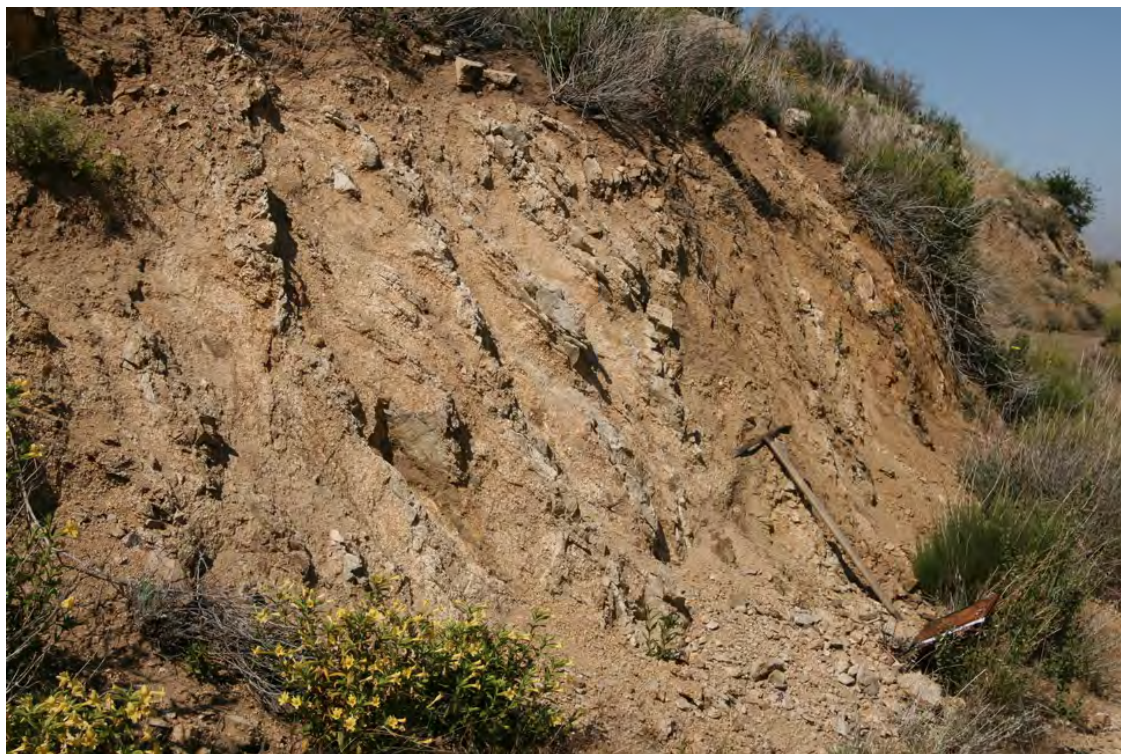
Photos 24 and 25. Thick shear zone interpreted as the southern part of the Goetz fault zone. View looking southwest.

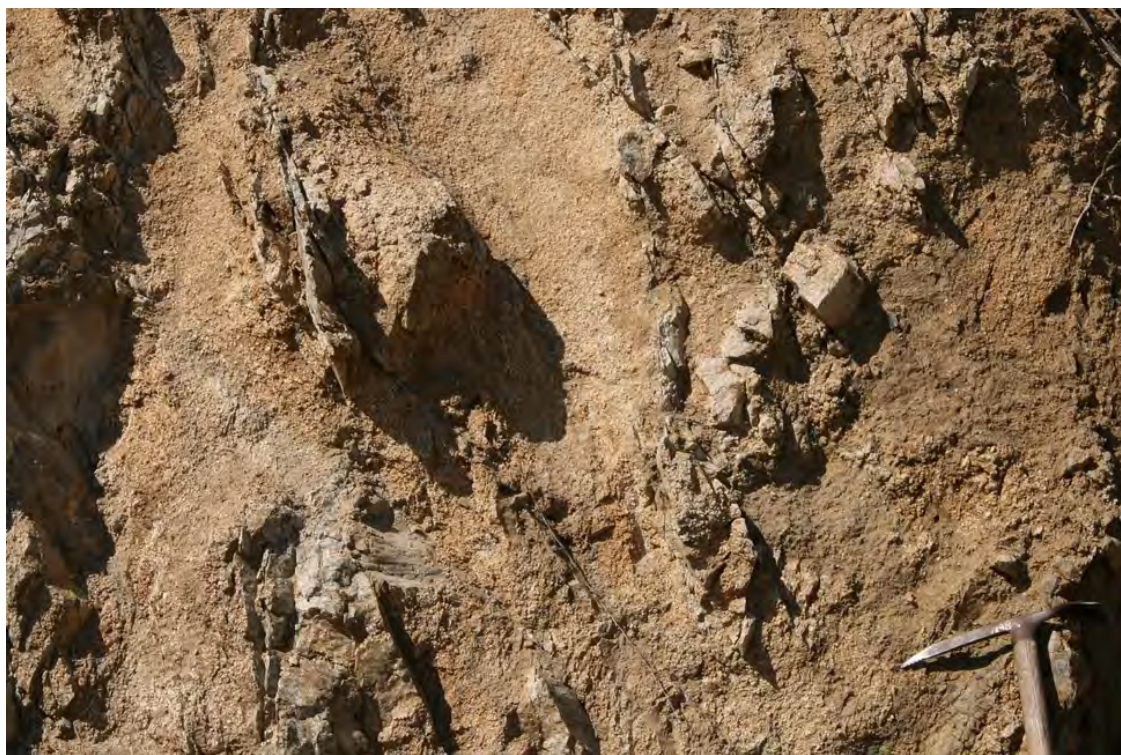
Photo 25. Detail of the shear zone. Note some slickensides oriented near normal to the outcrop face and other shears oriented parallel to the outcrop face with horizontal slickensides.
