Lineament Study Lockheed Martin Corporation, Beaumont Site 1 Beaumont, California

The primary objective of this investigation was to perform a structural analysis of Potrero Valley (i.e., lineament study and geologic mapping) to better understand the influence of local faulting and fracturing on groundwater flow in the area. Douglas M. Morton, PhD, a retired geologist from the U.S. Geological Survey and regional expert on the structural framework and geologic history of the Transverse and Peninsular Ranges of southern California, performed this lineament study under subcontract to Tetra Tech, Inc. The lineament study at Site 1 consisted of the following Tasks: Task 1 was an archival literature and stereographic aerial photography search followed by analysis of available literature; Task 2 was identification of lineaments on archival aerial photography; and Task 3 was a geologic field investigation of Site 1. This task included checking the location of previously mapped faults, examination of various lineaments, reconnaissance geologic investigation of Site 1 area and the area east of Site 1, and geologic mapping in selected areas. Emphasis was placed on the detection of faults tha

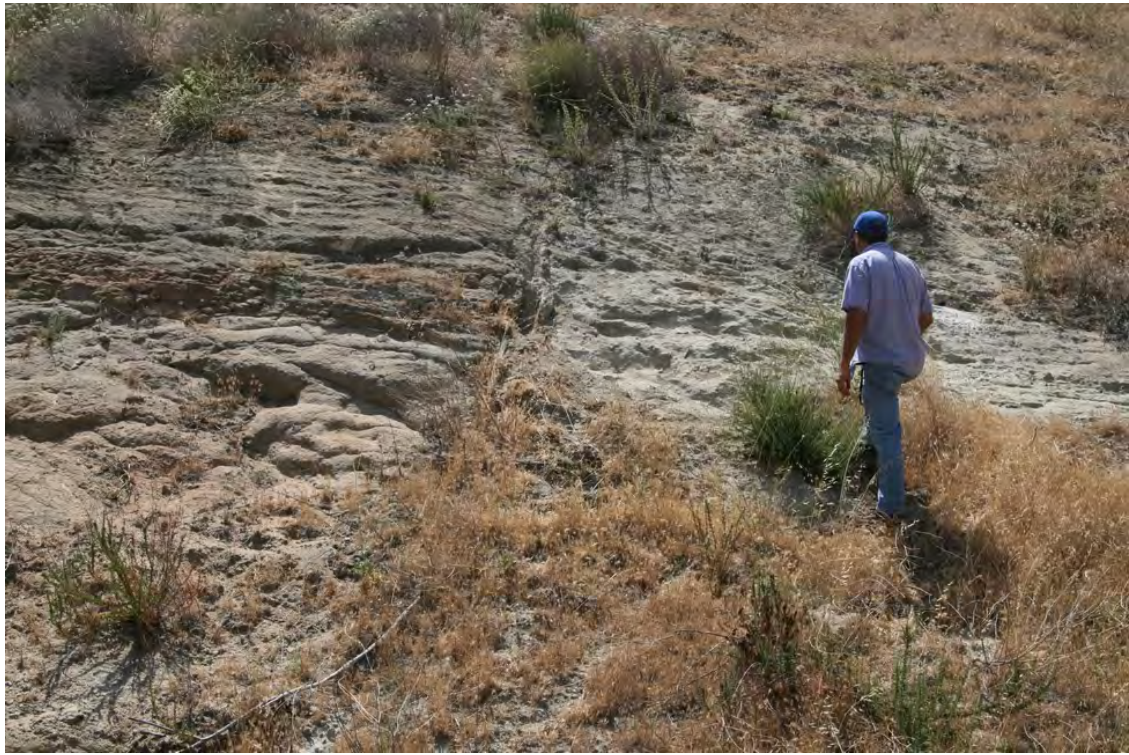
Photos 26 and 27. Photos of fault north of the Lawrence fault. Fault apparently interpreted by the Leighton Report (1986) as the Lawrence Fault. Photo 26 shows the fault in Potrero beds on the west side of Potrero Creek. View looking west.

Lawrence Fault. This northern fault is well exposed in Potrero beds (Photographs 26 and 27). To the east of the well exposed fault is a curious break that appears to be a sand-filled break (Photographs 28, 29, and 30) in alluvium on the east side of Potrero Creek interpreted as a fault feature.

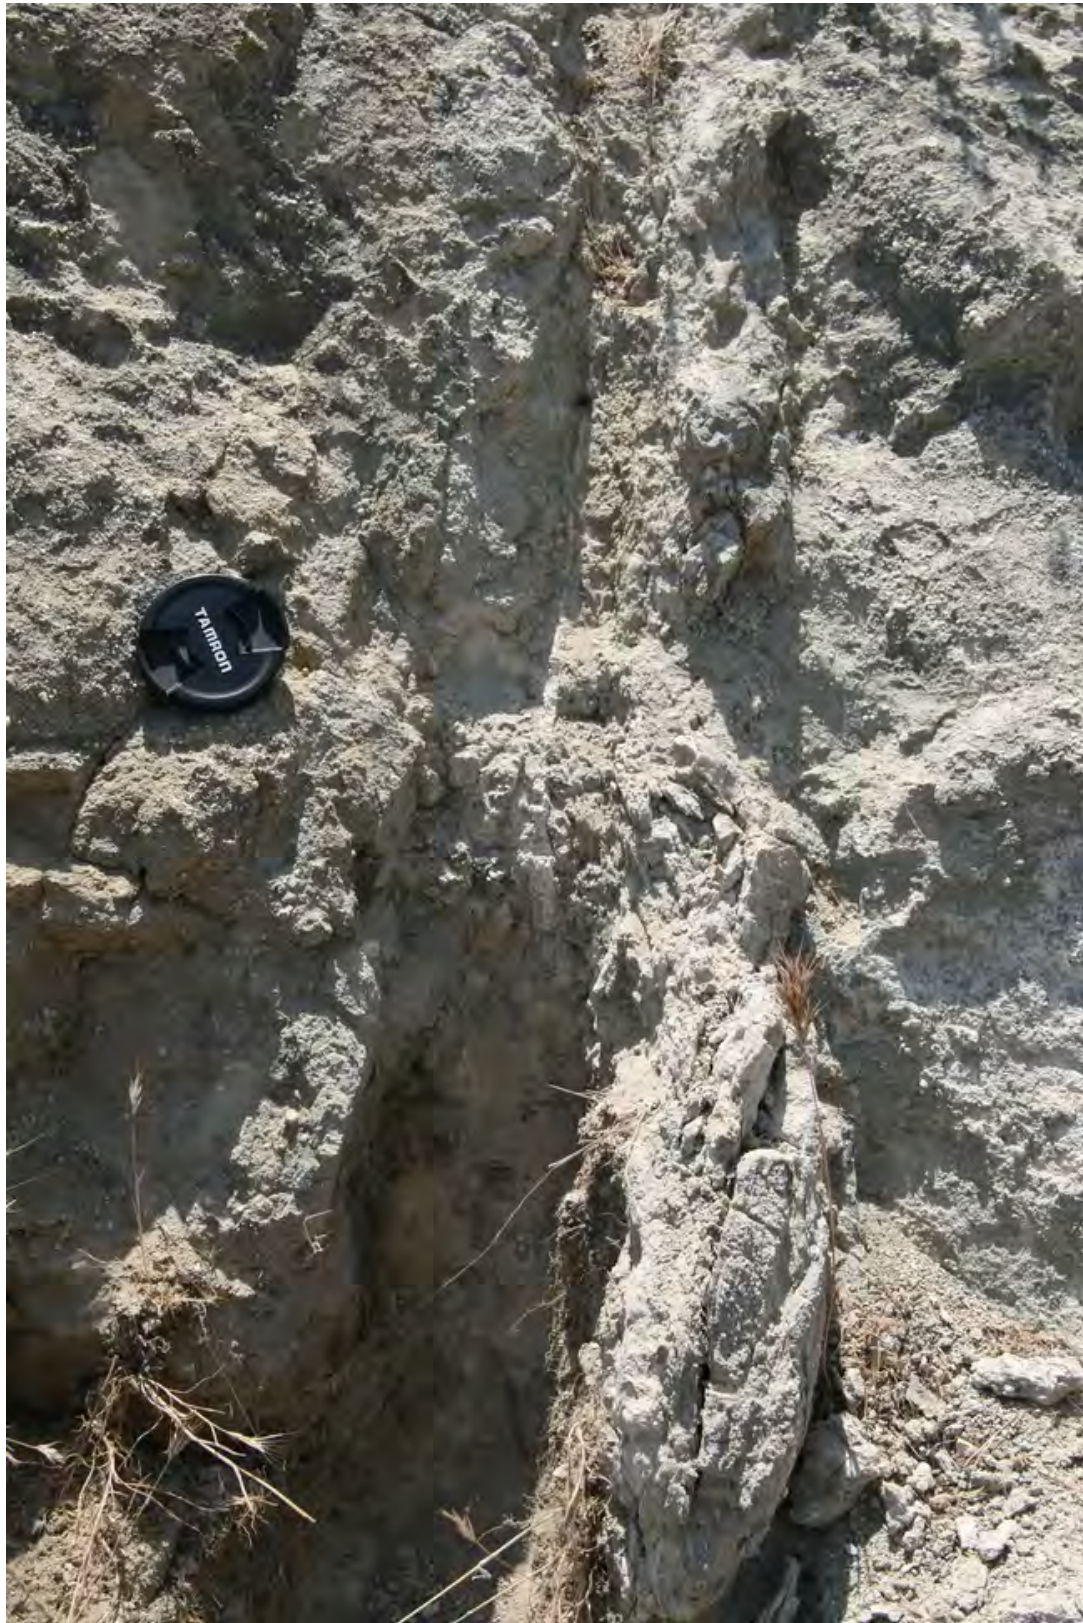
Photo 27. Details of the fault. Tectonically disturbed material is about 12 inches thick.

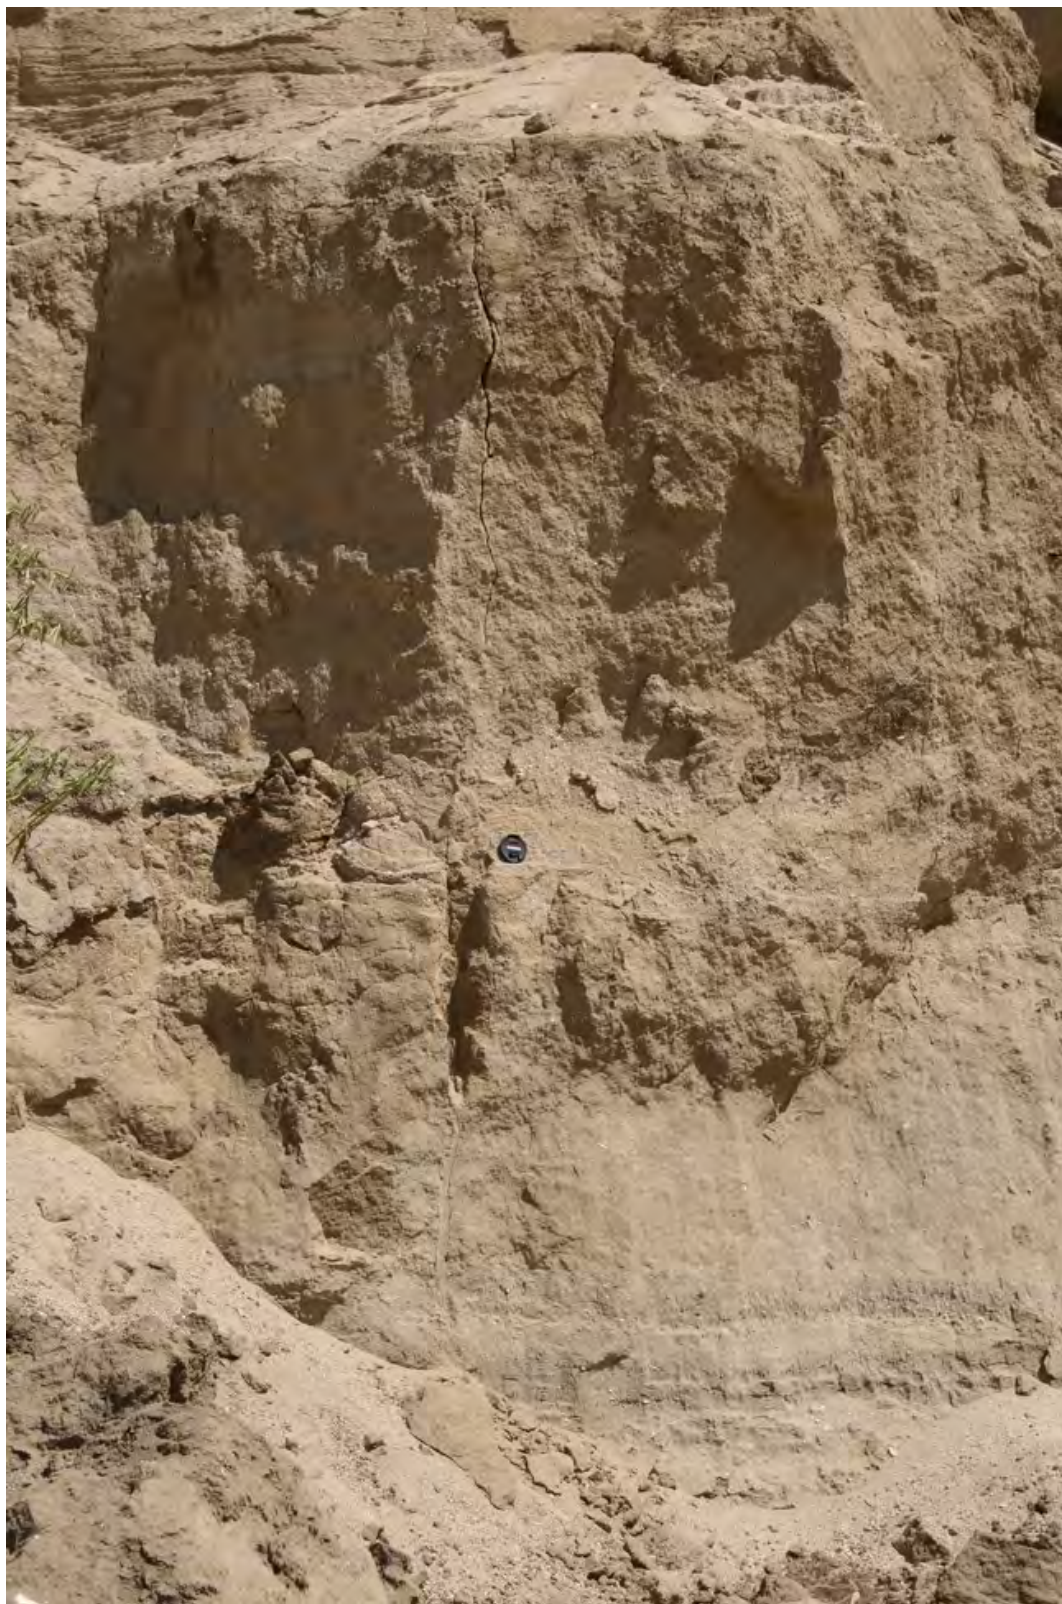
Photos 28, 29, and 30. Fault breaking Quaternary alluvium on east bank of Potrero Creek east of fault shown in Photo 26. Photo 28 shows open fracture in upper part of fracture and sand-‘filled’ lower part of fracture. View looking east.

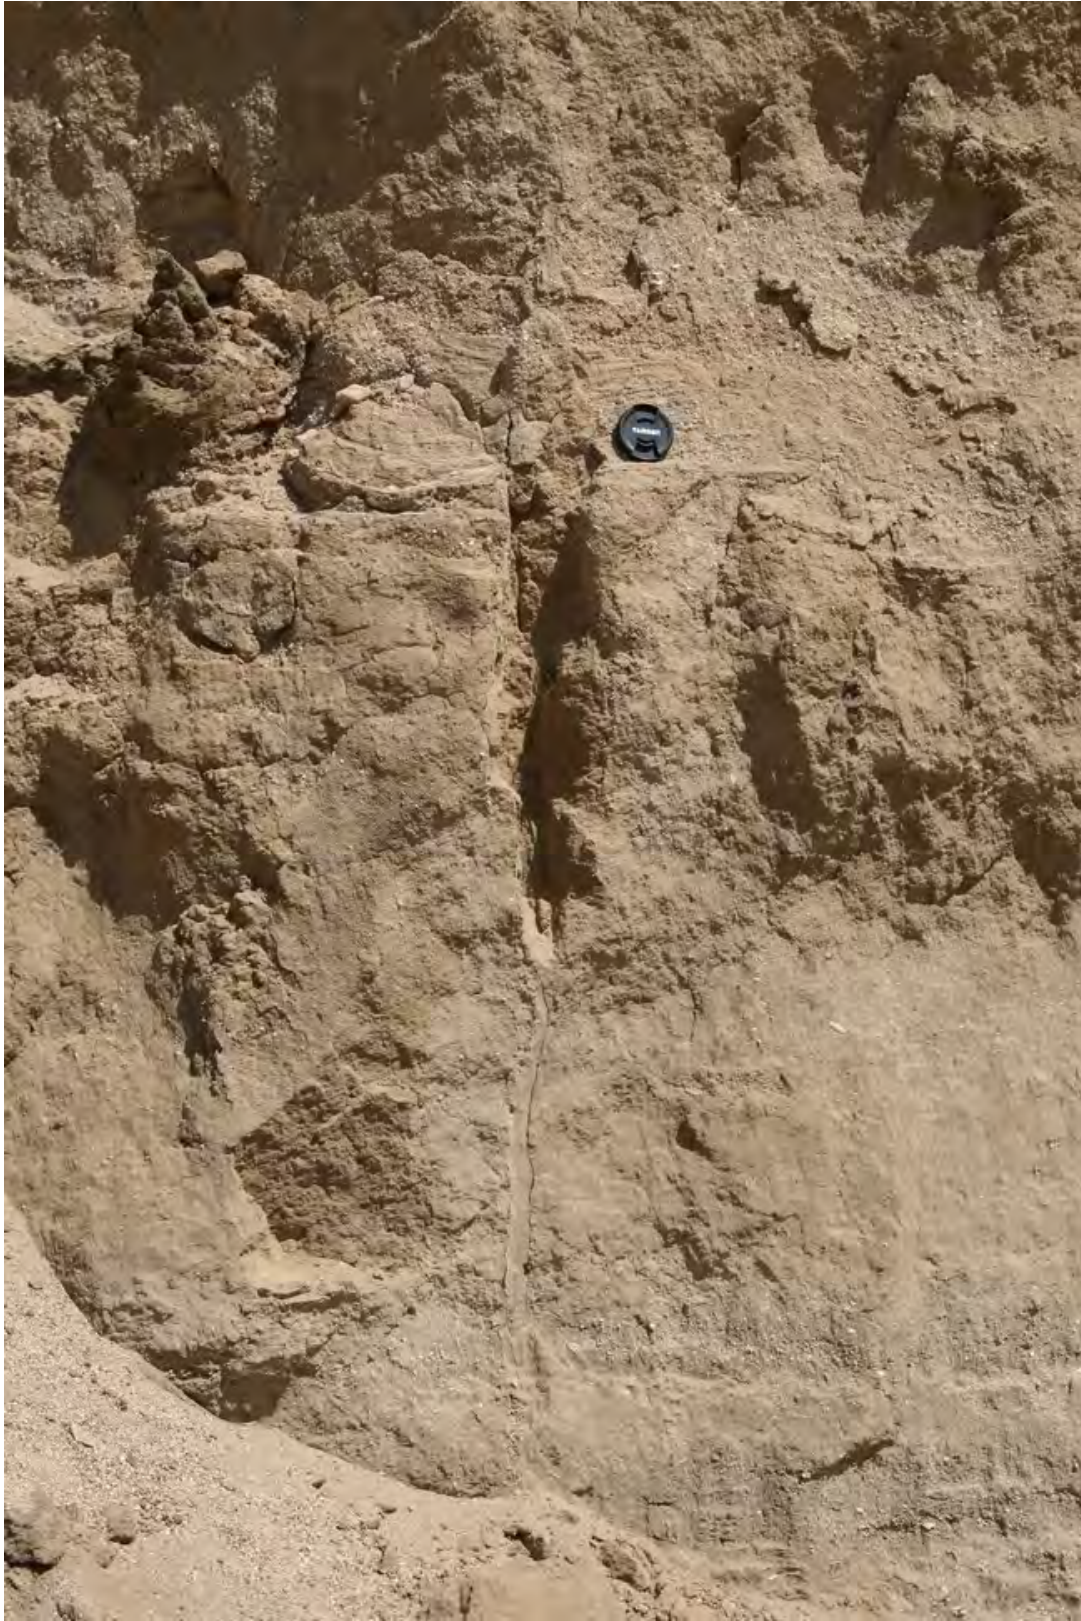
Photo 29. The transition between the open fracture and the sand-‘filled’ lower part of the fracture.

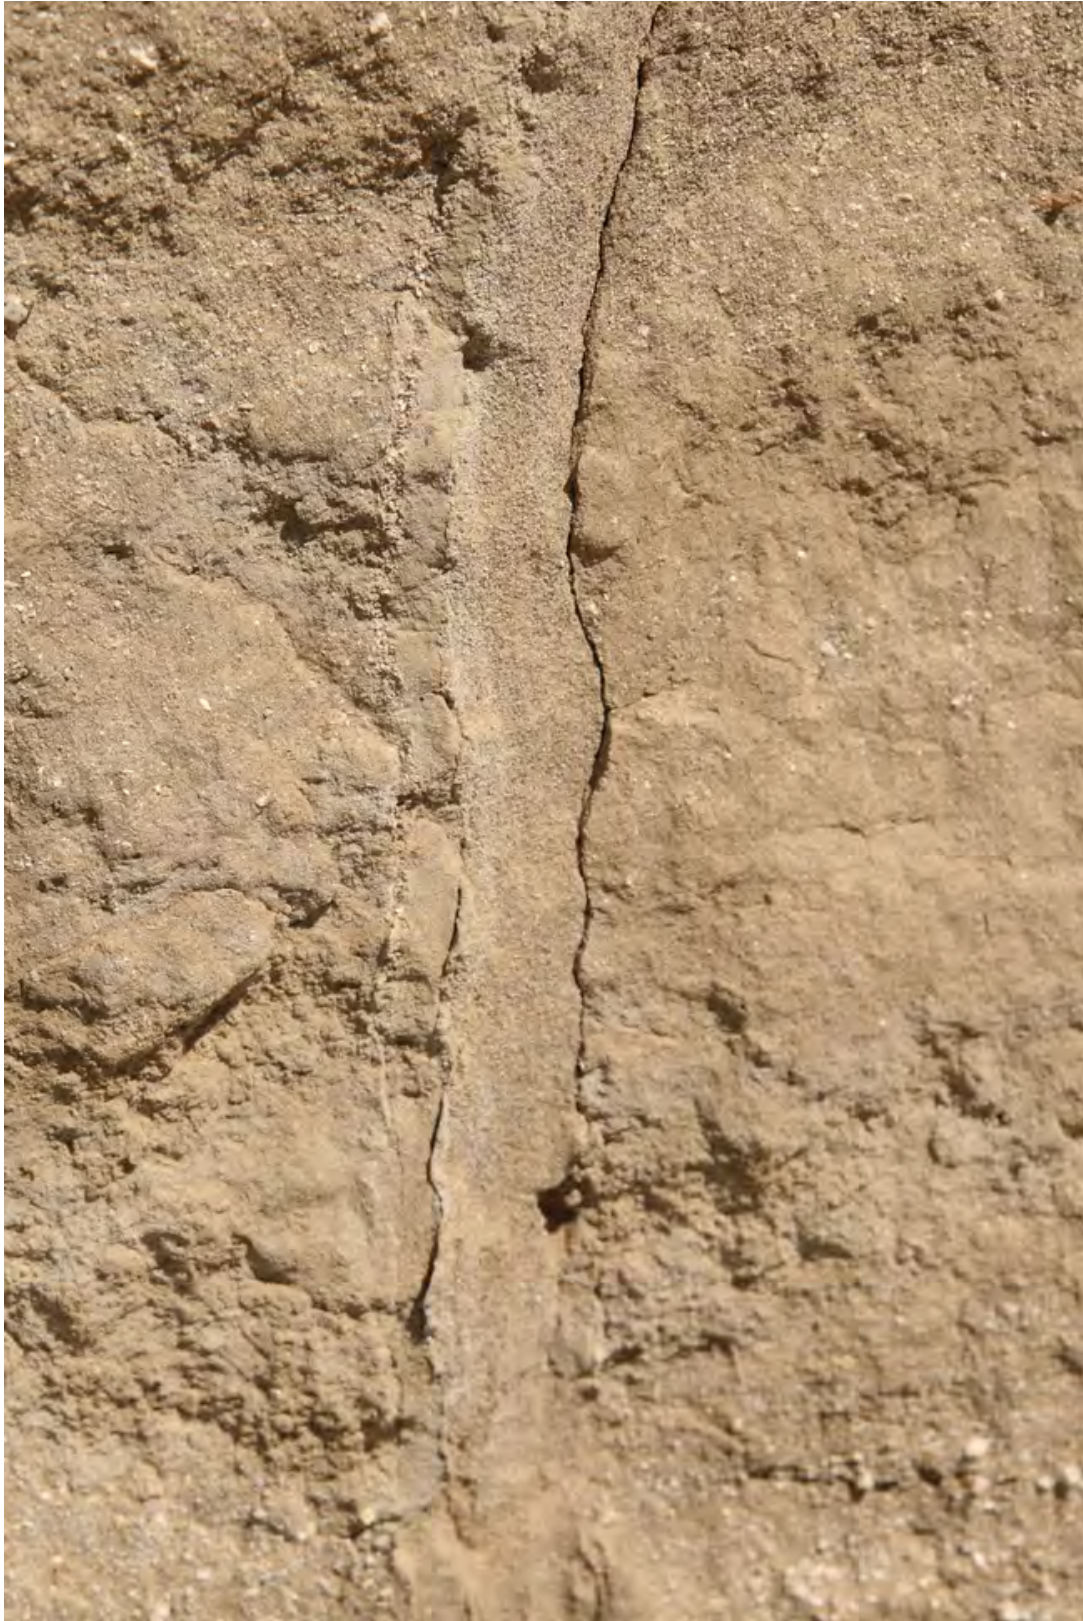
Photo 30. Detail view of the sand- 'filled' lower part of the fracture. Note the parallel fractures adjacent to the sand- 'filled' fracture.

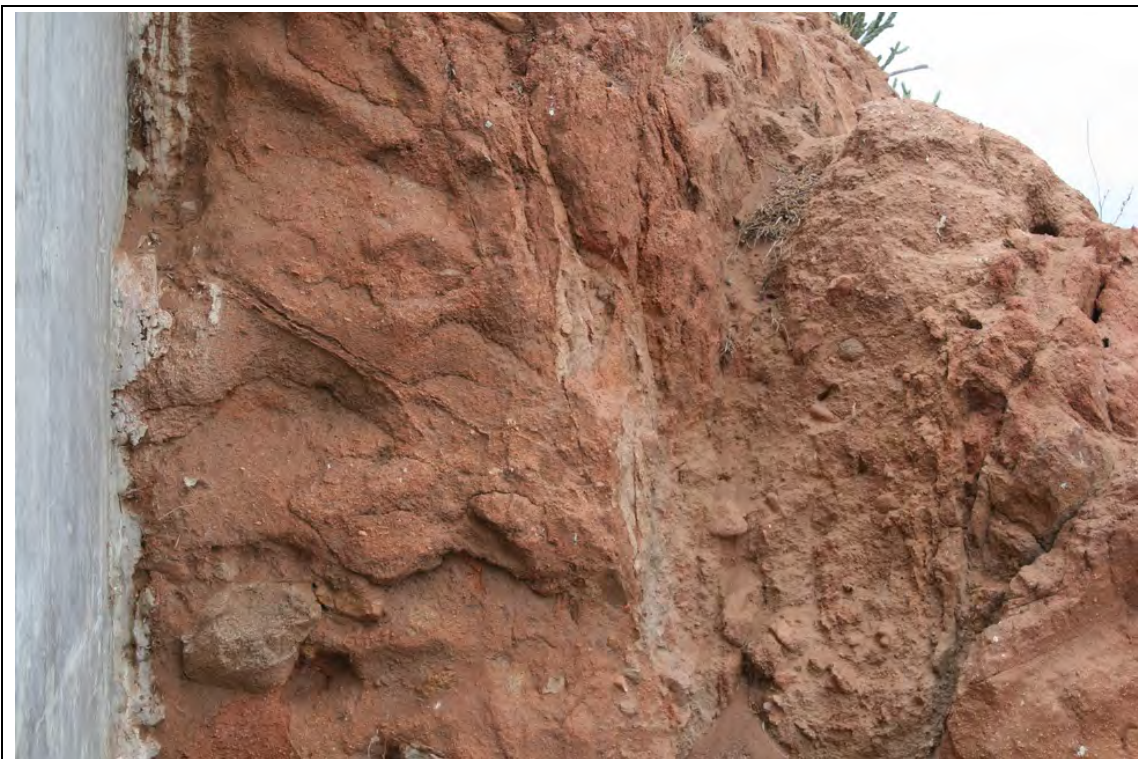
Photo 31. Northeast-striking fault exposed at the Test Personnel Bunker.

A number of minor faults of various orientations were found. Northeast striking faults occur at the Testing/Instrumentation Personnel Bunker (Feature F-45, Photograph 31) and at the low hills where the Leighton report map showed their northwest oriented Bedsprings fault (Photograph 32). A large number of north striking faults are located just west of where the road into Potrero branches ($33^{\circ} 52' 22.2''$; $116^{\circ} 55' 59.5''$). Exposed in the northern road between the branch and the site of the old Potrero ranch house and the low hills north of the old ranch house site are a number of minor north striking faults in the Mount Eden formation. Fault orientations range between $N40^{\circ}W$ and $N32^{\circ}E$ and dip at steep angles both to the

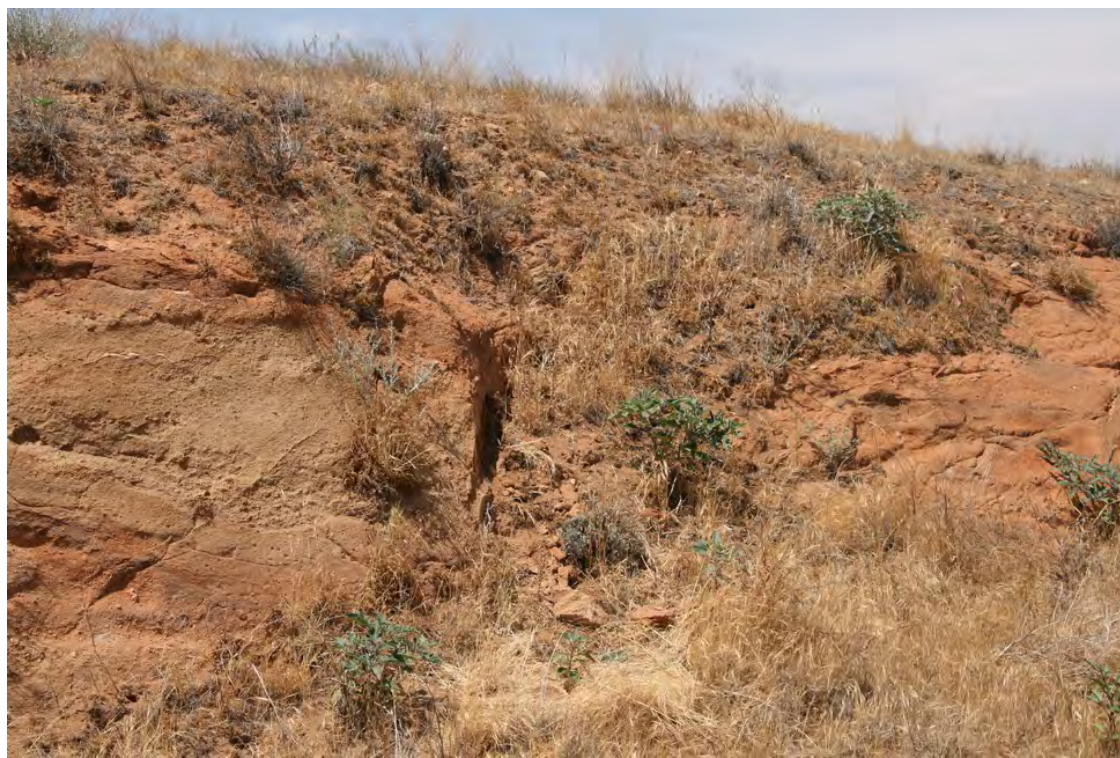
Photo 32. Northeast-striking fault exposed in a road cut in a low hill east of Potrero Creek. This is near where the Leighton report (1986) had mapped the Bedsprings fault.

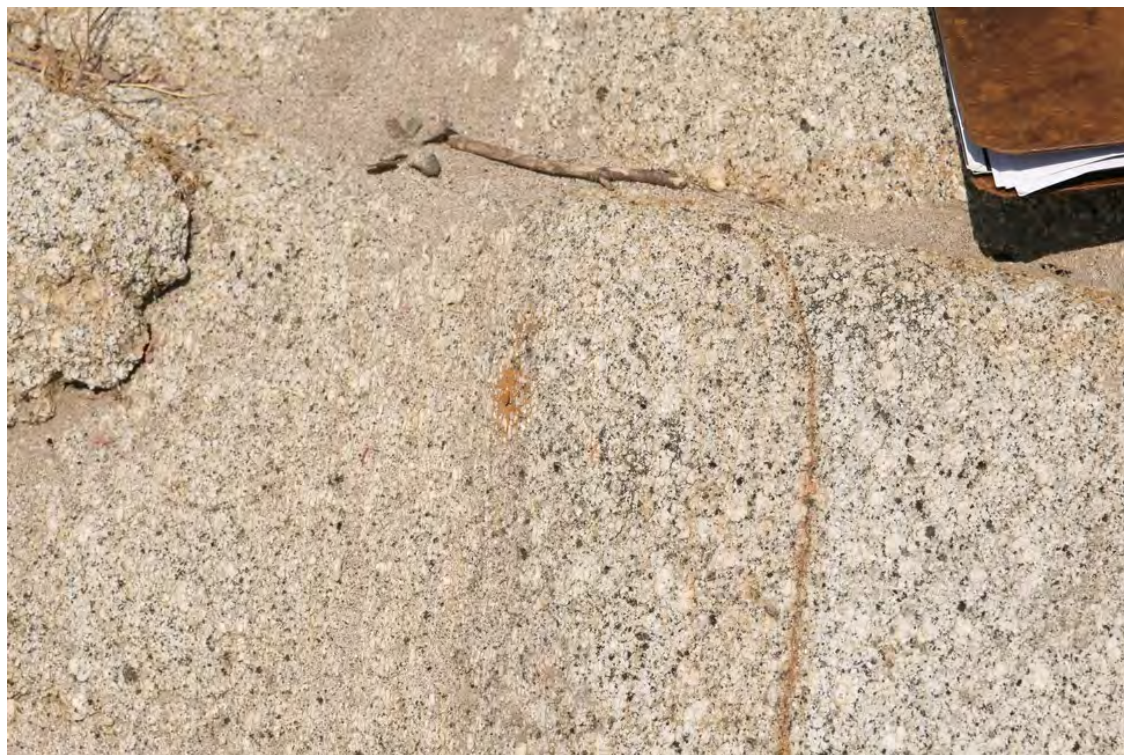
Photo 33. Tonalite located to the south of area of photo 36. Tonalite has normal texture in right half of the photograph and incipient cataclastic (protoclastic?) texture in the left half of the photo.

east and west. None of these faults were found in the tonalite exposed along the abandoned and eroded old road bed just to the south. The only deformation found in the tonalite were a few northwest oriented linear zones of incipient mylonitic fabric (Photograph 33); the texture of this deformed rock appears to be protoclastic indicating a very old age, probably Cretaceous.

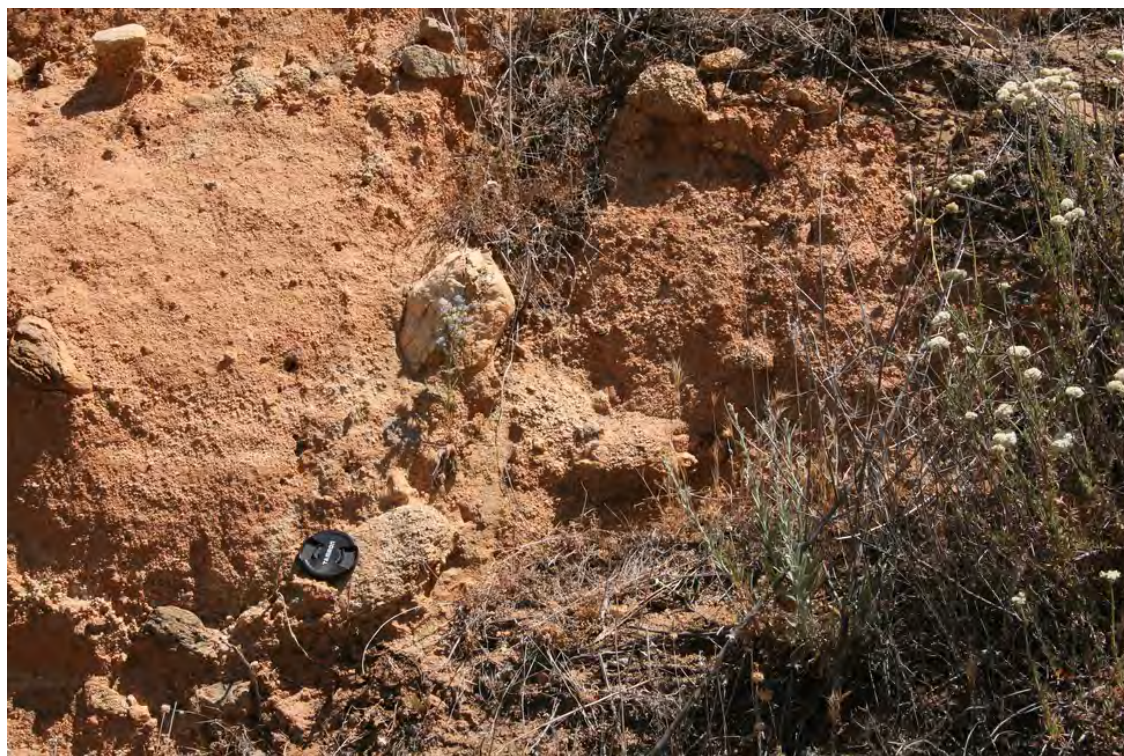
Photos 34, 35, and 36. Examples of north-striking faults in Mount Eden formation. Faults are located west of entrance road split (33° 52' 22.2"; 116° 55' 59.5"). Photo 34 has what appears to be a tectonically-rotated clast on the left side of the fault.

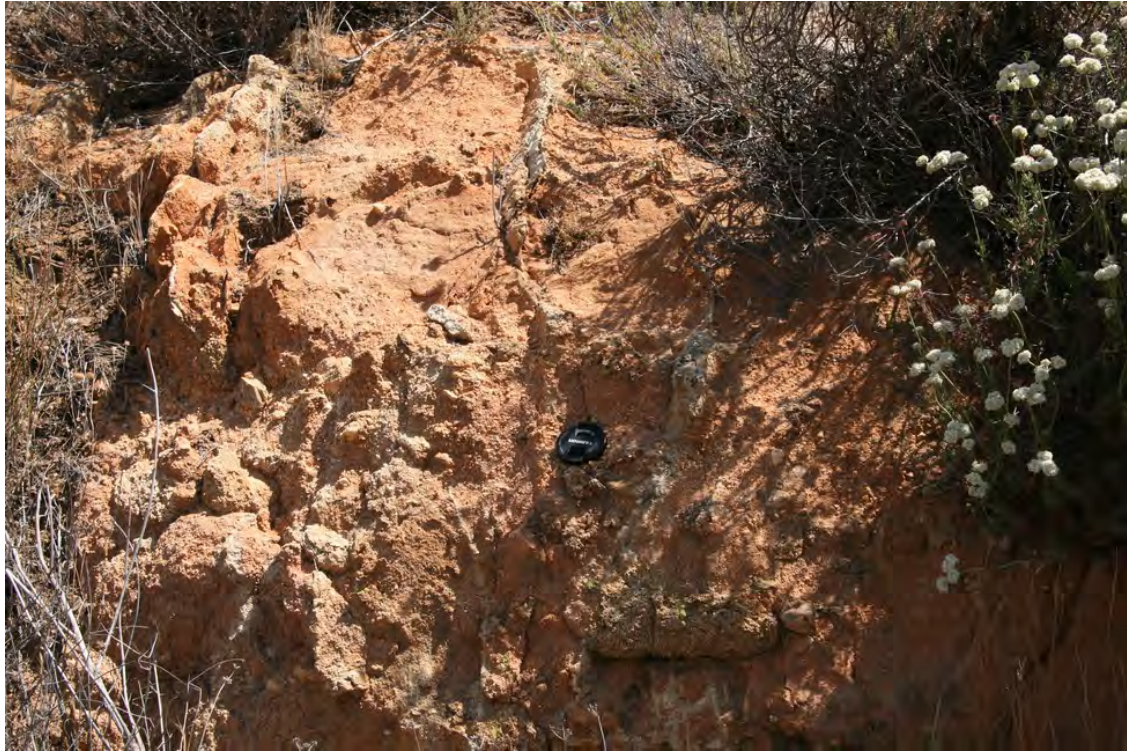
Photos 35 and 36. Multiple closely-spaced carbonate-filled minor faults west of entrance road split.

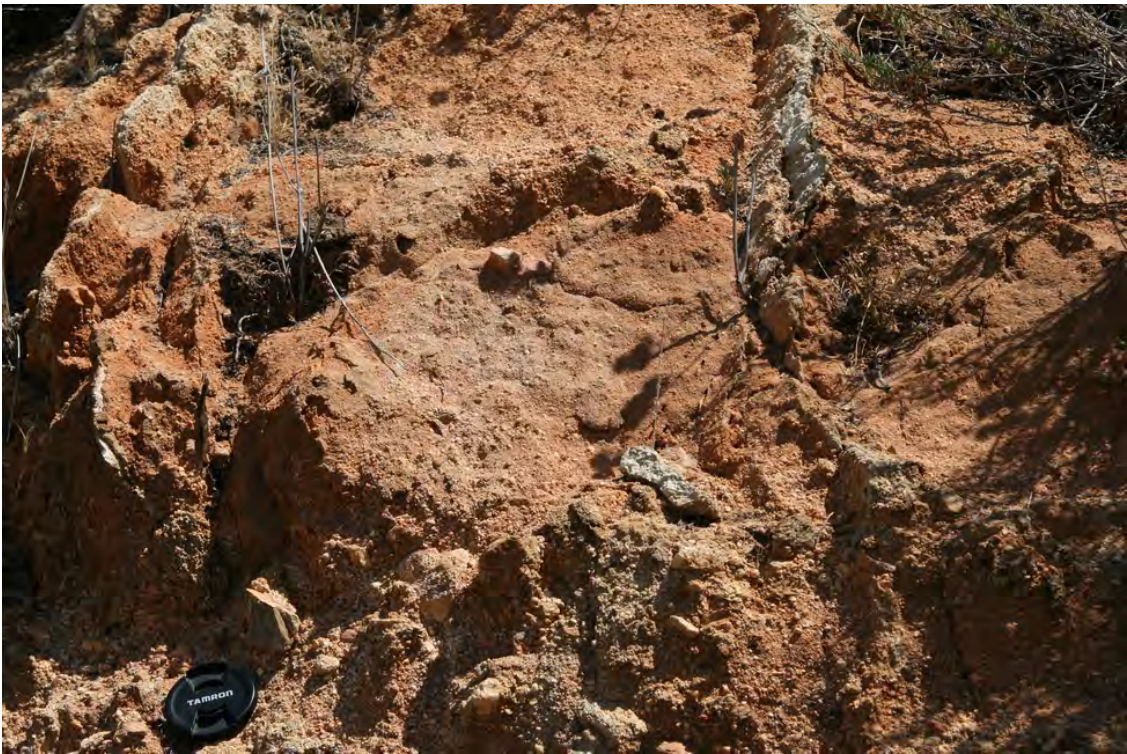
Photo 36. Carbonate-filled minor faults west of entrance road split.
