# **Bloody Brook**

**ONONDAGA COUNTY**

**LIVERPOOL, NEW YORK**

## **Periodic Review Report March 31, 2018 to July 31, 2019 July 2019**

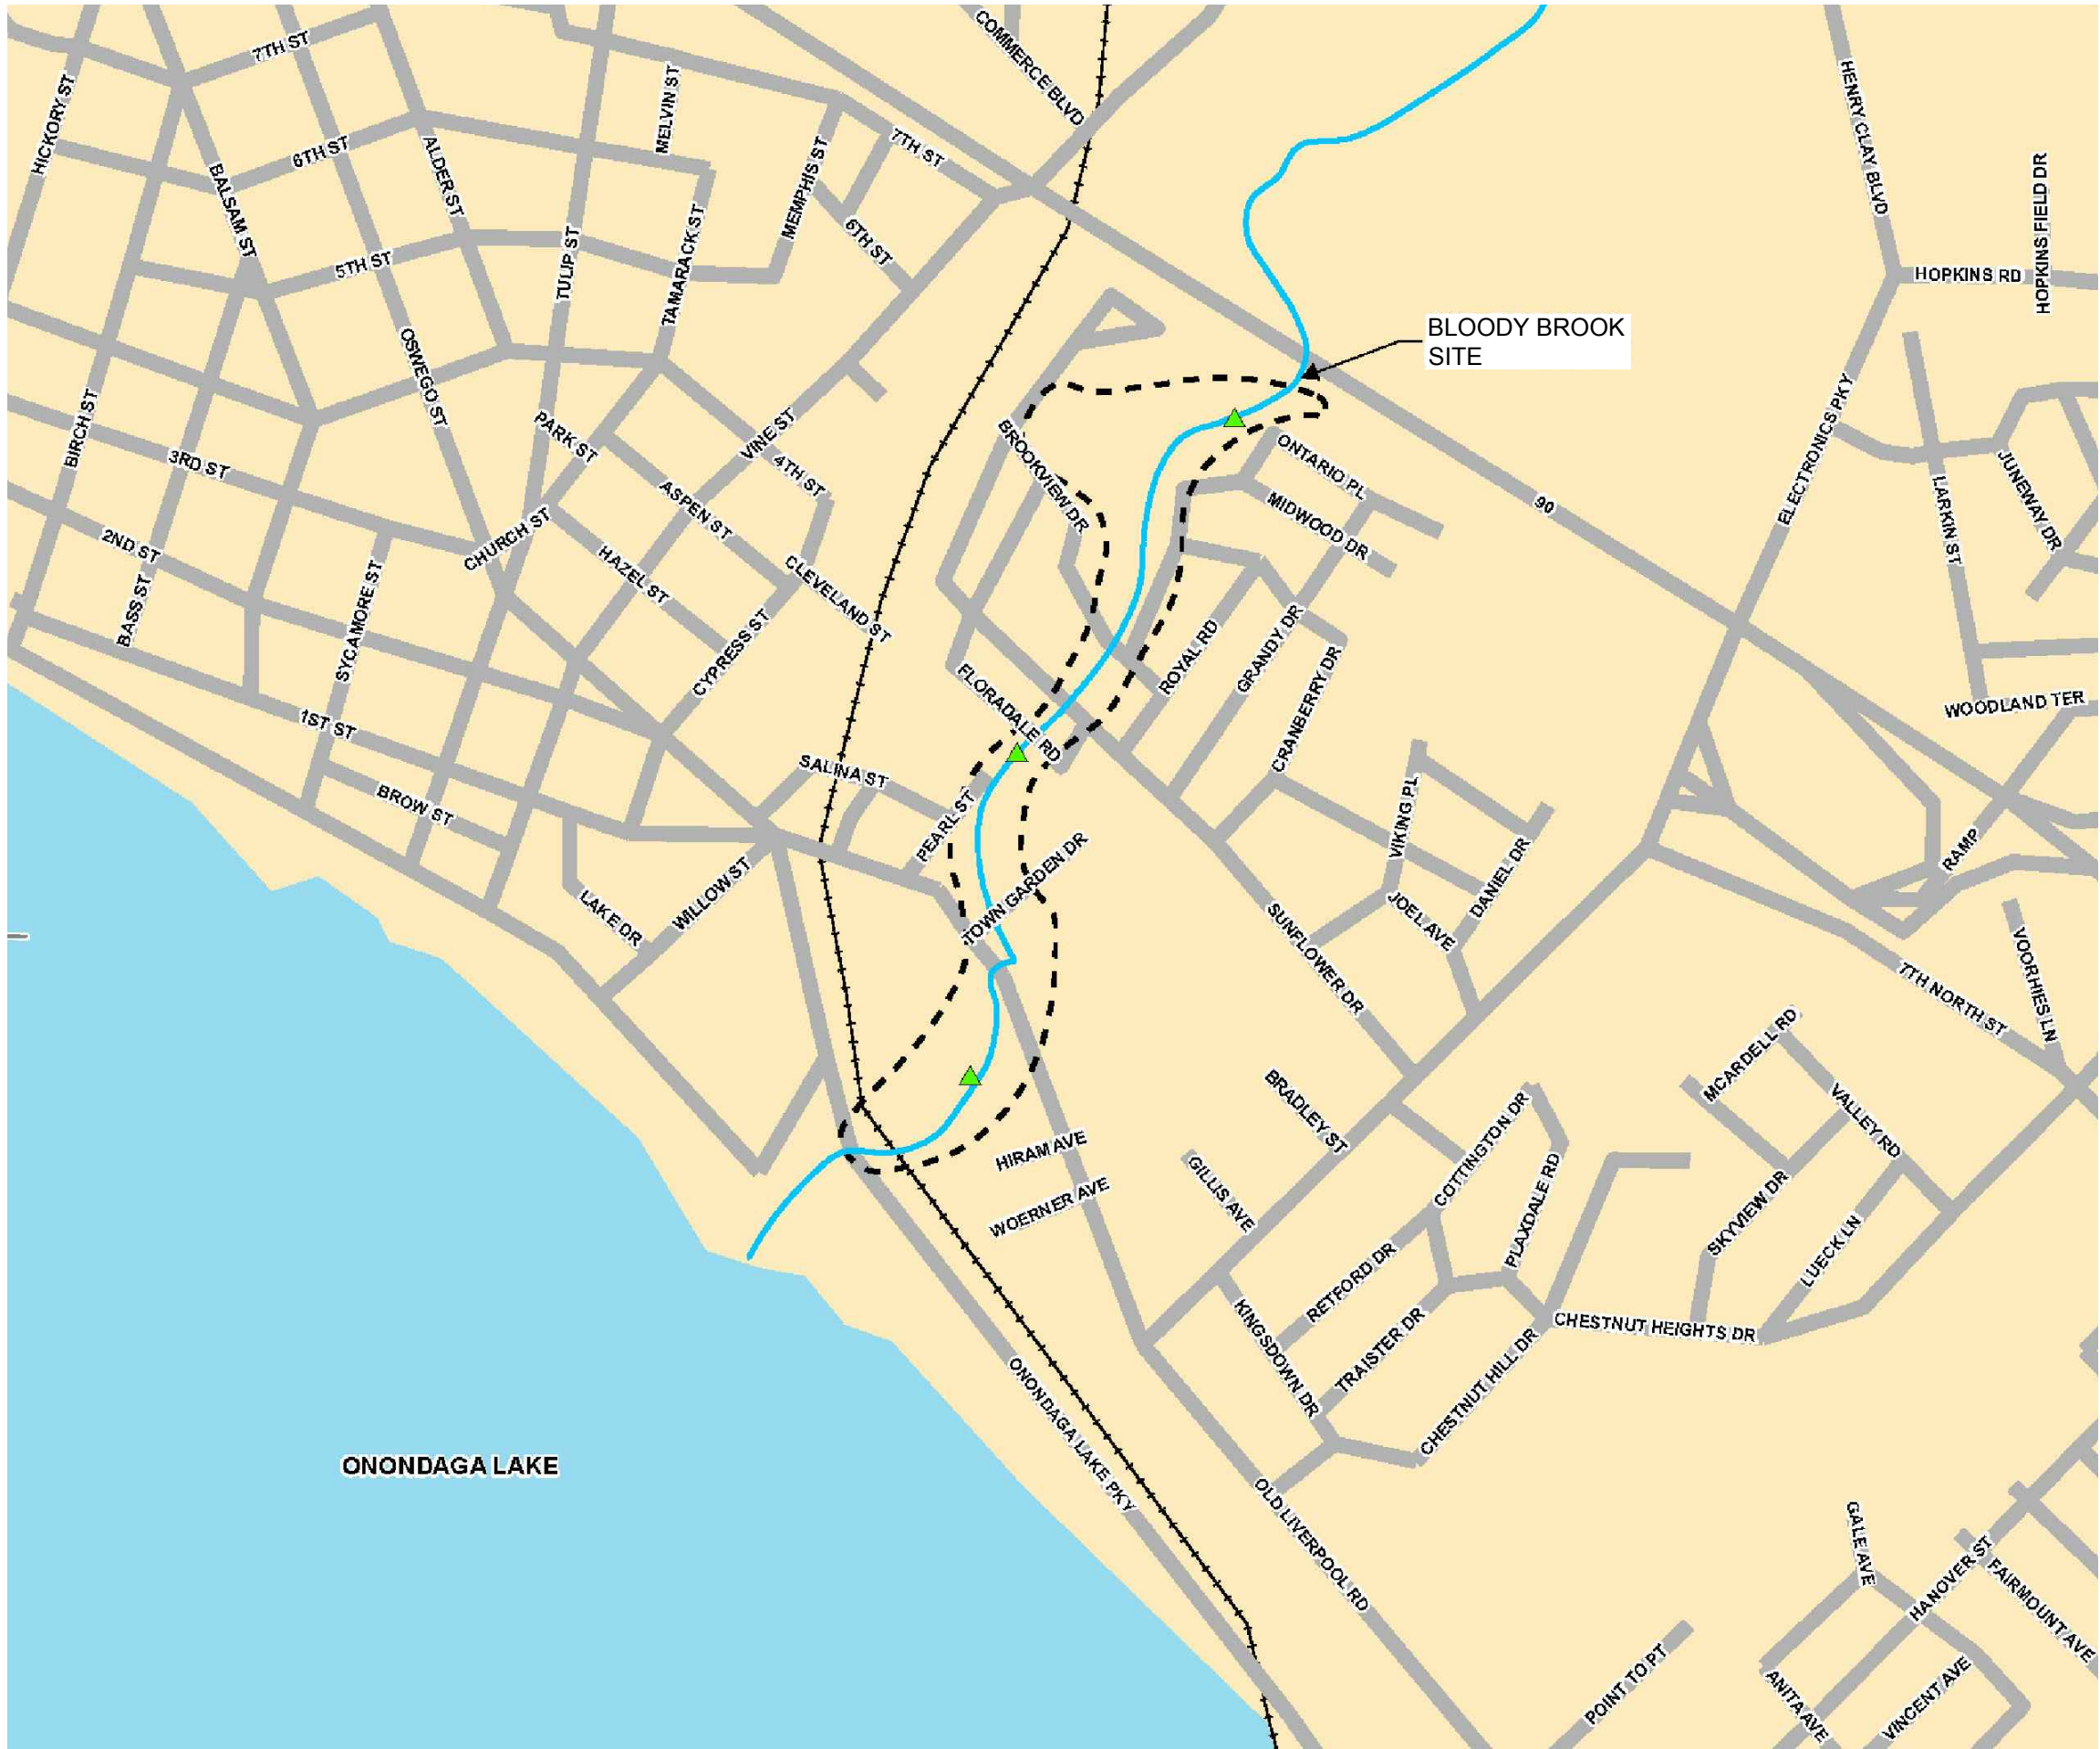
FILE NAME: Bio Mon Plan.dwg	DRN ---	PROJECT NO. 60338140	DATE 7 / 2019	FIGURE NO. 4
--------------------------------	------------	-------------------------	------------------	-----------------

- LEGEND:
- APPROXIMATE BIOTA MONITORING SAMPLE LOCATION
  - BLOODY BROOK
  - APPROXIMATE SITE BOUNDARY

In July 2014, biota samples were collected from within the Bloody Brook site to evaluate possible cadmium exposure for aquatic receptors prior to the start of remediation activities in the WBBB. Samples were collected from three general locations in WBBB, including an upper location (between Ontario Place and Cranberry Drive), a middle location (downstream from Floradale Road), and a lower location (upstream from Onondaga Lake Parkway). See Figure 4 for approximate sample locations. The 2014 data were provided to New York State Department of Environmental Conservation (NYSDEC) in the September 9, 2014 Monthly Progress Report for the Bloody Brook site and were included in Appendix F (Field Sampling Plan [FSP]) of the SMP.

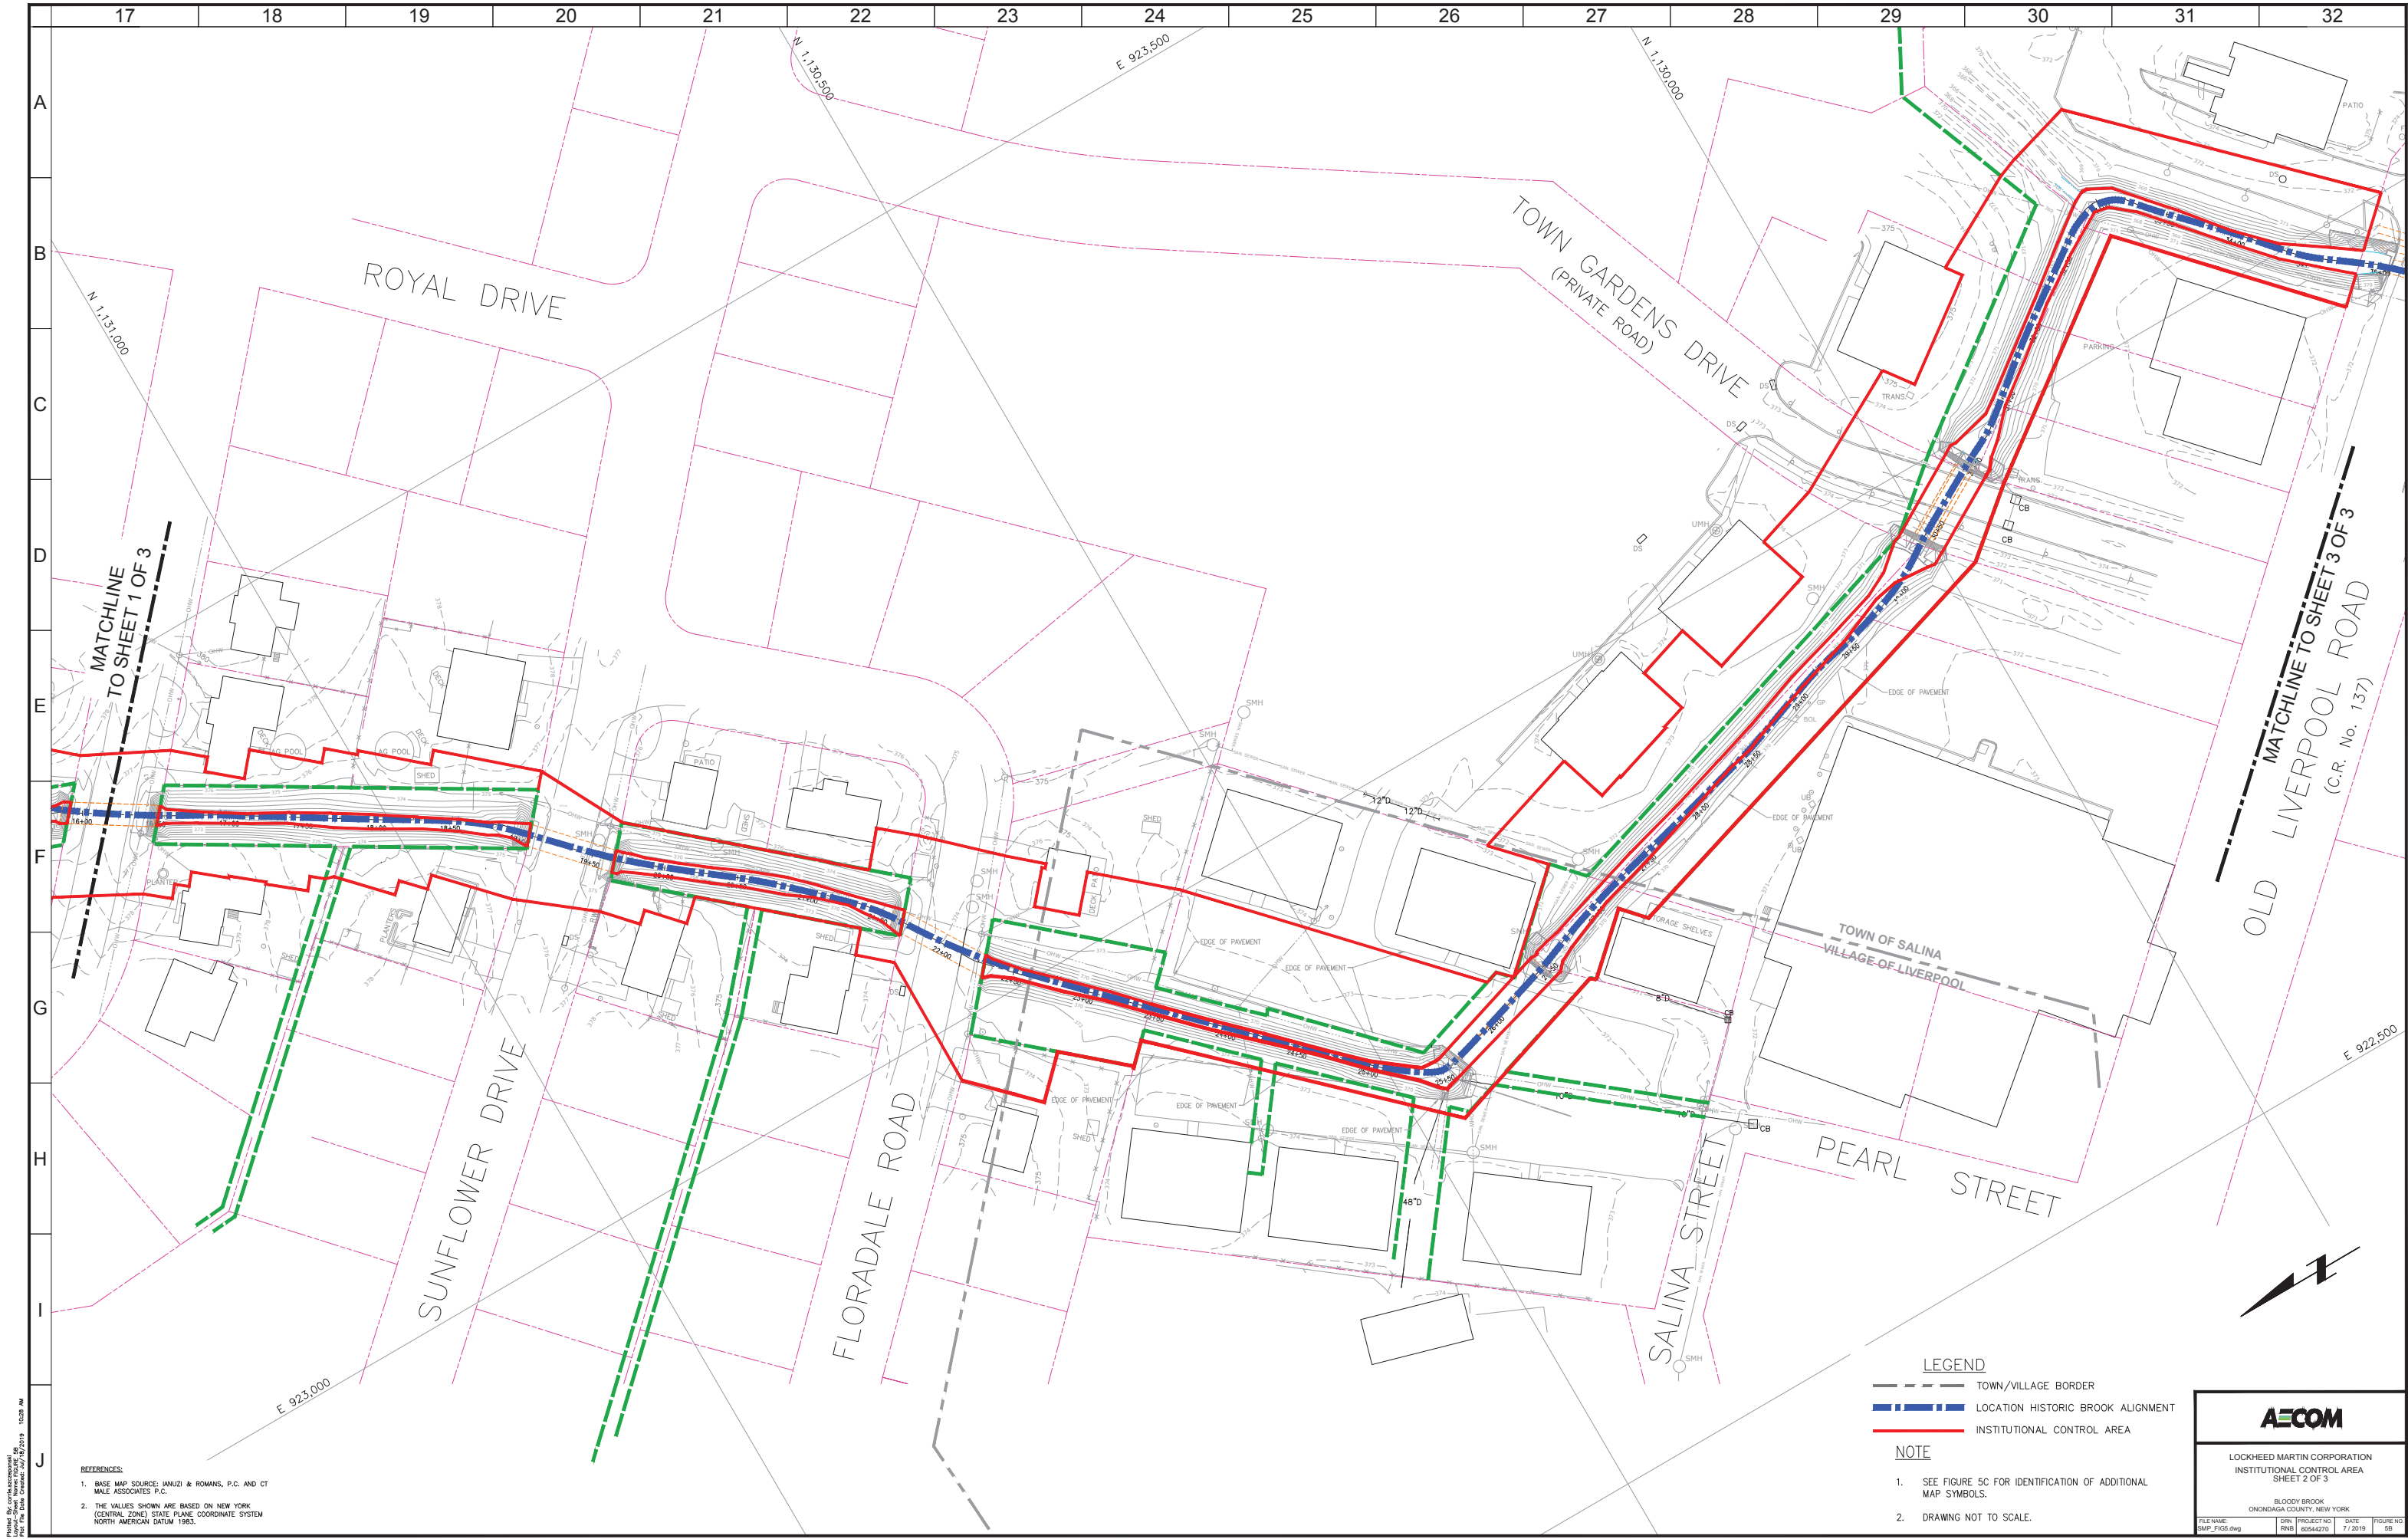
FILE NAME: SMP_FIG5.dwg	DIN RWB	PROJECT NO. 80544270	DATE 7/2019	FIGURE NO. 5B
----------------------------	------------	-------------------------	----------------	------------------

- LEGEND
- TOWN/VILLAGE BORDER
  - LOCATION HISTORIC BROOK ALIGNMENT
  - INSTITUTIONAL CONTROL AREA
- NOTE
- SEE FIGURE 5C FOR IDENTIFICATION OF ADDITIONAL MAP SYMBOLS.
  - DRAWING NOT TO SCALE.

A series of ICs is required by the 2014 Decision Document and SMP to: (1) implement, maintain and monitor EC systems; (2) prevent future exposure to remaining contamination; and, (3) limit the use and development of the site to appropriate uses for each area. Adherence to these ICs on the site is required by the 2014 Decision Document and is implemented under the site SMP. The IC boundaries are shown on Figures 5A through 5C and include the following:
