2022 RESTORATION MONITORING SUMMARY REPORT

Bloody Brook
Onondaga County, New York

Lockheed Martin Corporation
Syracuse, New York

AECOM Technical Services Northeast, Inc.
40 British American Boulevard
Latham, New York 12110

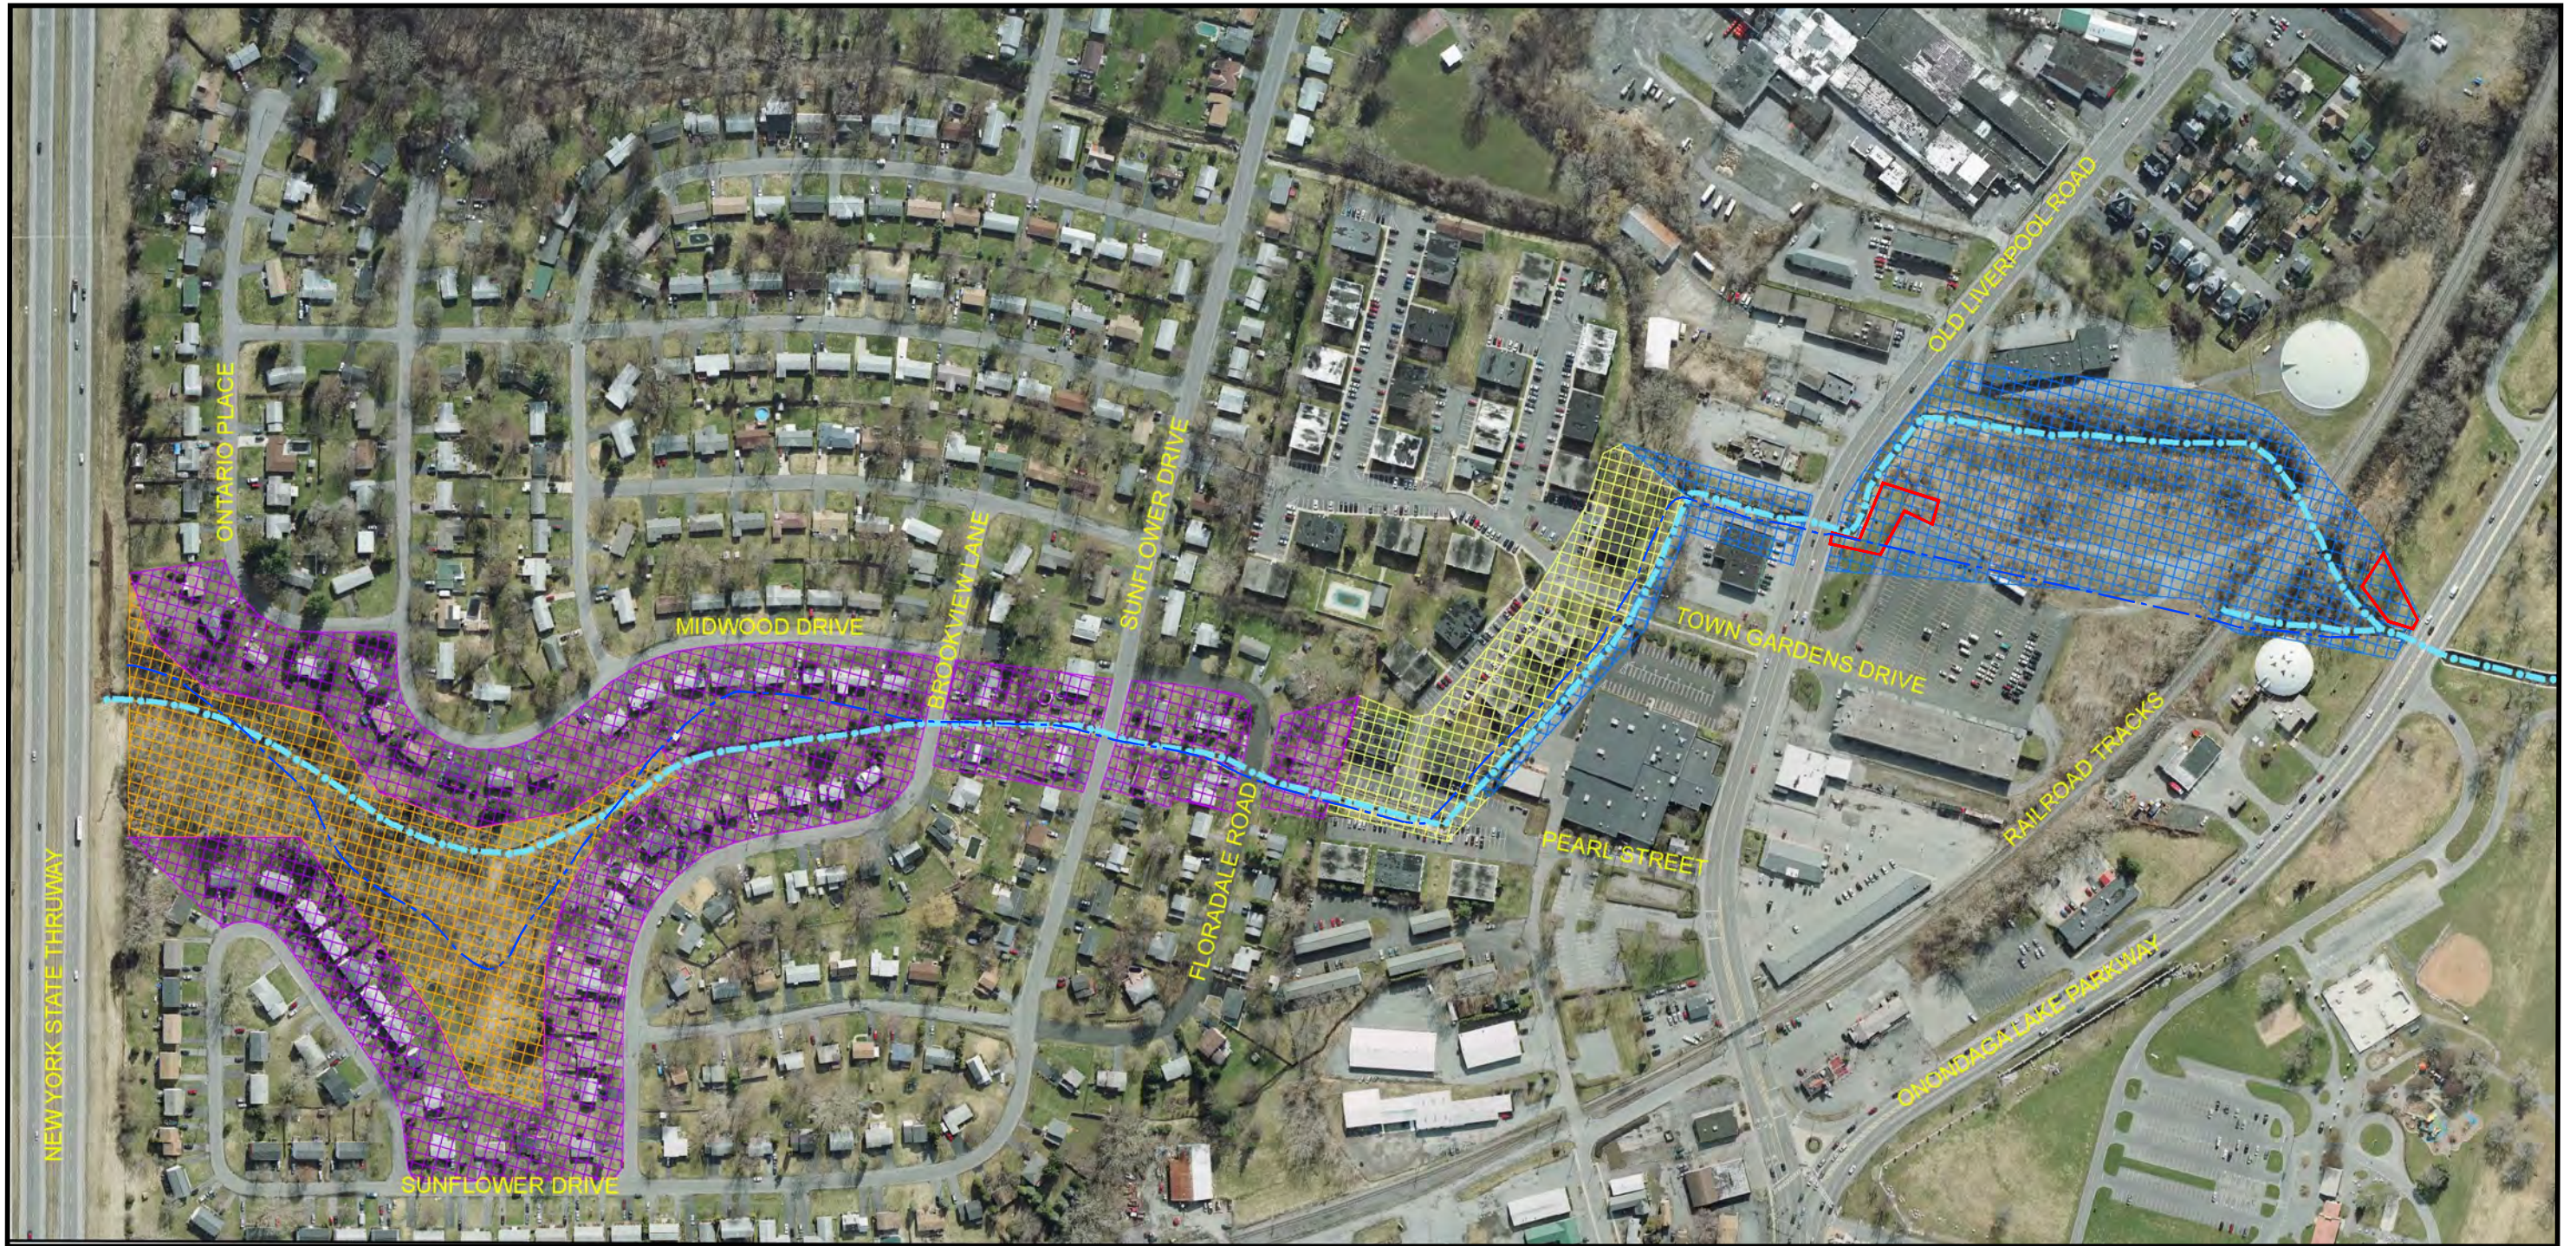
LOCKHEED MARTIN CORPORATION
SITE AREA MAP

The Bloody Brook site was broken into four distinct areas based on land use and characteristics as shown on Figure 2 and described below.
