SERVICE NEWS

A SERVICE PUBLICATION OF LOCKHEED-GEORGIA COMPANY, A DIVISION OF LOCKHEED CORPORATION

Power Plant Rigging

Vol. 5, No. 1 January - March 1978

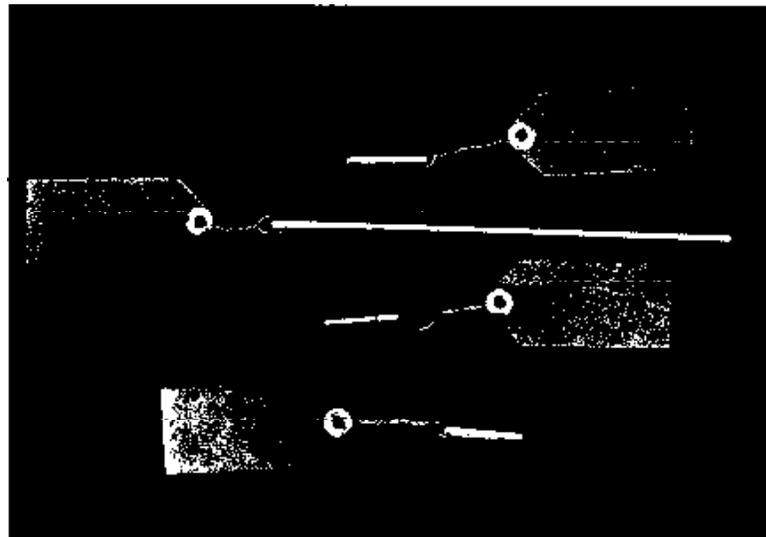
Provide all rigging pins with prominent red warning tags.

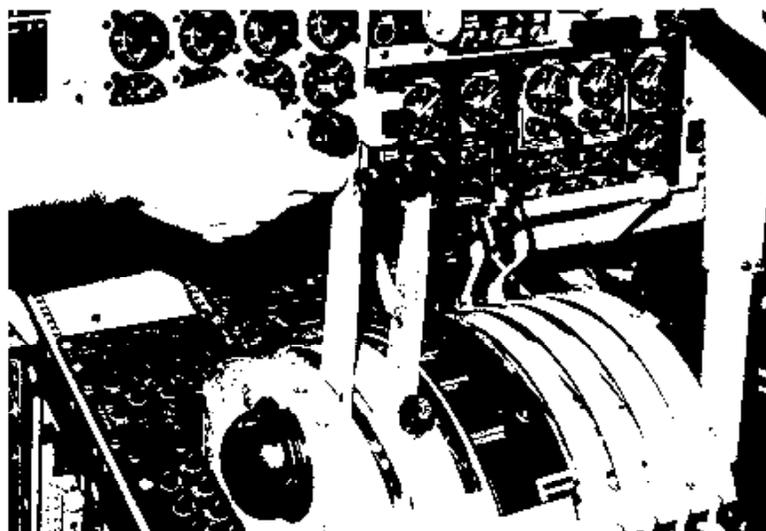
Checking throttle lever for free movement at the flight idle gate.

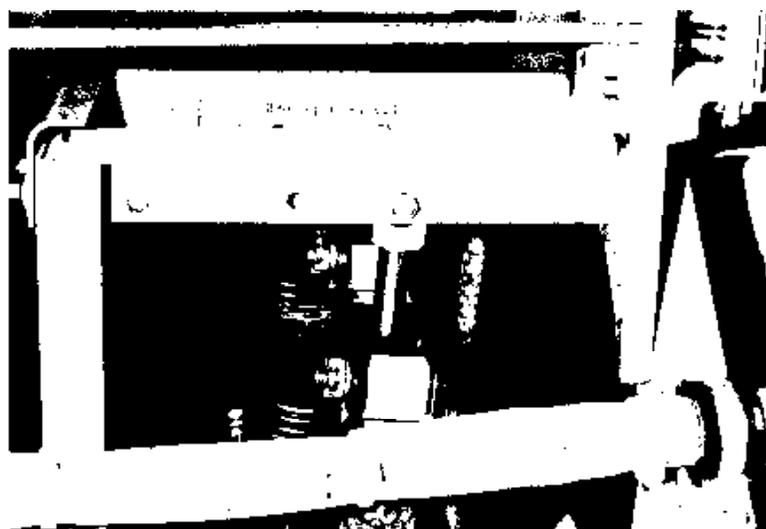
No. 1 engine throttle cable tension regulator indicating between 7 and 8.

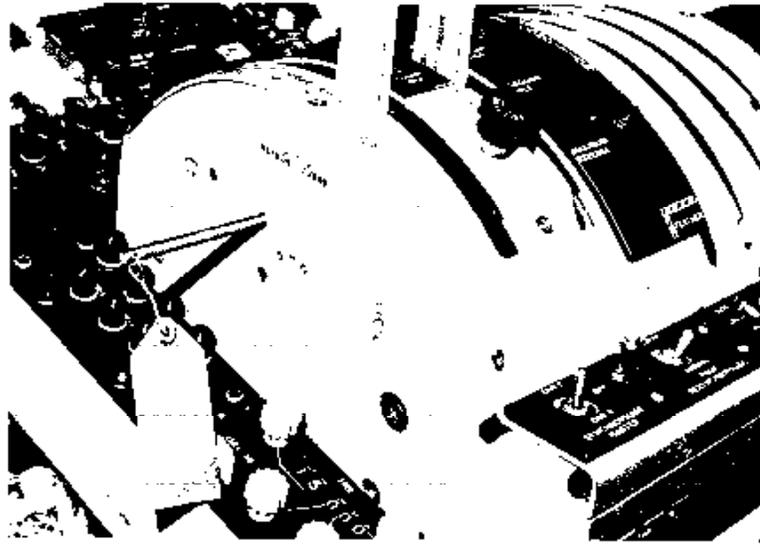
Throttle levers pinned at FLIGHT IDLE.

To adjust the short cable, first place the condition levers in RUN and then pin the throttle levers in FLIGHT IDLE by inserting one of the long X-inch diameter rig pins through the rig pin hole in the side of the control quadrant.

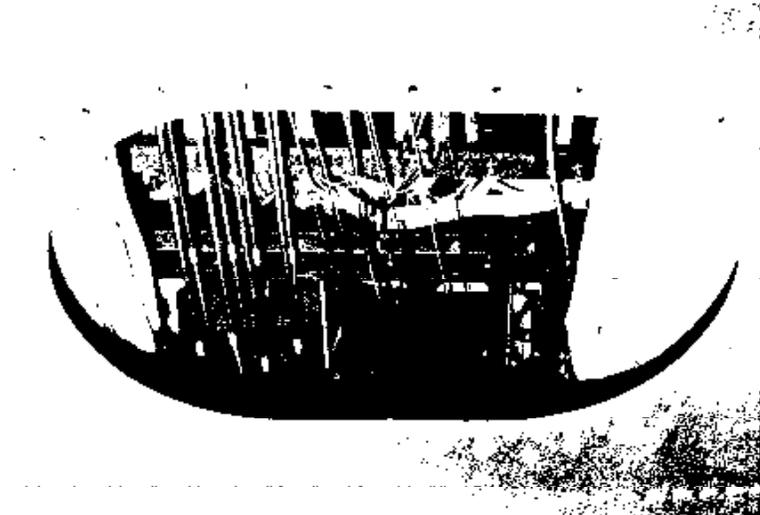
Access to the lower pulley assembly under the flight station.

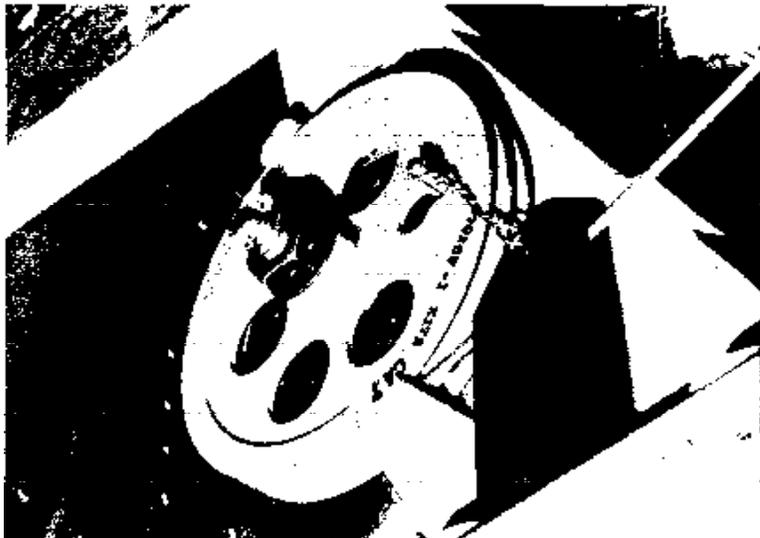
Throttle cable pulley pinned at the fire seal.

Have the throttle lever in the flight station placed in FLIGHT IDLE, and pin the throttle pulley at the fire seal with the 3/16-inch diameter rig pin. Use the C-8 cable tensiometer to check the tension in the outboard upper control cable and adjust the turnbuckle as necessary to obtain a cable tension of $65(+10 - 20)$ pounds. Remember that with a short cable like this a small adjustment in the turnbuckle makes a considerable difference in the cable tension. Avoid disturbing the setting of the turnbuckle when installing a locking clip or safety wire.

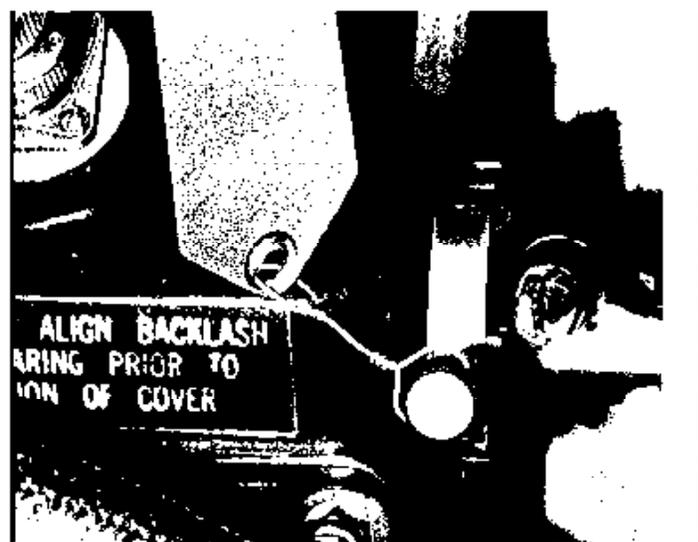
Propeller indexing lever pinned at flight idle.

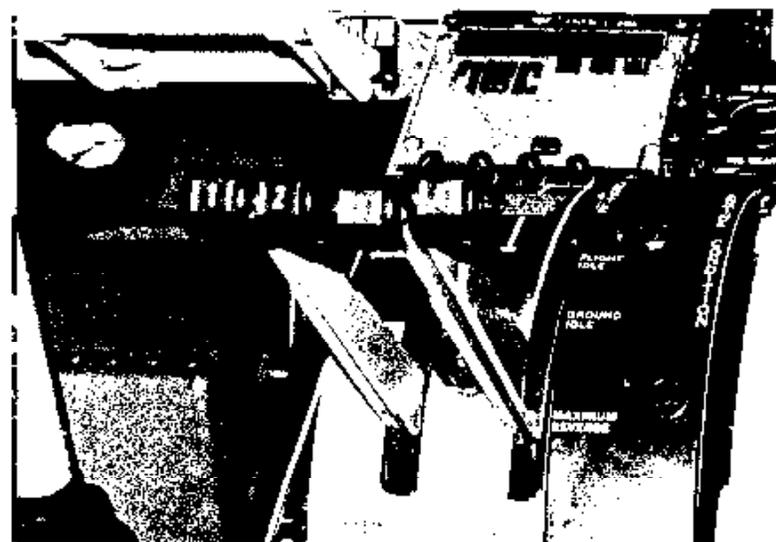
Throttle levers lined up at MAXIMUM REVERSE.

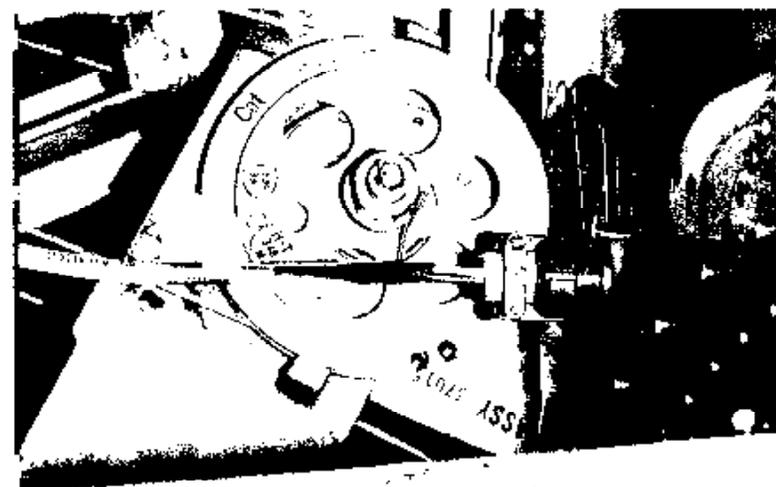
Note lack of rig pin hole alignment at fire seal condition control pulley with condition lever in FEATHER and correct QEC cable preload applied.

Have the condition lever placed in FEATHER and examine the fire seal condition control pulley for wear. A 3/16-inch diameter rig pin hole is provided in this

pulley for checking the airplane condition control cable length; however, with the QEC attached and the correct preload on the cables the pulley hole will not line up with the hole in the fire seal bracket. If the system checkout turns up evidence of misadjustment in this cable run, it will be necessary to relieve the QEC cable preload before a check at the fire seal condition control pulley can be made. Section 2 of this article contains the details of this procedure.

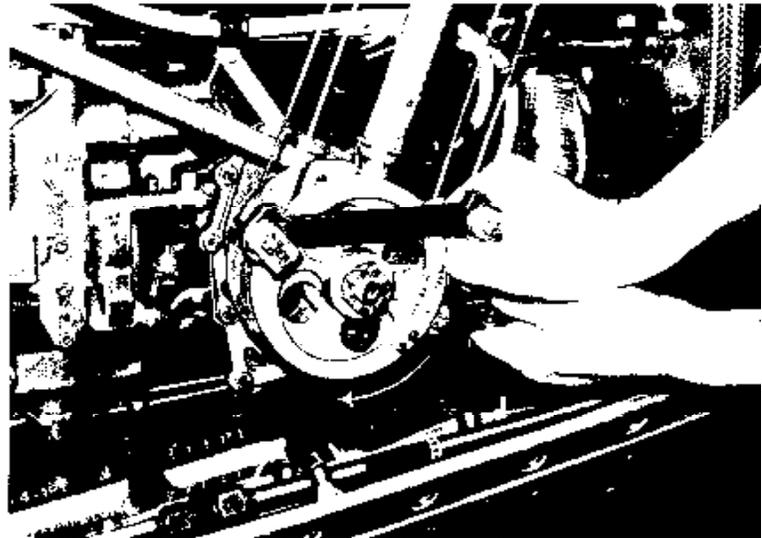
Checking feather preload at the lower condition control pulley.

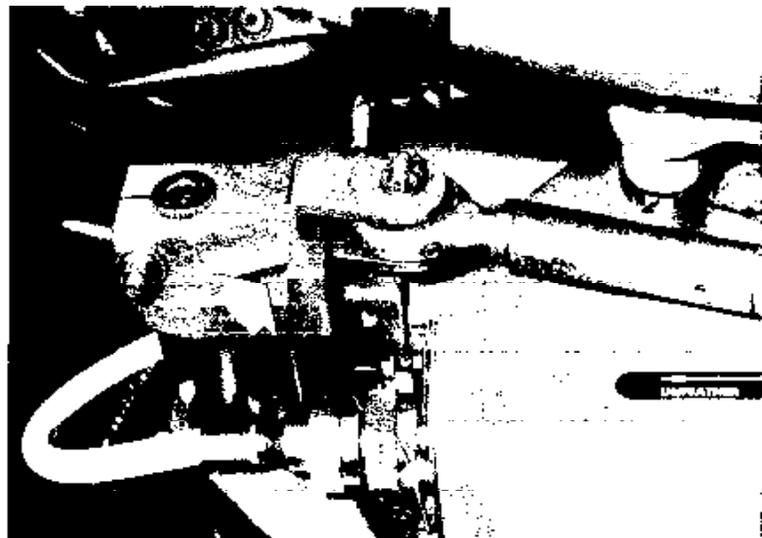
Condition transfer clevis against the external feather stop.

With the throttle lever in the FLIGHT IDLE position, and the condition lever still in FEATHER, check to see that the condition transfer clevis on the back of the coordinator is firmly against the feather stop.

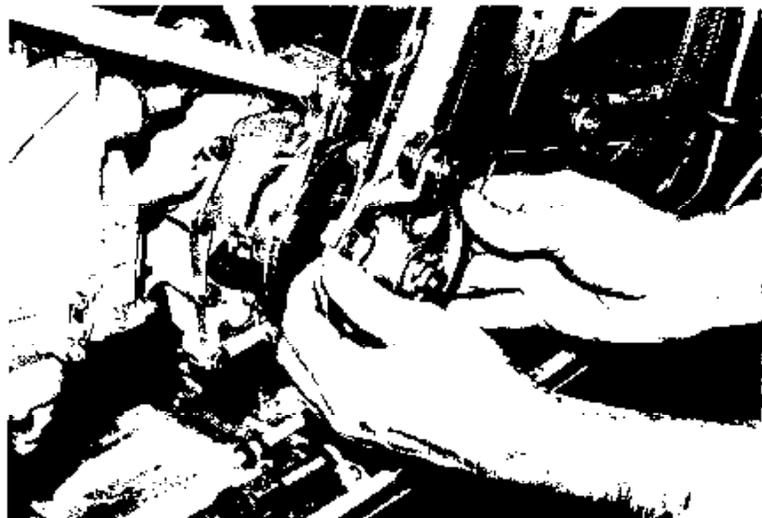
Checking lower throttle and condition control pulleys for wear.

The final part of the system checkout procedure is to check for excessive wear of the throttle pulley gimbal ring and yoke. Attempt to wobble the pulley assembly back and forth. The total back and forth movement at the rim should not exceed 3/32 of an inch.

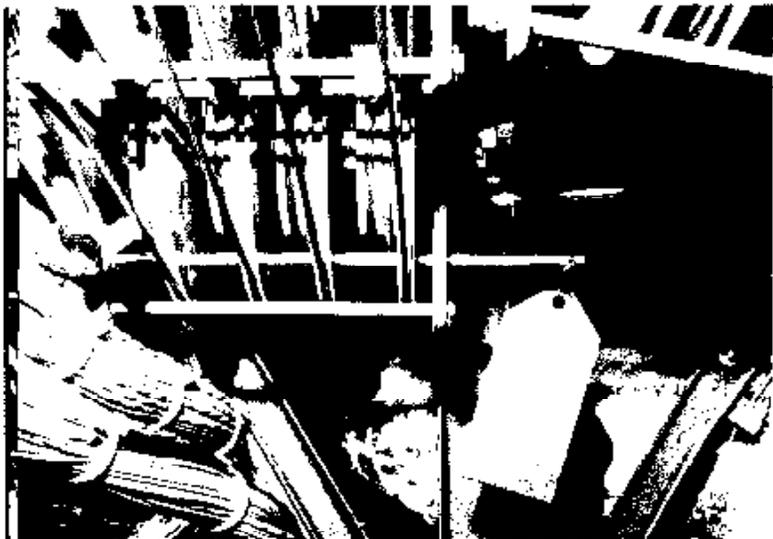
Throttle cable pulleys under the flight station pinned at flight idle.

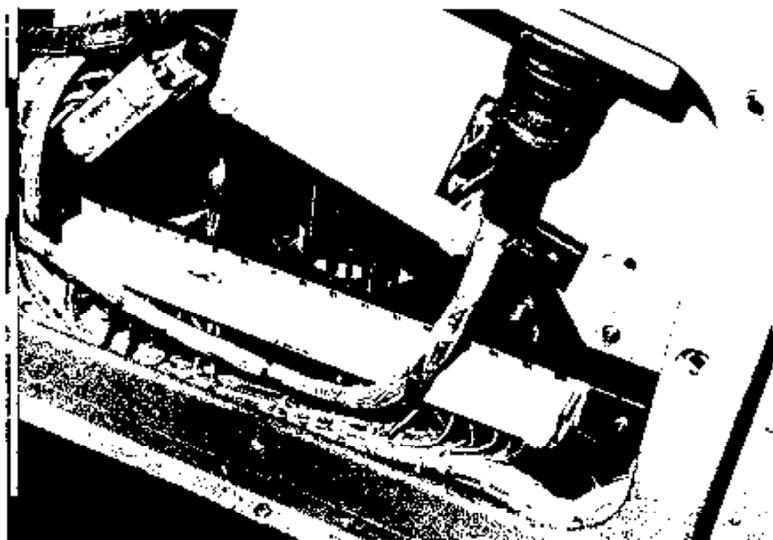
Access to cable turnbuckles in the control quadrant.

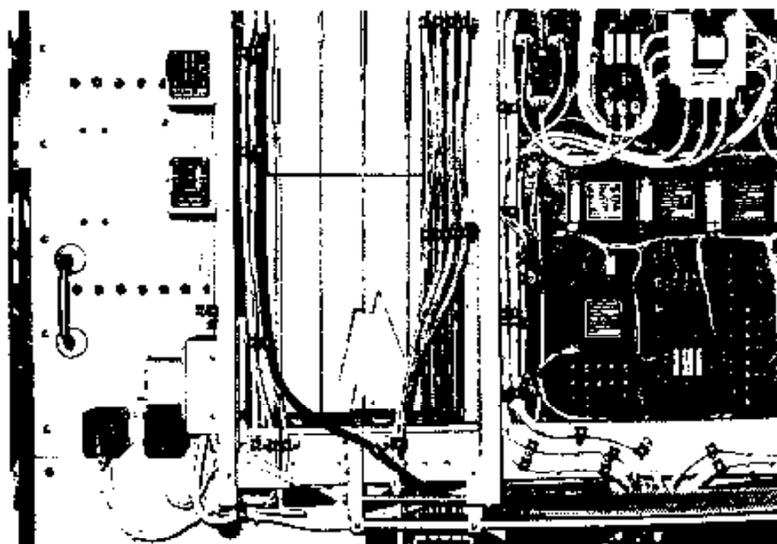
Engine control system cable turnbuckles at the FS 245 bulkhead.

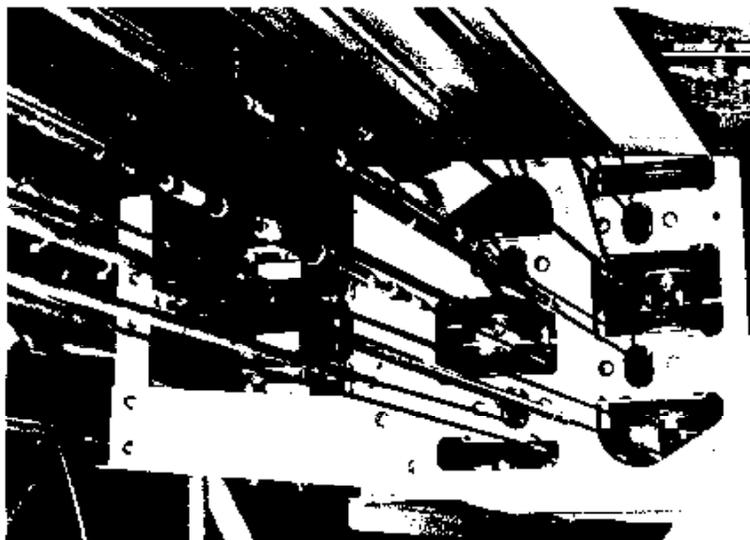
Turnbuckles located overhead in the cargo compartment near the tension regulators.

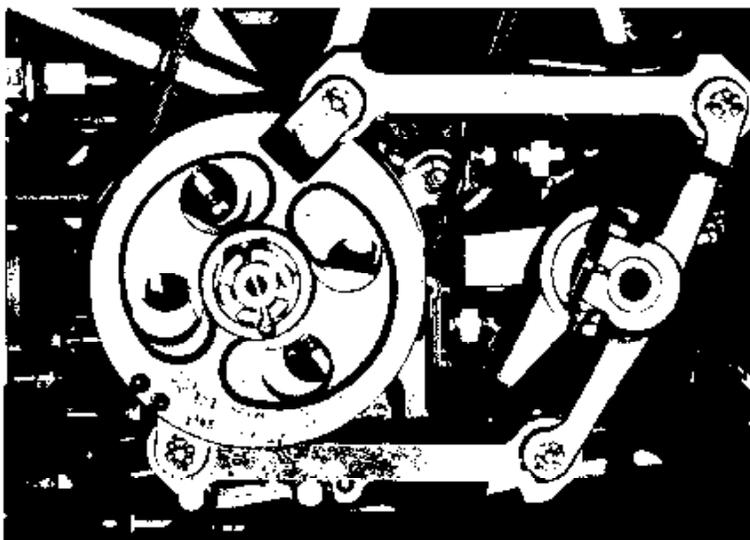
Disconnect the links of the outboard condition control transfer assembly to relieve QEC cable preload.

To adjust the cable rigging of the condition control system properly, it is best to completely separate the QEC control cable system from the airplane control system. First, relieve the preload on the condition control cables by moving the condition lever to RUN; then disconnect both links of the outboard condition control transfer assembly from the lower control pulley. Don't try to do this with the condition lever in FEATHER; the cable preload is transmitted to the pulley and it may rotate suddenly when the links are unfastened.

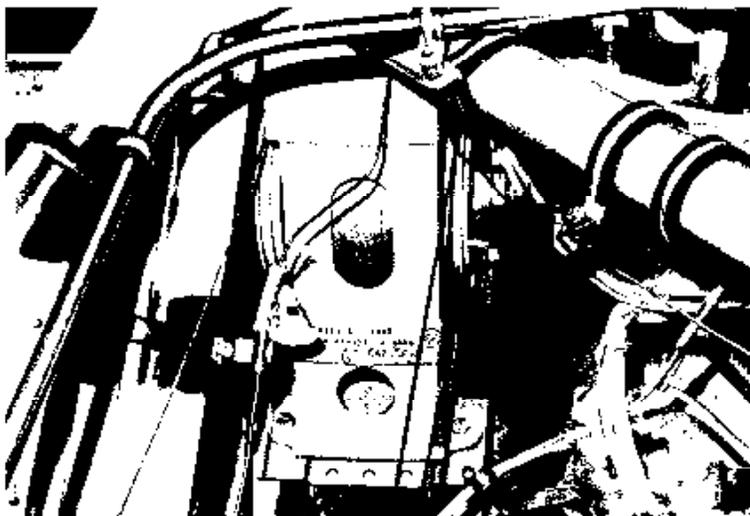
Condition control pulley at the fire seal with rig pin installed.

With the condition lever in the flight station still placed in the FEATHER position, try to insert the 3/16-inch diameter rig pin through the hole in the condition control pulley at the fire seal and into the support bracket.

Attempt to reinstall the rig pin in the control pulley at the fire seal. Readjust the cable turnbuckles as necessary to obtain an easy fit. If any readjustment is required, again have your assistant move the condition lever through its travel five times and recheck for an easy fit of the rig pin. Repeat the procedure as many times as necessary to obtain the desired results.

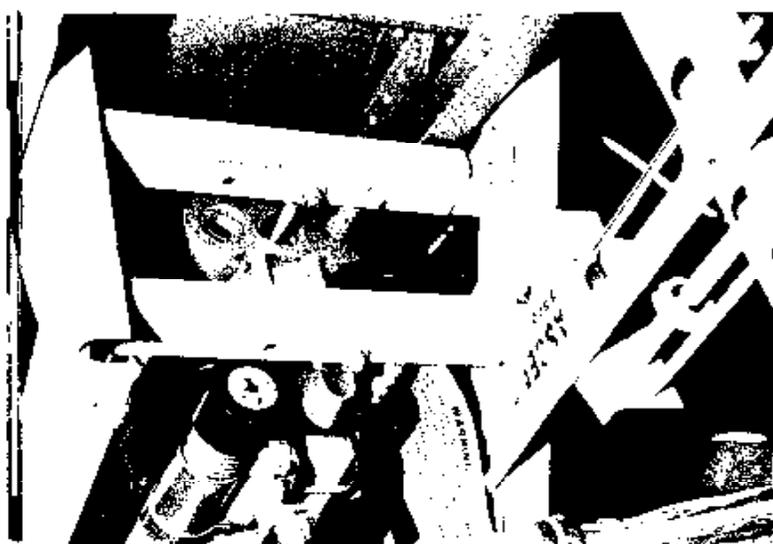
No. 1 engine condition cable tension regulator indicating between 6 and 7.

Now have the condition lever moved to the RUN position and check the scale reading on the appropriate condition cable tension regulator in the cargo compartment. The reading should be between 6 and 7 for an ambient temperature of 40 to 100 degrees F.

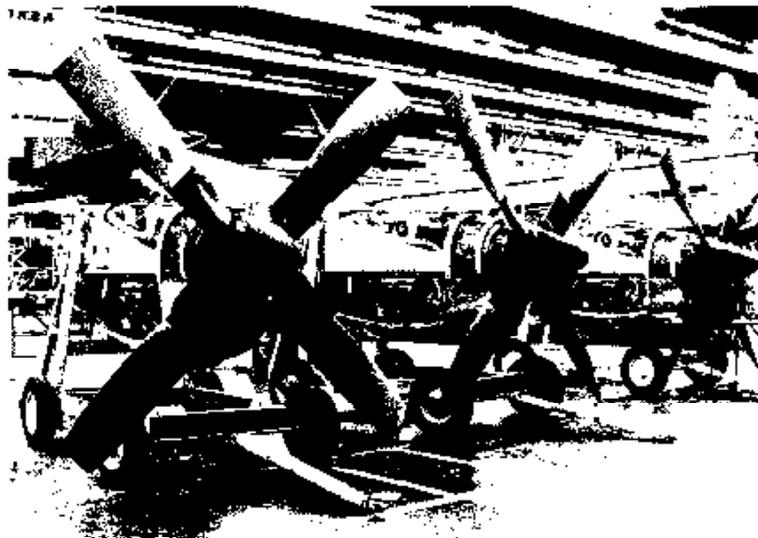
QECs with pre-rigged control cables ready for installation.

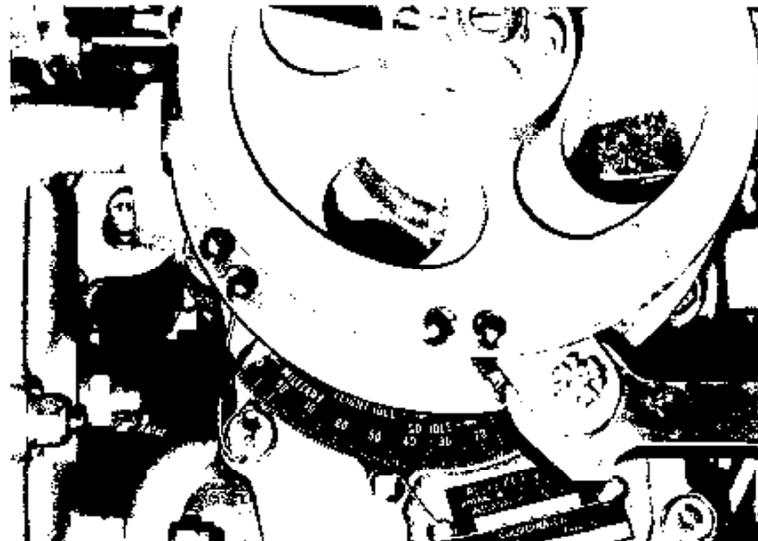
Engine control coordinator at 90 degrees (takeoff).

The coordinator pointer should read 90 degrees when the shaft is rotated against the internal stop. Loosen the screws which hold the pointer and reposition it if necessary.

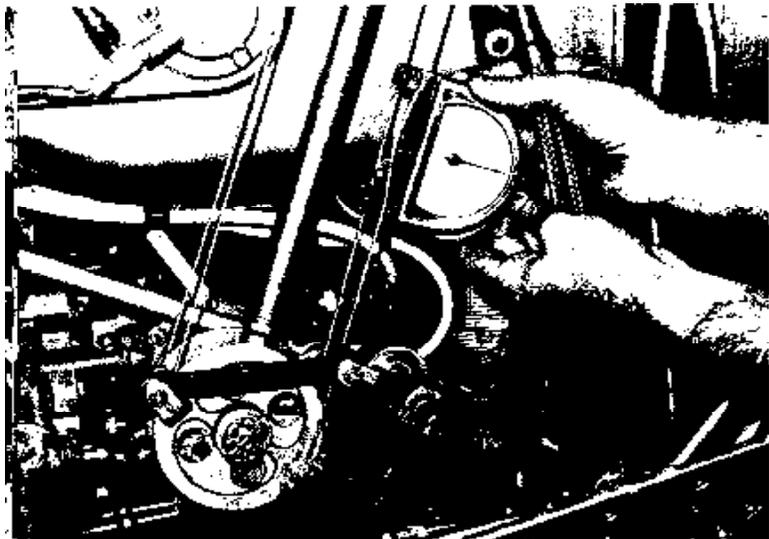
Checking tension in the lower control cables.

Now check the coordinator pointer and see that it indicates $34(+/- 1)$ degrees. If it does not, adjust the turnbuckles on the inboard lower control cables until the coordinator shows 34 degrees. Adjust the cable tension to $65(+10 - 20)$ pounds while making sure

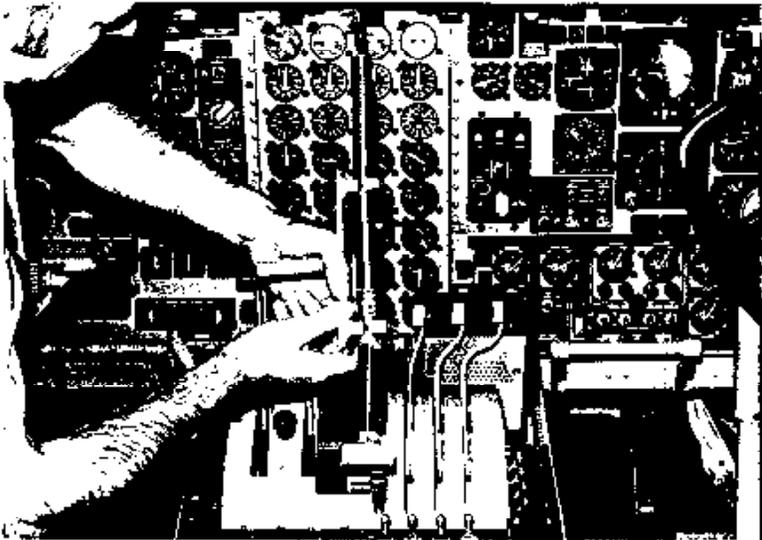
Measuring condition lever preload at the flight station.

Condition Lever Preload-Use the 15-pound capacity spring scale to check the force required to move the condition lever from RUN to FEATHER. The force should not exceed 7-1/2 pounds through the first 80 degrees of travel, and should increase gradually through the last 20 degrees of travel until the force is 8 to 13 pounds when the condition lever reaches the feather detent.

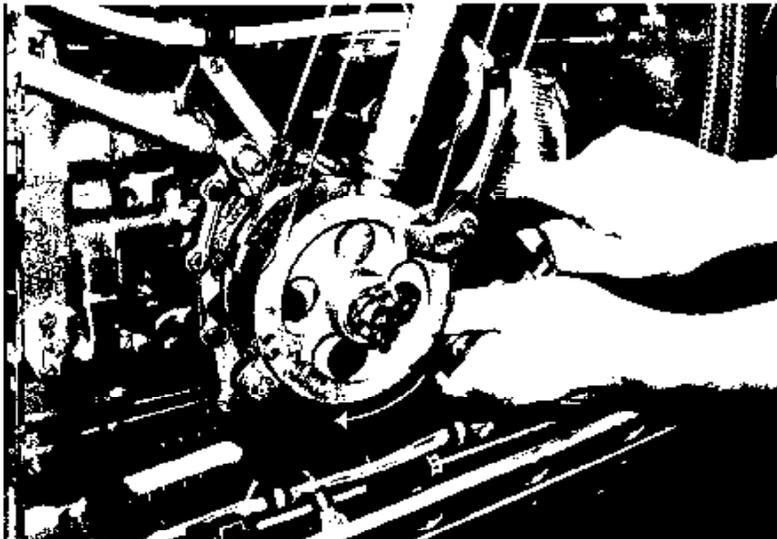
Checking QEC condition cable adjustment with control levers in MAXIMUM REVERSE and RUN.

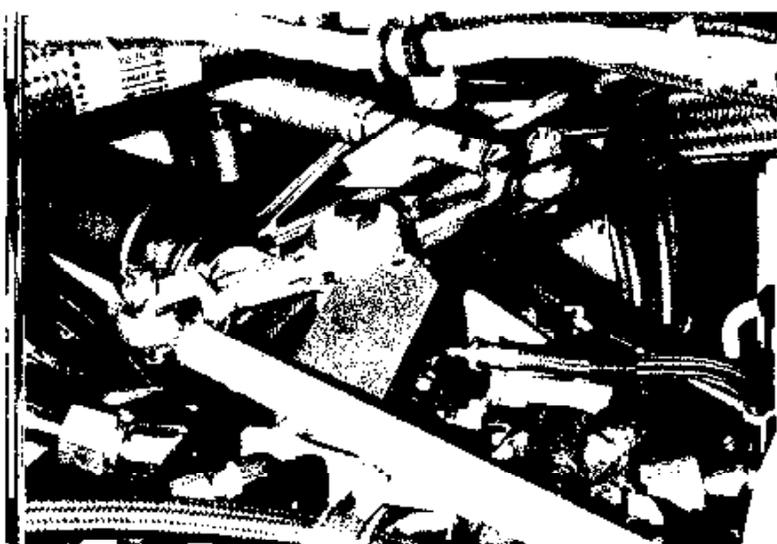
Rig pin installed in propeller control rear lever assembly at flight idle.

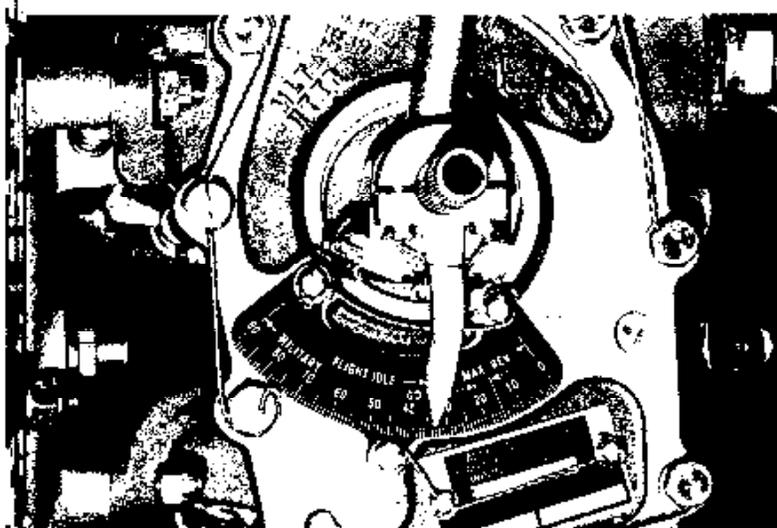
Engine control coordinator at 34 degrees (flight idle). Note screws to allow pointer adjustment.

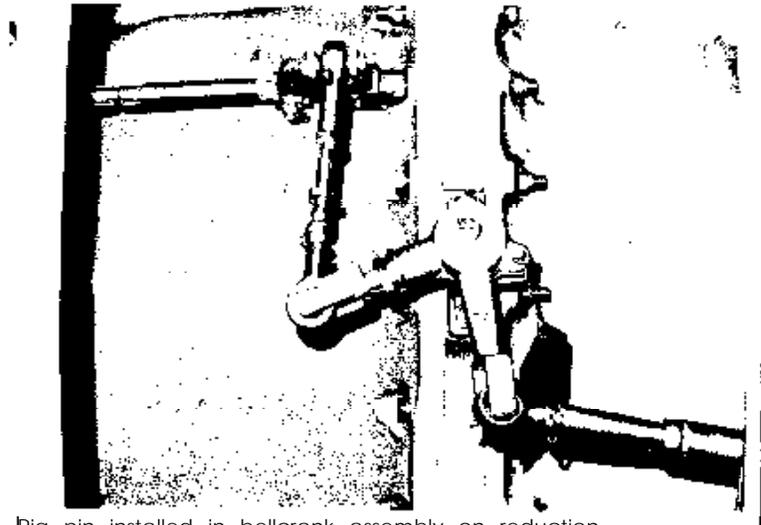
Rig pin installed in bellcrank assembly on reduction gearbox. Note (1) propeller control forward link; (2) bellcrank clevis rod.

If the throw of the lever appears to be too long or too short, adjust the length of the bellcrank clevis rod. Check the progress of your adjustments as you go by reconnecting the forward link to the clevis rod and observing the movement of the propeller indexing lever as your assistant moves the flight station throttle lever through its full range.

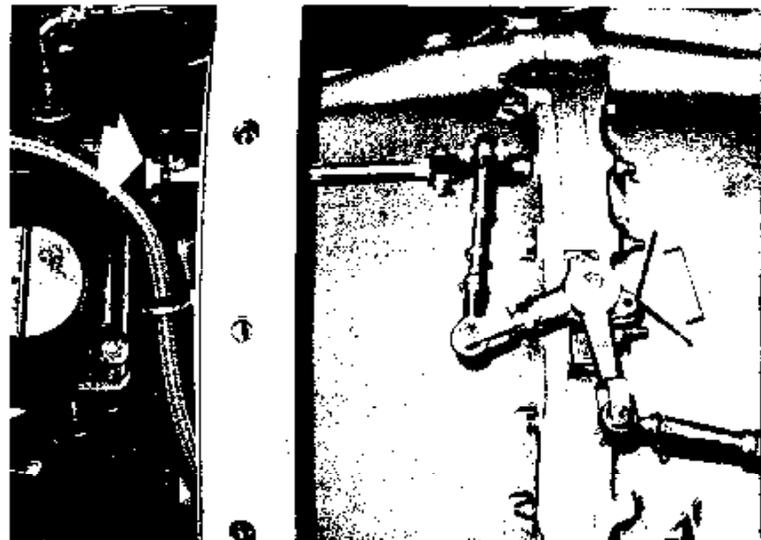
Bellcrank assembly and propeller indexing lever correctly aligned at flight idle.

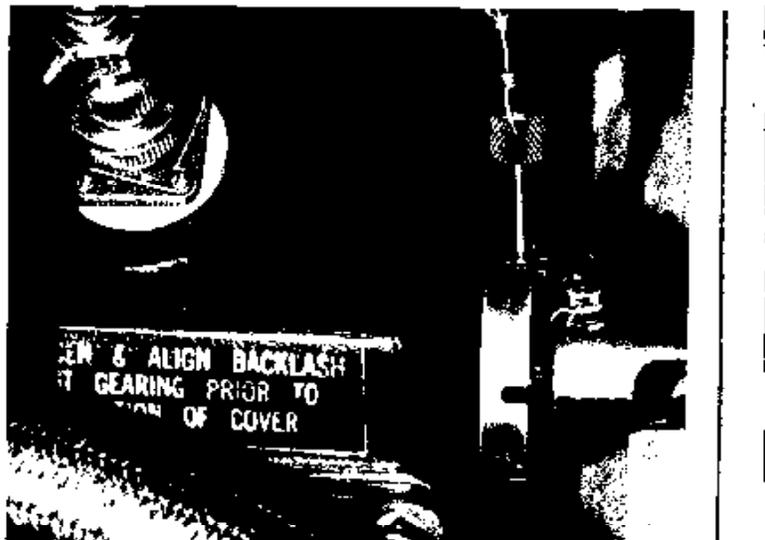
Propeller indexing lever pinned at takeoff.

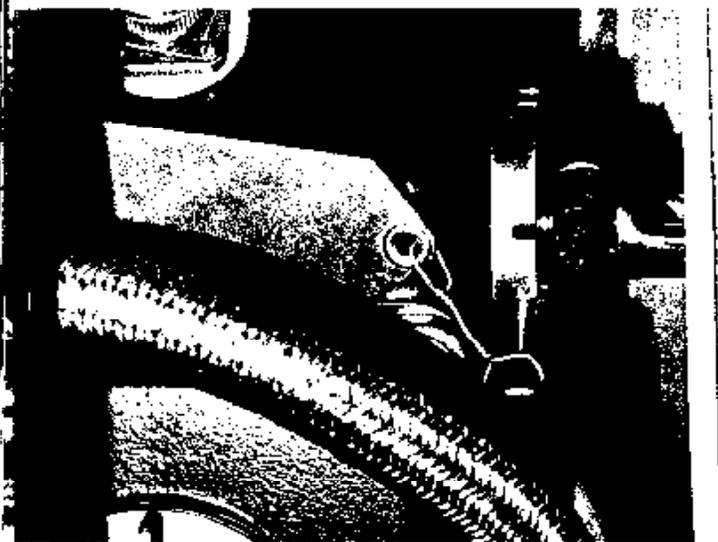
Propeller indexing lever pinned at maximum reverse.

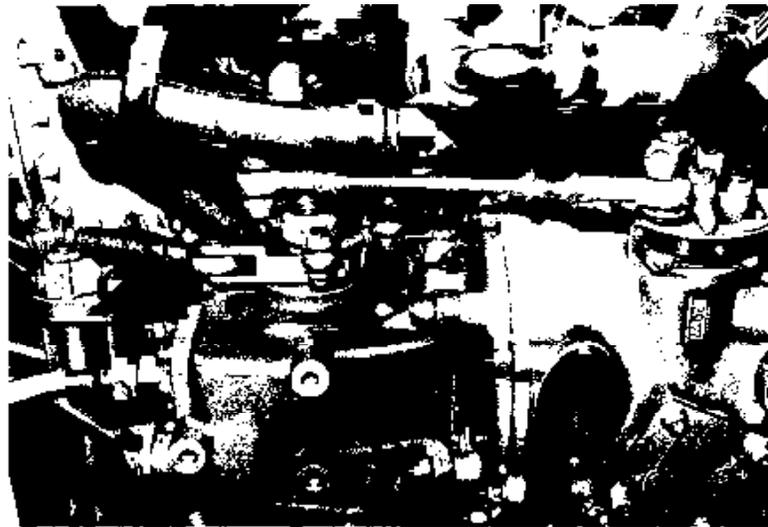
Disconnect indicated rod assemblies to make coordinator to fuel control rigging adjustments.

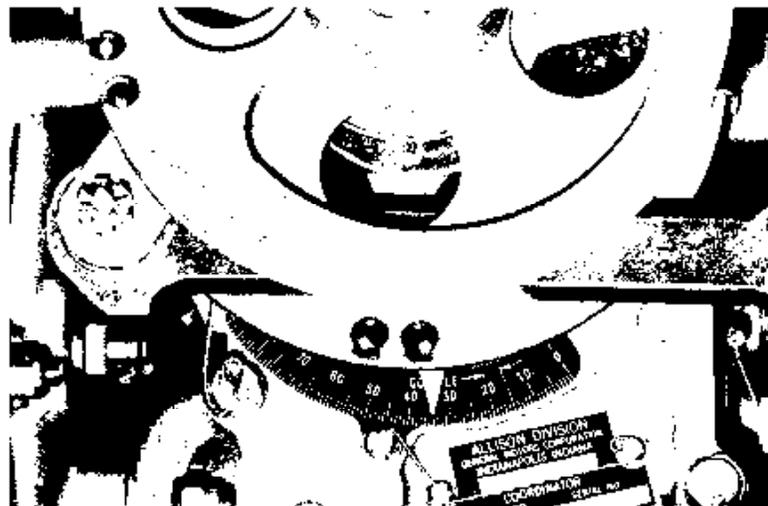
Engine control coordinator with indicator at 34 degrees. Identical values must always be shown on both protractors.

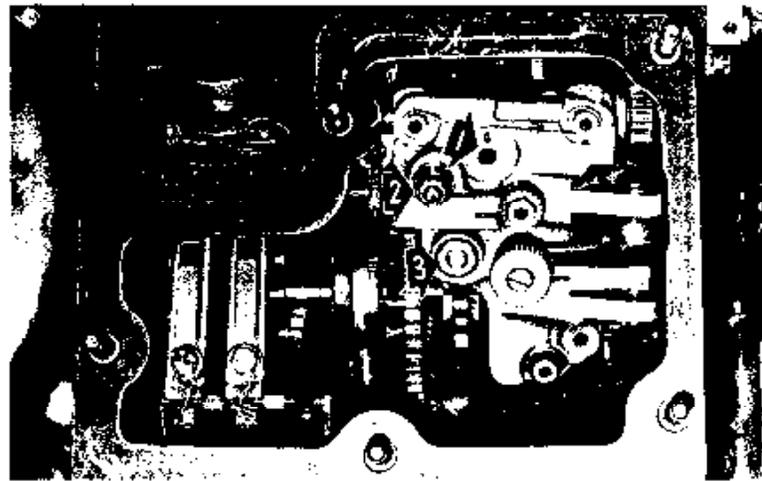
Propeller control valve assembly with access plate removed. Note (1) beta schedule rig pin hole; (2) reverse stop adjustment; (3) beta schedule adjusting nut.

As the first step in this procedure, you will want to confirm that the input shaft assembly has been properly adjusted during the installation of the propeller control valve housing cover. This may be done before providing AC power to the airplane, if desired. Have the flight station condition lever placed in RUN, and the throttle lever in FLIGHT IDLE. Remove the access plate from the cover of the valve housing assembly, and locate the beta schedule rig pin hole in the control valve assembly.

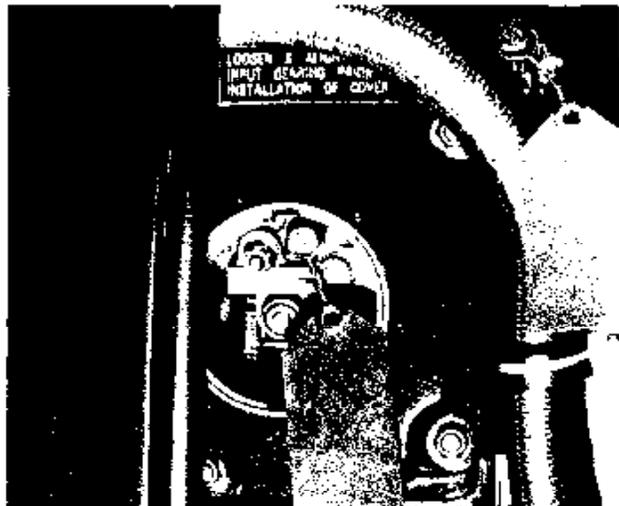
Alignment pins installed in beta schedule rig pin hole and propeller indexing lever. (Remove entire access plate to make adjustments.)

Attempt to insert the three-step propeller alignment pin through the beta schedule rig pin hole and into the slot in the alpha shaft. If the pin fits properly, leave it installed and attempt to insert a second three-step alignment pin through the flight idle slot of the propeller index bracket into the indexing lever.

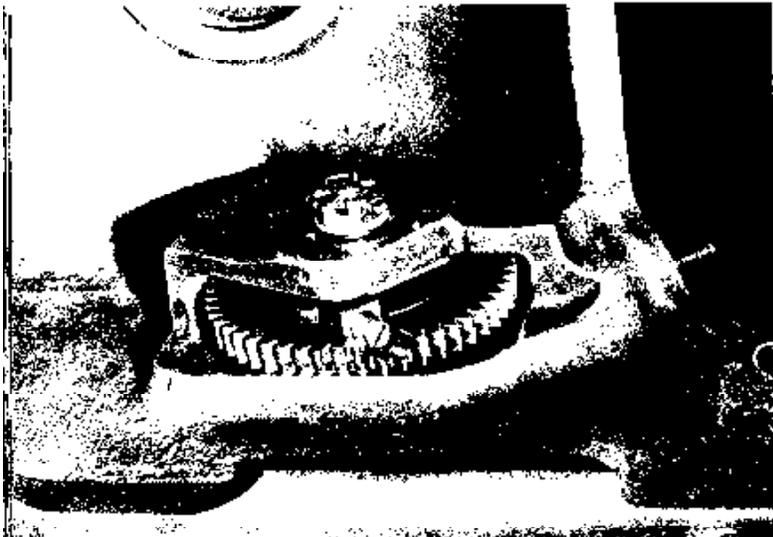
View of split gear inside propeller control valve housing cover.

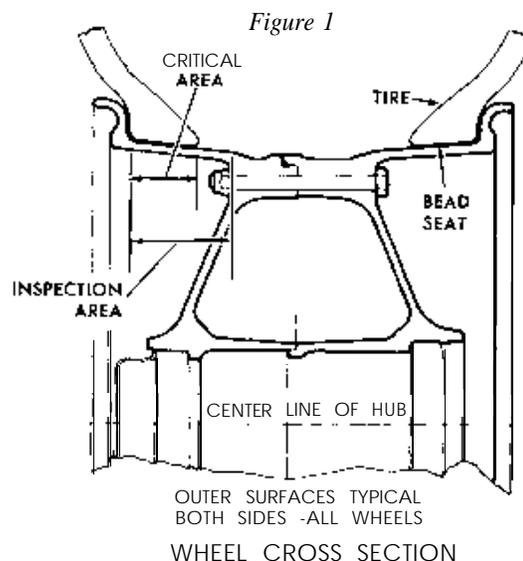
The best way to avoid such a possibility is to put special emphasis on close examination of the critical area of the tubewell, as well as the bead seat. During inspections or disassembly of a wheel, take the time to examine each

wheel half carefully. Check the surfaces of the tubewell area for cracks or potential cracks, and pay particular attention to the section from the bead radius to the end of the toe of the tire.
