VOL. 16, NO. 4, OCTOBER-DECEMBER 1989

# *SERVICE NEWS*

# Four-Engine Power Fluctuation

## Propeller Retaining Nut Torque Values

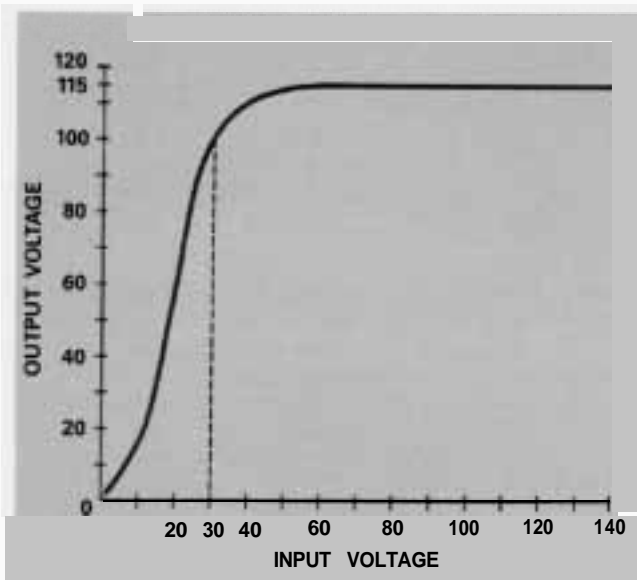
Figure 5. Typical CVT input/output curve with 100-watt load.

A constant voltage transformer (CVT) was inserted in the power line to the synchrophaser during the engine tests to see if it would provide stable electrical power during transient voltage changes and thereby stabilize engine performance. The CVT employed was designed to provide a constant output voltage with input voltage that varied between 40 and 140 VAC.

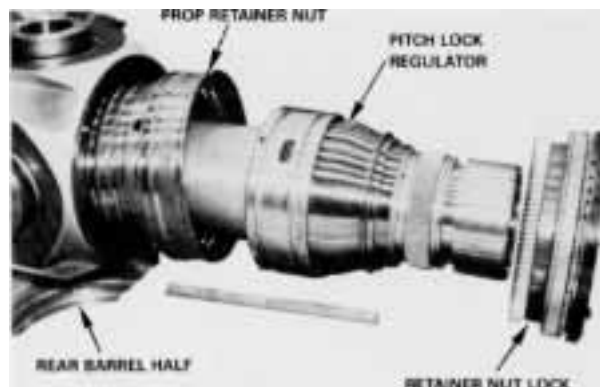
**Correct propeller retaining nut torque is essential to prevent component damage.**

- Place the torque wrench on the propeller retaining nut. Apply the wrench in the tightening direction to ascertain nut pretorque. Note the pretorque value and refer to the information below for appropriate maintenance action.
- If the pretorque is 1500 foot-pounds or more, the shaft is serviceable. Retorque the propeller retaining nut to 1900-2200 foot-pounds and return the aircraft to service.
- If the pretorque is less than 1500 foot-pounds, the metal structure of the propeller shaft may have been excessively fatigued. The affected shaft must be removed from service immediately and condemned. Be sure that all condemned propeller shafts are mutilated with a hack saw or similar tool to preclude further use.

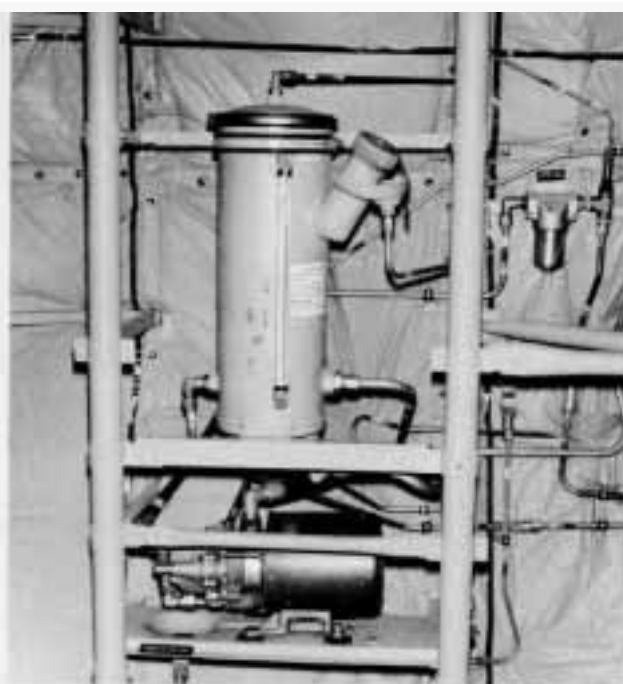
Drain the auxiliary system reservoir when removing system pump, ramp and door manifold, or hand pump.
