Re: *Section 404 Nationwide Permit Application,  
Haley's Ditch Restoration Project  
North of East Archwood Avenue and south of Triplett Boulevard,  
Akron, Summit County, Ohio 44306*

## Haley's Ditch Restoration Plan

**Lockheed Martin**  
**Haley's Ditch Stream and Wetland Restoration Plan**

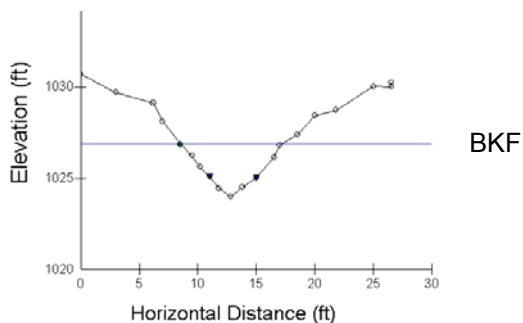
**Figure 2. Cross Section 1 Riffle**

Cross sections were surveyed in four riffle areas to characterize channel conditions and their relationship to depositional and floodplain features and terraces (Figures 2-5). The results characterize the channel as a low width:depth ratio (ie. narrow deep) resembling a Type G or E channel. The cross sections represent a likely recovered condition (Type E) for the channelized ditch as there are indications of a small floodplain that has equilibrated within the bank levees. Nonetheless, the channelization and bank levels as they currently exist inhibit frequent flood inundation to the larger floodplain.

Because the existing drainage channel will be excavated and relocated as part of the remediation efforts, limited channel morphology measurements were collected on the existing conditions. Four cross sections were performed in representative areas to assess channel characteristics and conditions. A longitudinal profile was not performed

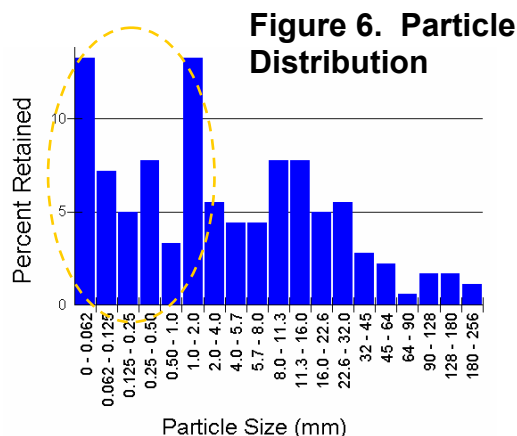
| Figure 6. Particle Distribution | 3 |

Streambed substrates were characterized using the Wolman pebble count methods. Samples were collected in riffle areas as these would represent best substrate conditions due to the depositional nature of pools. Below, Table 2 and Figure 6 summarize the particle distribution in riffle areas. Notice the high percentage of silt (13.2%) and its corresponding proportion (orange outline) in the bar chart depicting bimodal distribution. This is typical of many channelized or incised streams which do not have access to floodplains for storage of this finer material.
