Block E Underground Storage Tank Closure Report Lockheed Martin Middle River Complex 2323 Eastern Boulevard Middle River, Maryland

Facility ID - 14810

Case # 14-0076BA

Tetra Tech, Inc.

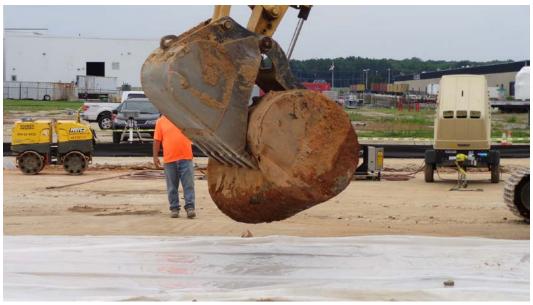
UST #1 extraction

On July 31, 2013, Elite Environmental and Petroleum Services, Inc. (Elite) mobilized equipment to Block E of the MRC to remove UST 1 (500 gallon capacity) and UST 2 (275 gallon capacity). UST removal activities in Block E were conducted by MDE-certified technician Mr. Lawrence Macher (MDIC 2013-1907R; expires April 1, 2015) of Elite, under the supervision of MDE manager Ms. Jenny Herman. UST 1 was located between a footer of the former building and a storm sewer. UST 2 was located adjacent to a storm sewer and the basement floor of the former building. A concrete pad was encountered below UST 2. Photographic documentation of the UST removal is in Appendix B.

Both USTs were removed from the ground and cleaned by pressure washing over the excavation to remove any residual soil. Disposal receipts are in Appendix C. During excavation, a MiniRae[®] combustible-gas indicator monitored the workers' breathing zone; no alarms sounded during the removal activities. Multiple visible perforations were observed in the removed tanks, including small holes and tears in both tanks.

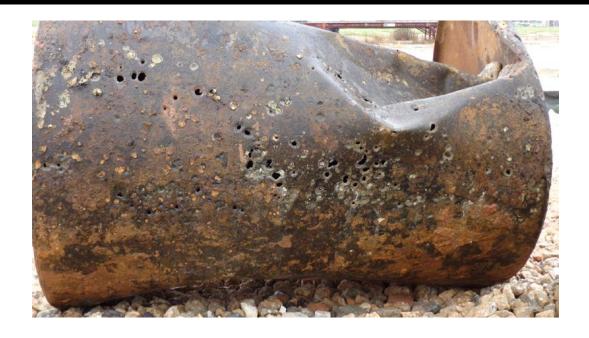
UST # 1 perforations

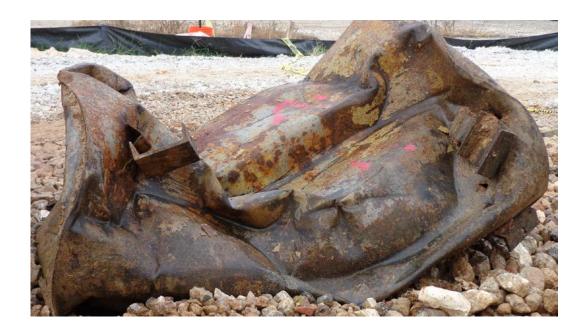
Close-up of UST #2 following extraction and washing
