# SERVICE NEWS

## **VOL. 4, NO. 2, April - June 1977** **CONTENTS**

# Leaky Fasteners

by M. G. Billias, *Development Engineer Specialist*  
M. V. Cobb, Jr., *Design Engineer, Senior*  
F. D. Poss, *Components Engineer, Senior*

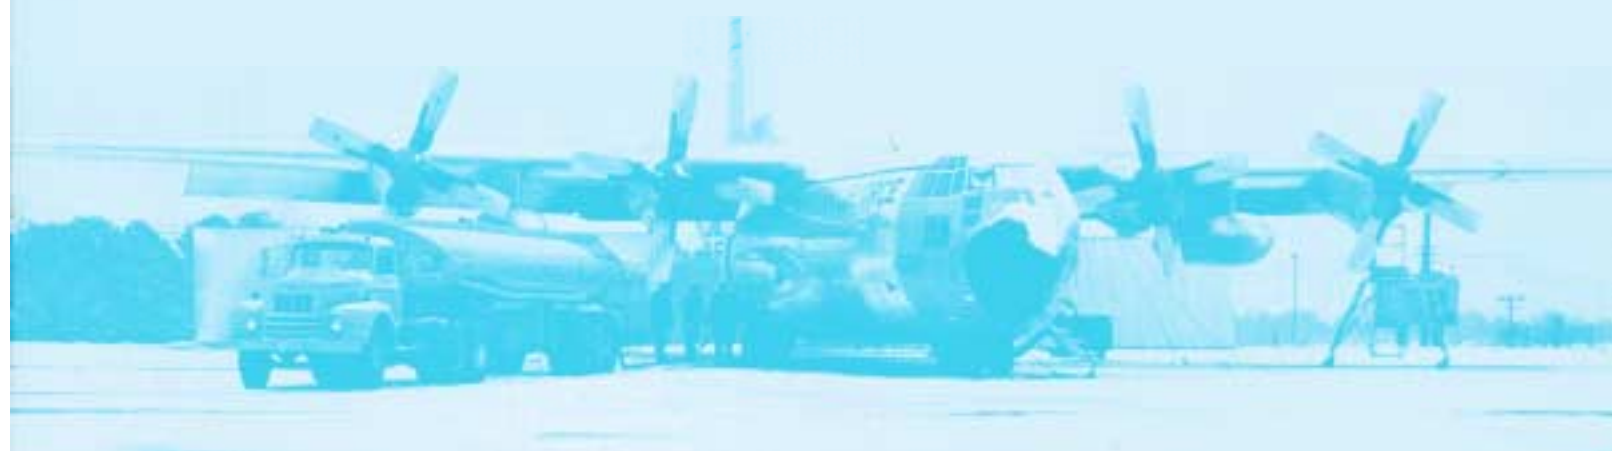
Figure 1 SUMMARY OF SEALING MATERIALS

LOCKHEED A/C NO.	TANK COATING	FAY SEALANT	POST- ASSEMBLY SEALANT	TOP- COAT
3001/3122	Buna-N		MI L-S-7502	Buna-N
312313164	Buna-N		MI L-S-8802	Buna-N
316513231	Spray Polysulfide/ Bona-N		MI L-S-8802	Buna-N
(323213500 Not Assigned)				
350113882	Spray Polysulfide/ Buna-N	Polysulfide Film	MI L-S-8802	Buna-N
388314126	Polyurethane MI L-C-27725	Polysulfide Film	MI L-S-8802	
4127/4313	Polyurethane MI L-C-27725	Polysulfide LAC 40-105	MI L-S-8802	-
431414330	Polyurethane MI L-C-27725 w/biocidal dye	Polysulfide LAC 40-105	MI L-S-8802	MIL-C- 83019
4331 & up	Polyurethane MI LX-27725 w/biocidal dye	Inhibited Polysulfide STM 40-111, STM 40-112 (MIL-S-81733)	MI L-S-8802	MI L-C- 83019

Lockheed has always used the latest state-of-the-art materials for sealing and coating the fuel tanks; and, as a result, various sealing and coating materials can be found in the fuel tanks. A summary of the materials used in the manufacture of the Hercules is listed in Figure 1. It should be realized that the original materials used in sealing and coating the tanks may no longer be in service. Certain older aircraft that have undergone numerous modifications or update programs will probably contain the latest coatings and sealants.

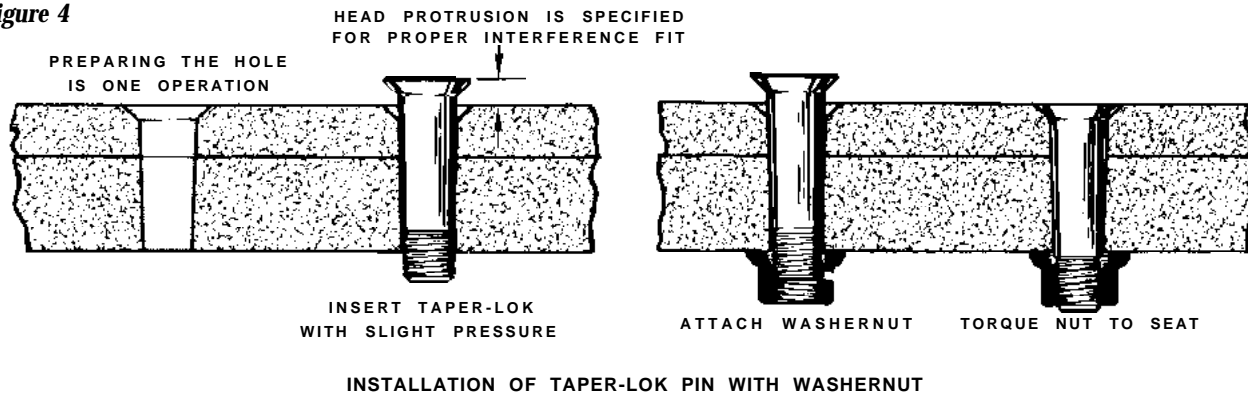
**Figure 4**

## HISTORY OF FASTENERS USED IN HERCULES INTEGRAL WING TANKS

REAR BEAM WEB TO CAP SPLICES	PRIOR TO 4542 - ALL	WEB TO CAP - OWS 6 TO 36	STEEL LOCKBOLT
		WEB TO CAP - OWS 36 TO 401	2024-T3 RIVET
		WEB TO CAP - OWS 401 TO 562	2117-T3 RIVET
		STIFFENER TO WEB AND CAP	ALUMINUM LOCKBOLT
		STIFFENER TO WEB ONLY	2117-T3 RIVET
		EXTERNAL FUEL TANK ATTACH. FITTING TO WEB AND CAP	STEEL LOCKBOLT
	4542 AND Up	WEB TO CAP - OWS 6 TO 18	TAPER-LOK
		ALL ATTACHMENTS - OWS 18 TO 401	STEEL LOCKBOLT
		ALL ATTACHMENTS - OWS 401 TO 456	STEEL HI-LOK
		WEB TO CAP - OWS 456 TO 562	2117-T3 RIVET
	STIFFENER TO WEB ONLY - OWS 6 TO 562	2117-T3 RIVET	
	STIFFENER TO CAP AND WEB OWS 401 TO 562	STEEL LOCKBOLT	
① AIRCRAFT NOT MODIFIED BY T.O. 1C-130-857 (ECP 954)			
A2 AIRCRAFT MODIFIED BY T.O. 1C-130-857 (ECP 954)

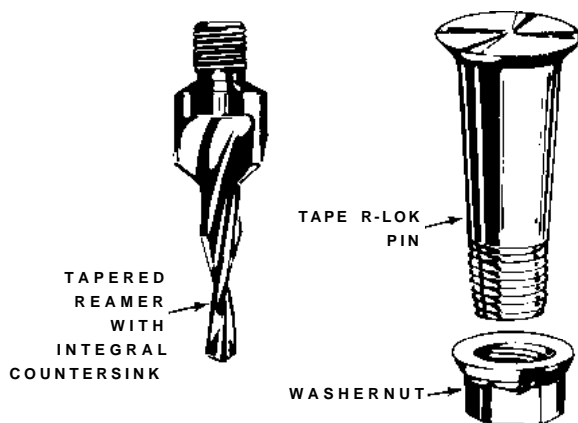
**Figure 5**

**Installation and Removal of Taper-Loks** – The condition of the Taper-Lok fastener hole is the most important consideration of the Taper-Lok fastener system. The hole is produced with a tapered reamer having an integral countersink or a radius on the reamer which creates the complete hole in one step (see Figure 5). The tapered pin is inserted into the hole with slight pressure and the pin head protrusion is measured to assure proper interference when the pin is fully seated.

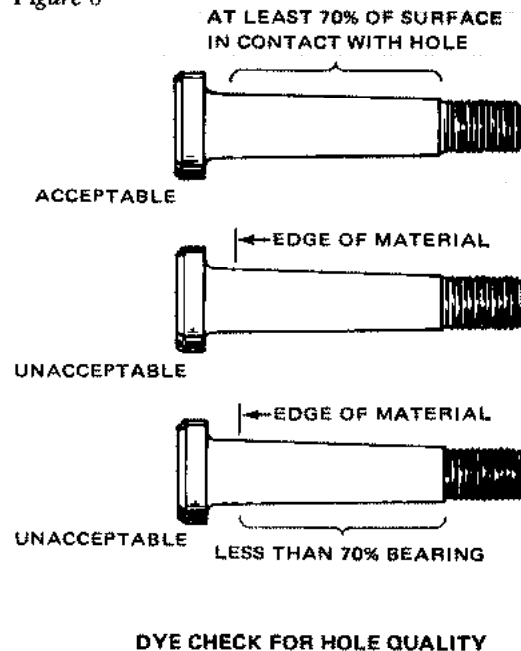
**Figure 6**

the pin into the hole, carefully removing the pin, and reading the contact of the hole on the surface of the pin. The pattern for an acceptable hole is shown in Figure 6.

An additional check for hole quality is known as a dye check. Its purpose is to determine the amount of contact area between the pin and hole, and is used only when it is necessary to verify the quality. This check is accomplished by applying a dye to the pin shank and pressing

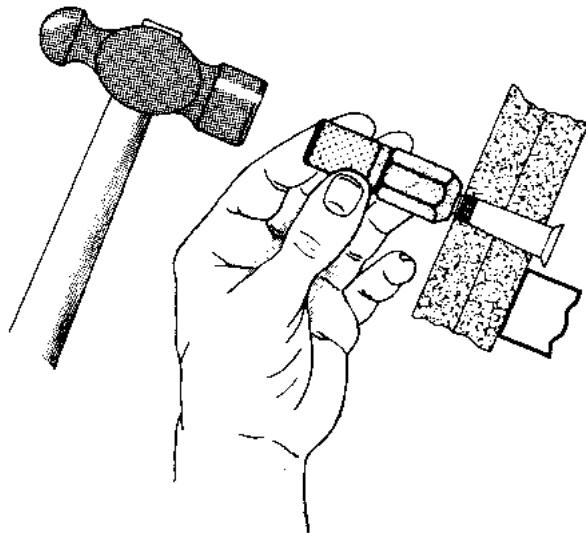
Figure 7

THREADED REMOVAL TOOL  
FOR TAPER-LOK TYPE FASTENERS

Essentially, the removal procedure is as follows: The nut is removed and the shank is driven out of the hole with the proper tools (Figure 7). Be careful not to damage the nut-bearing area around the hole,

Removal of the tapered pin fastener assembly is a critical procedure and should be avoided if possible. A slightly improper installation is more acceptable than removal and reinstallation because most removal procedures risk damaging the structure or the hole. If a tapered pin must be removed and replaced, there is a removal procedure with special tools described in your Hercules Structural Repair Manual.

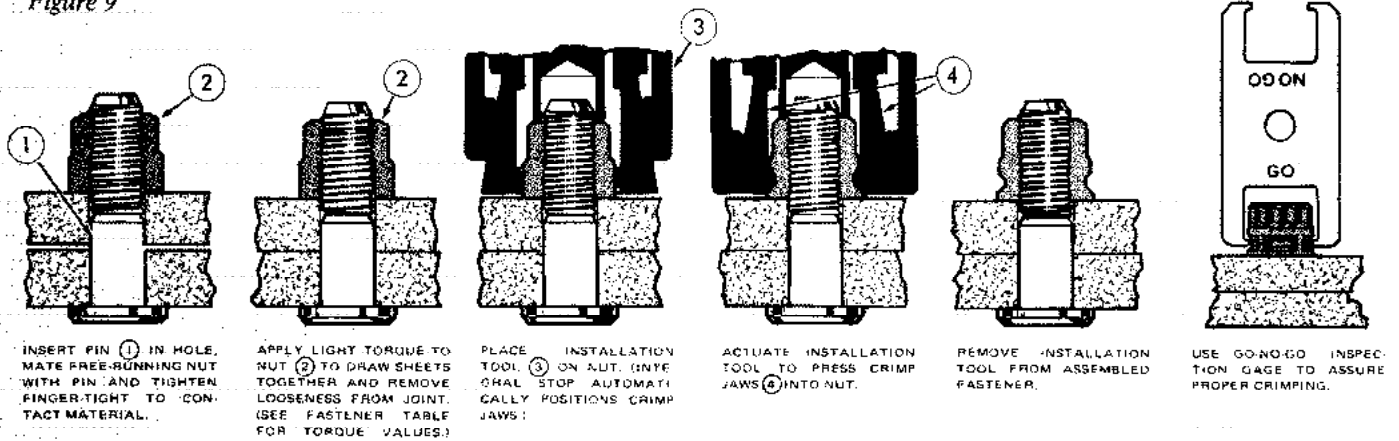
Figure 9

**Installation and Removal of Huckrimps** - Except for special crimping tools, which fit the regular Huck Lockbolt tools, the installation of Huckrimp is quite simple (see Figure 9). A straight hole is required and the pin is inserted into the hole; a slight interference is preferred, but not required, to hold the pin while the Krimpnut is pretorqued onto the pin. This pretorque of the Krimpnut is important - especially when uncured sealant is present in the joint and on the pin - before the crimping operation which causes the high tension preload in the joint. If the Krimpnut is not properly pretorqued, the required tension preload will not be achieved.

#### INSTALLATION SEQUENCE FOR HUCKRIMP FASTENING SYSTEM

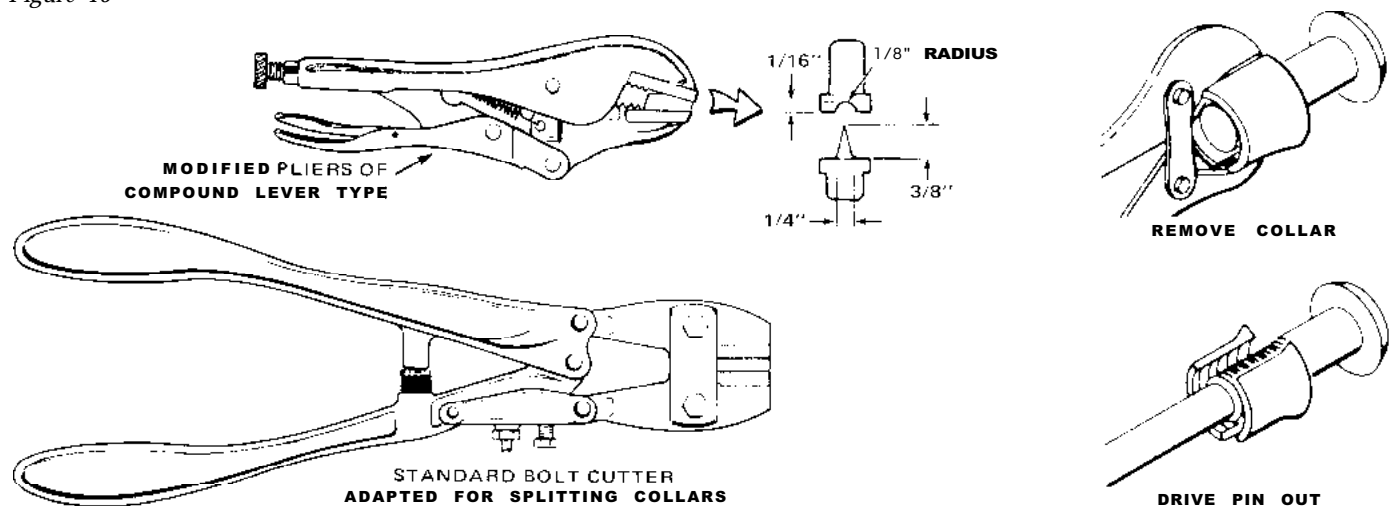
Figure 10

Removal of the Huckrimp assembly can be somewhat difficult because the pin will sometimes turn in the hole when an attempt is made to remove the collar (Krimpnut). When the pin turns in the hole, the collar must be cut off of the pin with a collar splitter (see Figure 10)

or the pin must be drilled out from the nut side or, if inaccessible, the pin may be drilled from the head side with a drill slightly smaller than the pin.

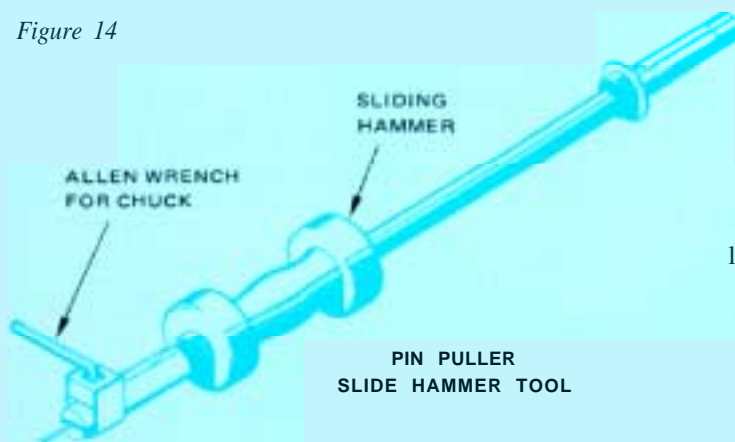
Figure 14

A hole is drilled into the fastener body and threaded. A screw is then inserted in the hole and a slide hammer puller is used to withdraw the fastener. The hard and tough alloys of certain fasteners may present an extra challenge to the mechanic performing this operation. A typical pin puller/slide hammer type tool is shown in Figure 14.

If the fastener stem has an interference fit or is corroded, the next problem may be to force the stem back out of the hole. If the working space doesn't allow use of standard knockout tools, there is another approach, but it should be used only as a last resort.

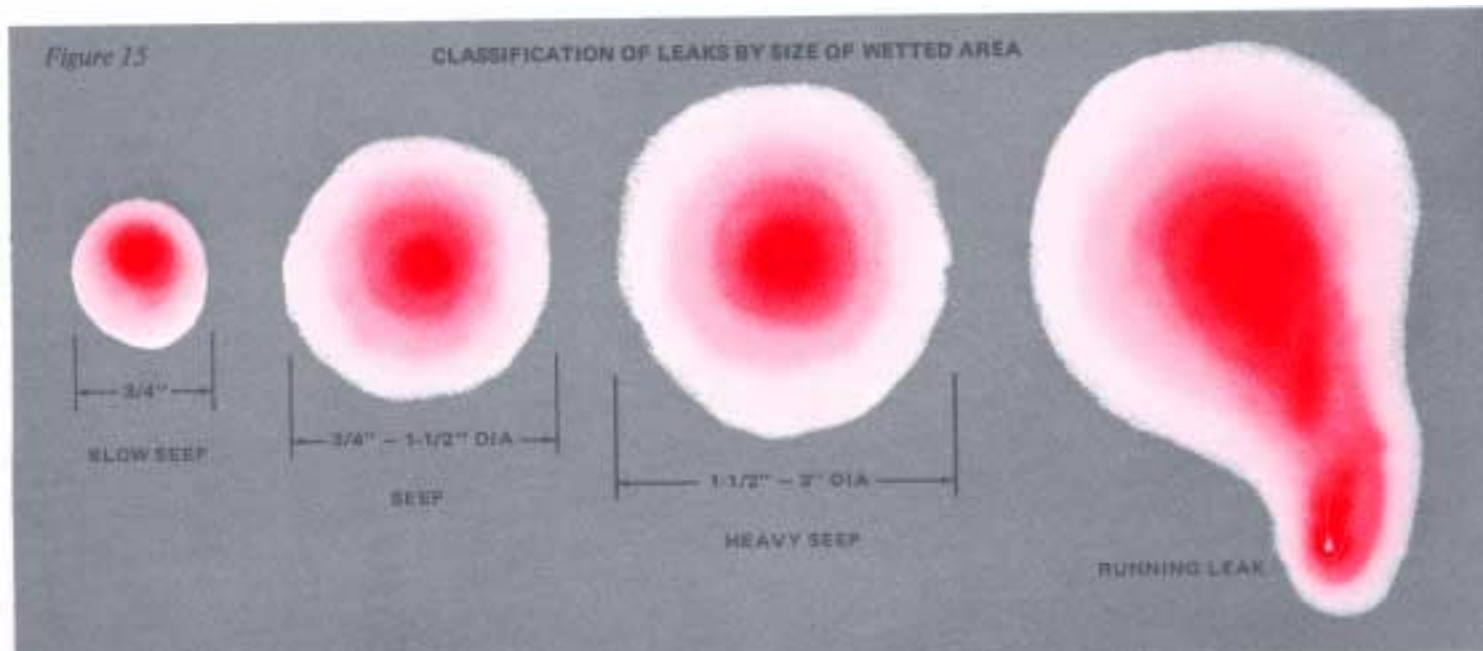
All fuel leaks create hazardous conditions and must be repaired. Even small seeps, in confined areas, can be cause to ground an airplane. First, the leak should be classified. The following definitions and Figure 15 provide a good explanation of the various leaks:

**Running Leak** – Fuel immediately reappears after being wiped away and can be seen to spread on surrounding surface and drips or runs from the surface. This type leak requires the immediate grounding of aircraft for leak repair. Next, the type of repair to be made, temporary or permanent, should be decided upon and then the repair procedure determined.

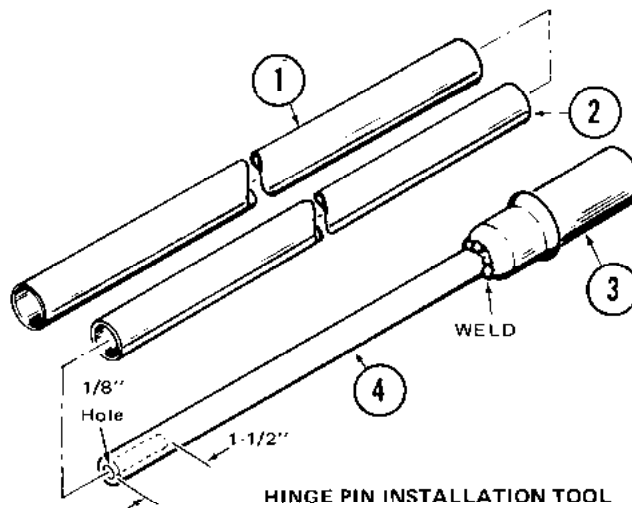
tubes support the rod and telescope within each other as the hinge pin is installed.

The end of the hinge pin being inserted should be tapered slightly to facilitate installation and to protect the hinge. Dry film lubricant should not be removed from the 302H steel pin-if it is, the pin should be sprayed with MIL-L-46147 dry film lubricant before installation.
