Airdock Pavement Debris Removal

Project Report
Akron, Ohio

October 14, 2008

Prepared for:
Lockheed Martin Corporation

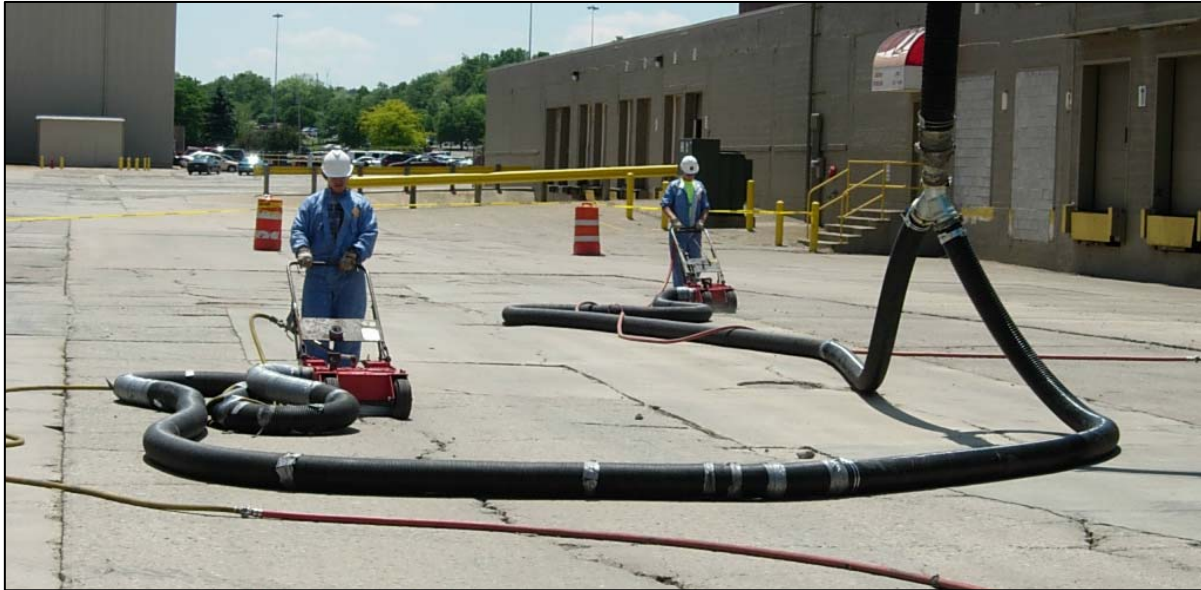
Photo 1 – Debris removal with shrouded mobile chambers

In order to remove debris from the cracks and construction joints, a small shrouded mobile chamber, similar in shape to a push lawn mower, was equipped with a series of air nozzles. These air nozzles were directed strategically in order to provide the best debris removal results. A compressed air line was attached to the chamber along with a 6" vacuum line extending from a vacuum truck. As the debris was loosened from the cracks and construction joints, it was immediately vacuumed into the truck. An air compressor was used as the air feed to the chamber. The volume of air supplied from the compressor was significantly less than the volume of air removed from the mobile chamber by the vacuum truck ensuring a negative pressure inside the shrouded mobile chamber and no escape of mobilized debris.

The vacuum truck was equipped with HEPA filters and a bag house to remove all air and debris and prevent release of fine particles from the vacuum exhaust. Two mobile chambers were operated from a single compressor and vacuum truck combination. A photograph of this unit as described above is shown in Photo 1.

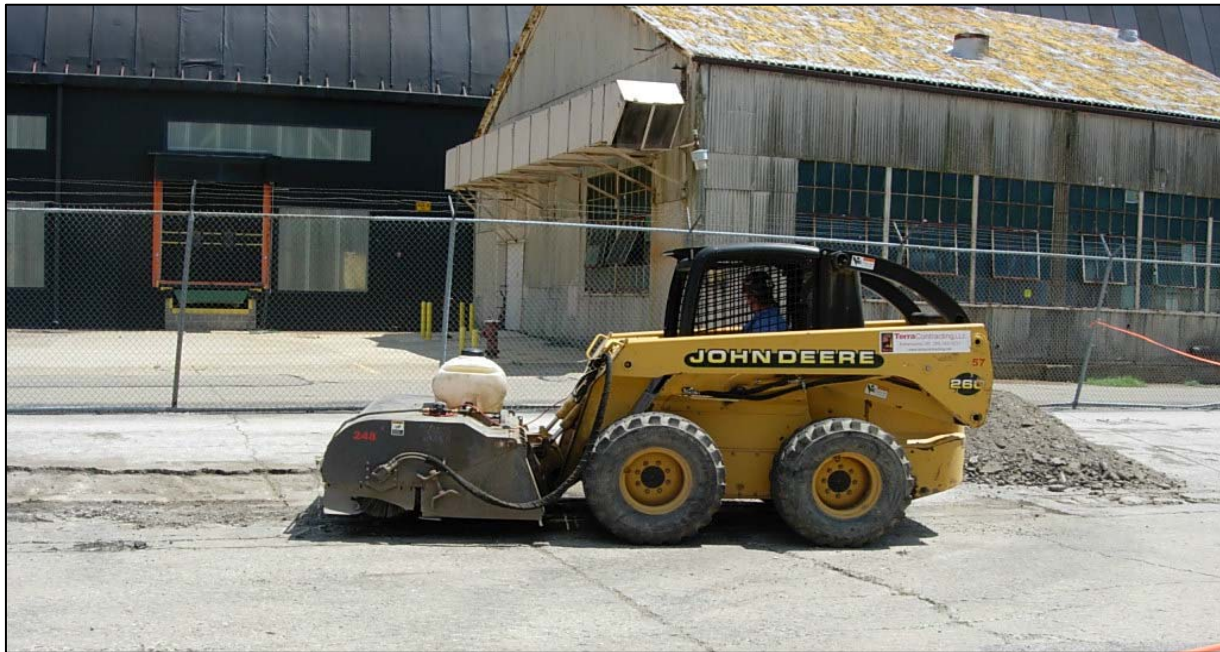
Photo 2 - Skid Steer debris removal operation

Once scraping activities were completed, the skid steer, mounted with a power broom equipped with a water mister to prevent dust generation as shown in Photo 2 was used to collect most of the remaining loose debris generated during the scraping operations.

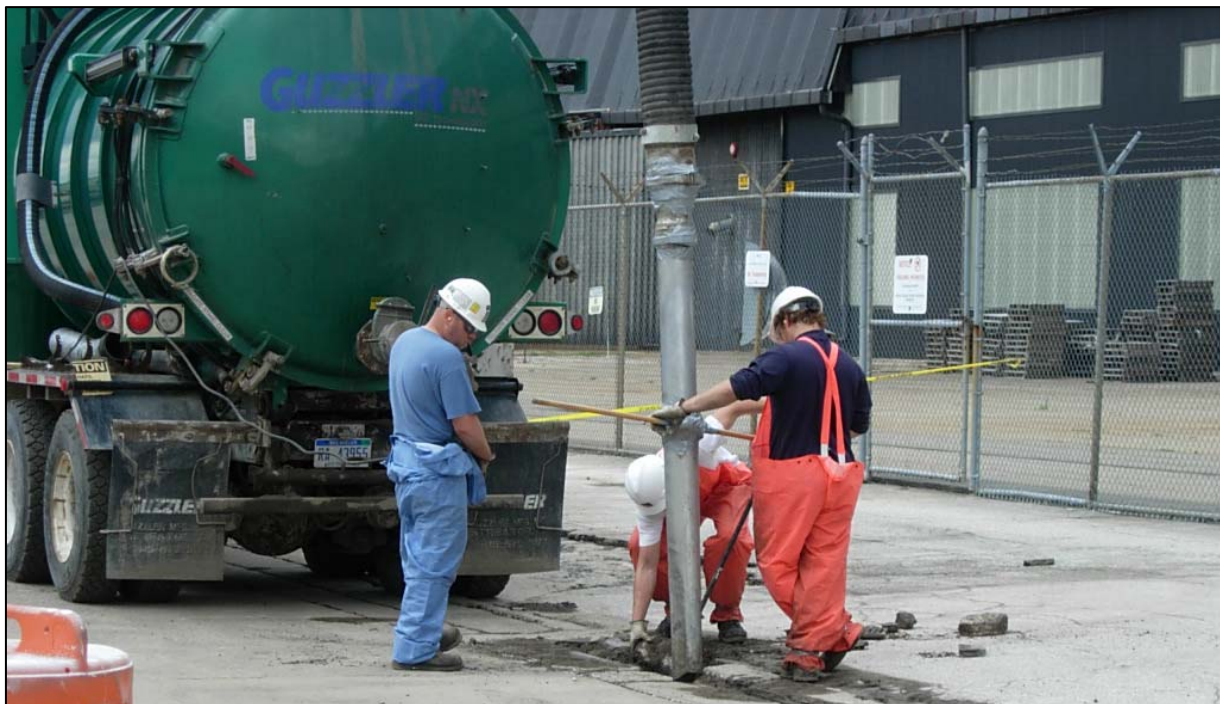
Photo 3 – Hand lance vacuum process removal

To complete the debris removal, the pavement was subsequently vacuumed using the vacuum truck equipped with a mobile chamber and hand lance. A photograph depicting this operation is in Photo 3.

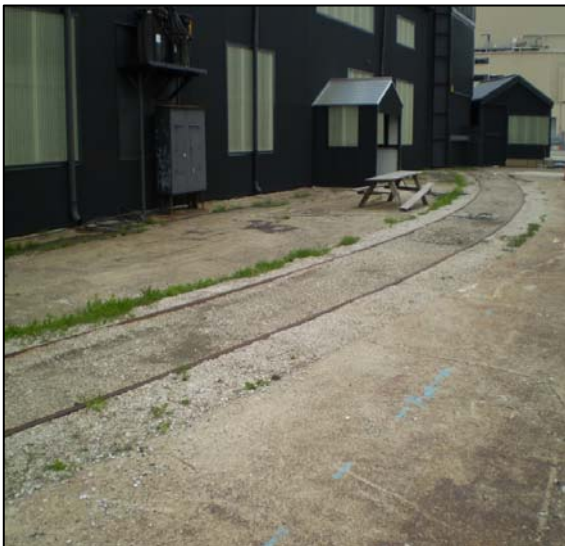
Photo 4a – Southwest Airdock door track before debris removal

Before and after examples of the results obtained by the cleaning technique are depicted in Photos 4a and 4b.

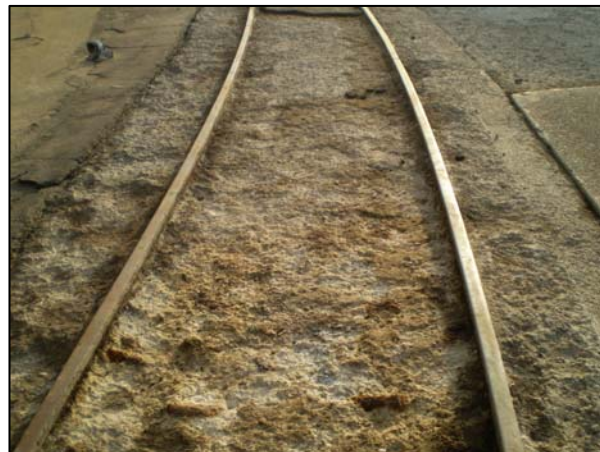
Photo 4b – Southwest Airdock door tracks close-up view after debris removal exposing underlying concrete track foundation.

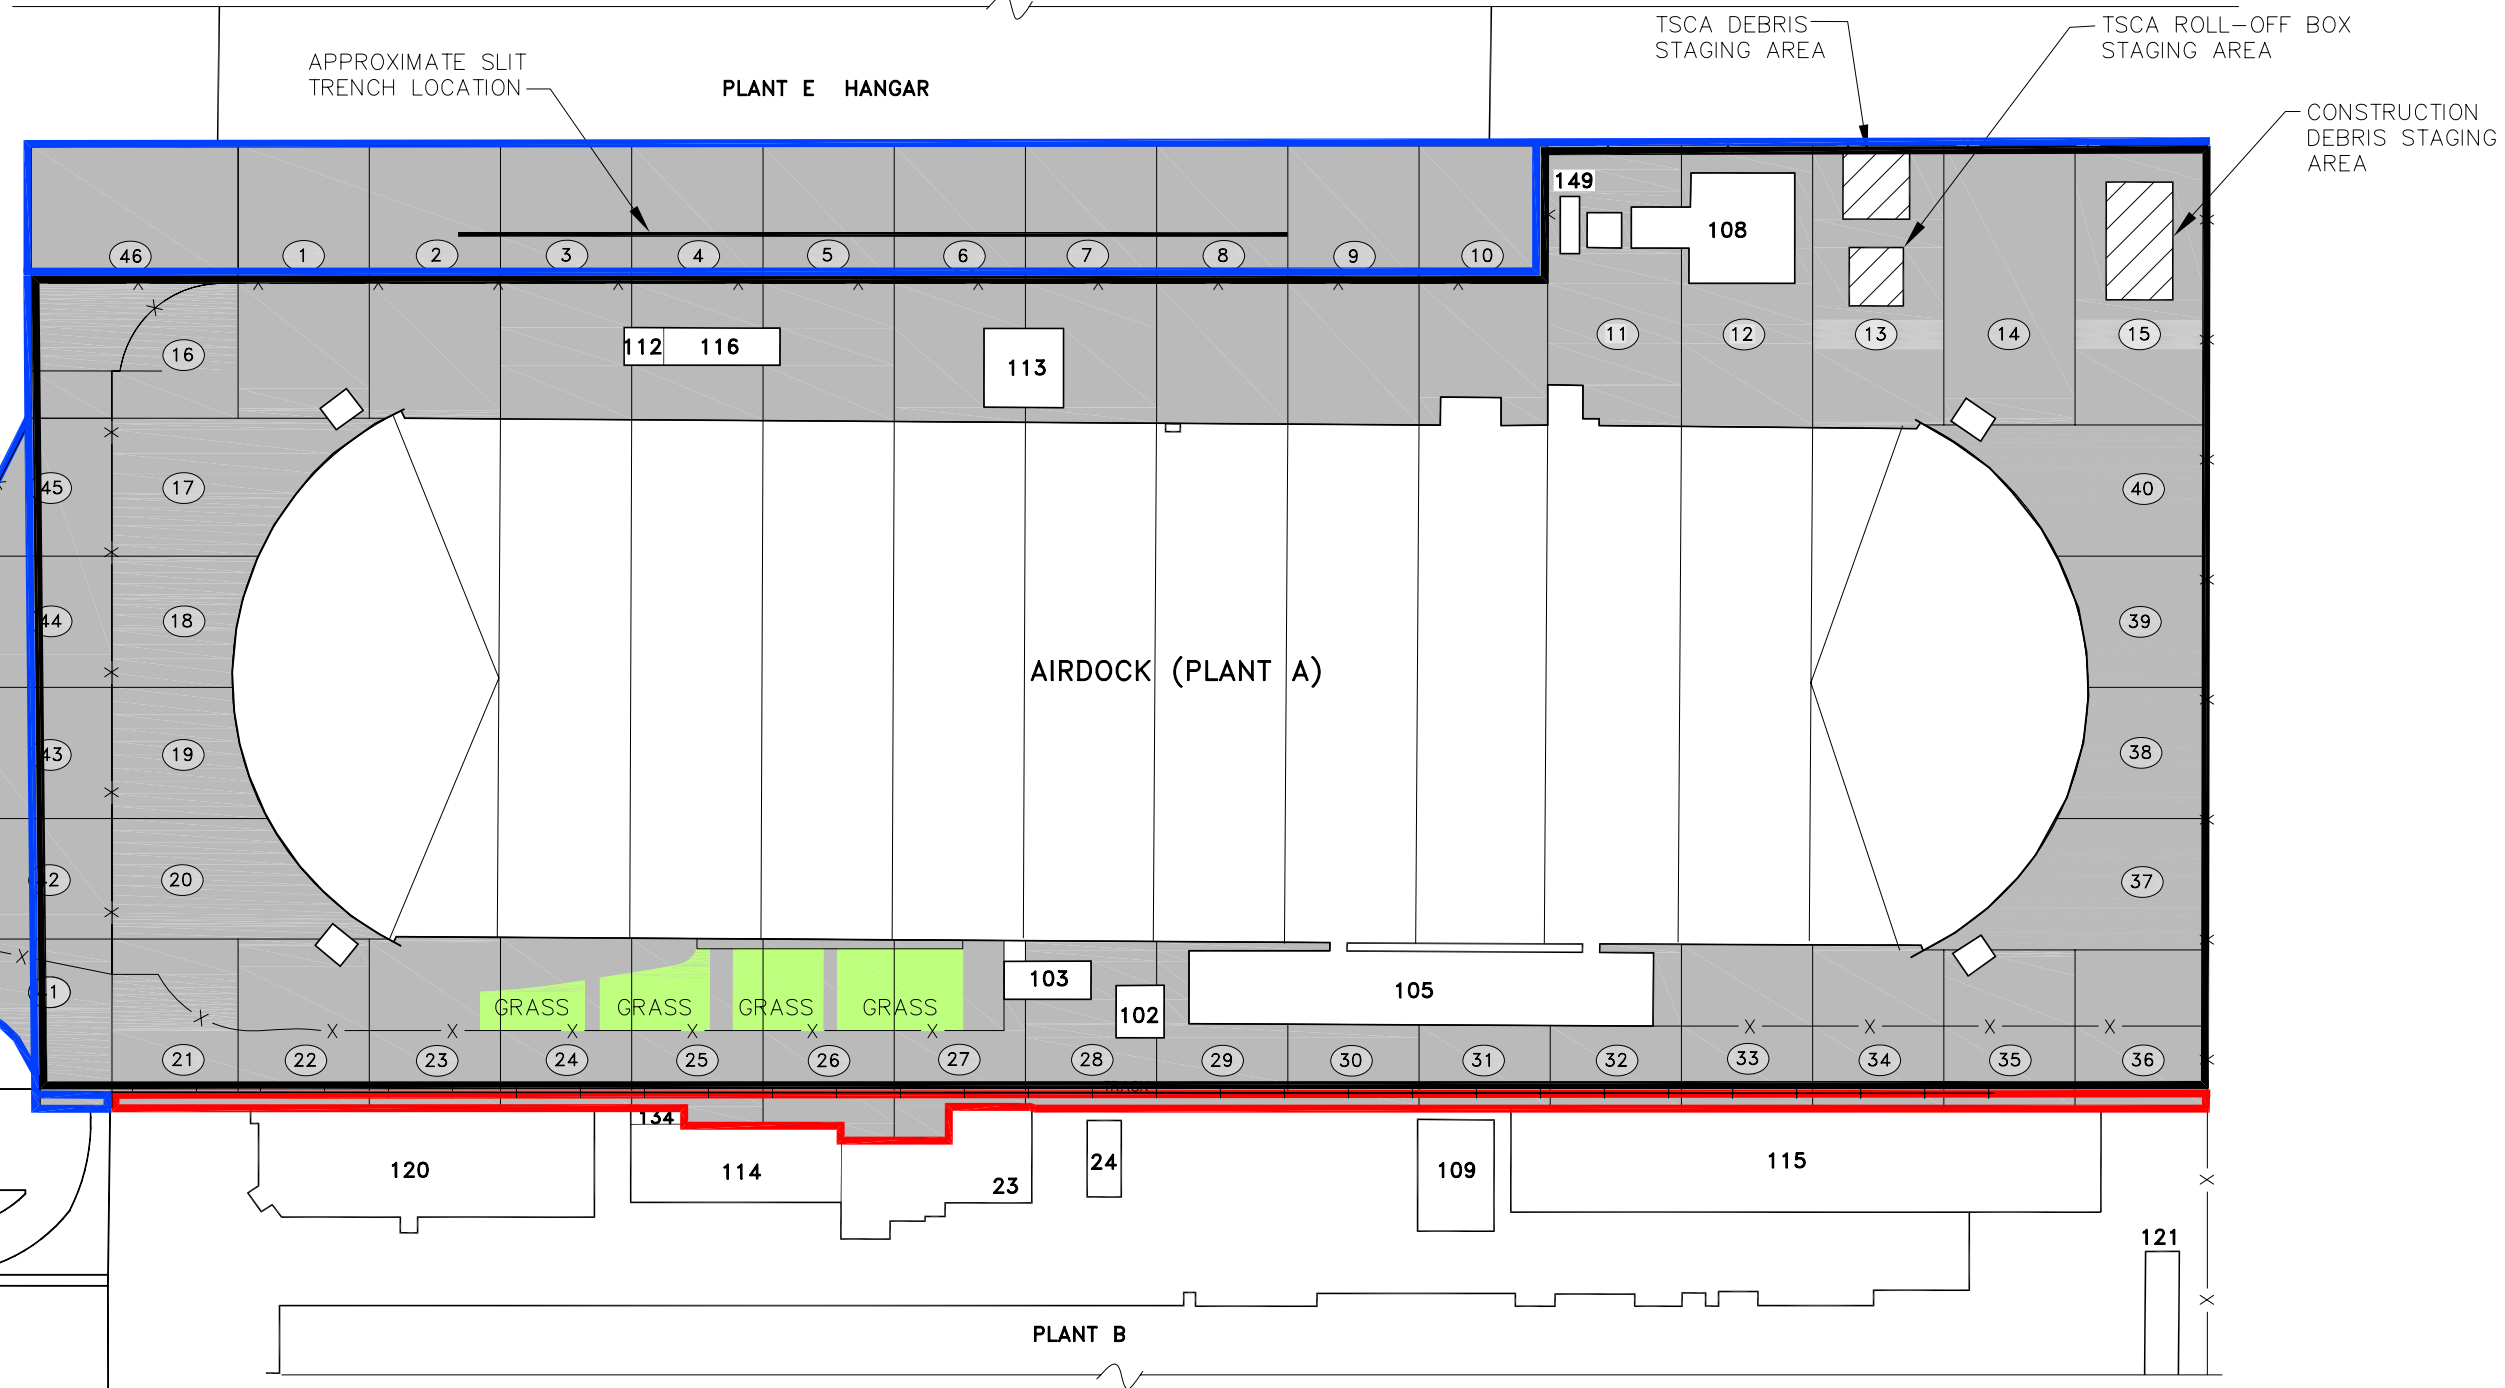
LOCKHEED MARTIN CORPORATION AKRON AIRDOCK FACILITY AKRON, OHIO PAVEMENT DEBRIS CLEANING	
GRID LOCATION MAP	
	FIGURE 1

The debris removal activities were set up into approximately 80 feet by 80 feet grids as shown in Figure 1. Debris removal began on the west side the Airdock. The west side work began west of the fence line and continued toward Plant E working from the south end to the north end of the Airdock. Work on the west side of the Airdock included the slit trench (approximately 5 inches wide and approximately 11 inches deep) which contained highly compacted sediment. The compacted sediment in the slit trench was loosened by hand tools and subsequently removed by vacuum with a Vac-Truck. Work then moved on the east side of the west fence line and continued from the south end to the north end of the Airdock. Once the west side grids were completed, the project continued on the south end side of the Airdock. At the completion of the south end grids, work continued on the east side grids working from the south doors to the north doors. Because accumulation of debris was more substantial on the north end of the Airdock, this area, along with the debris removal at three (3) catch basins was the final area completed.

The work area includes the paved area surrounding the Airdock as outlined in Figure 1. Due to weathering and routine use, the asphalt and concrete pavement surfaces developed cracks and the condition degraded to varying degrees. Debris collected in the cracks of the pavement surface may contain PCB particles, so the purpose of this project is to remove as much of this debris as feasible.
