Lockheed Martin Corporation Beaumont Site 1 & 2 Safety & Toxics Assessment Beaumont, California

March 19, 2003

TC 12866-03

Tetra Tech, Inc.
San Bernardino, California

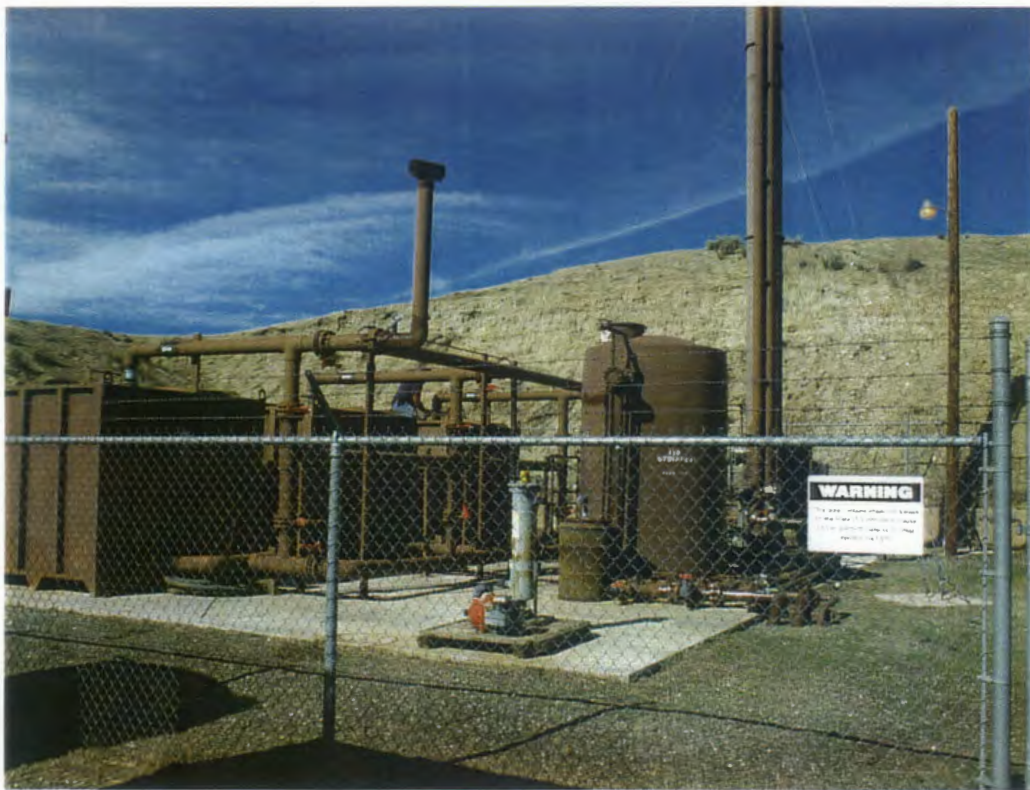
Photograph 2. Groundwater Treatment System (Remediation System)

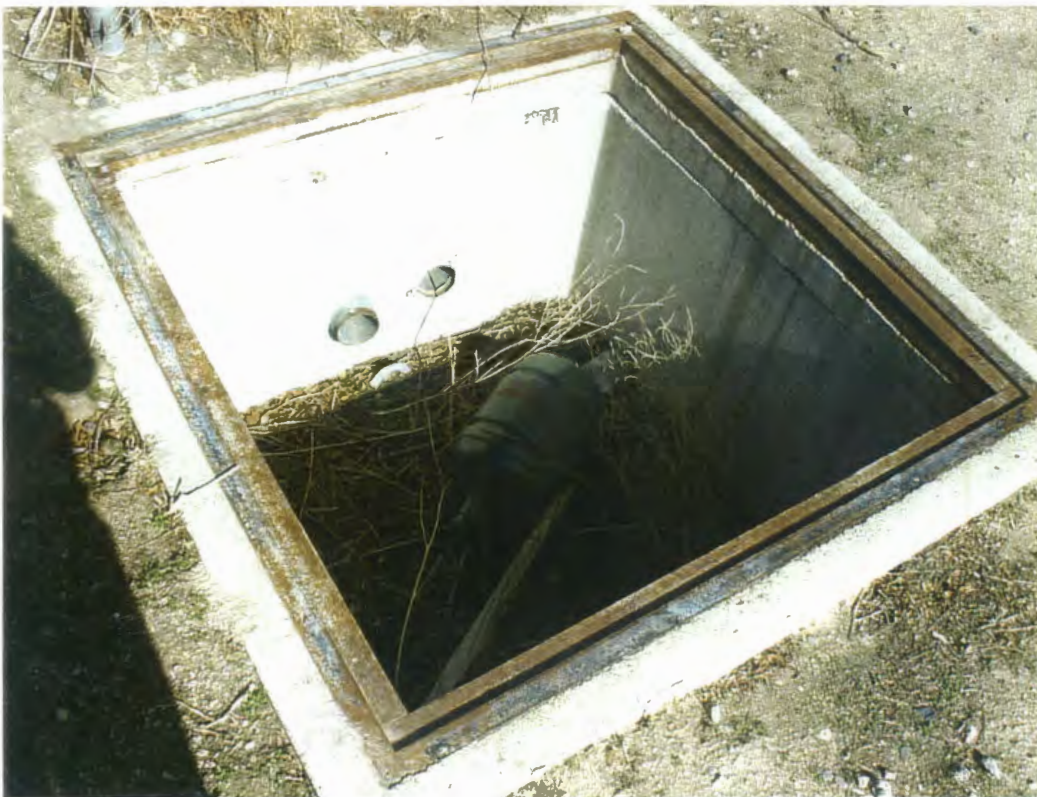
Photograph 6. Typical Vault (Old Structure)

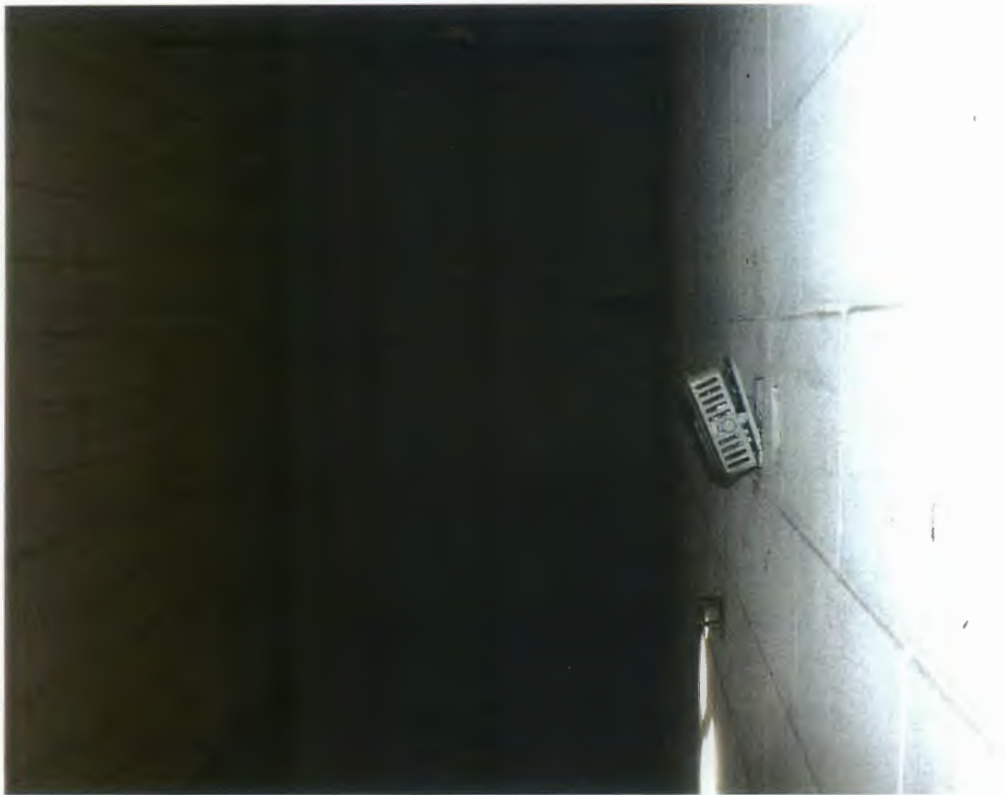
Photograph 7. Mercury Switch (Toxics)

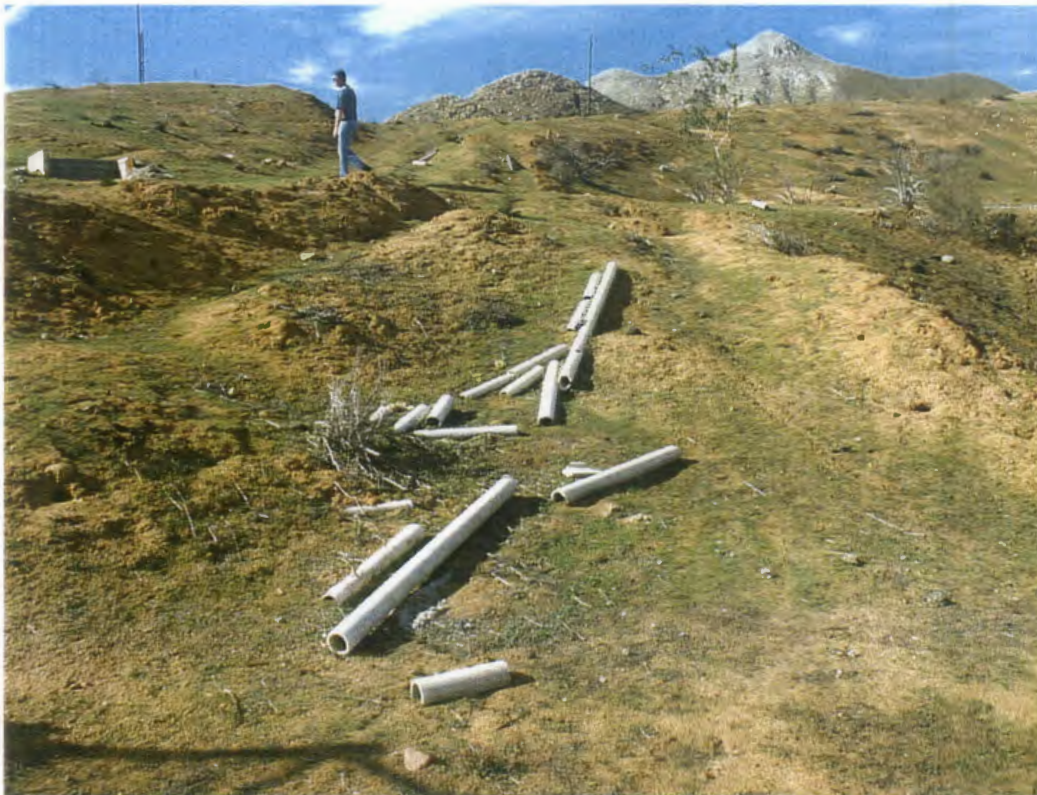
Photograph 8. Transite Pipe (ACM)

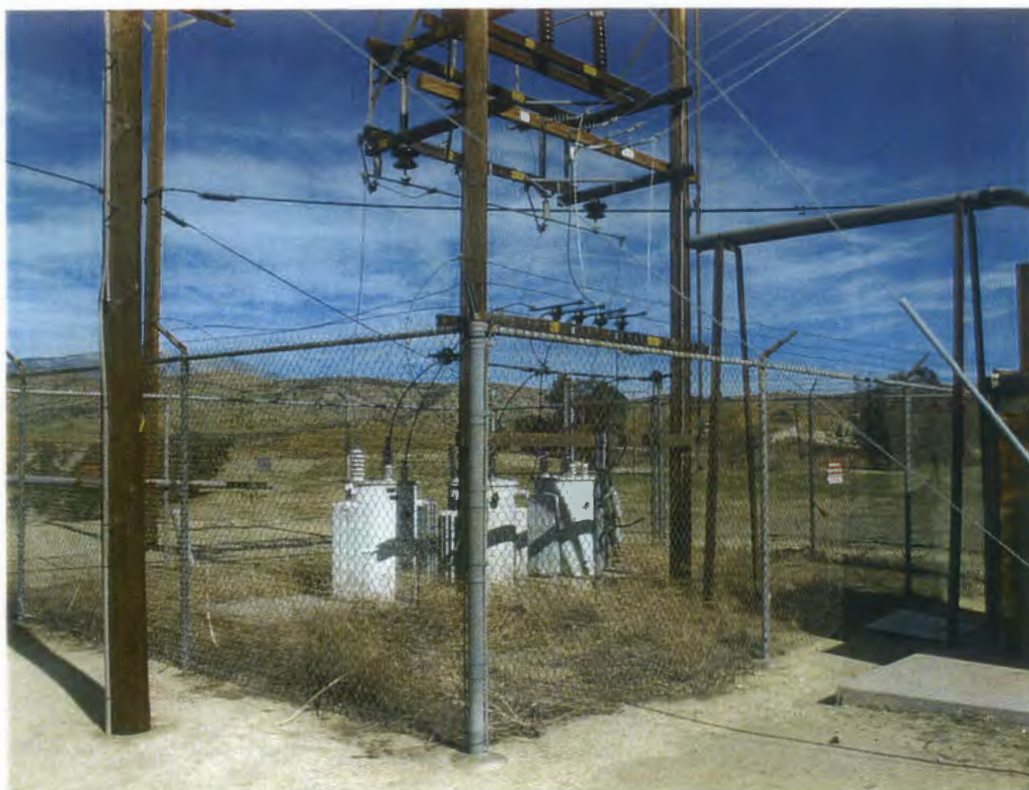
Photograph 12. Transformers (Possible Toxics)

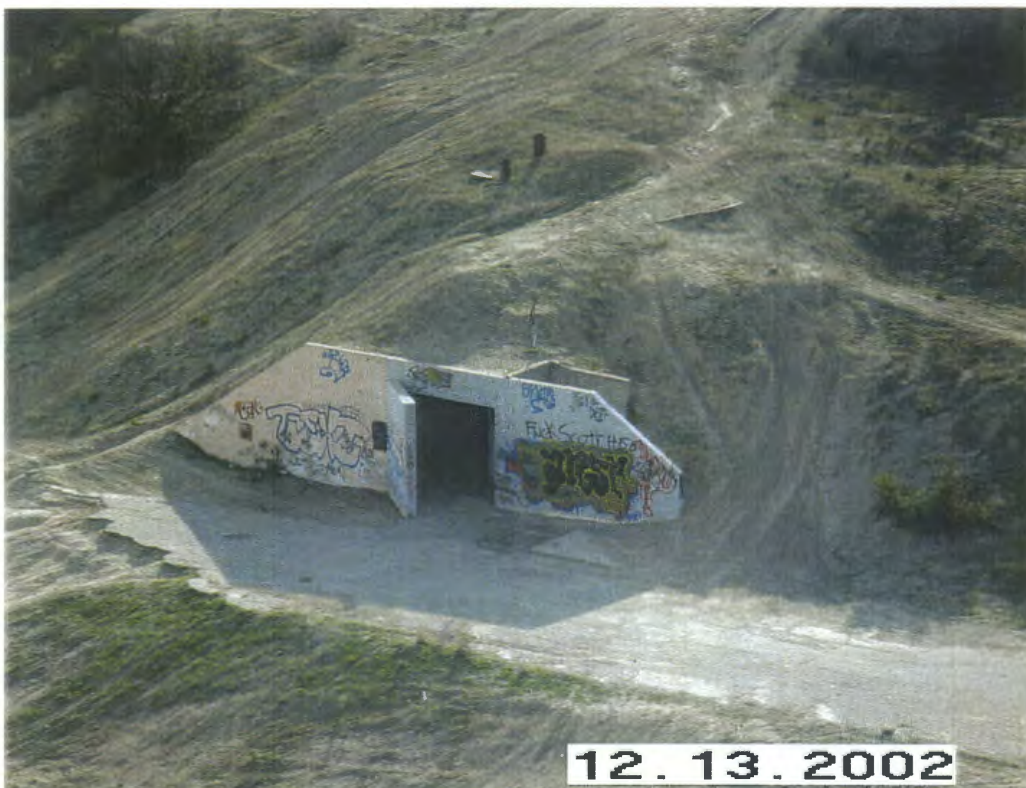
Photograph 2. Typical Bunker (Old Structure)

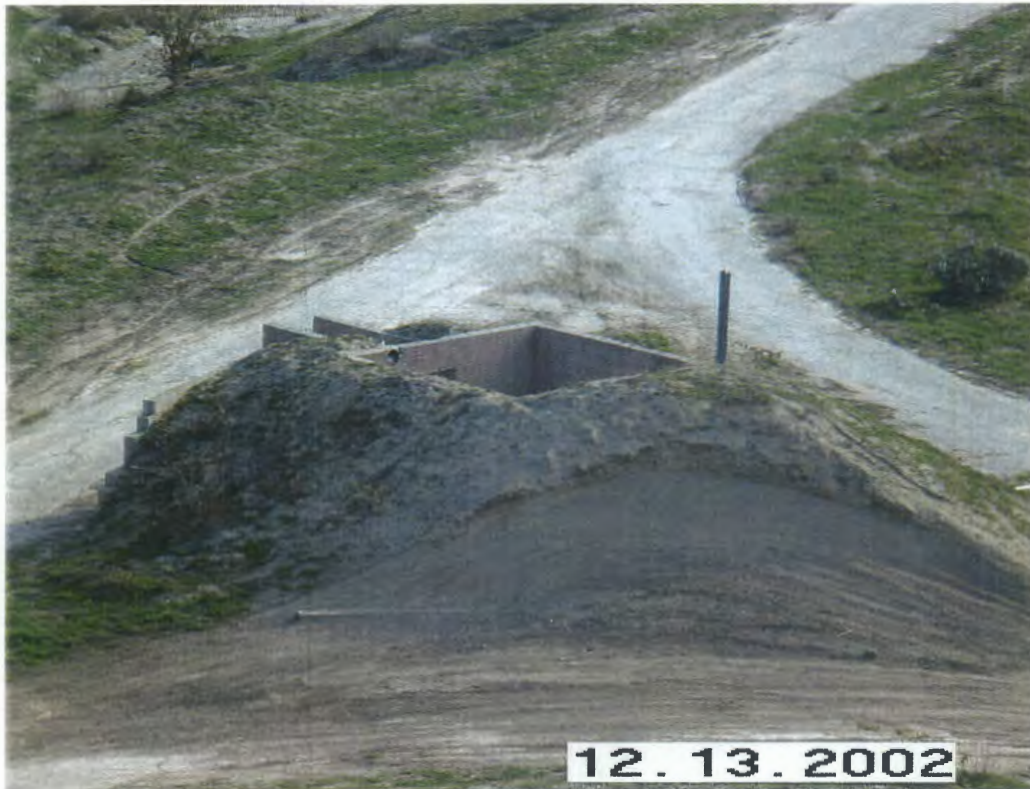
Photograph 5. Bunker at Junction of Y, GPS pt. 33 (Old Structure)

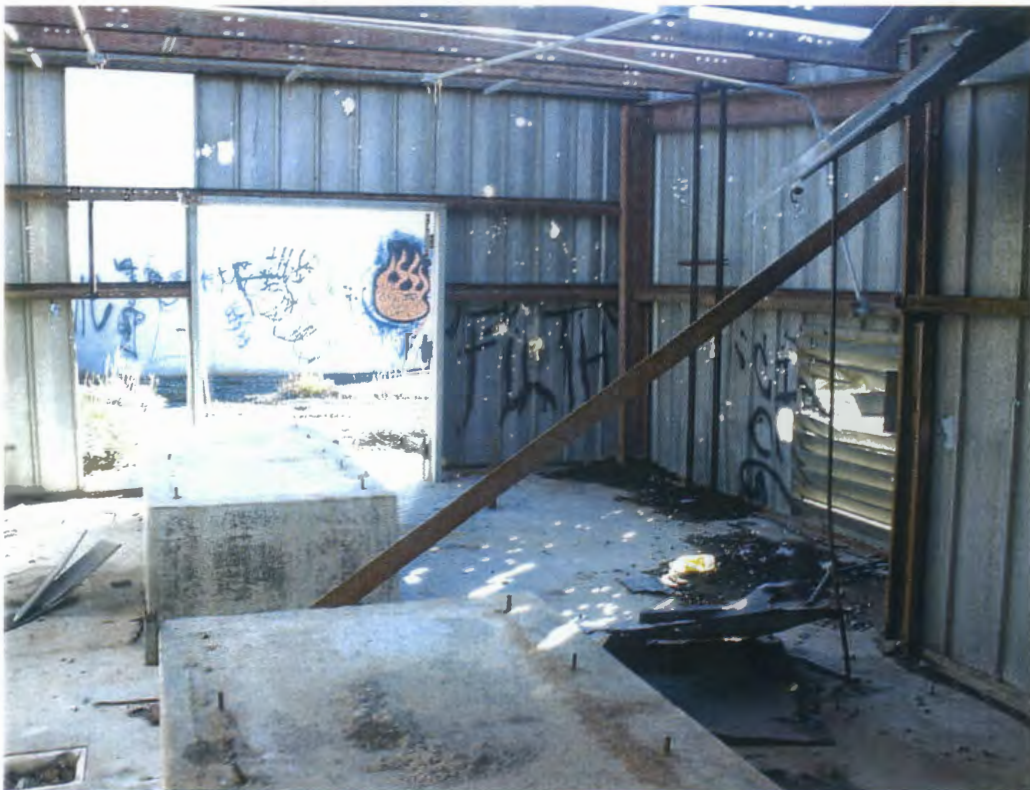
Photograph 6. Interior of Pump House, GPS pt. 2 (Old Structure)

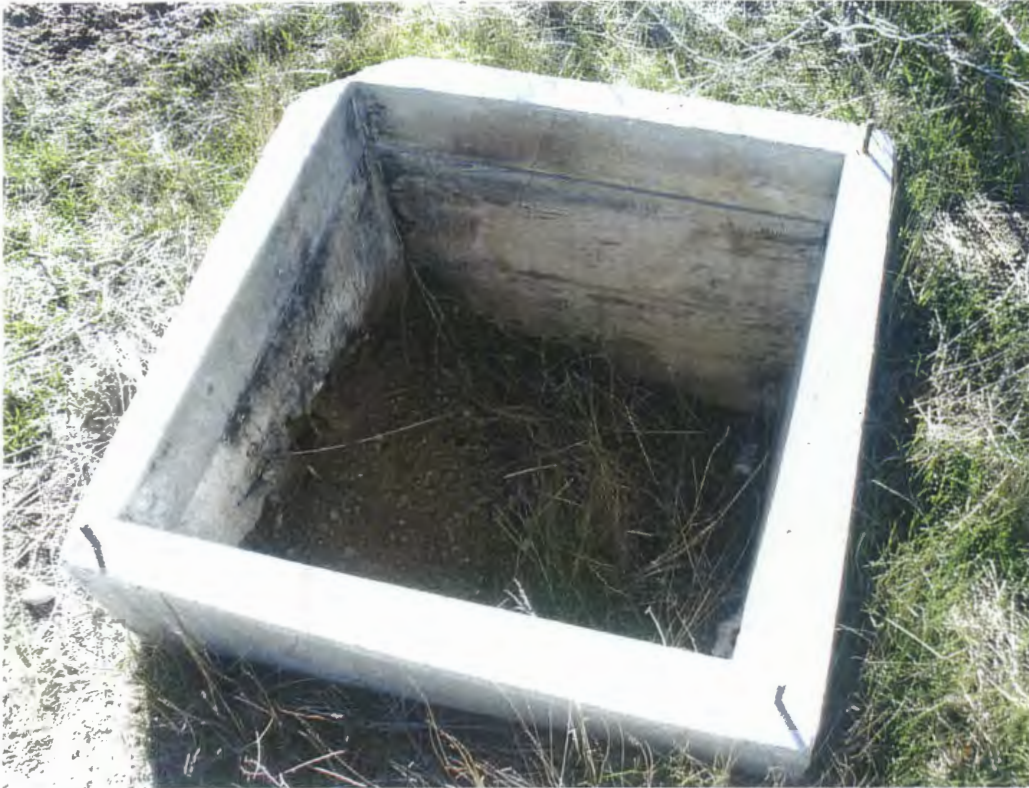
Photograph 9. Vault (Old Structure)

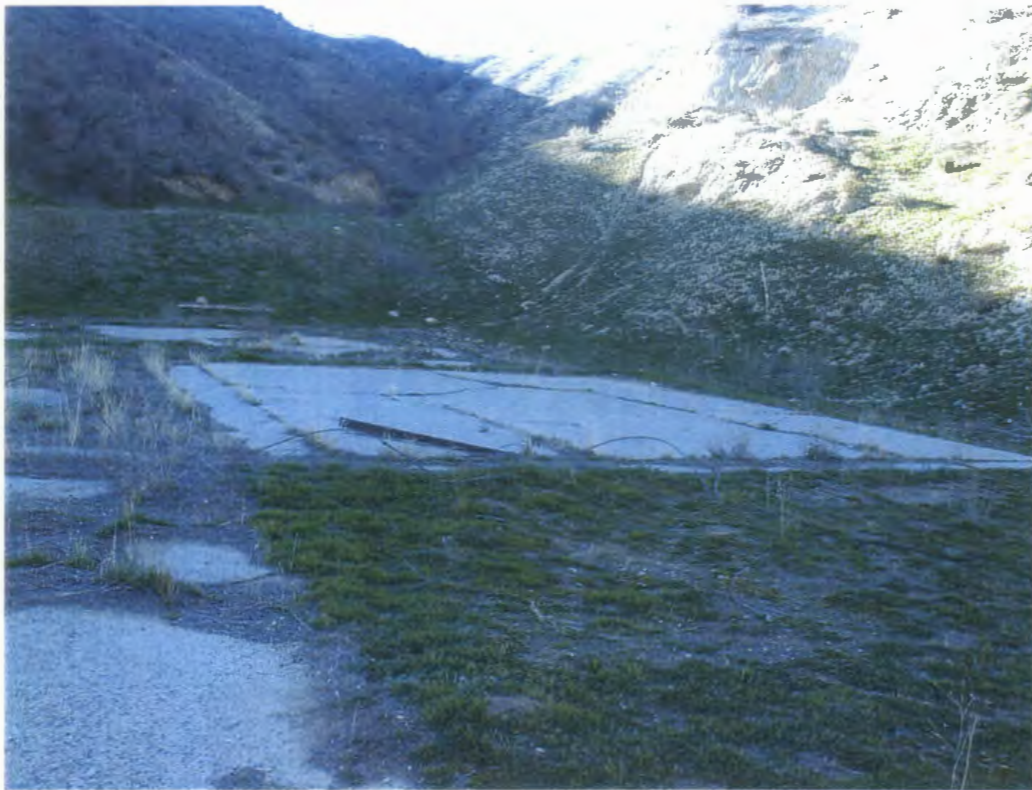
Photograph 12. Typical Concrete Pad (Old Structure)

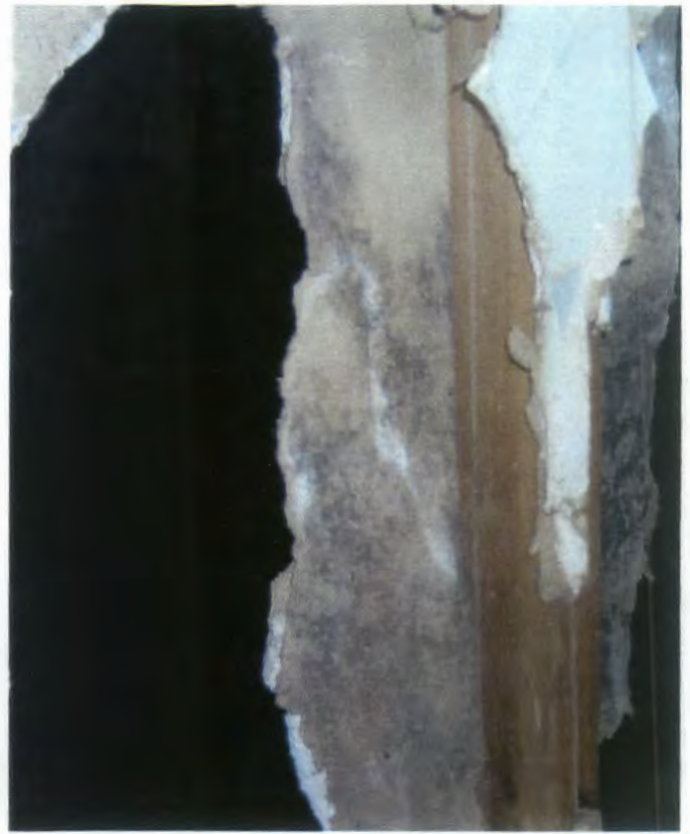
Site 1, Bldg 305, Asbestos Containing Drywall Joint Compound & Mold Growth

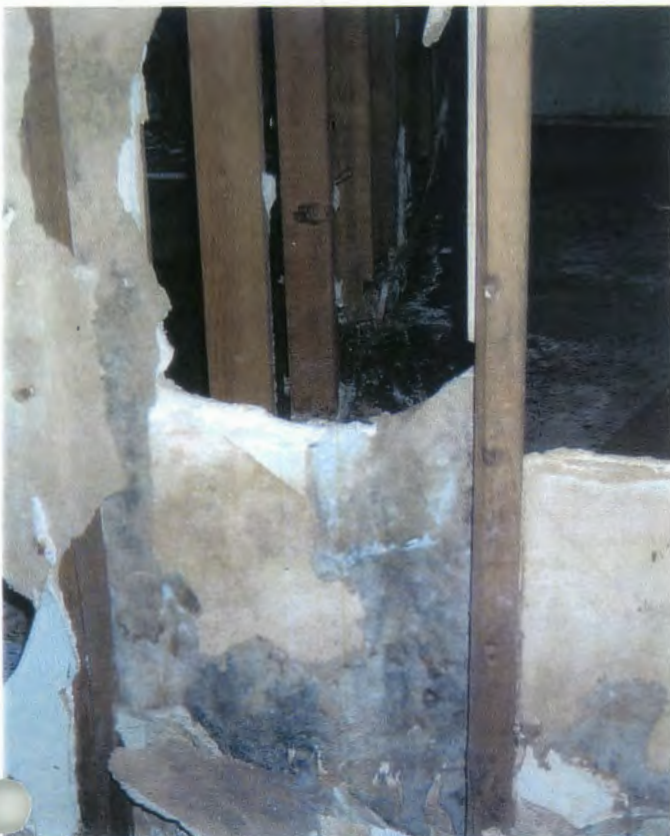
Site 1, Bldg 305, Asbestos Containing Drywall Joint Compound & Mold Growth

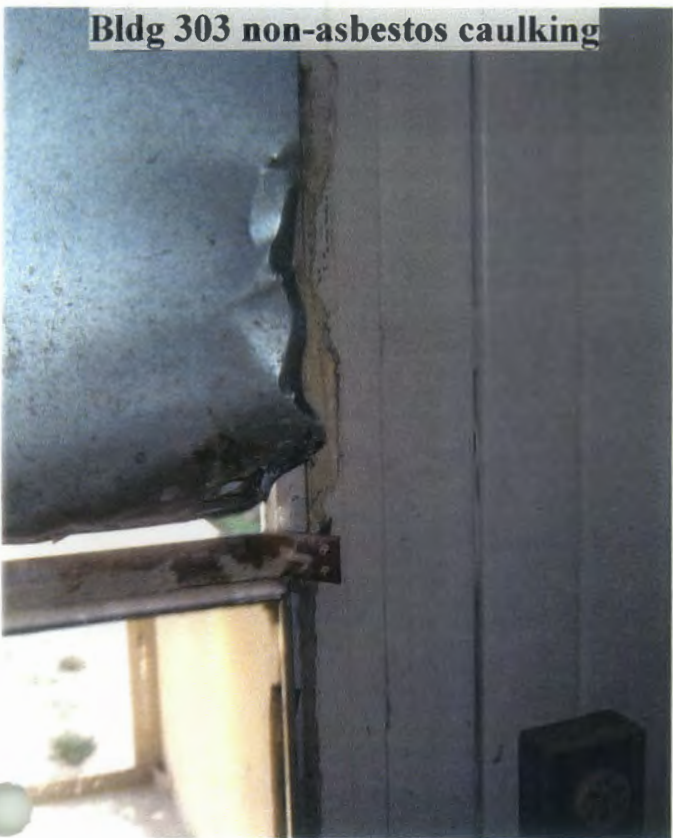
Site 1, Bldg. 303, Non-Asbestos Caulking

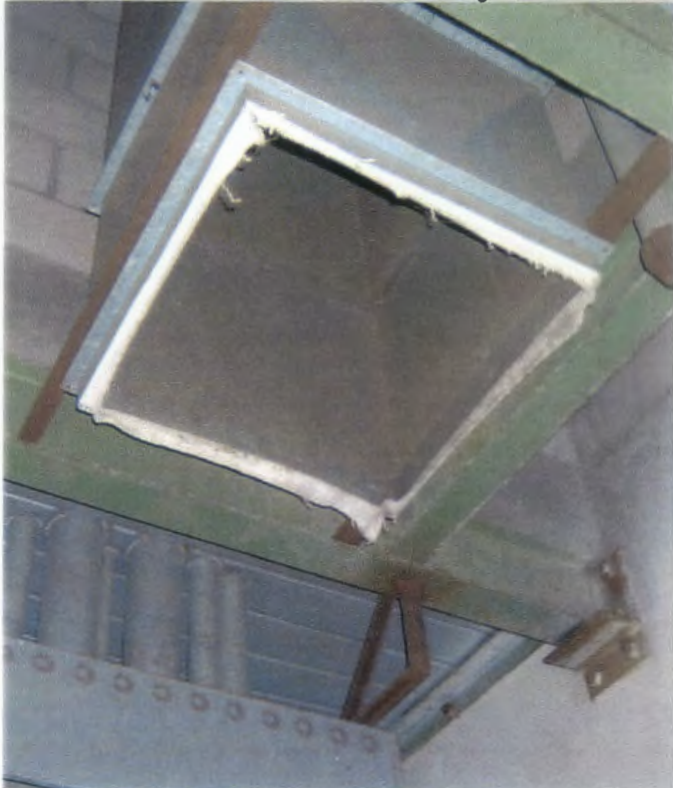
Site 1, Bldg. 303, Asbestos Containing HVAC Vibration Damper Cloth

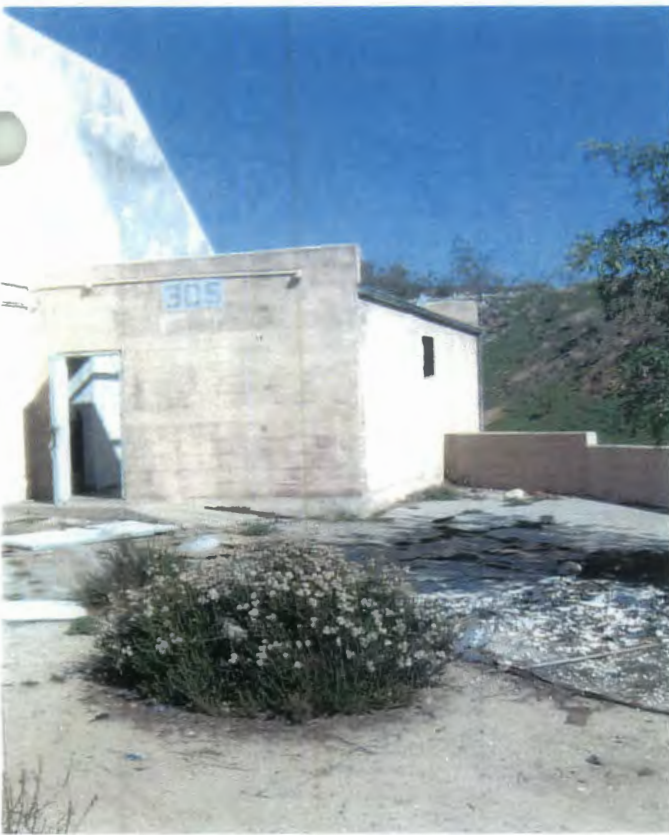
Site 1, Bldg. 305, Lead Paint on Exterior Walls

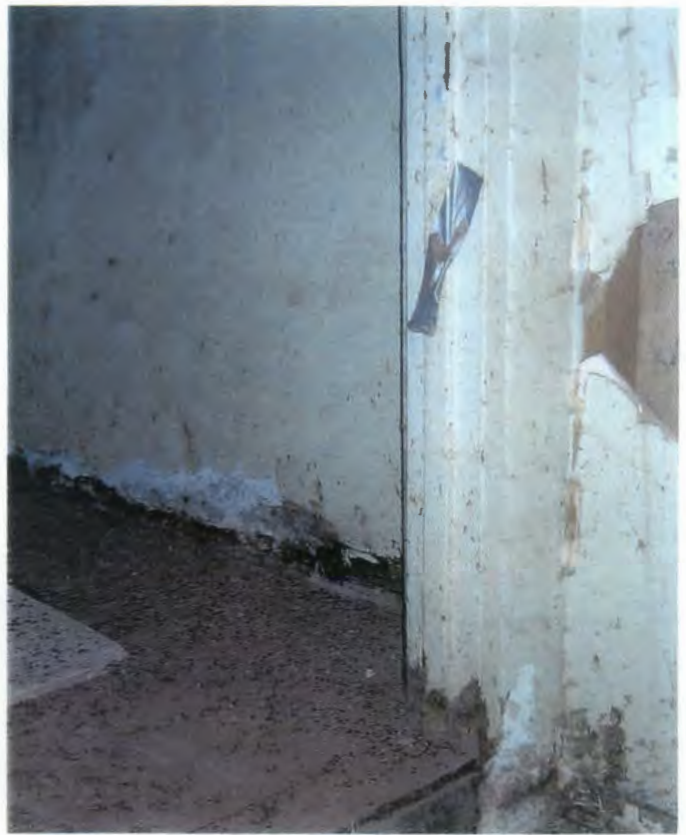
Site 1, Bldg. 305, Asbestos Containing Drywall Joint Compound

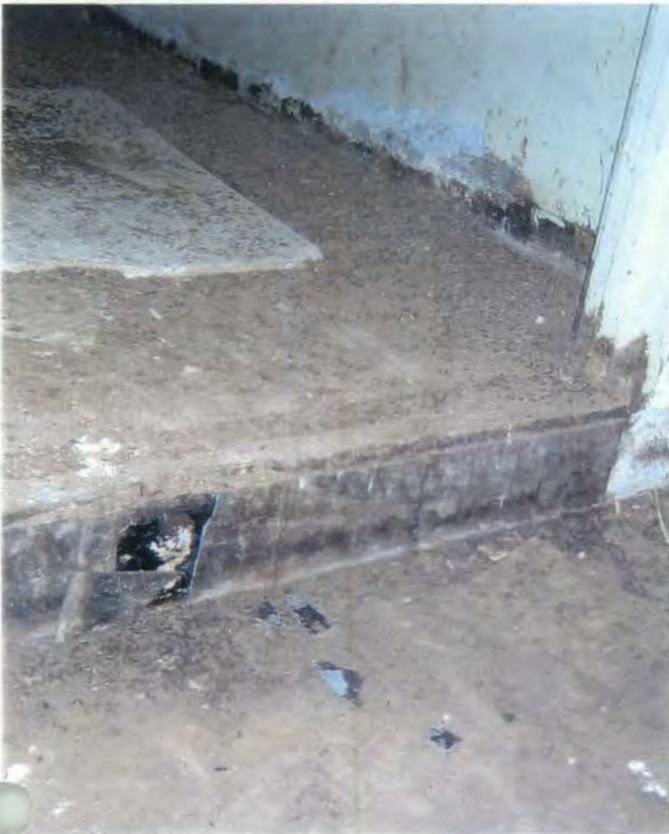
Site 1, Bldg. 305, Asbestos Containing Vinyl Floor Tile & Mastic
& Base of Step

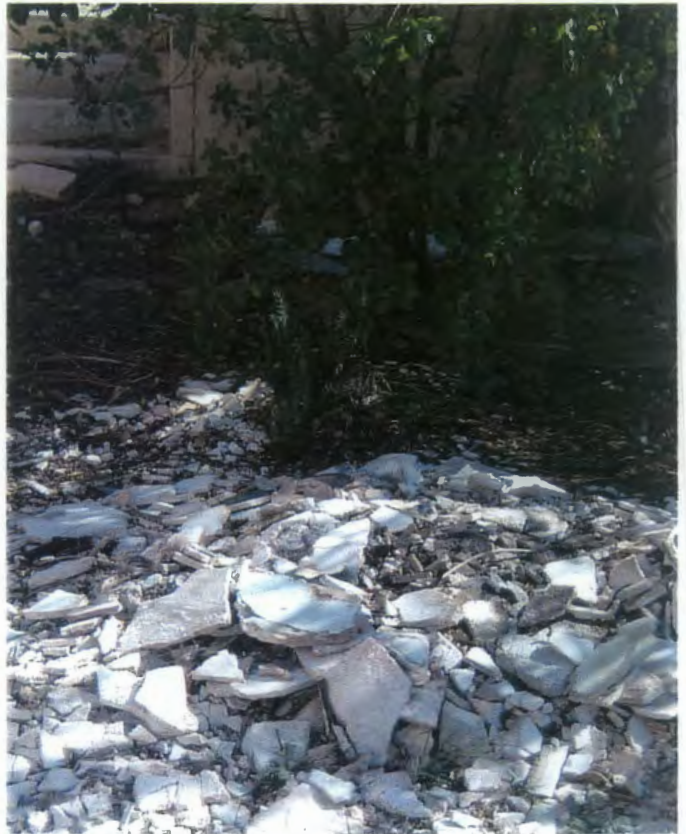
Site 1, Bldg. 305, Non-Asbestos Plaster Debris

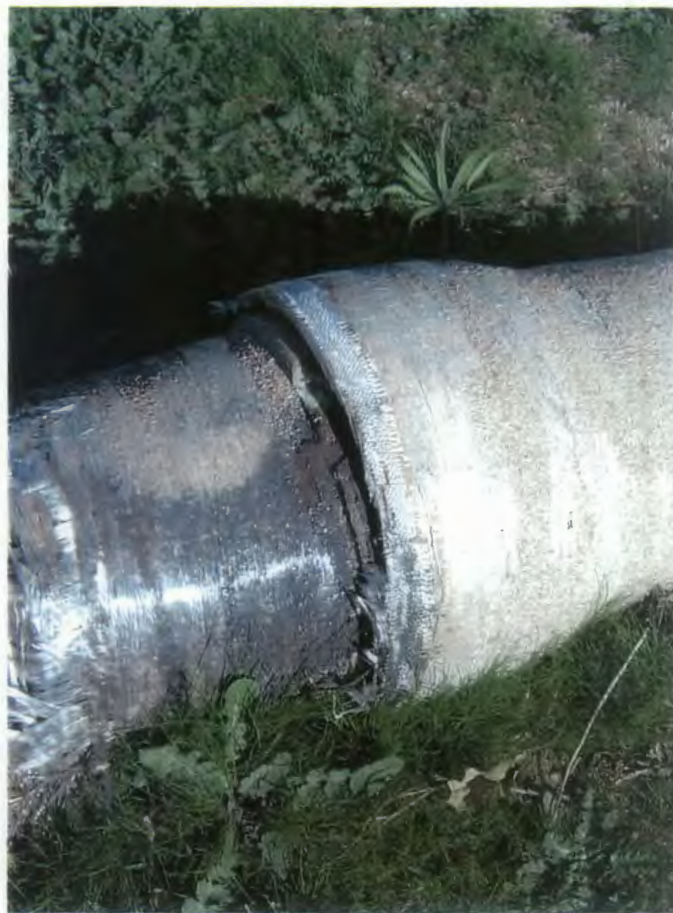
Site 1, Bldg. 305, Non-Asbestos Containing Pipe Insulation Layers

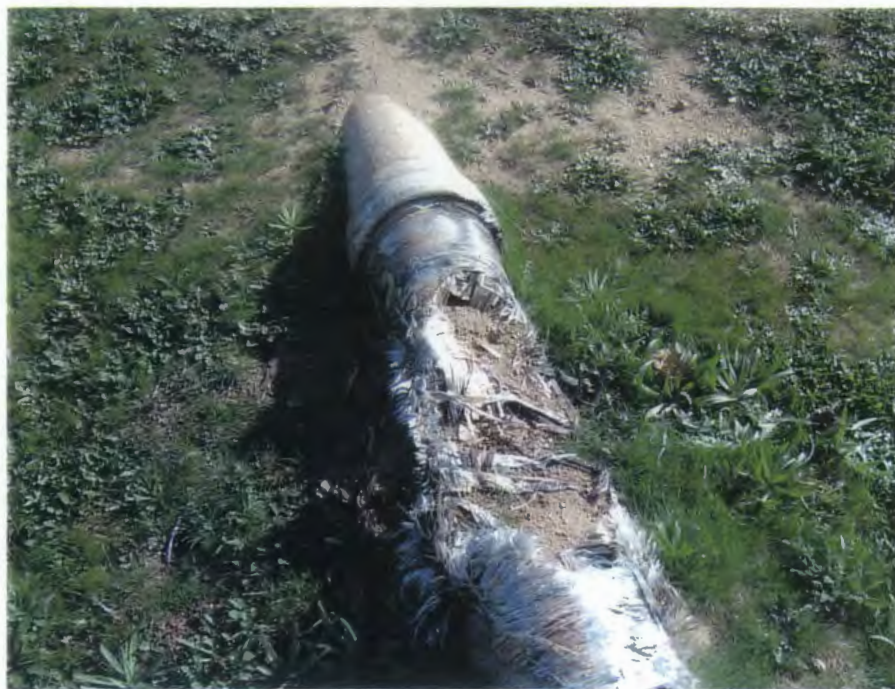
Site 1, Bldg. 305, Non-Asbestos Pipe Insulation Layers

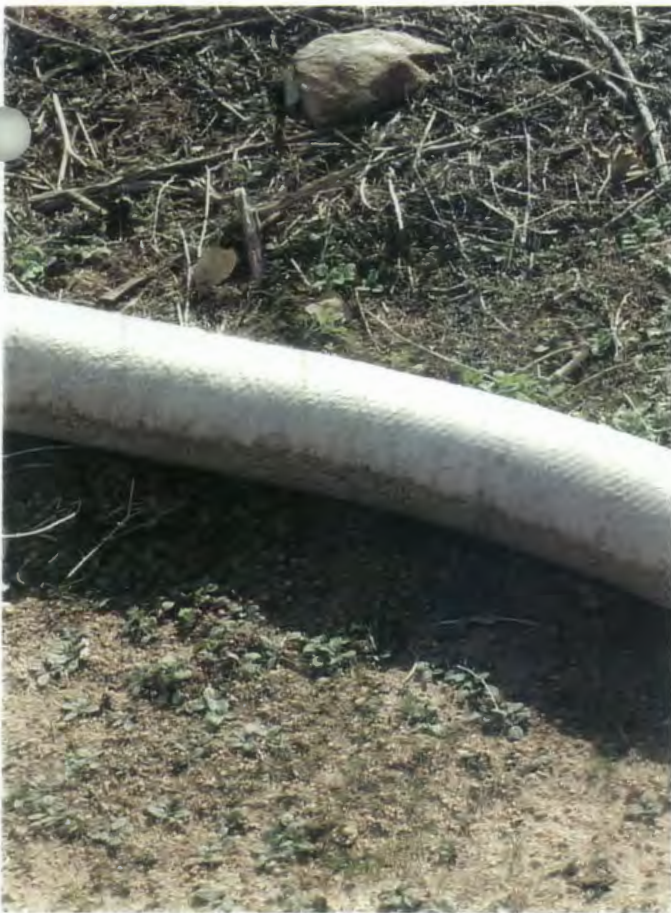
Site 1, Asbestos Transite Pipe Debris Scattered on Hillside Around Buidlings 308 and 305

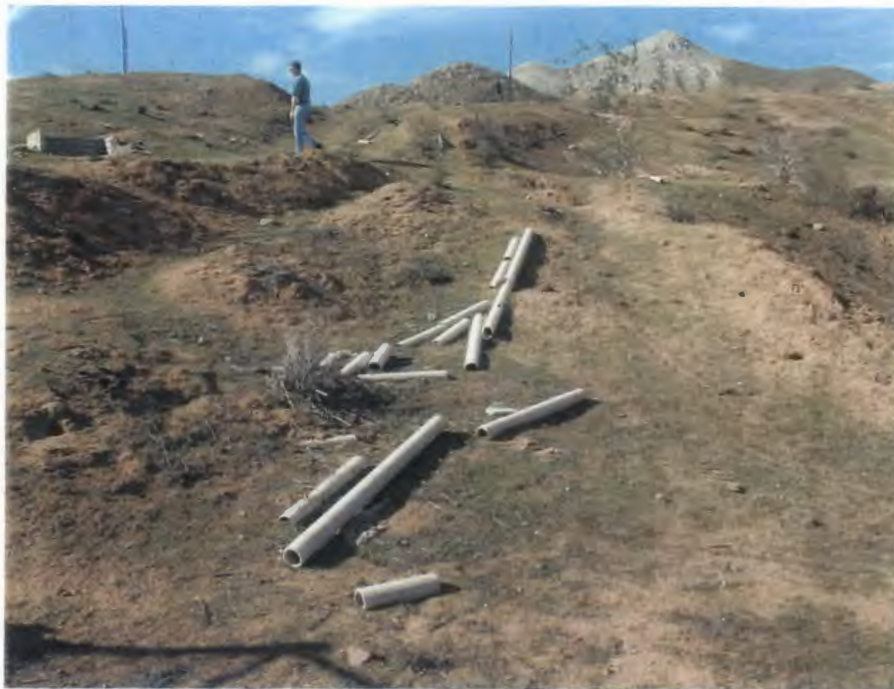
Site 1, Asbestos Transite Pipe Debris Scattered on Hillside Around Buidlings 308 and 305

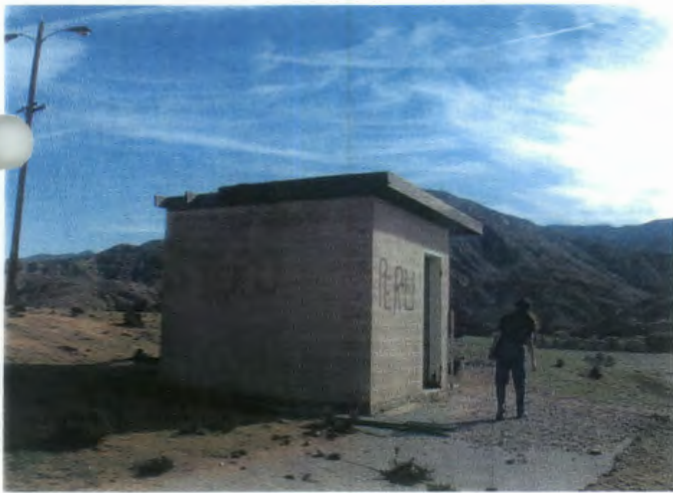
Site 1, Bldg T4, Lead Paint on Exterior Walls & Wood Components

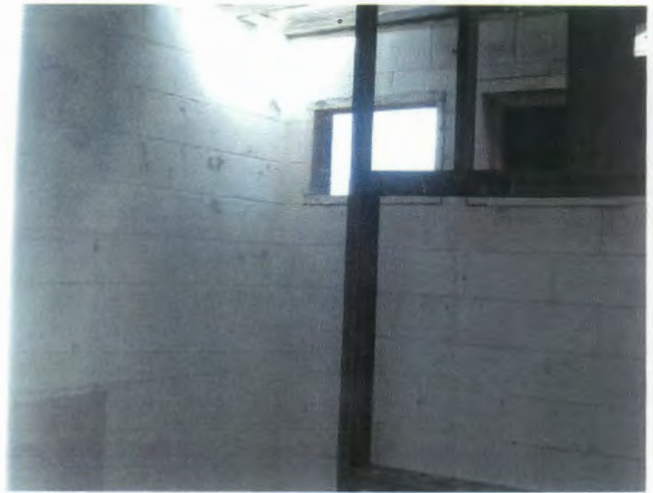
Site 1, Bldg. T4, Lead Paint on Interior Walls

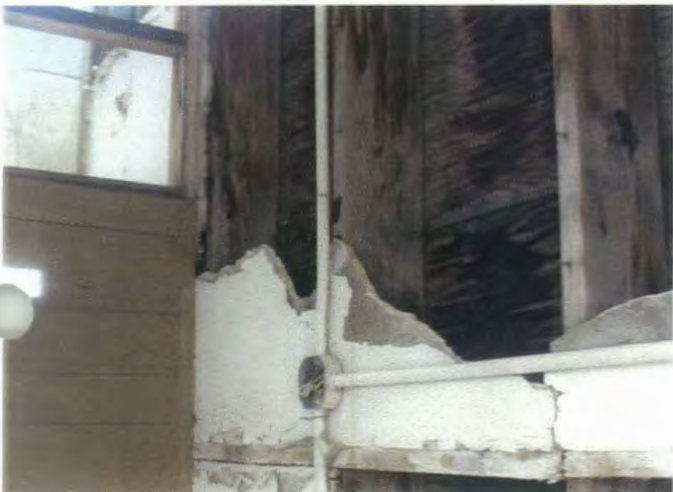
Site 1, Bldg T4, Non-Asbestos Wall/Ceiling Material

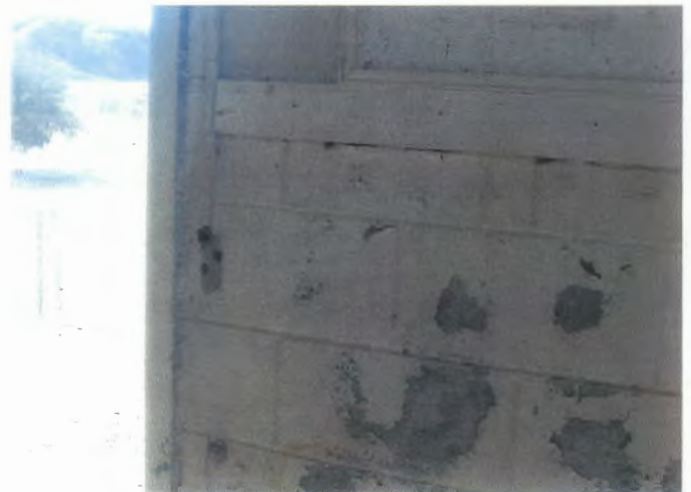
Site 1, Bldg. T4, Lead Paint on Exterior Walls

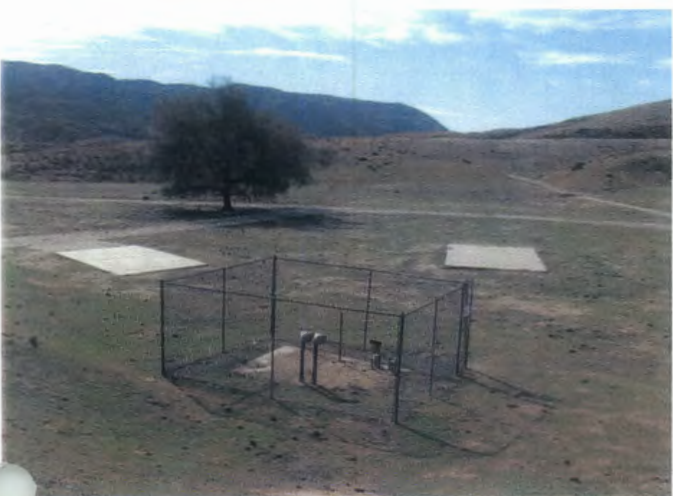
Site 1, Bldg. T4, Lead Paint on Fence Components

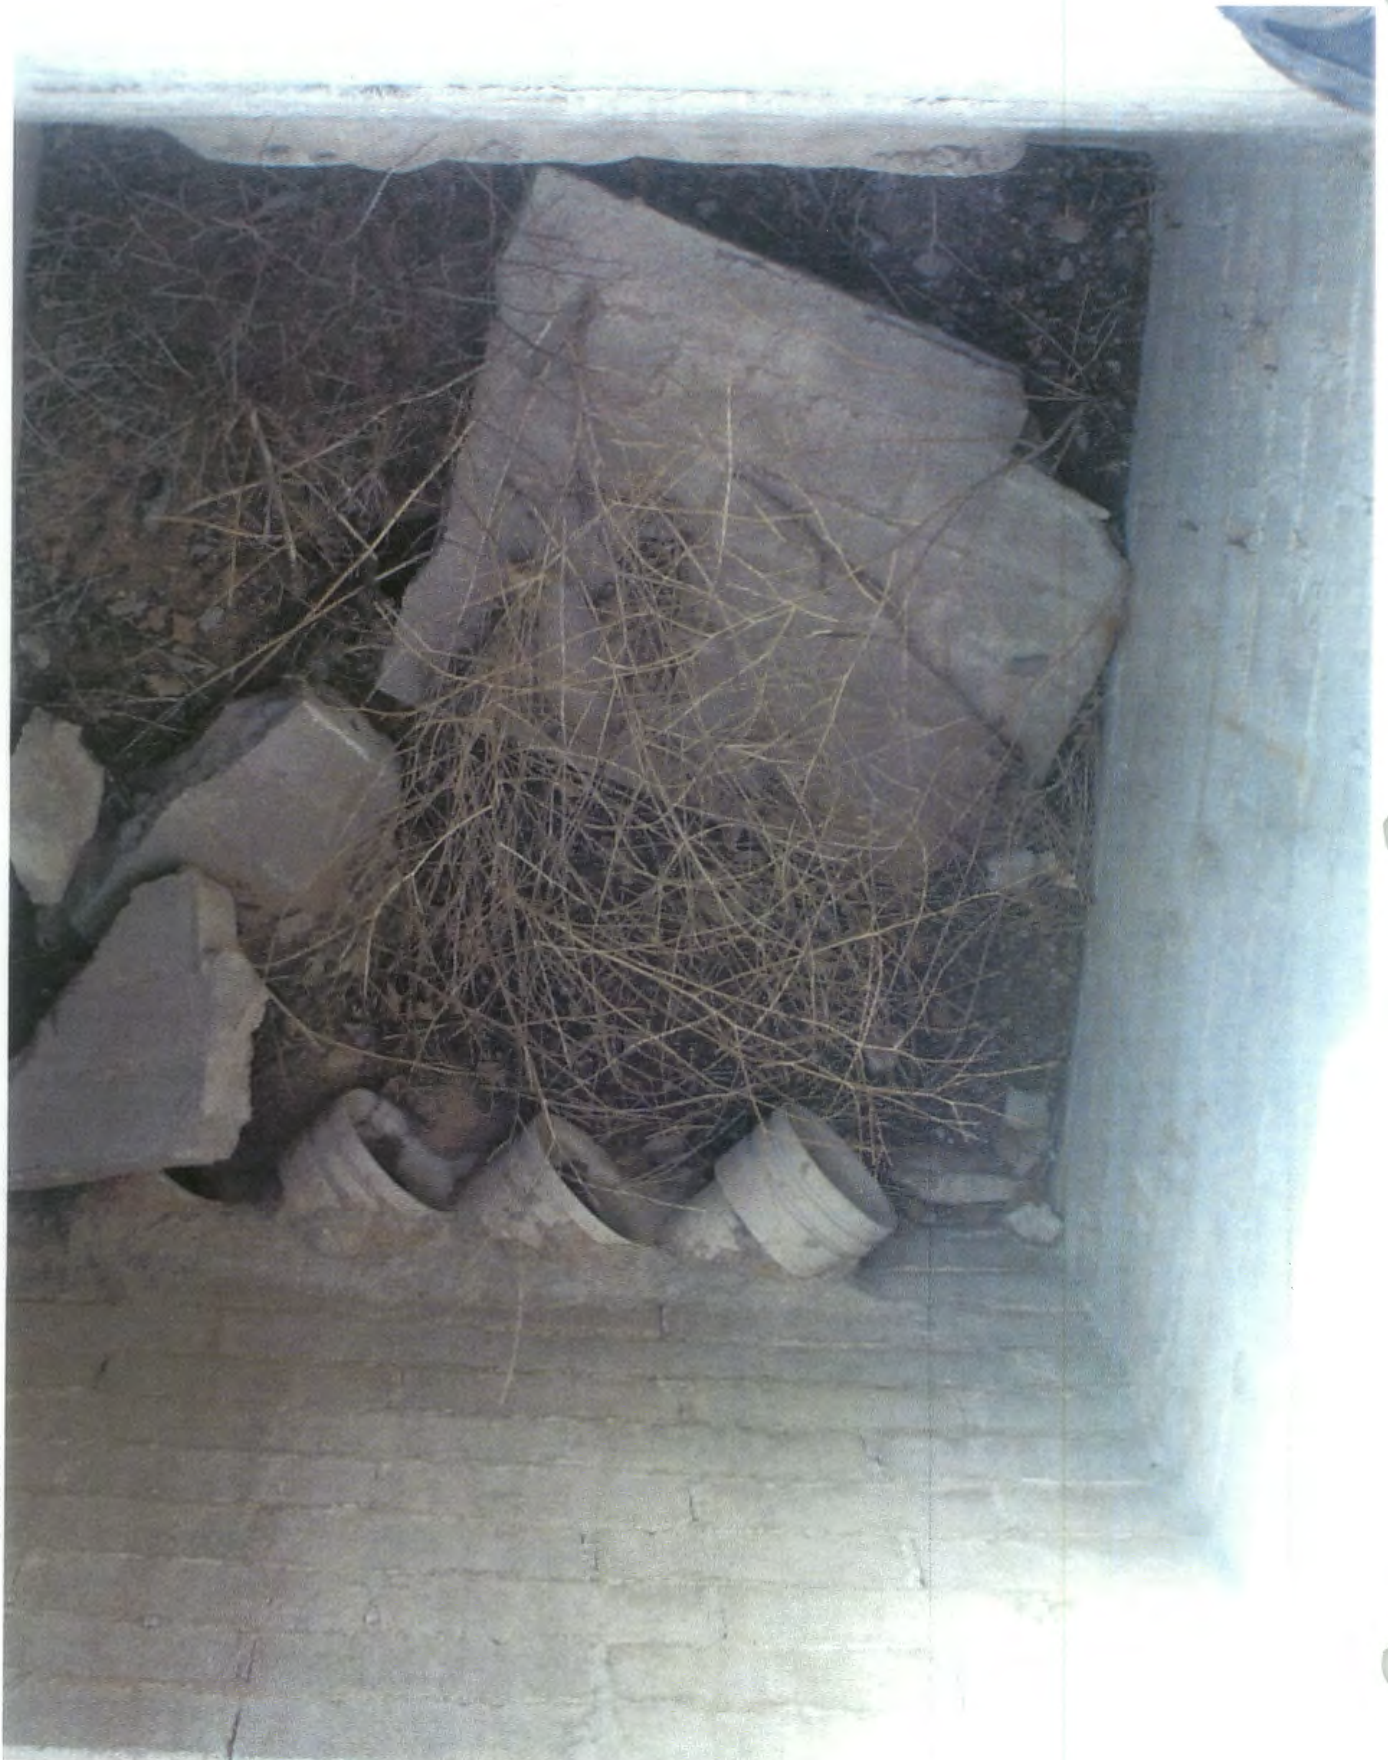
Site 1, Bldg 305, Asbestos Transit Pipes Extending Below Grade

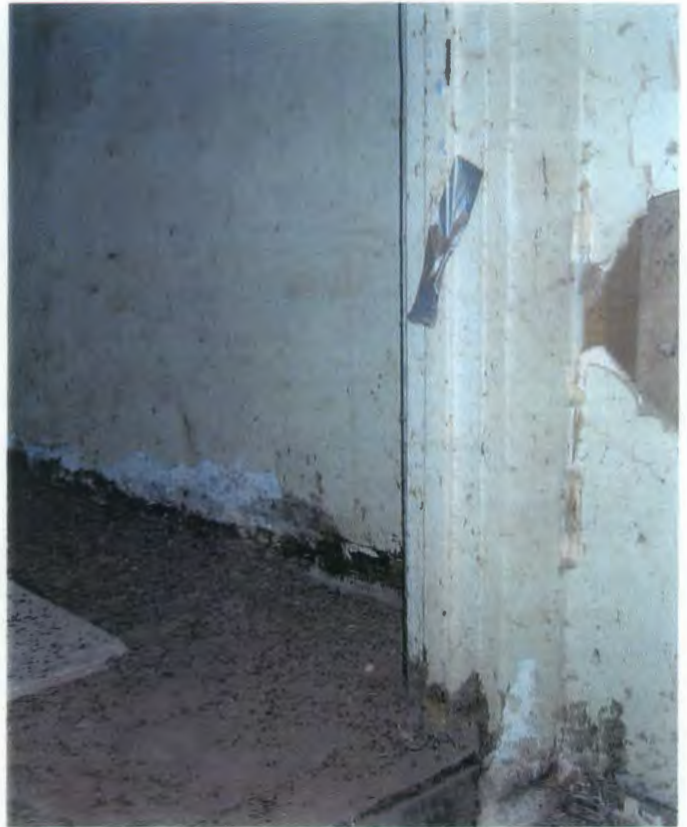
Site 1, Bldg. 305, Asbestos Containing Drywall Joint Compound

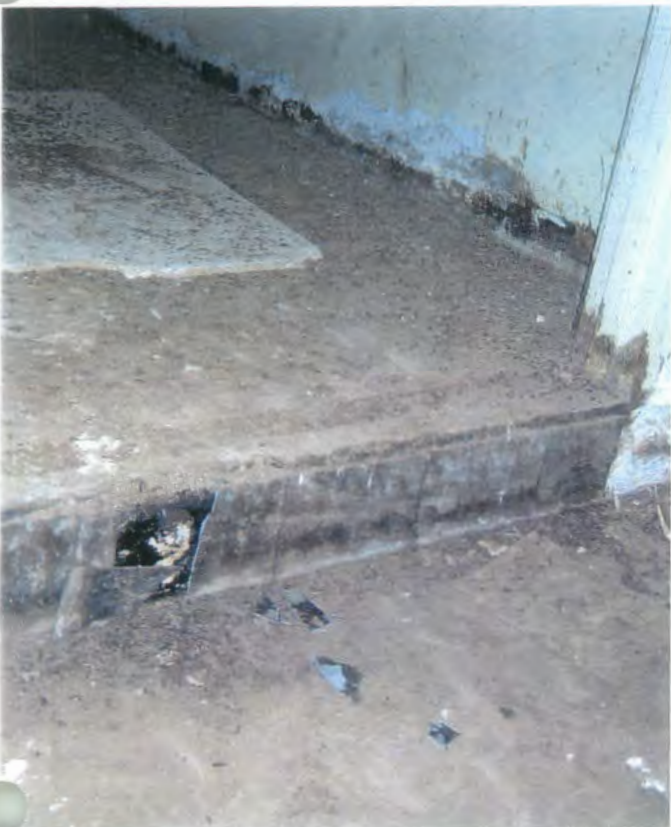
Site 1, Bldg. 305, Asbestos Containing Vinyl Floor Tile & Mastic
& Base of Step

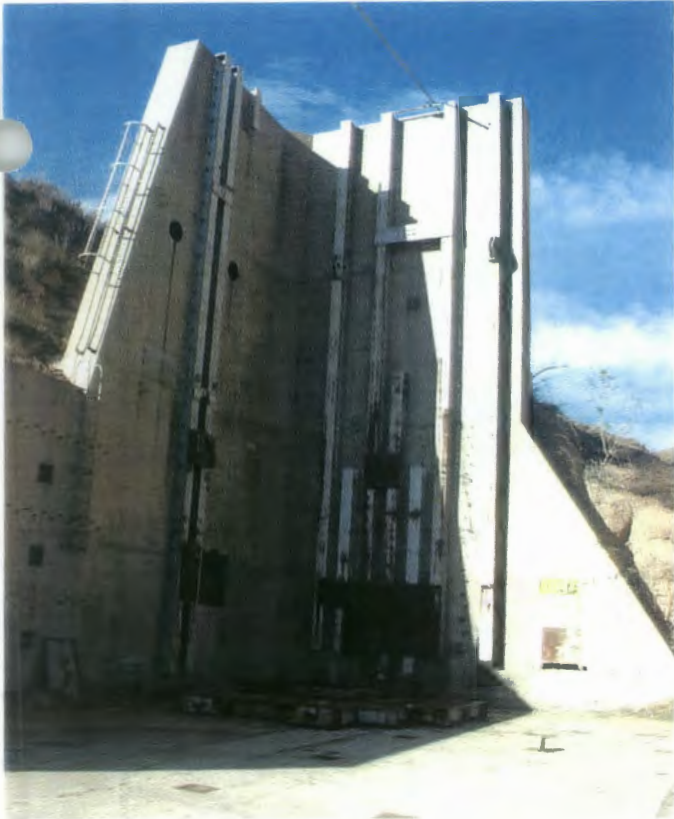
Site 1, Bldg. 308, Lead Paint on Walls & Steel Components

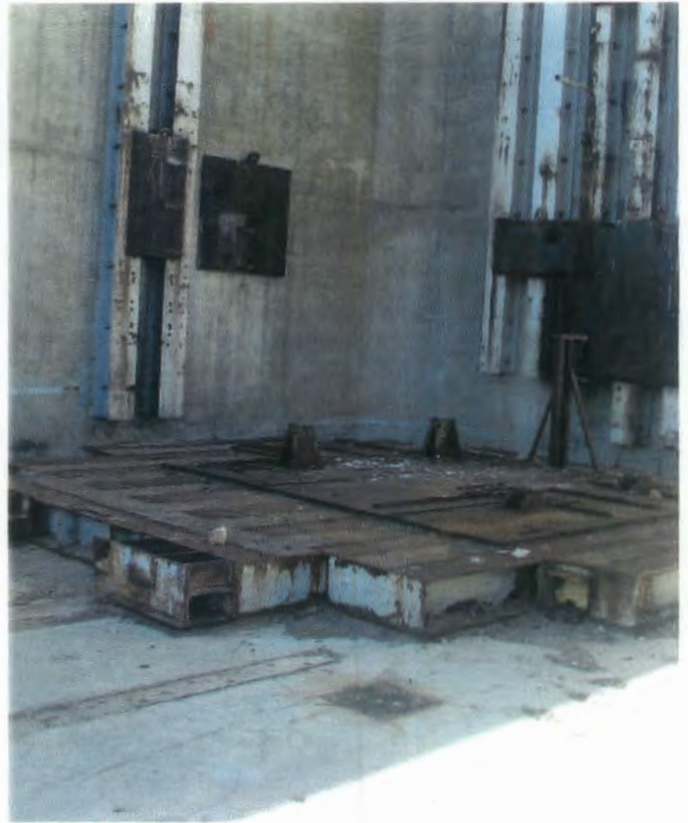
Site 1, Bldg. 308, Lead Paint on Walls & Steel Components

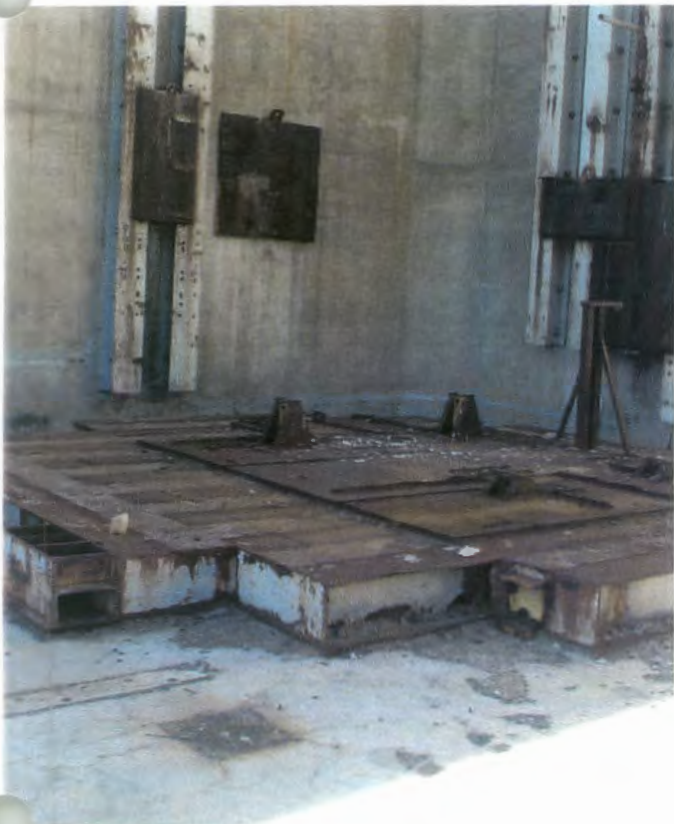
Site 1, Bldg. 308, Lead Paint on Walls & Steel Components

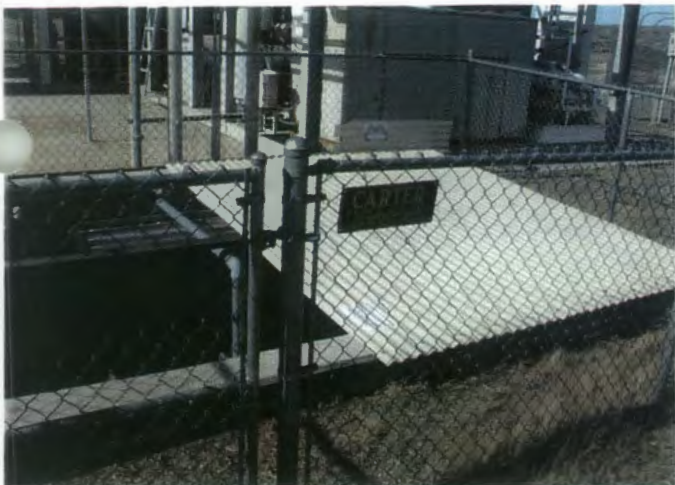
Site 1, Lead Paint on all Steel/Metal Components

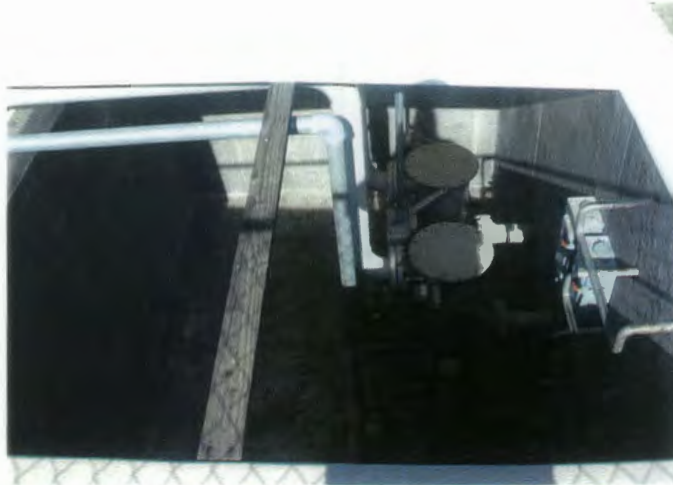
Site 1, Lead Paint on all Steel/Metal Components
