Lockheed Martin Corporation Beaumont Site 1 & 2 Safety & Toxics Assessment Beaumont, California

March 19, 2003

TC 12866-03

Tetra Tech, Inc.
San Bernardino, California

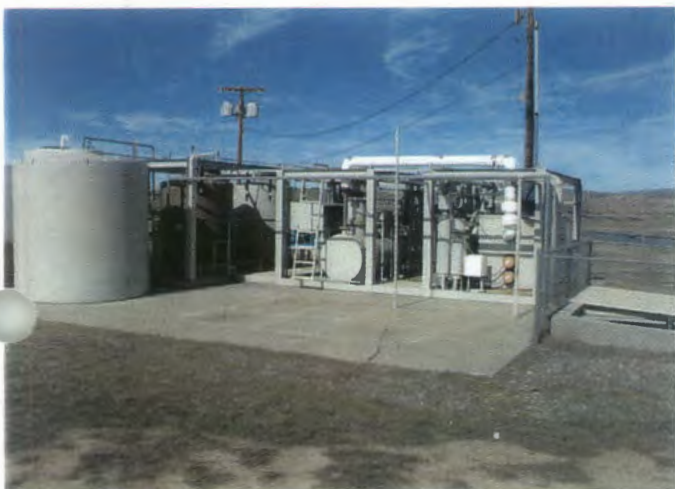
Site 1, Lead Paint on all Steel/Metal Components

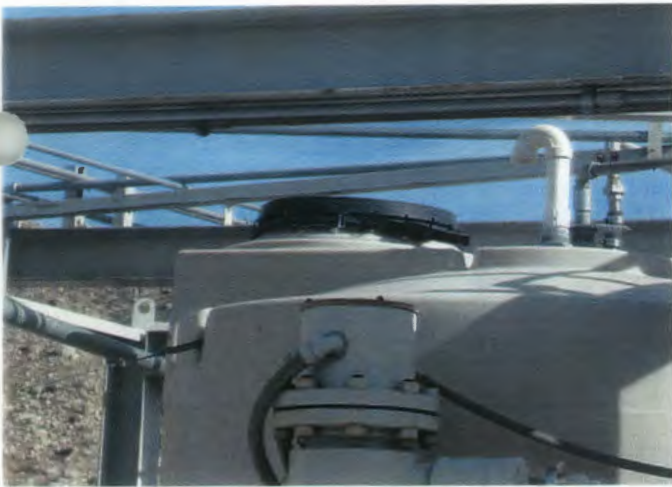
Site 1, Lead Paint on all Steel/Metal Components

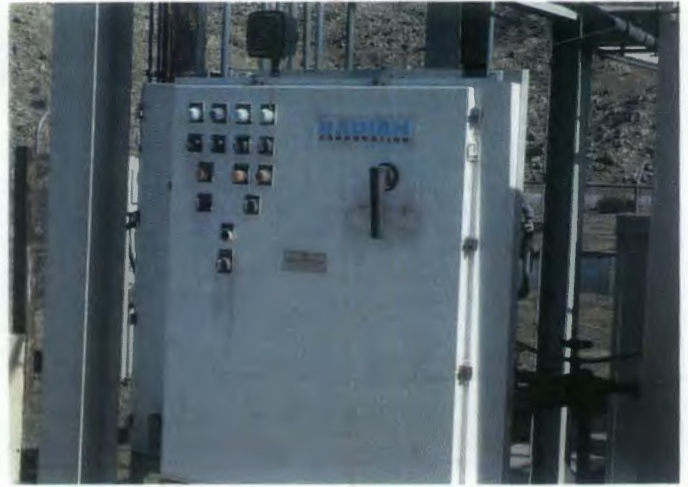
Site 1, Lead Paint on all Steel/Metal Components

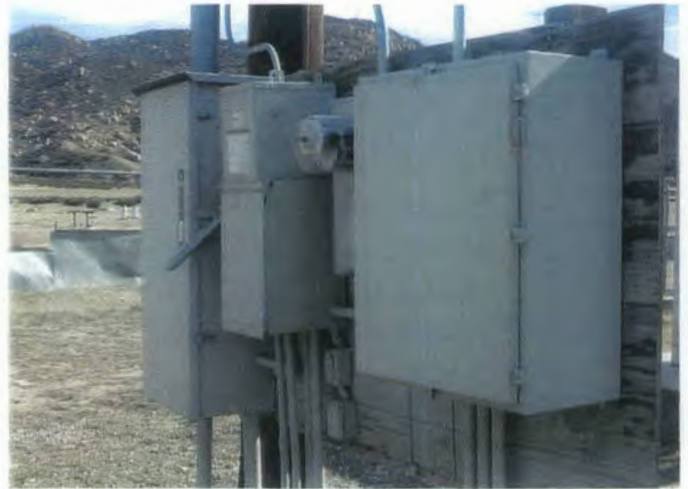
Site 1, Lead Paint on all Steel/Metal Components

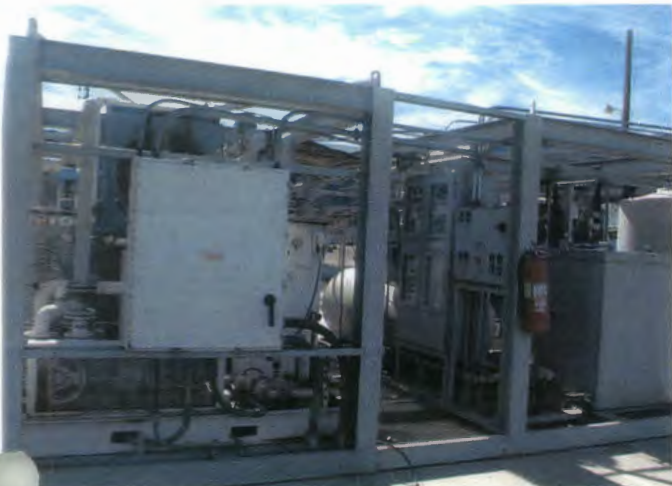
Site 1, Lead Paint on all Steel/Metal Components

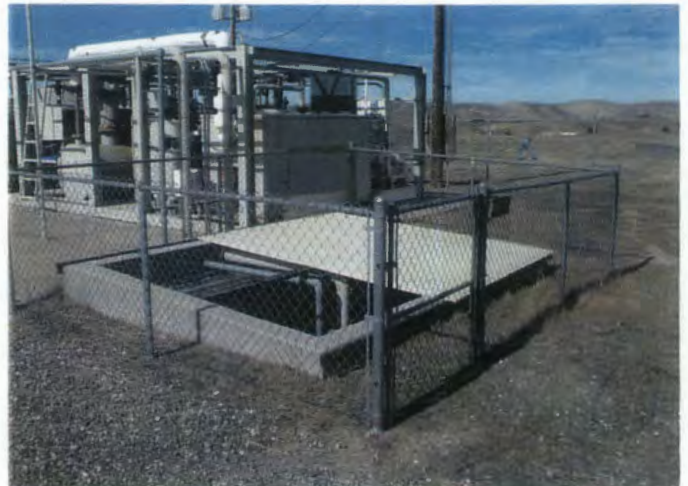
Site 1, Lead Paint on all Steel/Metal Components

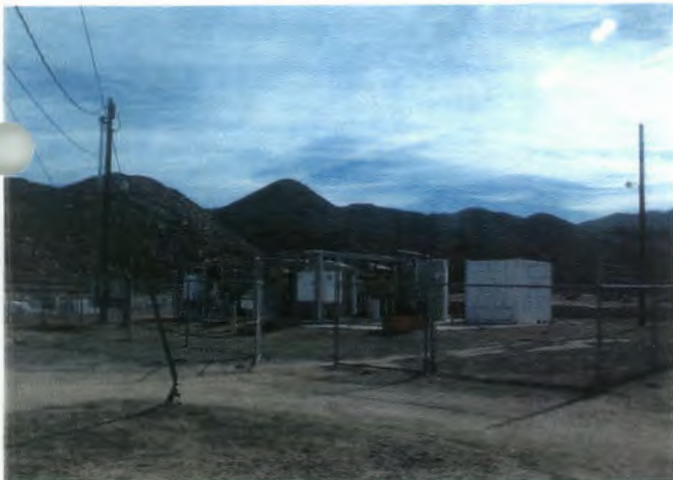
Site 1, Lead Paint on all Steel/Metal Components

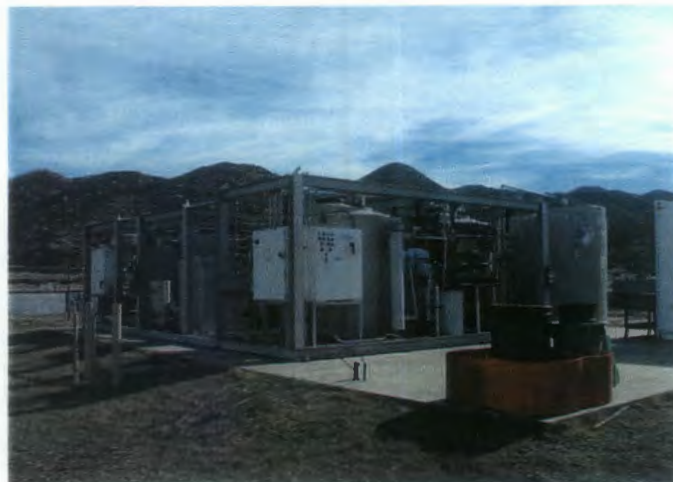
Site 1, Lead Paint on all Steel/Metal Components

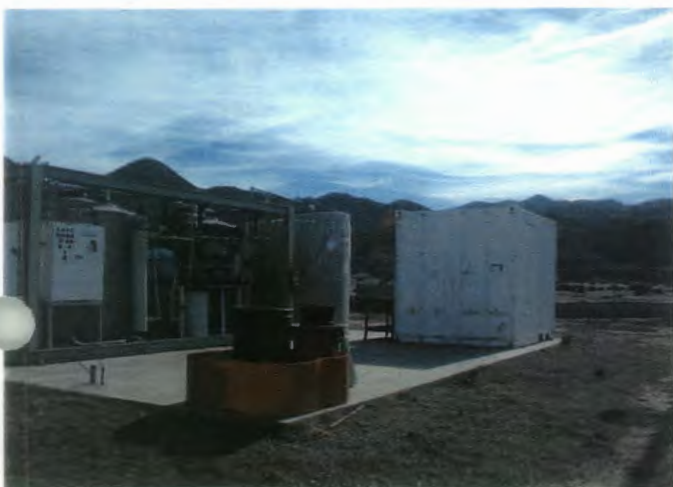
Site 1, Lead Paint on all Steel/Metal Components

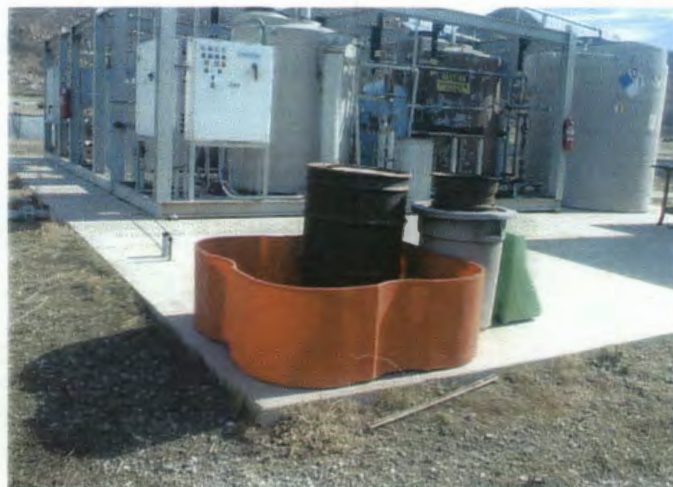
Site 1, Lead Paint on all Steel/Metal Components

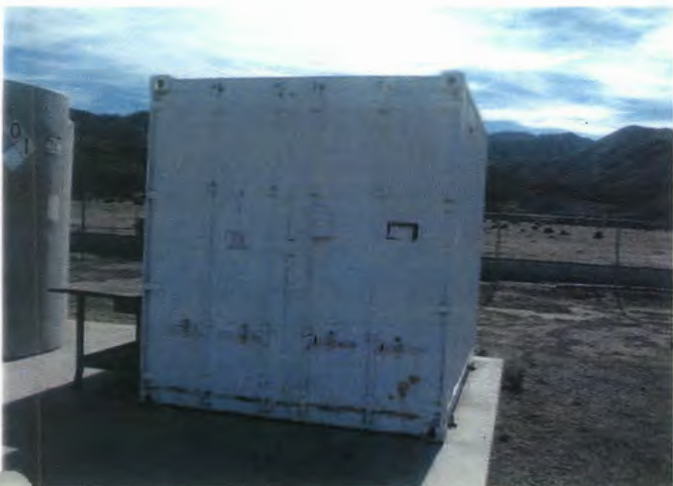
Site 1, Lead Paint on all Steel/Metal Components

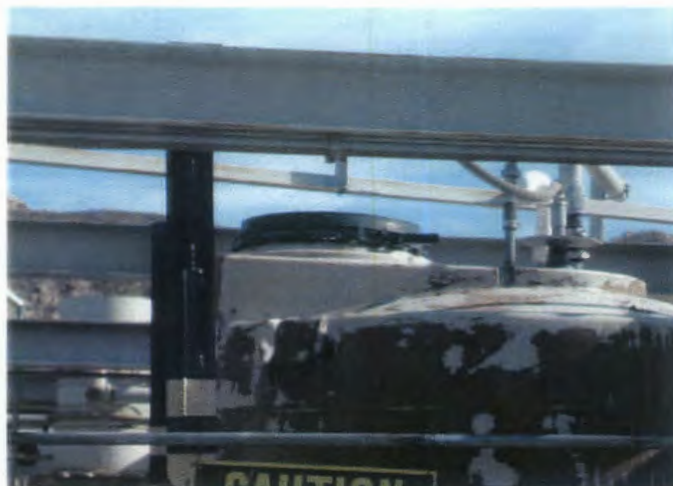
Site 1, Lead Paint on all Steel/Metal Components

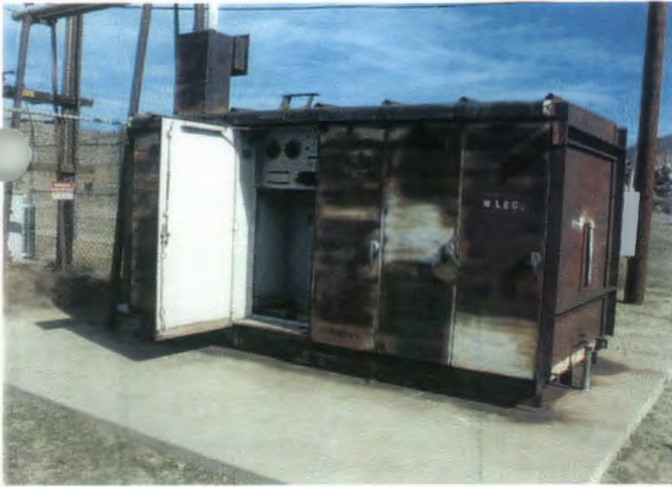
Site 1, Lead Paint on all Steel/Metal Components

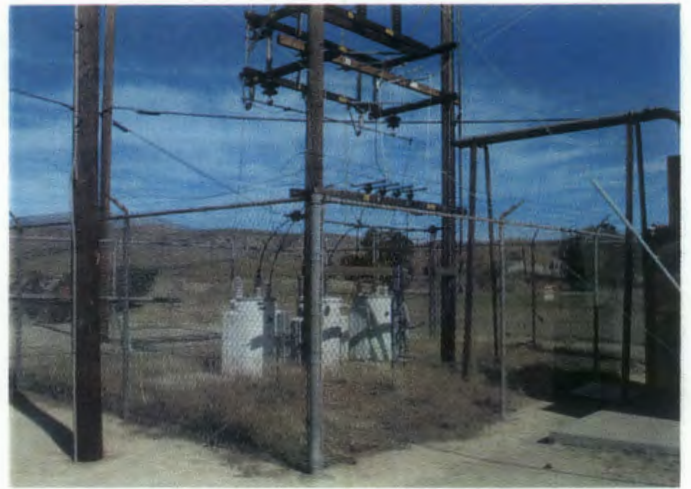
Site 1, Lead Paint on all Metal Components

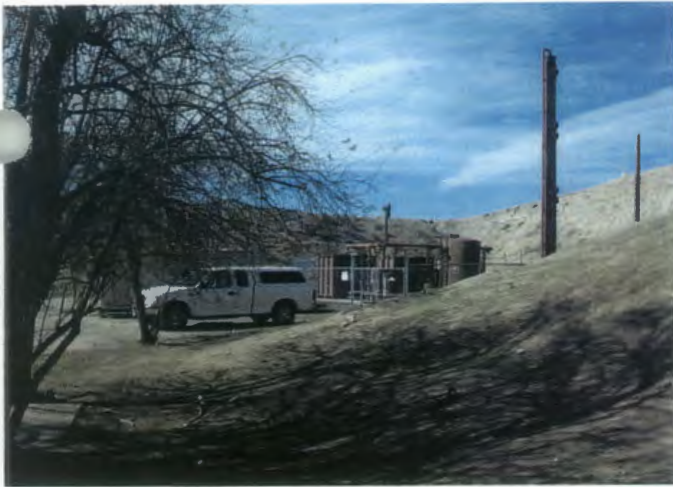
Site 1, Lead Paint on all Metal Components

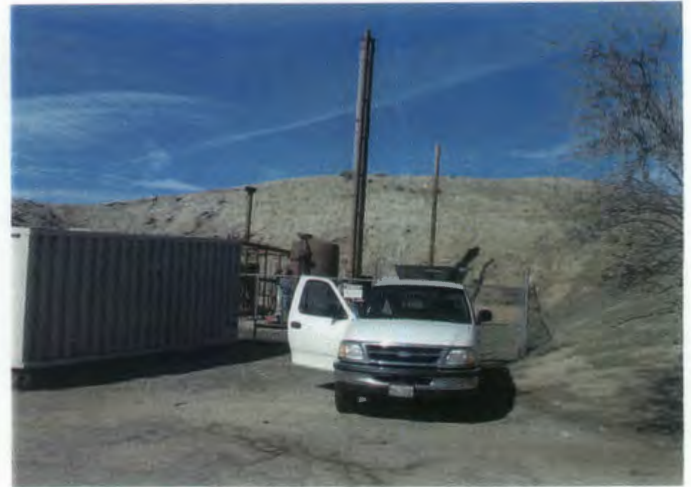
Site 1, Lead Paint on all Metal Components

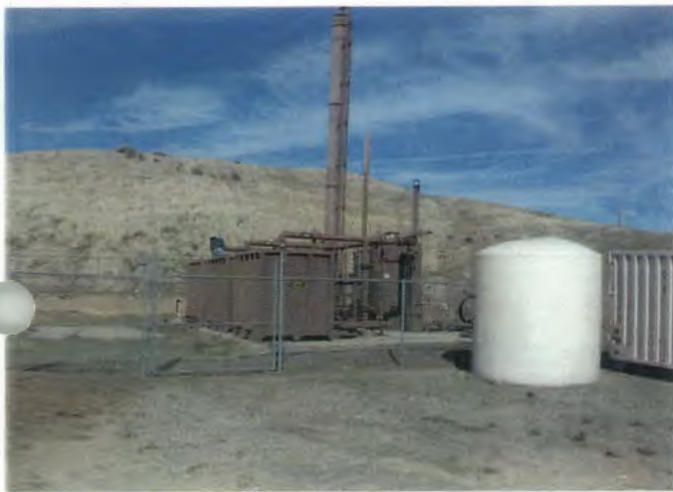
Site 1, Lead Paint on all Metal Components

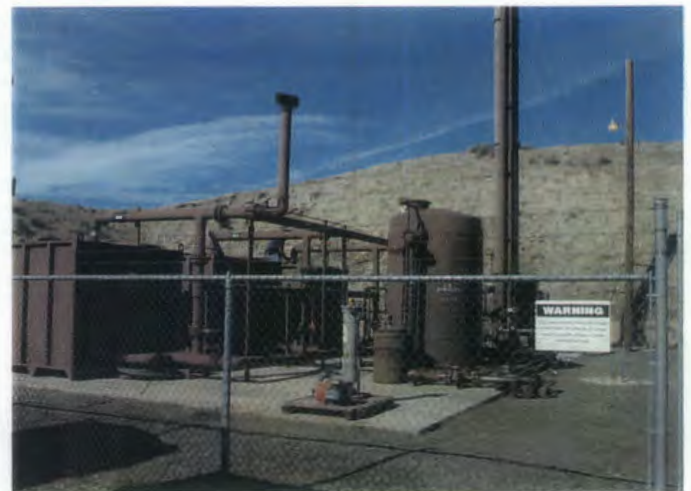
Site 1, Lead Paint on all Metal Components

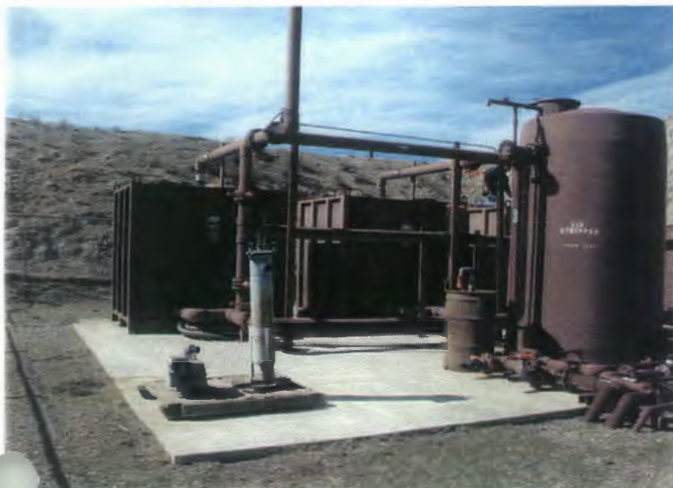
Site 1, Lead Paint on all Metal Components

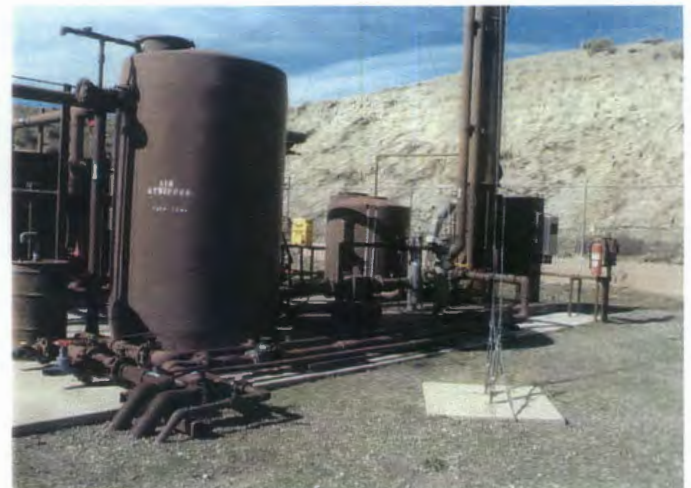
Site 1, Lead Paint on all Metal Components

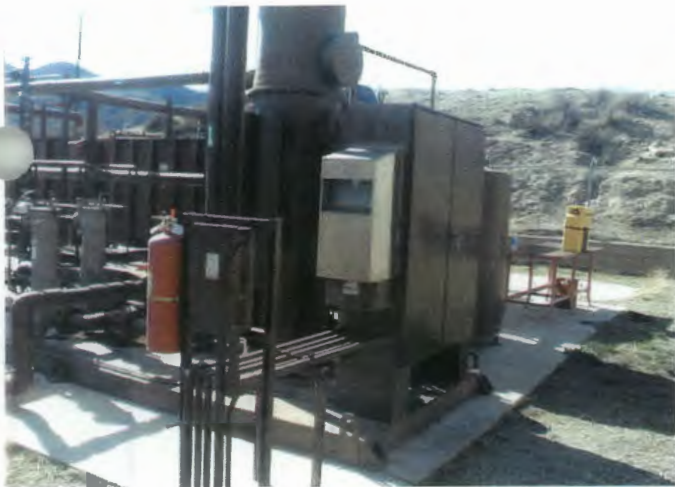
Site 1, Lead Paint on all Metal Components

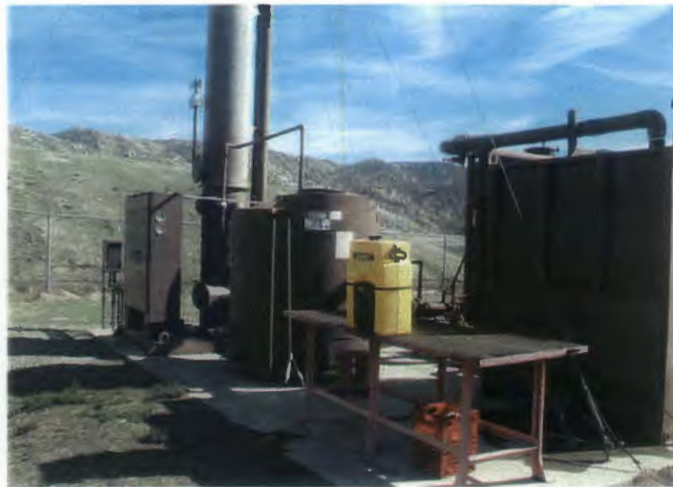
Site 1, Lead Paint on all Metal Components

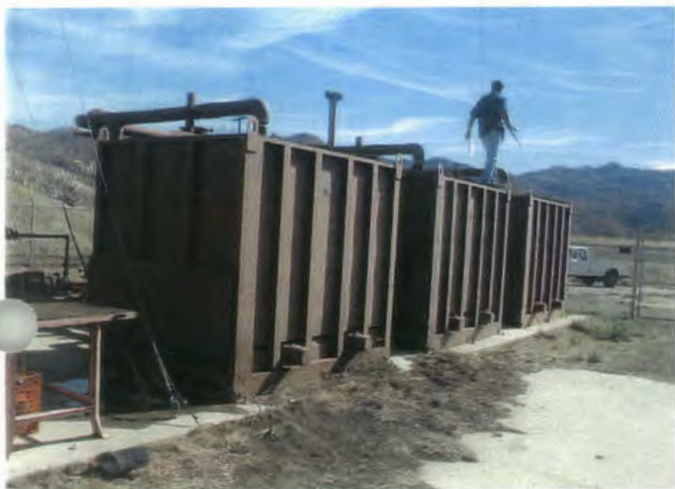
Site 1, Lead Paint on all Metal Components

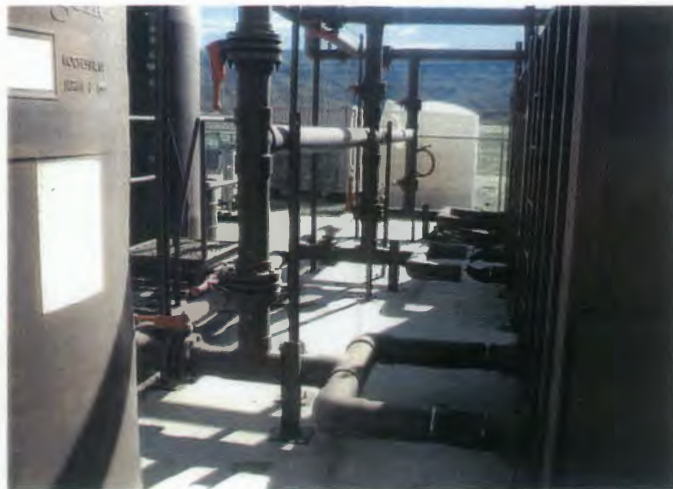
Site 1, Lead Paint on all Metal Components

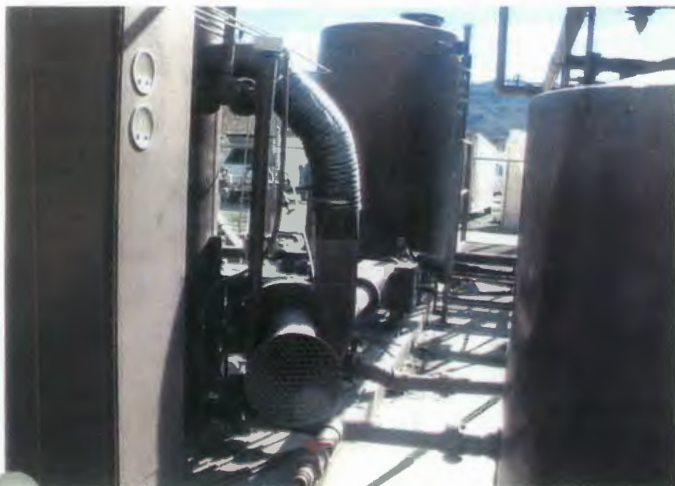
Site 1, Lead Paint on all Metal Components

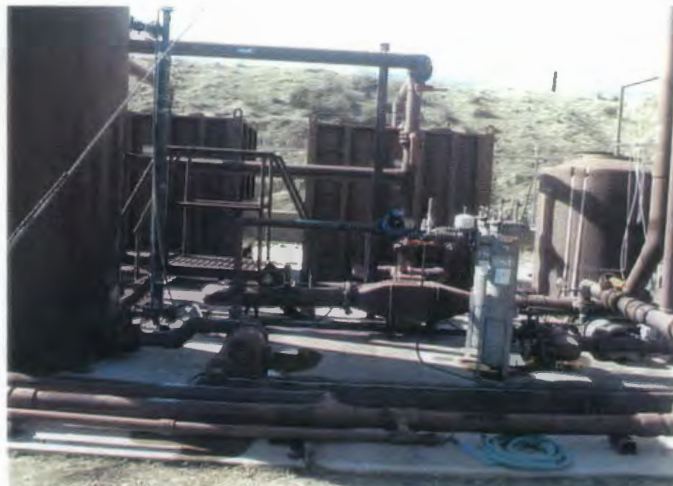
Site 1, Lead Paint on all Metal Components

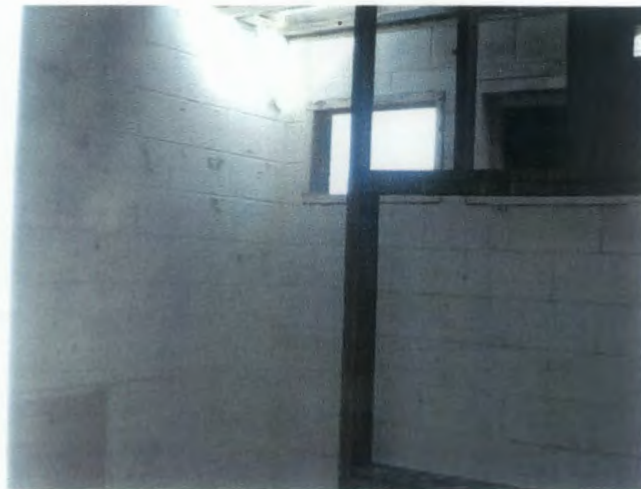
Site 1, Bldg T4, Lead Paint on Exterior Walls & Wood Components

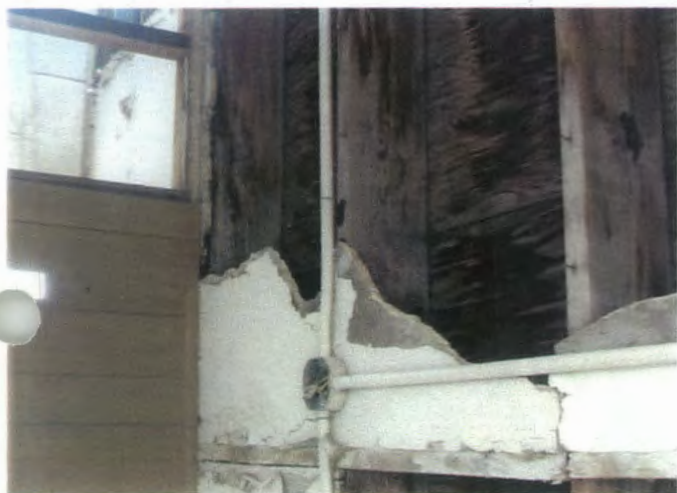
Site 1, Bldg. T4, Lead Paint on Interior Walls

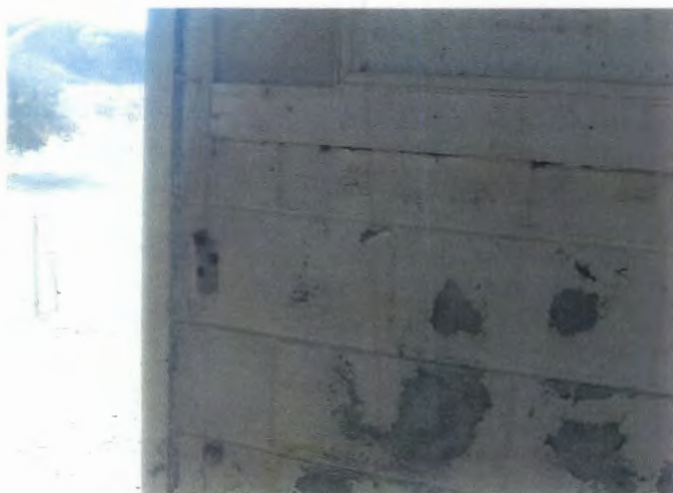
Site 1, Bldg T4, Non-Asbestos Wall/Ceiling Material

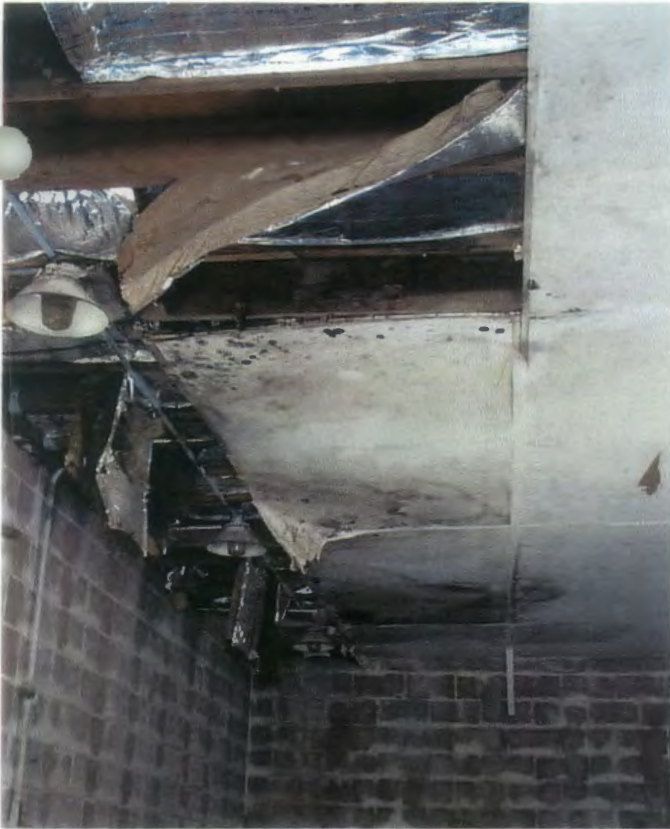
The source of moisture intrusion for all three building is apparently the roofs and roofing membranes of the buildings. CITY did not observe any leaking plumbing lines while at the site.

Site 1, Bldg. 312, Mold Growth on Ceiling Components

To prevent further growth of molds in this unit, all sources of water intrusion must be repaired/remediated. The surfaces with mold growth should remain dried and dehumidified. Ceiling space or other inaccessible areas must be ventilated. The building components showing visible mold growth as well as those surfaces confirmed, by tape-lift sampling, to contain mold should be removed. Additional investigation may be necessary to determine the full extent of mold growth in other possible locations. Exhaust/ventilation systems should be cleaned as deemed appropriate using HEPA vacuuming and/or biocide gas treatment techniques. Walls, ceilings, floors, counters, fixtures (within the work area) and other surfaces deemed appropriate that do not show visible mold growth should be cleaned using HEPA vacuuming and/or biocide agent-cleaning techniques. Walls/ceilings may then be painted with paint containing a biocide additive.

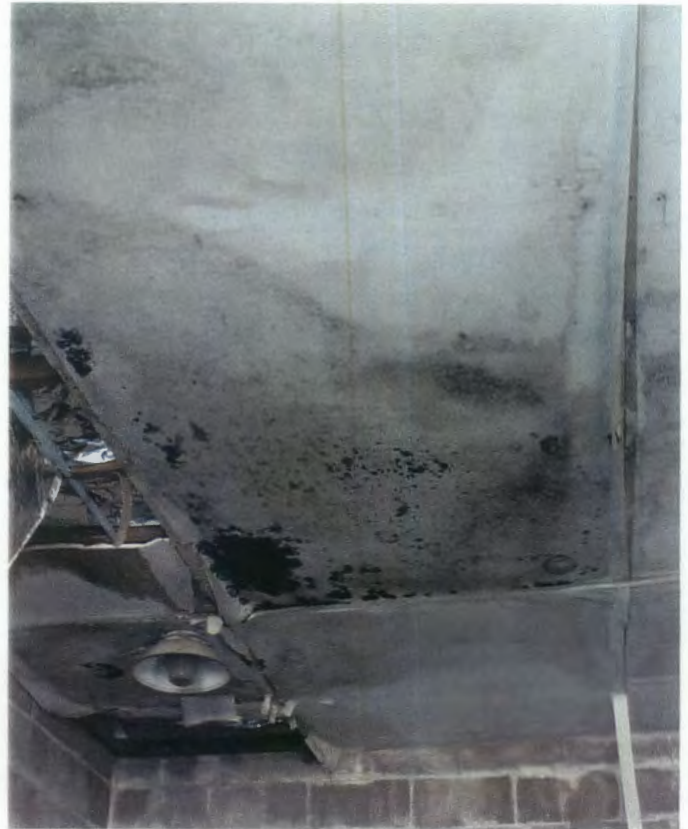
Site 1, Bldg. 312, Mold Growth on Ceiling Components

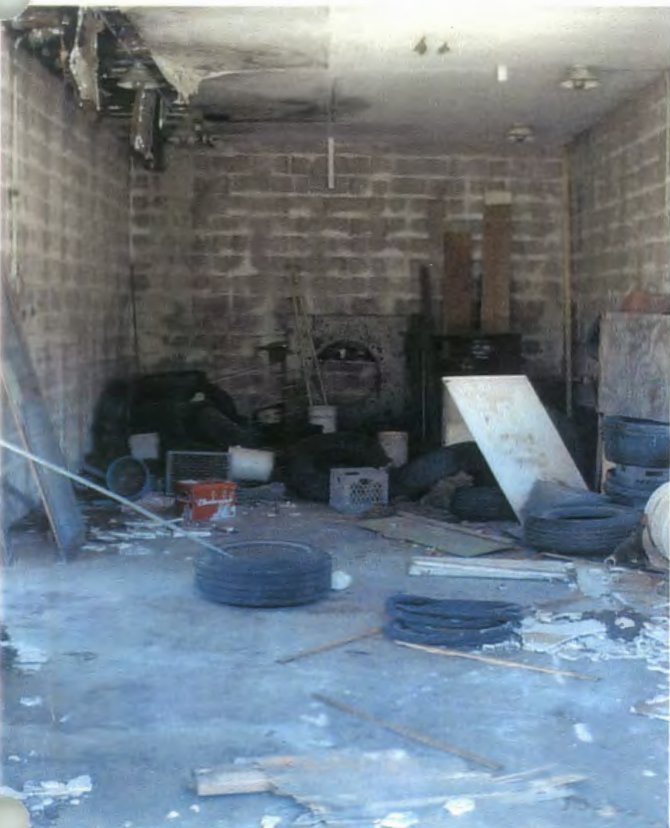
Site 1, Bldg. 312, Mold Growth on Ceiling Components

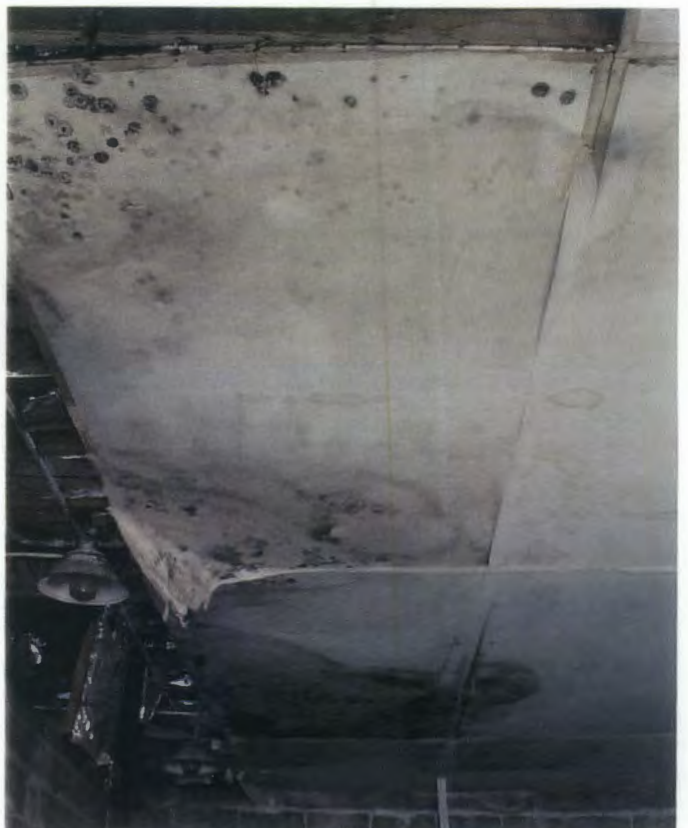
Site 1, Bldg. 312, Mold Growth on Ceiling Components

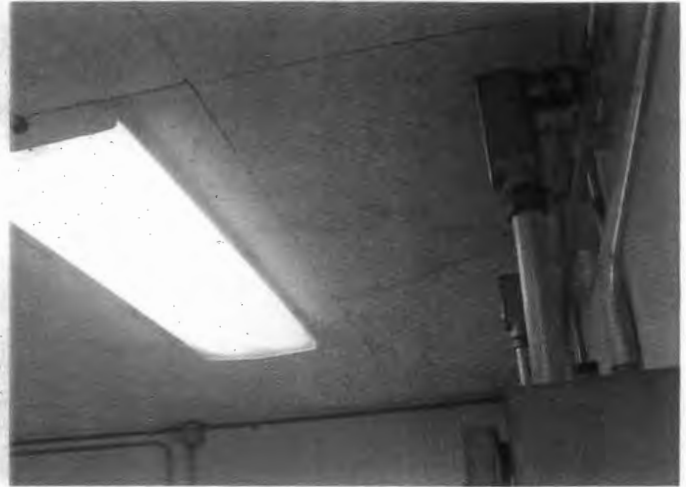
Site 1, Bldg. 315, Mold Growth on Interior Ceiling Components

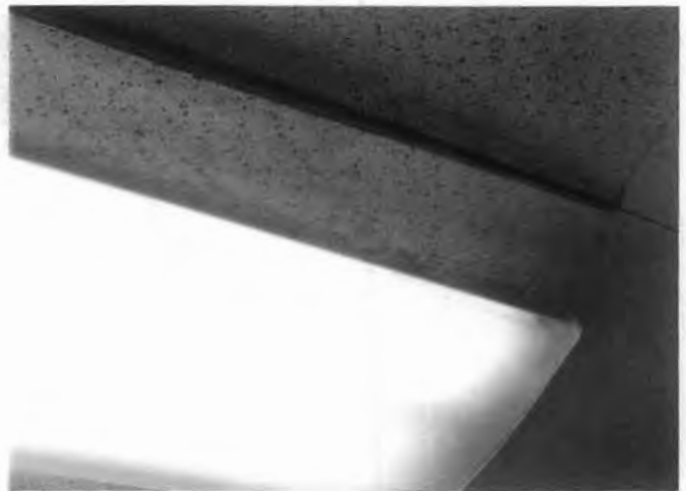
Site 1, Bldg. 315, Mold Growth on Interior Ceiling Components

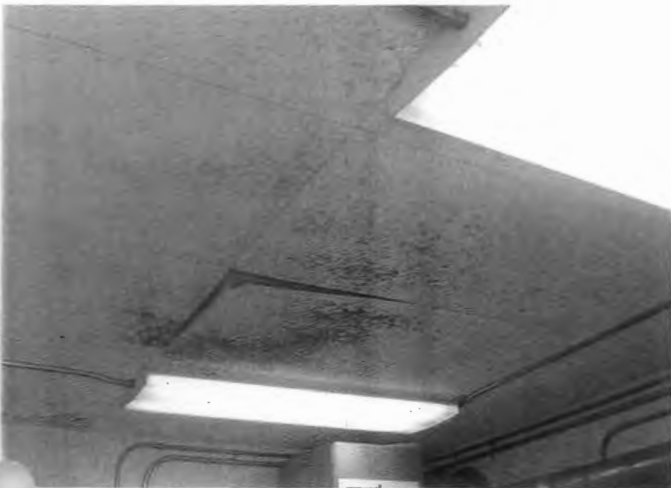
Site 1, Bldg. 315, Mold Growth on Interior Ceiling Components

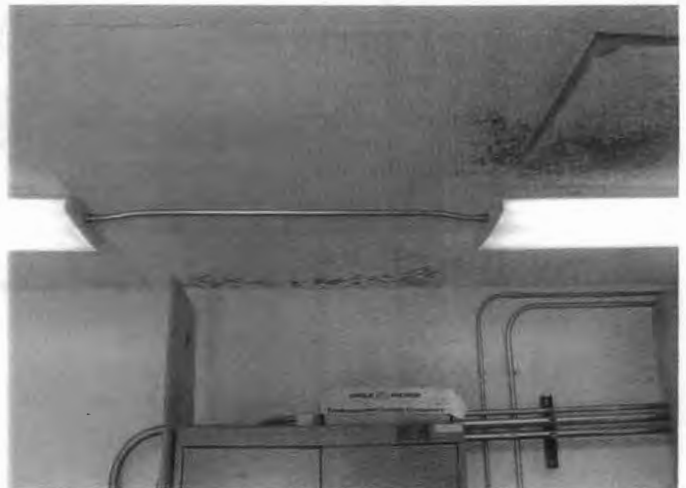
Site 1, Bldg. 315, Mold Growth on Interior Ceiling Components

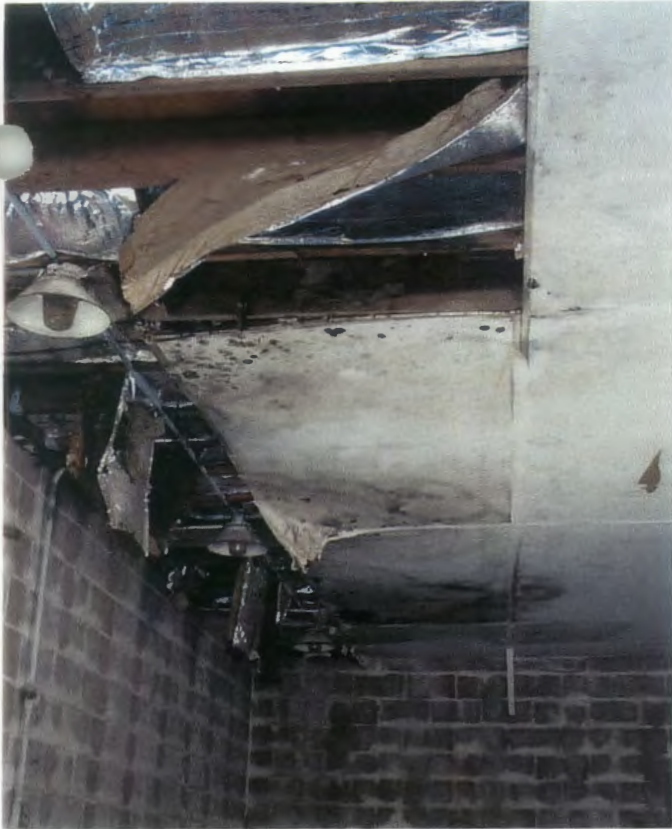
Site 1, Bldg. 312, Mold Growth on Ceiling Components

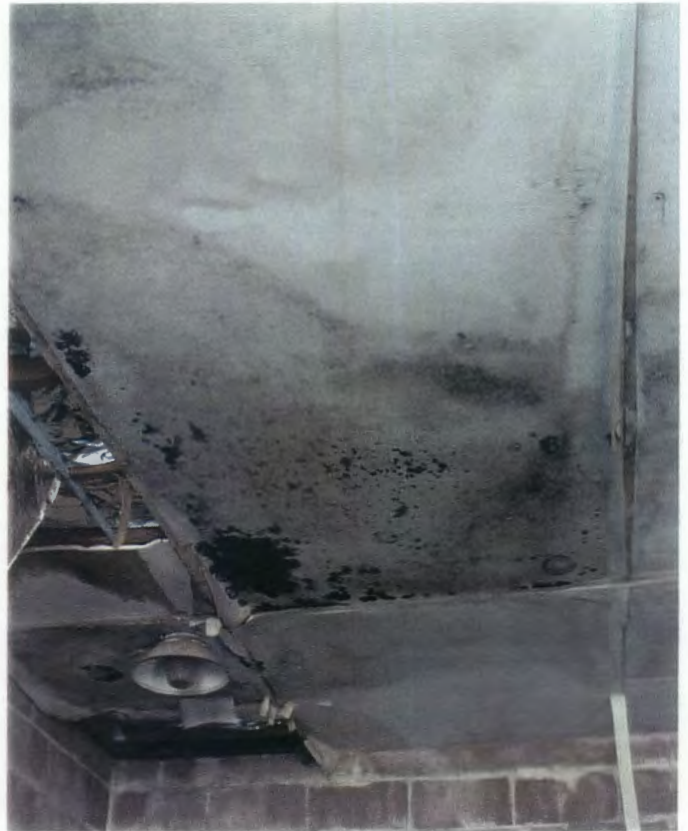
Site 1, Bldg. 312, Mold Growth on Ceiling Components

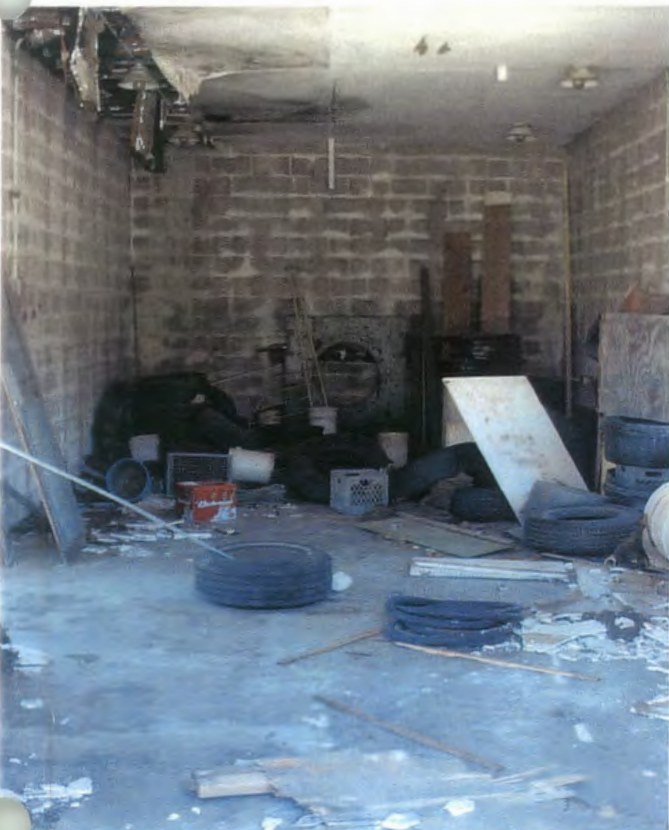
Site 1, Bldg. 312, Mold Growth on Ceiling Components

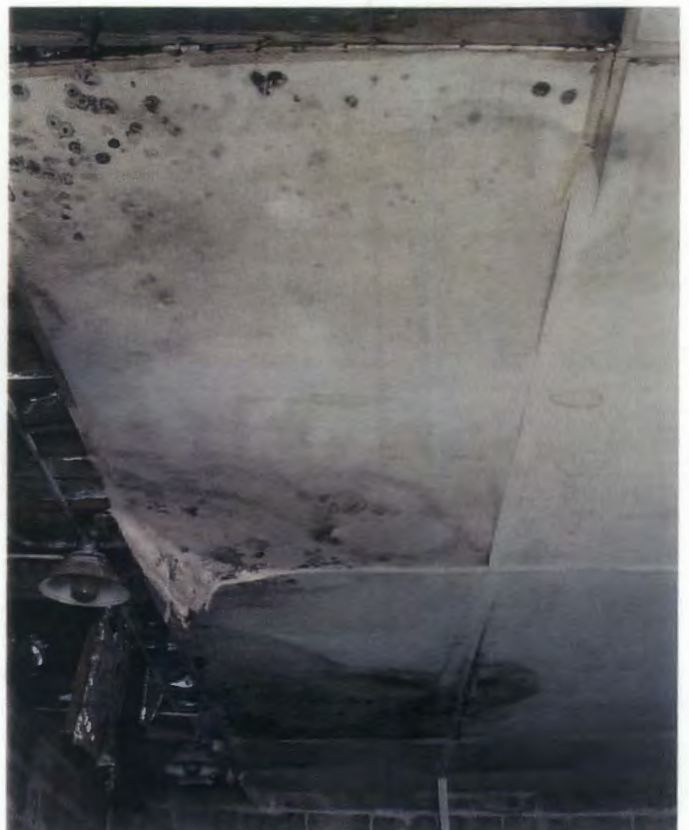
Site 1, Bldg. 312, Mold Growth on Ceiling Components
